**1-15 AND 2-12 CONFERTA AVENUE,
ROUSE HILL NSW 2155
TALLAWONG STATION PRECINCT SOUTH
PRE-DILAPIDATION REPORT**

**DEICORP PROJECTS
(TALLAWONG STATION) PTY LTD**

Job No. 191294.0
24/03/2020

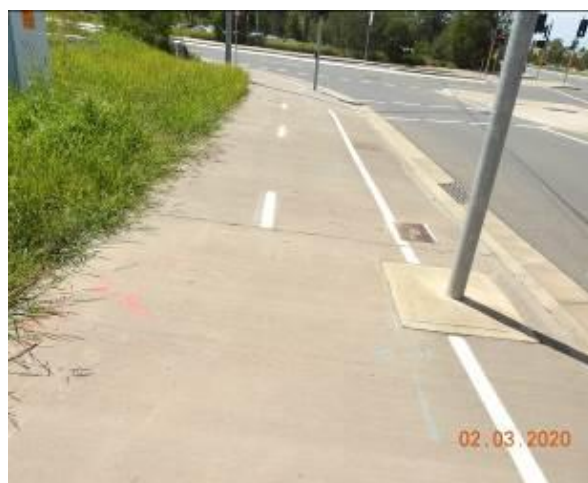
Figure 1436 – General Condition of footpath pavement

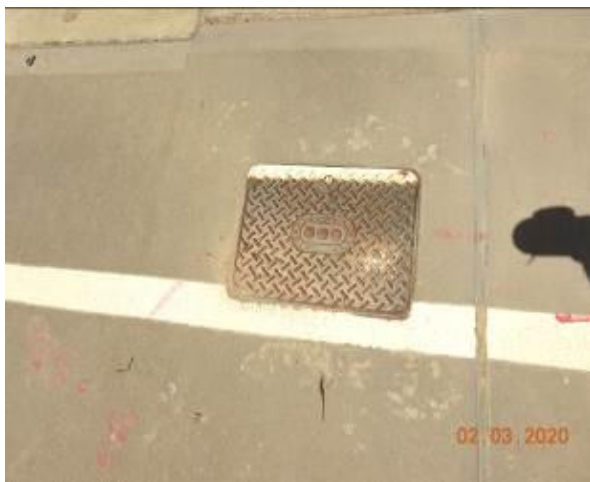
Figure 1437 – General Condition of footpath pavement

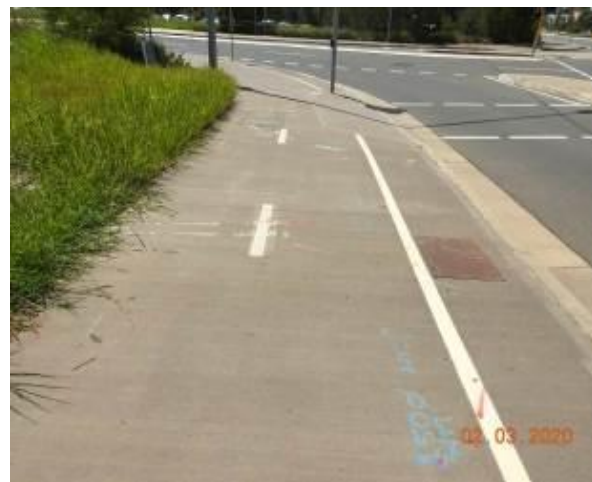
Figure 1438 – General Condition of service pit

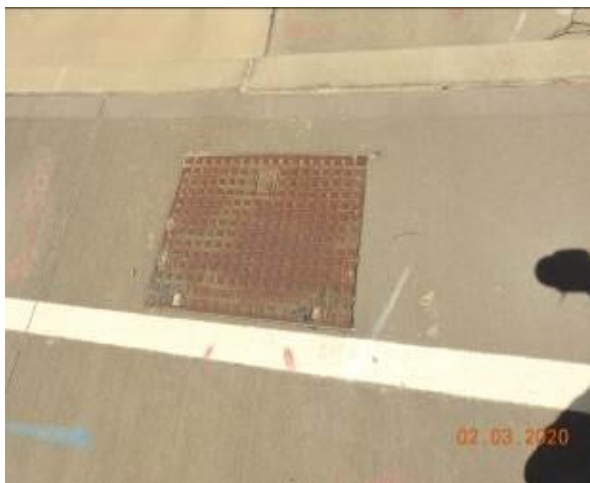
Figure 1439 – General Condition of footpath pavement

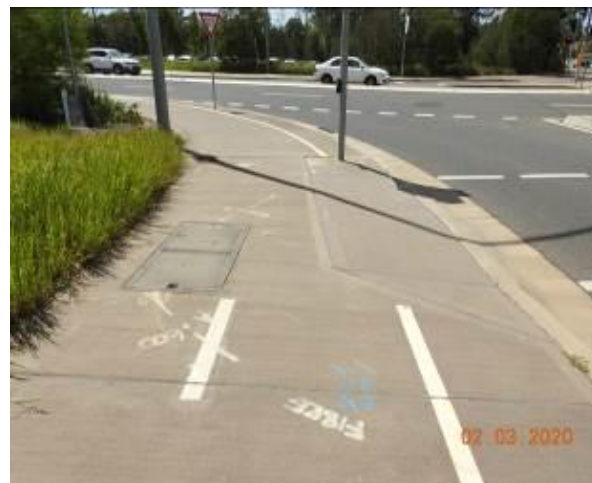
Figure 1440 – General Condition of service pit

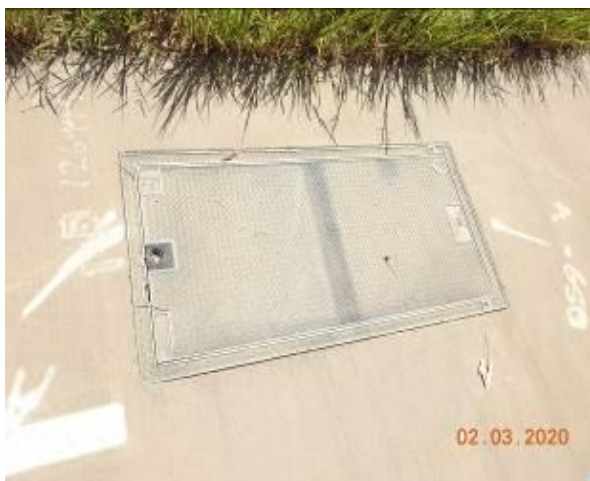
Figure 1441 – General Condition of footpath pavement

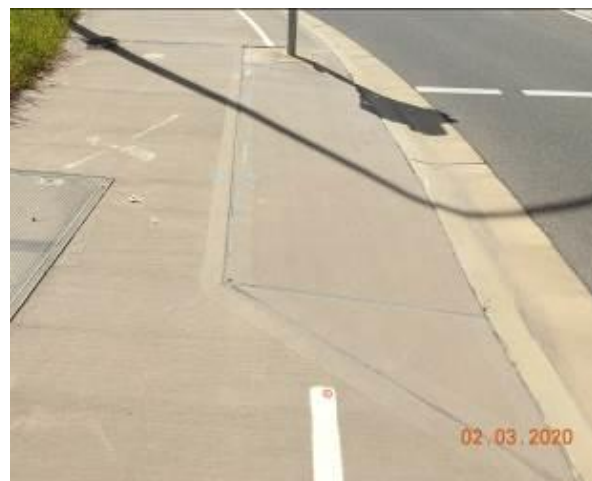
Figure 1442 – General Condition of service pit

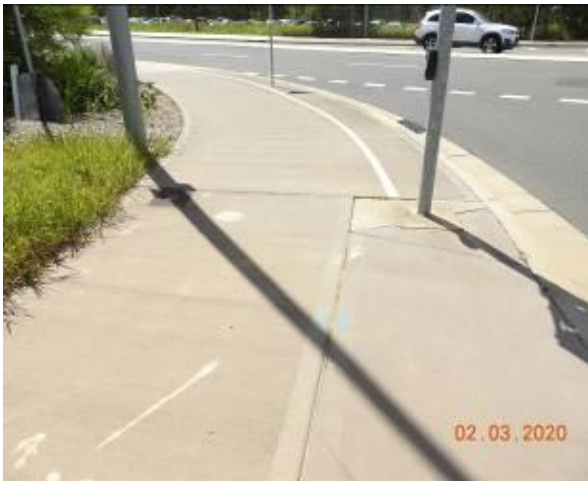
Figure 1443 – General Condition of footpath pavement

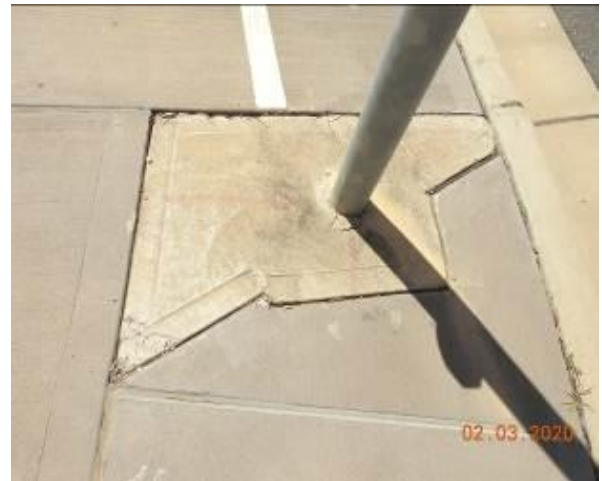
Figure 1444 – General Condition of footpath pavement

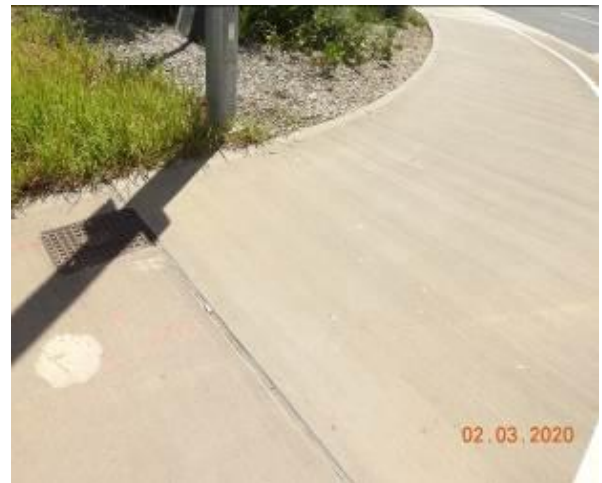
Figure 1446 – Crack propagation through footpath pavement

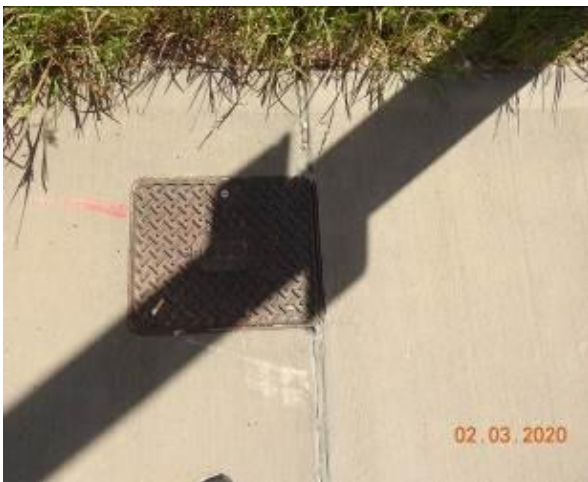
Figure 1447 – General Condition of footpath pavement

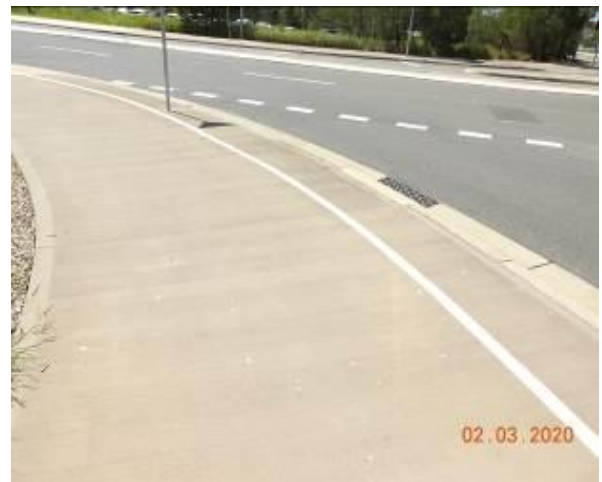
Figure 1448 – General Condition of service pit

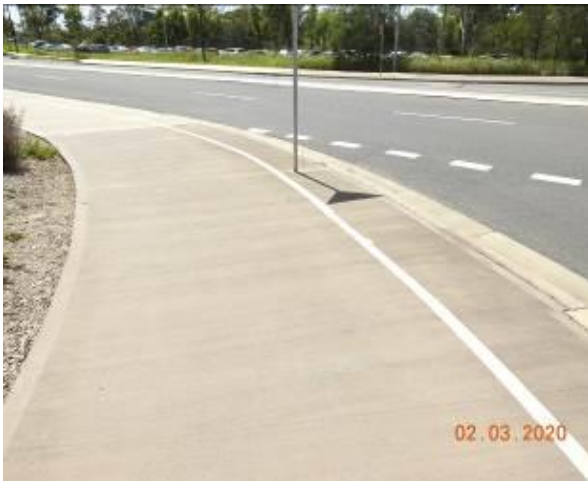
Figure 1449 – General Condition of footpath pavement

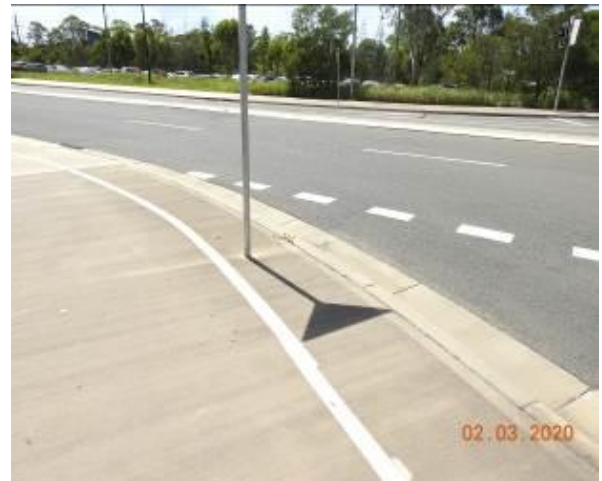
Figure 1450 – General Condition of footpath pavement

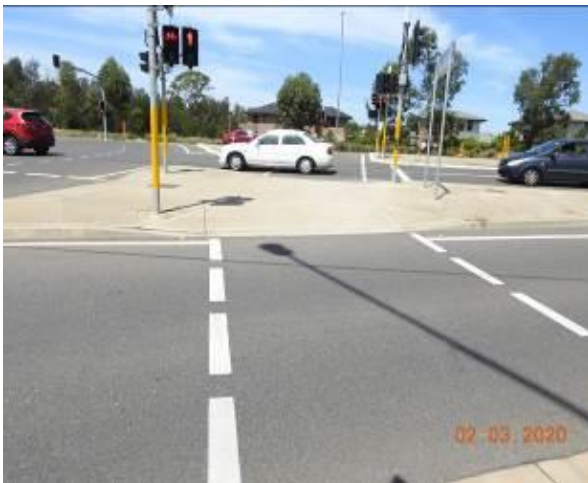
Figure 1451 – General Condition of footpath pavement

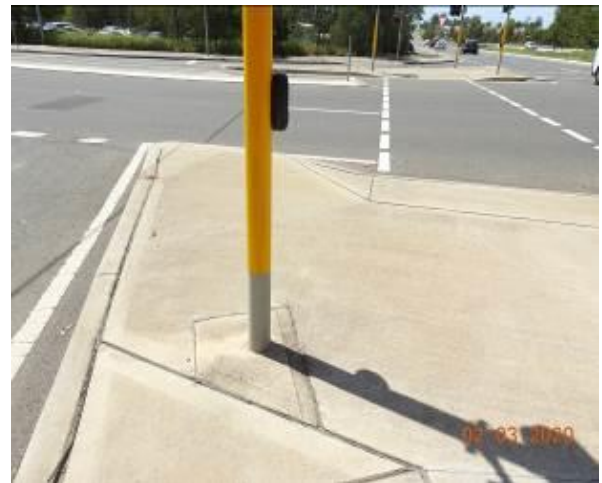
Figure 1452 – General Condition of footpath pavement

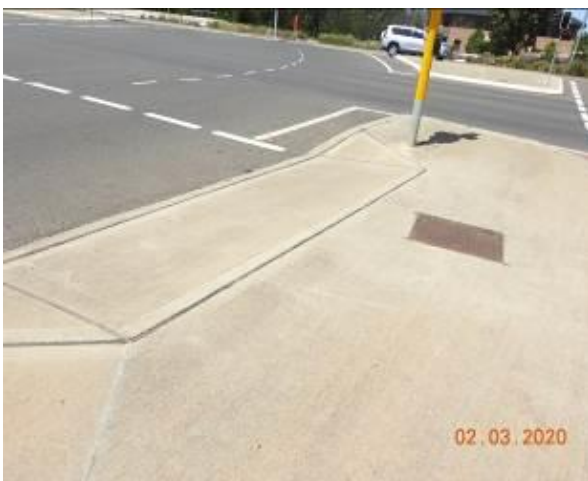
Figure 1453 – General Condition of footpath pavement

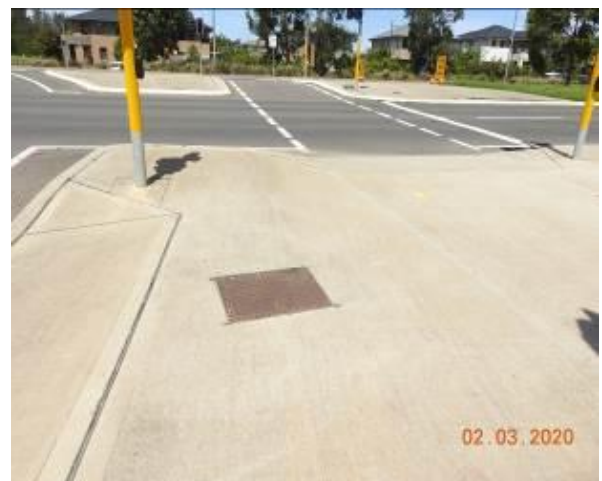
Figure 1454 – General Condition of footpath pavement

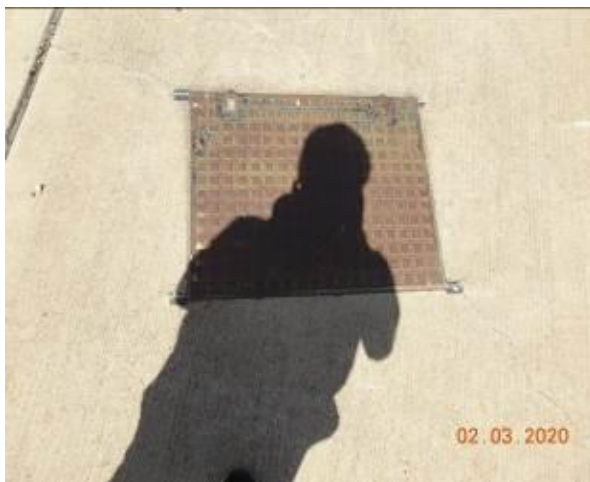
Figure 1455 – General Condition of footpath pavement

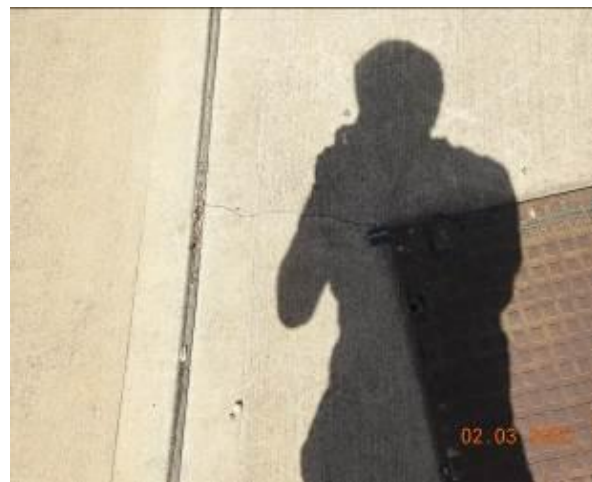
Figure 1456 – Crack propagation through service pit

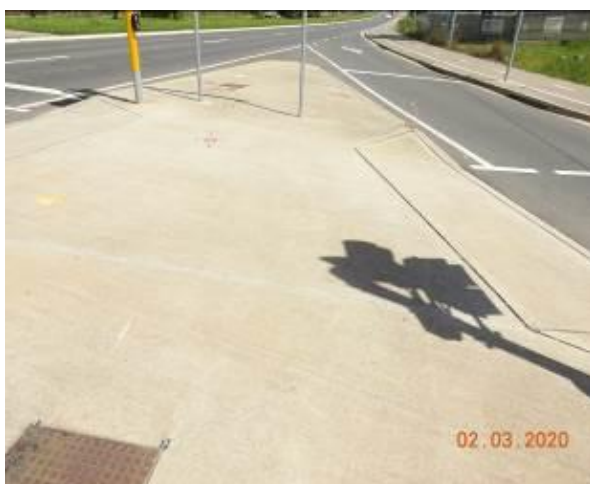
Figure 1457 – Crack propagation through footpath pavement

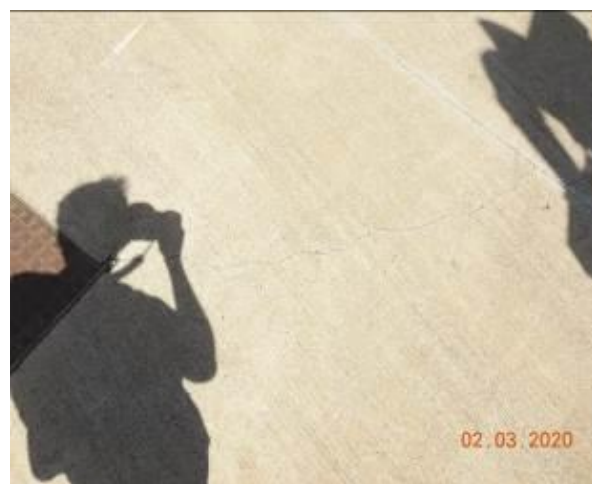
Figure 1458 – General Condition of footpath pavement

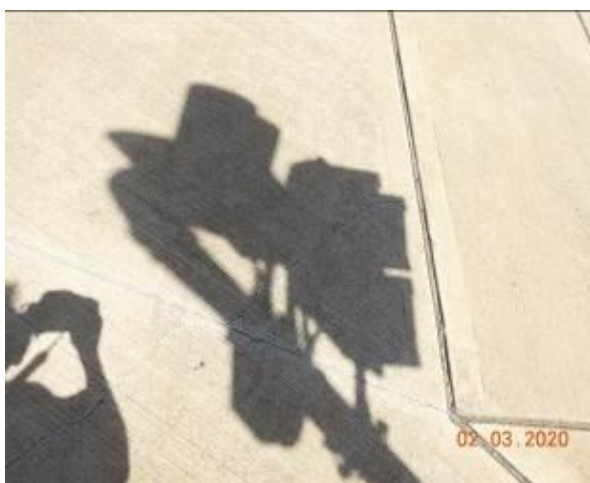
Figure 1459 – Crack propagation through footpath pavement

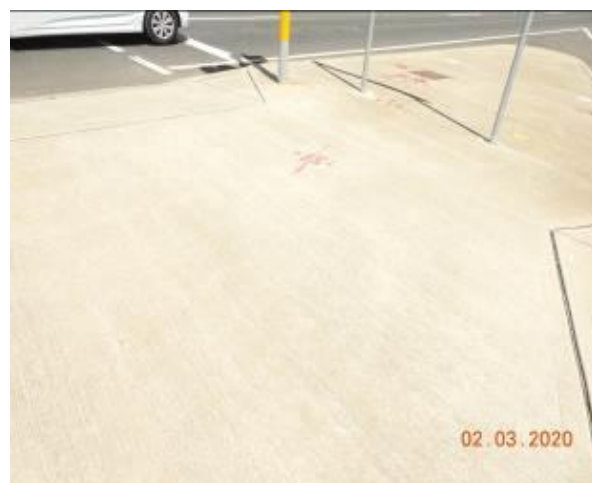
Figure 1460 – Crack propagation through footpath pavement

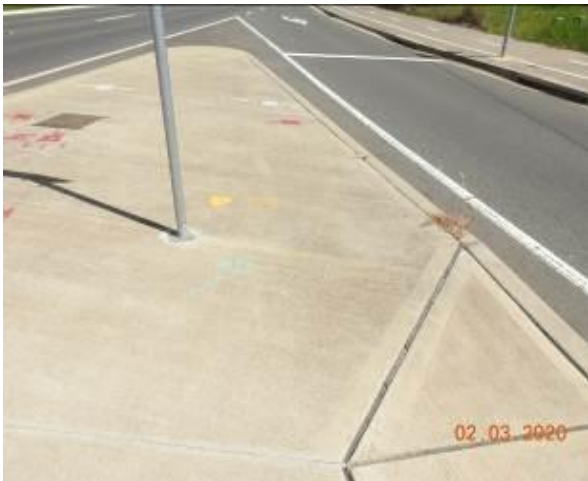
Figure 1461 – General Condition of footpath pavement

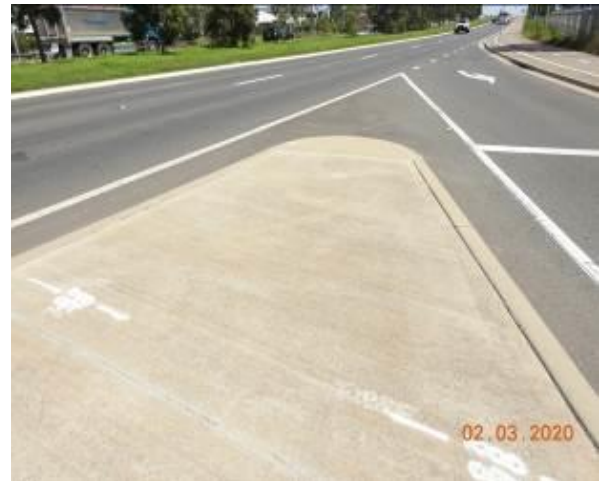
Figure 1462 – General Condition of footpath pavement

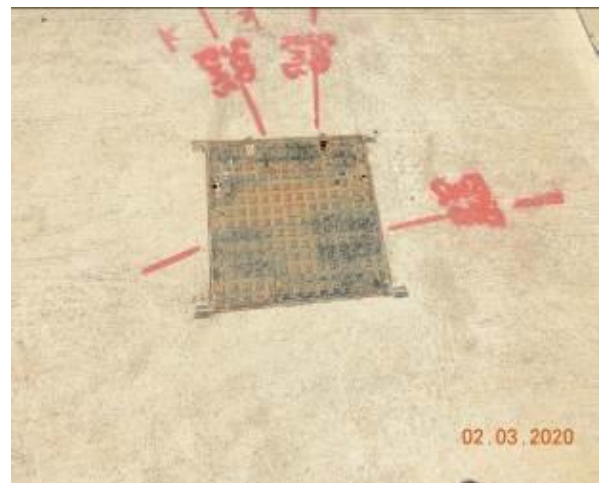
Figure 1464 – General Condition of footpath pavement

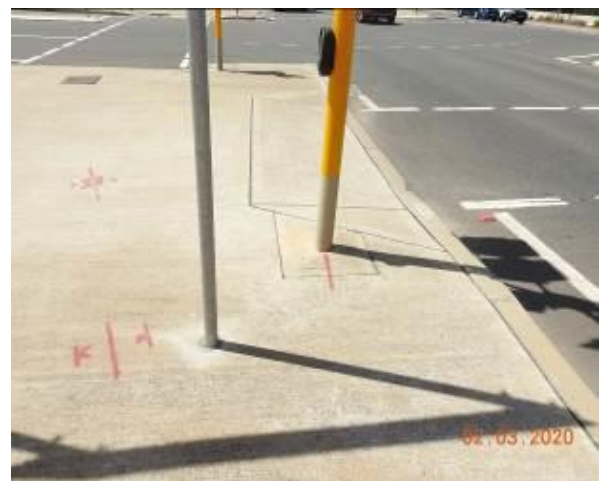
Figure 1466 – Crack propagation through footpath pavement

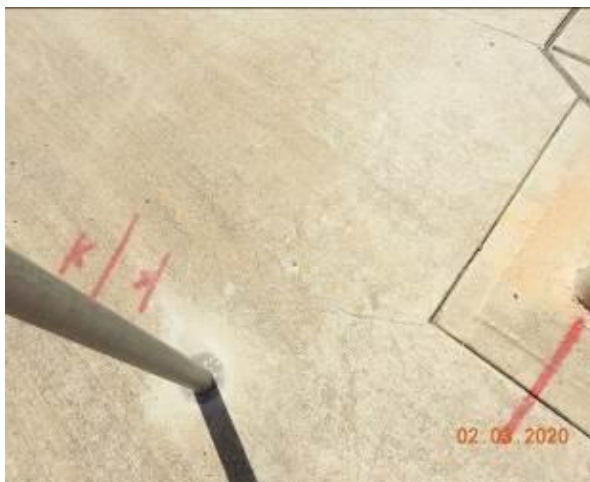
Figure 1467 – General Condition of footpath pavement

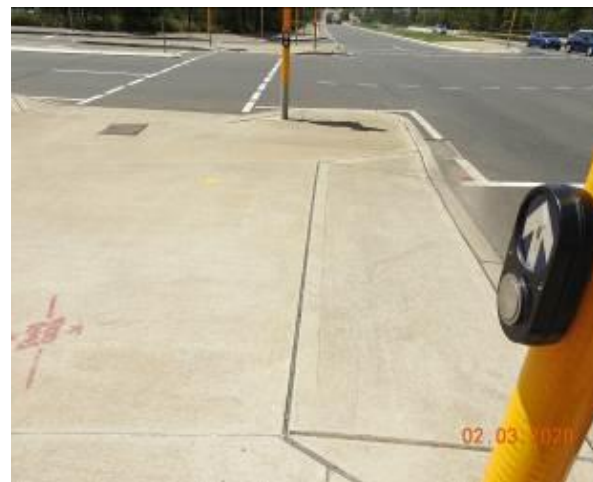
Figure 1468 – Crack propagation through footpath pavement

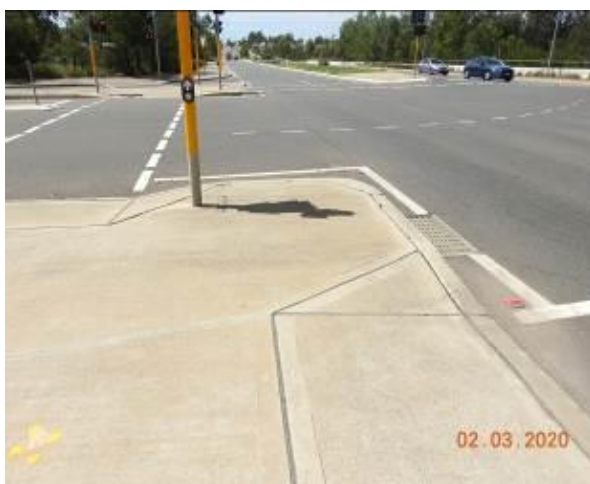
Figure 1469 – General Condition of footpath pavement

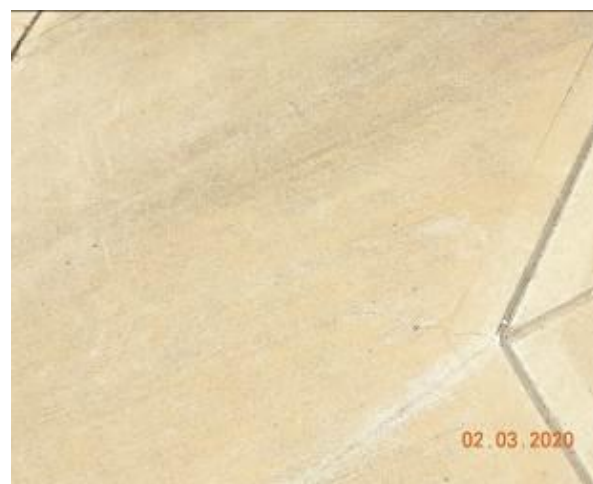
Figure 1470 – General Condition of footpath pavement

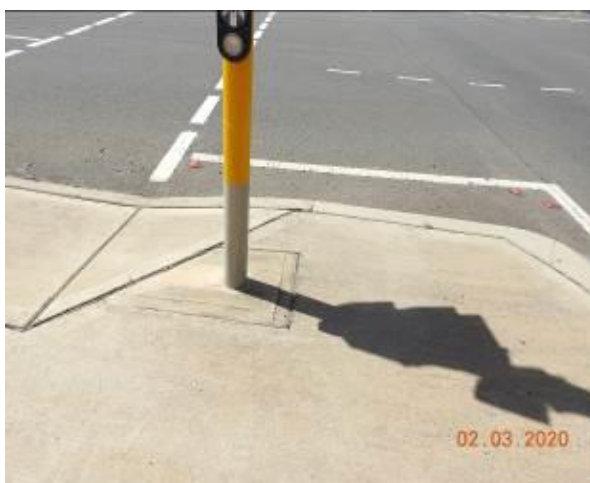
Figure 1471 – Crack propagation through footpath pavement

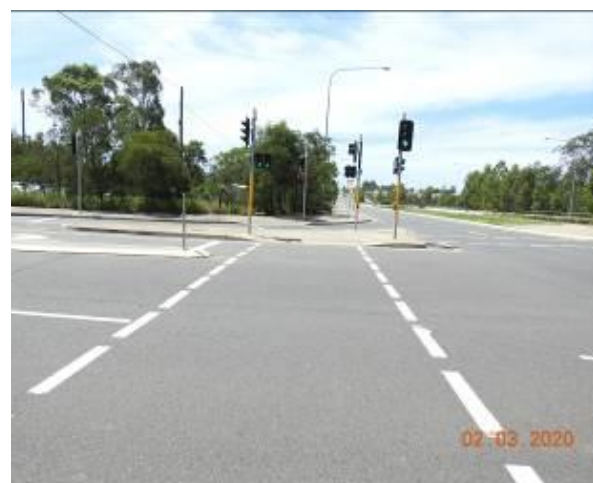
Figure 1472 – General Condition of footpath pavement

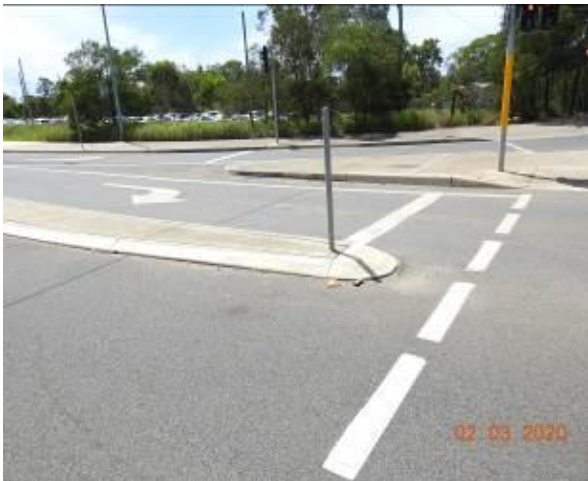
Figure 1473 – General Condition of road surface

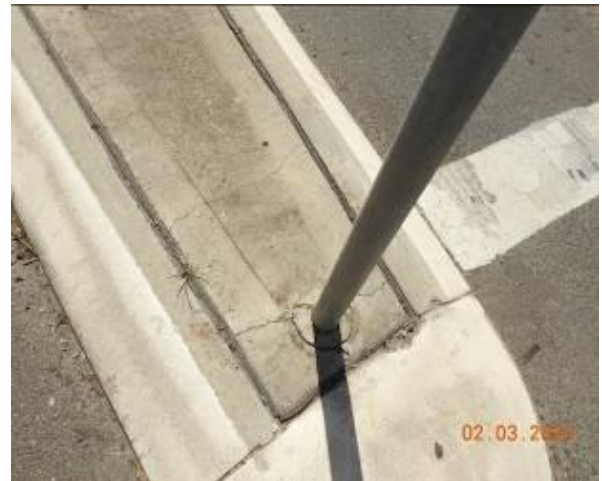
Figure 1474 – General Condition of traffic island

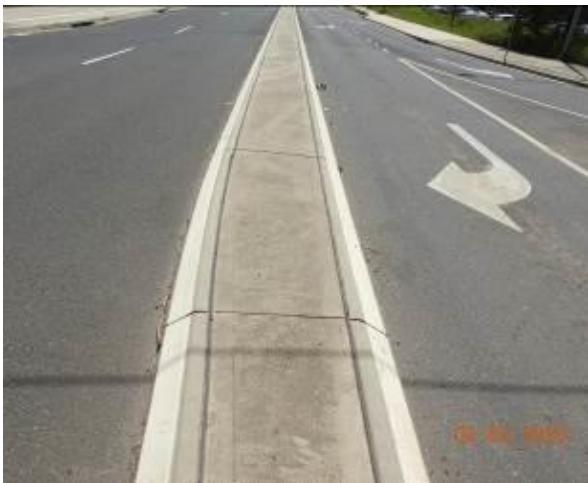
Figure 1475 – Crack propagation through traffic island footpath pavement

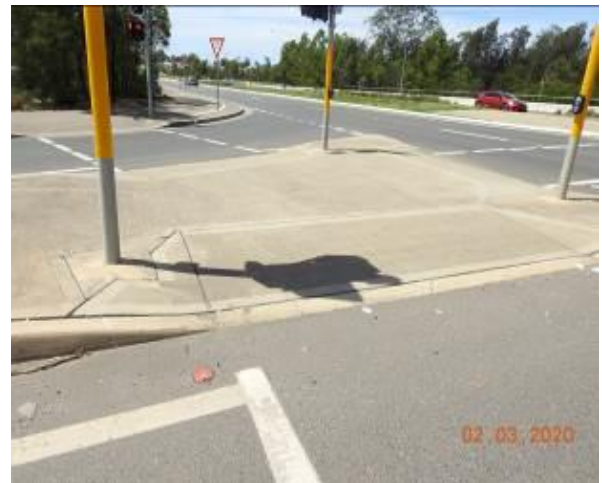
Figure 1476 – General Condition of traffic island

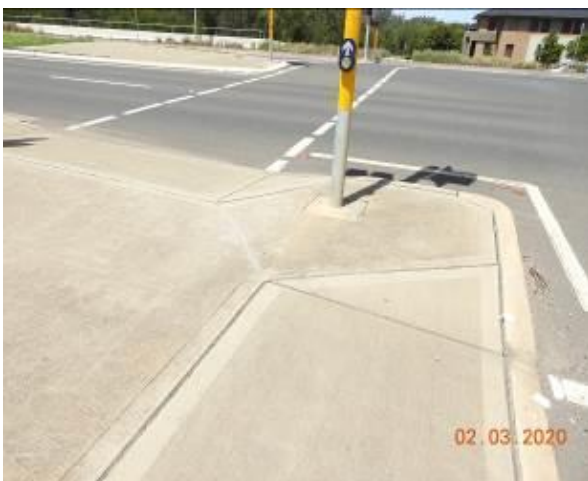
Figure 1477 – General Condition of footpath pavement

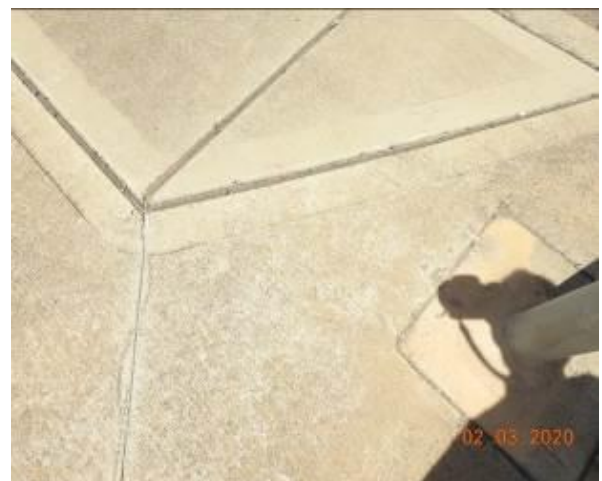
Figure 1478 – General Condition of footpath pavement

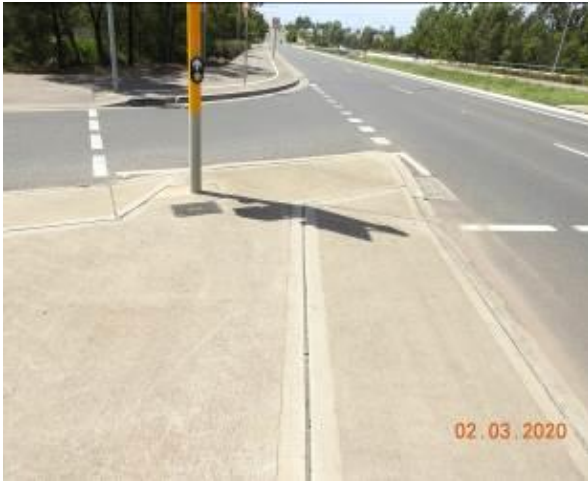
Figure 1479 – Crack propagation through footpath pavement

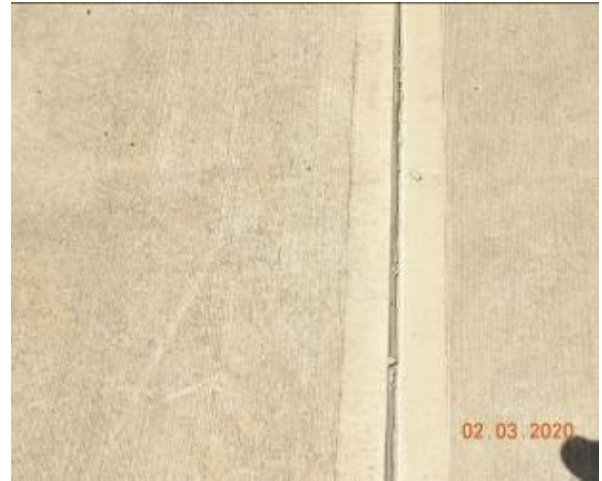
Figure 1480 – General Condition of footpath pavement

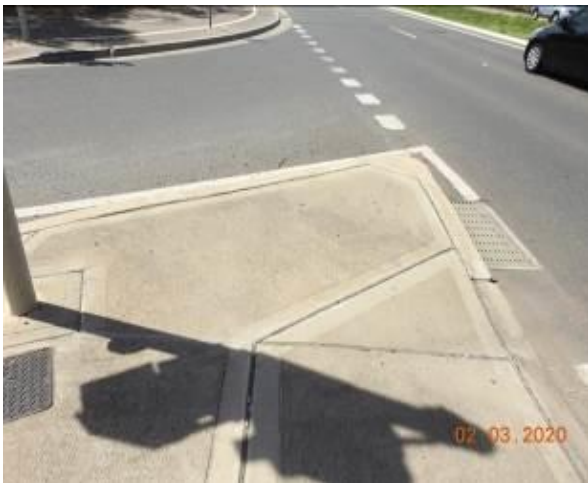
Figure 1481 – General Condition of footpath pavement

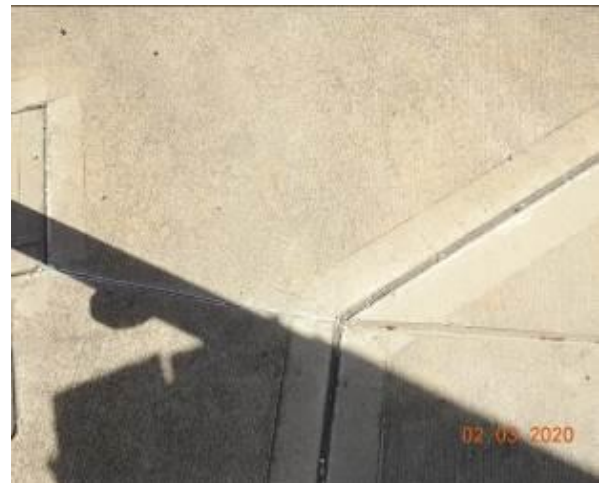
Figure 1482 – General Condition of footpath pavement

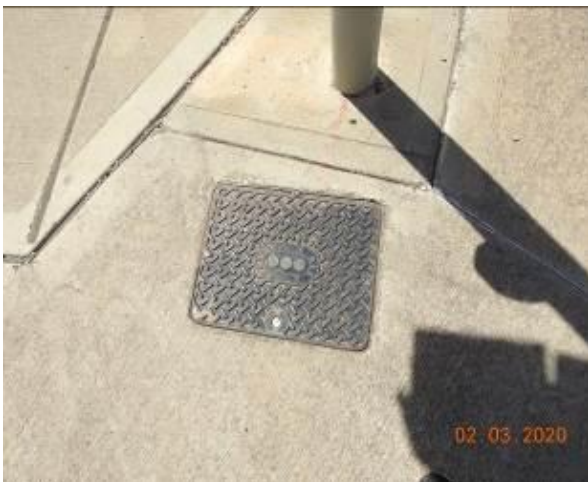
Figure 1483 – Crack propagation through footpath pavement

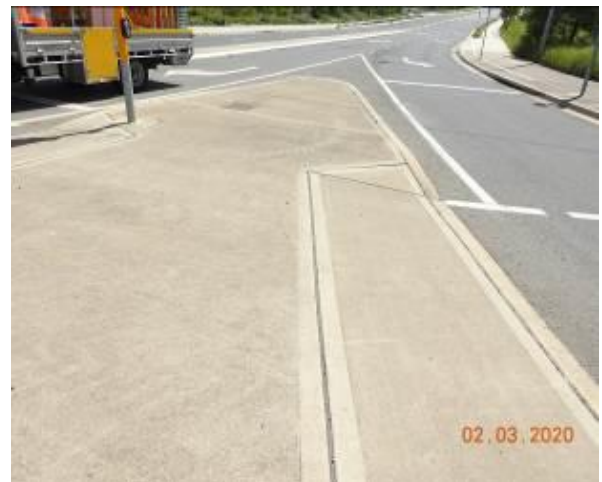
Figure 1484 – General Condition of service pit

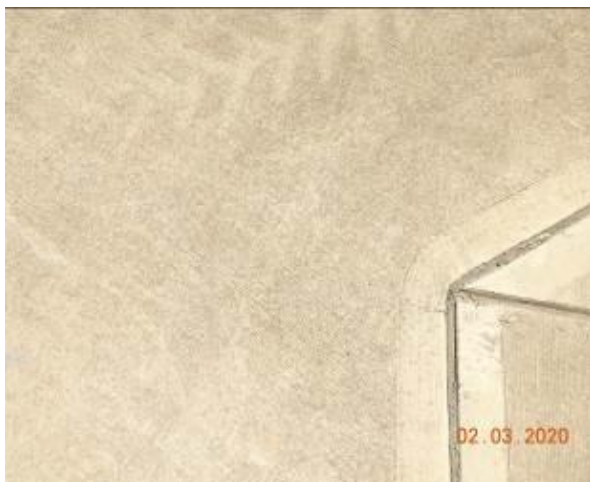
Figure 1485 – General Condition of footpath pavement

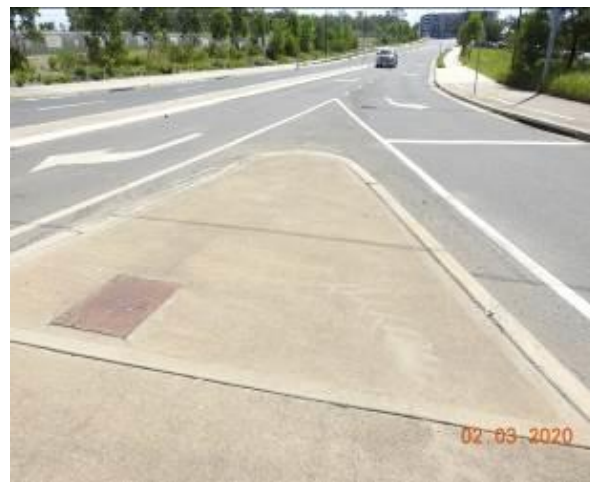
Figure 1486 – Crack propagation through footpath pavement

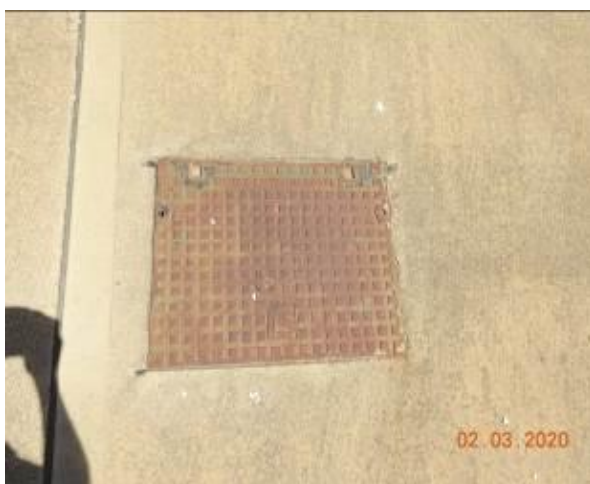
Figure 1487 – General Condition of footpath pavement

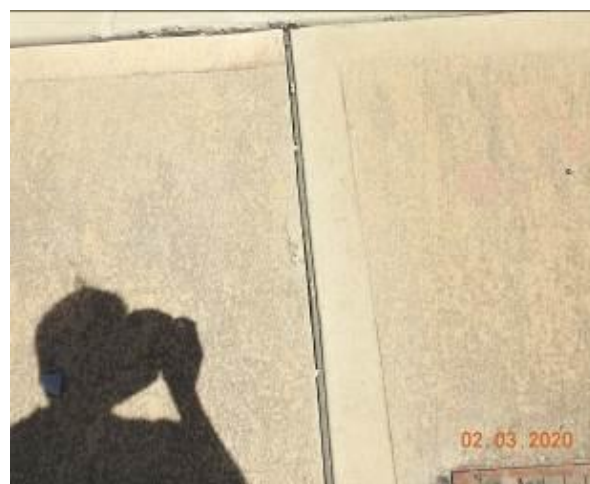
Figure 1488 – General Condition of service pit

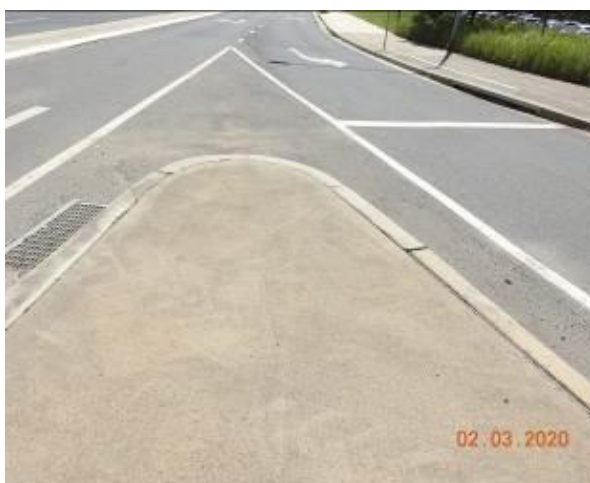
Figure 1489 – Crack propagation through footpath pavement

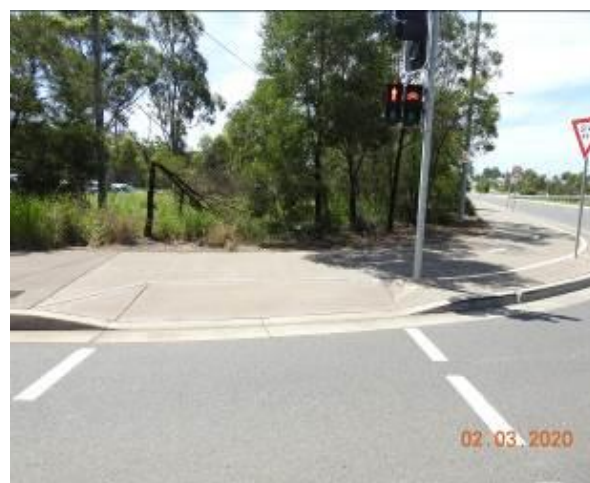
Figure 1490 – General Condition of footpath pavement

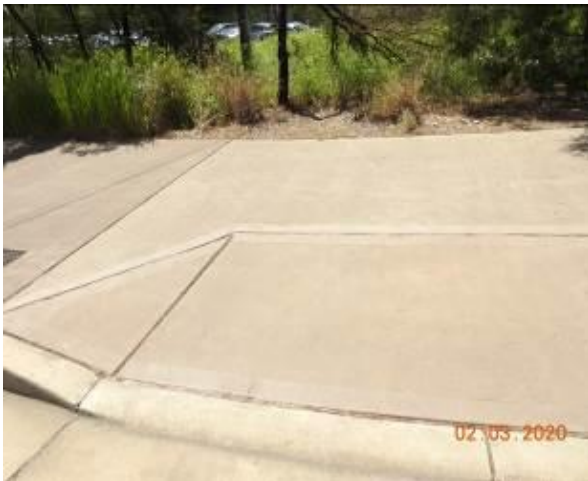
Figure 1491 – General Condition of footpath pavement

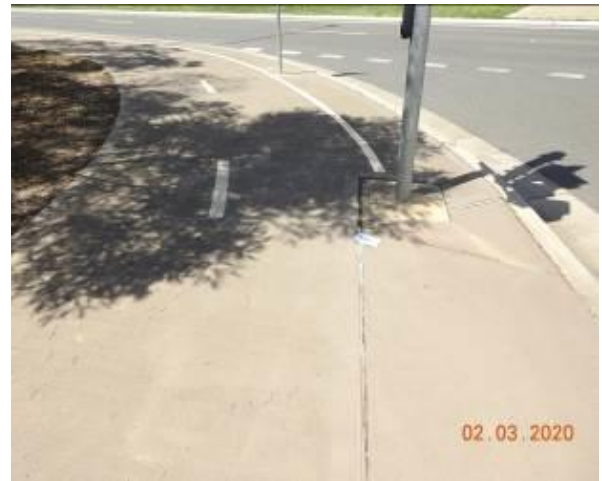
Figure 1492 – General Condition of footpath pavement

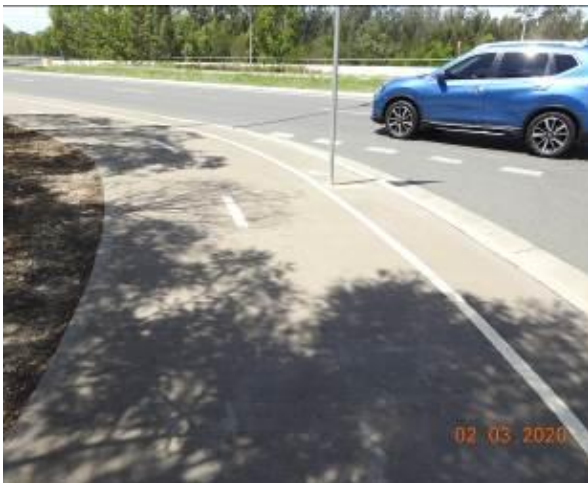
Figure 1493 – General Condition of footpath pavement

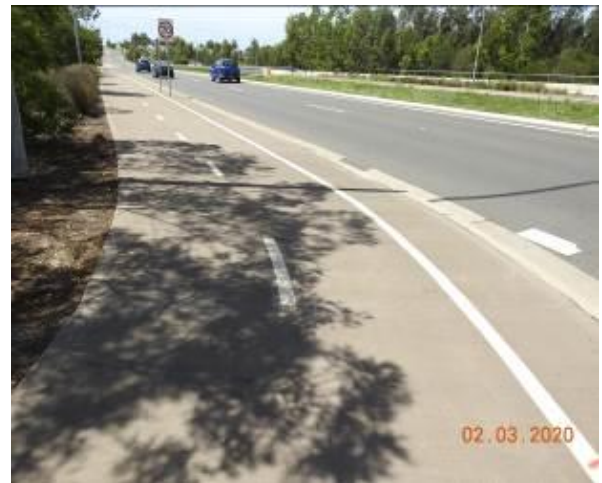
Figure 1494 – General Condition of footpath pavement

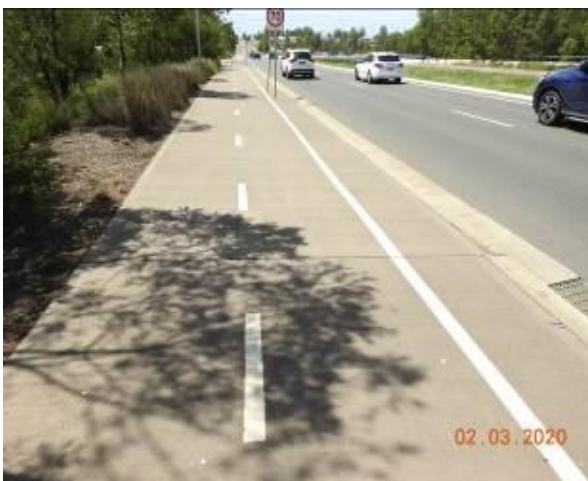
Figure 1495 – General Condition of footpath pavement

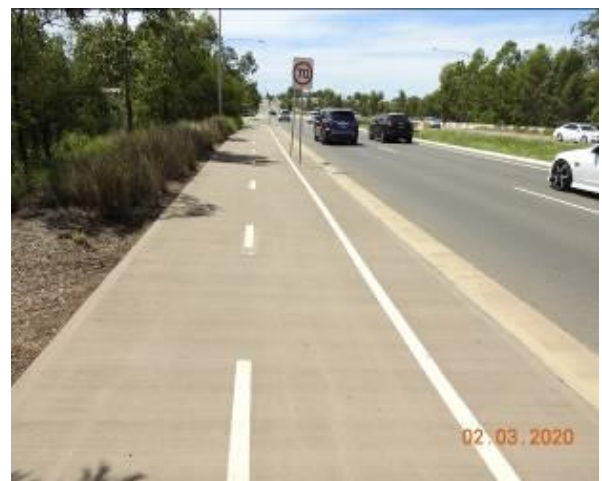
Figure 1496 – General Condition of footpath pavement

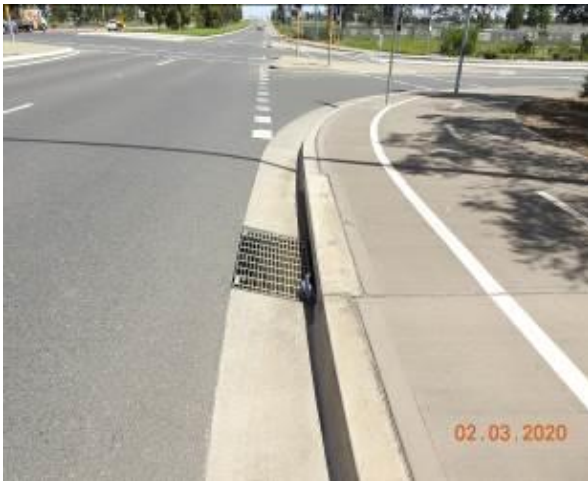
Figure 1497 – General Condition of footpath pavement

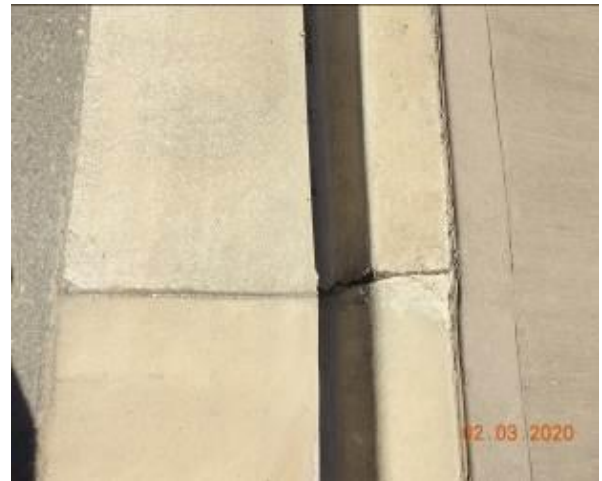
Figure 1498 – General Condition of kerb and gutter

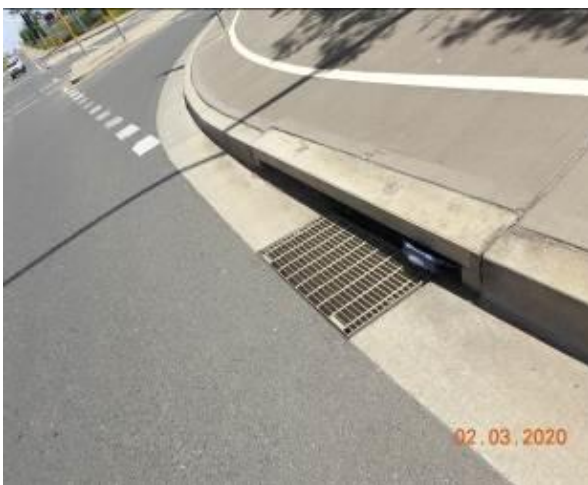
Figure 1499 – Crack propagation through kerb

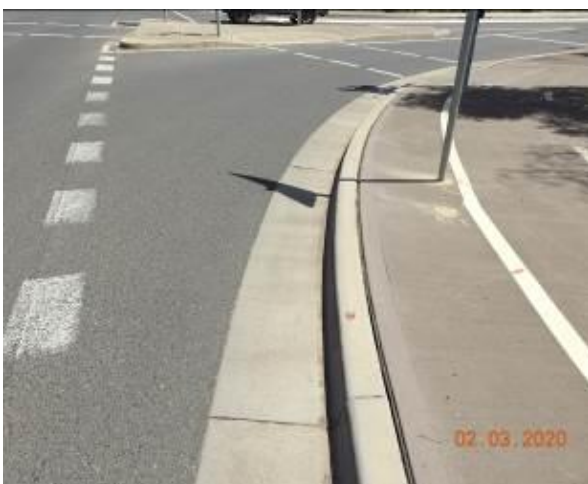
Figure 1501 – General Condition of kerb and gutter

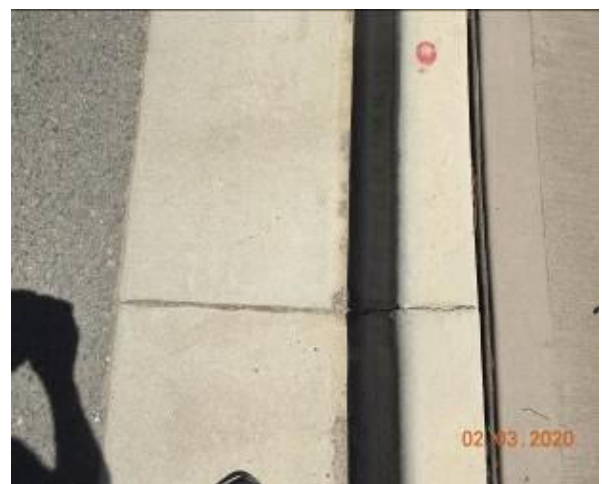
Figure 1502 – General Condition of kerb and gutter

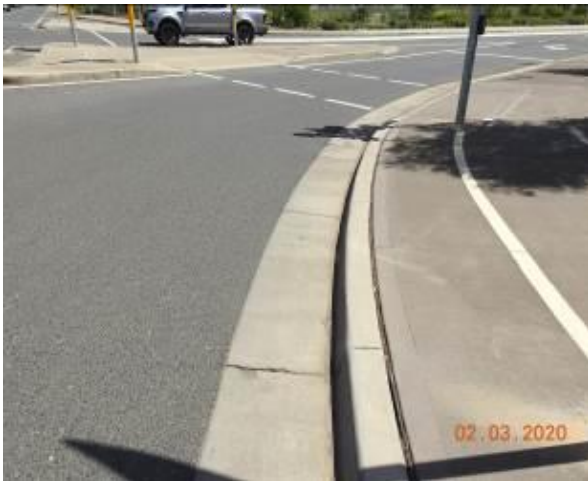
Figure 1503 – Crack propagation through kerb

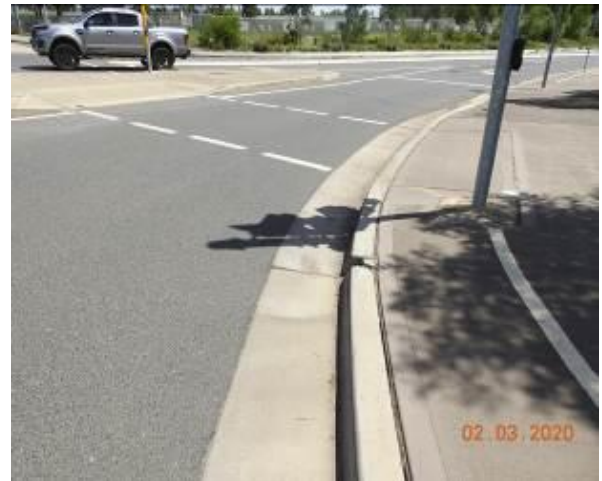
Figure 1504 – General Condition of kerb and gutter

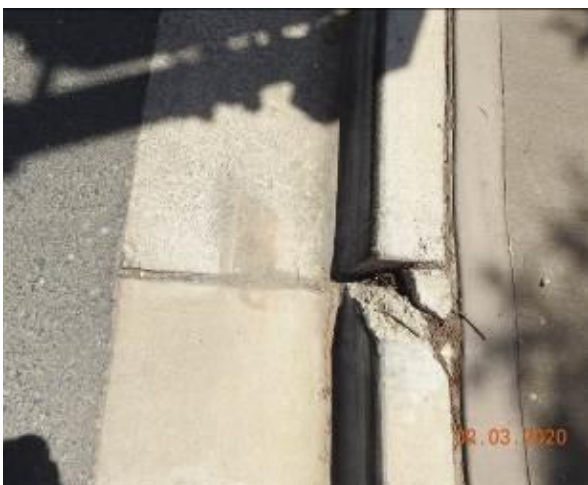
Figure 1505 – General Condition of kerb and gutter

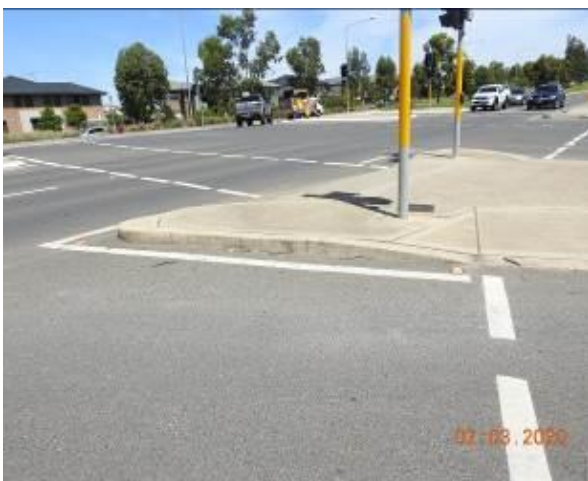
Figure 1507 – General Condition of kerb and gutter

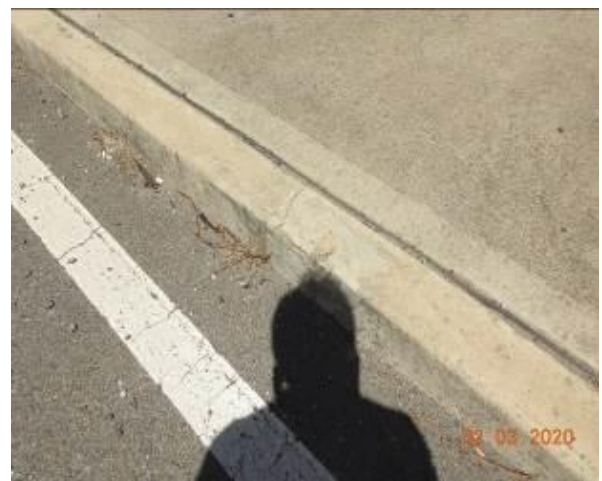
Figure 1508 – General Condition of kerb

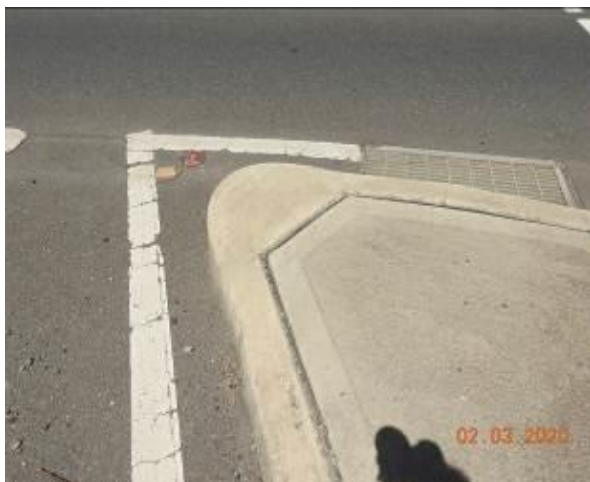
Figure 1509 – Crack propagation through kerb

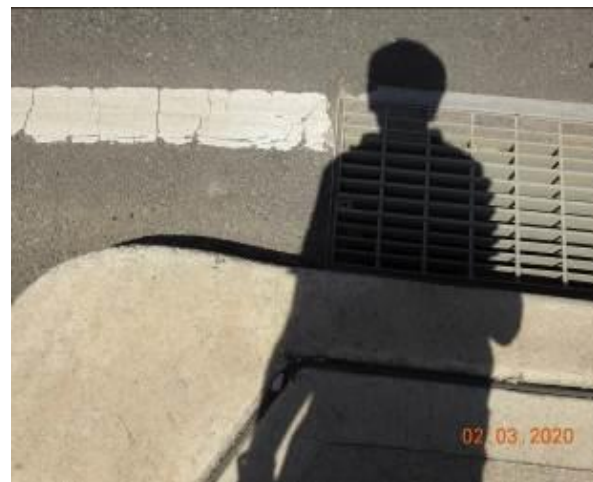
Figure 1510 – General Condition of kerb

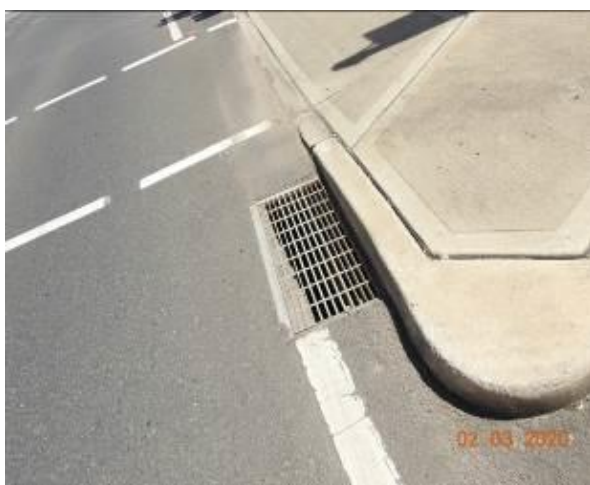
Figure 1511 – Crack propagation through kerb

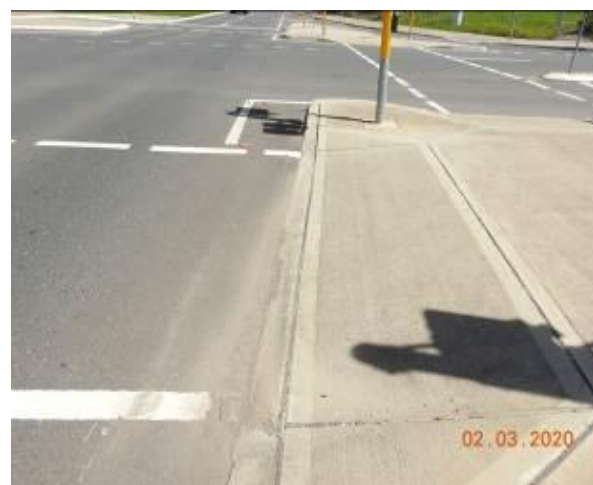
Figure 1512 – General Condition of stormwater inlet pit

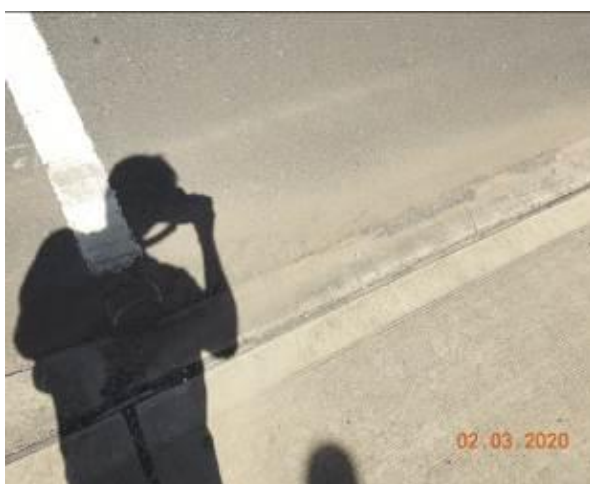
Figure 1513 – General Condition of layback

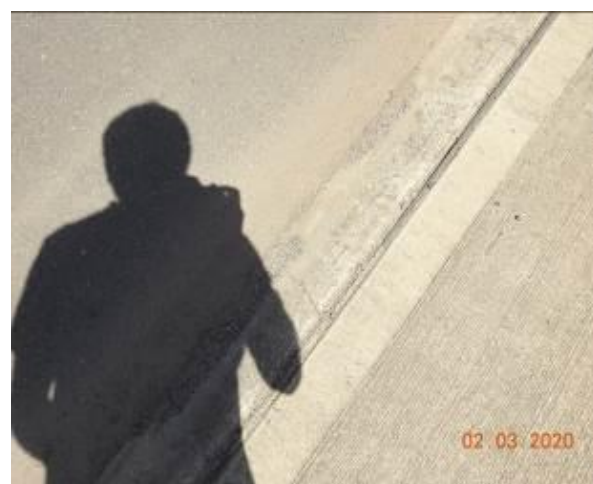
Figure 1514 – Crack propagation through layback

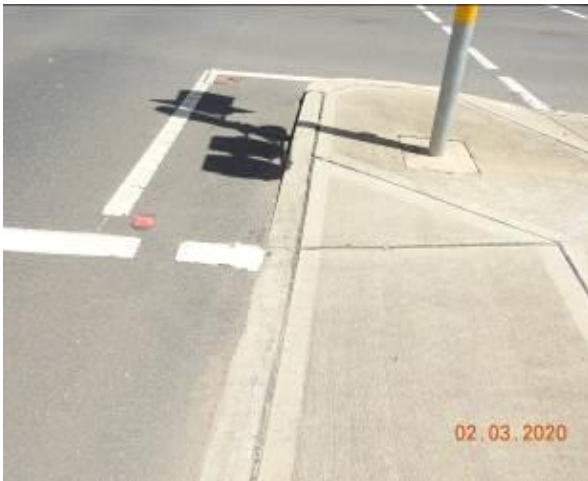
Figure 1515 – Crack propagation through layback

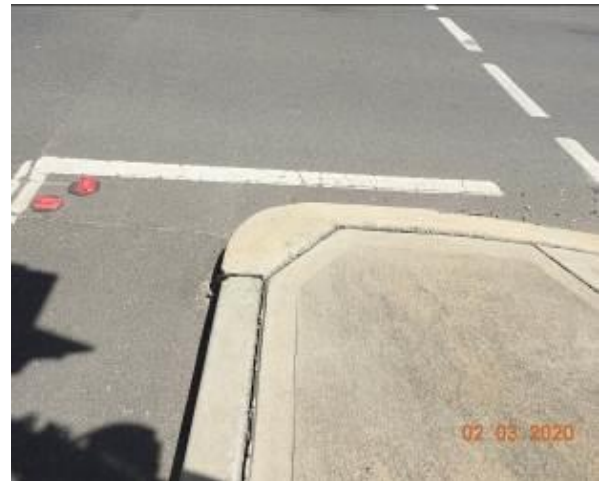
Figure 1516 – General Condition of layback

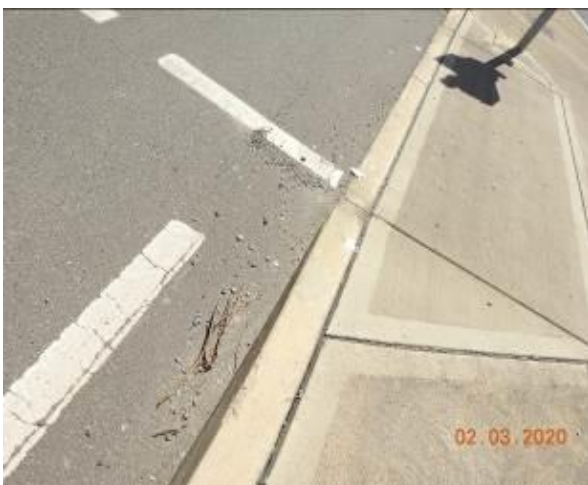
Figure 1517 – General Condition of kerb
