**1-15 AND 2-12 CONFERTA AVENUE,
ROUSE HILL NSW 2155
TALLAWONG STATION PRECINCT SOUTH
PRE-DILAPIDATION REPORT**

**DEICORP PROJECTS
(TALLAWONG STATION) PTY LTD**

Job No. 191294.0
24/03/2020

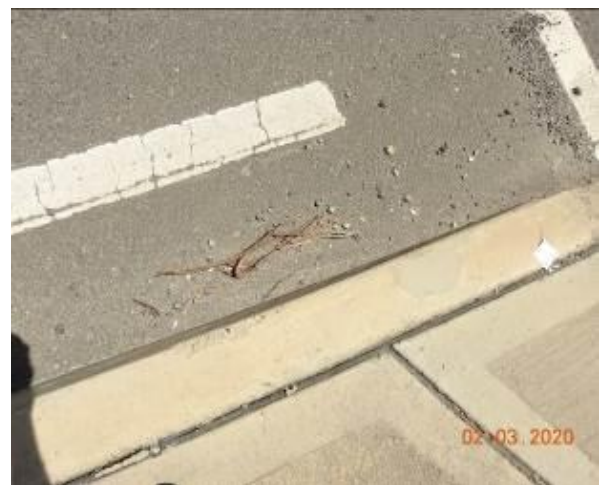
Figure 1518 – General Condition of kerb

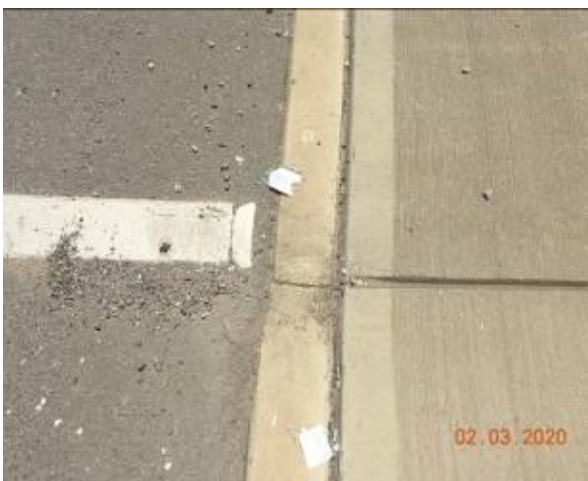
Figure 1519 – General Condition of kerb

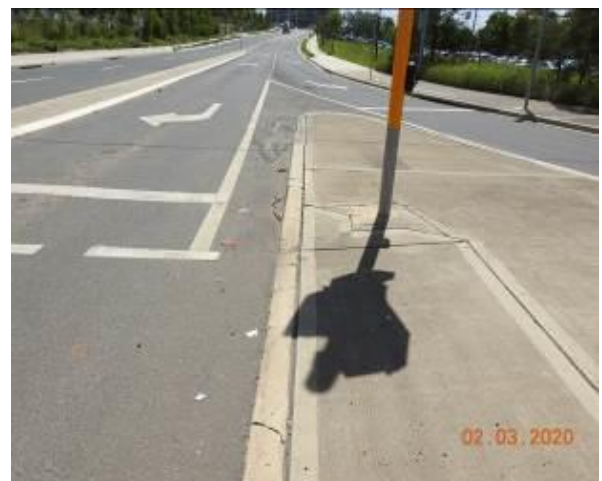
Figure 1520 – Crack propagation through layback

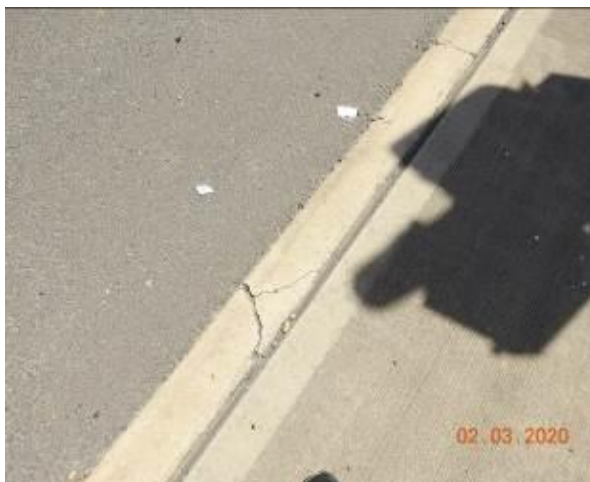
Figure 1521 – General Condition of layback

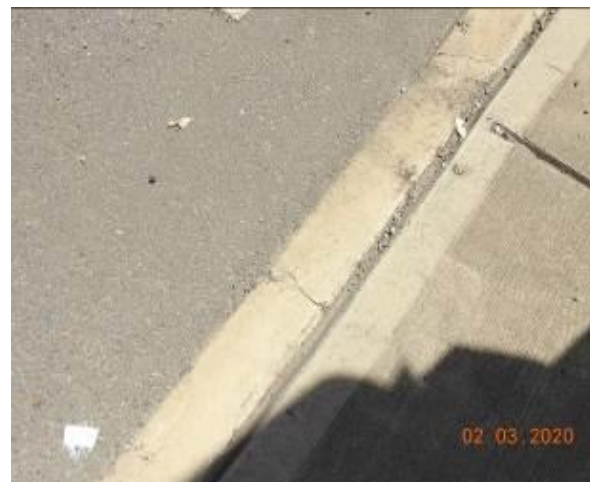
Figure 1522 – Crack propagation and loss of material through layback

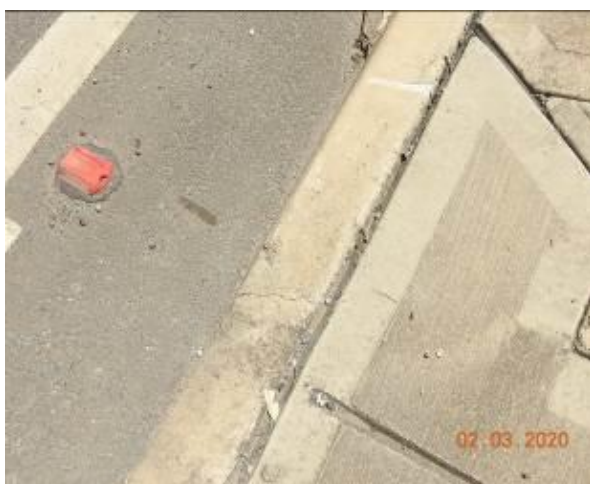
Figure 1523 – Crack propagation through layback

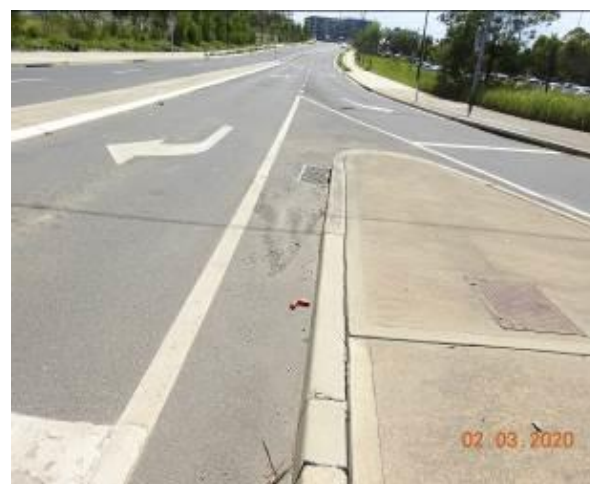
Figure 1524 – Crack propagation through layback

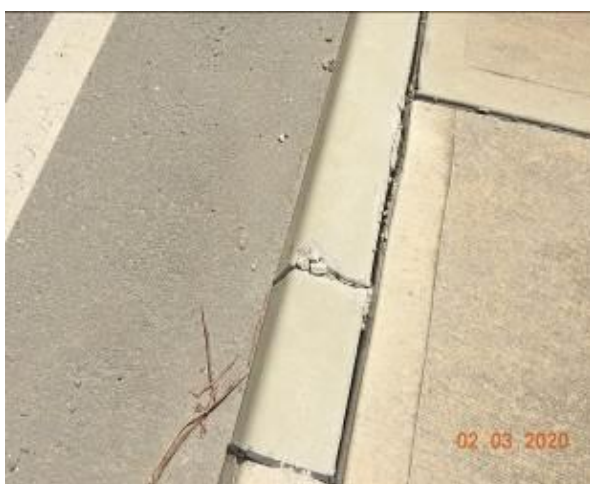
Figure 1525 – General Condition of kerb

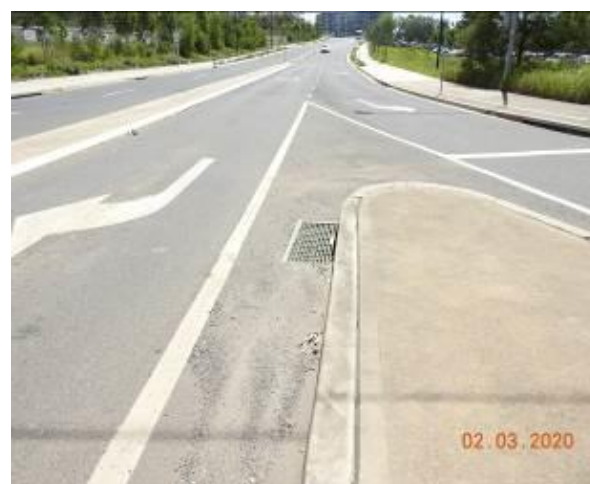
Figure 1526 – Crack propagation and loss of material through kerb

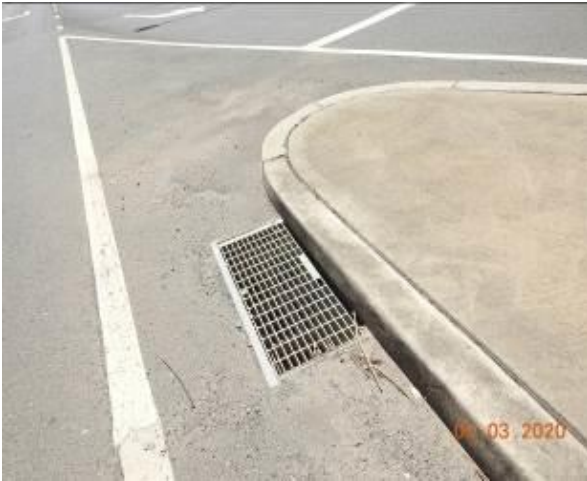
Figure 1527 – General Condition of kerb

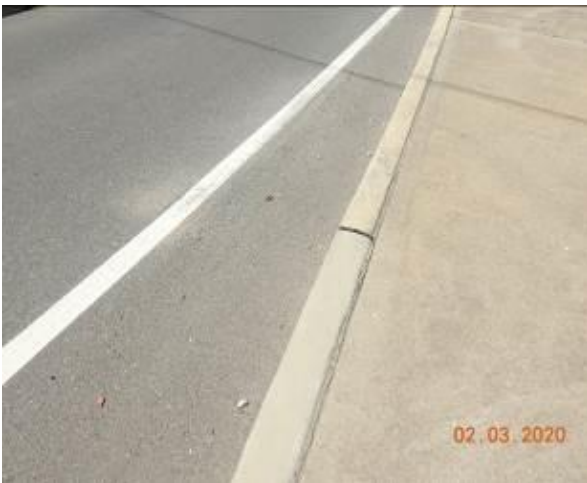
Figure 1529 – Loss of material through kerb

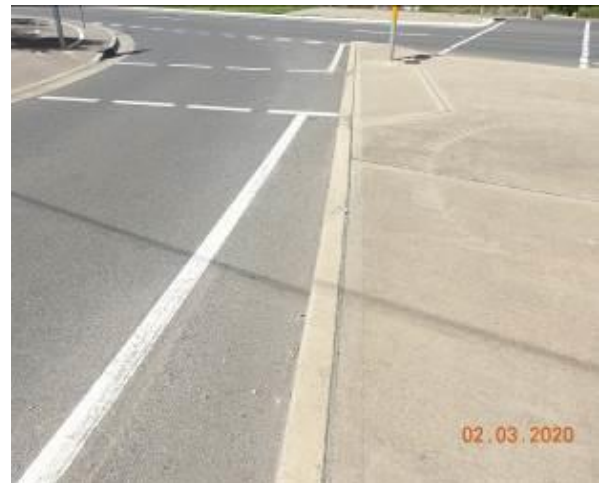
Figure 1530 – General Condition of kerb

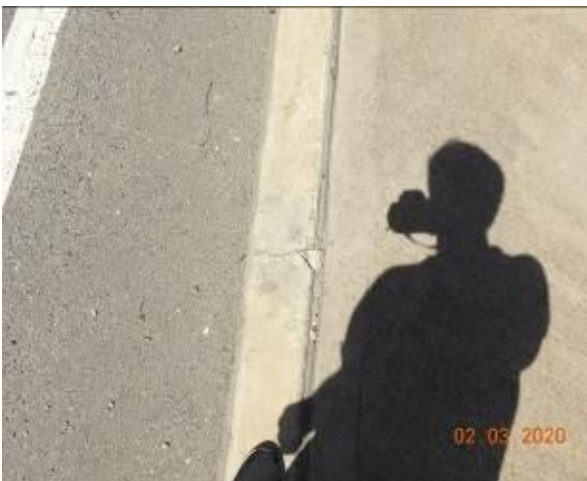
Figure 1531 – General Condition of kerb

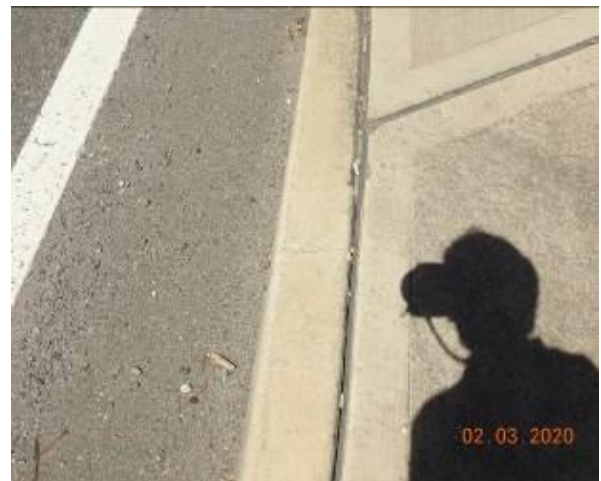
Figure 1532 – Crack propagation and loss of material through kerb

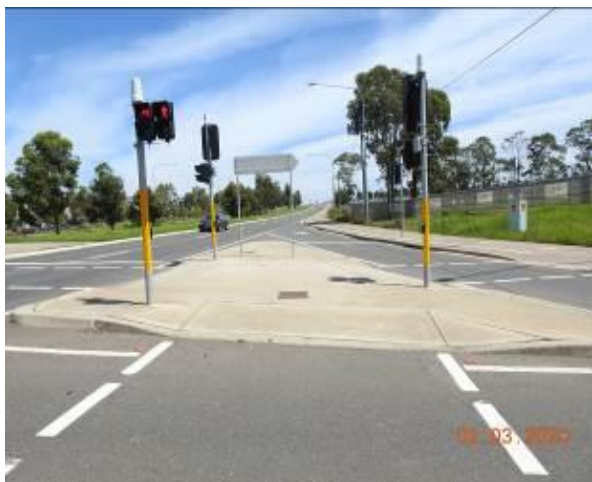
Figure 1533 – Crack propagation through kerb

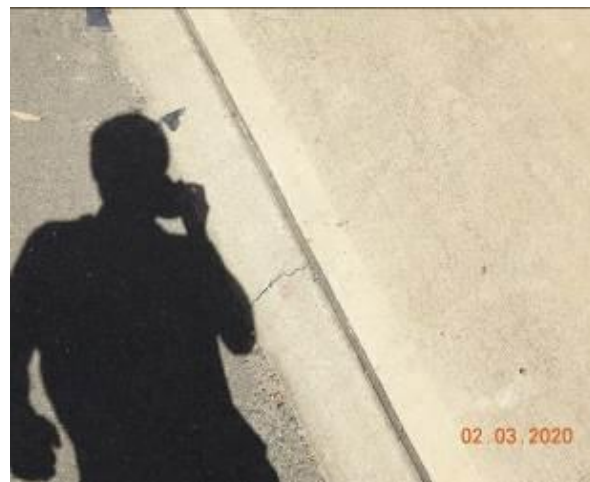
Figure 1534 – General Condition of traffic island

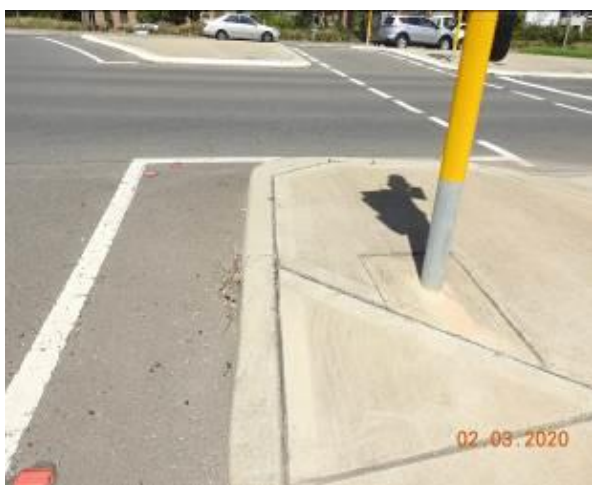
Figure 1535 – Crack propagation through kerb

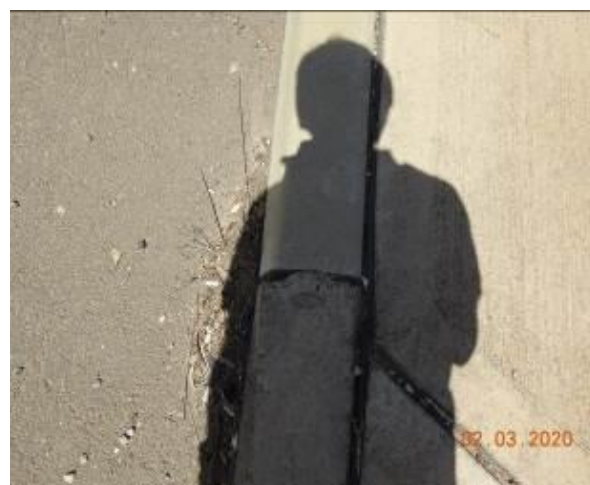
Figure 1536 – General Condition of kerb

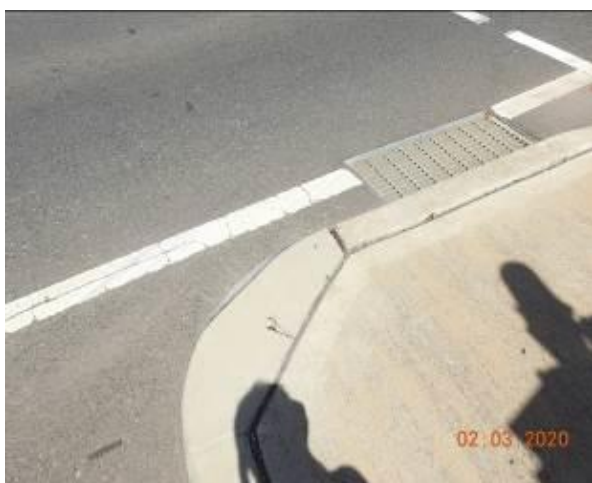
Figure 1537 – Loss of material through kerb

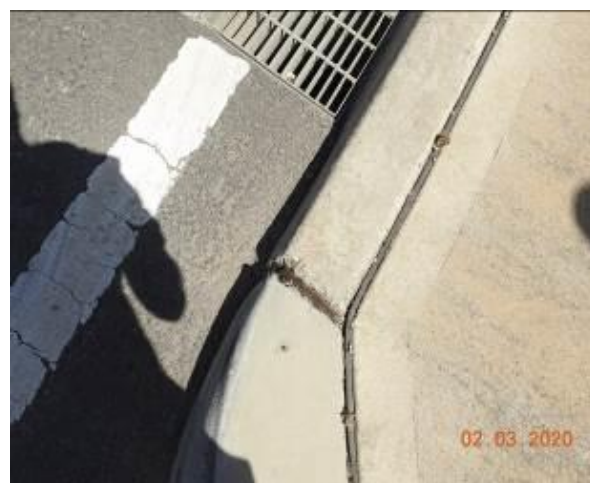
Figure 1538 – General Condition of kerb

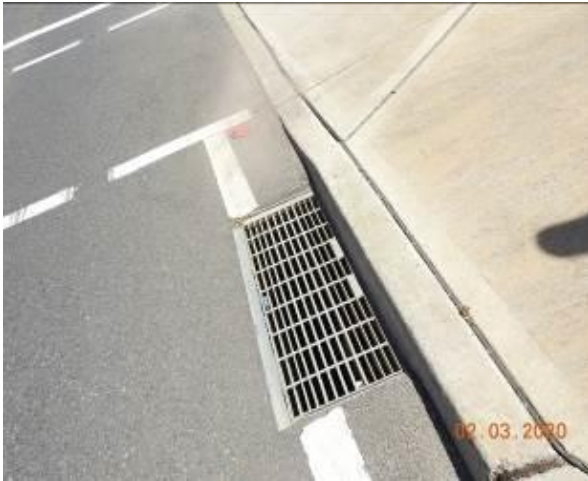
Figure 1539 – Loss of material through kerb

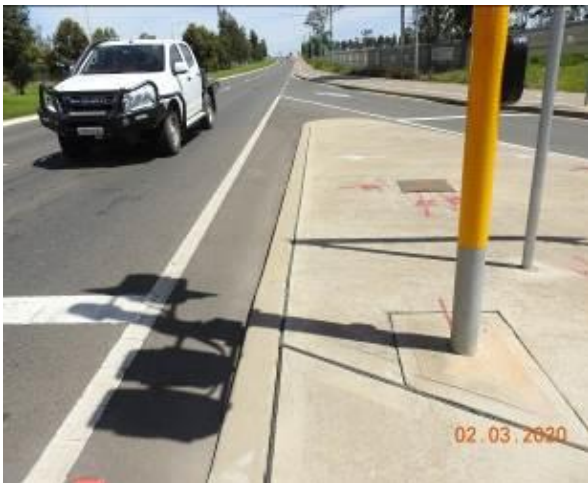
Figure 1541 – General Condition of layback

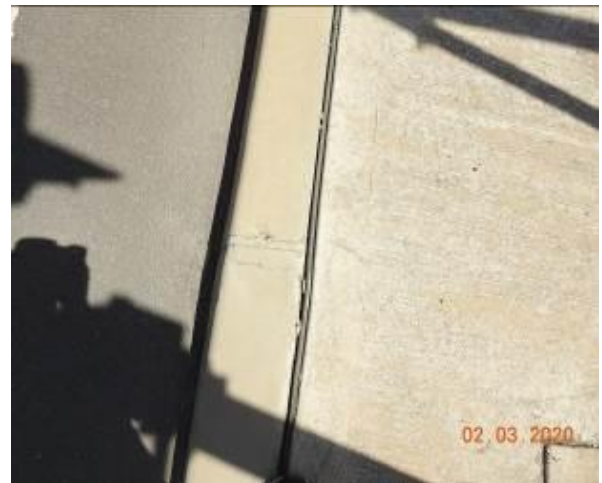
Figure 1542 – General Condition of kerb

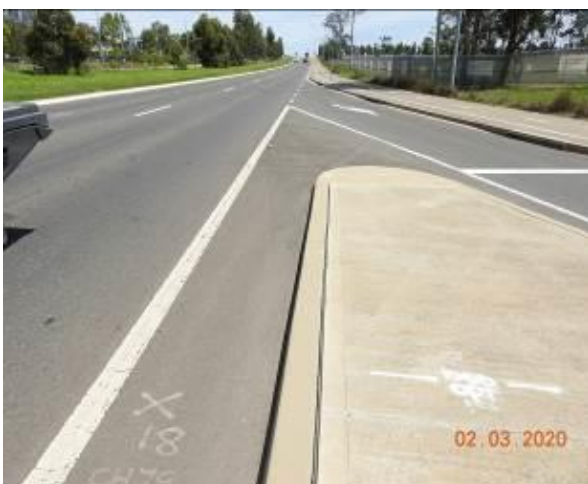
Figure 1543 – Crack propagation through kerb

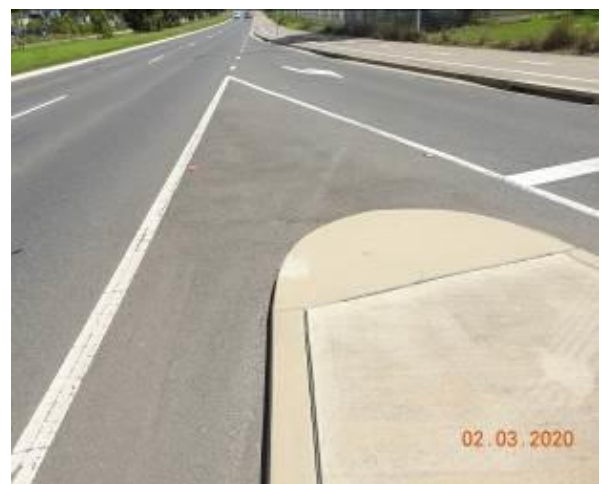
Figure 1544 – General Condition of kerb

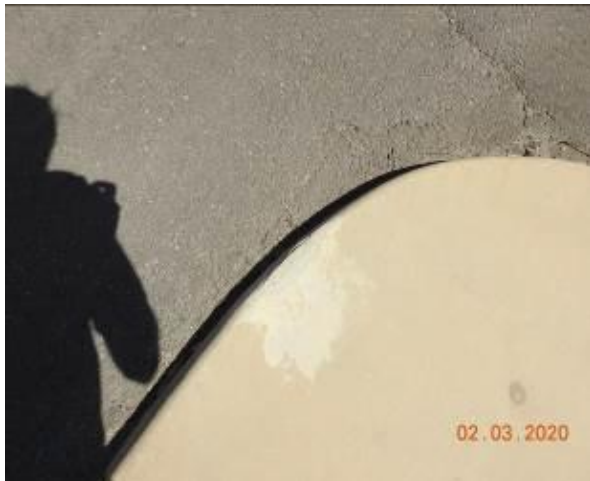
Figure 1545 – General Condition of kerb

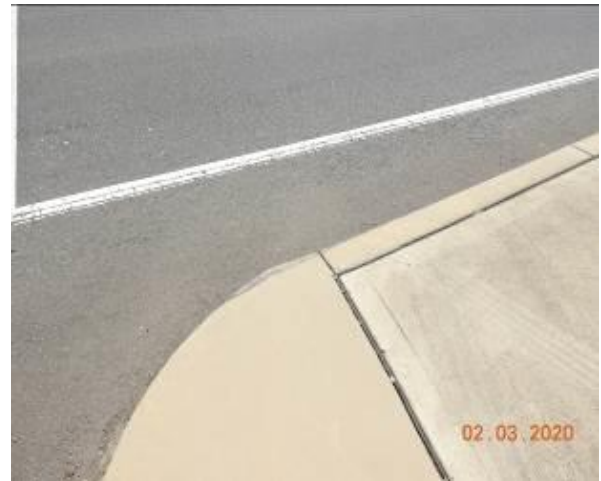
Figure 1546 – Loss of material through kerb

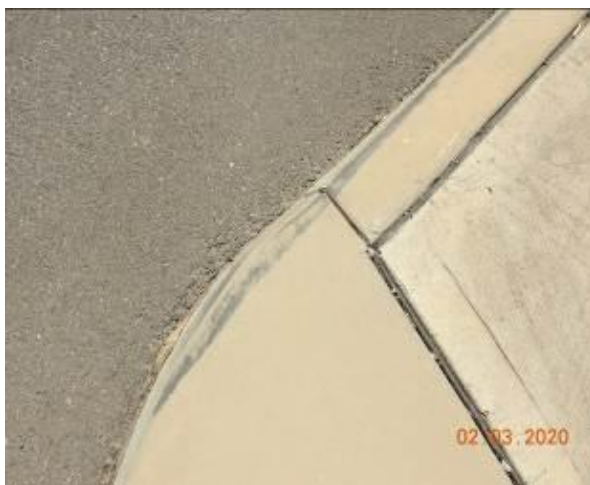
Figure 1547 – Crack propagation through kerb

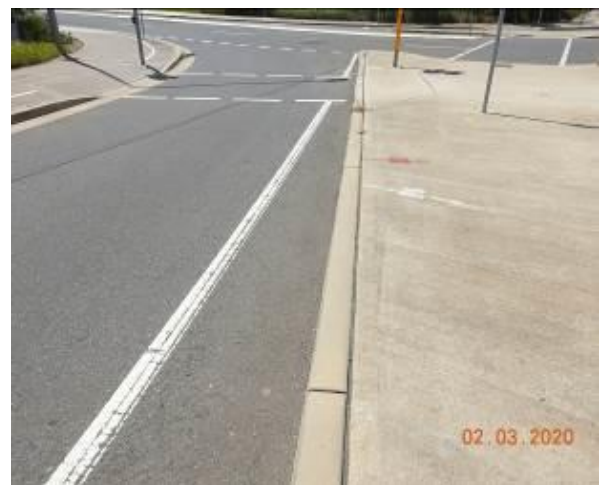
Figure 1548 – General Condition of kerb

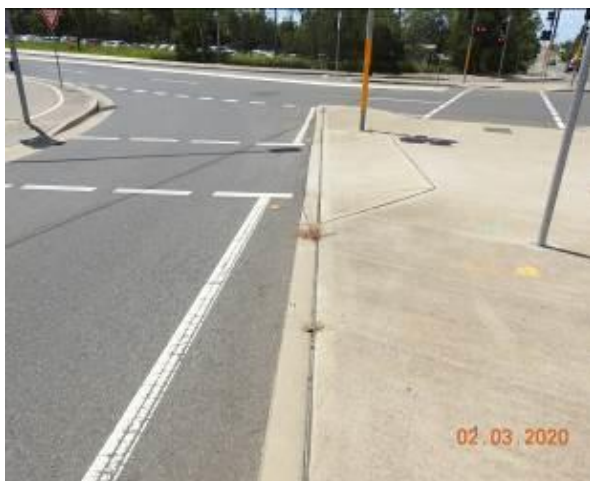
Figure 1549 – General Condition of kerb

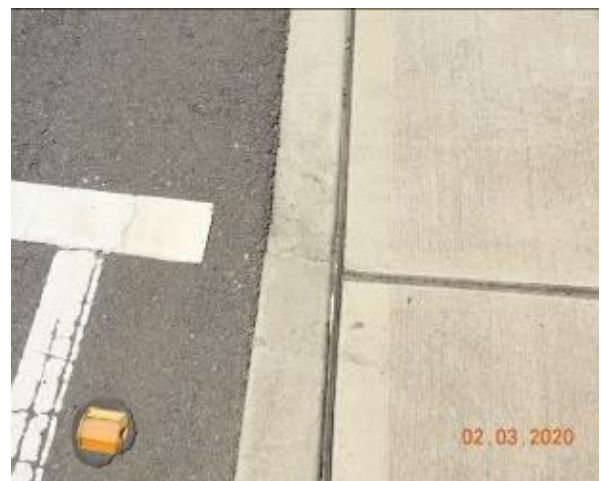
Figure 1550 – General Condition of kerb

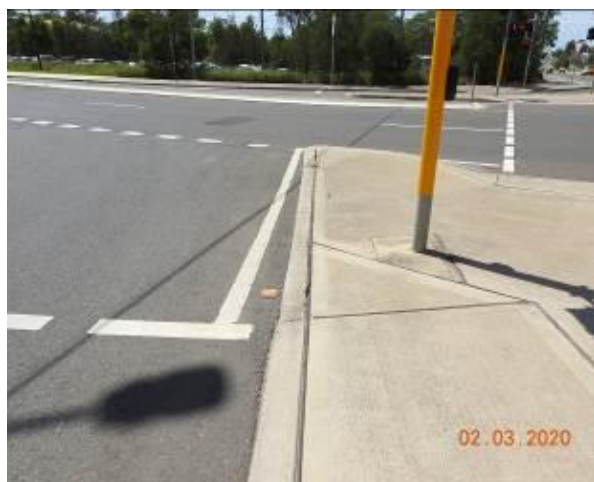
Figure 1551 – Crack propagation through kerb

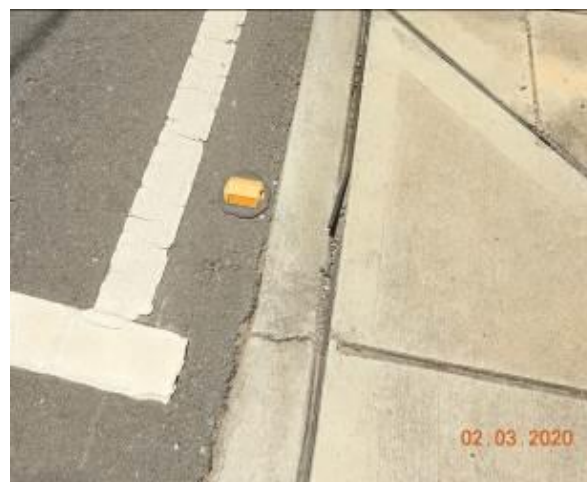
Figure 1552 – General Condition of layback

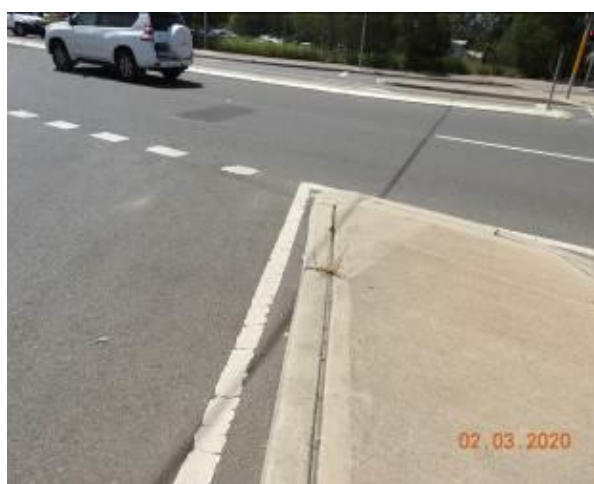
Figure 1553 – Crack propagation through kerb

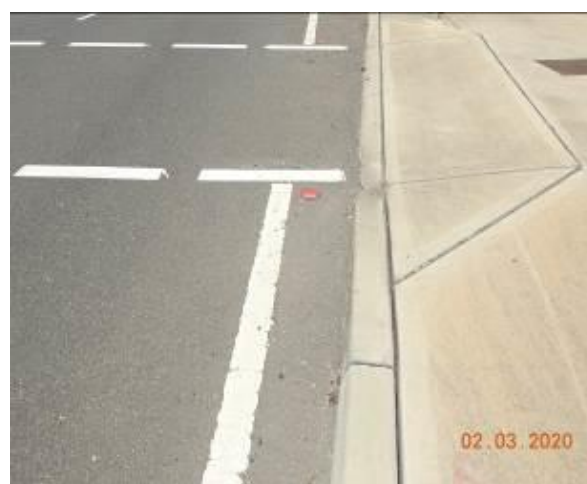
Figure 1554 – General Condition of kerb

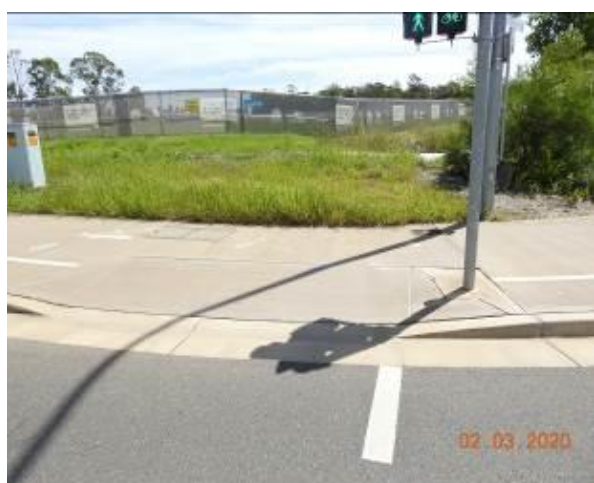
Figure 1555 – General Condition of kerb

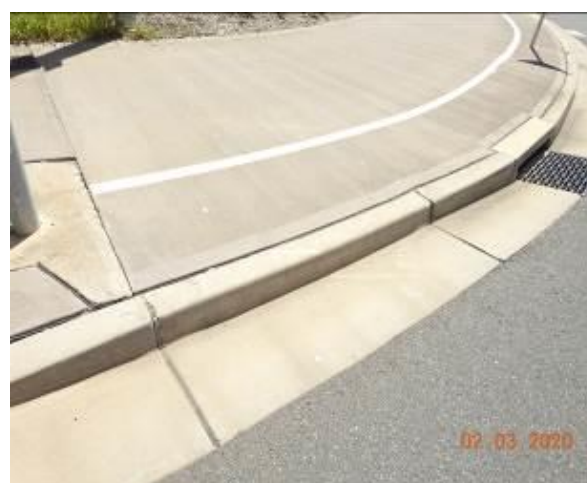
Figure 1556 – General Condition of layback and gutter

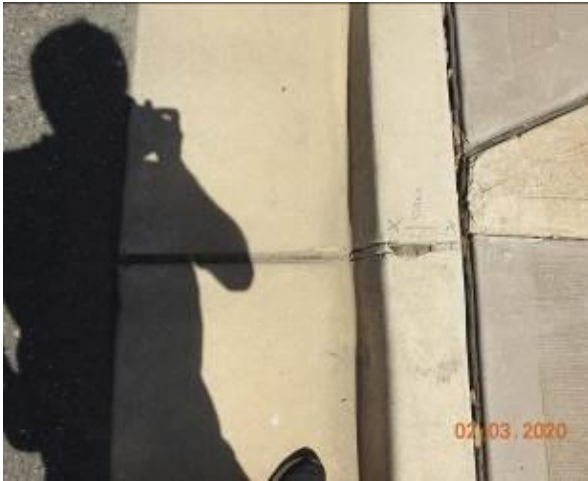
Figure 1557 – General Condition of kerb and gutter

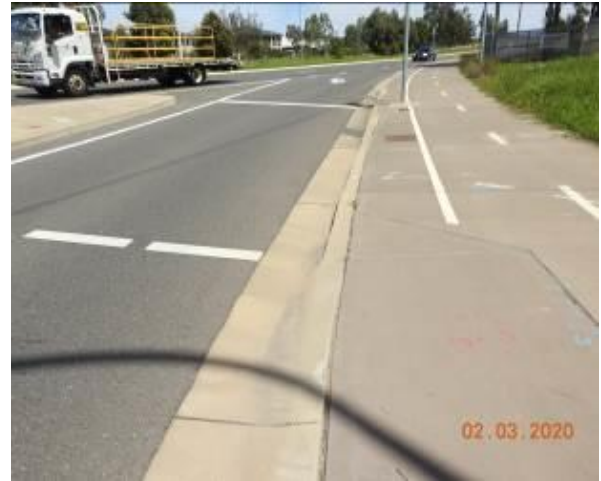
Figure 1558 – Crack propagation through kerb and gutter

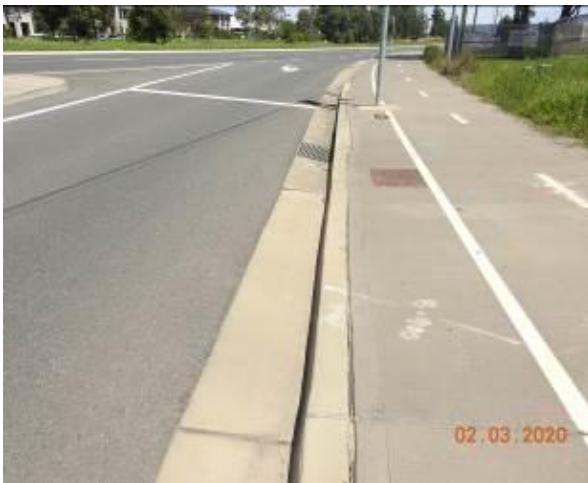
Figure 1559 – General Condition of gutter

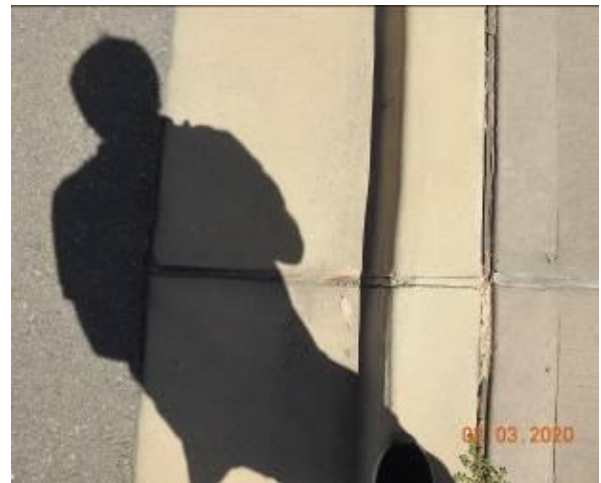
Figure 1560 – General Condition of kerb and gutter

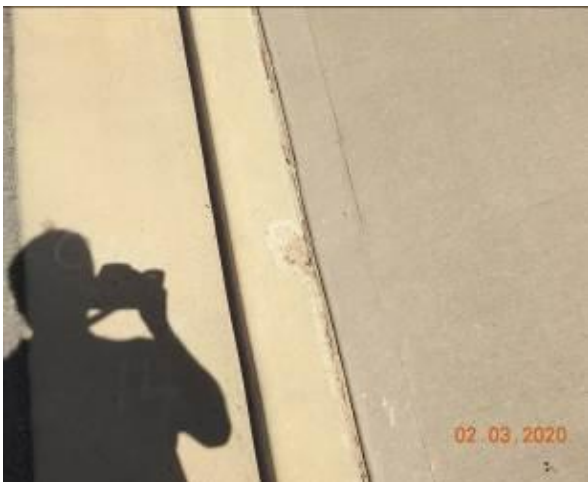
Figure 1561 – Crack propagation through kerb and gutter

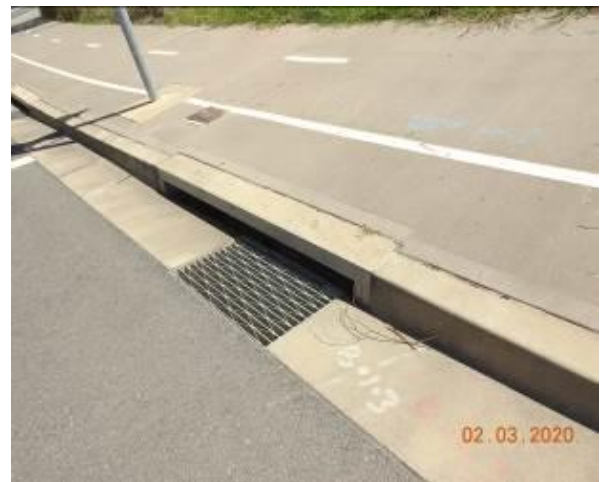
Figure 1562 – Loss of material through kerb

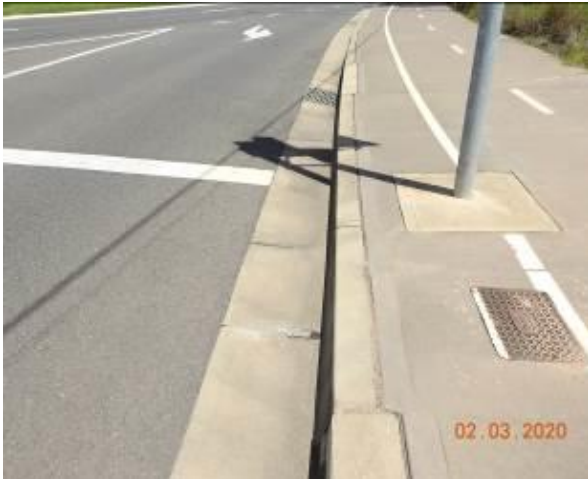
Figure 1563 – General Condition of stormwater inlet pit

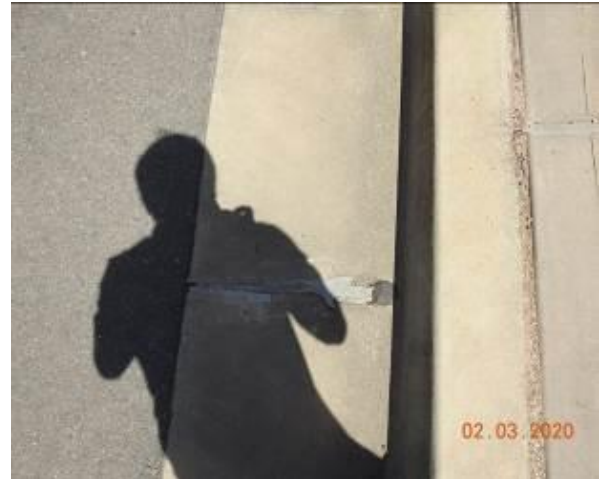
Figure 1564 – General Condition of kerb and gutter

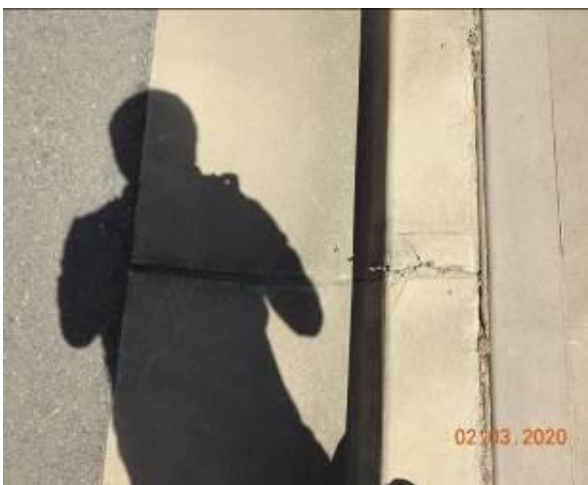
Figure 1565 – Evidence of patchwork through gutter

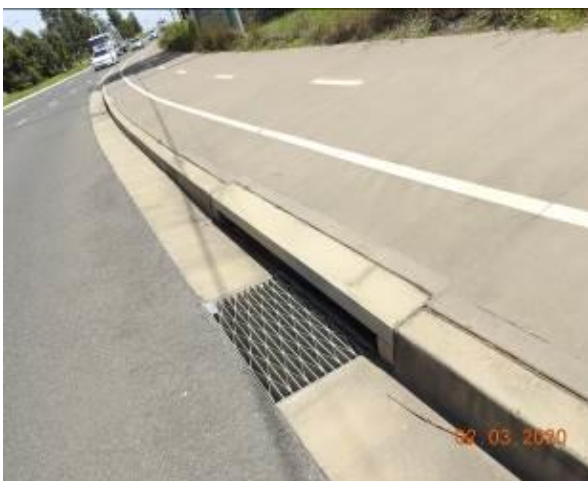
Figure 1567 – General Condition of kerb and gutter

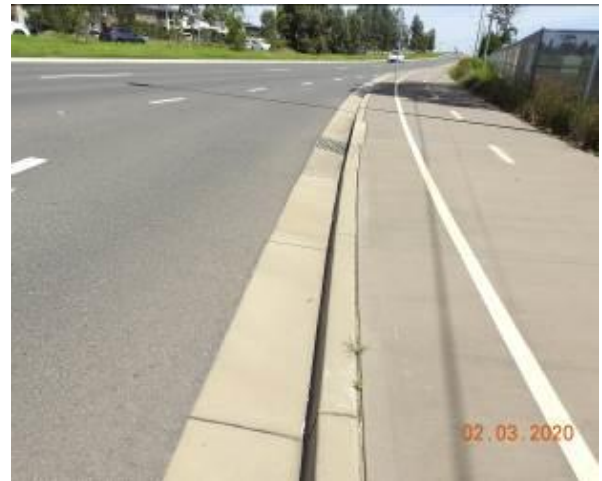
Figure 1570 – General Condition of kerb and gutter

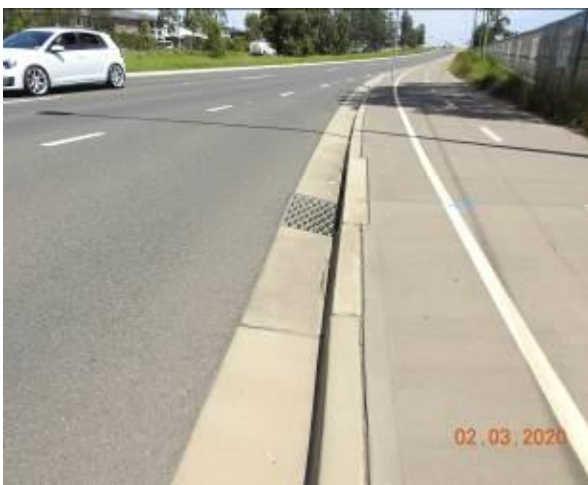
Figure 1571 – General Condition of kerb and gutter

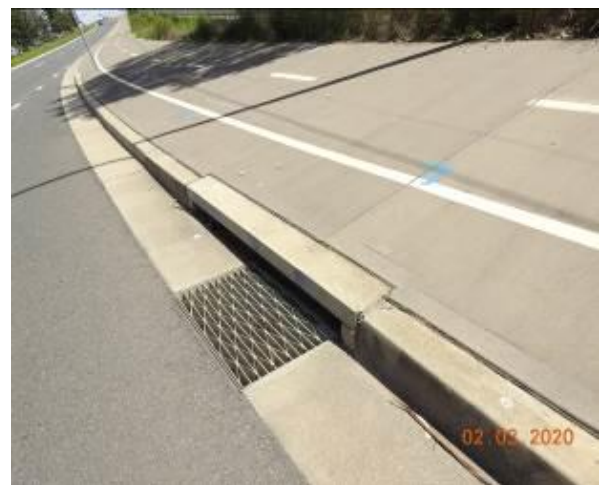
Figure 1572 – General Condition of kerb and gutter

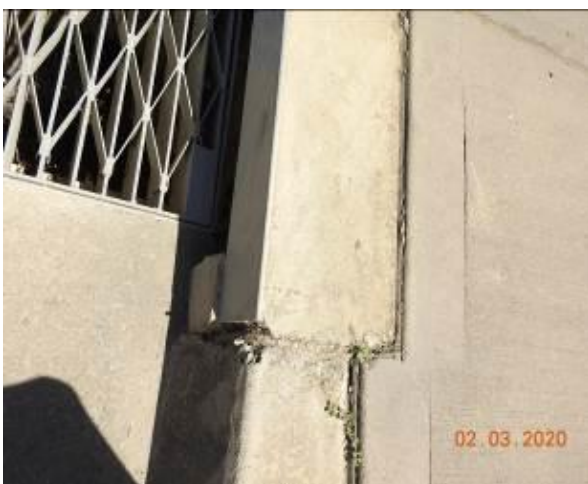
Figure 1573 – General Condition of stormwater inlet pit

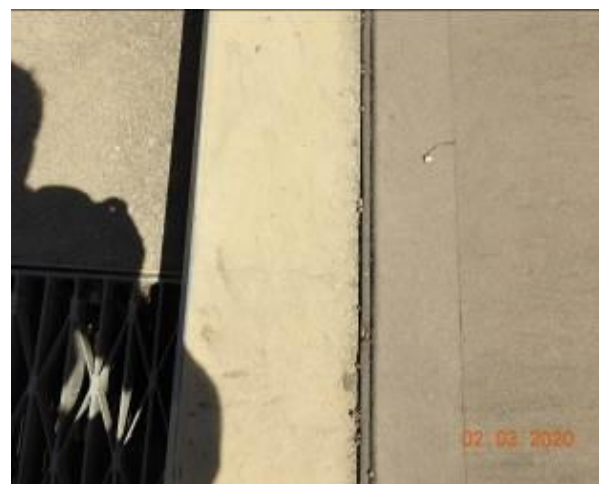
Figure 1574 – Loss of material through stormwater inlet pit

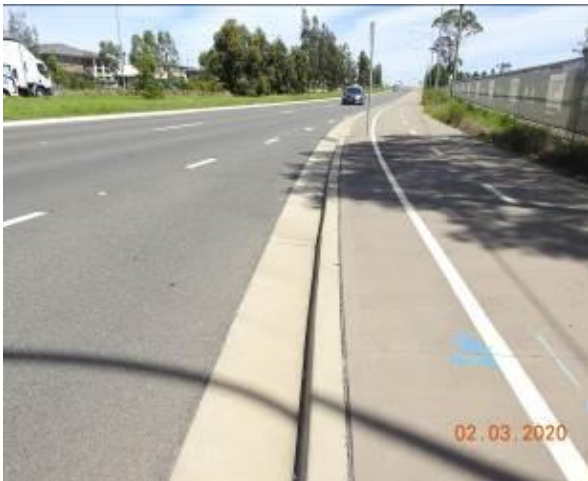
Figure 1575 – Crack propagation through stormwater inlet pit

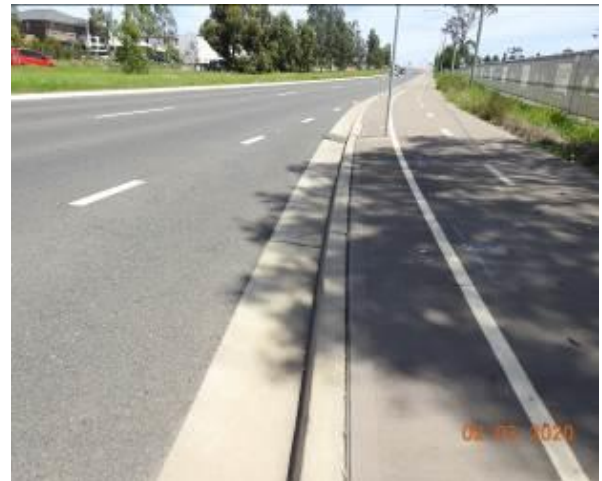
Figure 1576 – General Condition of kerb and gutter

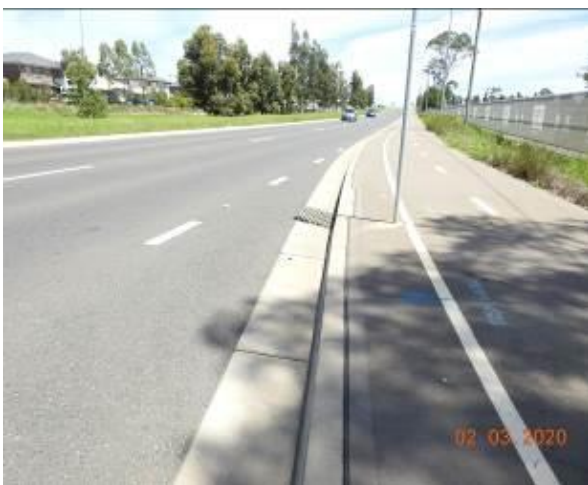
Figure 1577 – General Condition of kerb and gutter

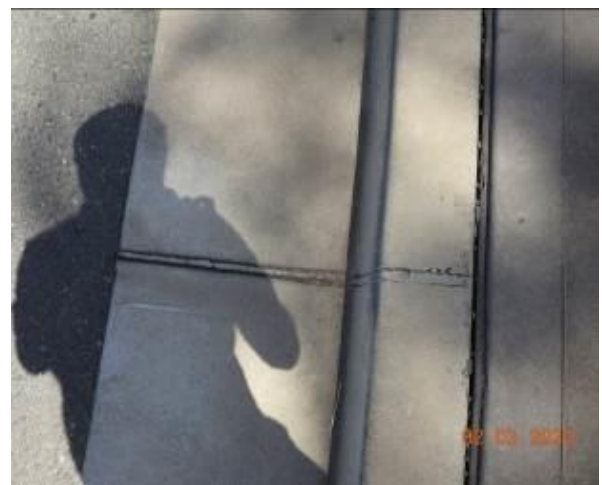
Figure 1578 – General Condition of kerb and gutter

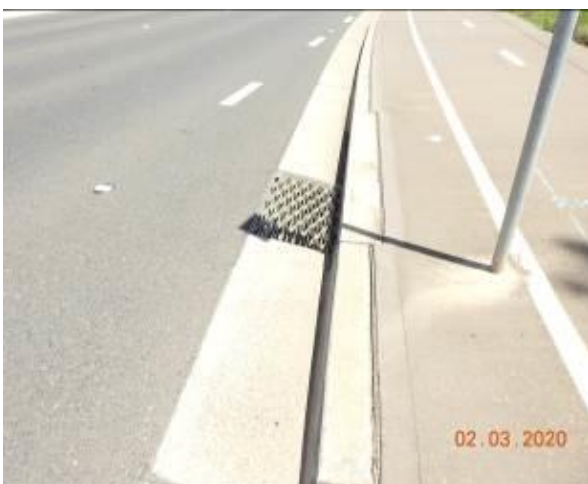
Figure 1579 – Crack propagation through kerb and gutter

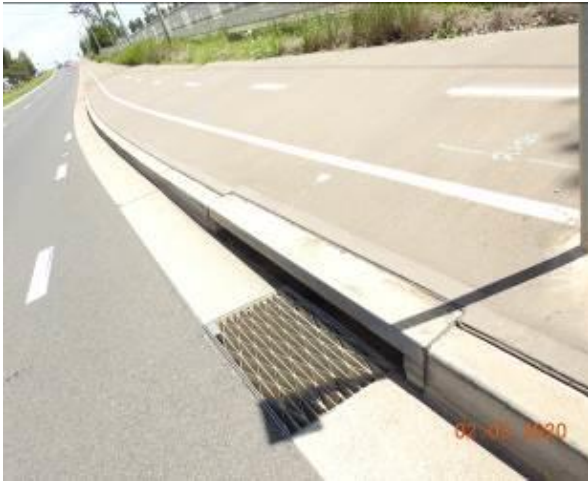
Figure 1581 – Crack propagation through kerb

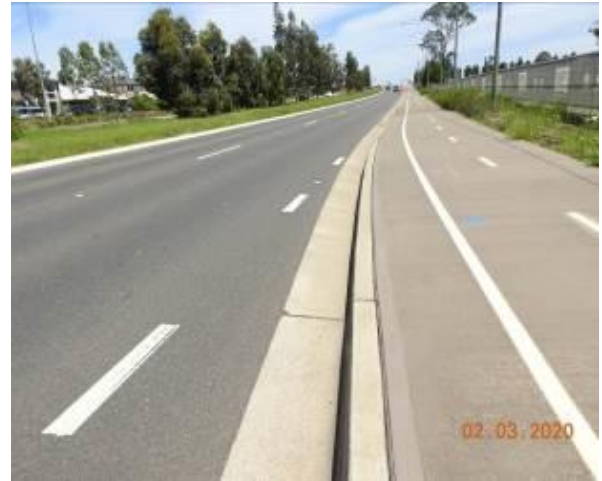
Figure 1582 – General Condition of stormwater inlet pit

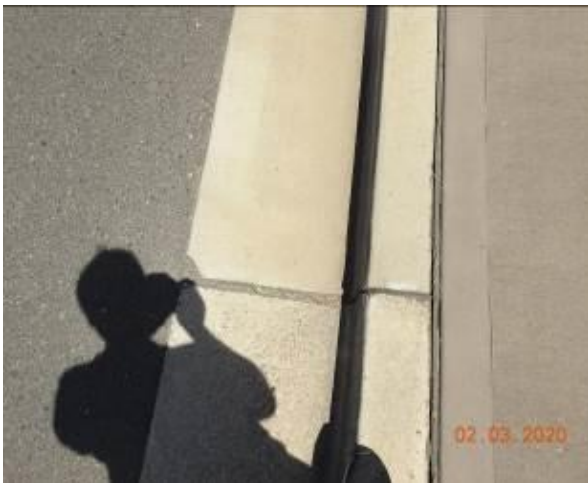
Figure 1583 – General Condition of kerb and gutter

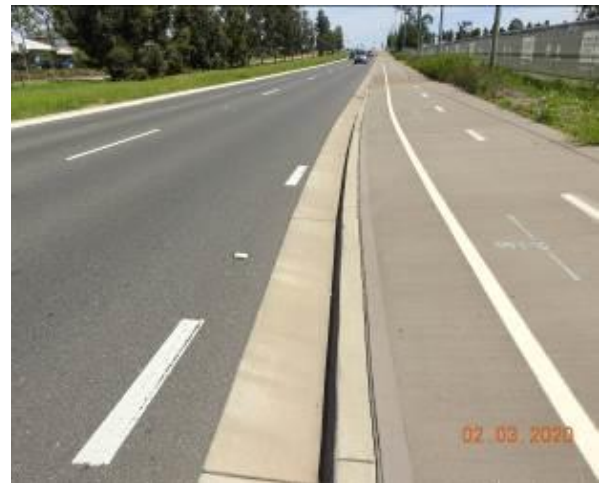
Figure 1584 – Loss of material through gutter

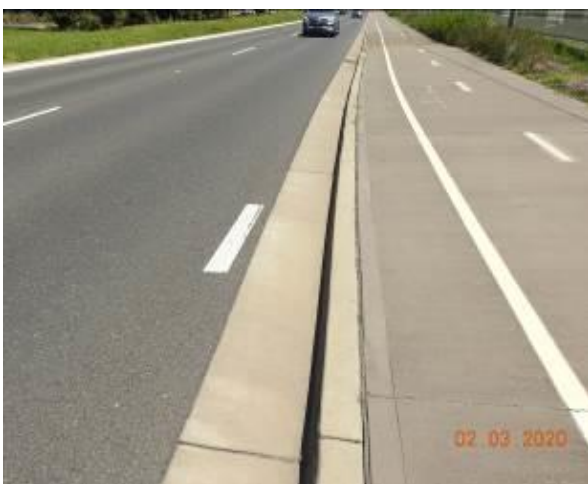
Figure 1585 – General Condition of kerb and gutter

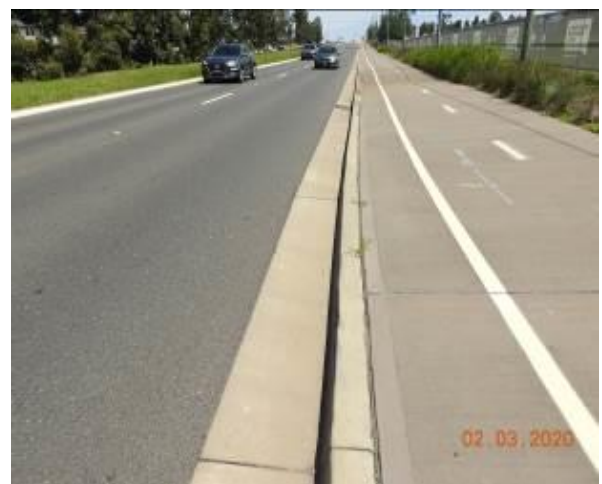
Figure 1586 – General Condition of kerb and gutter

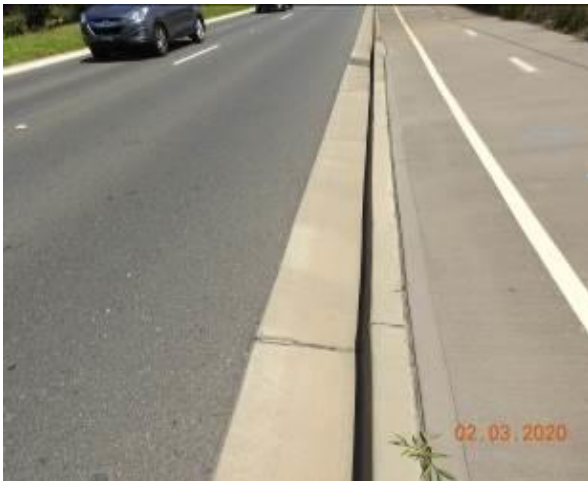
Figure 1587 – General Condition of kerb and gutter

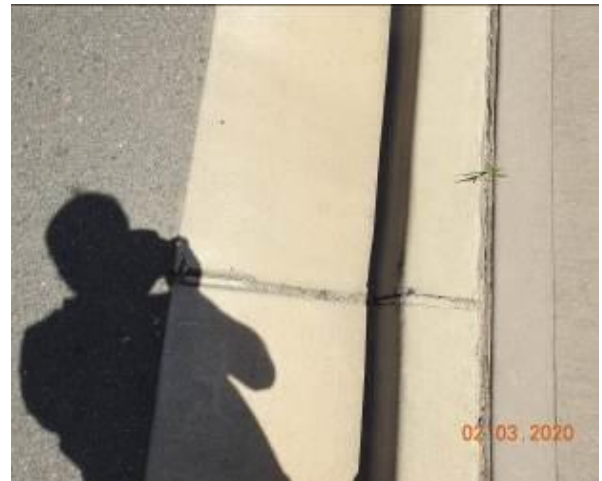
Figure 1589 – Crack propagation and loss of material through kerb and gutter

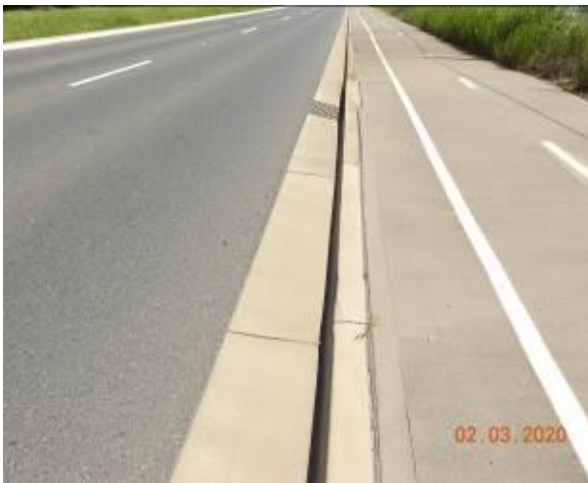
Figure 1590 – General Condition of kerb and gutter

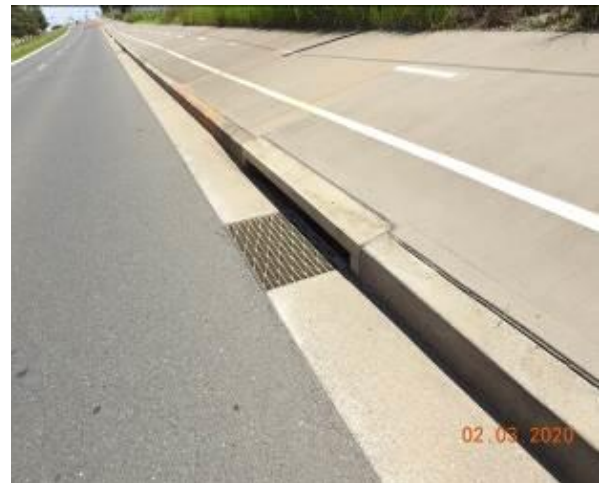
Figure 1591 – General Condition of stormwater inlet pit

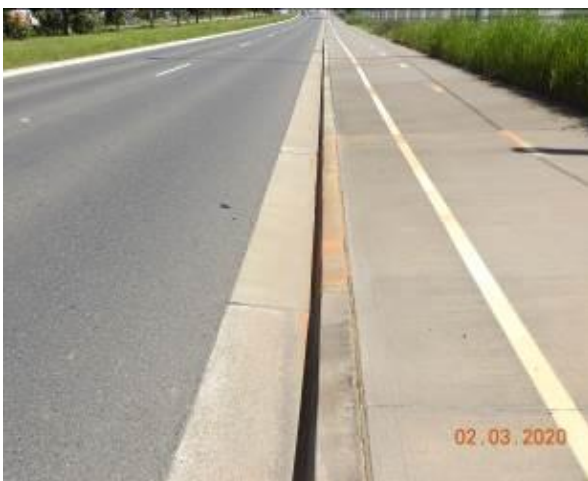
Figure 1592 – General Condition of kerb and gutter

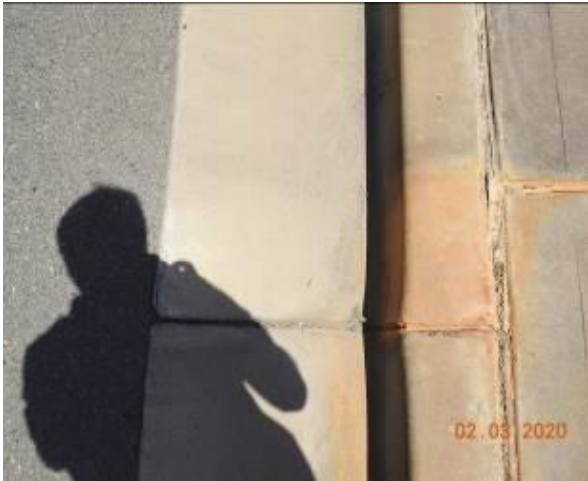
Figure 1594 – Loss of material through gutter

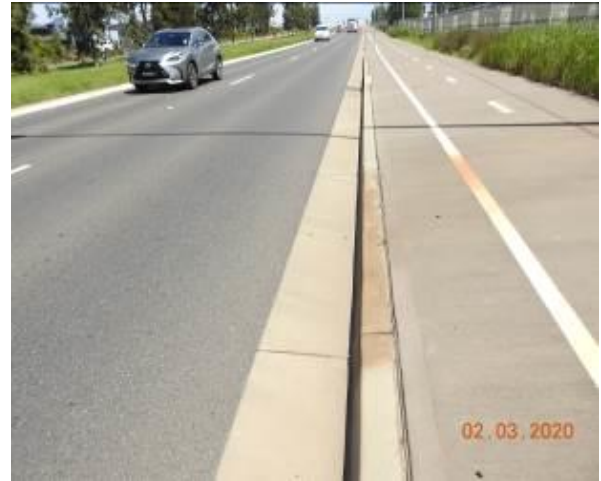
Figure 1595 – General Condition of kerb and gutter

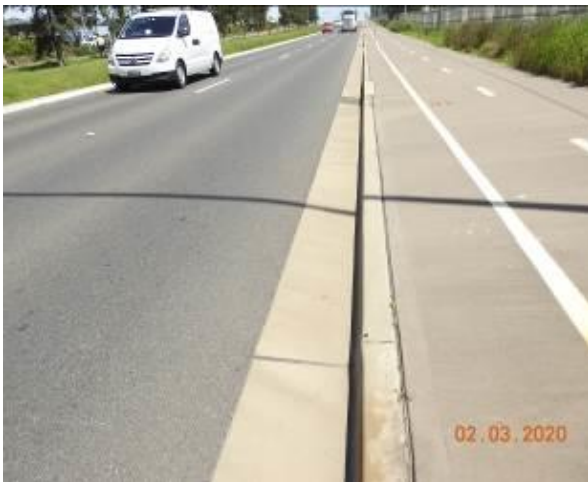
Figure 1596 – General Condition of kerb and gutter

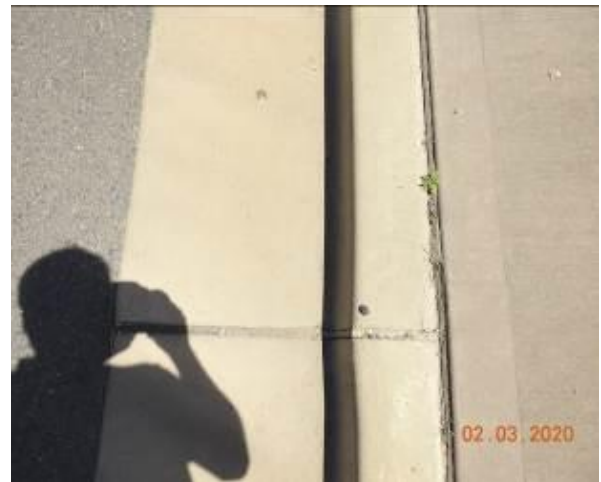
Figure 1597 – Crack propagation through kerb

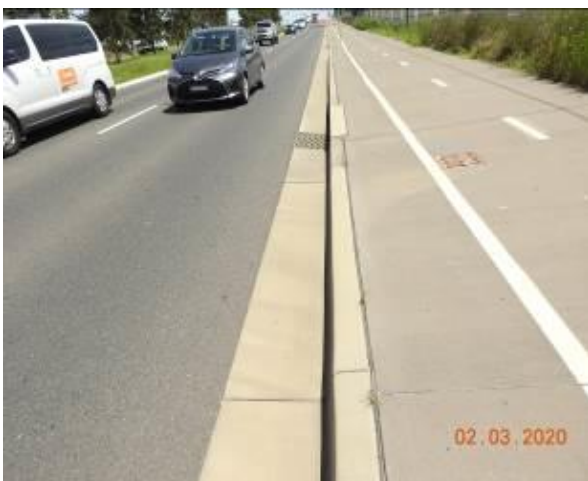
Figure 1598 – General Condition of kerb

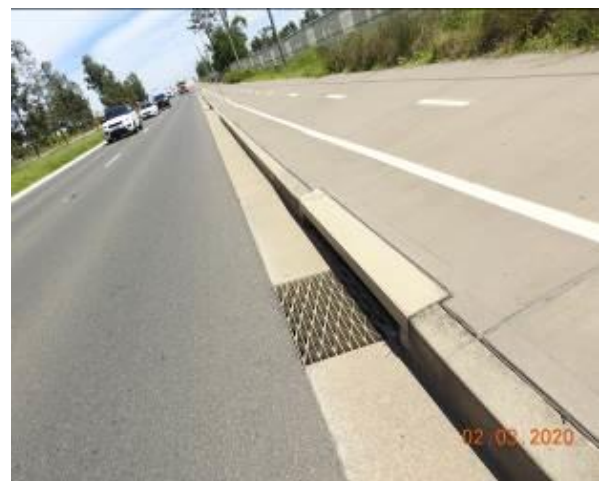
Figure 1599 – General Condition of stormwater inlet pit

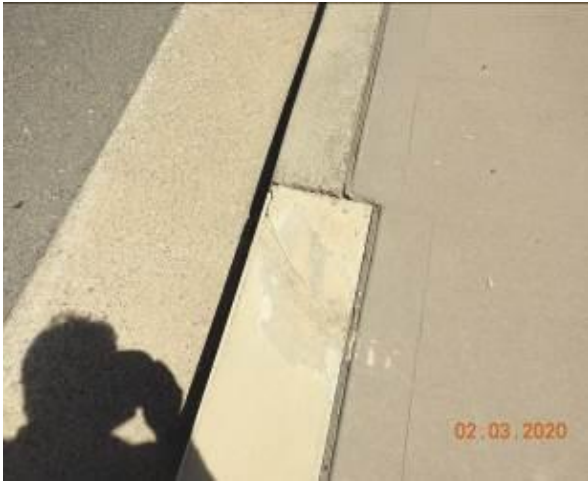
Figure 1600 – Crack propagation through stormwater inlet pit

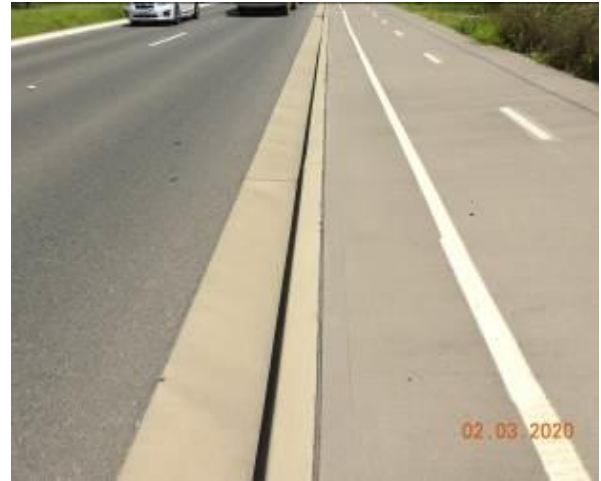
Figure 1601 – General Condition of kerb and gutter

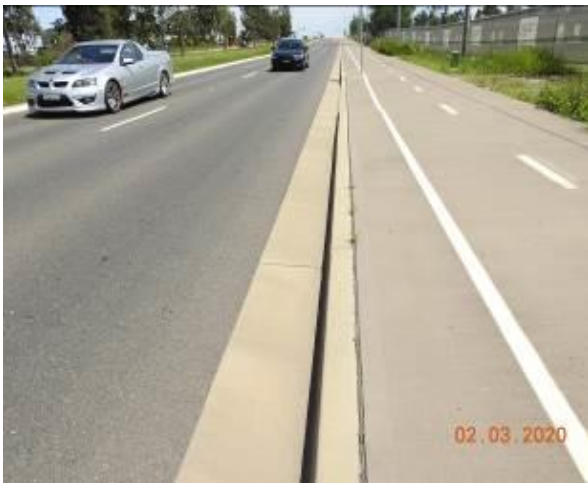
Figure 1602 – General Condition of kerb and gutter
