**1-15 AND 2-12 CONFERTA AVENUE,
ROUSE HILL NSW 2155
TALLAWONG STATION PRECINCT SOUTH
PRE-DILAPIDATION REPORT**

**DEICORP PROJECTS
(TALLAWONG STATION) PTY LTD**

Job No. 191294.0
24/03/2020

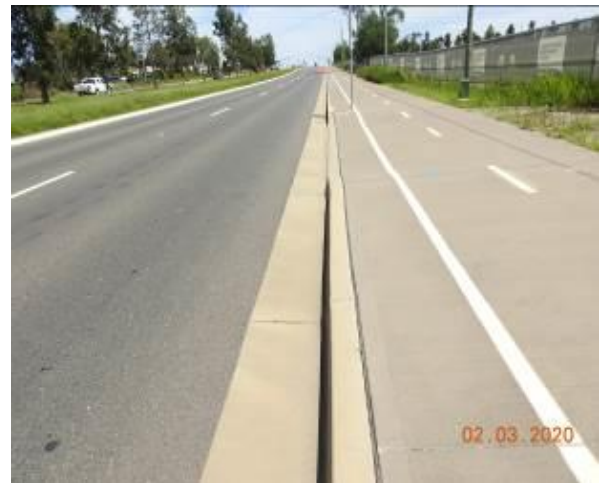
Figure 1603 – General Condition of kerb and gutter

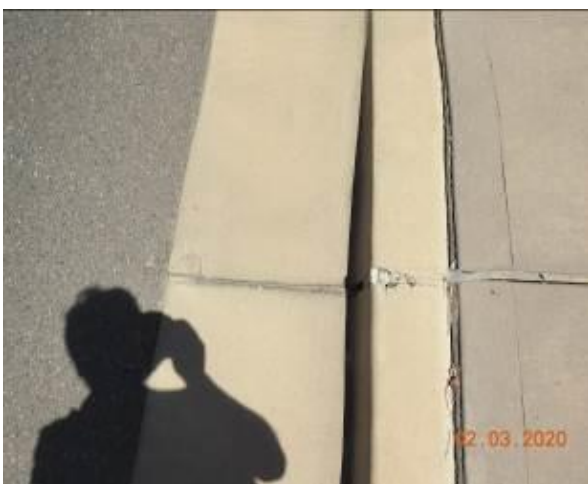
Figure 1604 – Loss of material through kerb and gutter

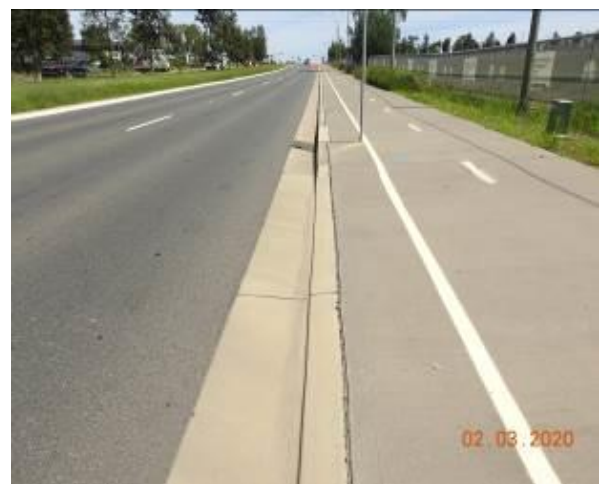
Figure 1605 – General Condition of kerb and gutter

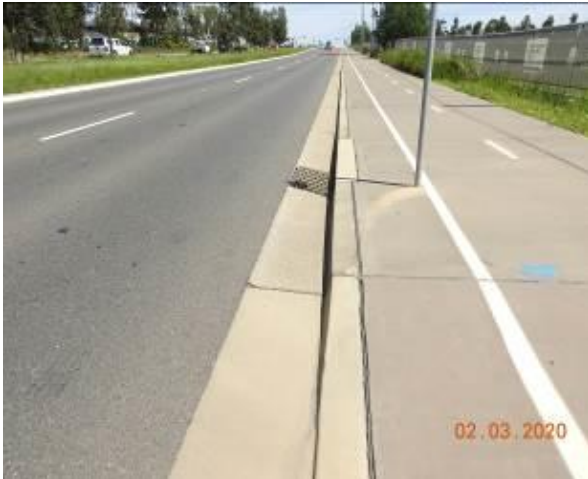
Figure 1606 – General Condition of kerb and gutter

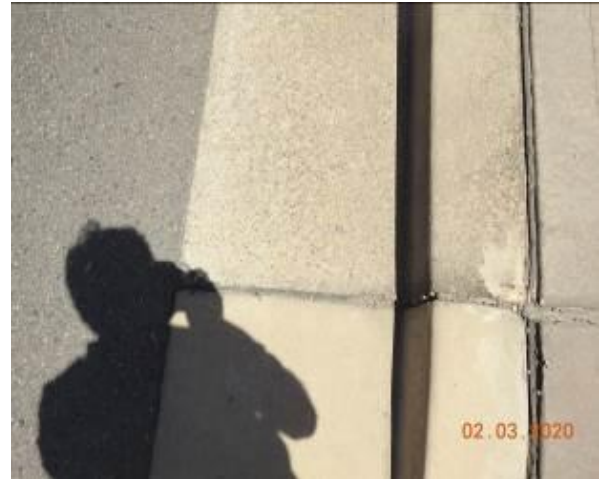
Figure 1607 – Loss of material through kerb

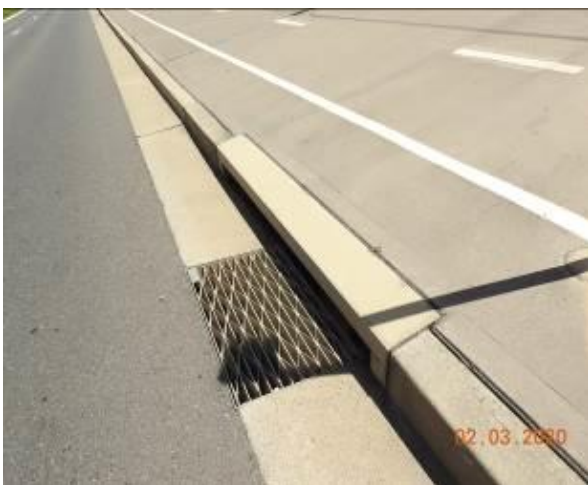
Figure 1608 – General Condition of stormwater inlet pit

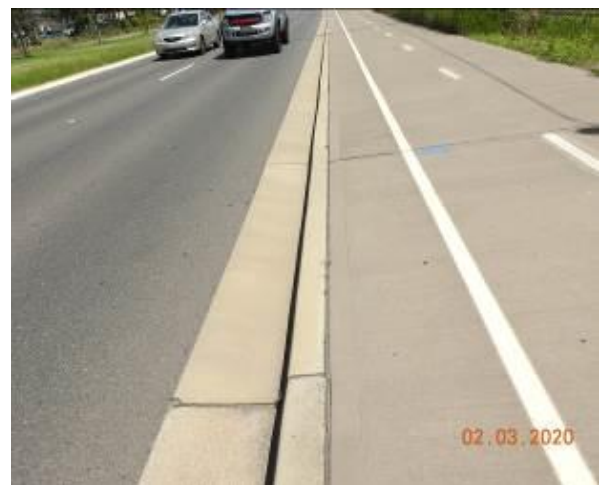
Figure 1609 – General Condition of kerb and gutter

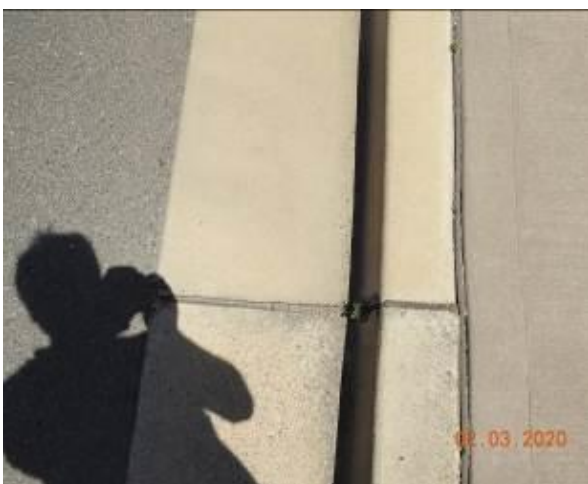
Figure 1610 – Crack propagation and loss of material through kerb and gutter

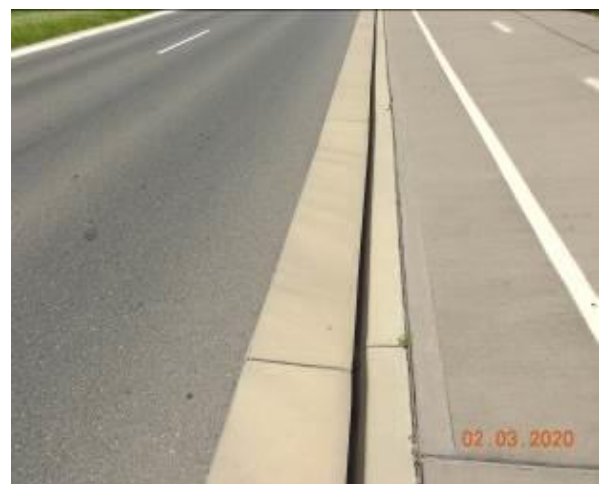
Figure 1611 – General Condition of kerb and gutter

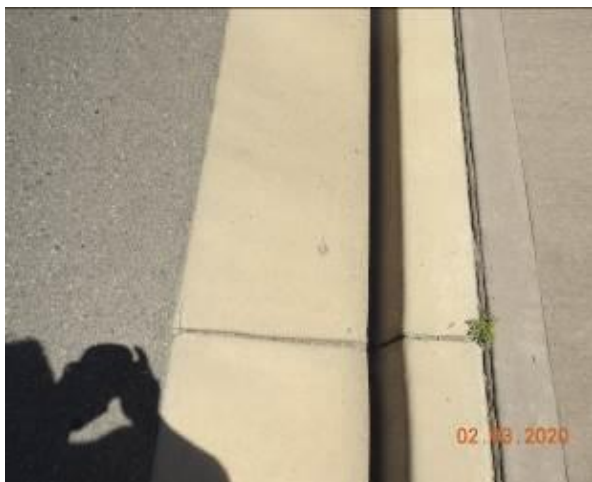
Figure 1612 – General Condition of kerb and gutter

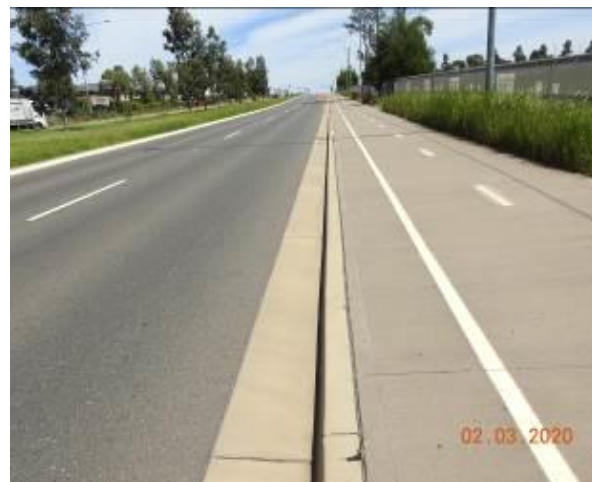
Figure 1613 – General Condition of kerb and gutter

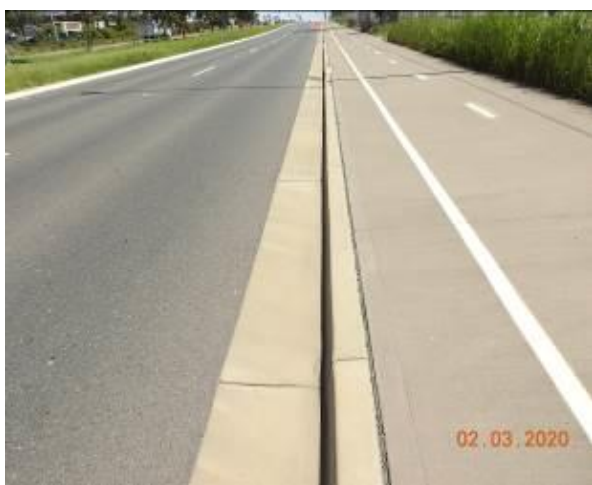
Figure 1614 – General Condition of kerb and gutter

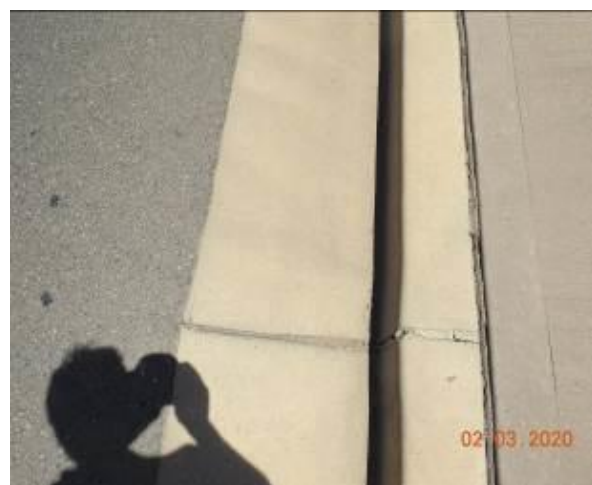
Figure 1615 – Crack propagation through kerb and gutter

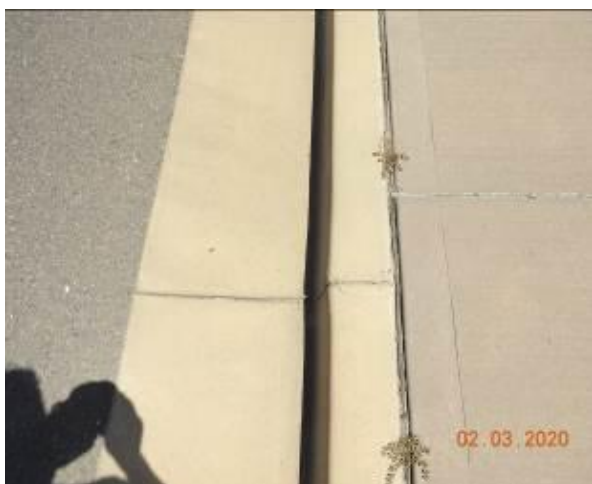
Figure 1616 – General Condition of kerb and gutter

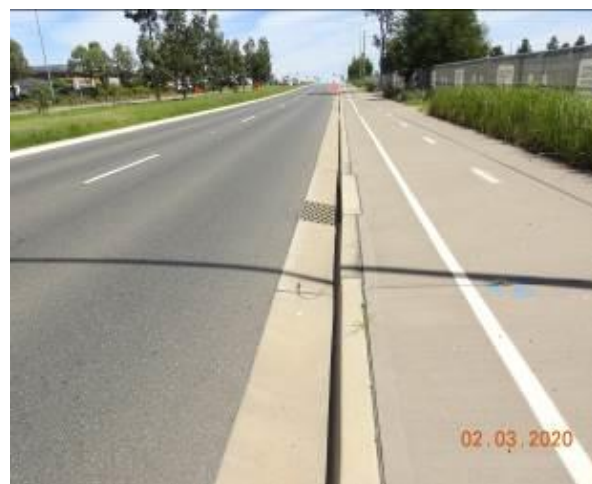
Figure 1617 – General Condition of kerb and gutter

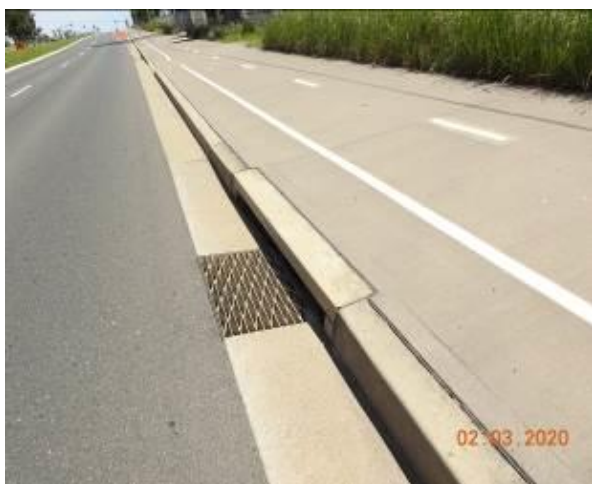
Figure 1618 – General Condition of stormwater inlet pit

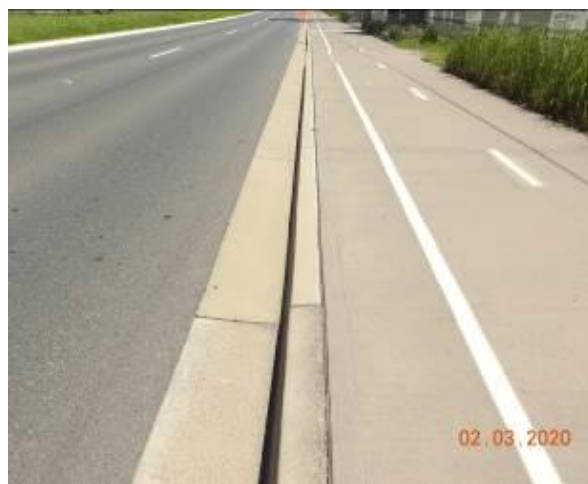
Figure 1619 – General Condition of kerb and gutter

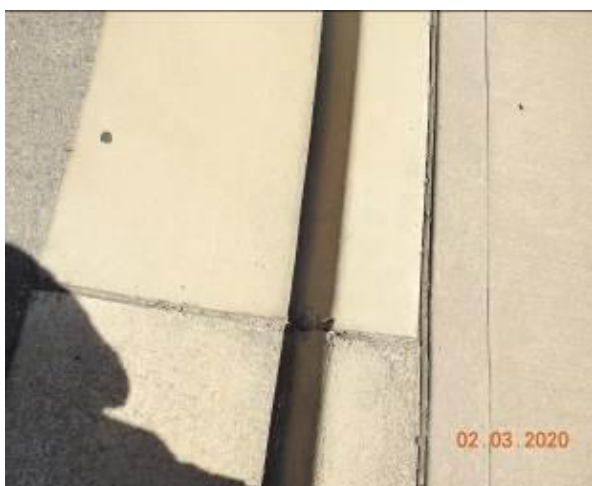
Figure 1620 – Loss of material through kerb

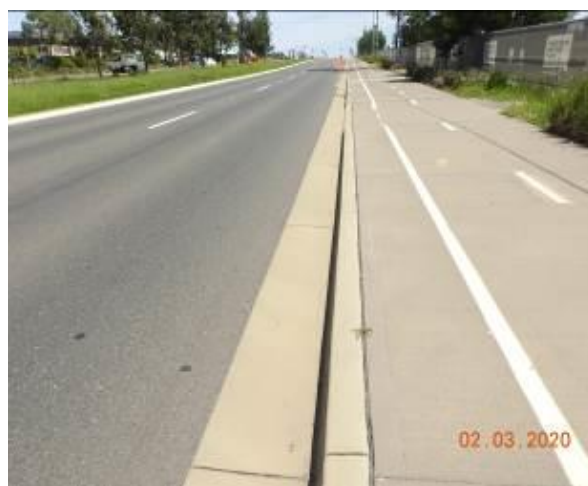
Figure 1621 – General Condition of kerb and gutter

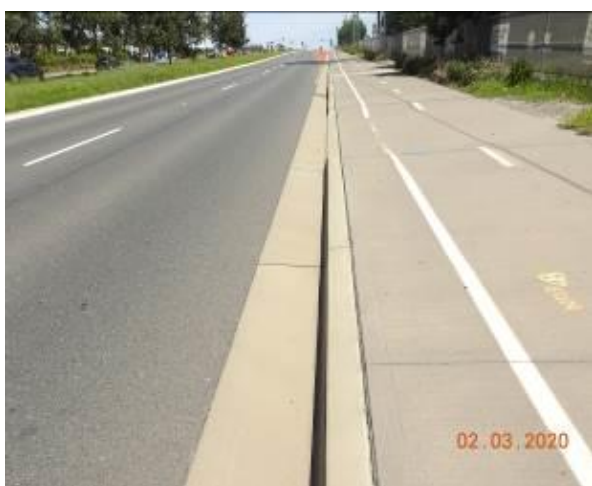
Figure 1622 – General Condition of kerb and gutter

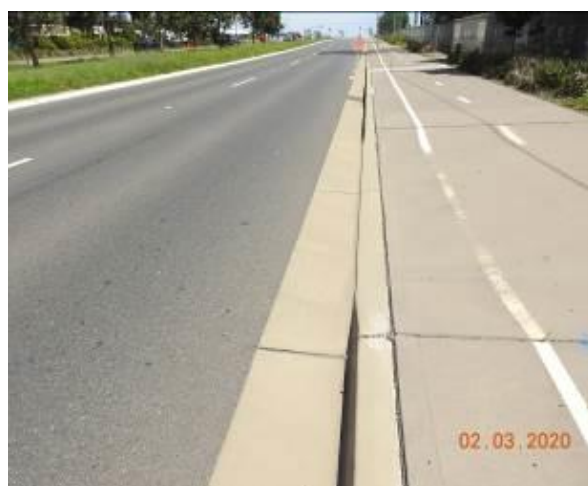
Figure 1623 – General Condition of kerb and gutter

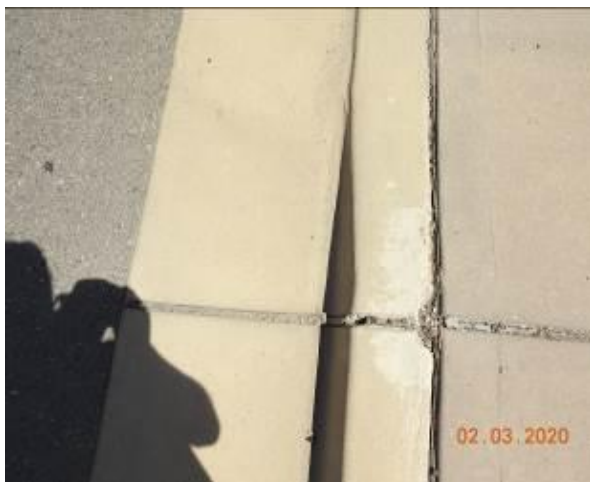
Figure 1624 – Loss of material through kerb

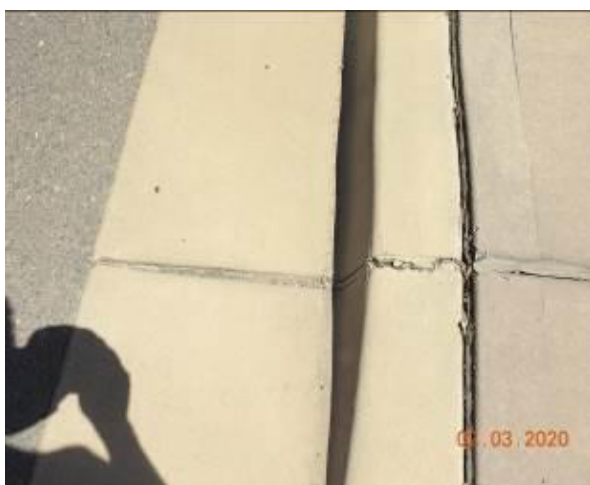
Figure 1626 – Crack propagation through kerb

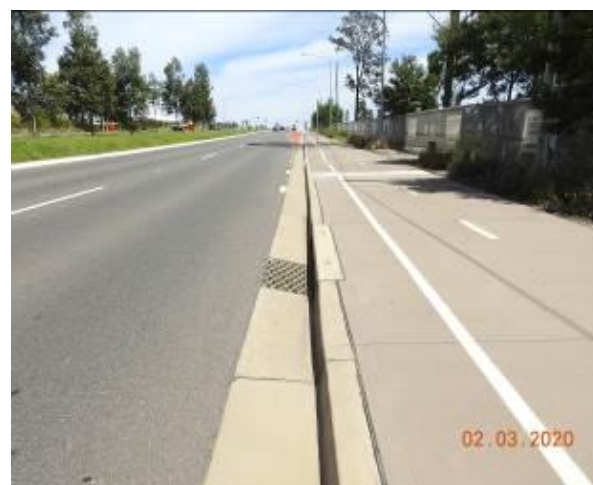
Figure 1627 – General Condition of kerb and gutter

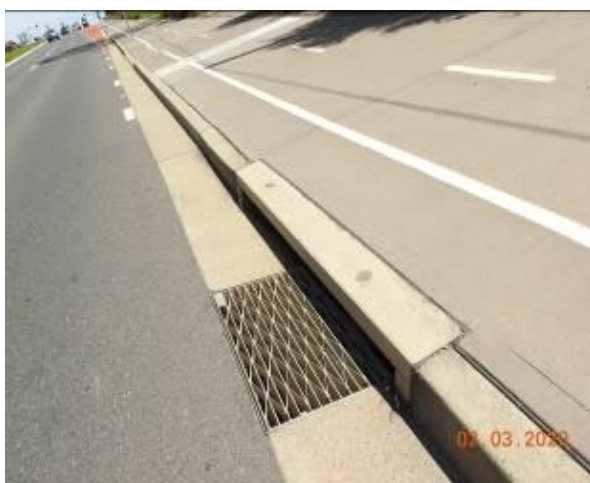
Figure 1628 – General Condition of stormwater inlet pit

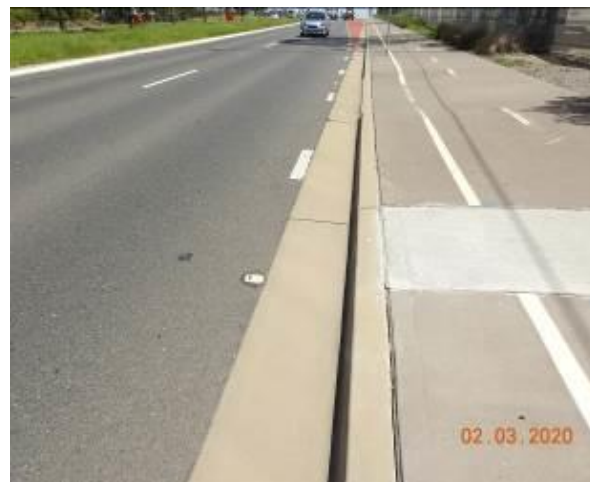
Figure 1630 – General Condition of kerb and gutter

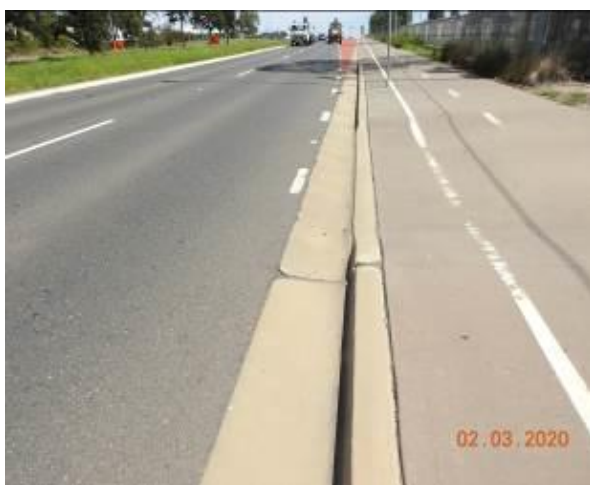
Figure 1631 – General Condition of kerb and gutter

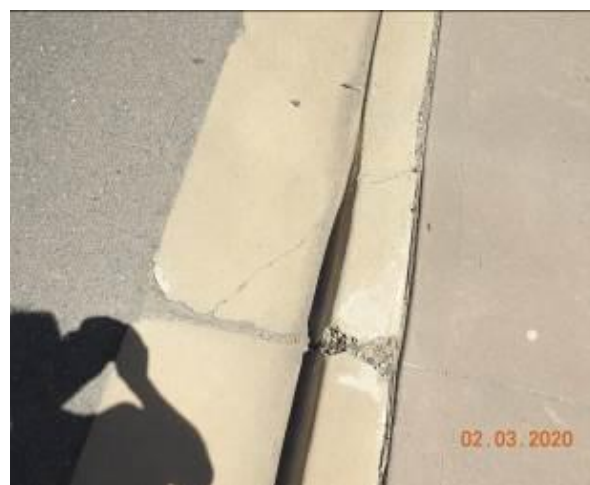
Figure 1632 – General Condition of kerb and gutter

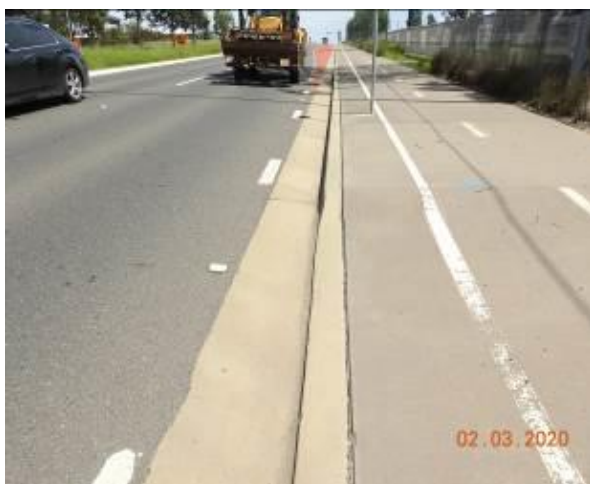
Figure 1633 – Crack propagation and loss of material through kerb and gutter

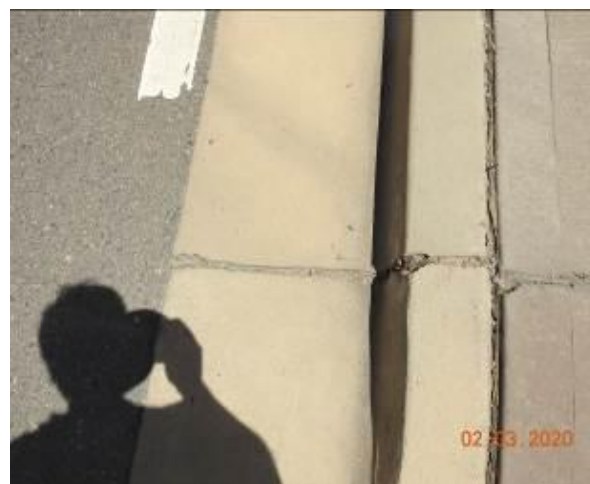
Figure 1634 – General Condition of layback and gutter

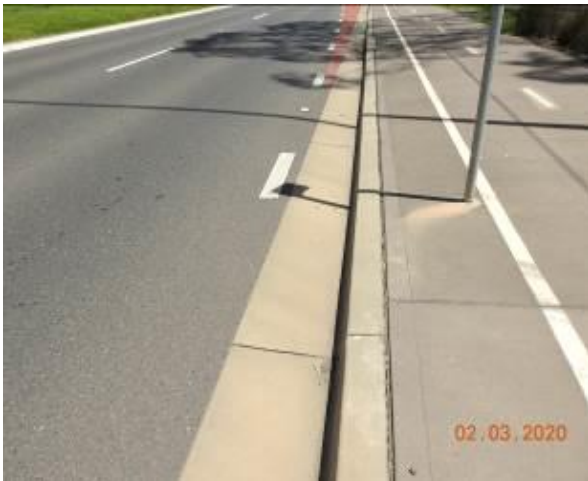
Figure 1635 – Loss of material through kerb

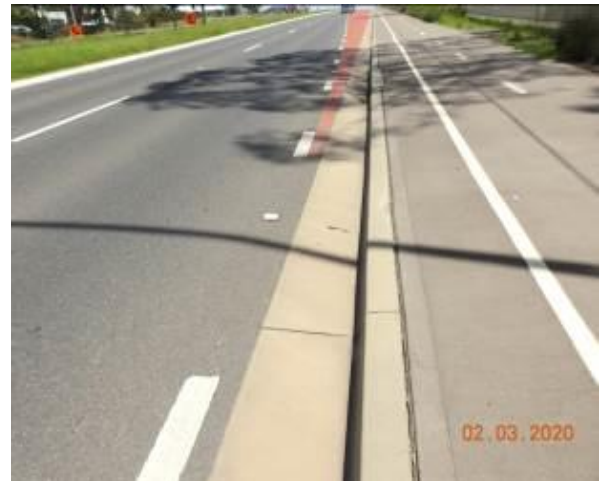
Figure 1636 – General Condition of kerb and gutter

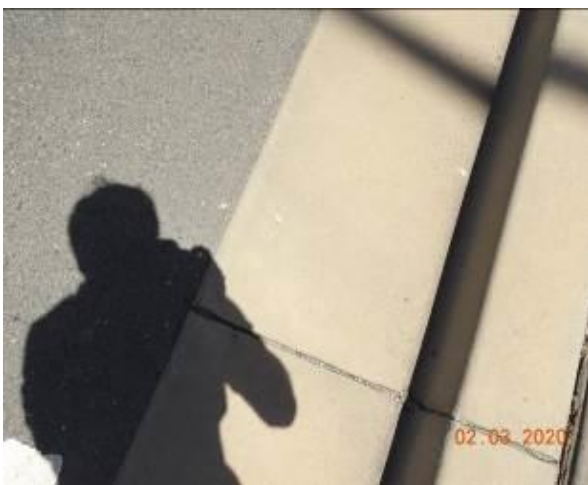
Figure 1637 – General Condition of kerb and gutter

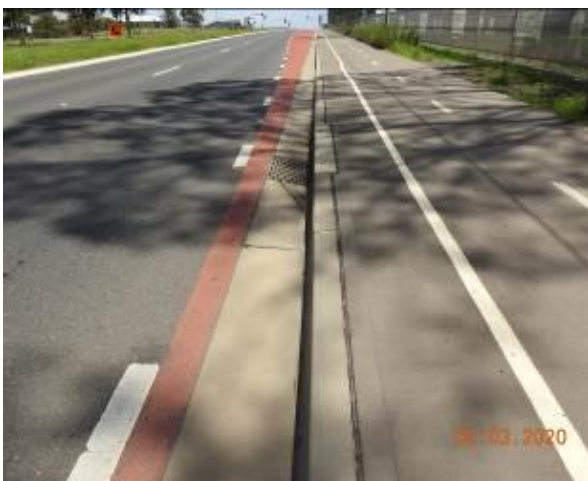
Figure 1639 – Loss of material through kerb

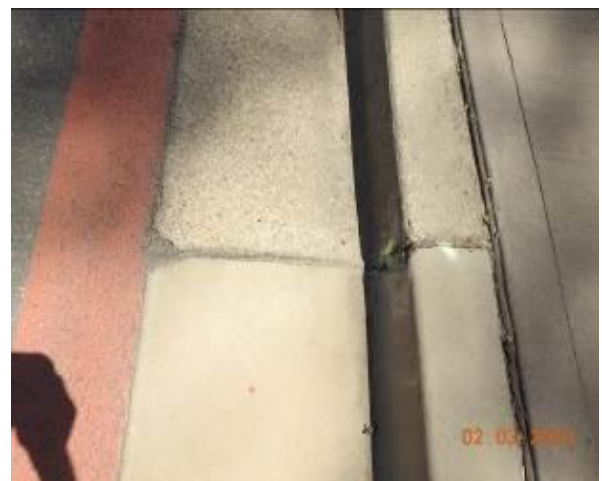
Figure 1640 – General Condition of kerb and gutter

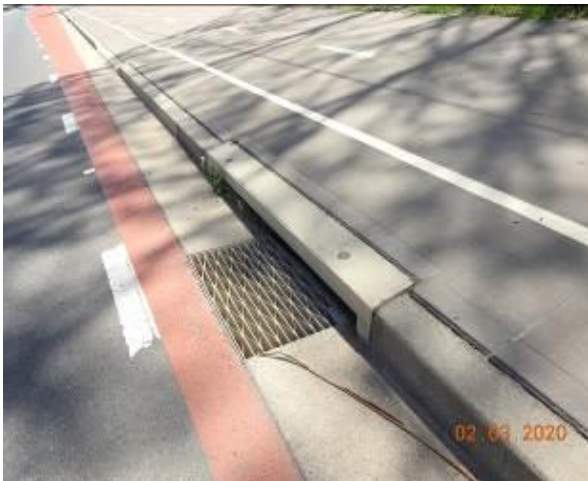
Figure 1641 – Loss of material through kerb and gutter

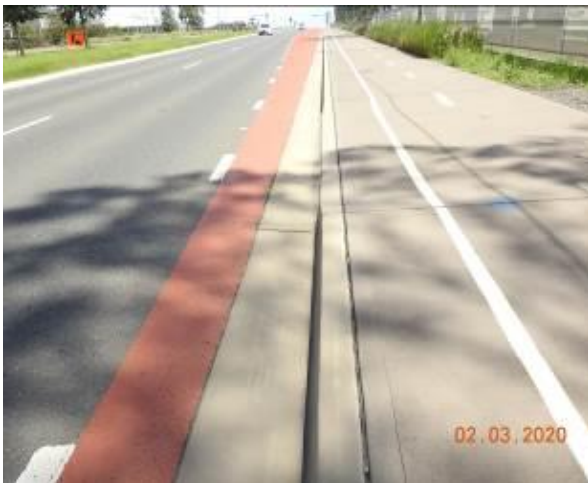
Figure 1643 – Loss of material through kerb

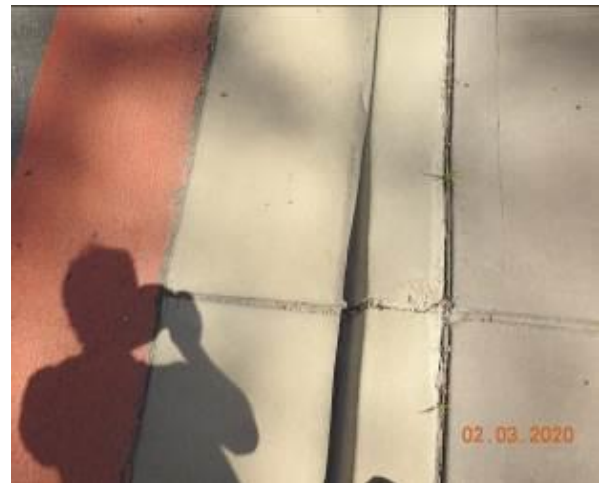
Figure 1644 – General Condition of kerb and gutter

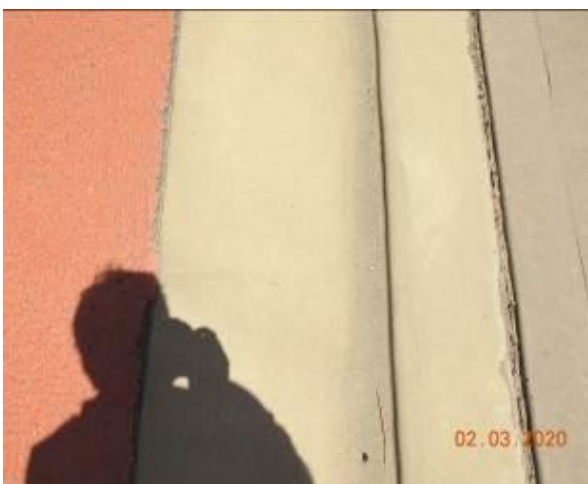
Figure 1645 – Loss of material through kerb

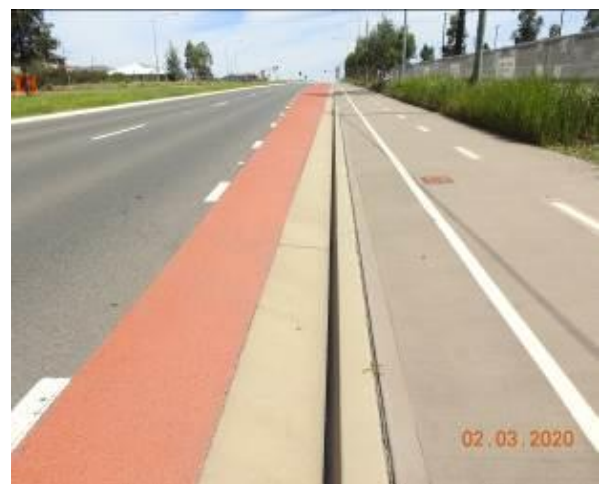
Figure 1646 – Crack propagation through layback and gutter

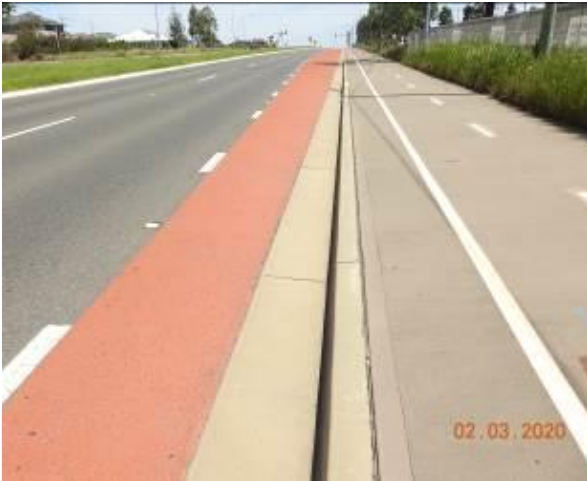
Figure 1647 – General Condition of kerb and gutter

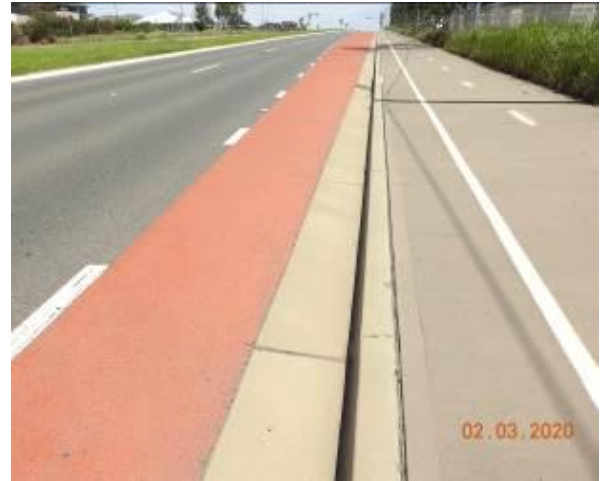
Figure 1648 – General Condition of kerb and gutter

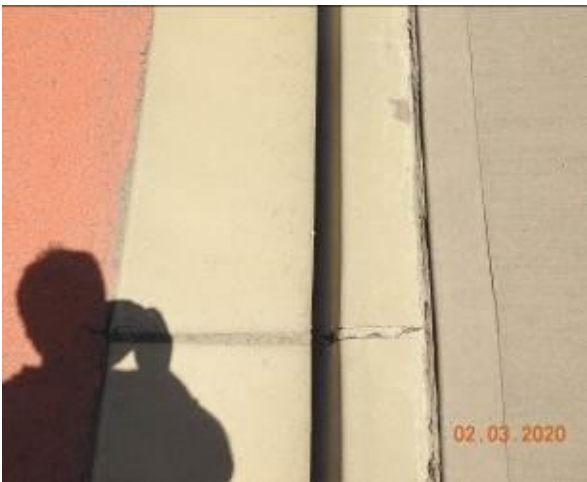
Figure 1649 – General Condition of kerb and gutter

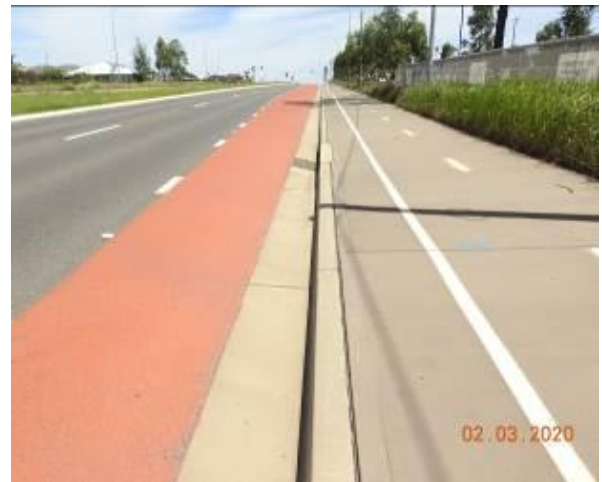
Figure 1650 – Crack propagation through kerb and gutter

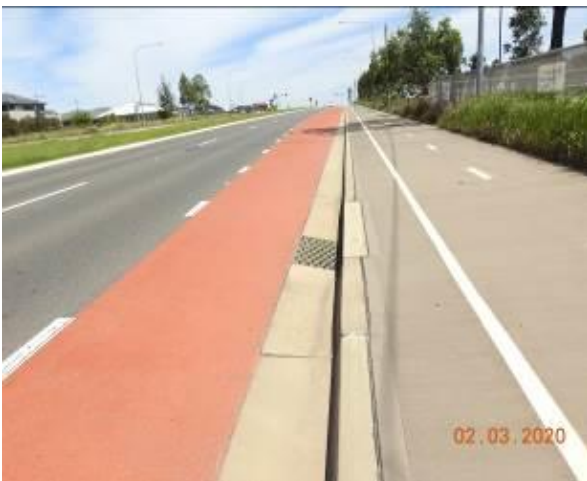
Figure 1651 – General Condition of kerb and gutter

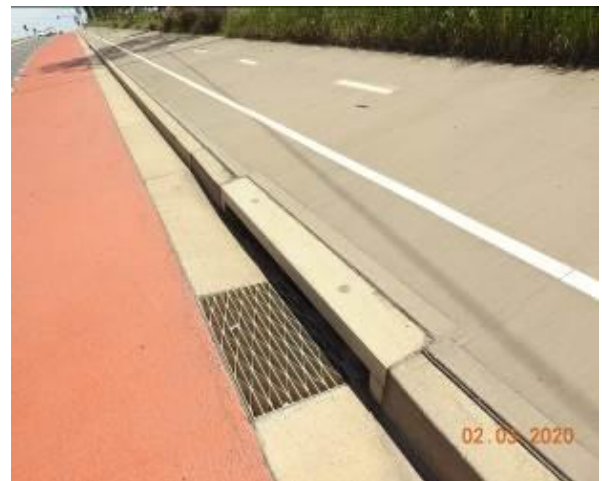
Figure 1652 – General Condition of kerb and gutter

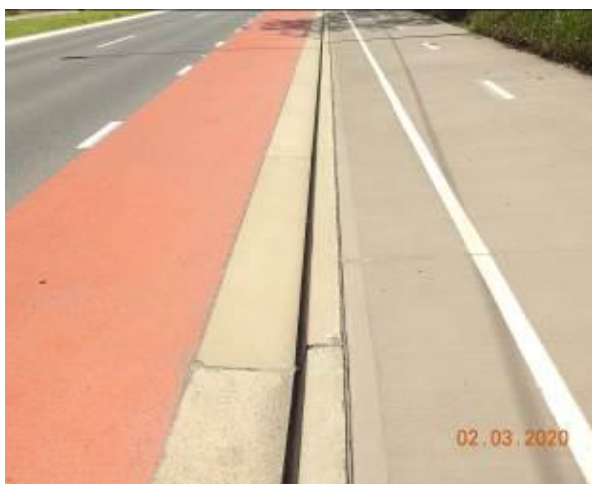
Figure 1653 – General Condition of stormwater inlet pit

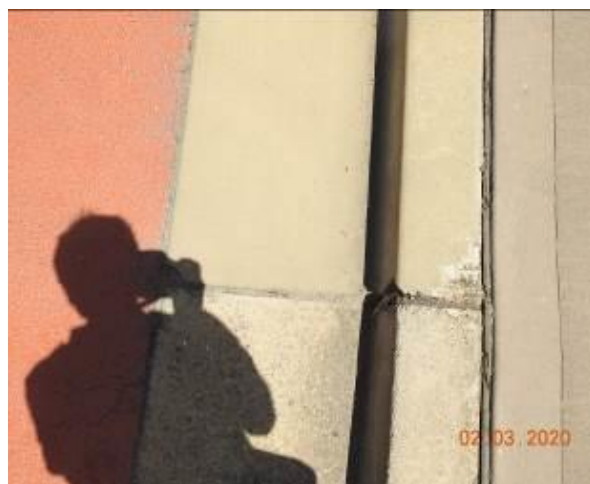
Figure 1654 – General Condition of kerb and gutter

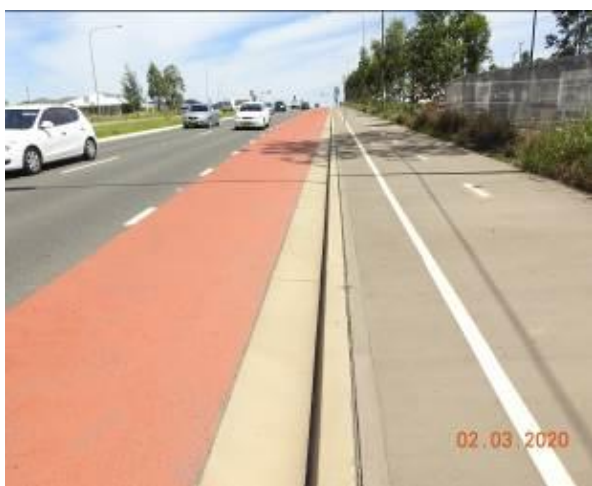
Figure 1655 – Loss of material through kerb and gutter

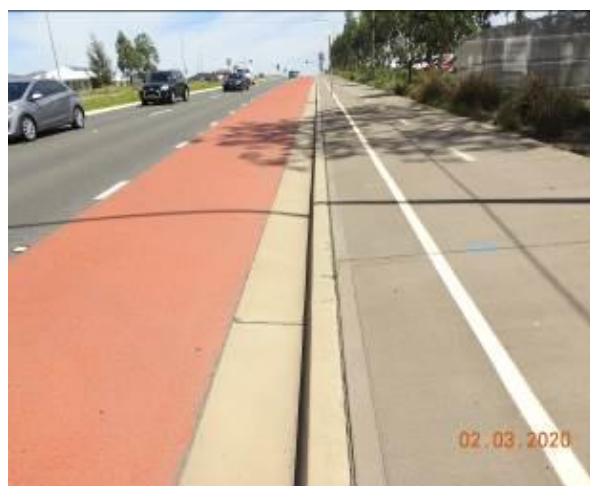
Figure 1656 – General Condition of kerb and gutter

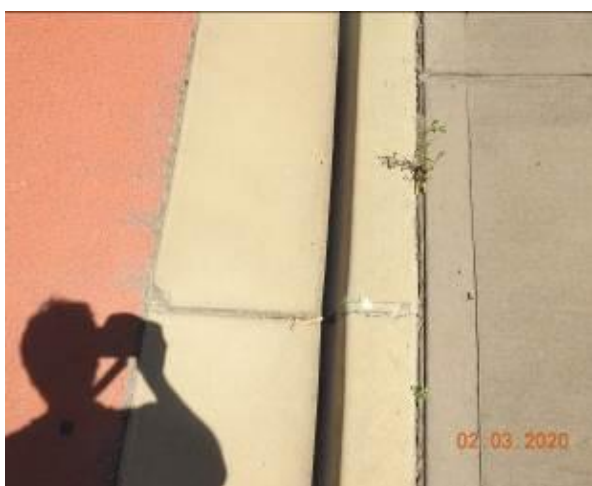
Figure 1657 – General Condition of kerb and gutter

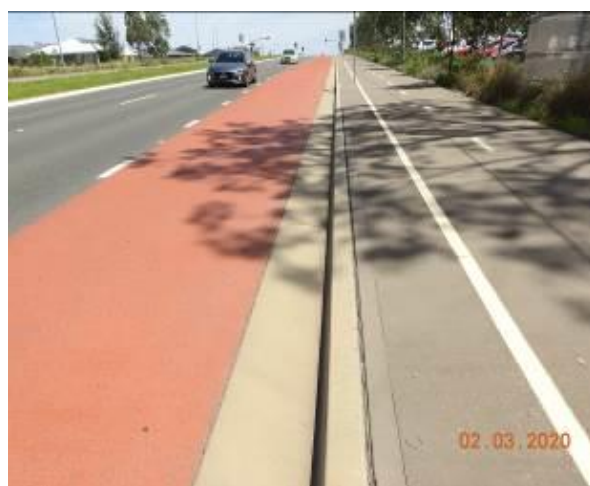
Figure 1658 – Crack propagation and loss of material through kerb and gutter

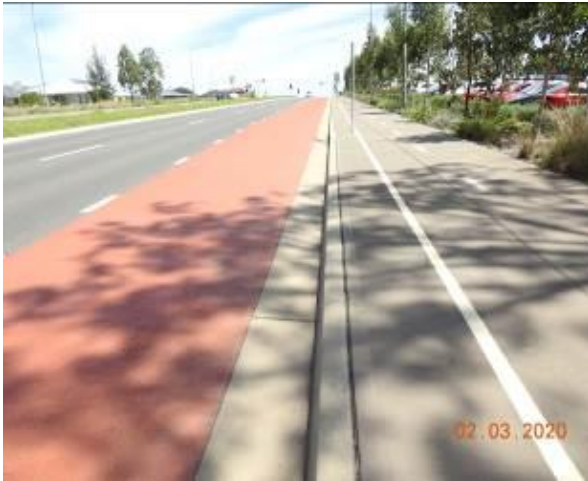
Figure 1659 – General Condition of kerb and gutter

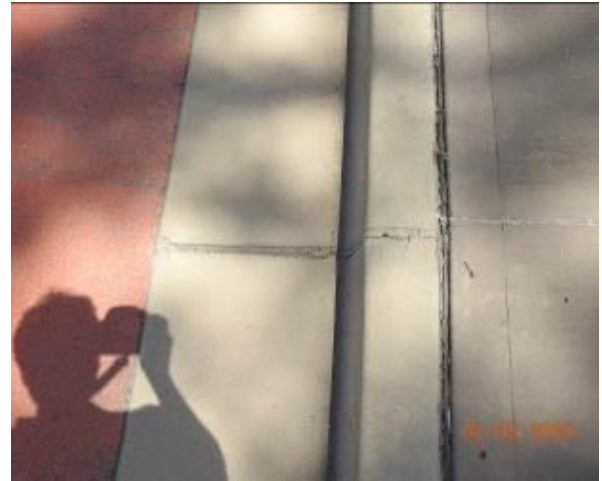
Figure 1660 – General Condition of kerb and gutter

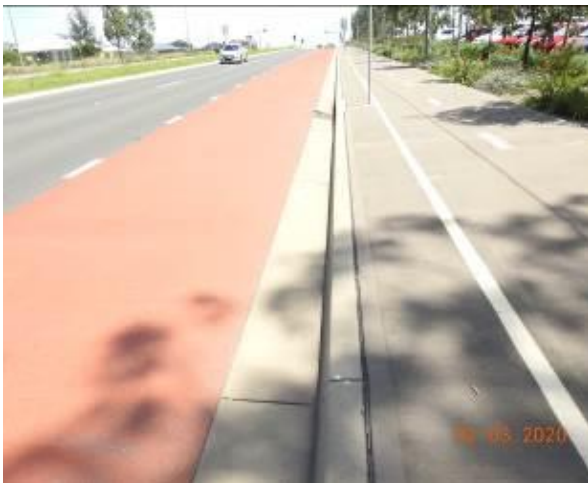
Figure 1661 – Crack propagation and loss of material through kerb and gutter

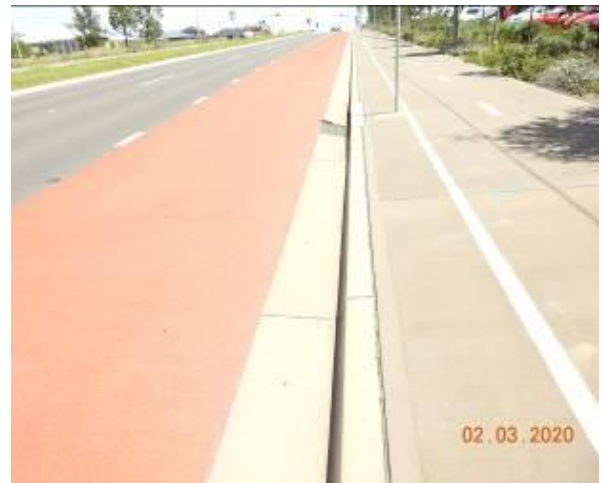
Figure 1662 – General Condition of kerb and gutter

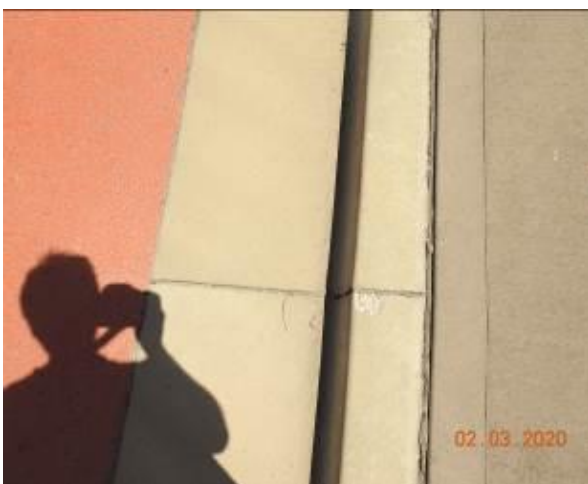
Figure 1663 – General Condition of kerb and gutter

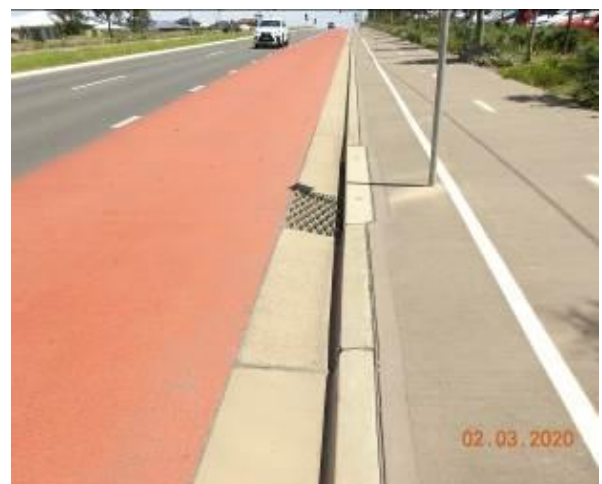
Figure 1664 – Loss of material through kerb

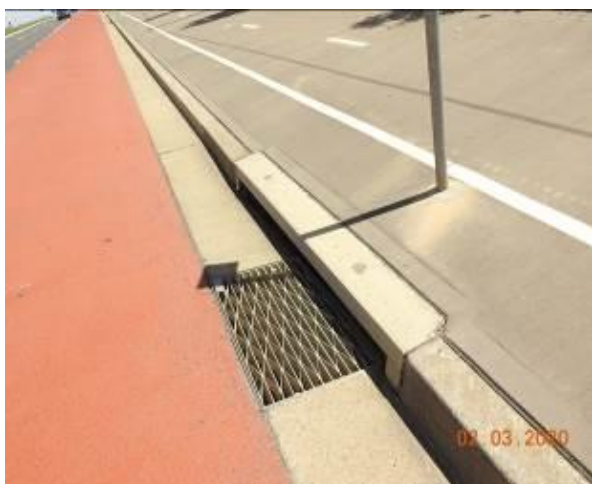
Figure 1665 – General Condition of kerb and gutter

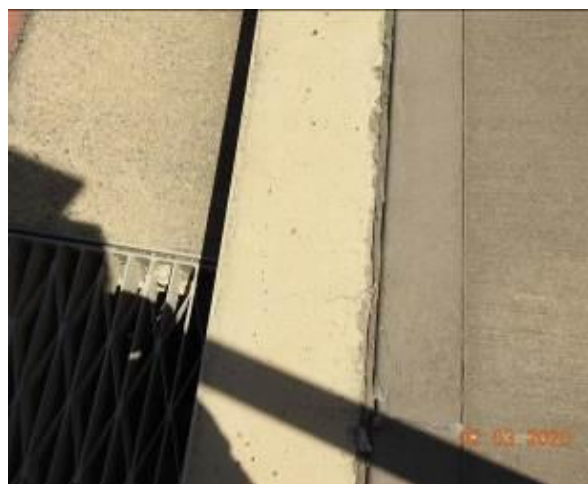
Figure 1666 – General Condition of stormwater inlet pit

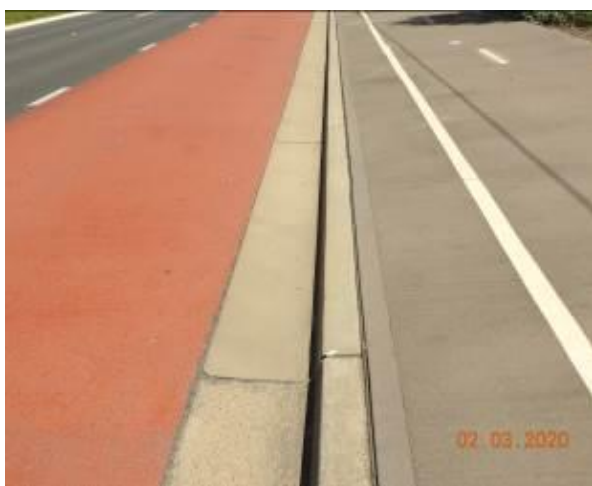
Figure 1667 – Crack propagation through stormwater inlet pit

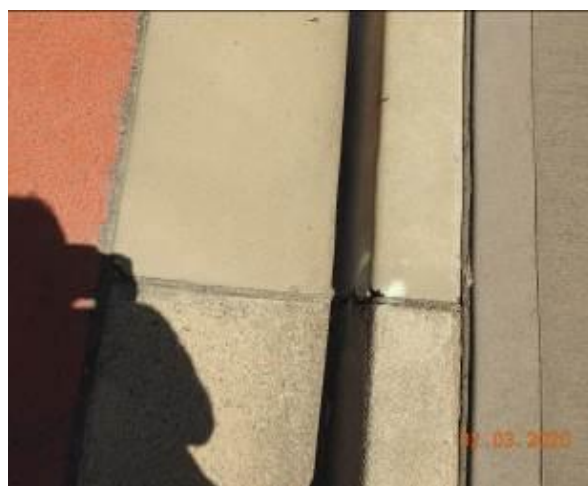
Figure 1668 – General Condition of kerb and gutter

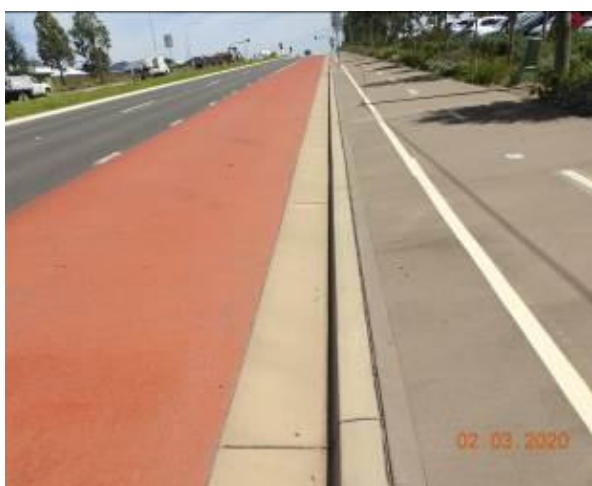
Figure 1670 – General Condition of kerb and gutter

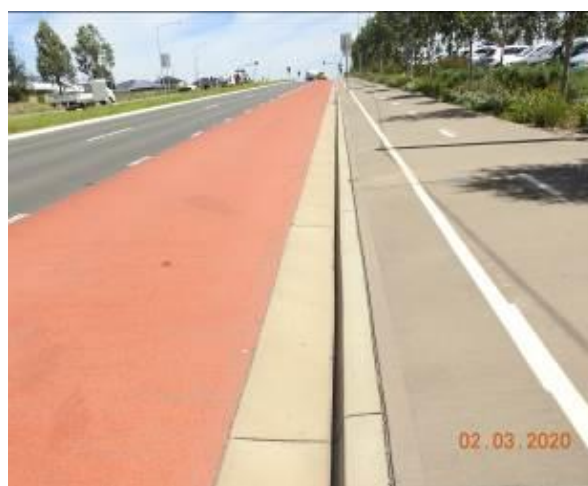
Figure 1671 – General Condition of kerb and gutter

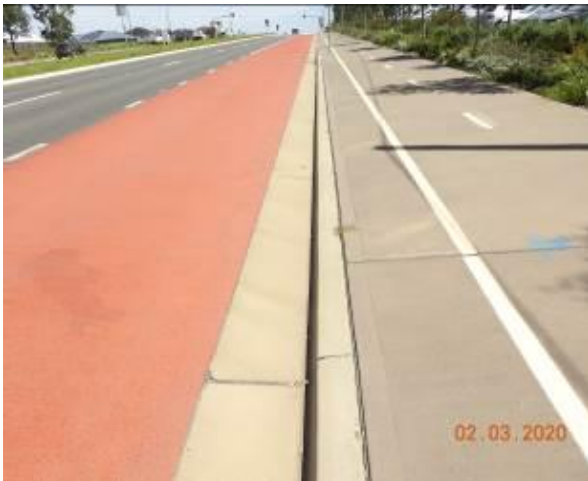
Figure 1672 – General Condition of kerb and gutter

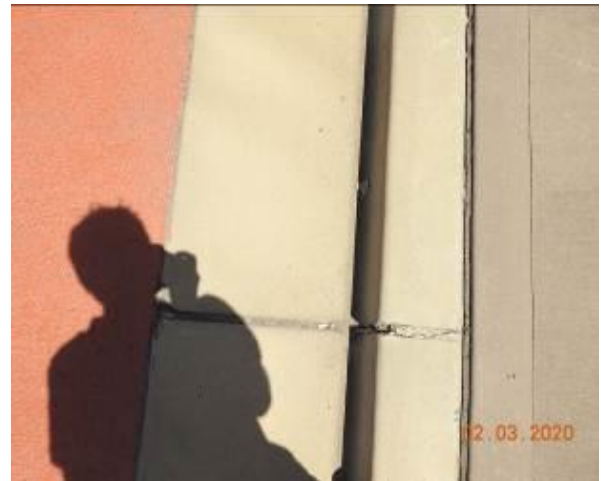
Figure 1673 – Crack propagation and loss of material through kerb and gutter

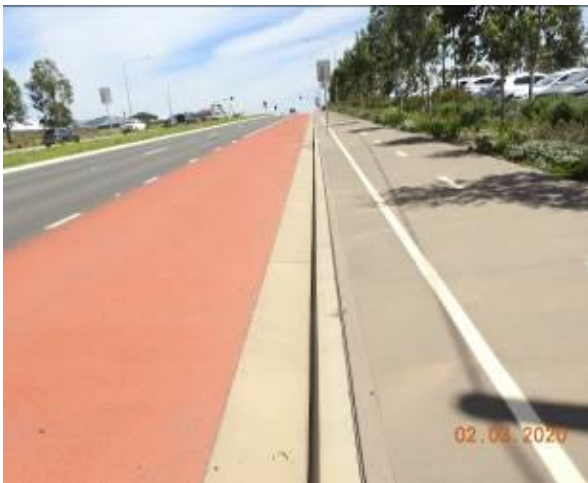
Figure 1674 – General Condition of kerb and gutter

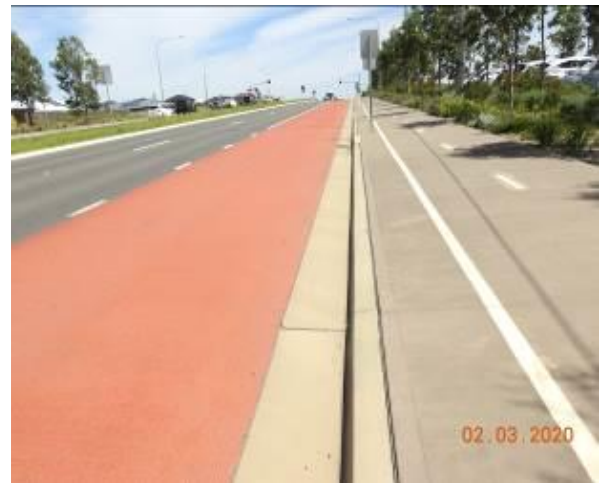
Figure 1675 – General Condition of kerb and gutter

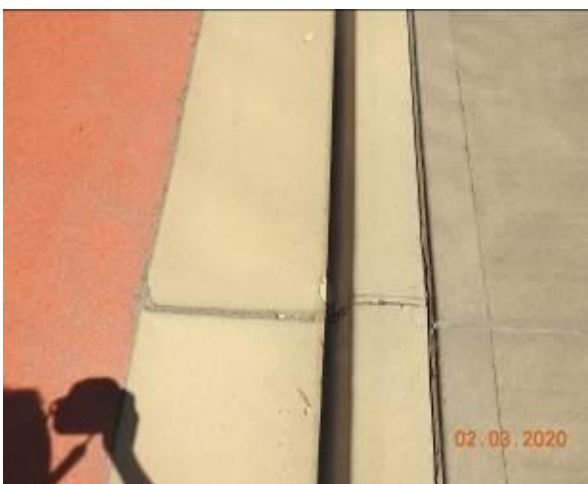
Figure 1676 – Crack propagation and loss of material through kerb and gutter

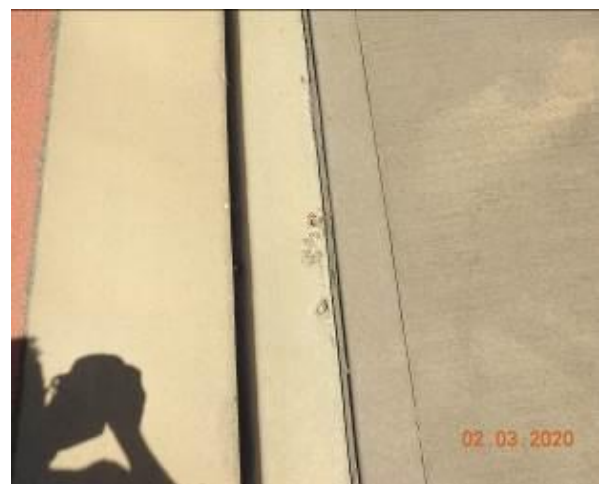
Figure 1677 – Loss of material through kerb

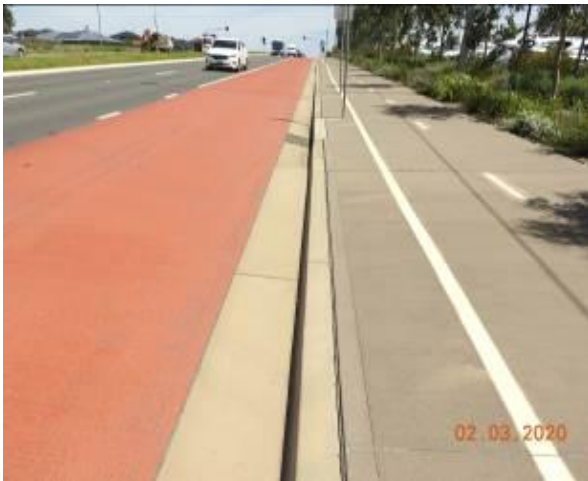
Figure 1678 – General Condition of kerb and gutter

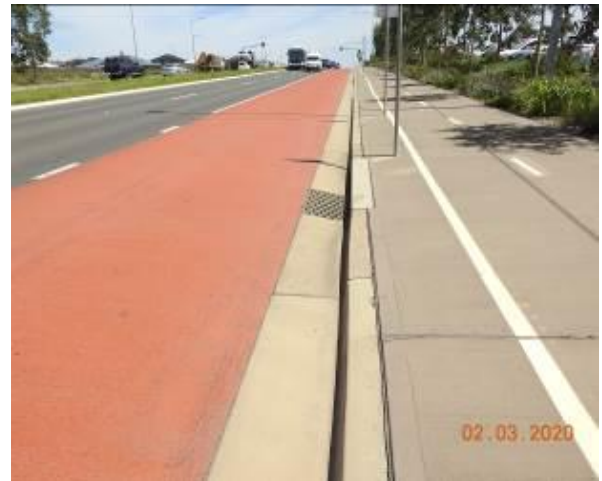
Figure 1679 – General Condition of kerb and gutter

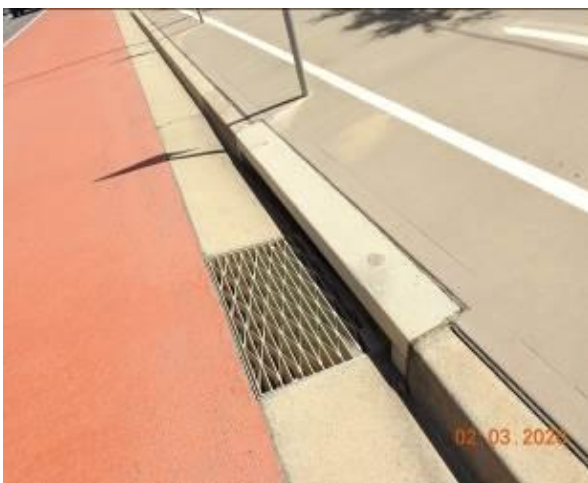
Figure 1680 – General Condition of stormwater inlet pit

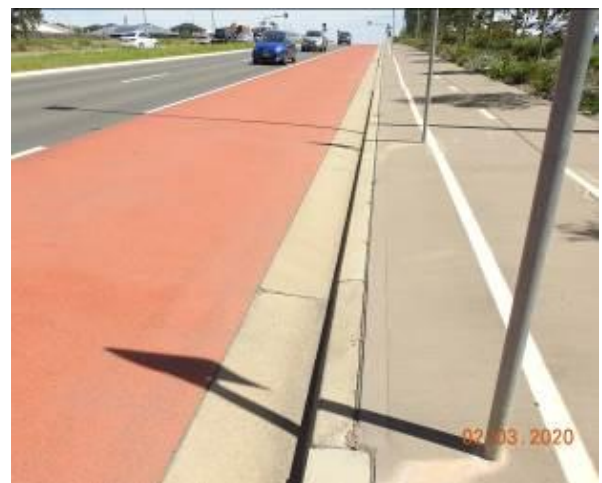
Figure 1681 – General Condition of kerb and gutter

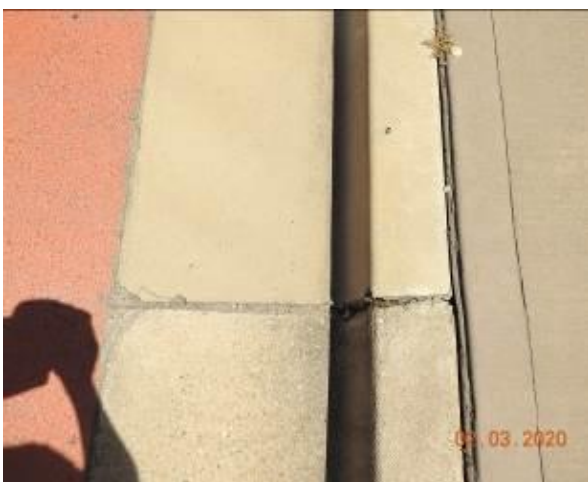
Figure 1682 – Crack propagation and loss of material through kerb and gutter

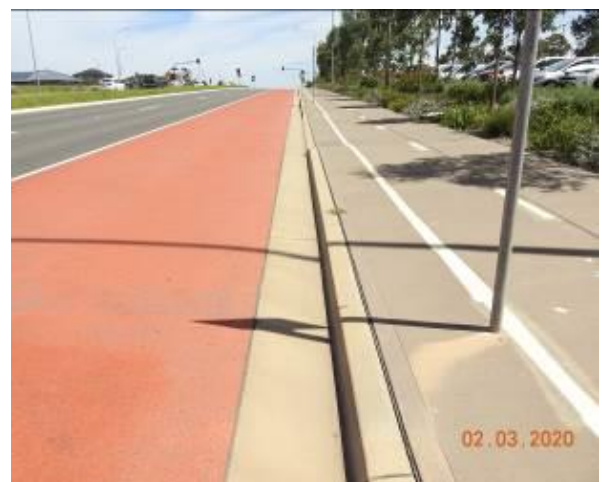
Figure 1683 – General Condition of kerb and gutter

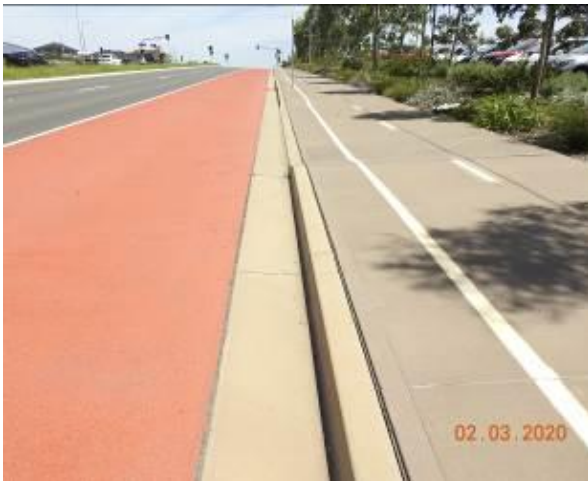
Figure 1684 – General Condition of kerb and gutter
