**1-15 AND 2-12 CONFERTA AVENUE,
ROUSE HILL NSW 2155
TALLAWONG STATION PRECINCT SOUTH
PRE-DILAPIDATION REPORT**

**DEICORP PROJECTS
(TALLAWONG STATION) PTY LTD**

Job No. 191294.0
24/03/2020

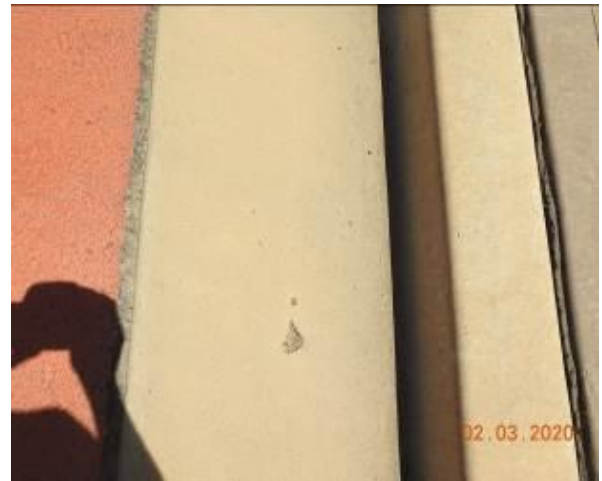
Figure 1685 – Loss of material through gutter

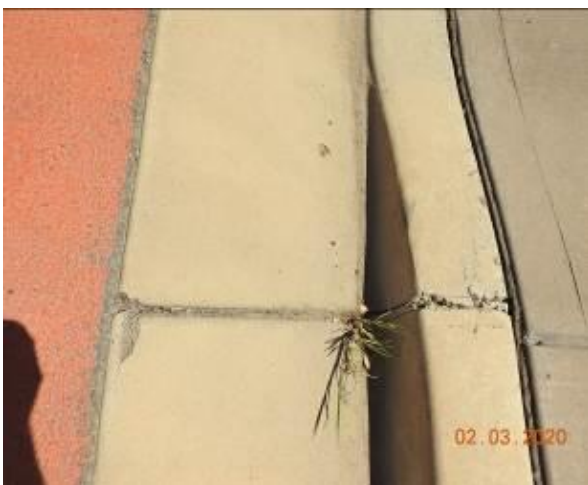
Figure 1686 – Loss of material through kerb and gutter

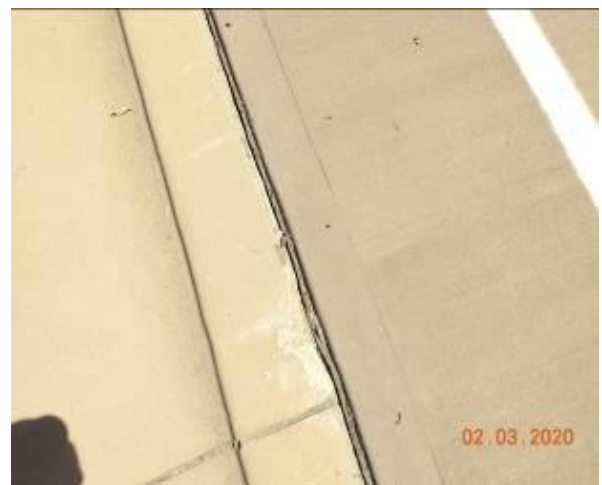
Figure 1687 – Loss of material through layback

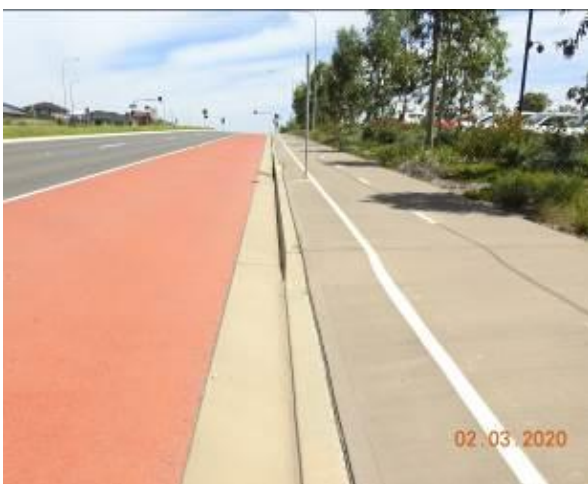
Figure 1688 – General Condition of layback and gutter

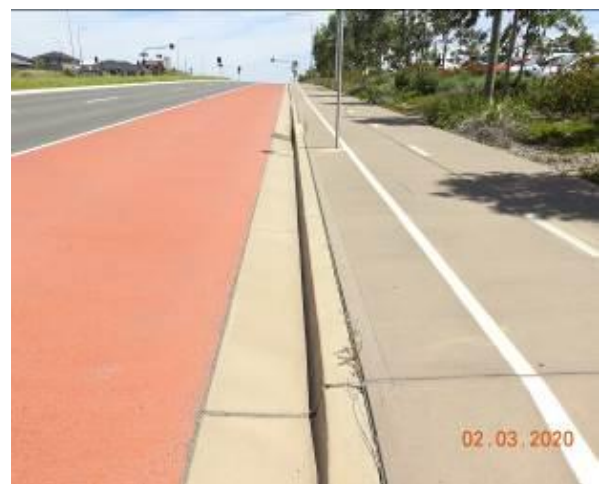
Figure 1689 – General Condition of kerb and gutter

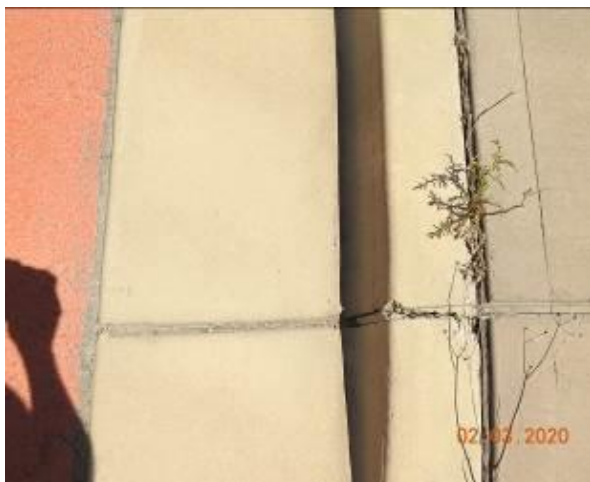
Figure 1690 – Crack propagation and loss of material through kerb

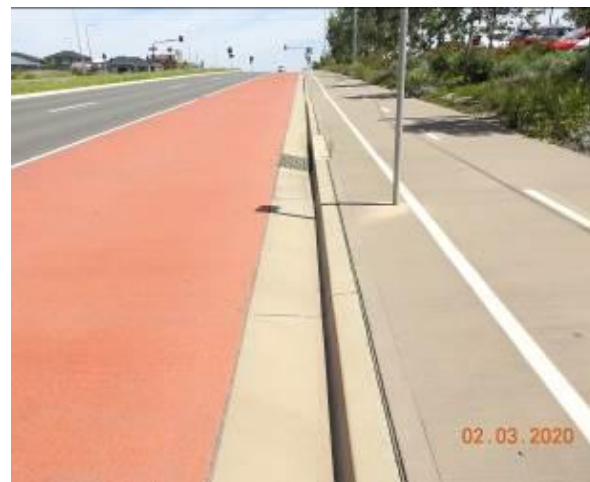
Figure 1691 – General Condition of kerb and gutter

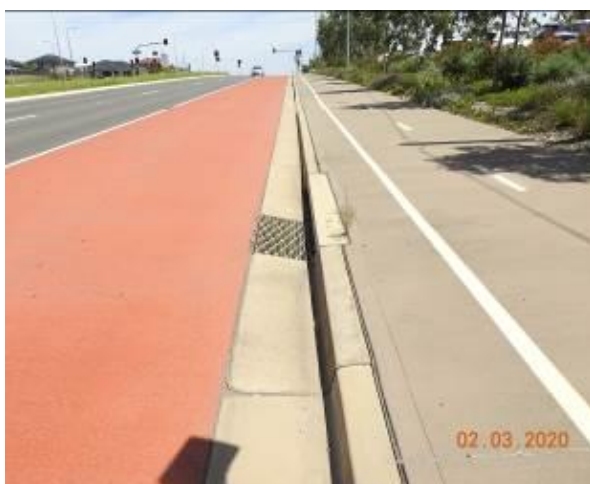
Figure 1692 – General Condition of kerb and gutter

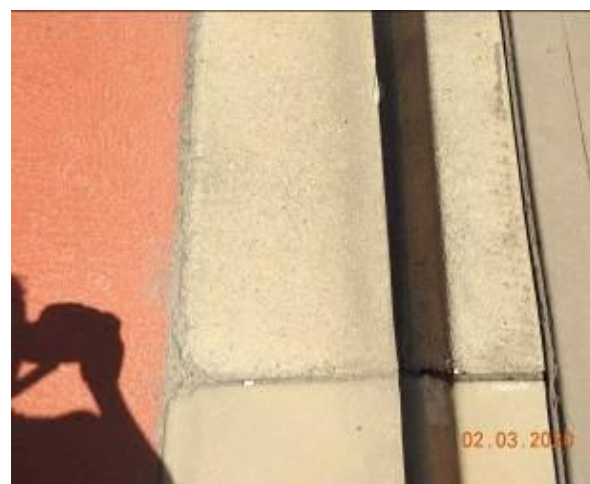
Figure 1693 – Crack propagation and loss of material through gutter

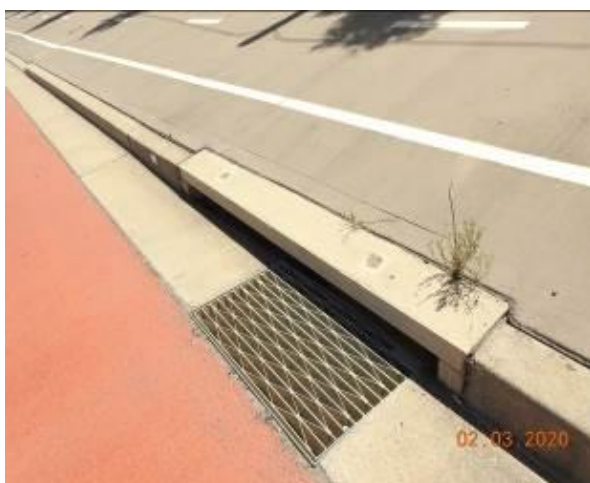
Figure 1694 – General Condition of stormwater inlet pit

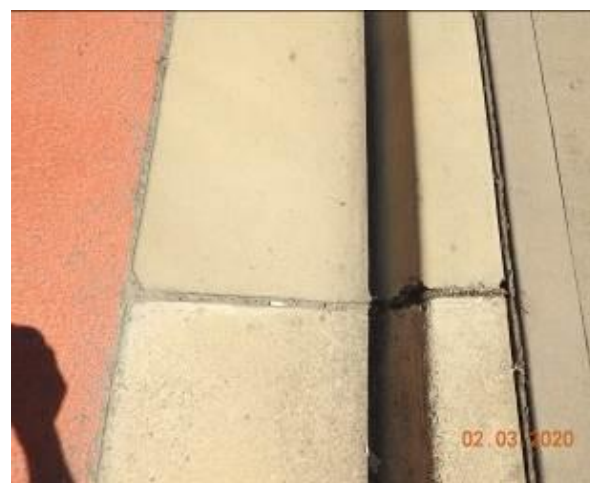
Figure 1695 – Loss of material through kerb and gutter

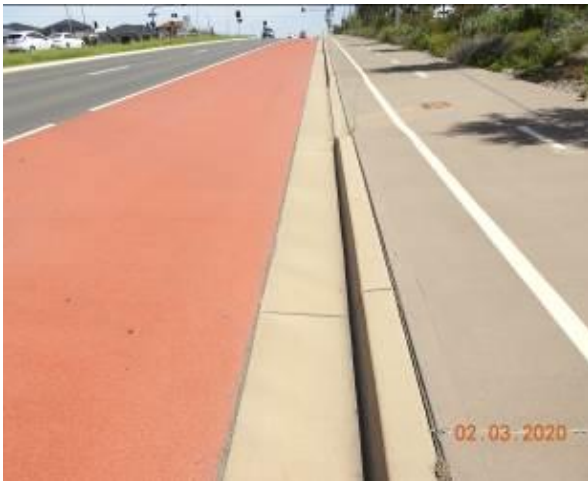
Figure 1696 – General Condition of kerb and gutter

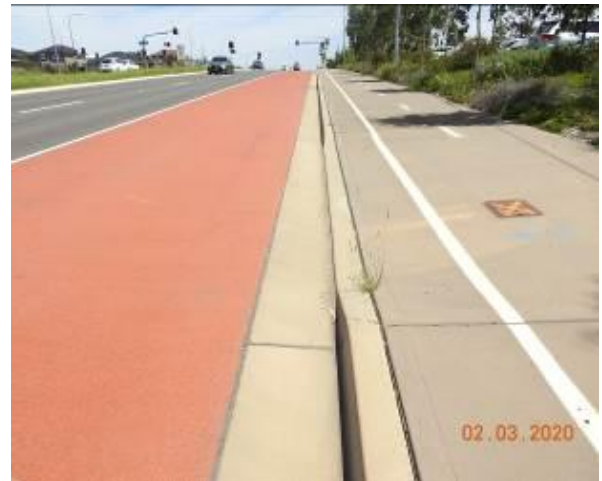
Figure 1697 – General Condition of layback and gutter

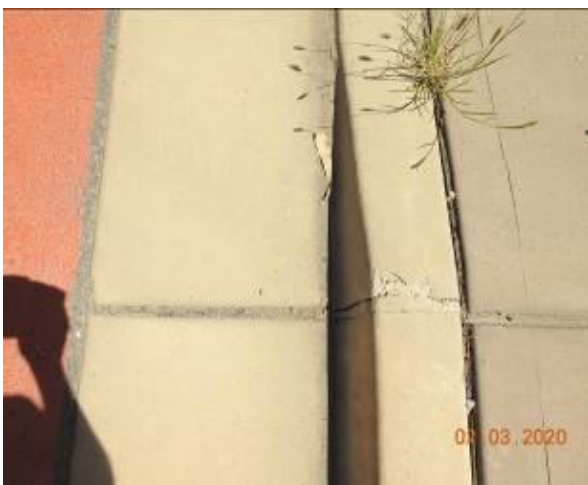
Figure 1698 – Loss of material through kerb

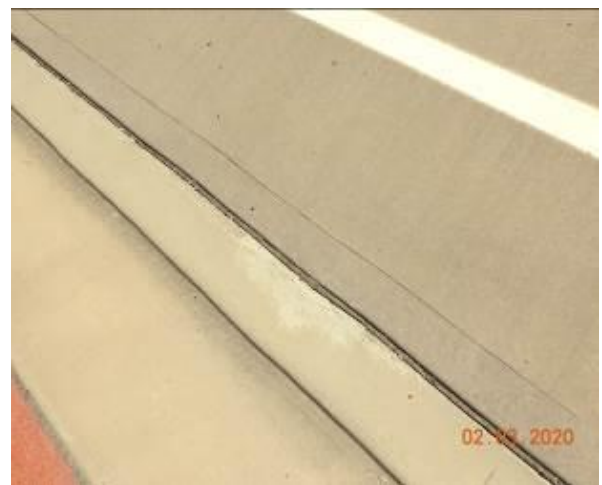
Figure 1699 – Loss of material through layback

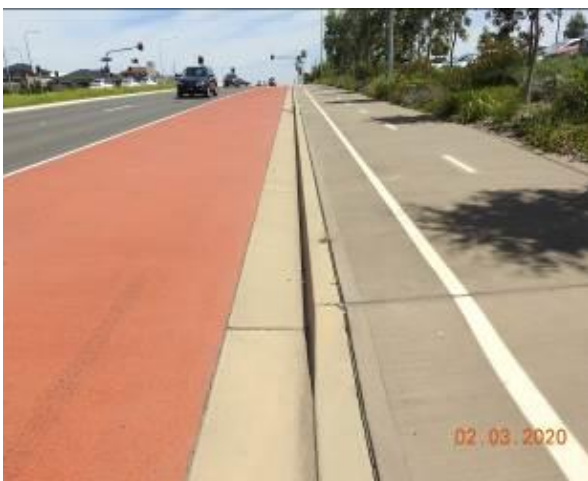
Figure 1700 – General Condition of layback and gutter

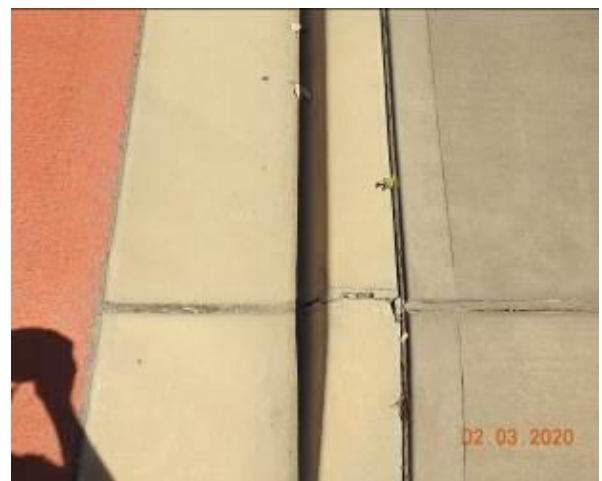
Figure 1701 – Crack propagation through kerb and gutter

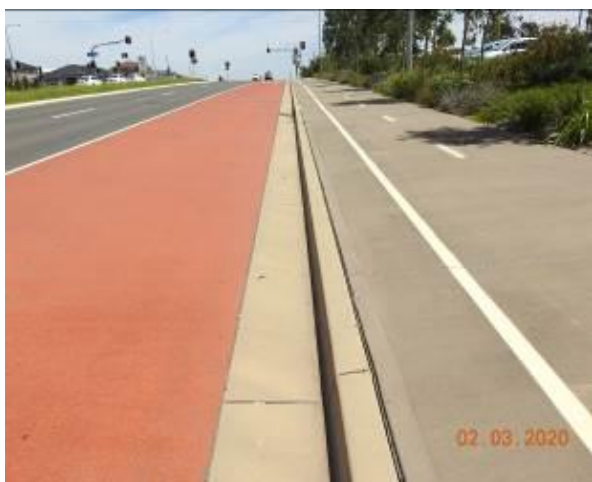
Figure 1702 – General Condition of kerb and gutter

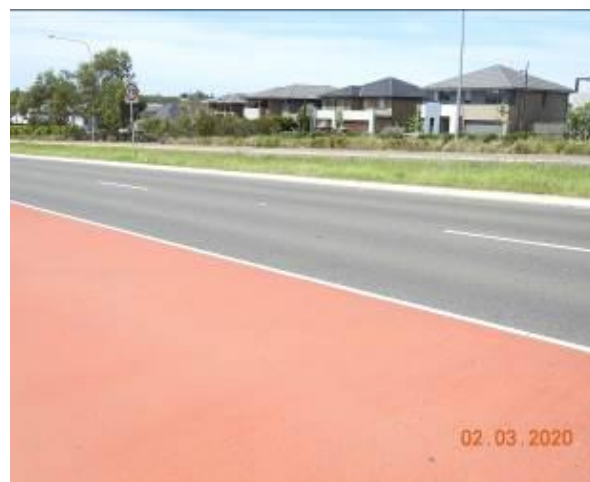
Figure 1703 – General Condition of road surface

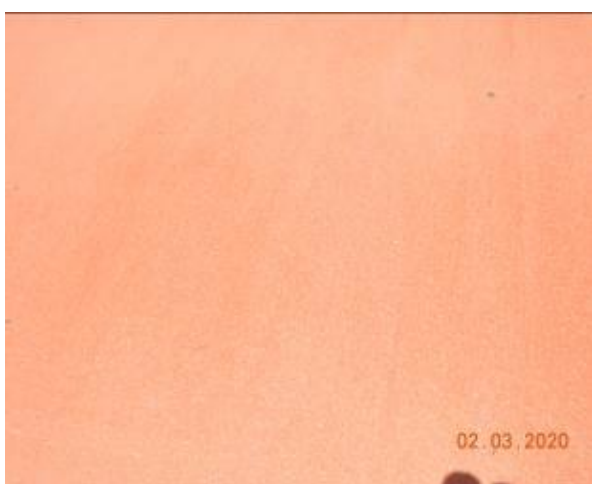
Figure 1704 – General Condition of road surface

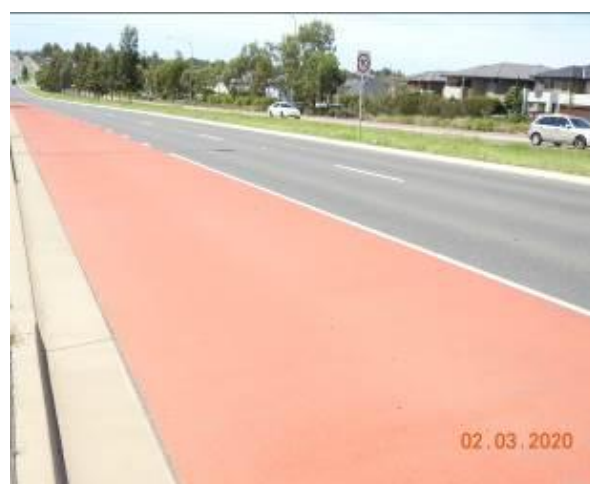
Figure 1705 – General Condition of road surface

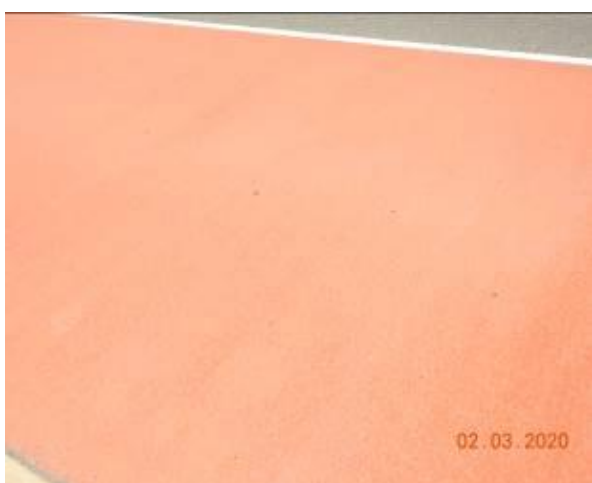
Figure 1706 – General Condition of road surface

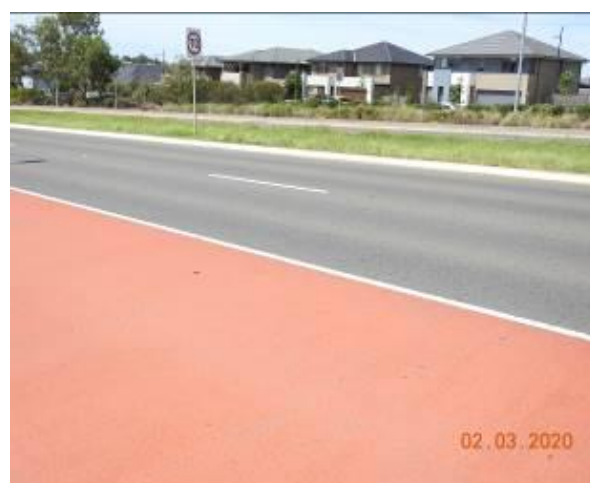
Figure 1707 – General Condition of road surface

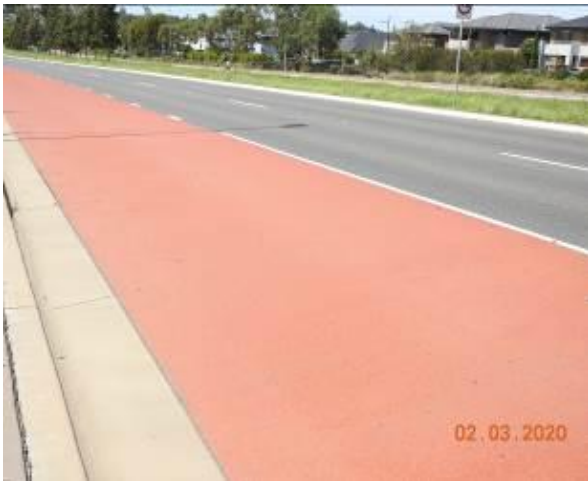
Figure 1708 – General Condition of road surface

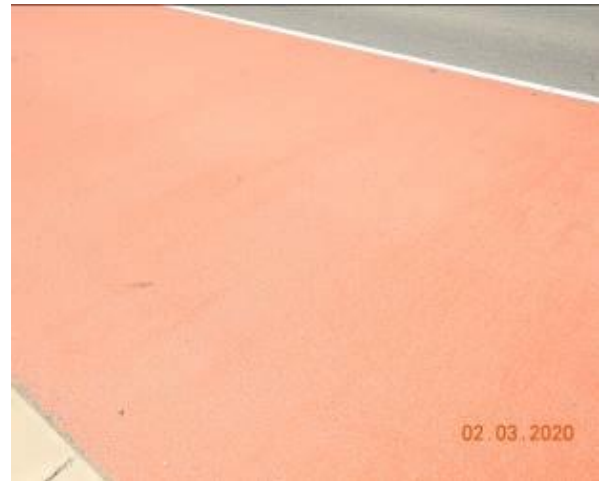
Figure 1709 – General Condition of road surface

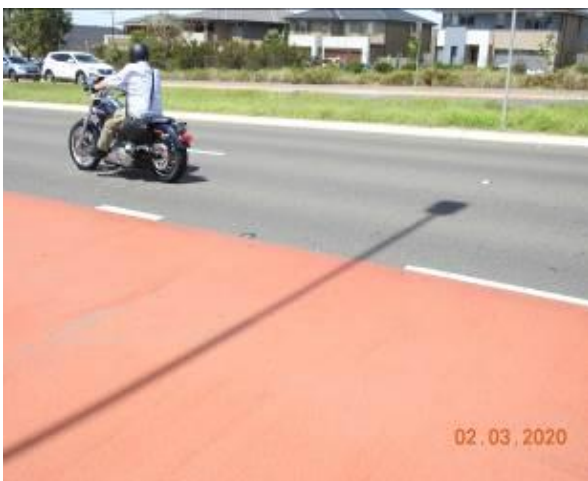
Figure 1711 – Crack propagation through road surface

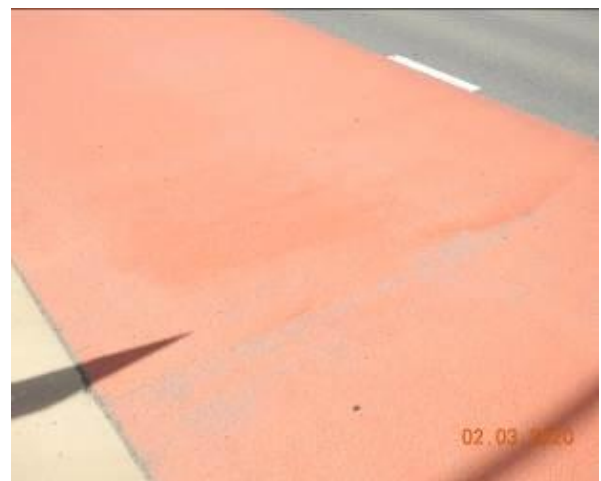
Figure 1712 – General Condition of road surface

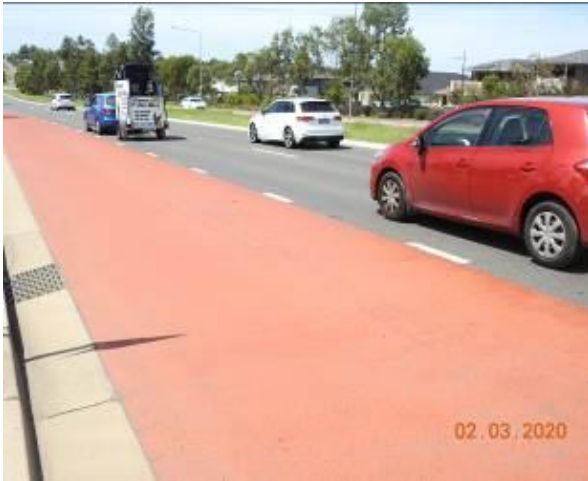
Figure 1713 – Crack propagation through road surface

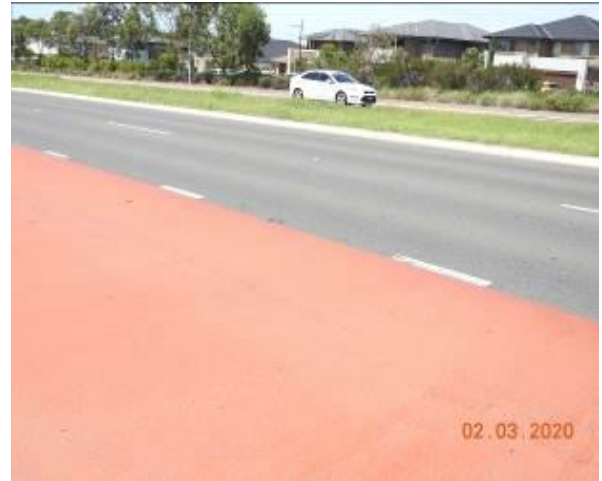
Figure 1714 – General Condition of road surface

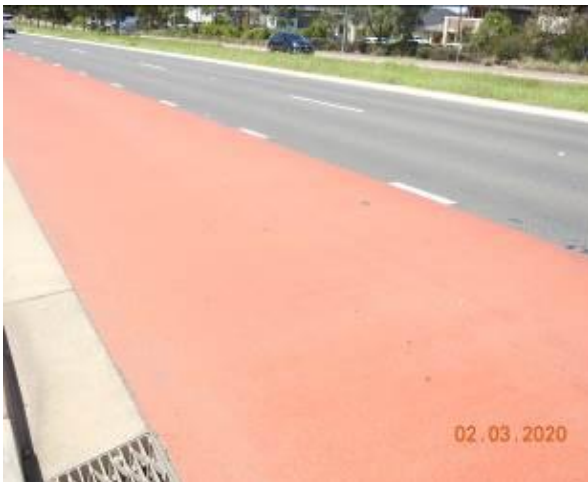
Figure 1715 – General Condition of road surface

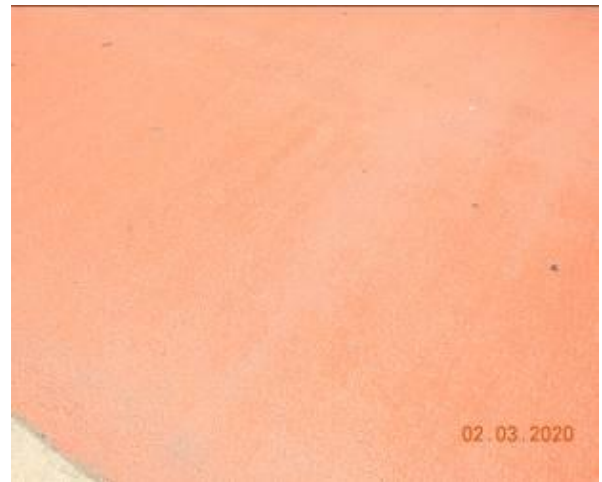
Figure 1716 – General Condition of road surface

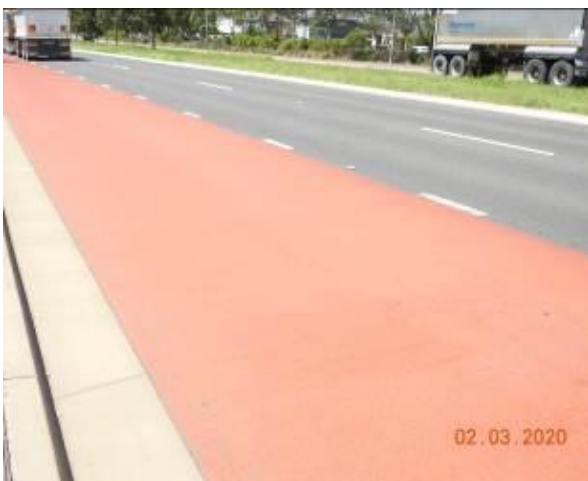
Figure 1717 – Crack propagation through road surface

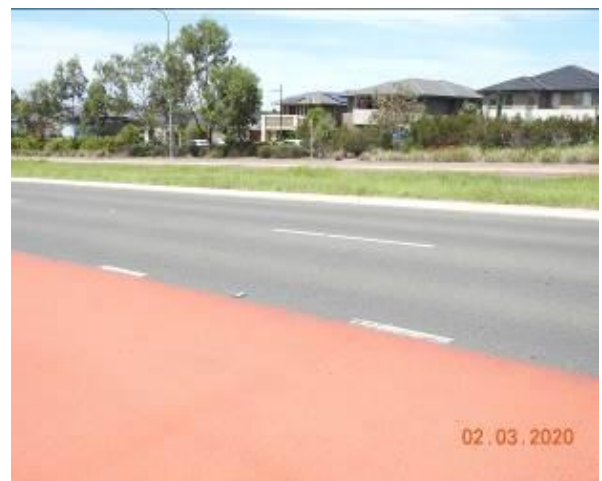
Figure 1718 – General Condition of road surface

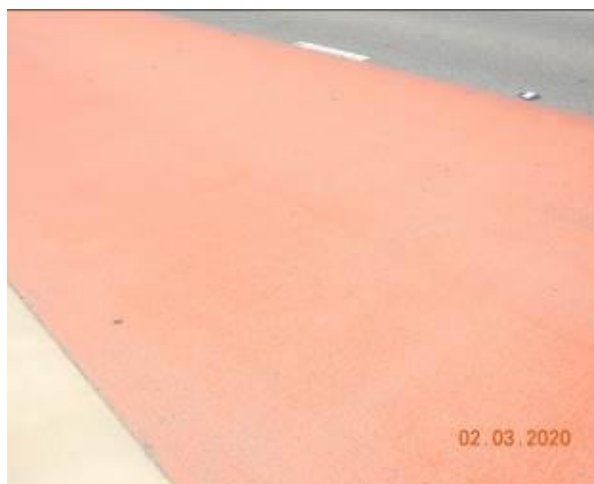
Figure 1719 – General Condition of road surface

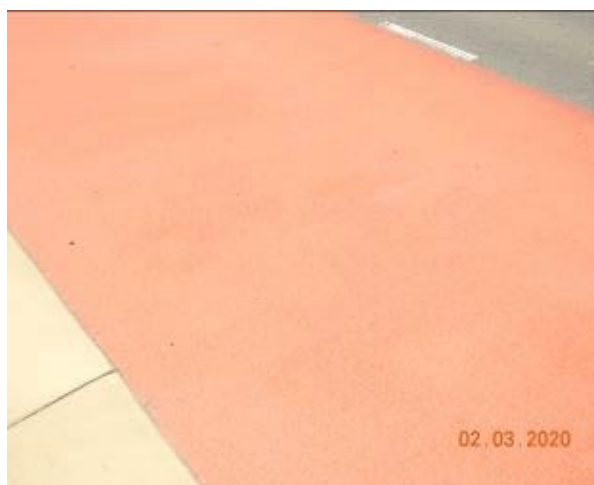
Figure 1720 – General Condition of road surface

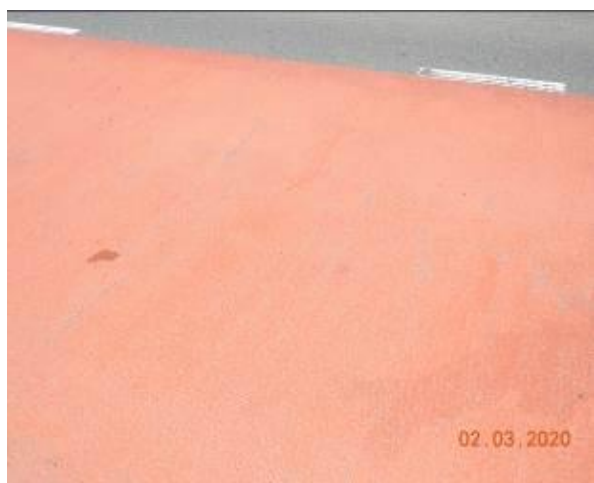
Figure 1722 – General Condition of road surface

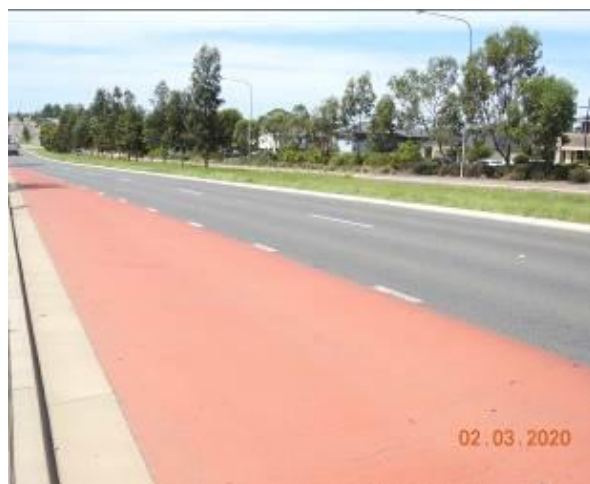
Figure 1724 – Crack propagation through road surface

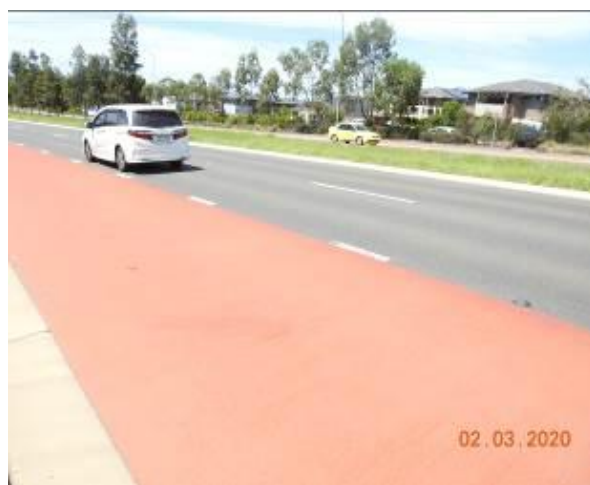
Figure 1721 – General Condition of road surface

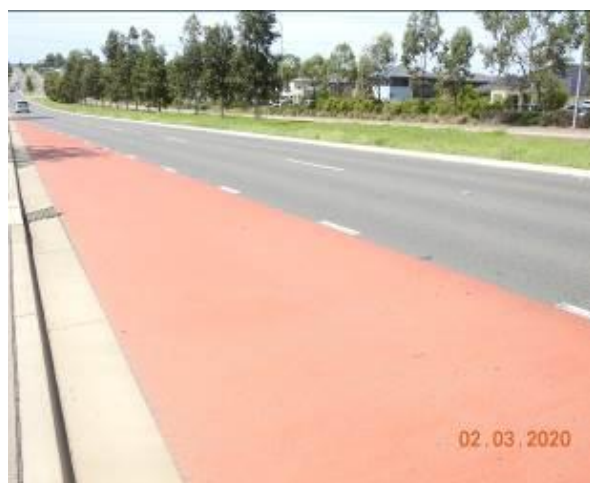
Figure 1723 – General Condition of road surface

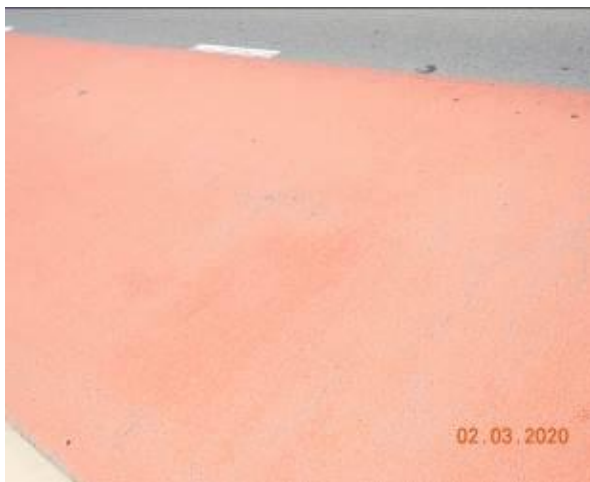
Figure 1725 – General Condition of road surface

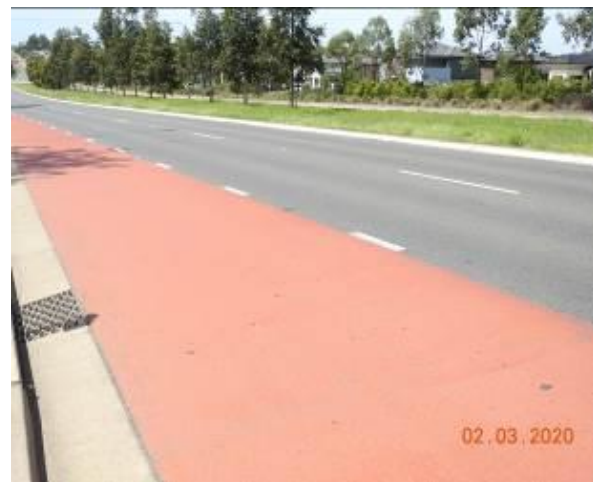
Figure 1726 – Crack propagation through road surface

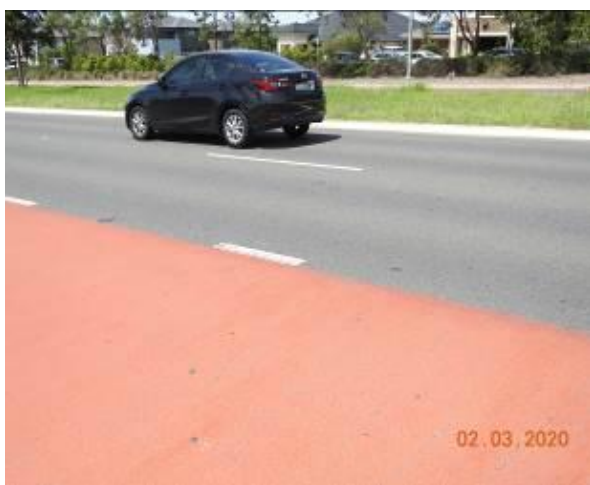
Figure 1727 – General Condition of road surface

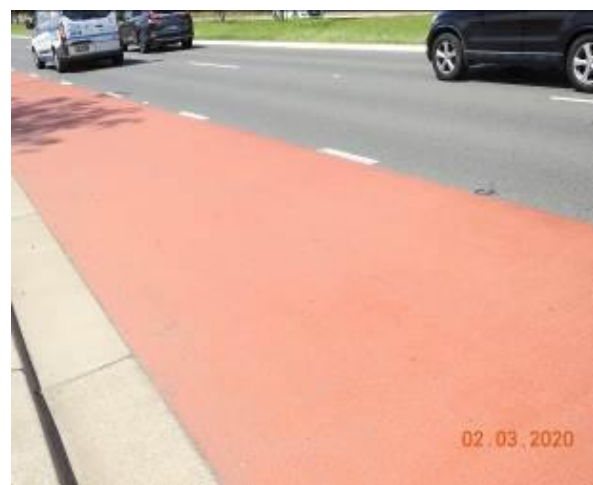
Figure 1728 – General Condition of road surface

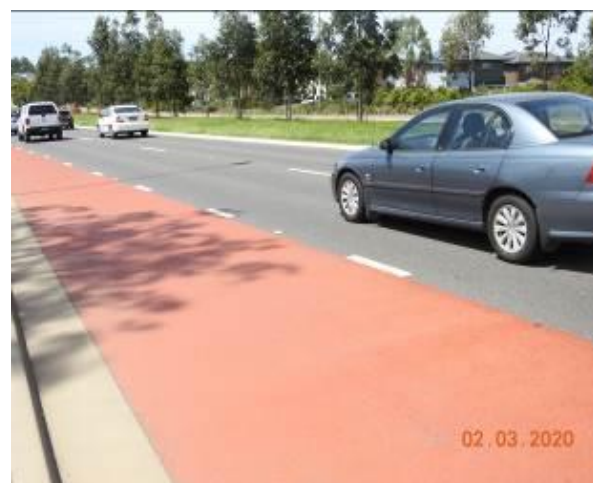
Figure 1730 – General Condition of road surface

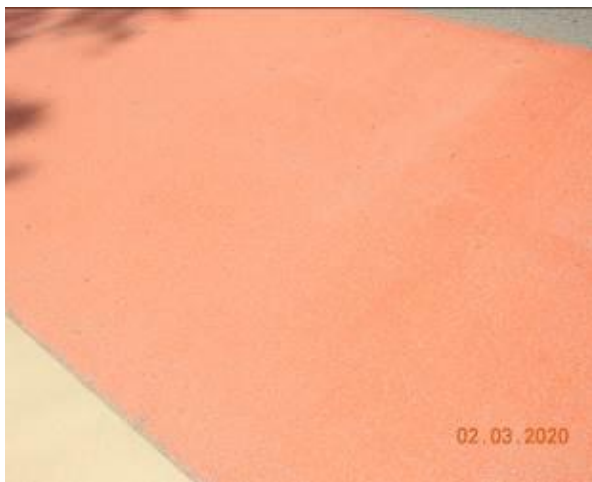
Figure 1731 – General Condition of road surface

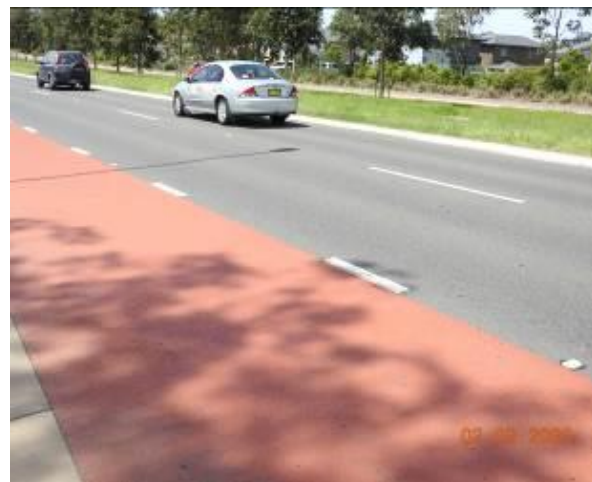
Figure 1732 – General Condition of road surface

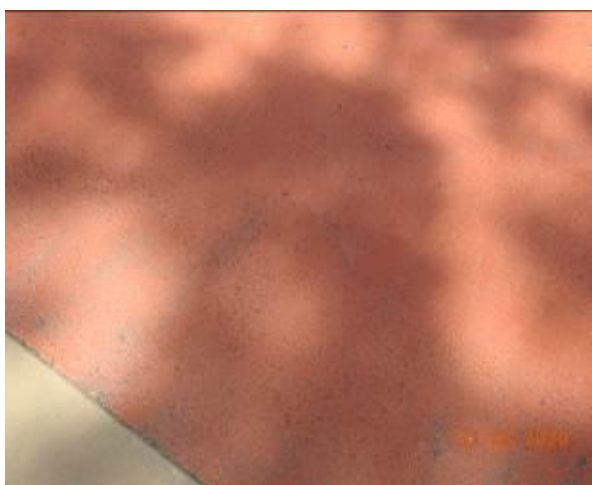
Figure 1733 – General Condition of road surface

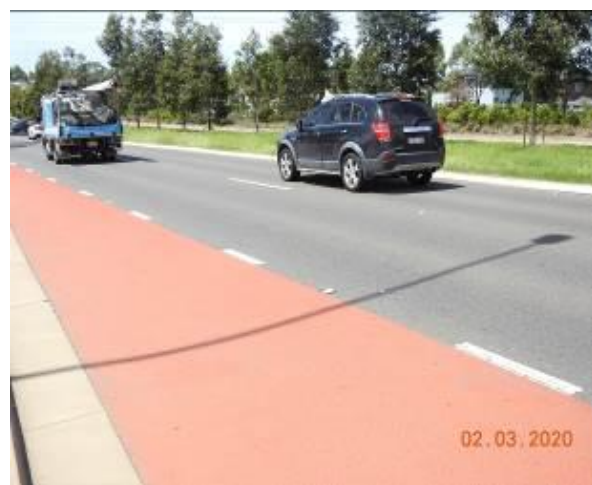
Figure 1734 – Crack propagation through road surface

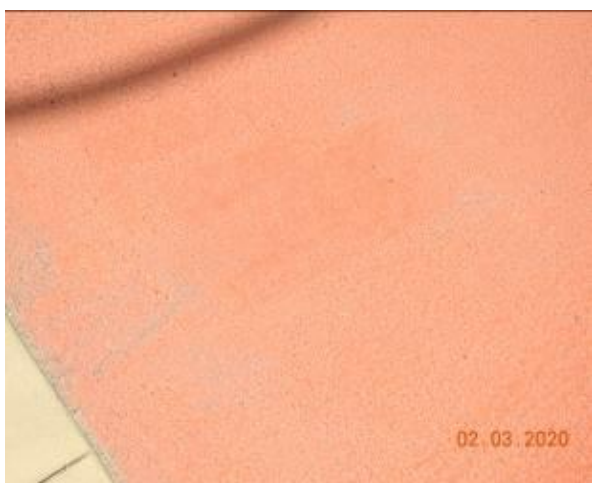
Figure 1735 – General Condition of road surface

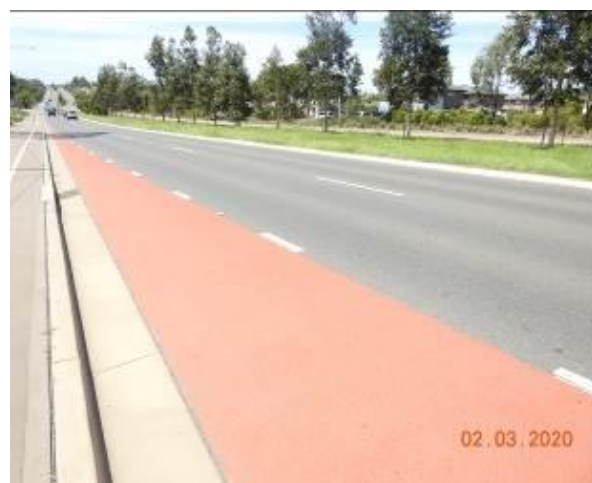
Figure 1736 – Crack propagation through road surface

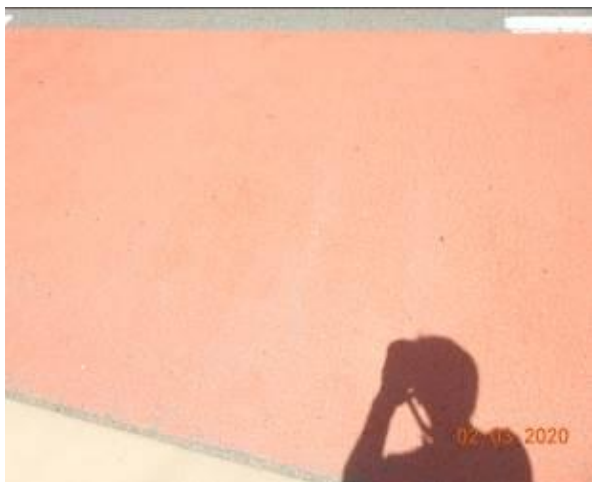
Figure 1737 – General Condition of road surface

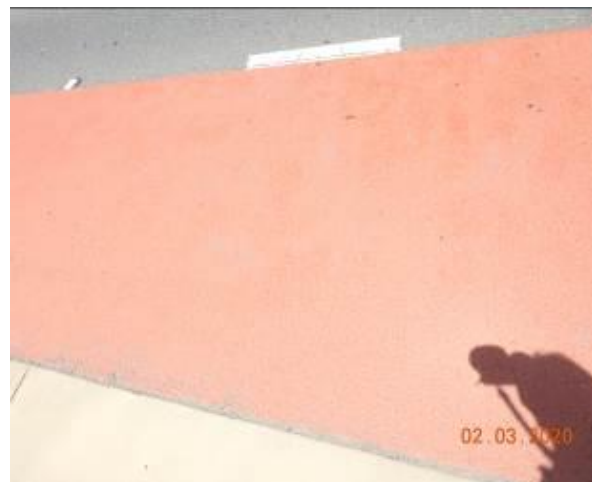
Figure 1738 – General Condition of road surface

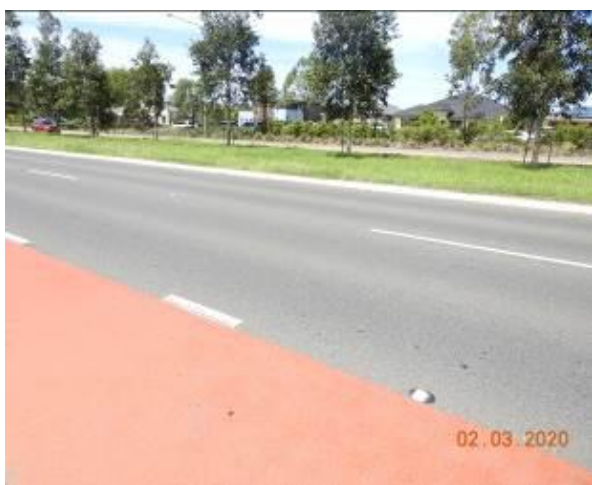
Figure 1739 – General Condition of road surface

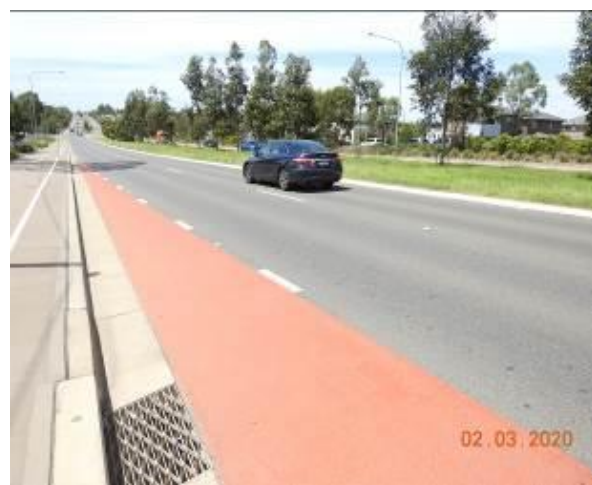
Figure 1740 – General Condition of road surface

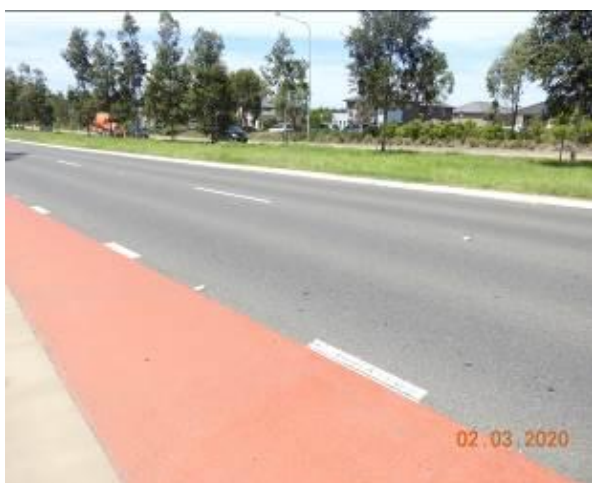
Figure 1741 – General Condition of road surface

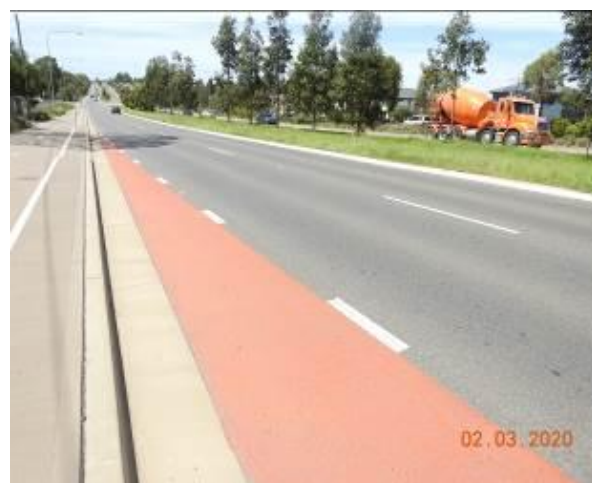
Figure 1742 – General Condition of road surface

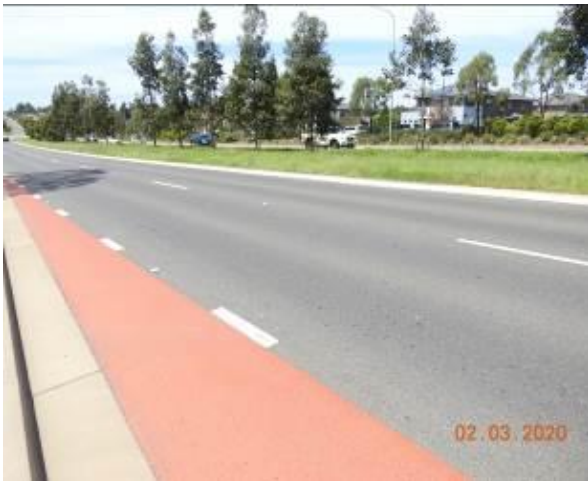
Figure 1743 – General Condition of road surface

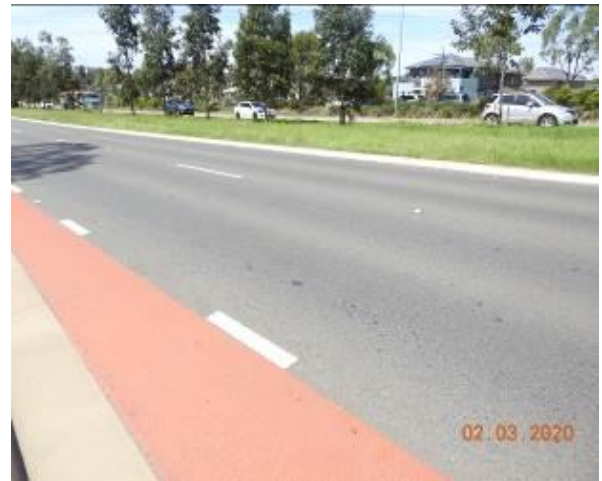
Figure 1744 – General Condition of road surface

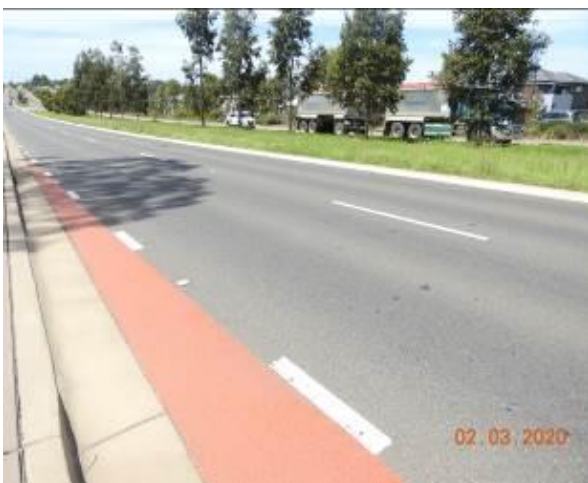
Figure 1745 – General Condition of road surface

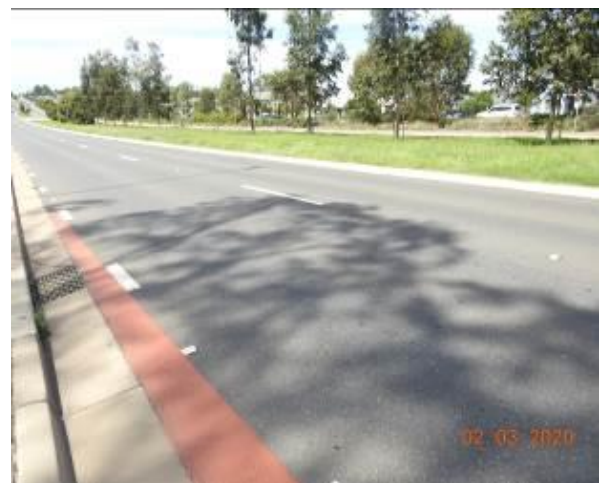
Figure 1746 – General Condition of road surface

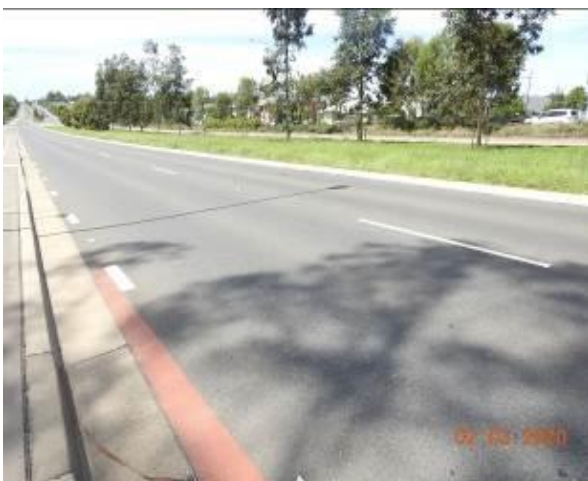
Figure 1747 – General Condition of road surface

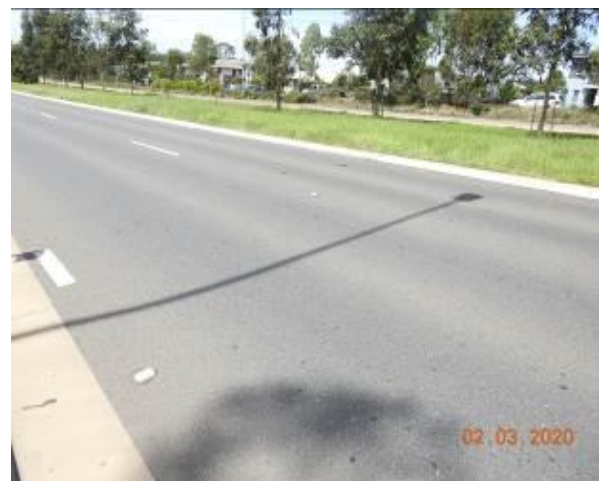
Figure 1748 – General Condition of road surface

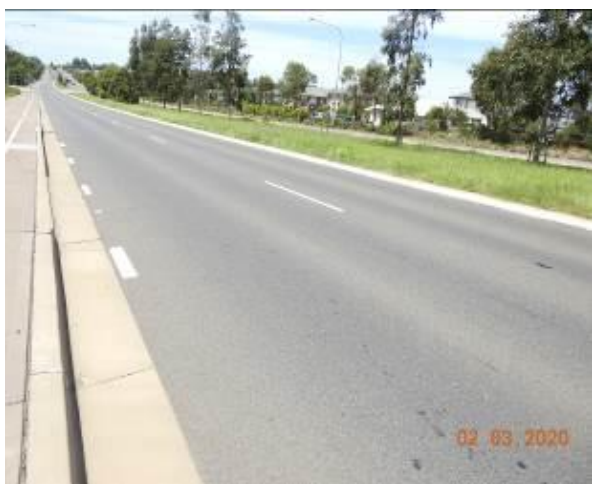
Figure 1749 – General Condition of road surface

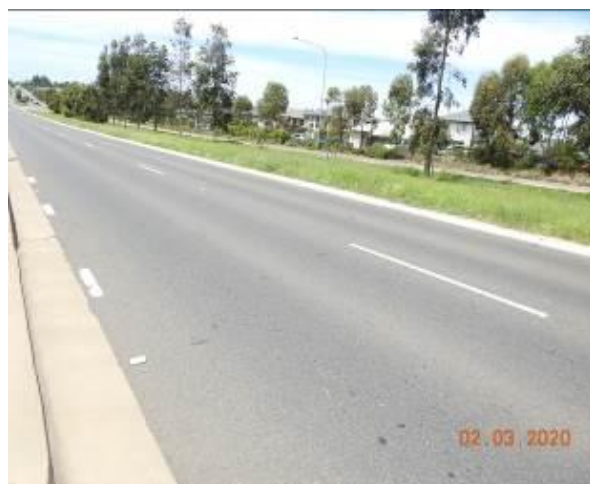
Figure 1750 – General Condition of road surface

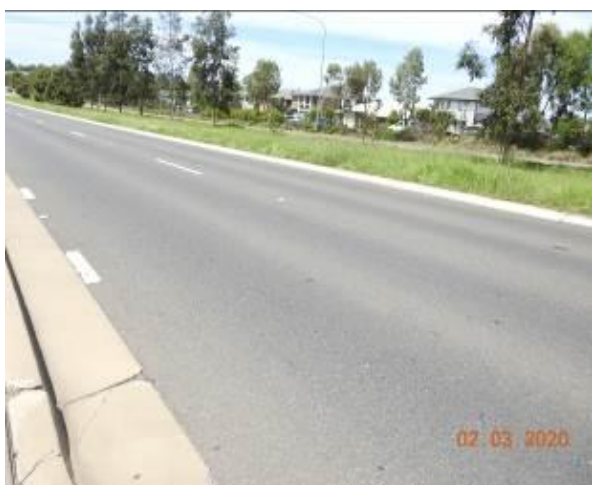
Figure 1751 – General Condition of road surface

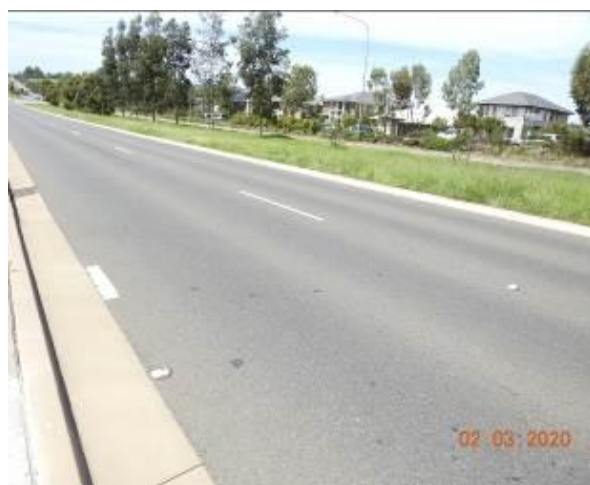
Figure 1752 – General Condition of road surface

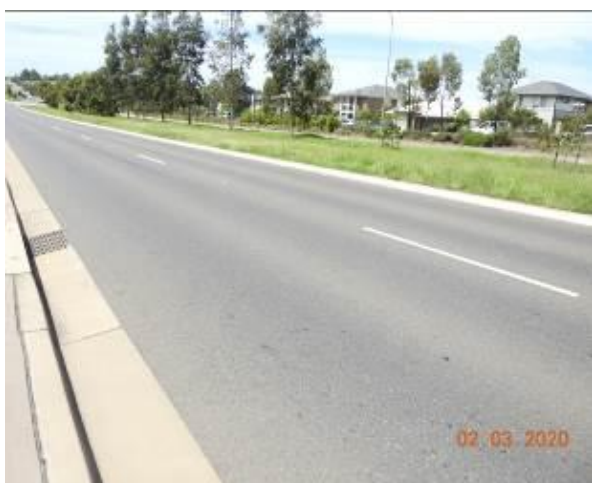
Figure 1753 – General Condition of road surface

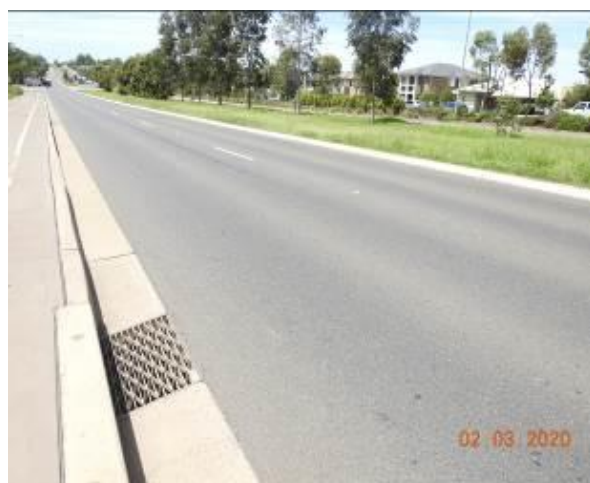
Figure 1754 – General Condition of road surface

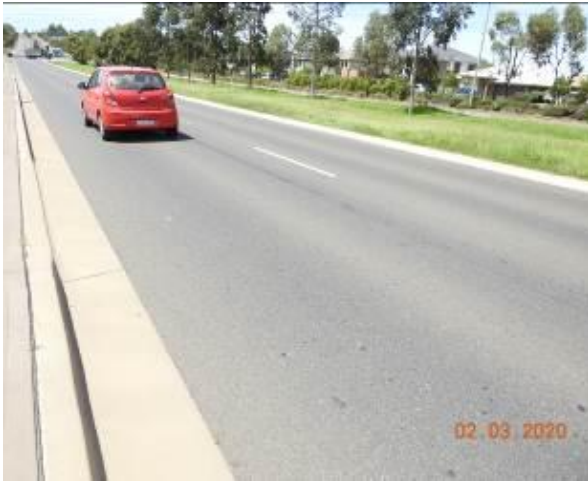
Figure 1755 – General Condition of road surface

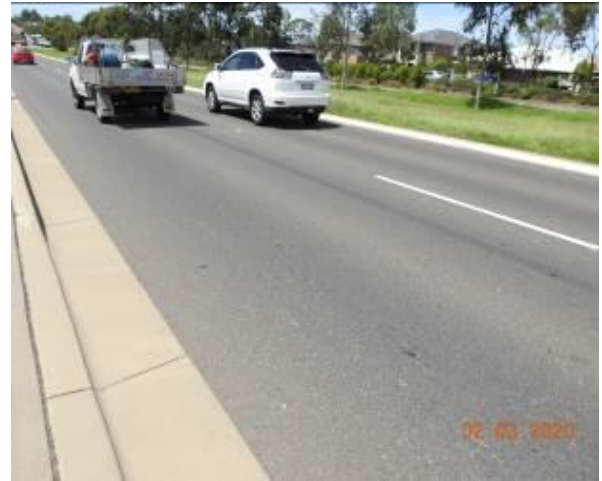
Figure 1756 – General Condition of road surface

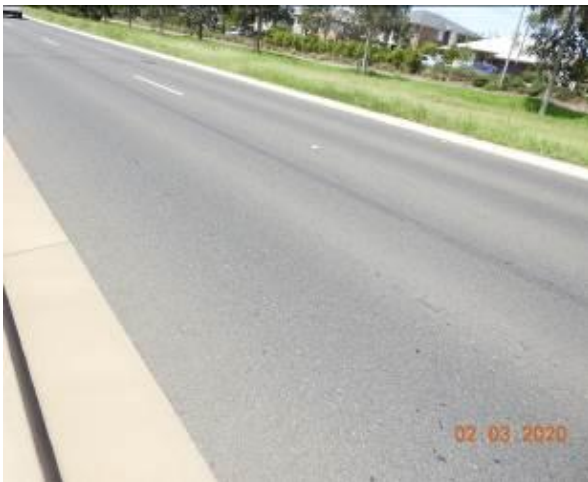
Figure 1757 – General Condition of road surface

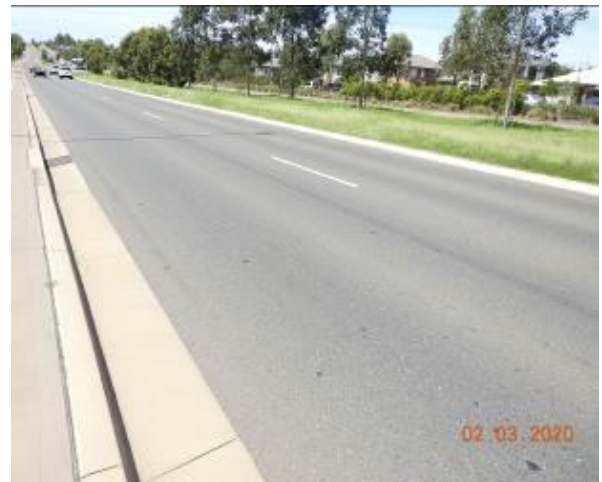
Figure 1758 – General Condition of road surface

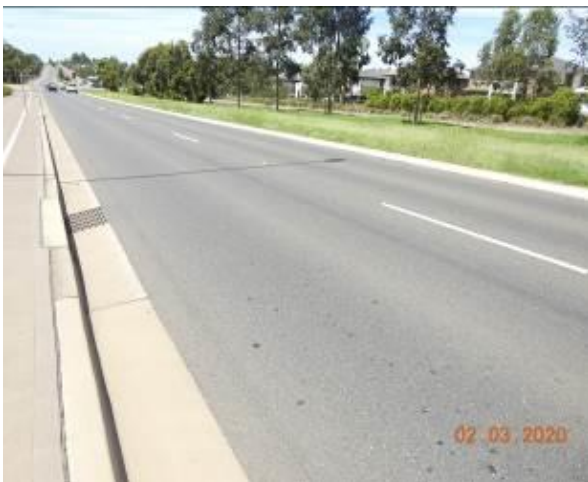
Figure 1759 – General Condition of road surface

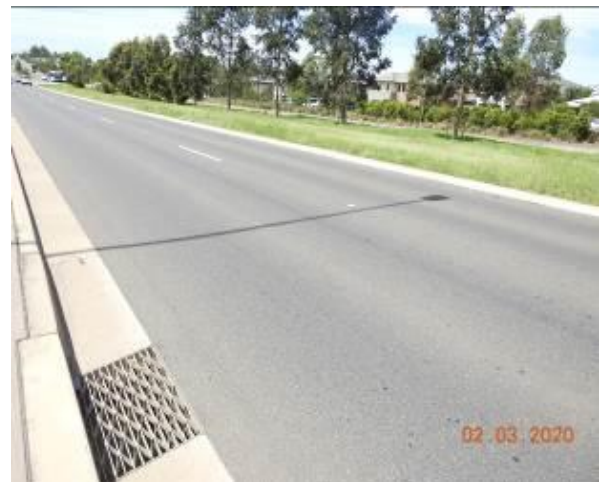
Figure 1760 – General Condition of road surface

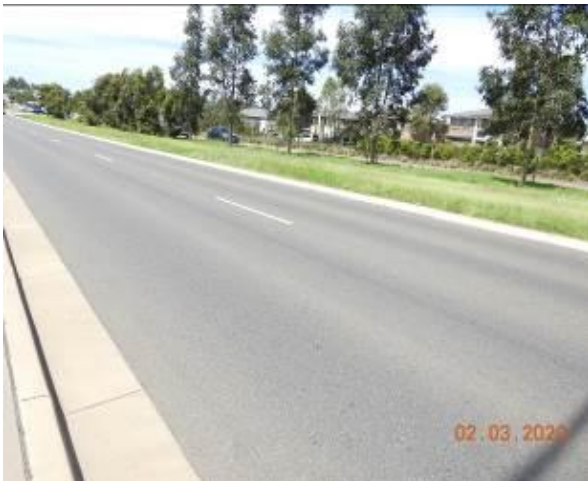
Figure 1761 – General Condition of road surface

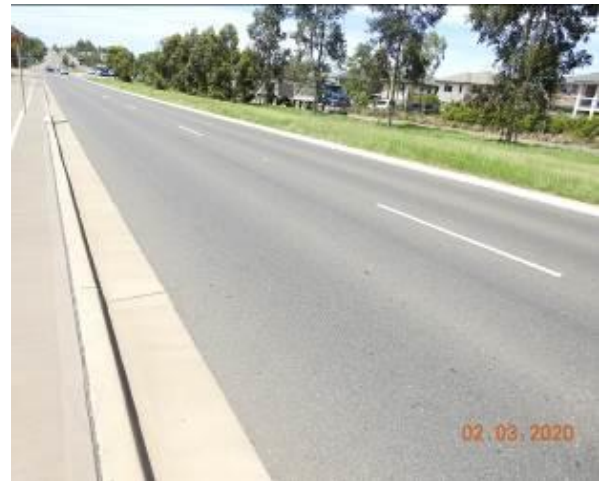
Figure 1762 – General Condition of road surface

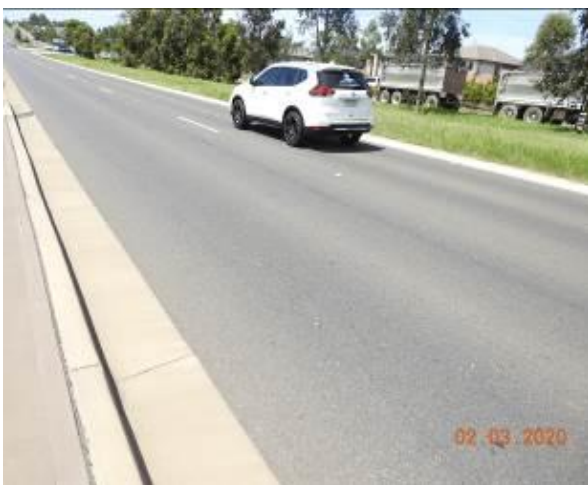
Figure 1763 – General Condition of road surface
