**1-15 AND 2-12 CONFERTA AVENUE,
ROUSE HILL NSW 2155
TALLAWONG STATION PRECINCT SOUTH
PRE-DILAPIDATION REPORT**

**DEICORP PROJECTS
(TALLAWONG STATION) PTY LTD**

Job No. 191294.0
24/03/2020

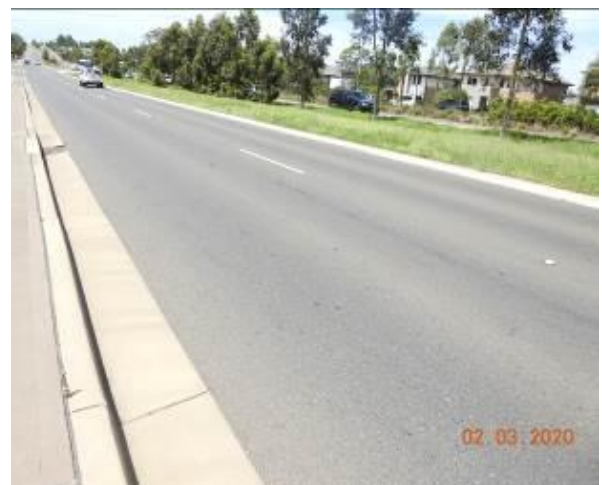
Figure 1764 – General Condition of road surface

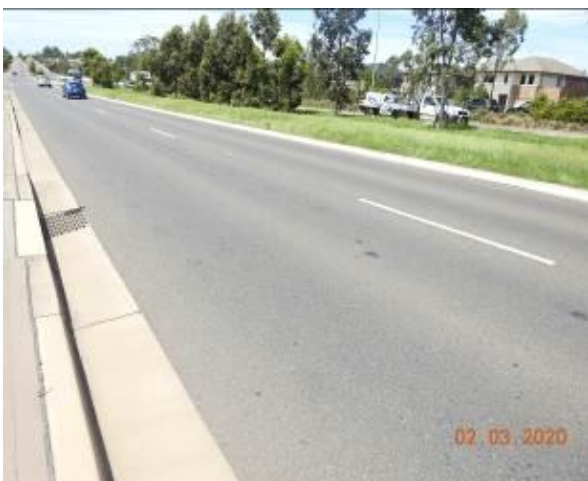
Figure 1765 – General Condition of road surface

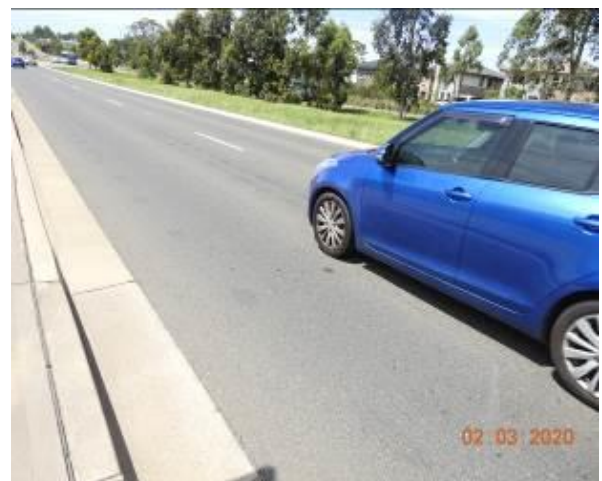
Figure 1766 – General Condition of road surface

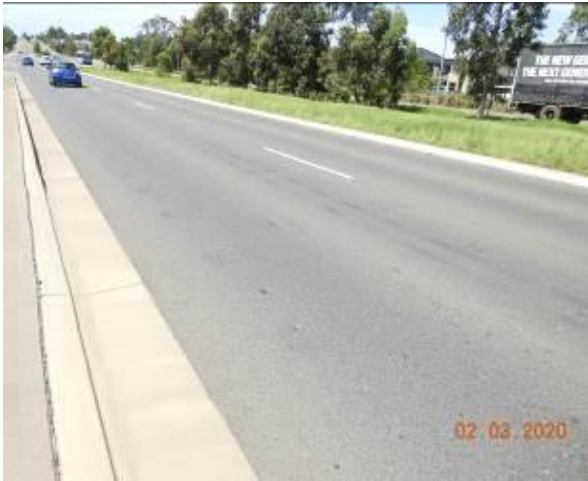
Figure 1767 – General Condition of road surface

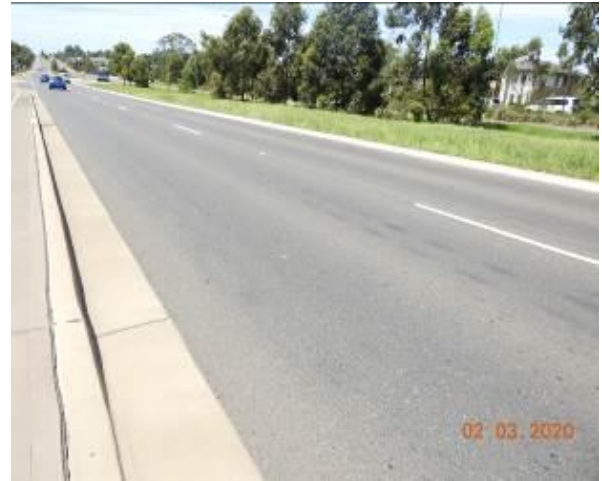
Figure 1768 – General Condition of road surface

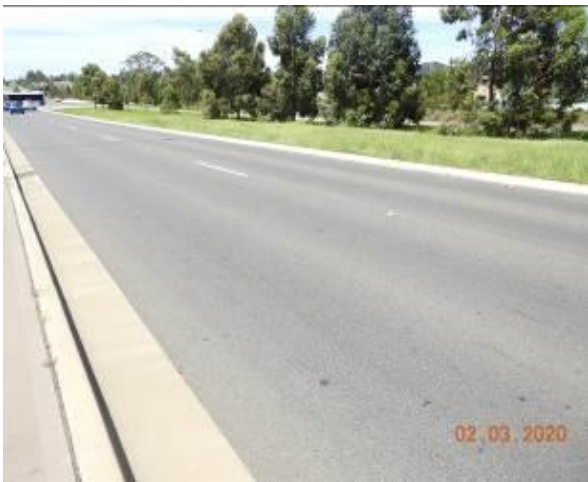
Figure 1769 – General Condition of road surface

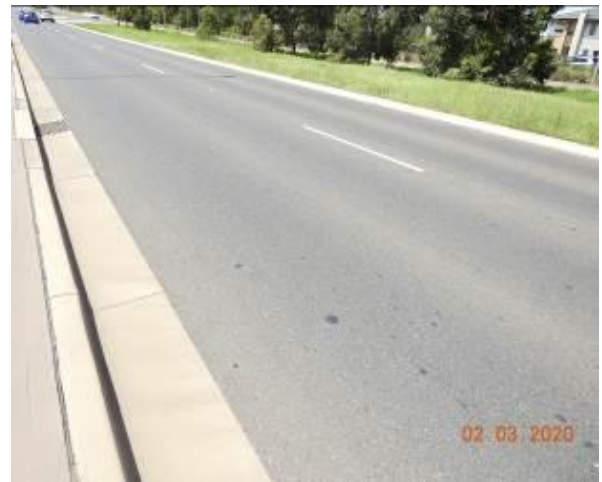
Figure 1770 – General Condition of road surface

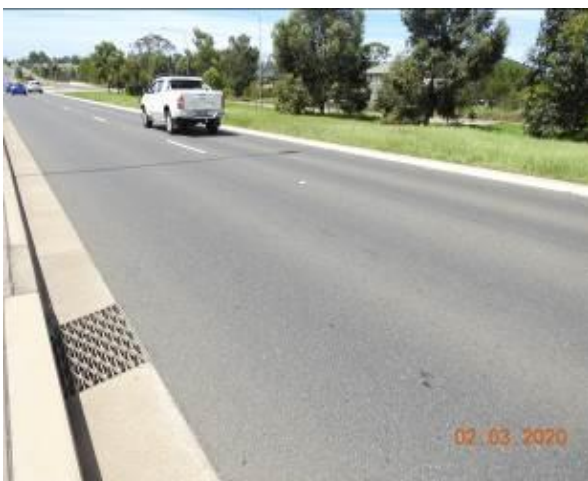
Figure 1771 – General Condition of road surface

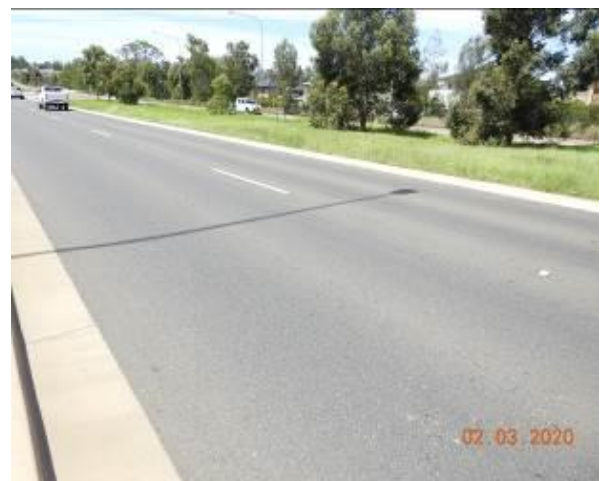
Figure 1772 – General Condition of road surface

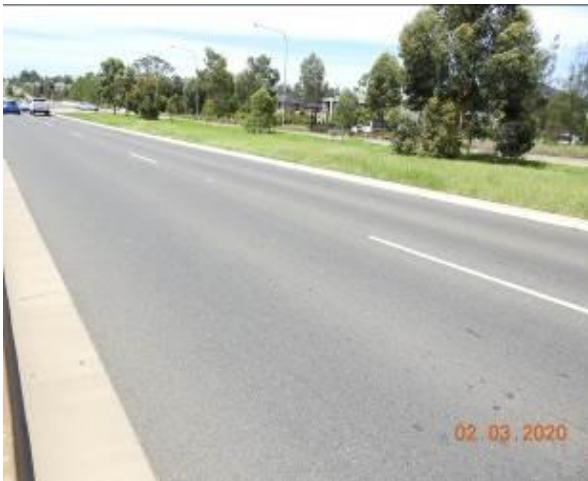
Figure 1773 – General Condition of road surface

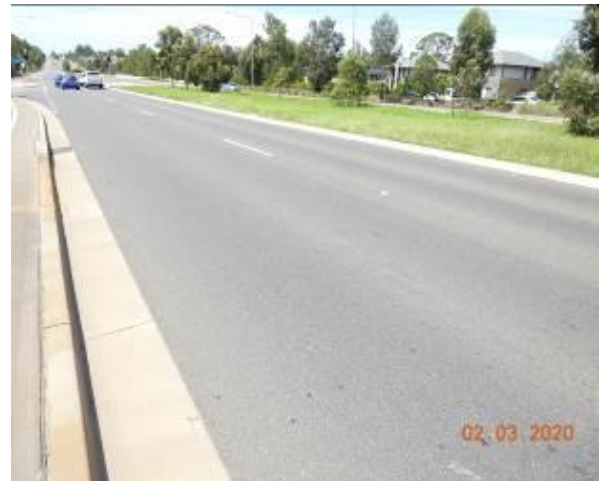
Figure 1774 – General Condition of road surface

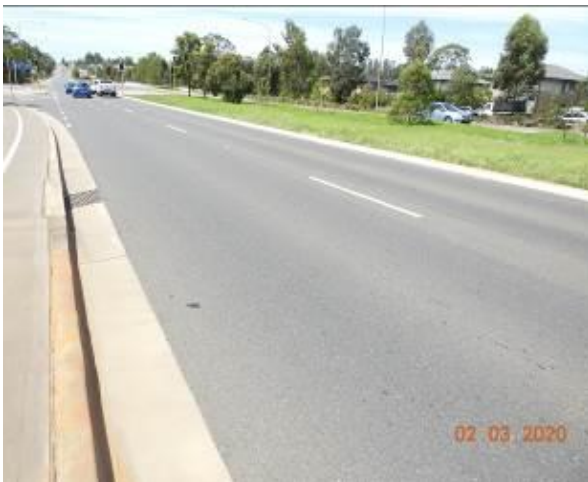
Figure 1775 – General Condition of road surface

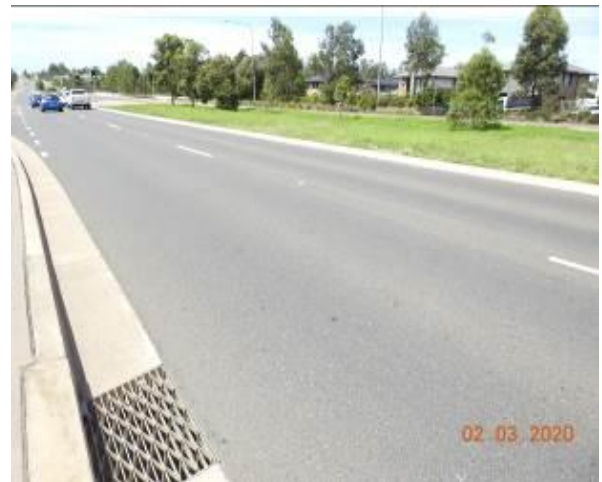
Figure 1776 – General Condition of road surface

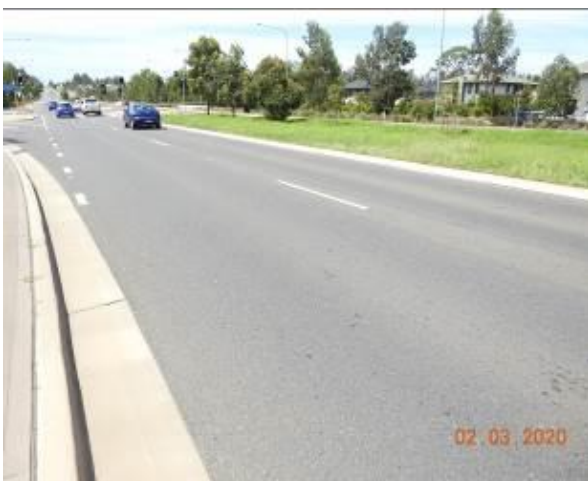
Figure 1777 – General Condition of road surface

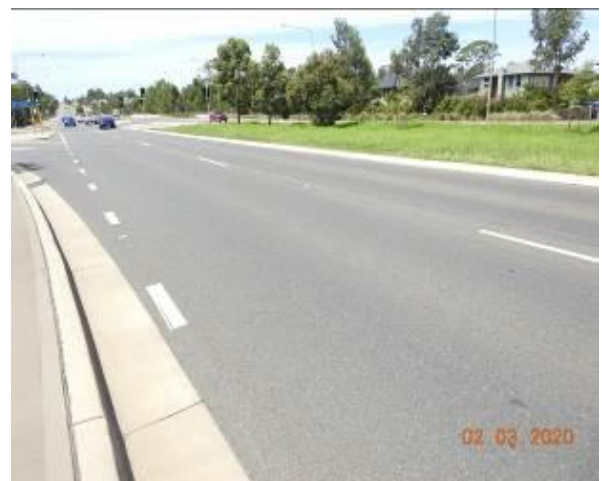
Figure 1778 – General Condition of road surface

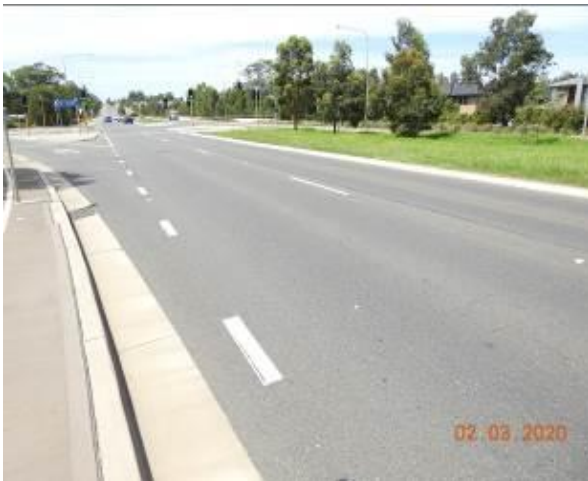
Figure 1779 – General Condition of road surface

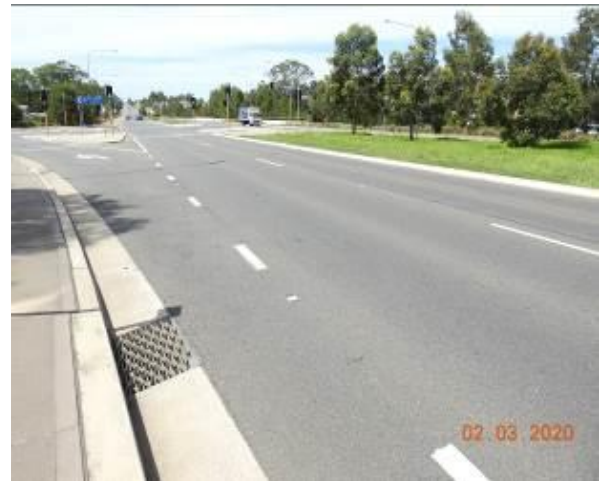
Figure 1780 – General Condition of road surface

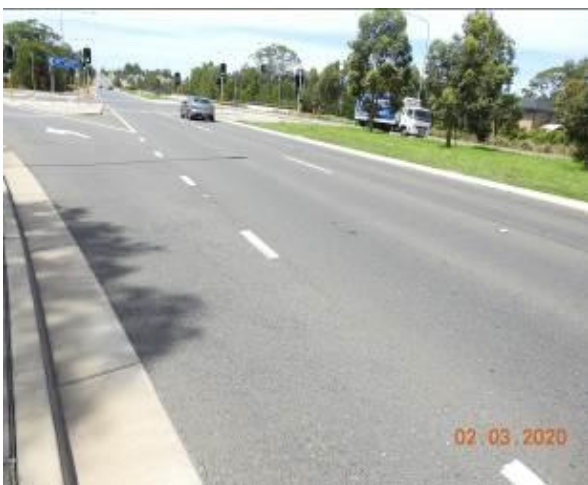
Figure 1781 – General Condition of road surface

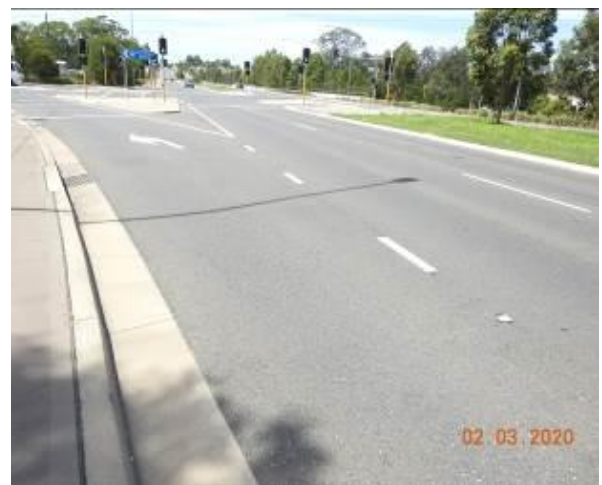
Figure 1782 – General Condition of road surface

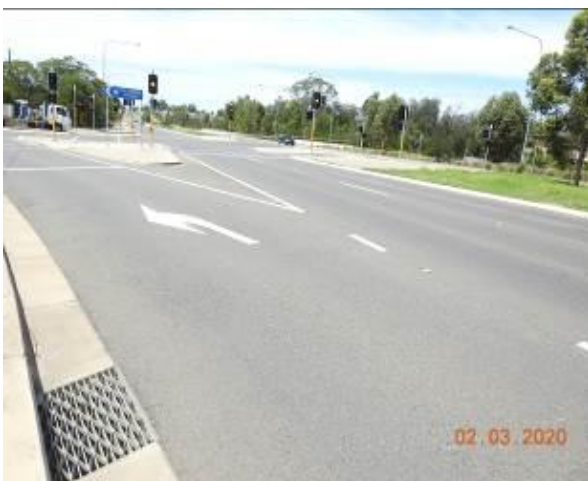
Figure 1783 – General Condition of road surface

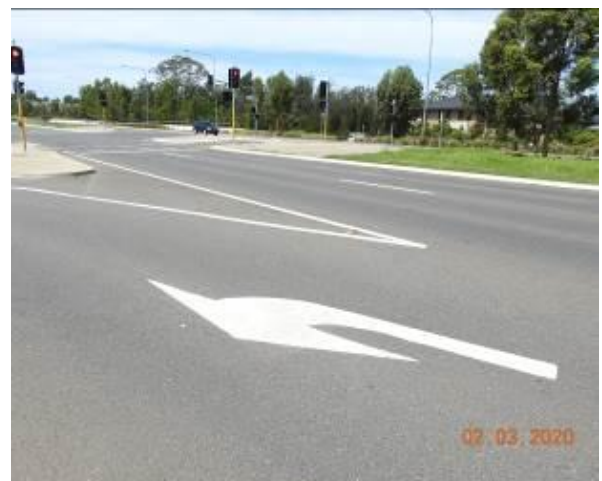
Figure 1784 – General Condition of road surface

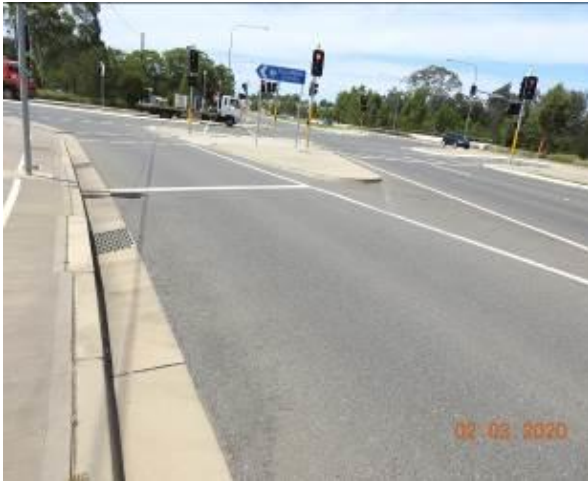
Figure 1785 – General Condition of road surface

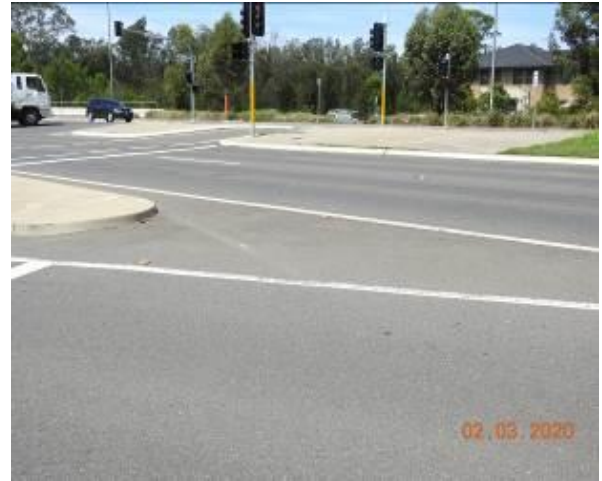
Figure 1786 – General Condition of road surface

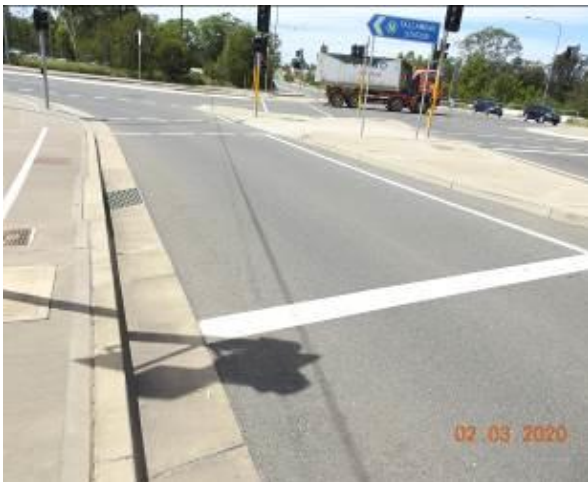
Figure 1787 – General Condition of road surface

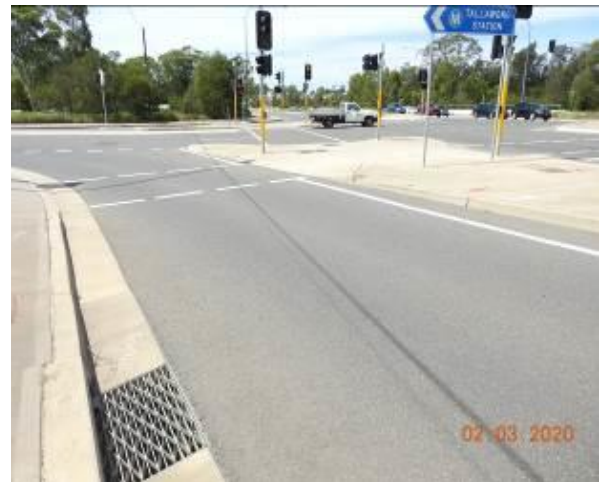
Figure 1788 – General Condition of road surface

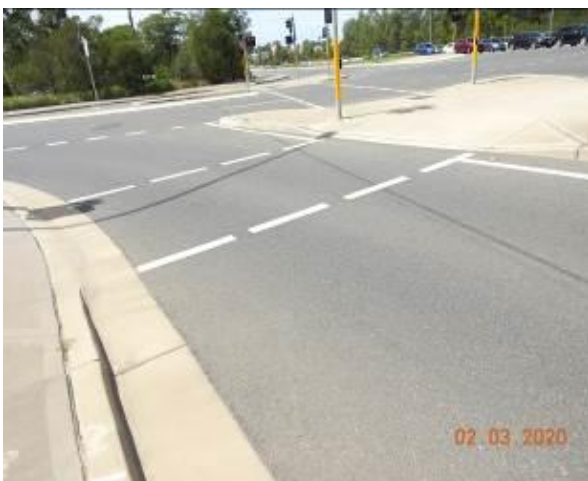
Figure 1789 – General Condition of road surface

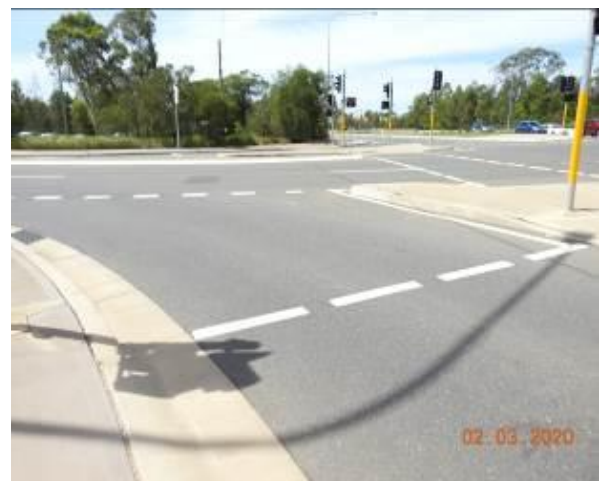
Figure 1791 – General Condition of road surface

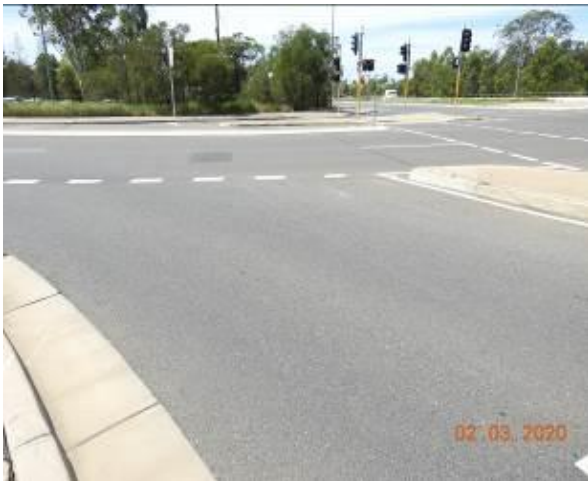
Figure 1792 – General Condition of road surface

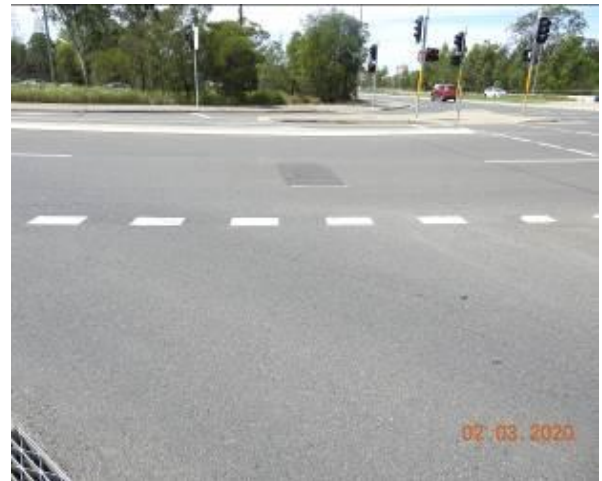
Figure 1793 – General Condition of road surface

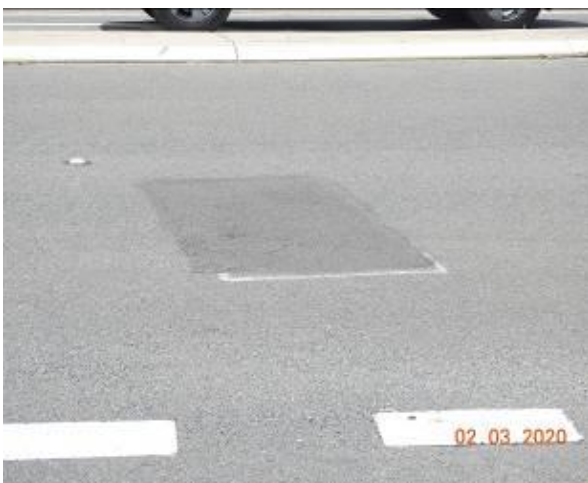
Figure 1794 – Evidence of patchwork through road surface

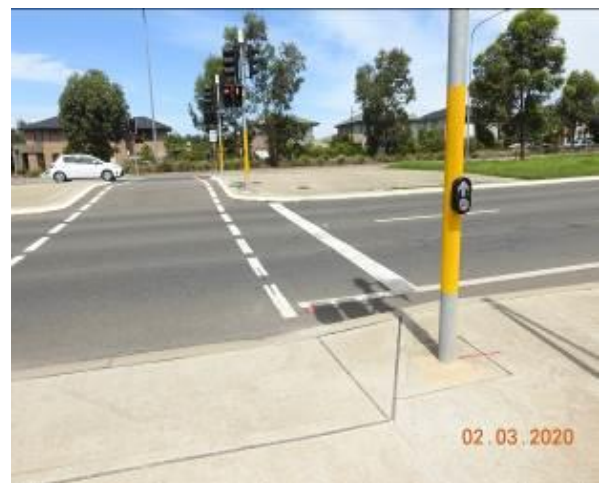
Figure 1795 – General Condition of road surface

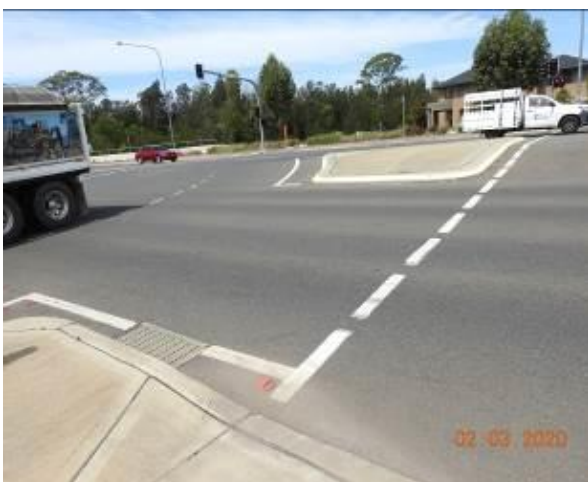
Figure 1796 – General Condition of road surface

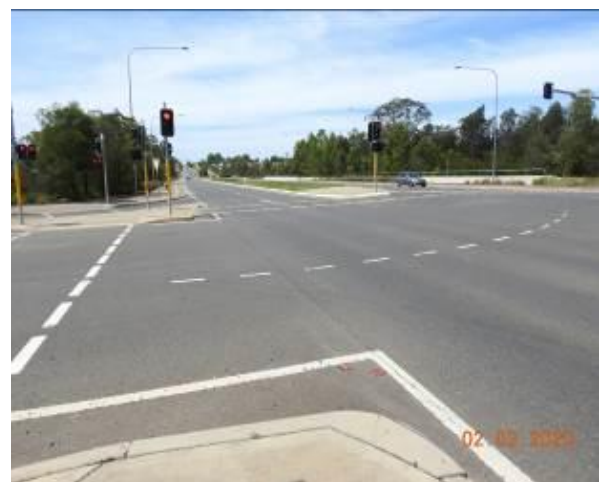
Figure 1797 – General Condition of road surface

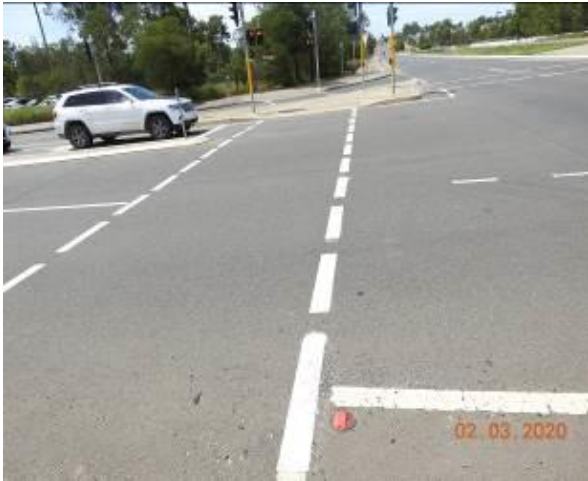
Figure 1798 – General Condition of road surface

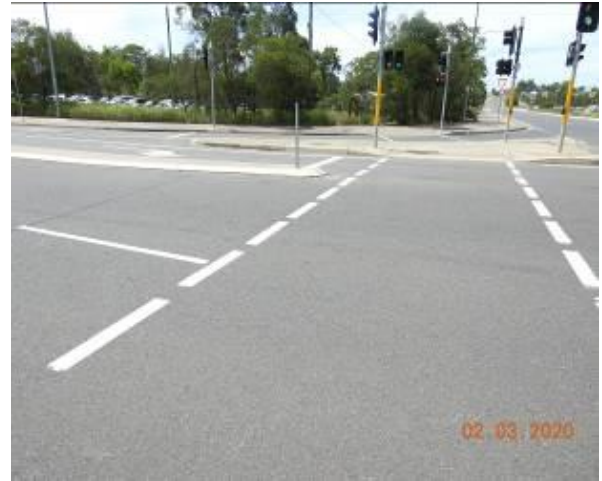
Figure 1799 – General Condition of road surface

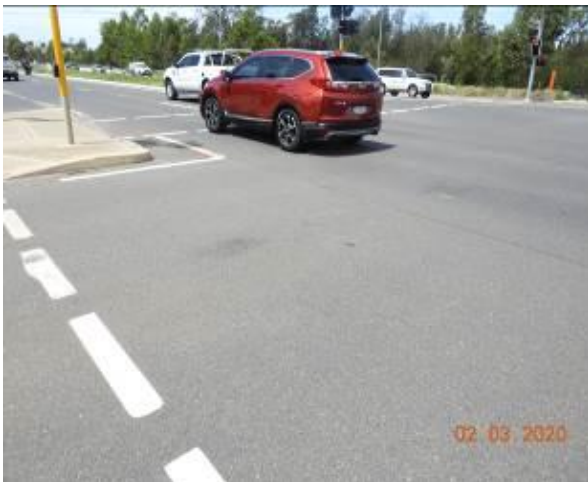
Figure 1800 – General Condition of road surface

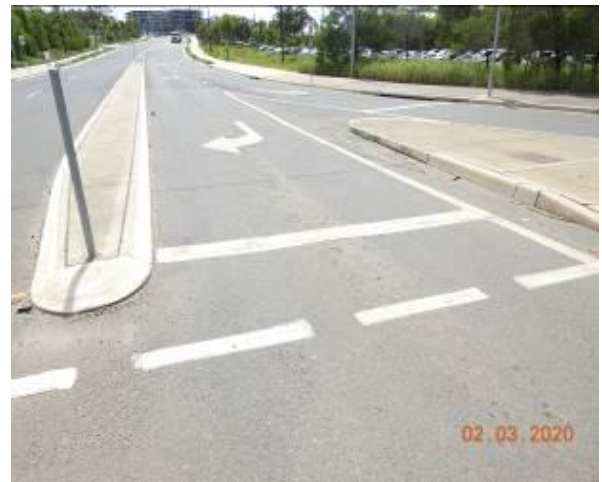
Figure 1801 – General Condition of road surface

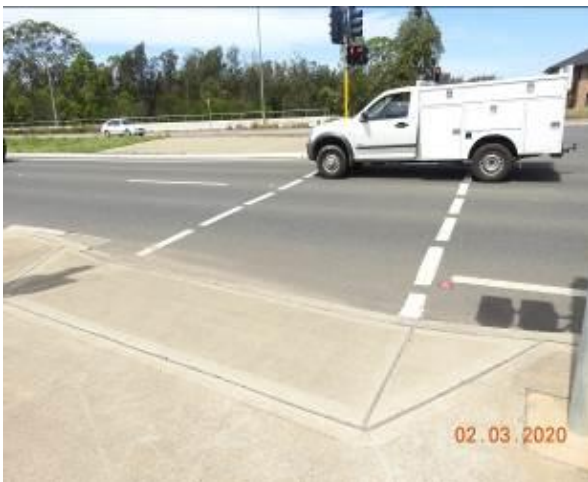
Figure 1802 – General Condition of road surface

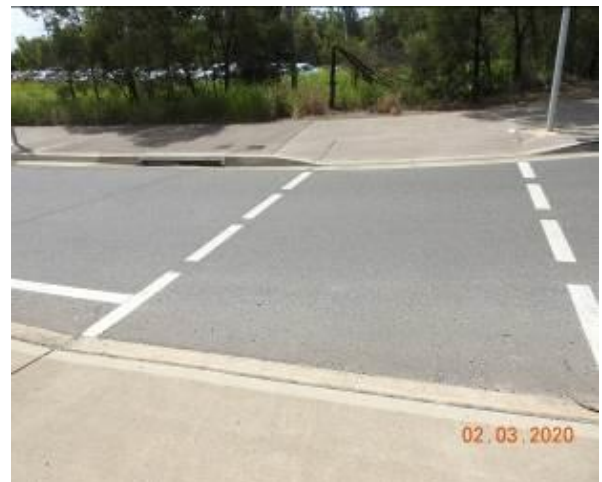
Figure 1803 – General Condition of road surface

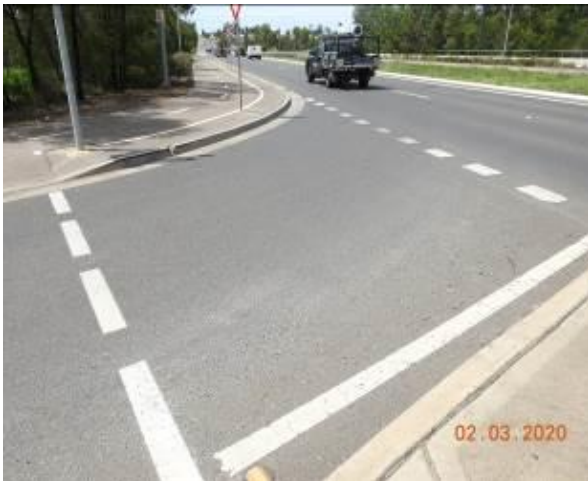
Figure 1804 – General Condition of road surface

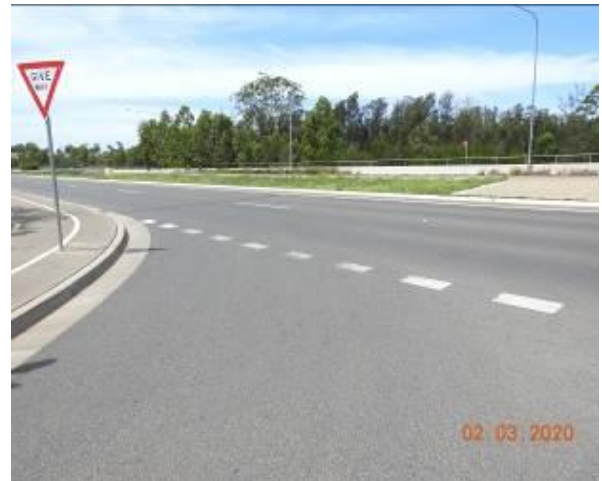
Figure 1805 – General Condition of road surface

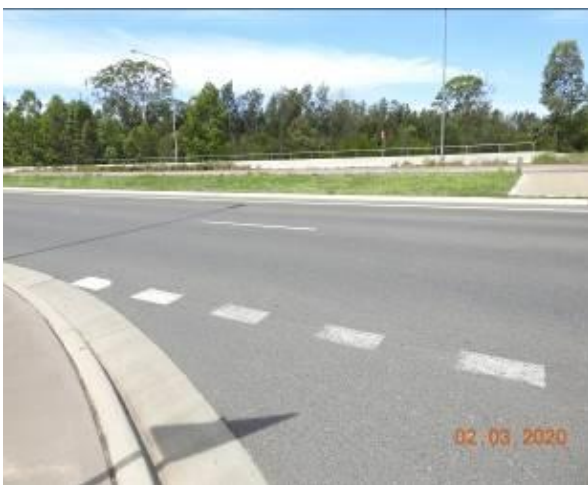
Figure 1806 – General Condition of road surface

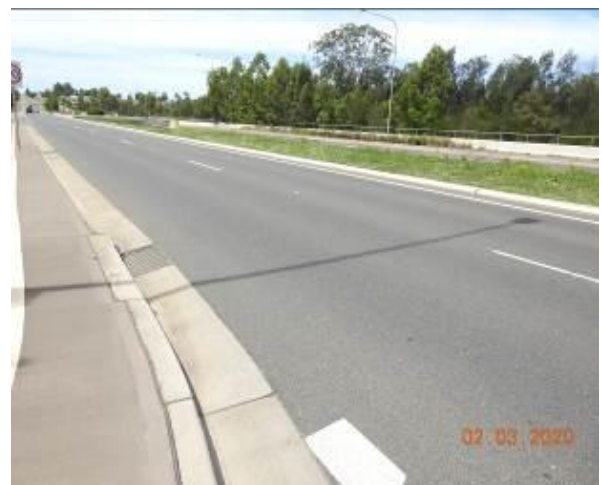
Figure 1807 – General Condition of road surface

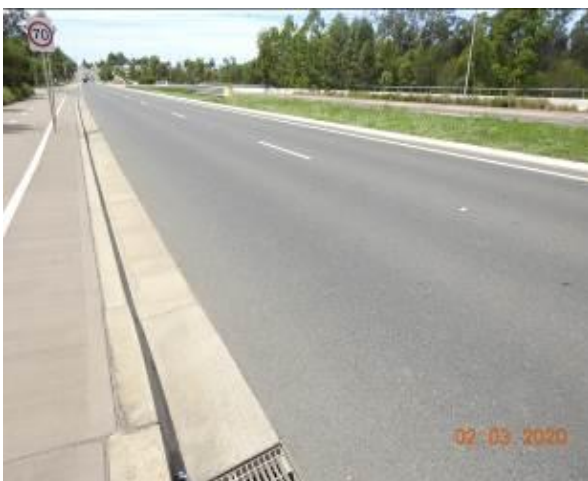
Figure 1808 – General Condition of road surface

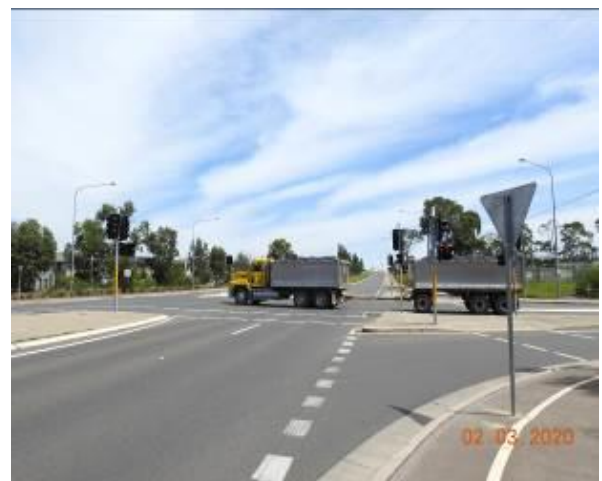
Figure 1809 – General Condition of road surface

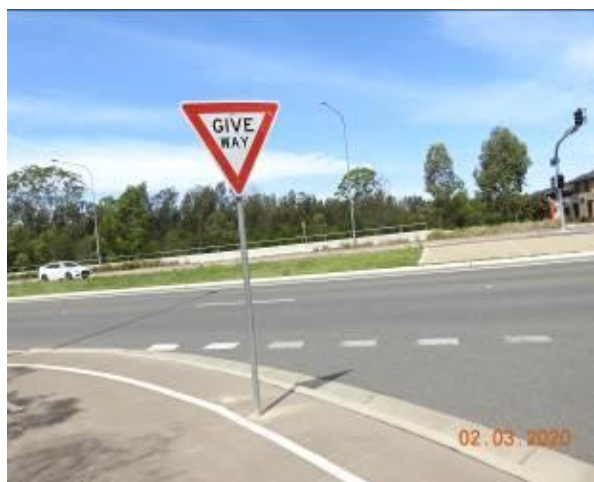
Figure 1810 –General Condition of street sign

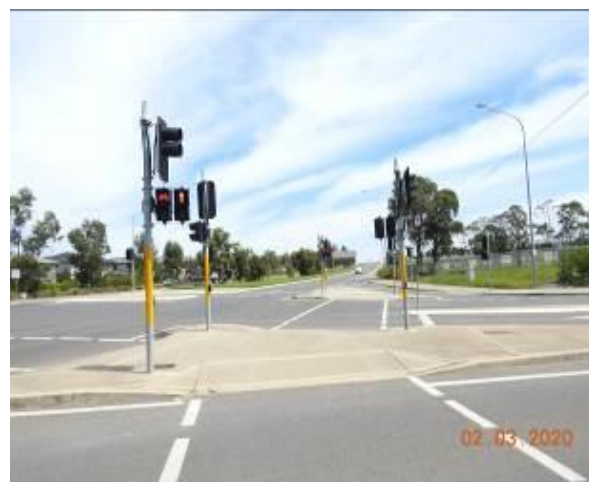
Figure 1811 – General Condition of traffic light

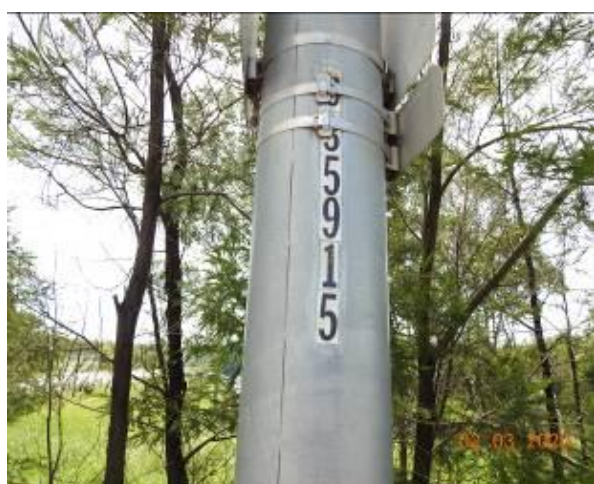
Figure 1812 – General Condition of lamp post
Identification No.835915

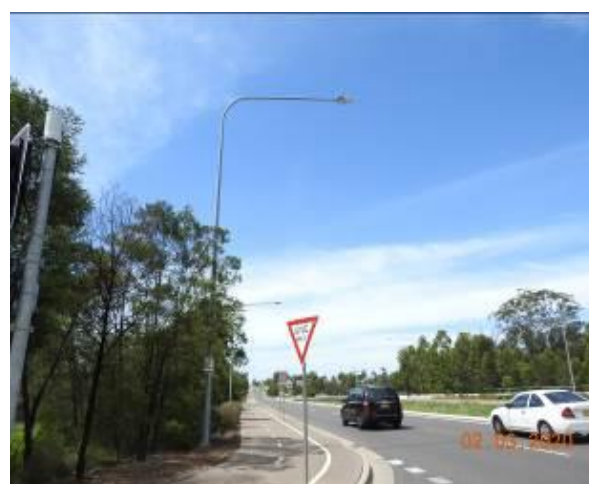
Figure 1813 – General Condition of lamp post

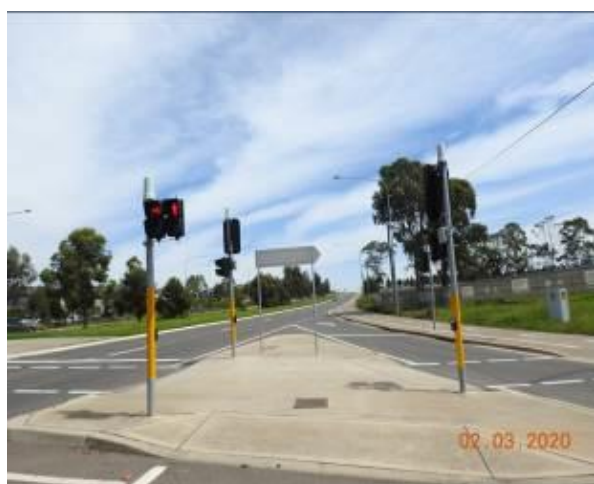
Figure 1814 – General Condition of traffic light

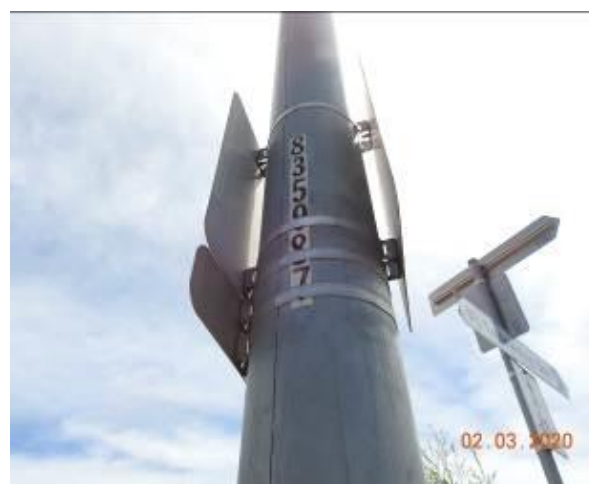
Figure 1815 – General Condition of lamp post
Identification No.835987

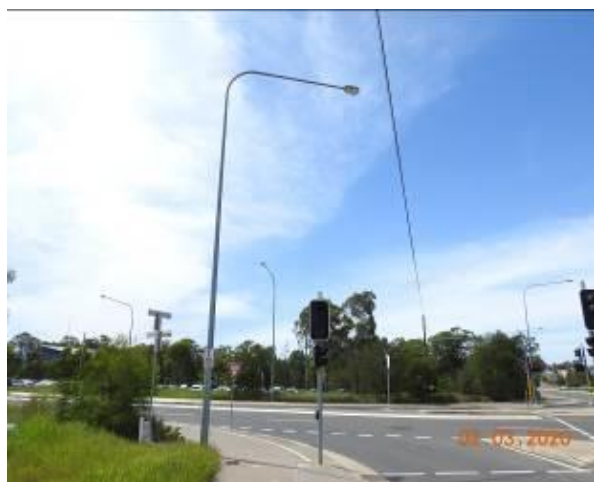
Figure 1816 – General Condition of lamp post

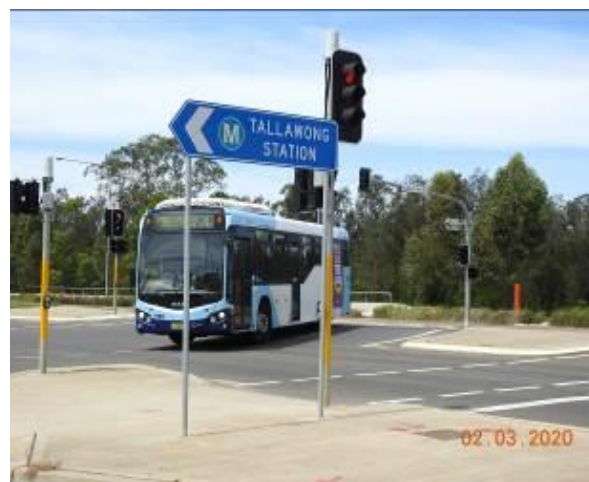
Figure 1817 – General Condition of street sign

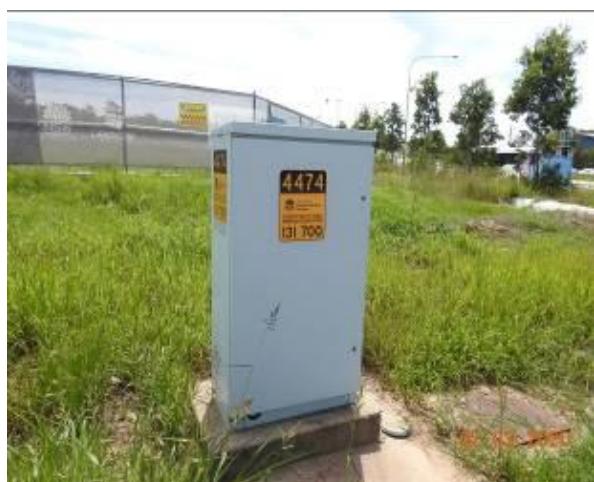
Figure 1818 – General Condition of electricity box
Identification No.4474

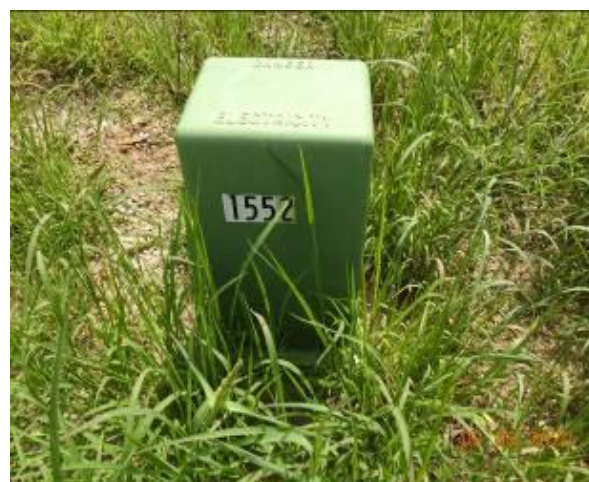
Figure 1819 – General Condition of electricity box
Identification No.1552

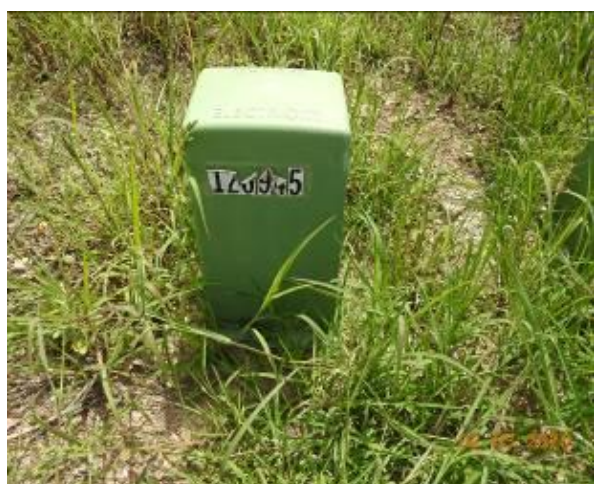
Figure 1820 – General Condition of electricity box
Identification No.126945

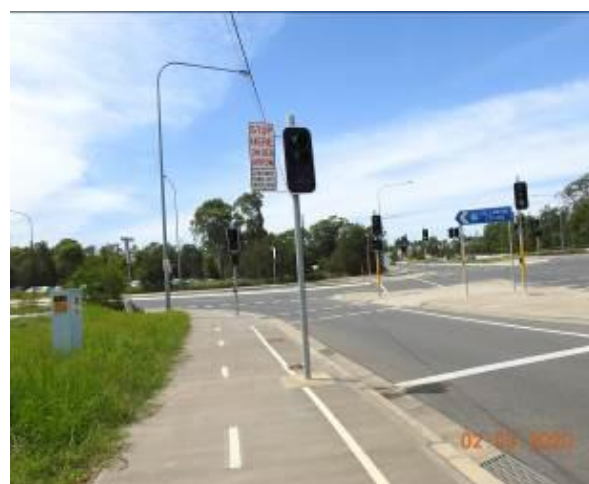
Figure 1821 – General Condition of street sign

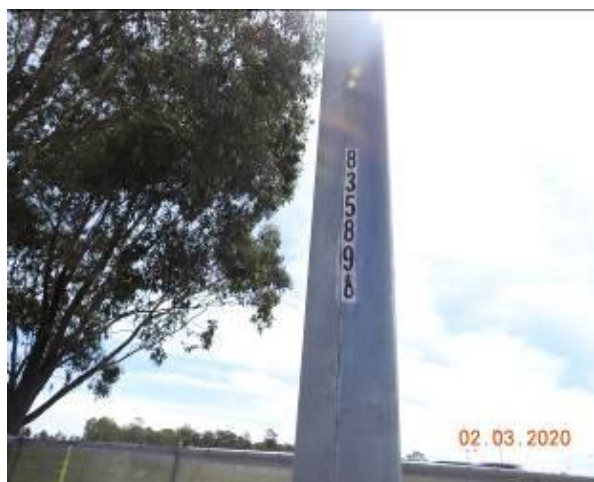
Figure 1822 – General Condition of lamp post
Identification No.835898

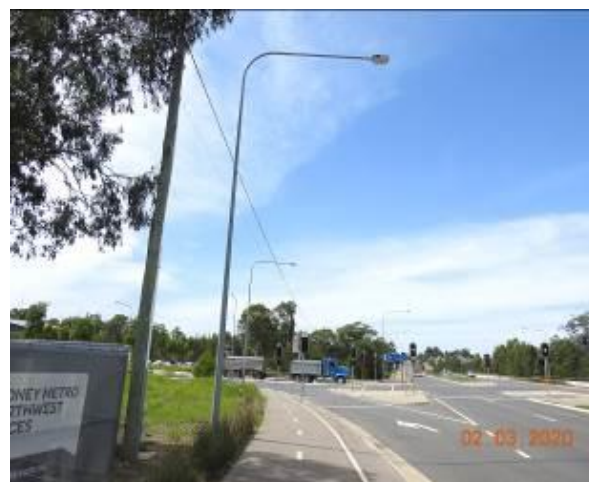
Figure 1823 – General Condition of lamp post

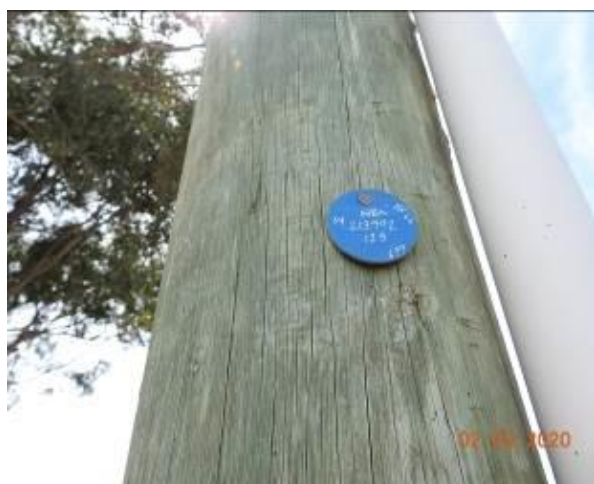
Figure 1824 – General Condition of telegraph pole
Identification No.213992/128

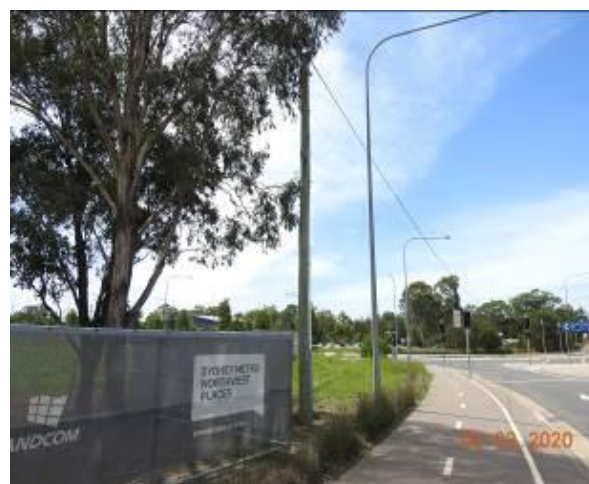
Figure 1825 – General Condition of telegraph pole

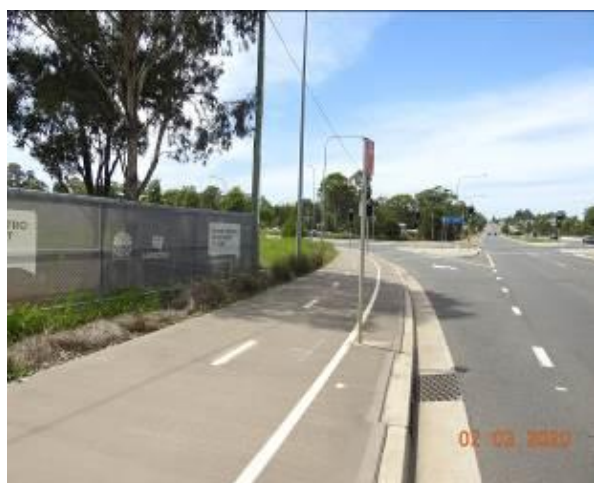
Figure 1826 – General Condition of street sign

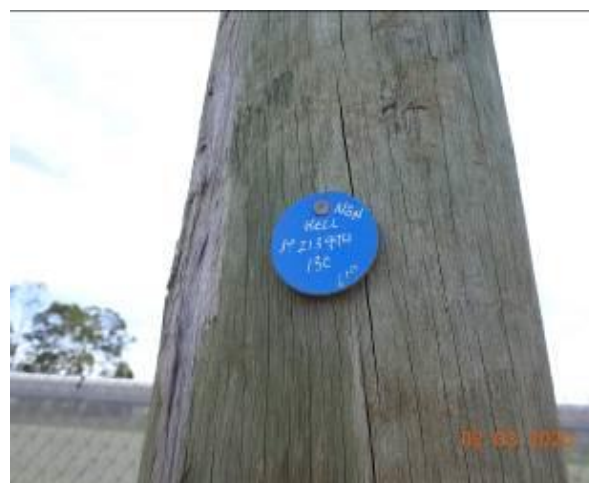
Figure 1827 – General Condition of telegraph pole
Identification No.213994/130

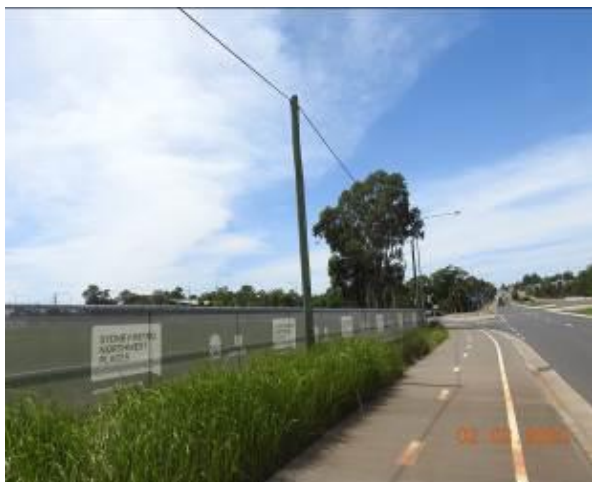
Figure 1828 – General Condition of telegraph pole

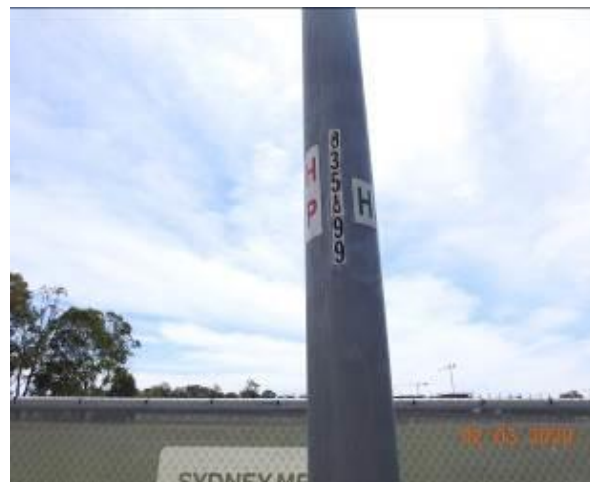
Figure 1829 – General Condition of lamp post
Identification No.213994/130

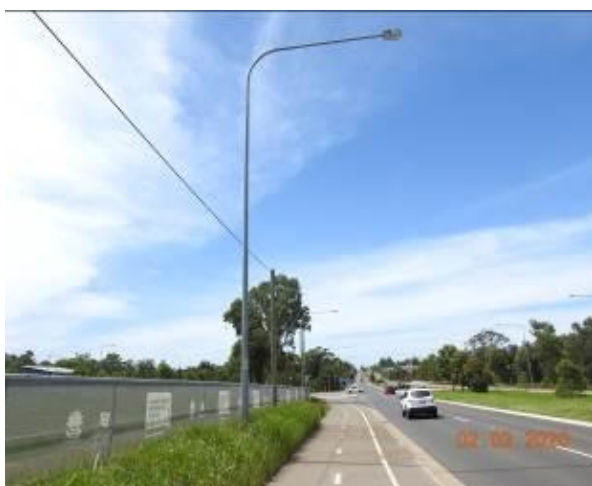
Figure 1830 – General Condition of lamp post

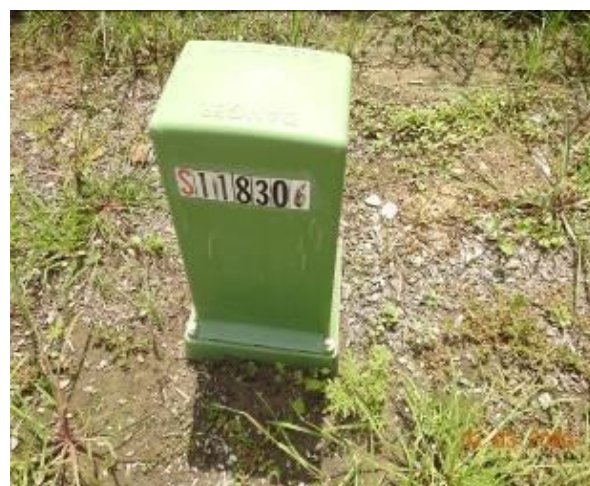
Figure 1831 – General Condition of electricity box
Identification No.S118306

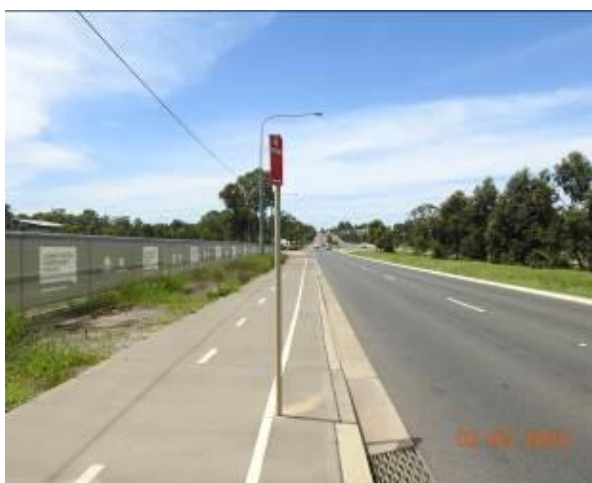
Figure 1832 – General Condition of street sign

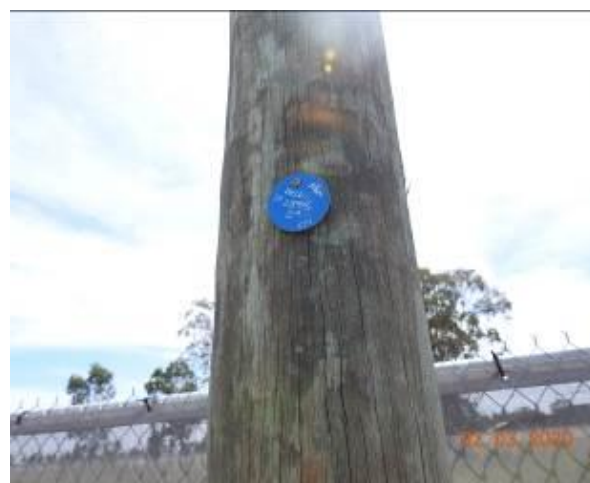
Figure 1833 – General Condition of telegraph pole
Identification No.213993 / 129

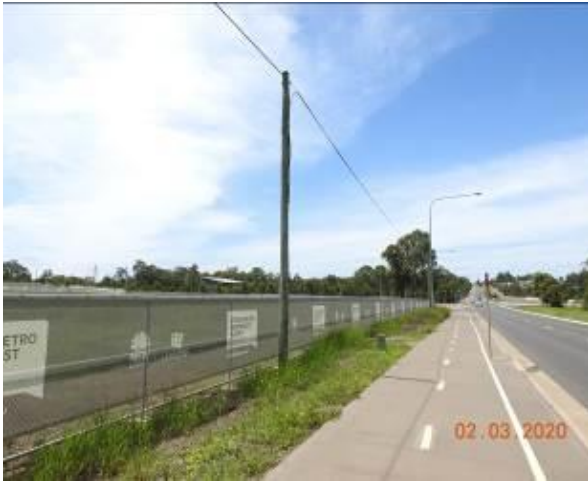
Figure 1834 – General Condition of telegraph pole

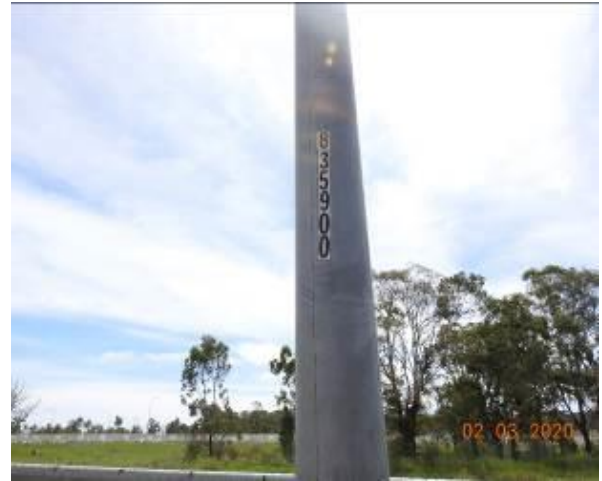
Figure 1835 – General Condition of lamp post
Identification No.835900

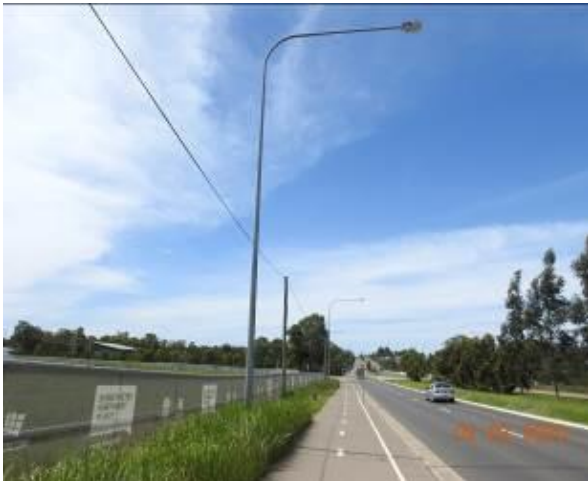
Figure 1836 – General Condition of lamp post

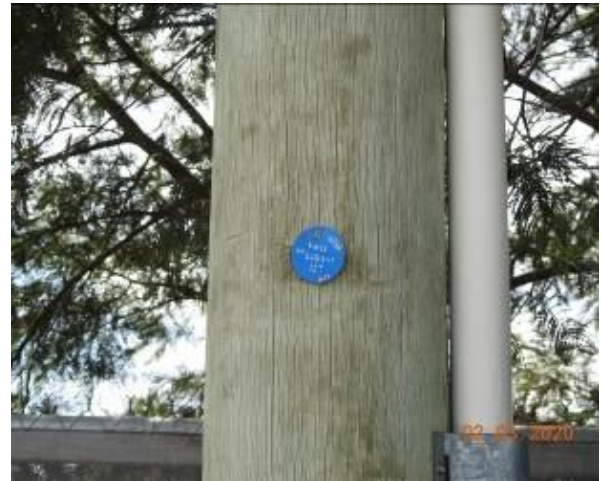
Figure 1837 – General Condition of telegraph pole
Identification No.213991 / 127

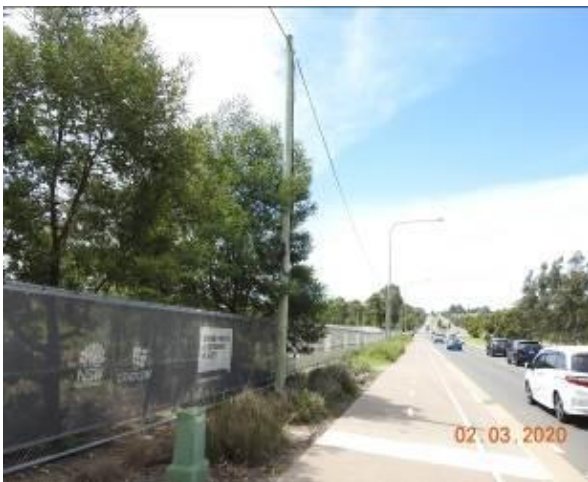
Figure 1838 – General Condition of telegraph pole

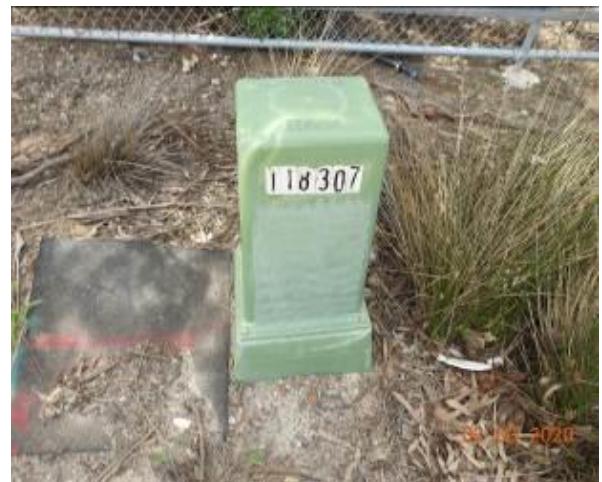
Figure 1839 – General Condition of electricity box
Identification No.118307

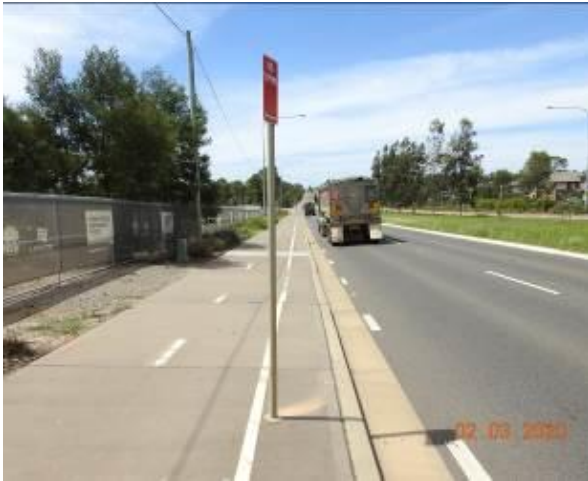
Figure 1840 – General Condition of street sign

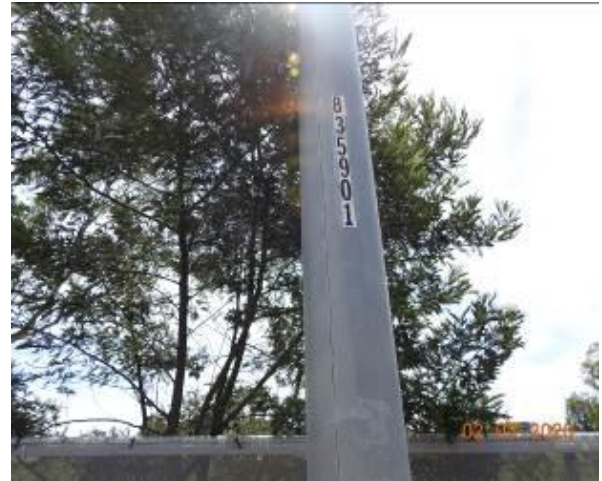
Figure 1841 – General Condition of lamp post
Identification No.835901
