**1-15 AND 2-12 CONFERTA AVENUE,
ROUSE HILL NSW 2155
TALLAWONG STATION PRECINCT SOUTH
PRE-DILAPIDATION REPORT**

**DEICORP PROJECTS
(TALLAWONG STATION) PTY LTD**

Job No. 191294.0
24/03/2020

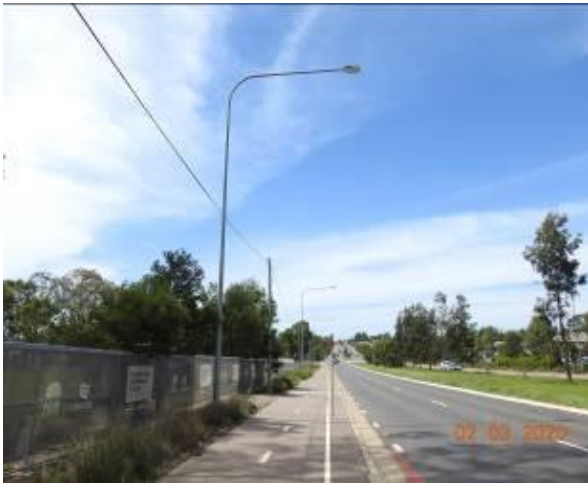
Figure 1842 – General Condition of lamp post

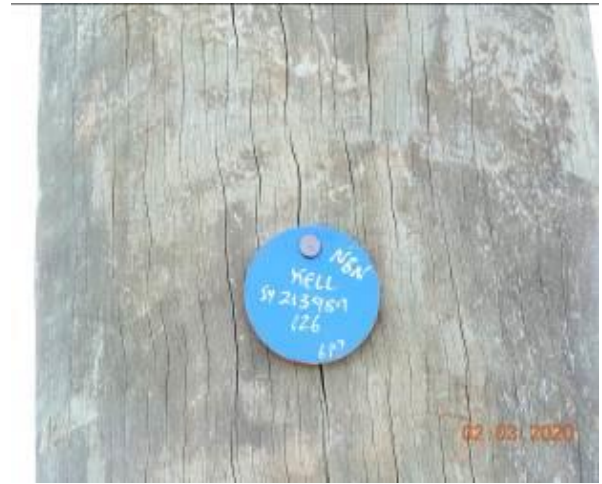
Figure 1843 – General Condition of telegraph pole
Identification No.213989 / 126

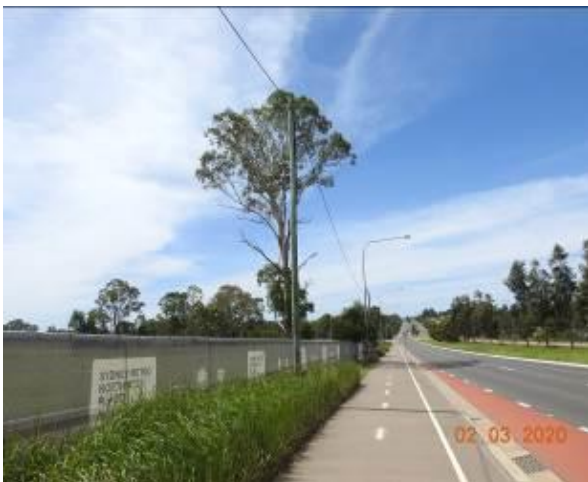
Figure 1844 – General Condition of telegraph pole

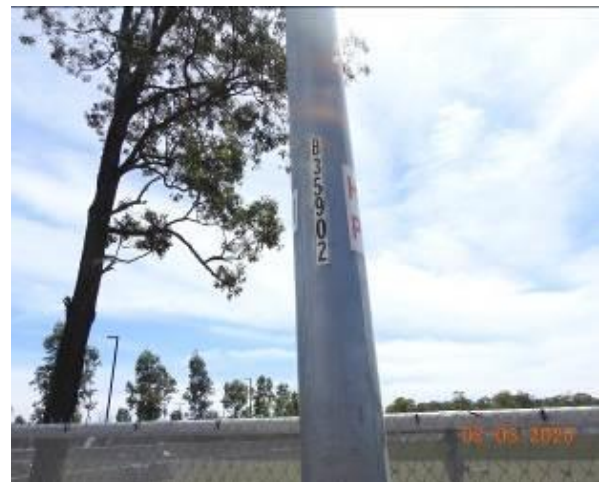
Figure 1845 – General Condition of lamp post
Identification No.835902

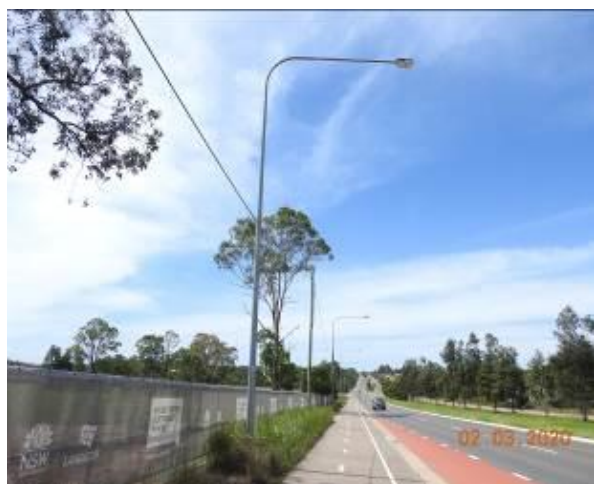
Figure 1846 – General Condition of lamp post

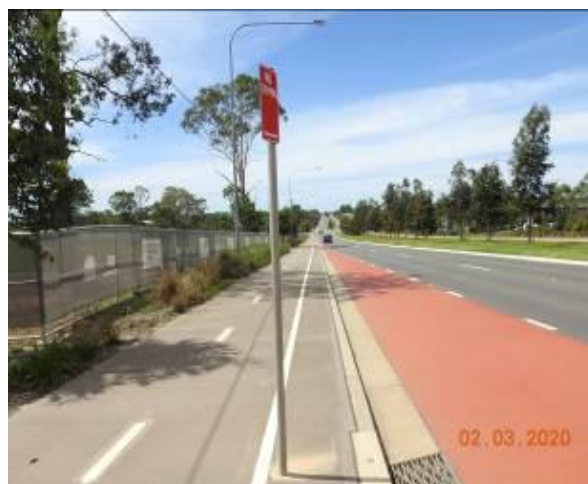
Figure 1847 – General Condition of street sign

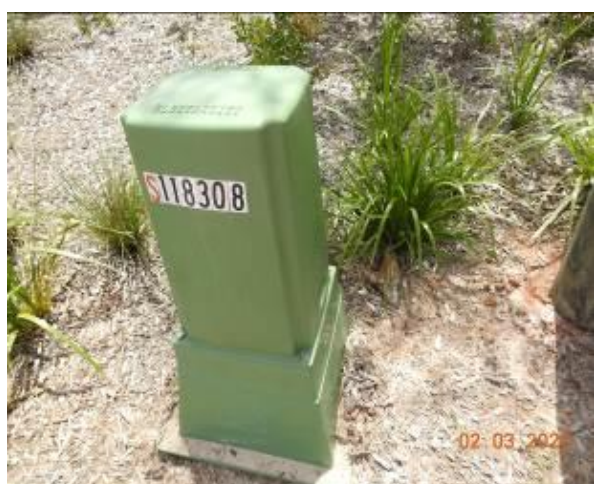
Figure 1848 – General Condition of electricity box
Identification No.S118308

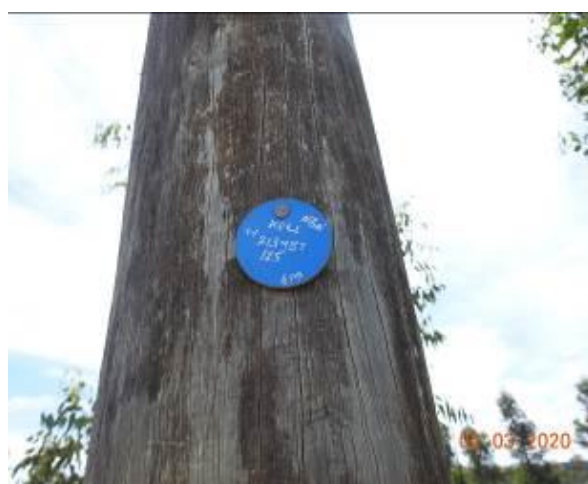
Figure 1849 – General Condition of telegraph pole
Identification No.213987 / 125

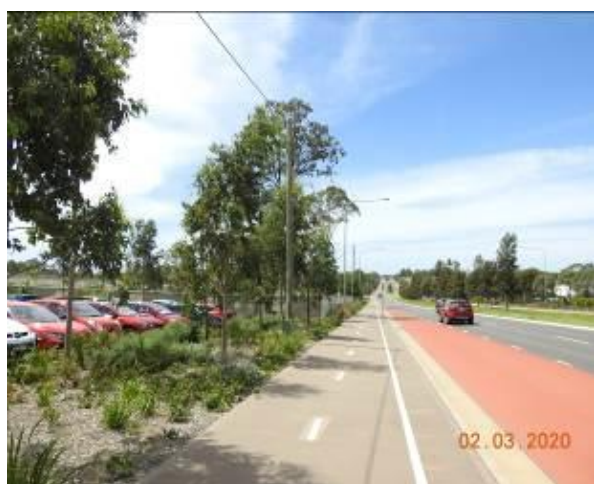
Figure 1850 – General Condition of telegraph pole

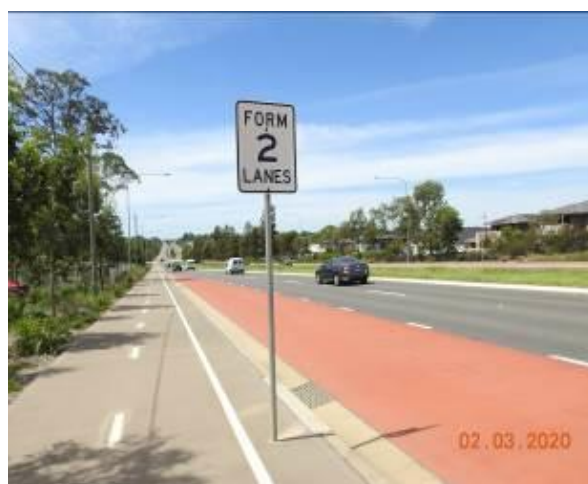
Figure 1851 – General Condition of street sign

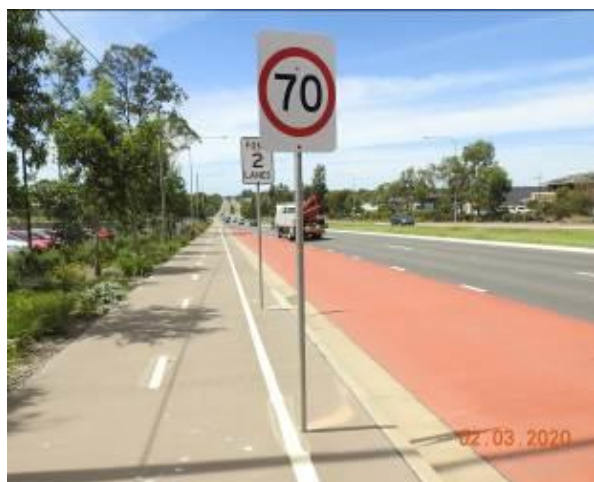
Figure 1852 – General Condition of street sign

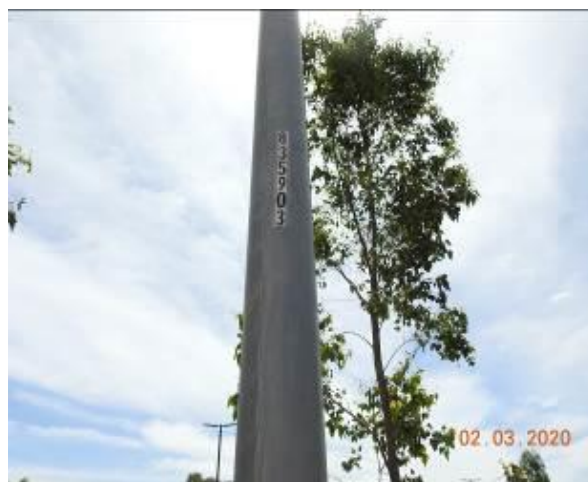
Figure 1853 – General Condition of lamp post
Identification No.835903

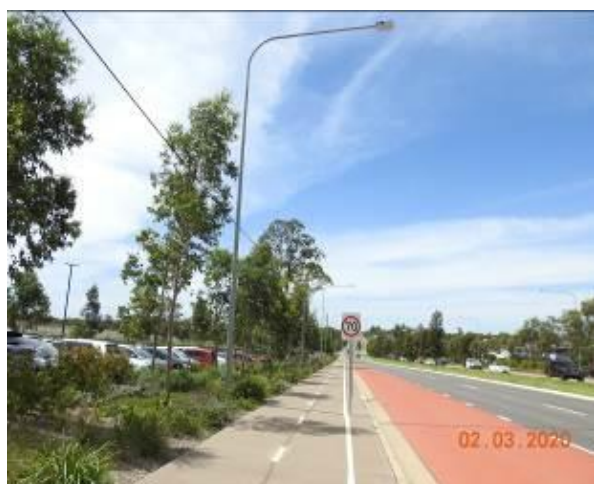
Figure 1854 – General Condition of lamp post

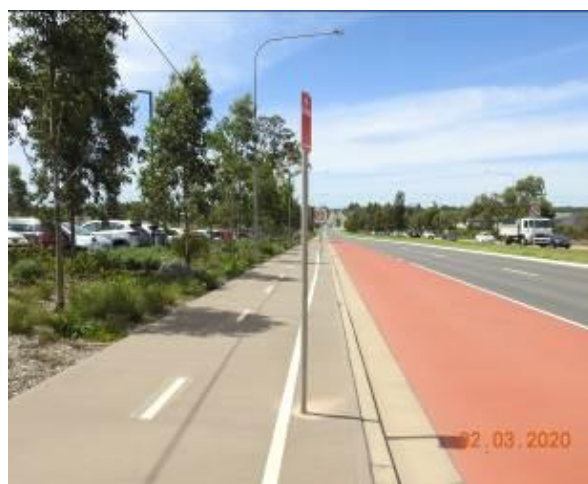
Figure 1855 – General Condition of street sign

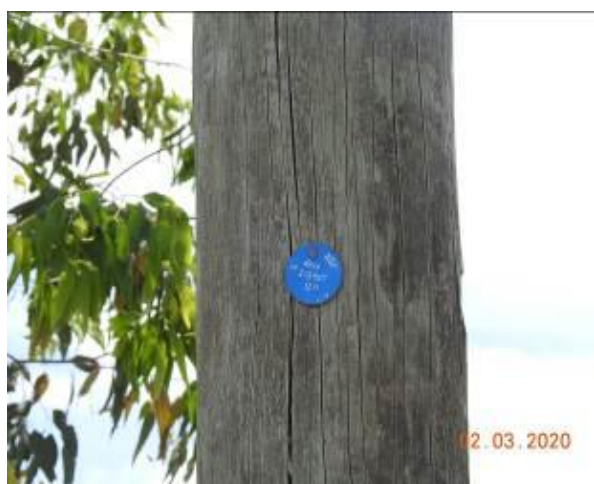
Figure 1856 – General Condition of telegraph pole
Identification No.213955 / 124

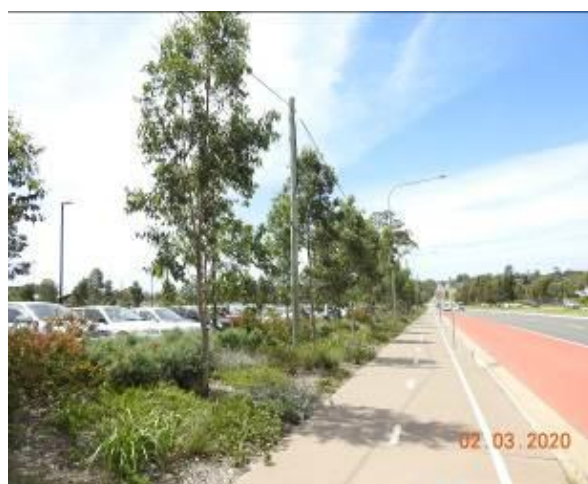
Figure 1857 – General Condition of telegraph pole

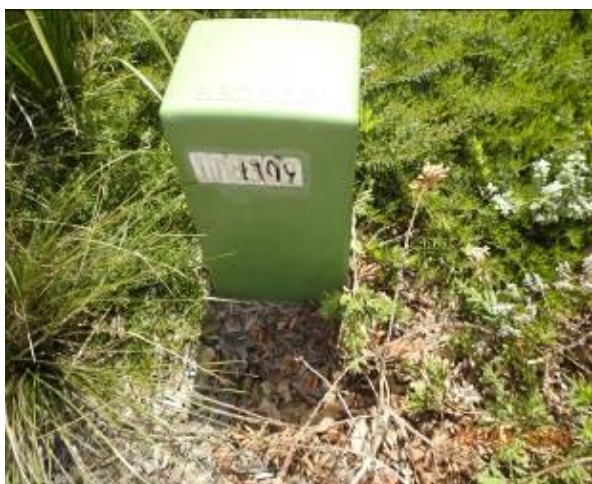
Figure 1858 – General Condition of electricity box
Identification No.118309

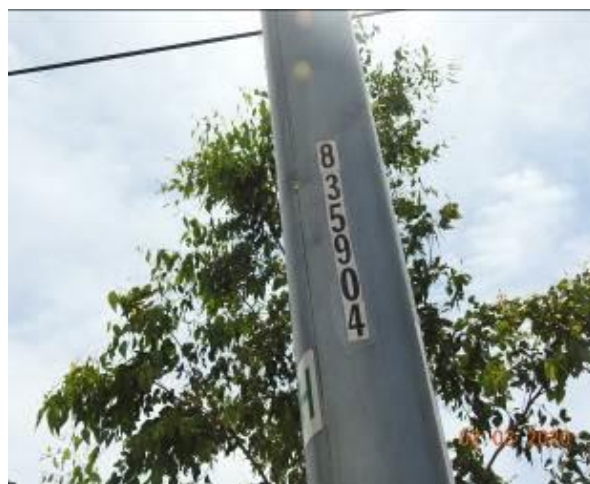
Figure 1859 – General Condition of lamp post
Identification No.835904

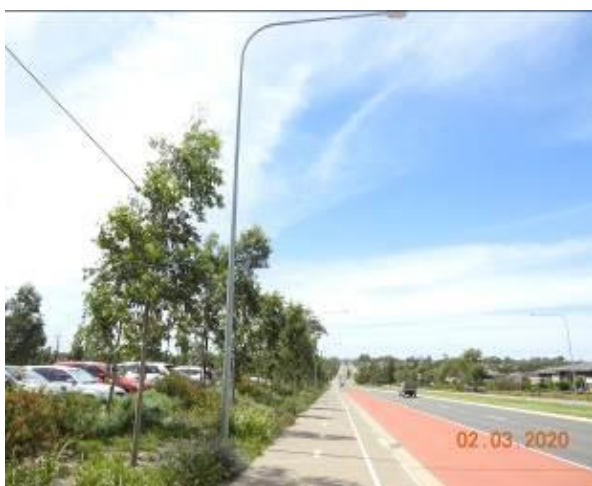
Figure 1860 – General Condition of lamp post

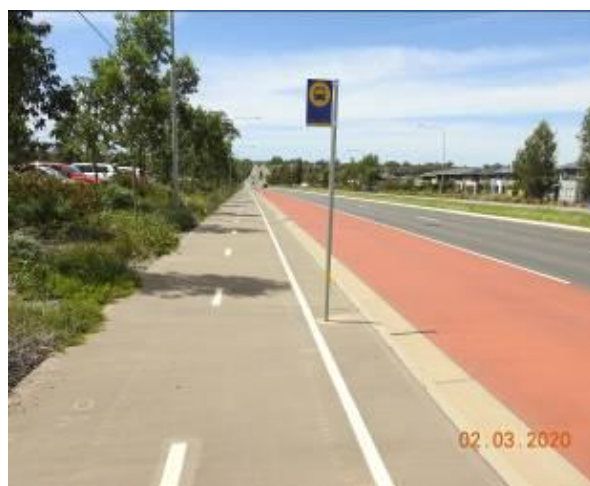
Figure 1861 – General Condition of street sign

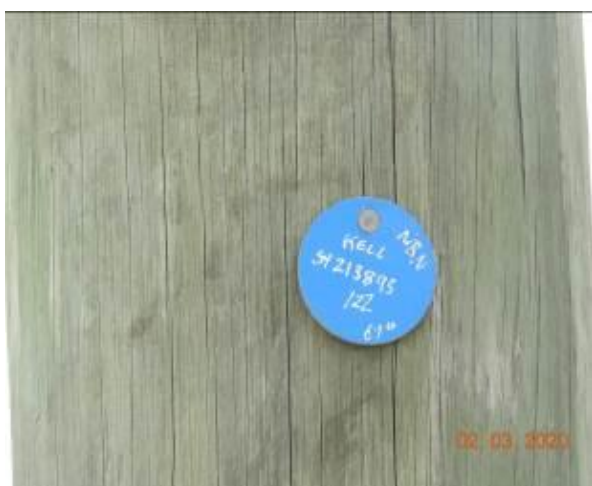
Figure 1862 – General Condition of telegraph pole
Identification No.213893 / 122

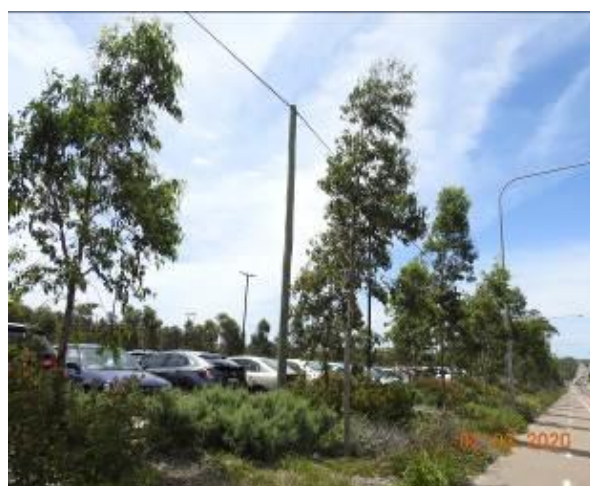
Figure 1863 – General Condition of telegraph pole

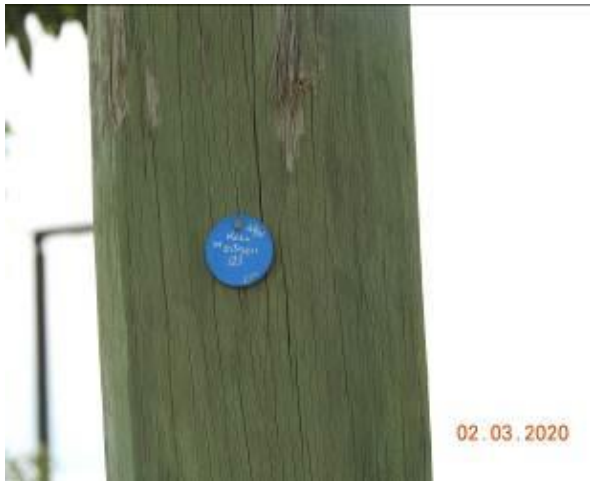
Figure 1864 – General Condition of telegraph pole
Identification No.213984 / 123

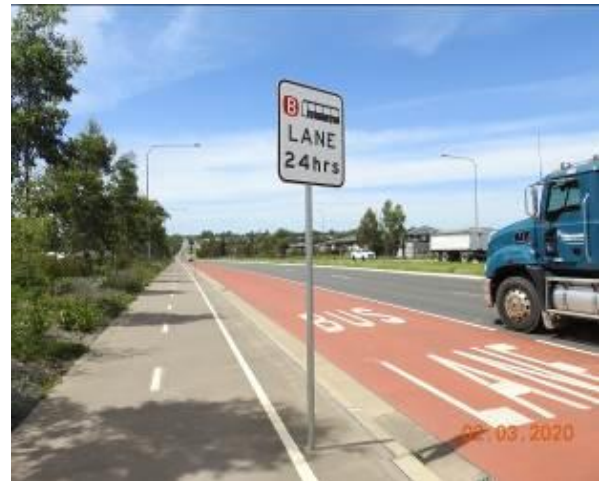
Figure 1865 – General Condition of street sign

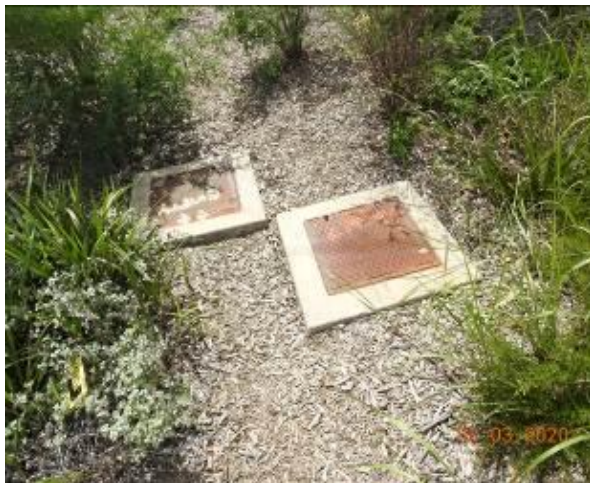
Figure 1866 – General Condition of service pit

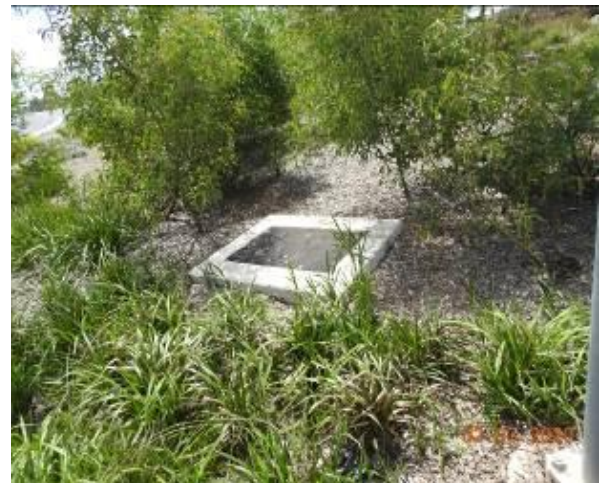
Figure 1867 – General Condition of service pit

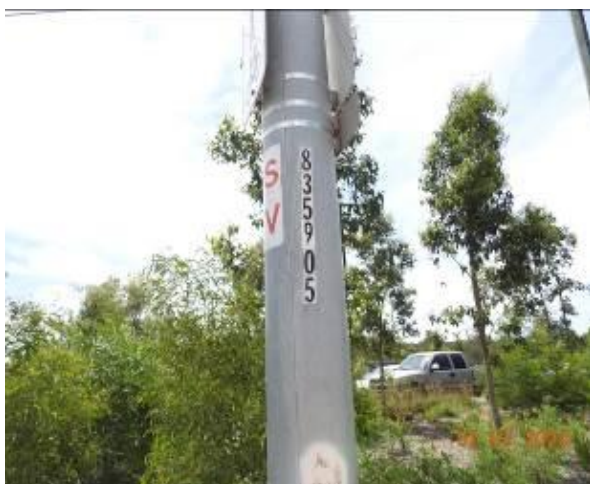
Figure 1868 – General Condition of lamp post
Identification No.835905

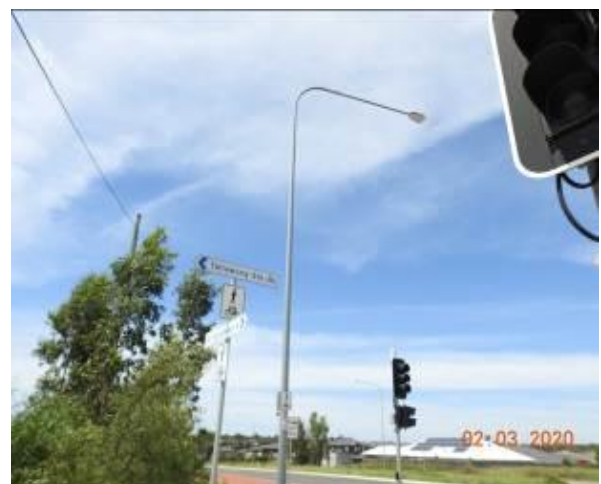
Figure 1869 – General Condition of lamp post

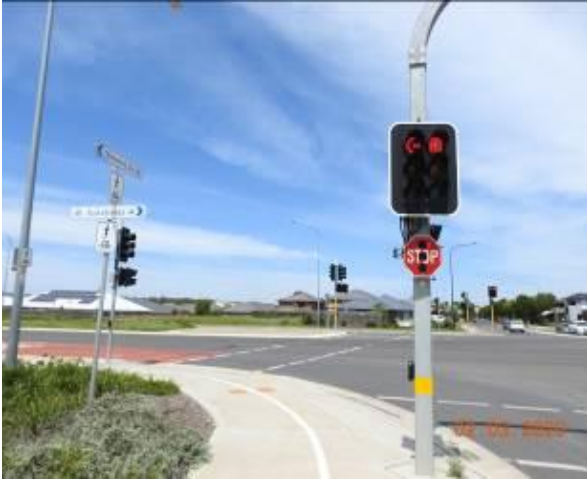
Figure 1870 – General Condition of traffic light / street sign

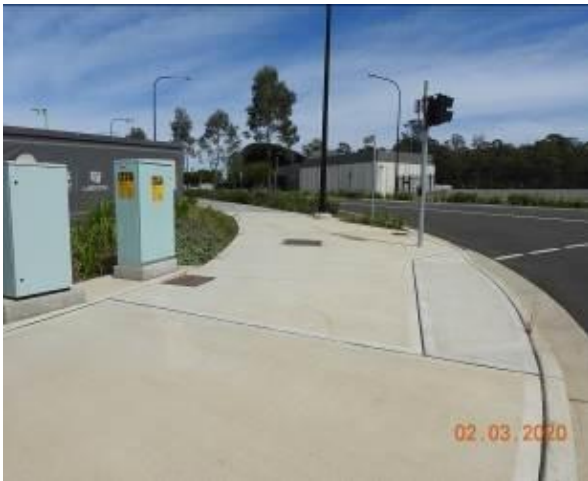
Figure 1871 – General Condition of footpath pavement

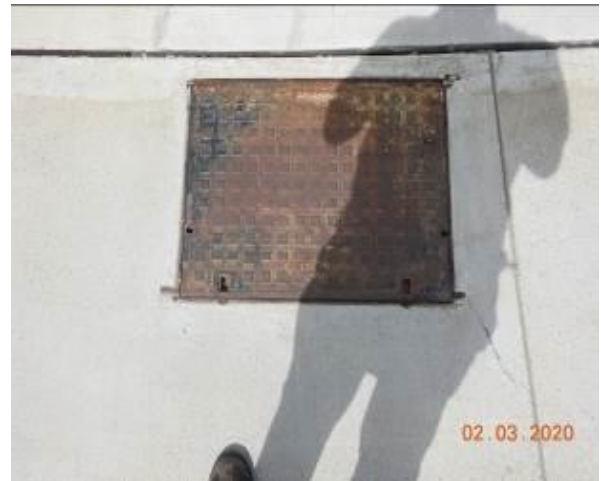
Figure 1872 – General Condition of service pit

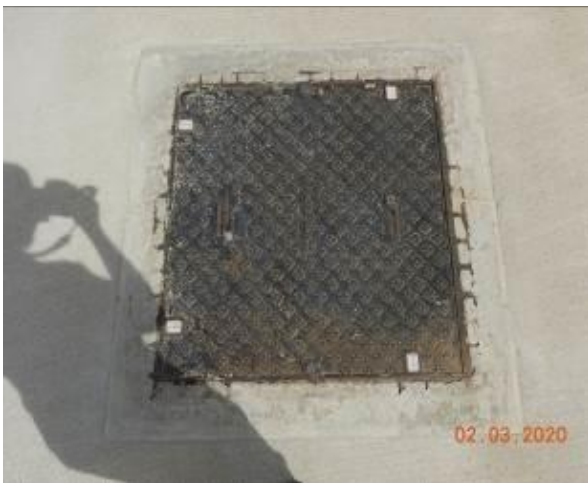
Figure 1873 – General Condition of service pit

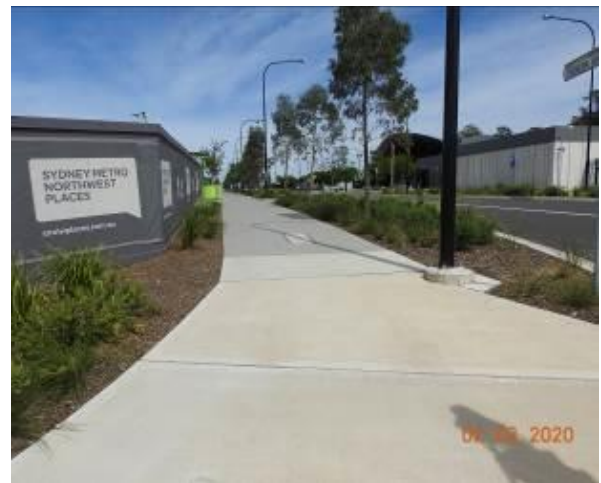
Figure 1874 – General Condition of footpath pavement

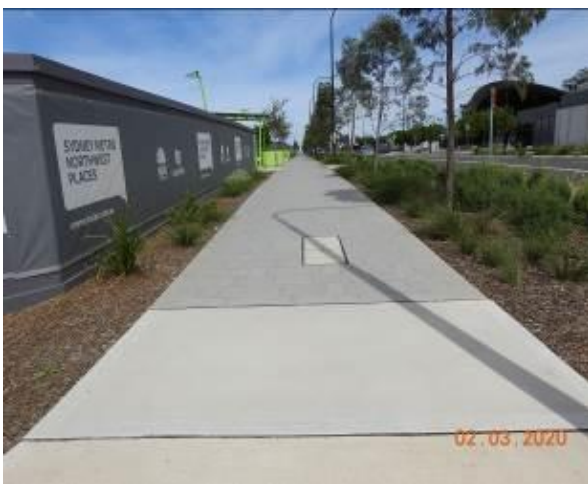
Figure 1875 – General Condition of footpath pavement

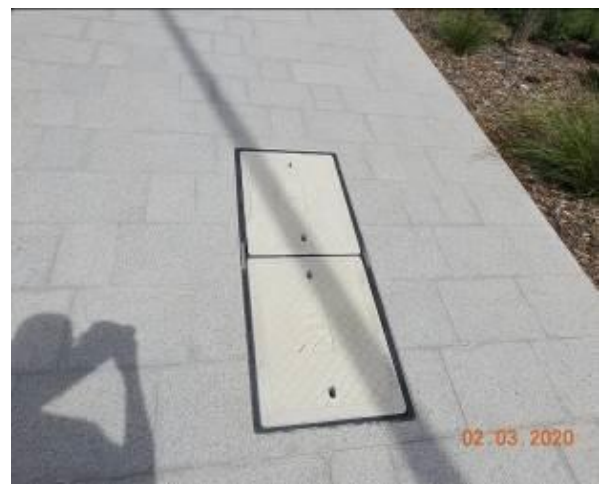
Figure 1876 – General Condition of service pit

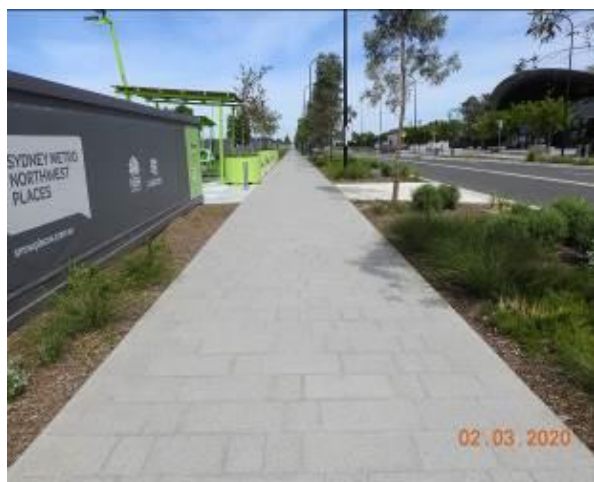
Figure 1877 – General Condition of footpath pavement

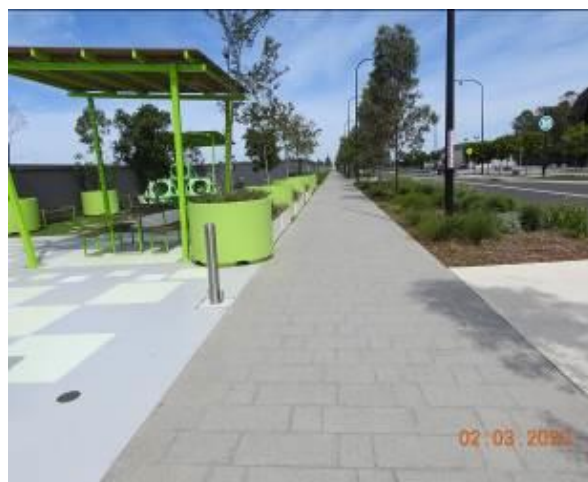
Figure 1878 – General Condition of footpath pavement

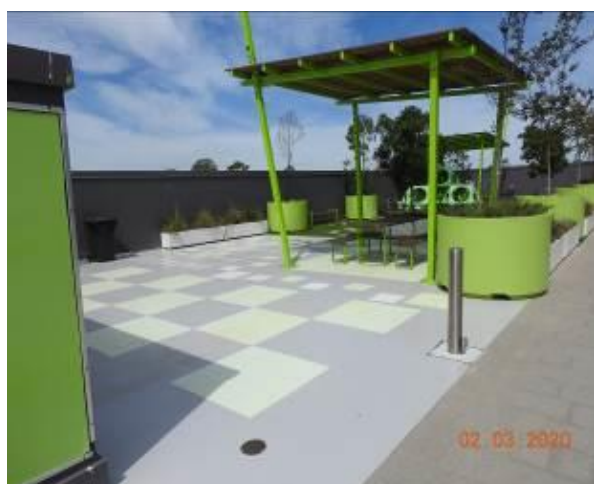
Figure 1879 – General Condition of footpath pavement

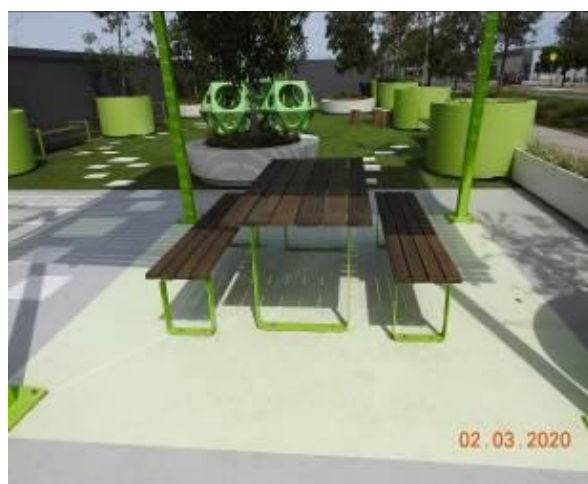
Figure 1880 – General Condition of park bench

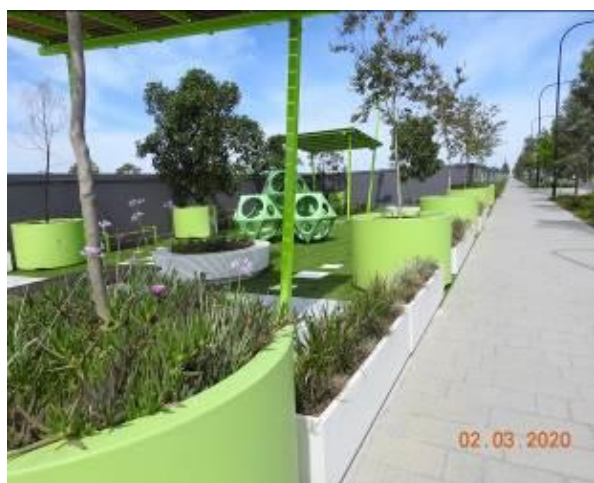
Figure 1881 – General Condition of public park area

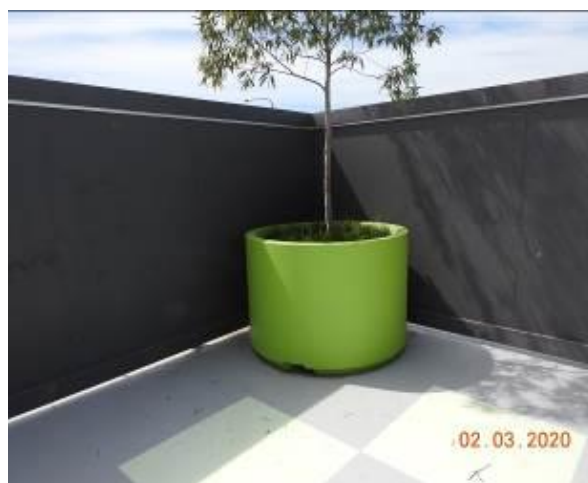
Figure 1882 – General Condition of plantation

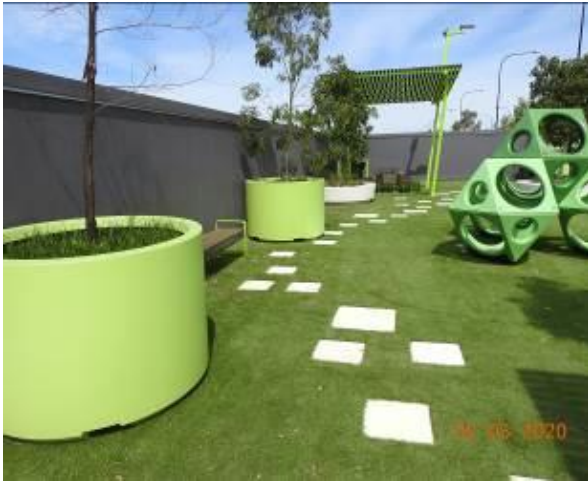
Figure 1883 – General Condition of park grass area

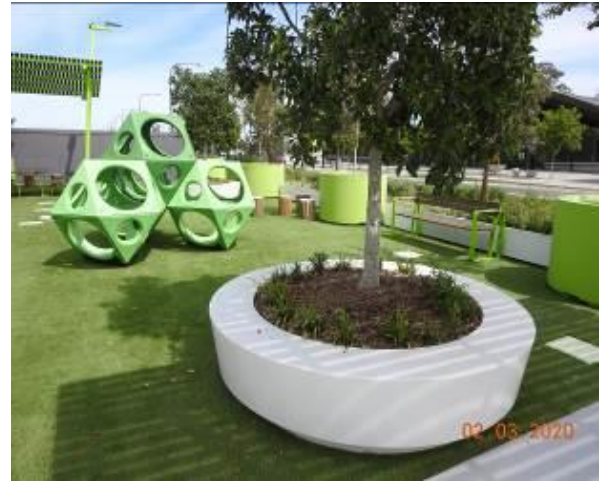
Figure 1884 – General Condition of park plantation

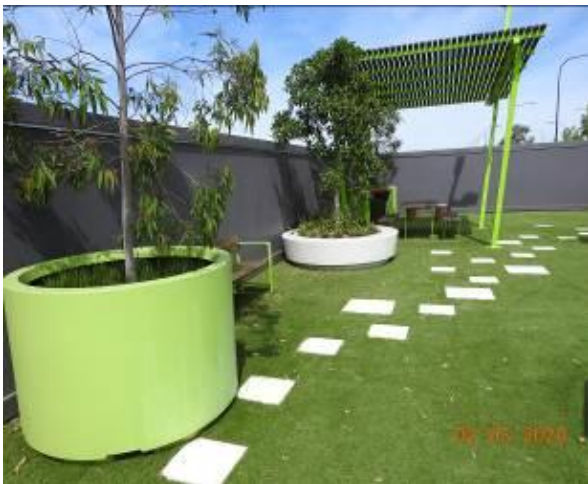
Figure 1885 – General Condition of park plantation

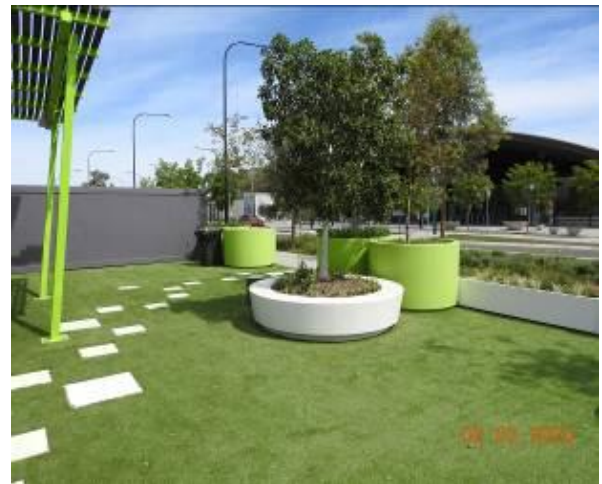
Figure 1886 – General Condition of park plantation

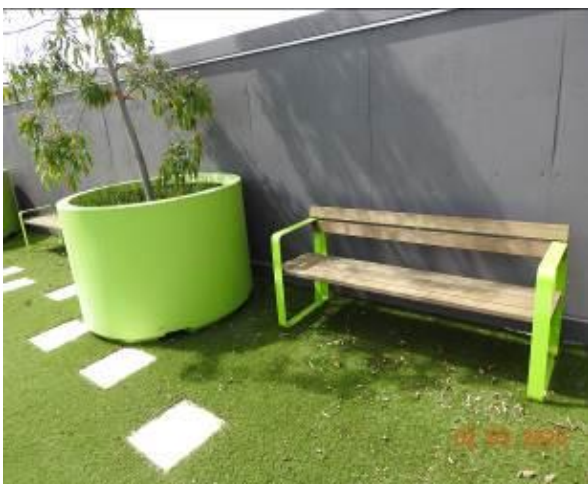
Figure 1887 – General Condition of park public bench

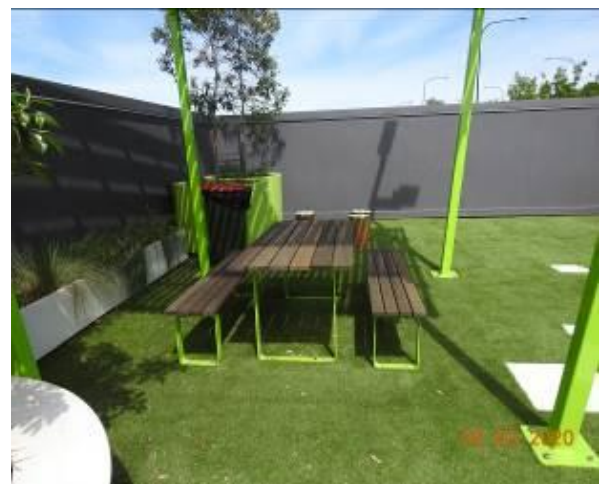
Figure 1888 – General Condition of park bench

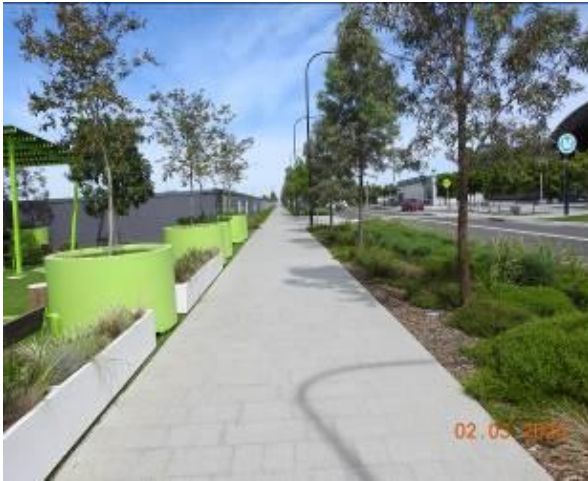
Figure 1889 – General Condition of footpath pavement

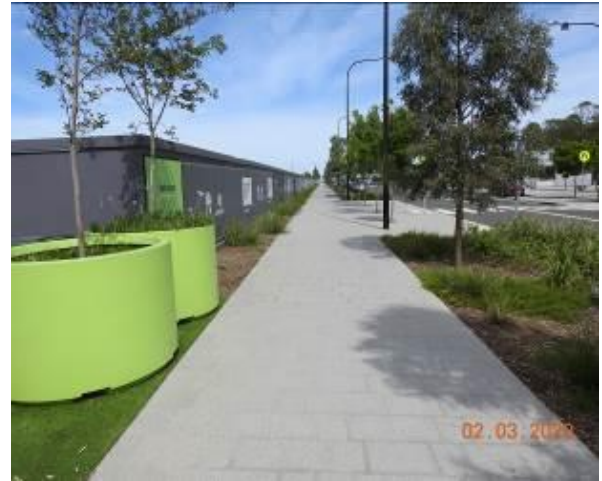
Figure 1890 – General Condition of footpath pavement

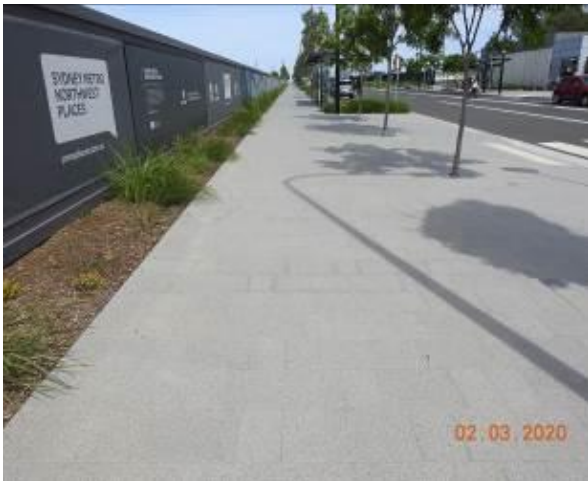
Figure 1891 – General Condition of footpath pavement

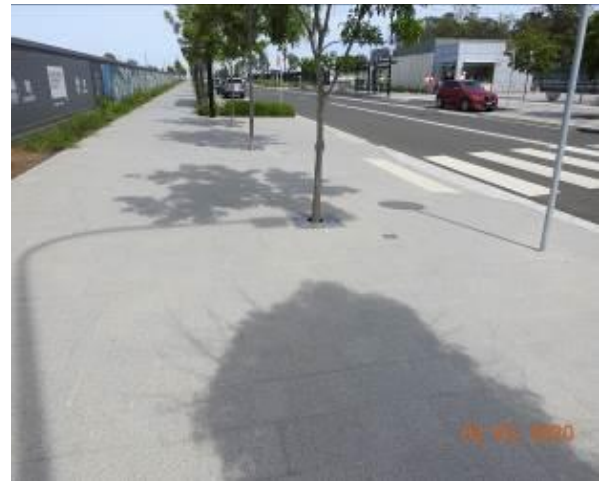
Figure 1892 – General Condition of footpath pavement

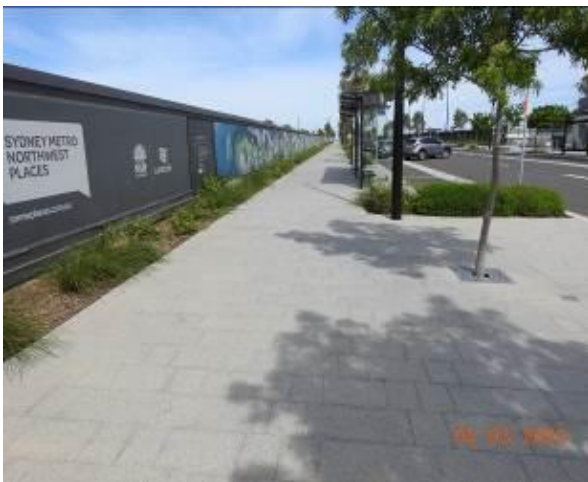
Figure 1893 – General Condition of footpath pavement

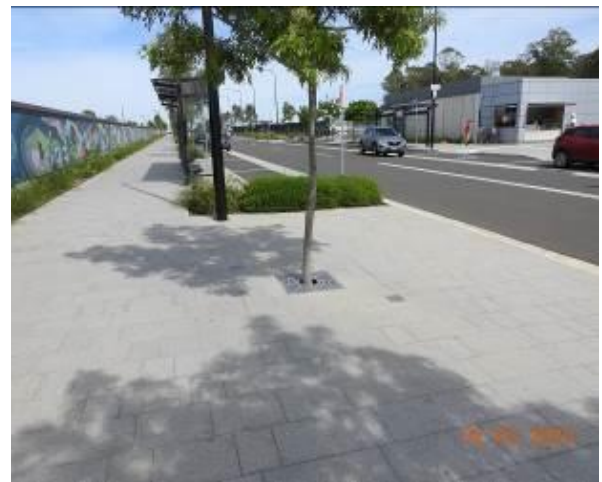
Figure 1894 – General Condition of footpath pavement

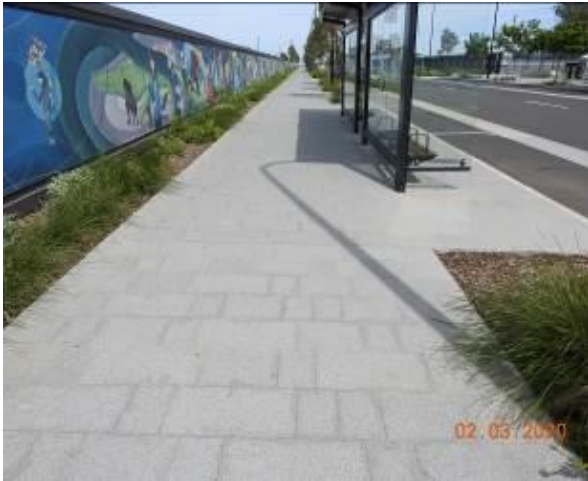
Figure 1895 – General Condition of footpath pavement

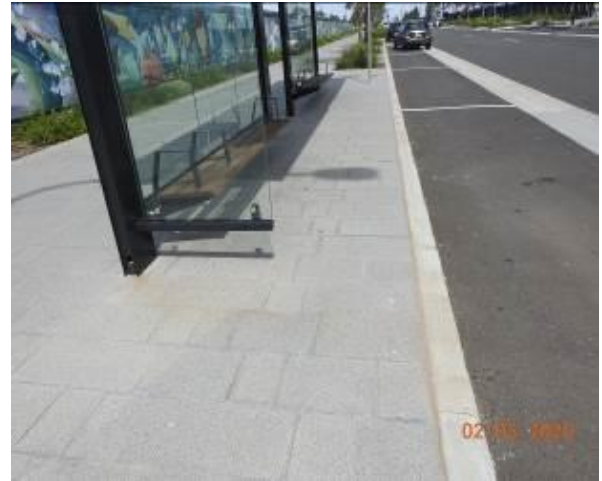
Figure 1896 – General Condition of footpath pavement

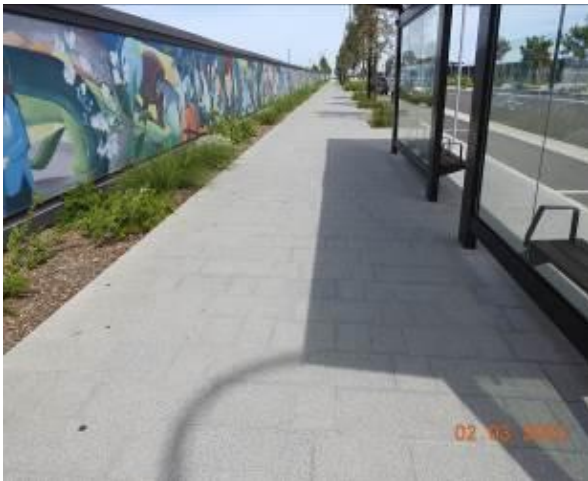
Figure 1897 – General Condition of footpath pavement

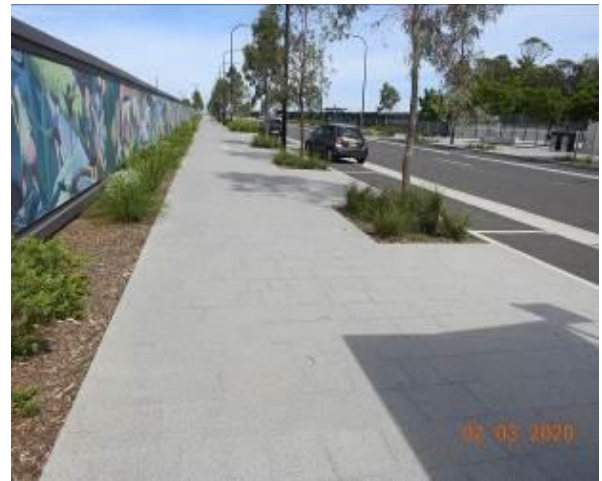
Figure 1898 – General Condition of footpath pavement

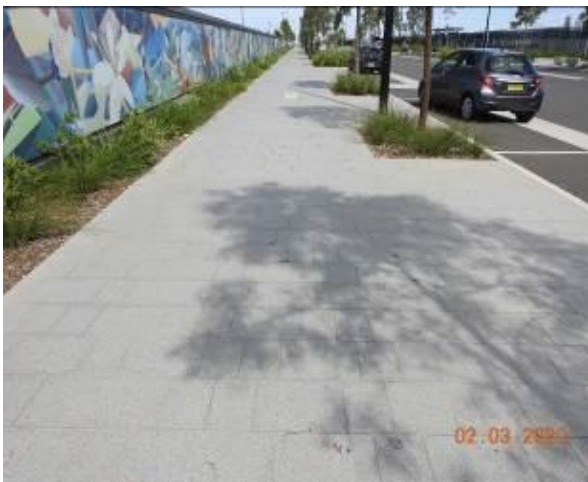
Figure 1899 – General Condition of footpath pavement

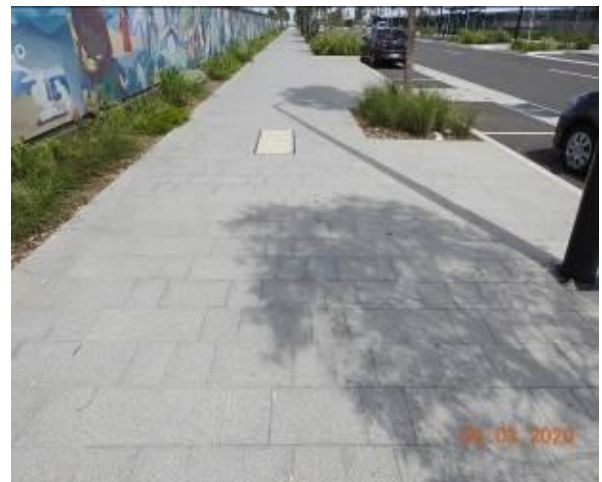
Figure 1900 – General Condition of footpath pavement

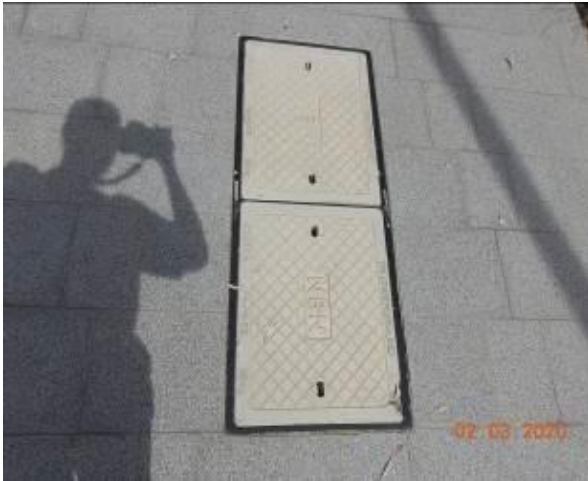
Figure 1901 – Loss of material through service pit

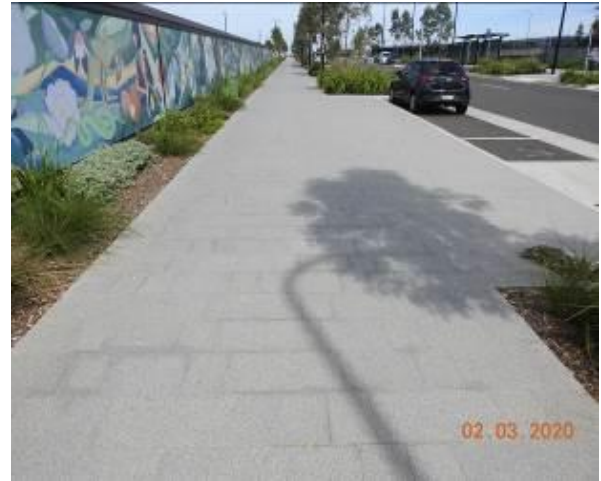
Figure 1902 – General Condition of footpath pavement

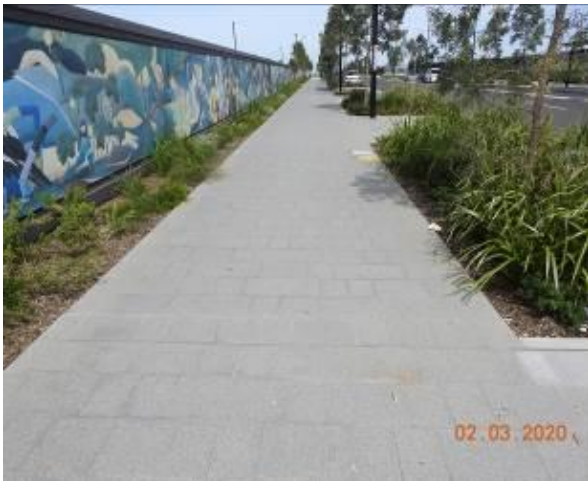
Figure 1903 – General Condition of footpath pavement

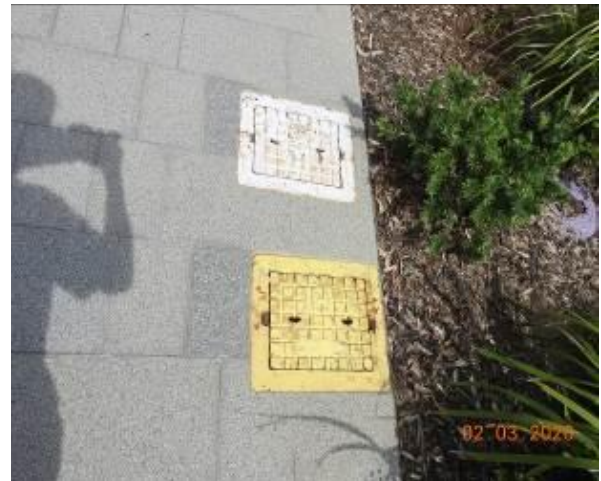
Figure 1904 – General Condition of service pit

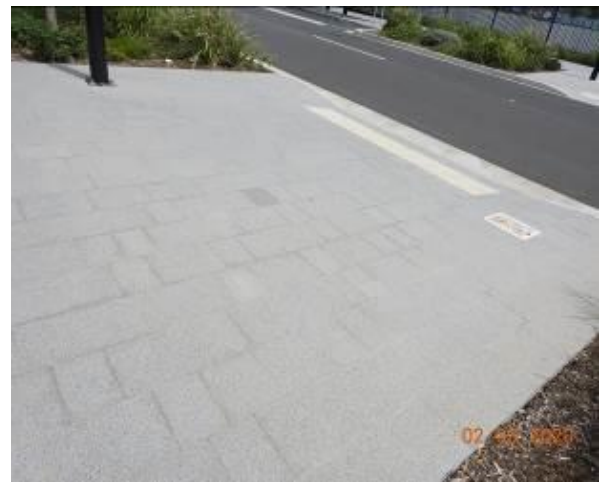
Figure 1906 – General Condition of footpath pavement

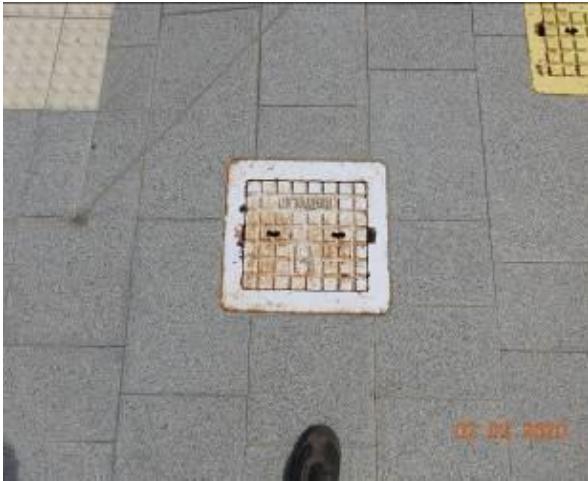
Figure 1907 – General Condition of service pit

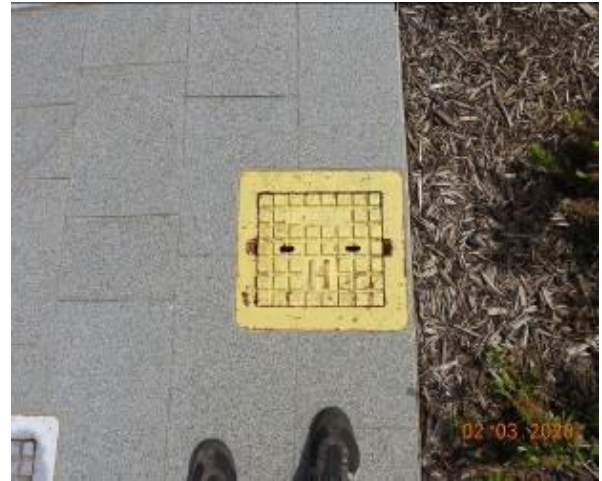
Figure 1908 – General Condition of service pit

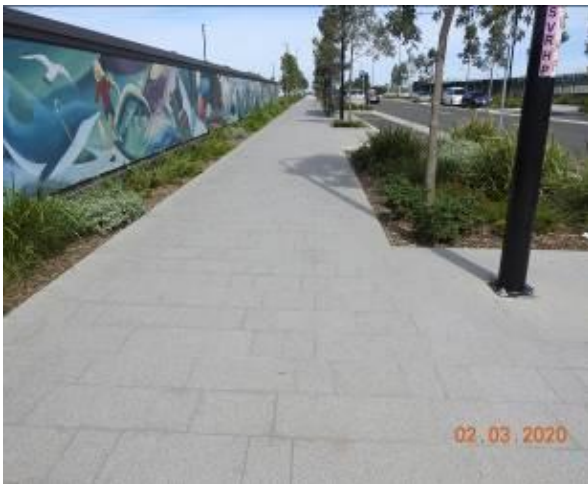
Figure 1909 – General Condition of footpath pavement

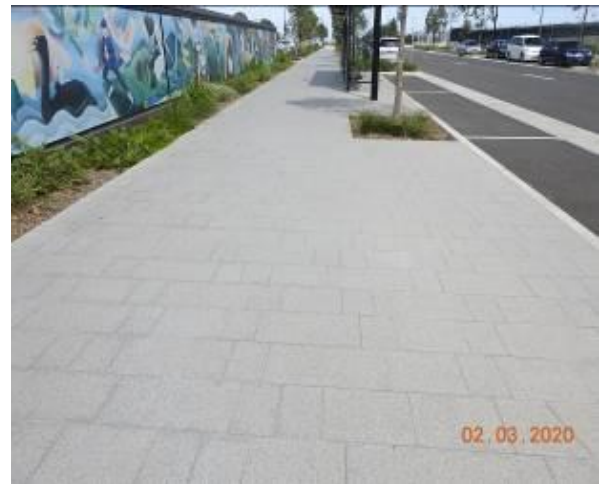
Figure 1910 – General Condition of footpath pavement

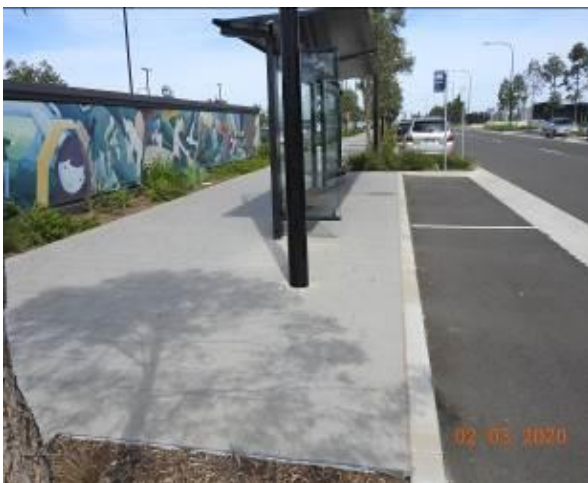
Figure 1911 – General Condition of footpath pavement

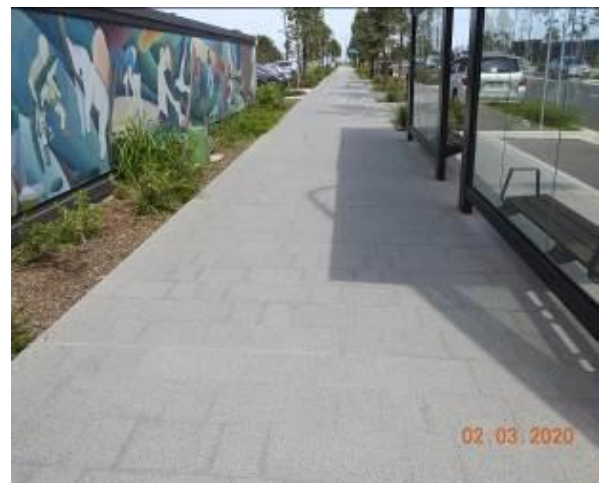
Figure 1912 – General Condition of footpath pavement

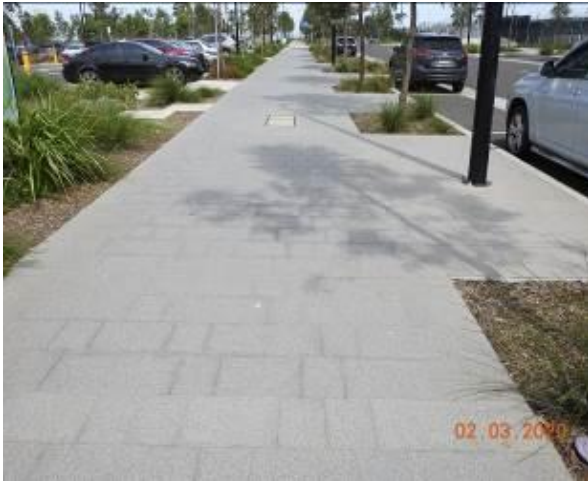
Figure 1913 – General Condition of footpath pavement

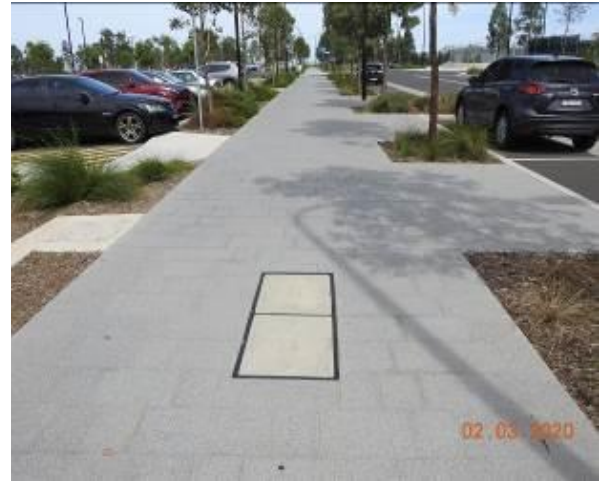
Figure 1914 – General Condition of service pit

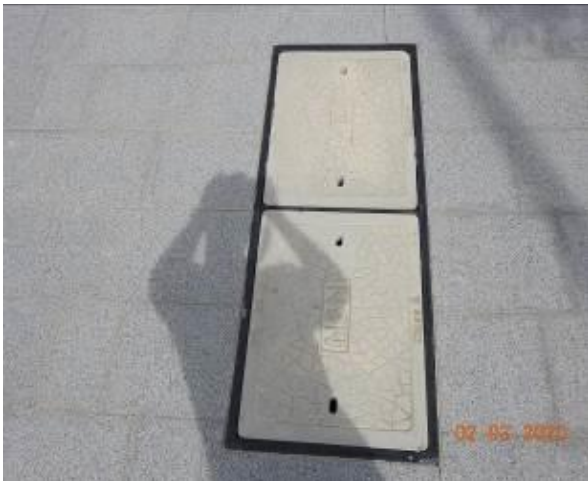
Figure 1915 – General Condition of service pit

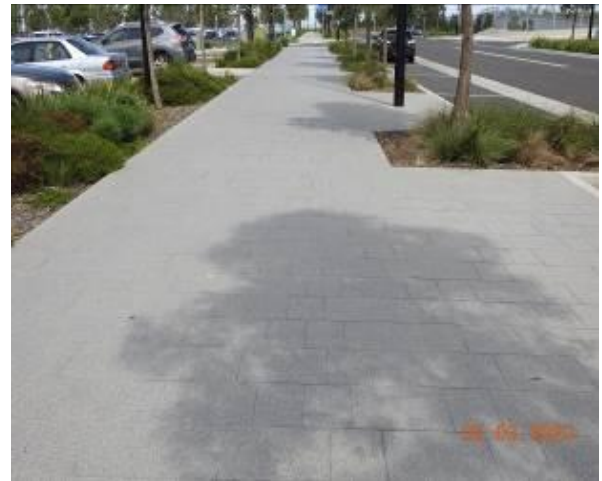
Figure 1916 – General Condition of footpath pavement

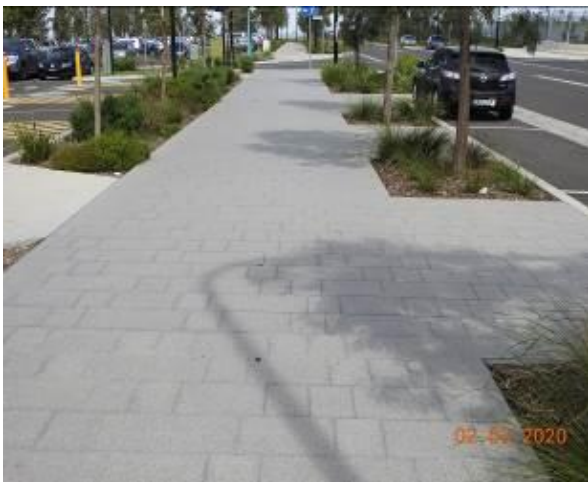
Figure 1917 – General Condition of footpath pavement

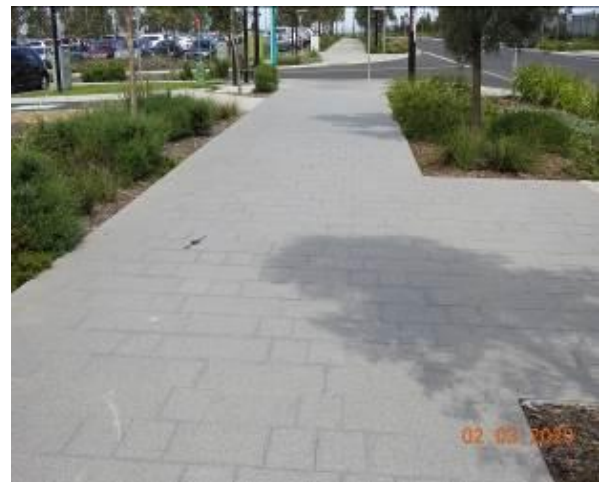
Figure 1918 – General Condition of footpath pavement

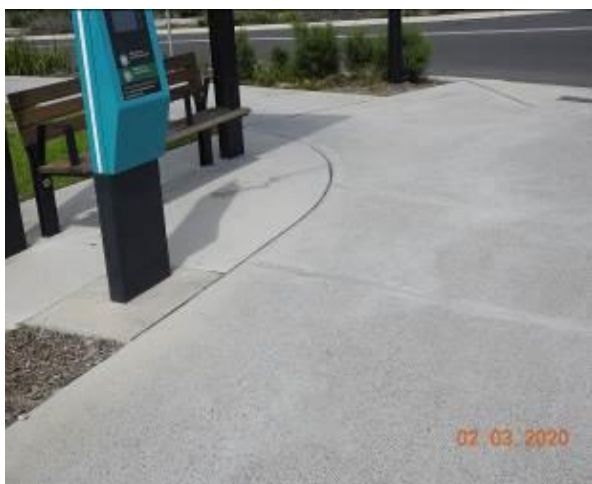
Figure 1919 – General Condition of footpath pavement
