**1-15 AND 2-12 CONFERTA AVENUE,
ROUSE HILL NSW 2155
TALLAWONG STATION PRECINCT SOUTH
PRE-DILAPIDATION REPORT**

**DEICORP PROJECTS
(TALLAWONG STATION) PTY LTD**

Job No. 191294.0
24/03/2020

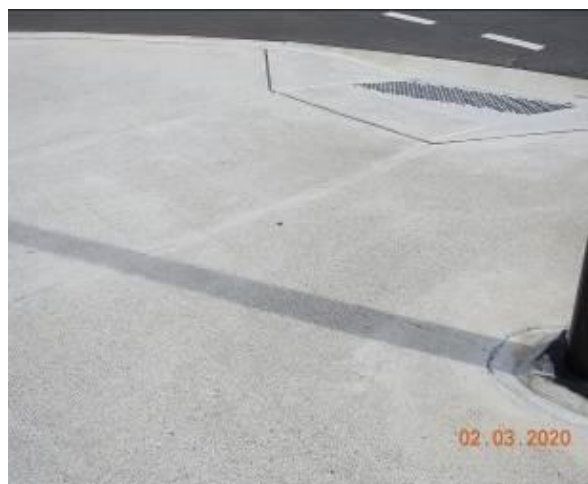
Figure 1920 – Crack propagation through footpath pavement

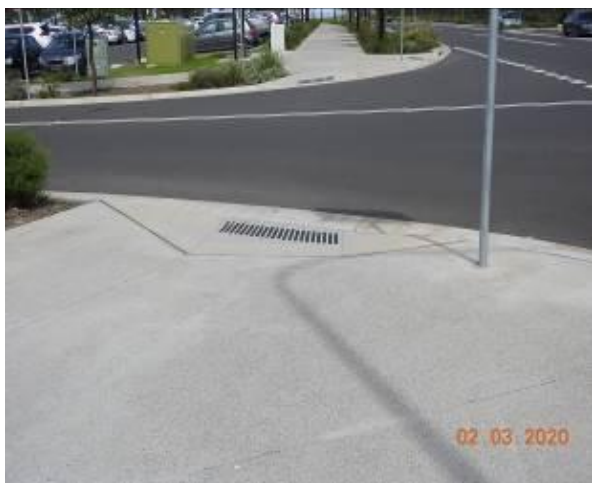
Figure 1921 – General Condition of footpath pavement

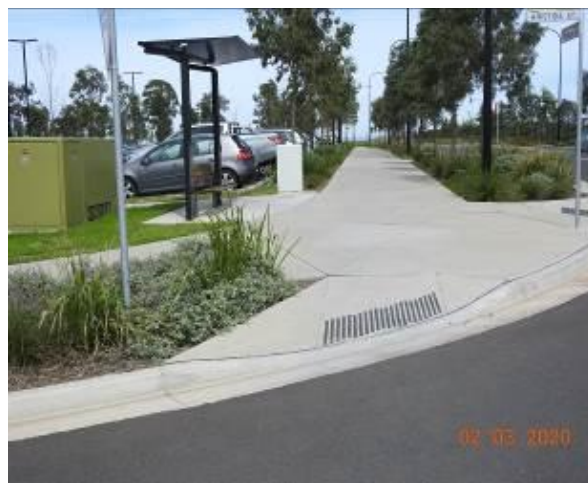
Figure 1922 – General Condition of footpath pavement

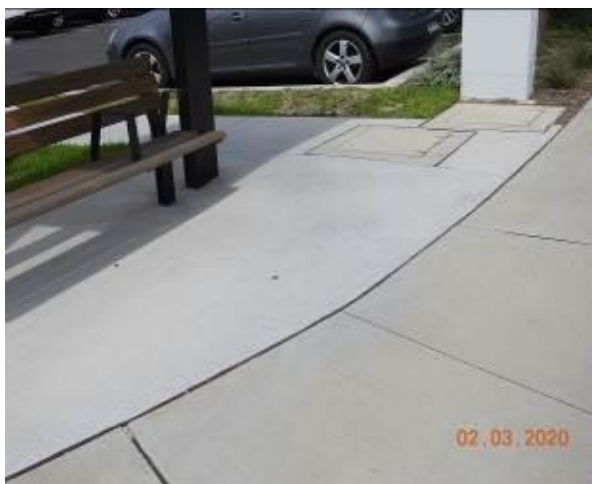
Figure 1923 – General Condition of footpath pavement

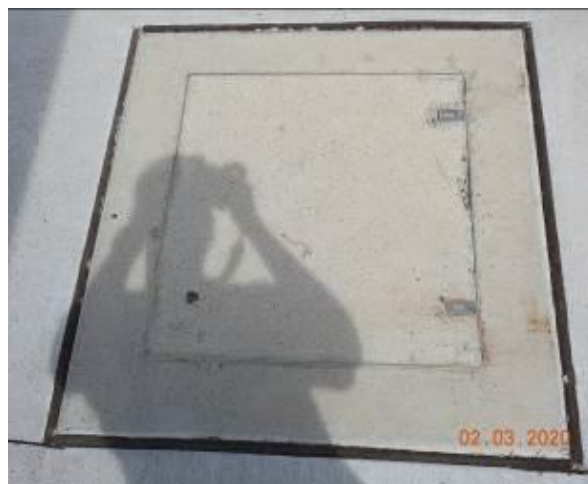
Figure 1924 – Loss of material through service pit

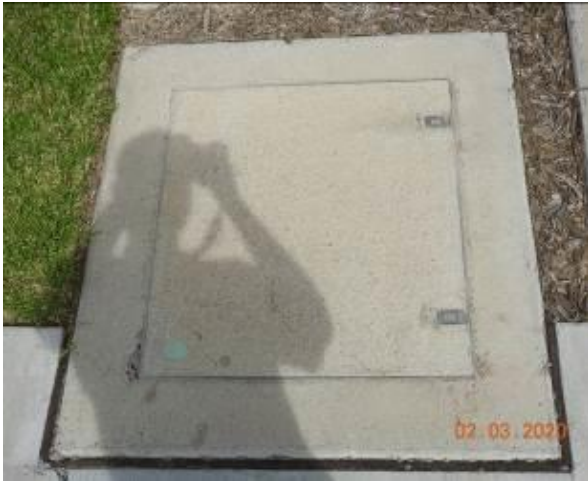
Figure 1925 – Loss of material through service pit

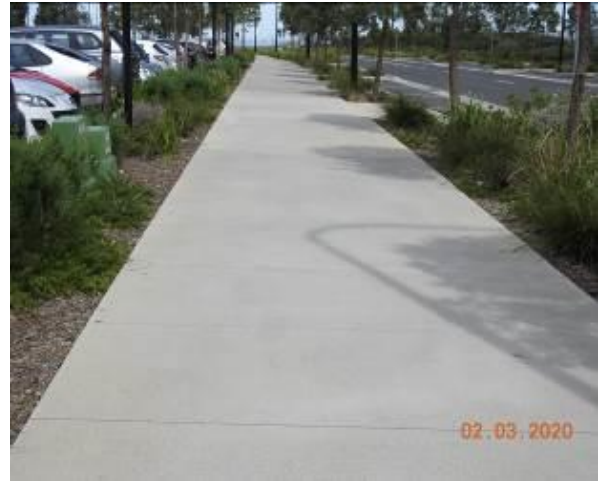
Figure 1926 – General Condition of footpath pavement

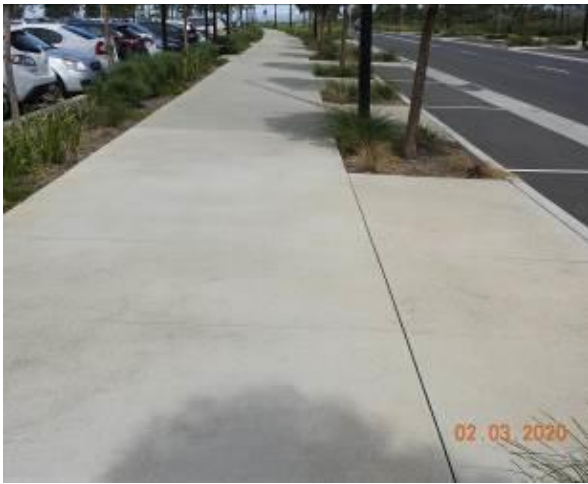
Figure 1927 – General Condition of footpath pavement

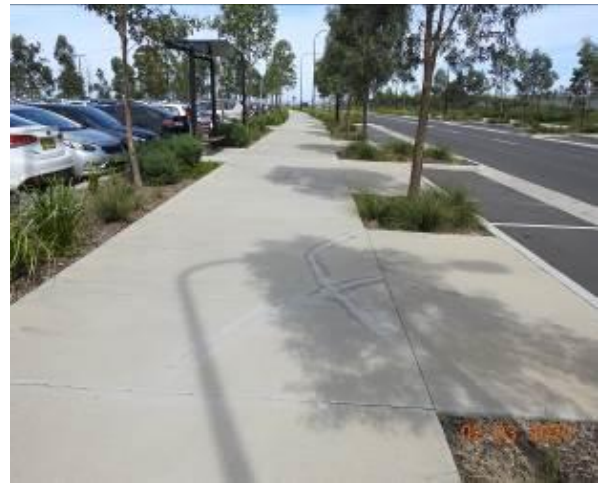
Figure 1928 – General Condition of footpath pavement

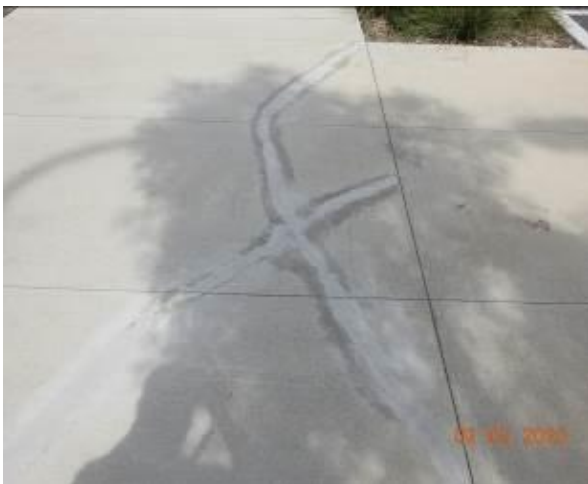
Figure 1929 – Crack propagation through footpath pavement

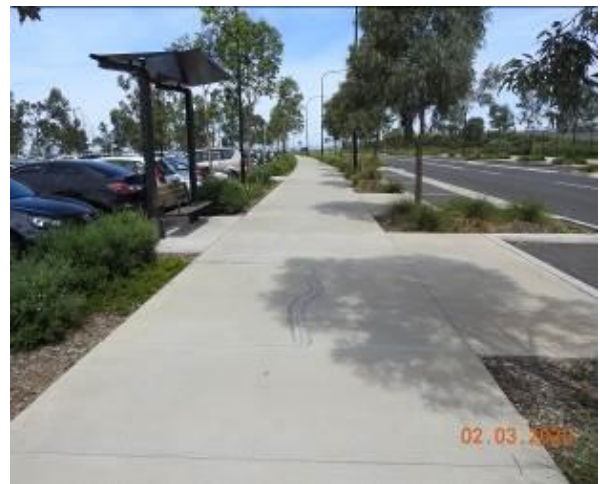
Figure 1930 – General Condition of footpath pavement

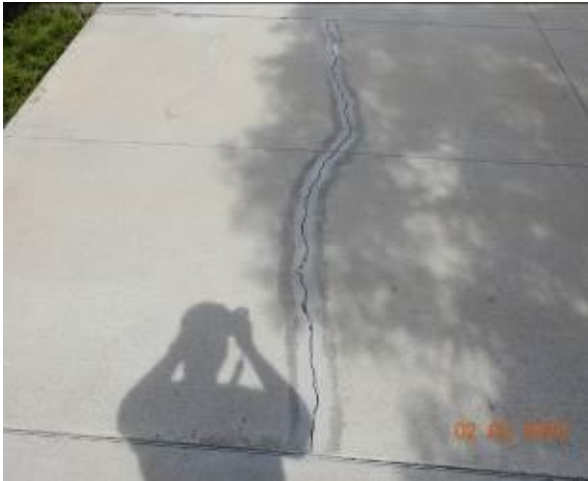
Figure 1931 – Crack propagation and loss of material through footpath pavement

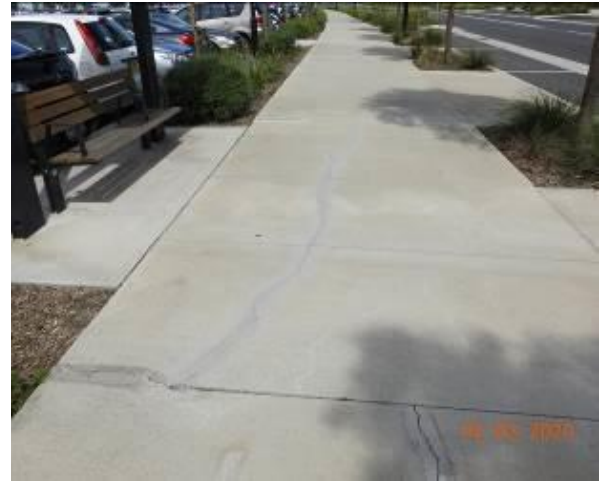
Figure 1932 – General Condition of footpath pavement

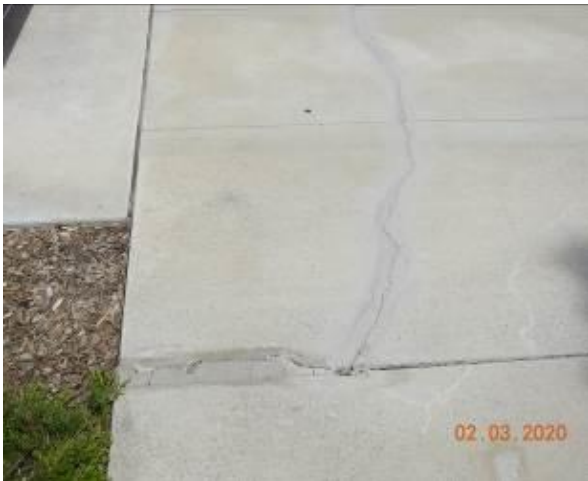
Figure 1933 – Crack propagation and loss of material through footpath pavement

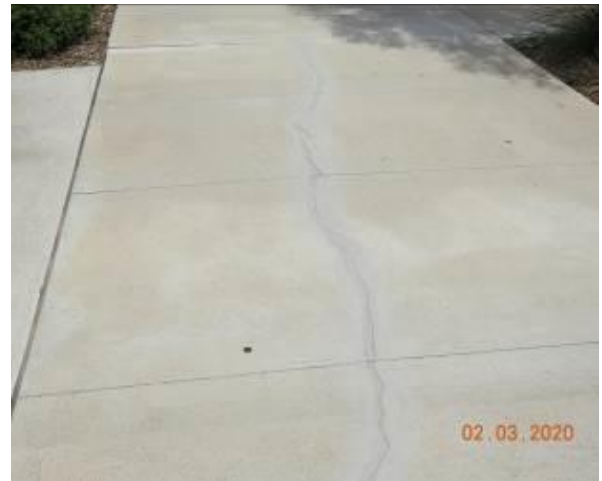
Figure 1934 – Crack propagation through footpath pavement

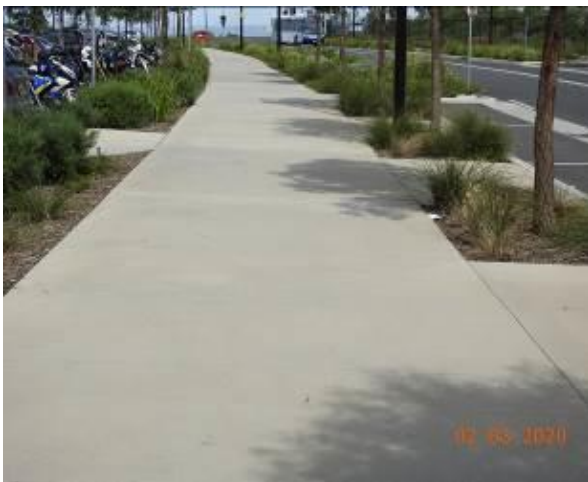
Figure 1935 – General Condition of footpath pavement

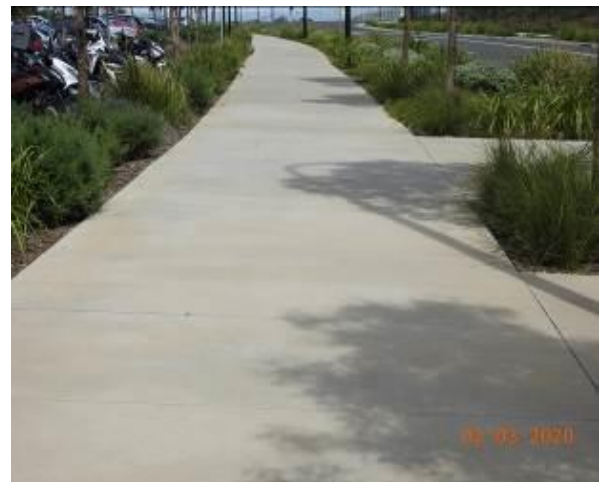
Figure 1936 – General Condition of footpath pavement

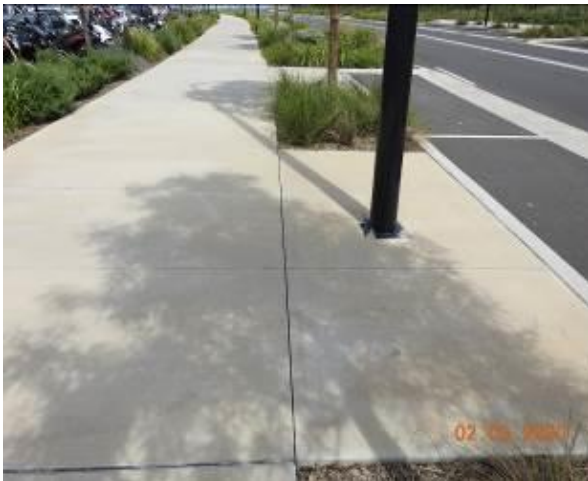
Figure 1937 – General Condition of footpath pavement

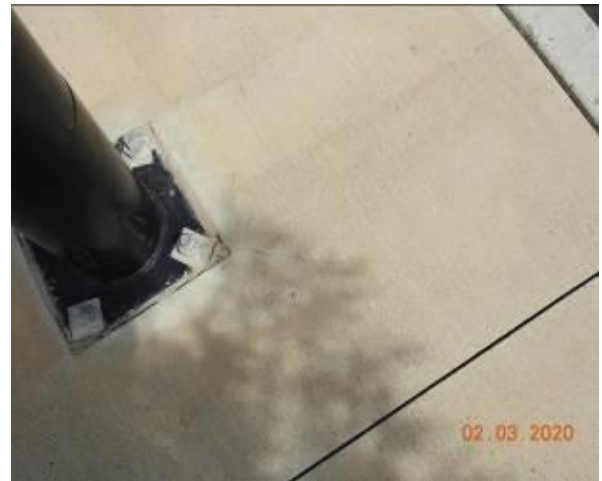
Figure 1938 – Crack propagation through footpath pavement

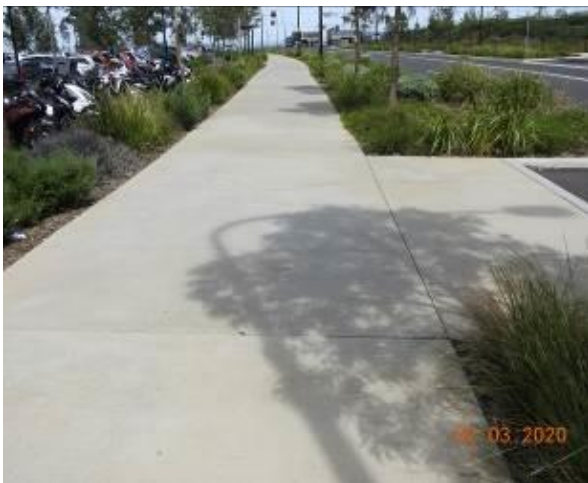
Figure 1939 – General Condition of footpath pavement

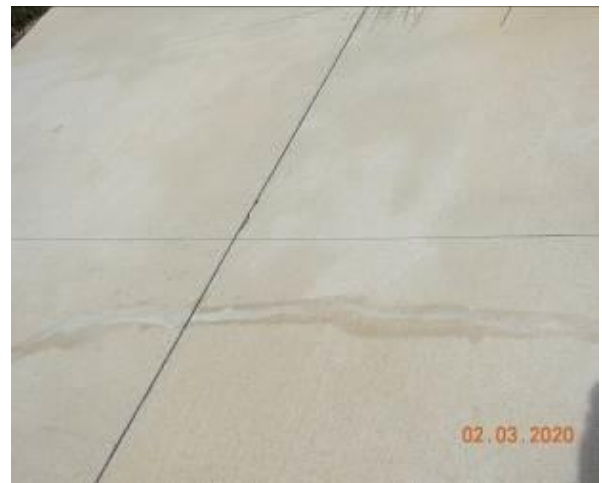
Figure 1940 – Loss of material through footpath pavement

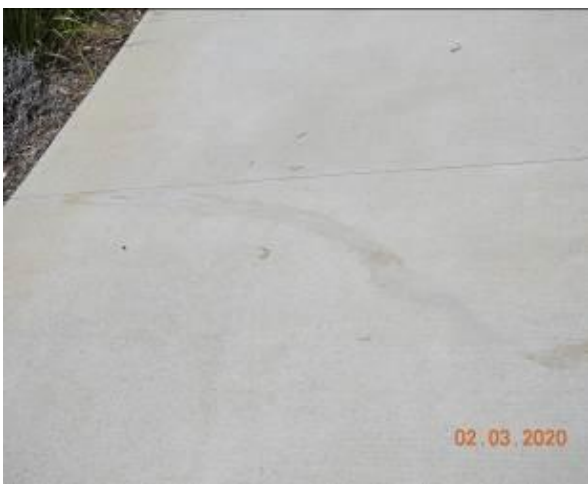
Figure 1941 – Crack propagation through footpath pavement

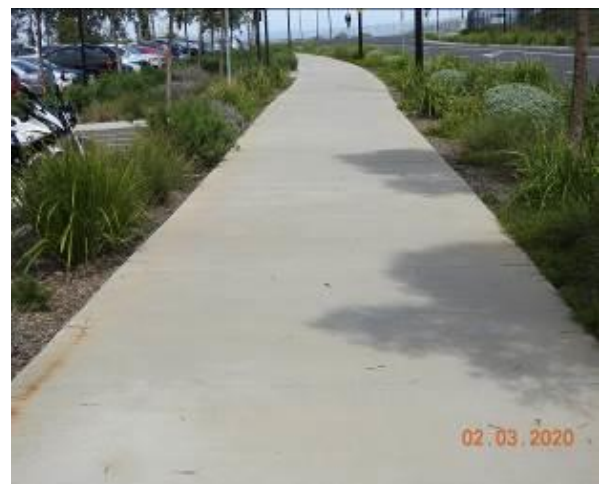
Figure 1942 – General Condition of footpath pavement

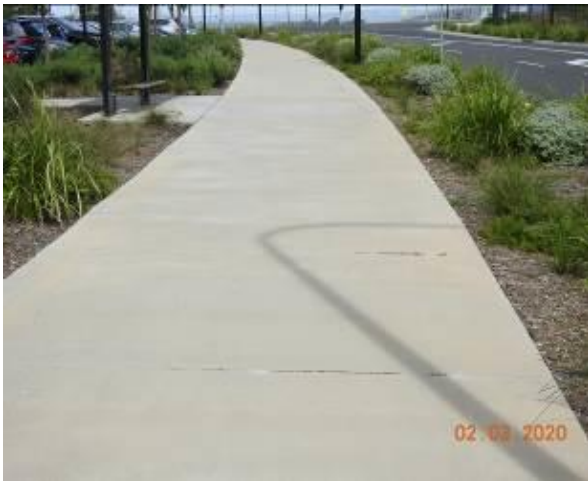
Figure 1943 – General Condition of footpath pavement

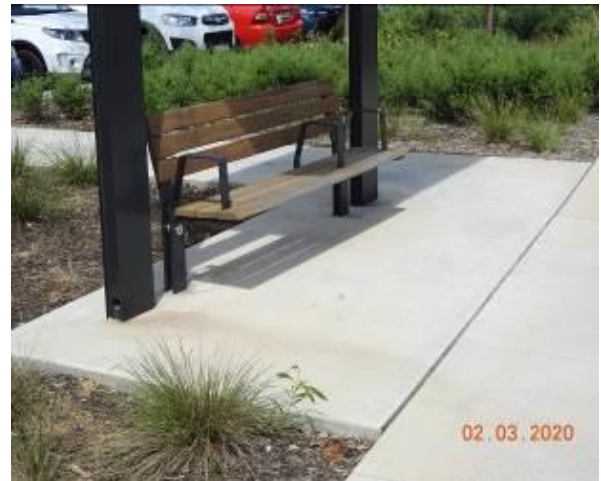
Figure 1944 – General Condition of public bench

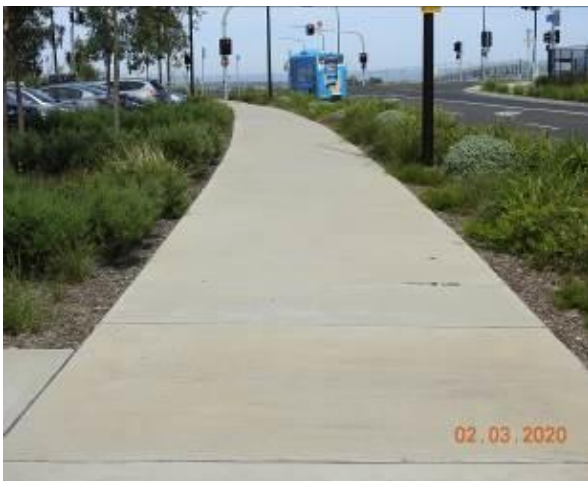
Figure 1945 – General Condition of footpath pavement

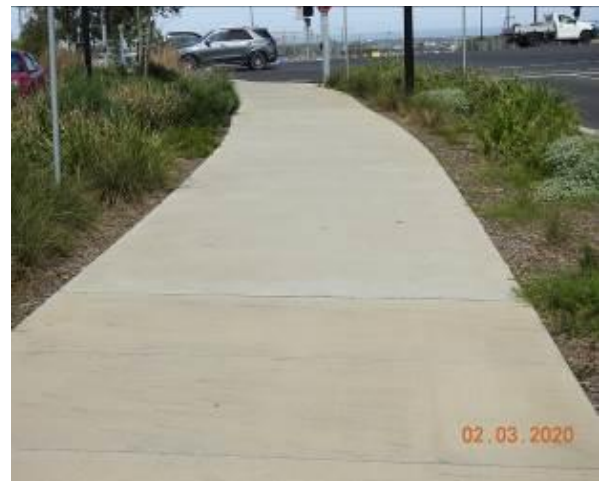
Figure 1946 – General Condition of footpath pavement

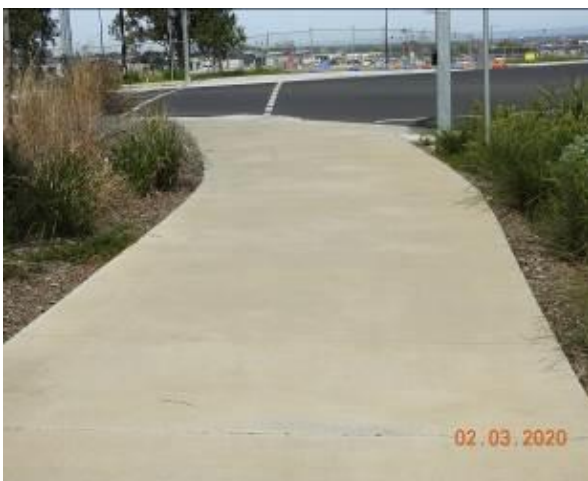
Figure 1947 – General Condition of footpath pavement

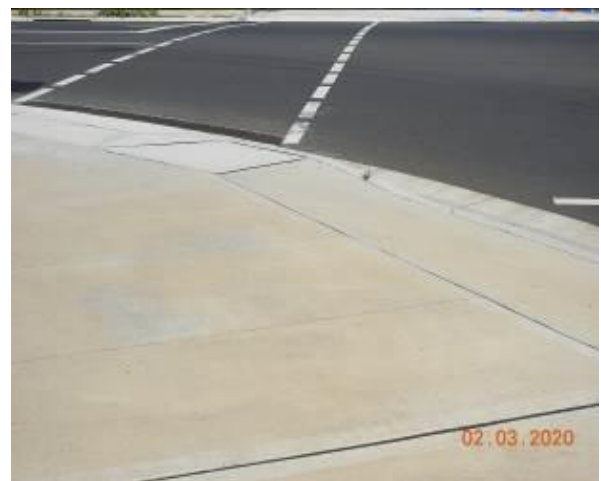
Figure 1948 – General Condition of footpath pavement

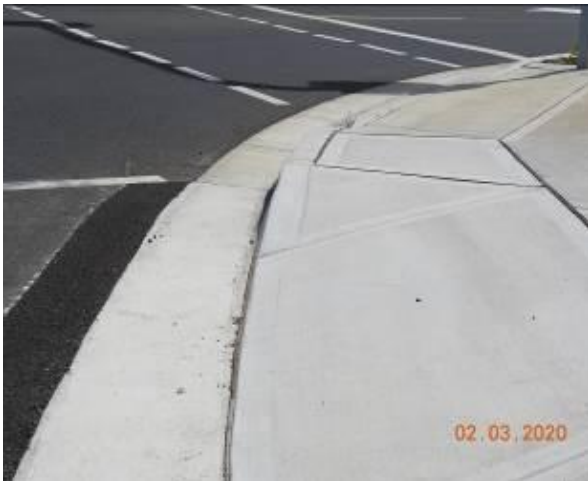
Figure 1949 – General Condition of kerb and gutter

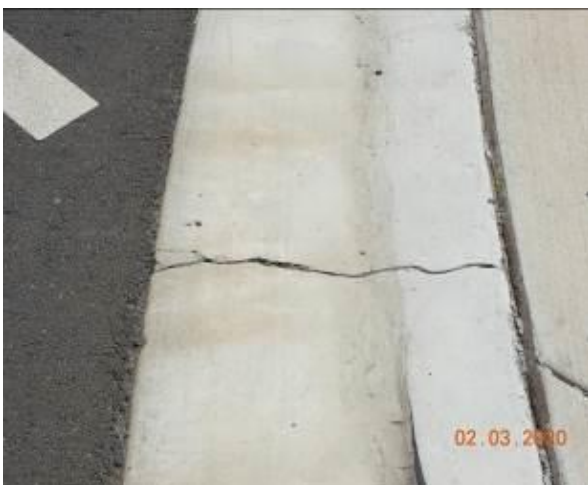
Figure 1950 – General Condition of kerb and gutter

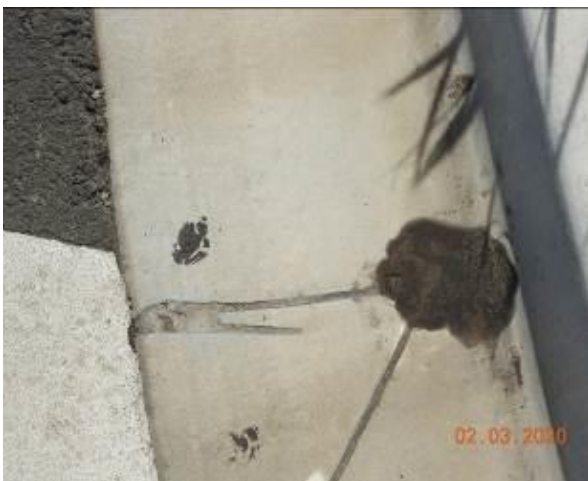
Figure 1952 – General Condition of kerb and gutter

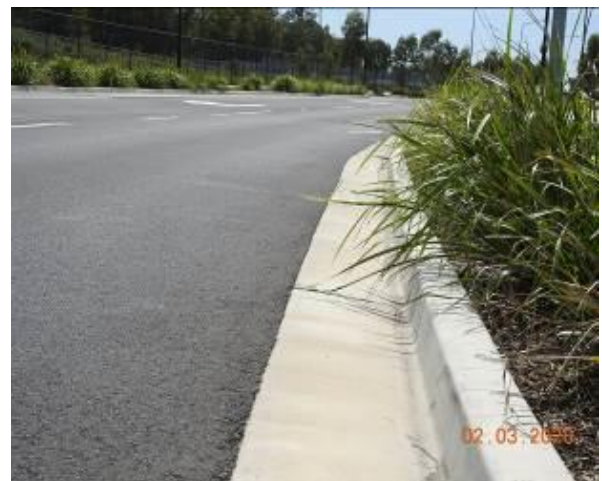
Figure 1953 – Loss of material through gutter

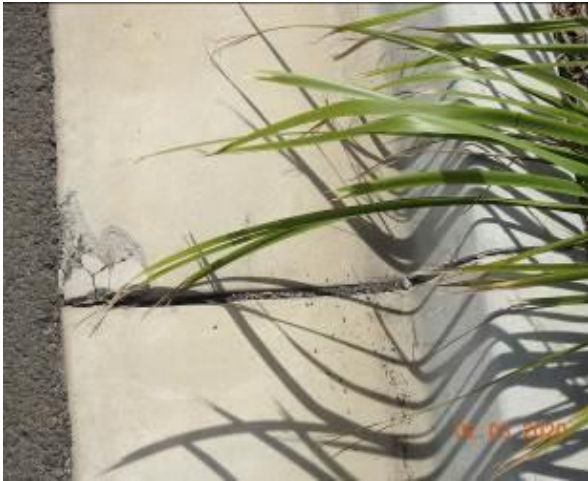
Figure 1954 – General Condition of kerb and gutter

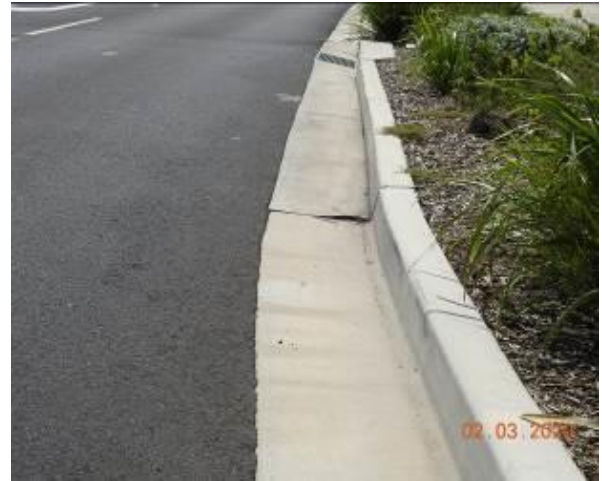
Figure 1955 – Crack propagation and loss of material through kerb and gutter

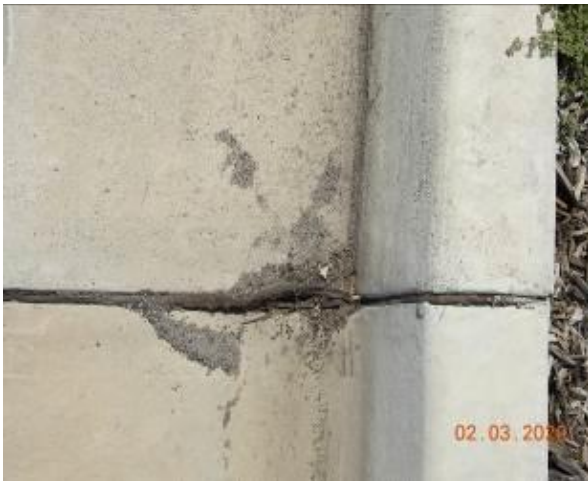
Figure 1956 – General Condition of kerb and gutter

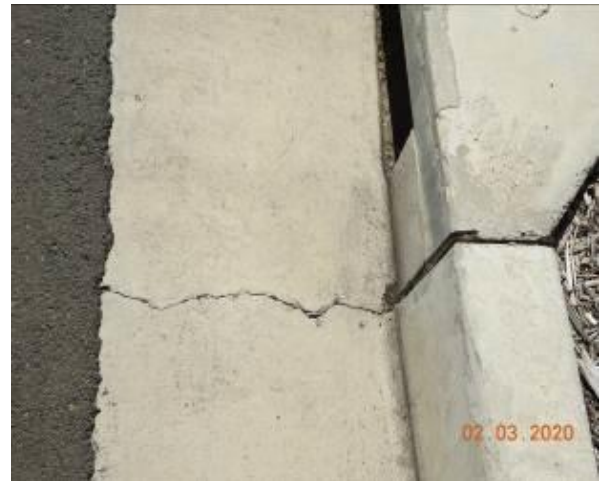
Figure 1957 – General Condition of kerb and gutter

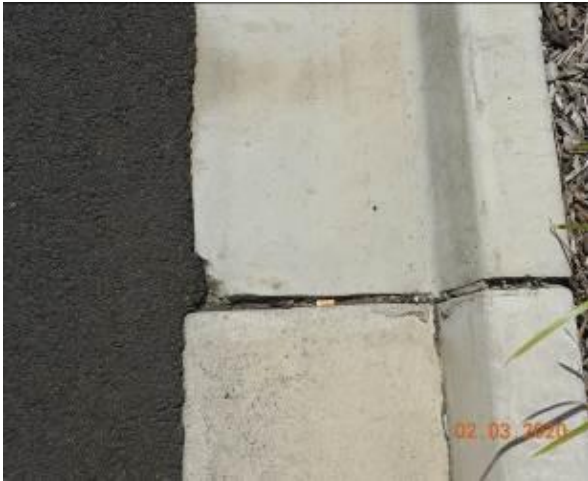
Figure 1960 – General Condition of kerb and gutter

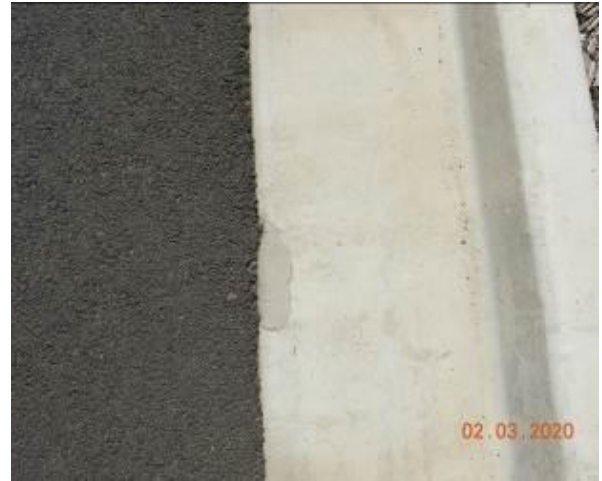
Figure 1961 – General Condition of kerb and gutter

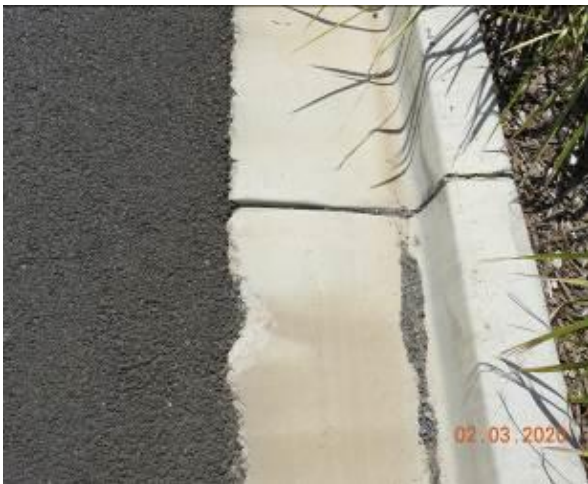
Figure 1962 – Evidence of patchwork through gutter

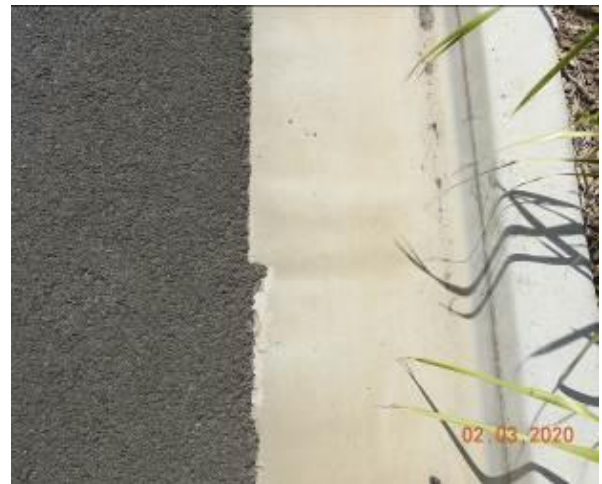
Figure 1963 – Loss of material through gutter

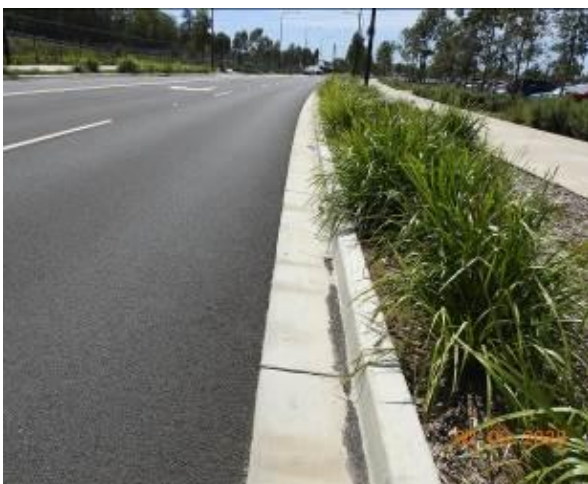
Figure 1964 – Loss of material through gutter

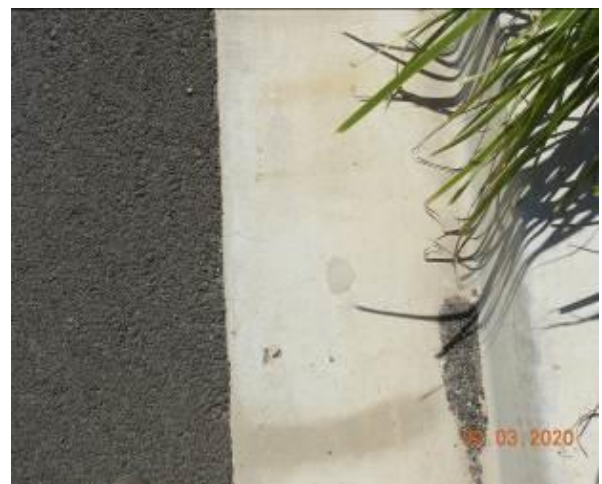
Figure 1965 – General Condition of kerb and gutter

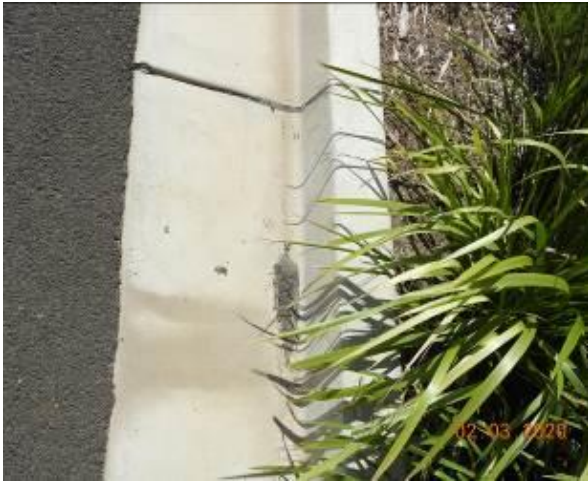
Figure 1966 – Crack propagation and Evidence of patchwork through gutter

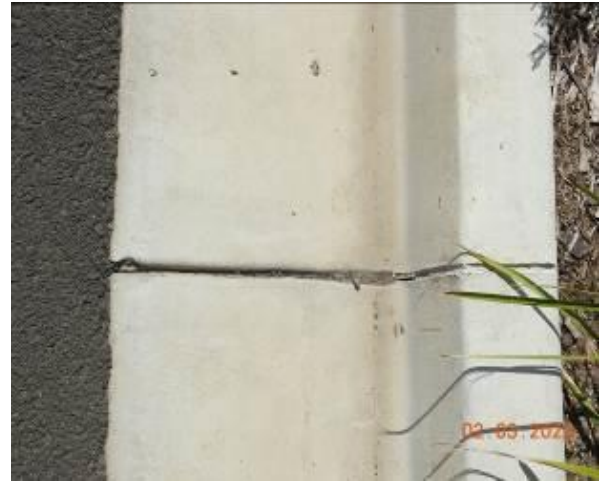
Figure 1967 – General Condition of kerb and gutter

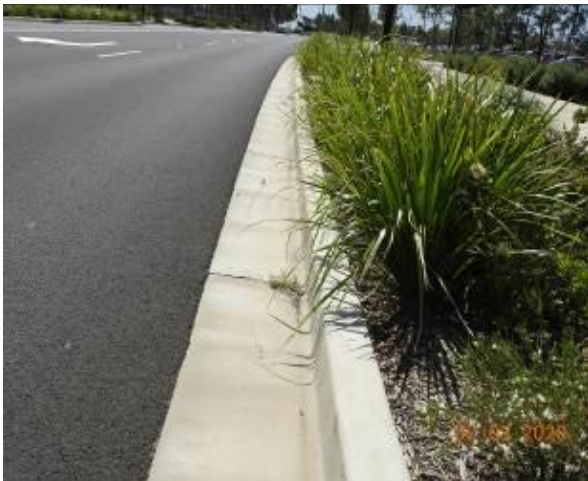
Figure 1968 – Crack propagation and loss of material through kerb and gutter

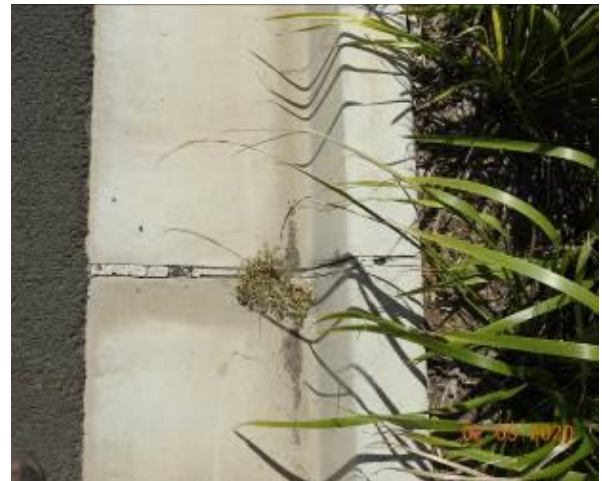
Figure 1969 – General Condition of kerb and gutter

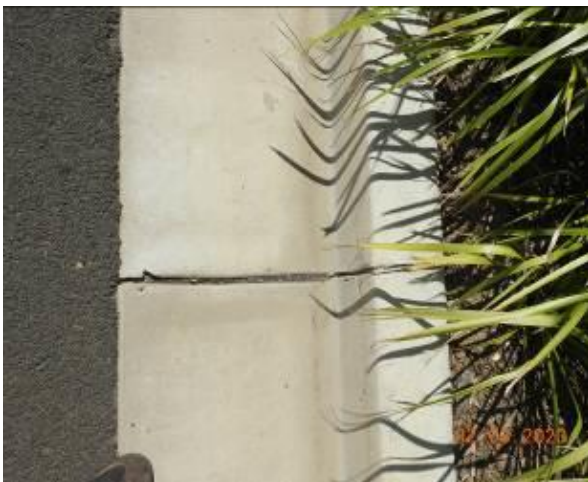
Figure 1970 – Crack propagation through kerb and gutter

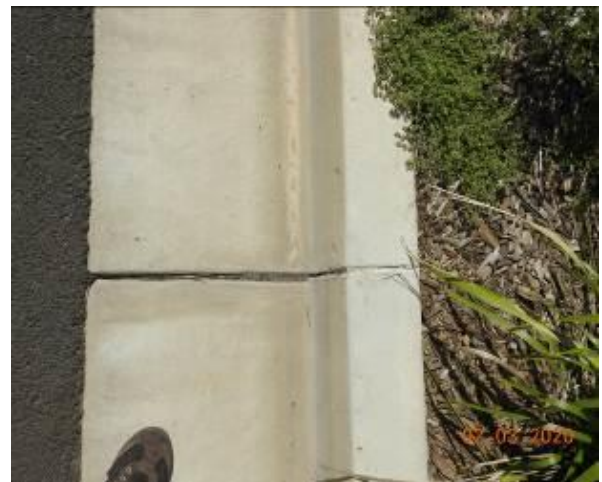
Figure 1971 – Loss of material through gutter

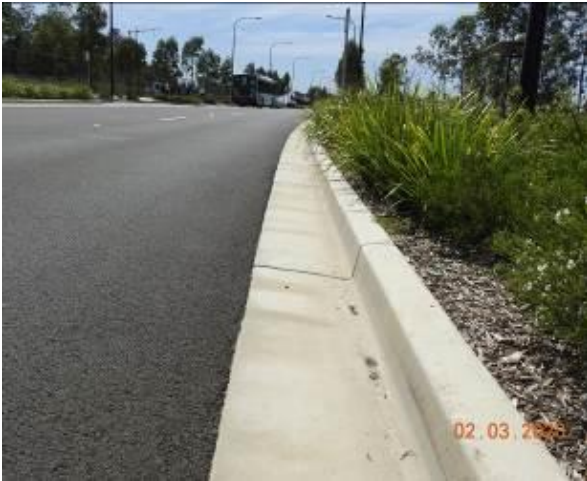
Figure 1972 – Crack propagation and loss of material through kerb and gutter

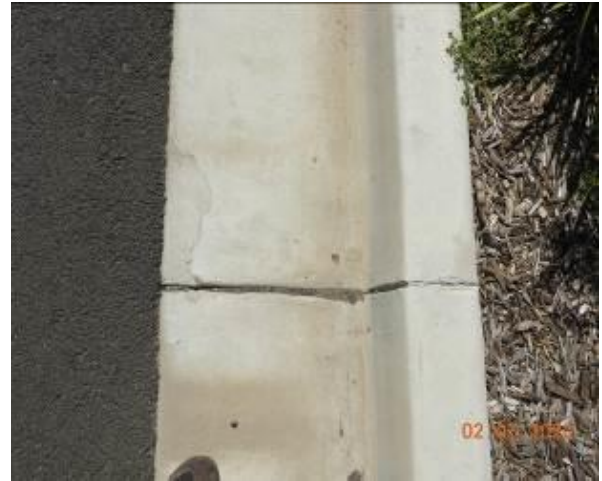
Figure 1973 – General Condition of kerb and gutter

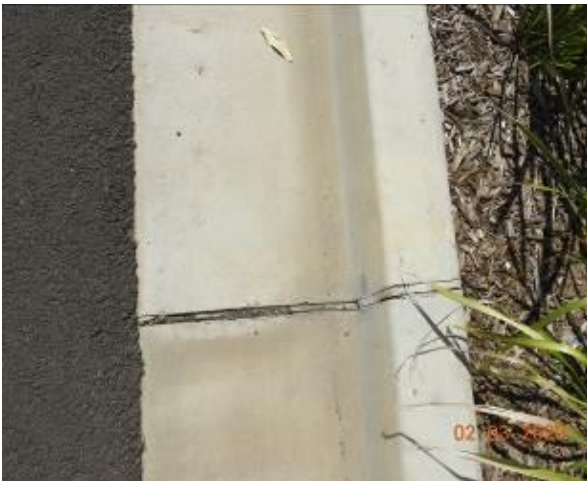
Figure 1974 – Crack propagation through kerb and gutter

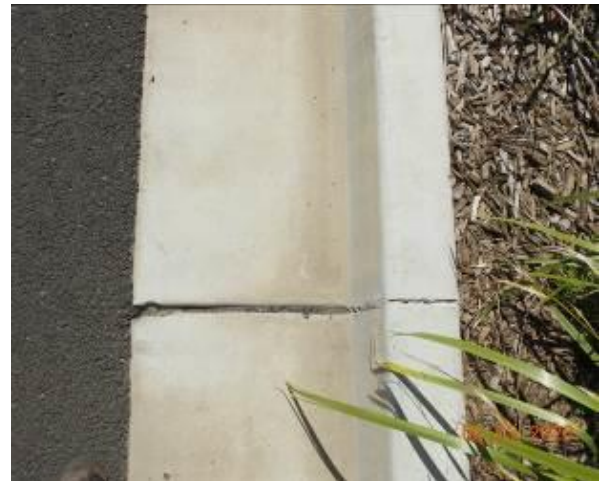
Figure 1975 – Crack propagation through kerb and gutter

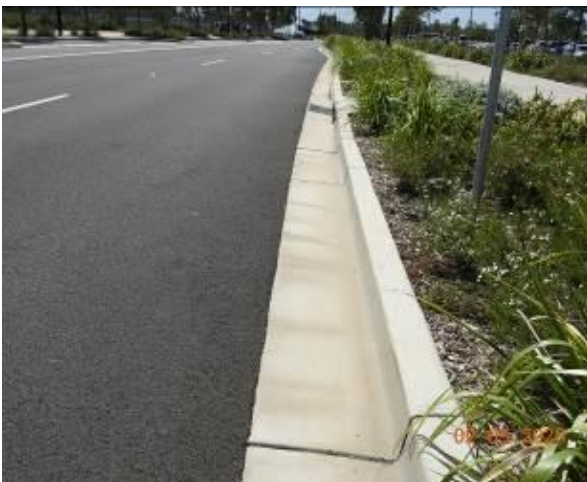
Figure 1976 – Crack propagation through kerb and gutter

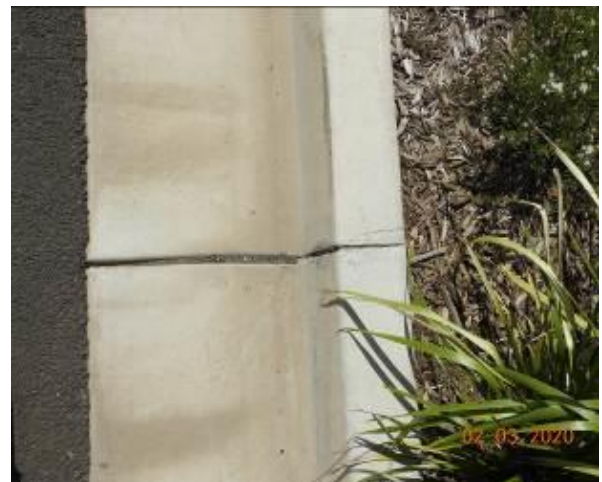
Figure 1977 – General Condition of kerb and gutter

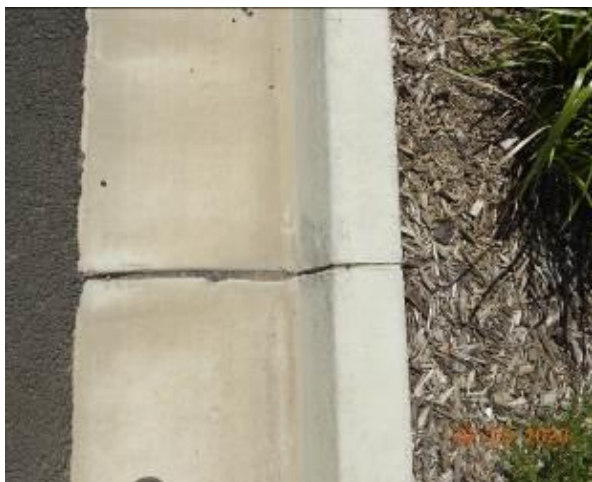
Figure 1978 – Crack propagation through kerb

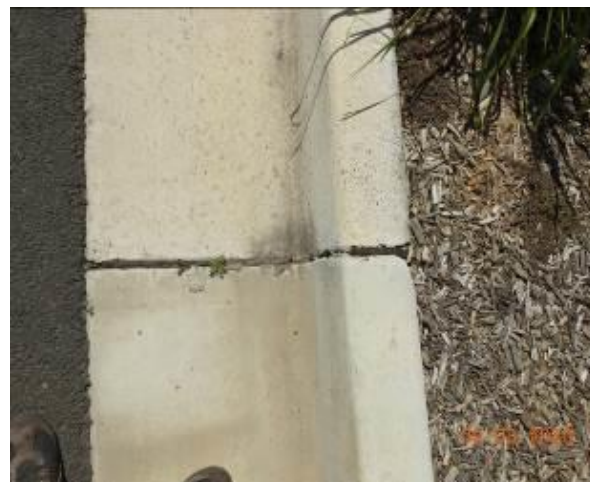
Figure 1979 – Loss of material through kerb and gutter

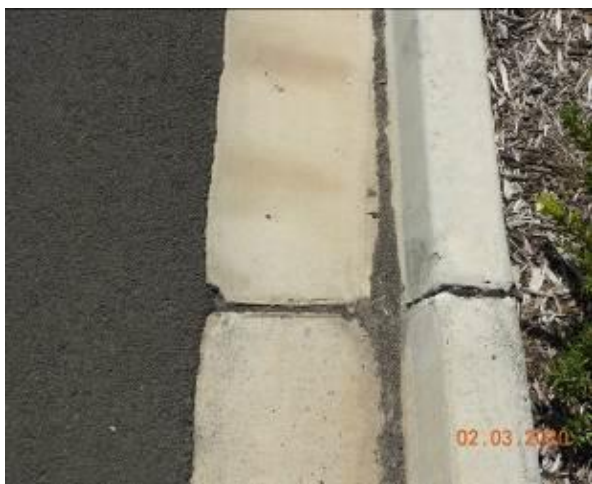
Figure 1982 – General Condition of kerb and gutter

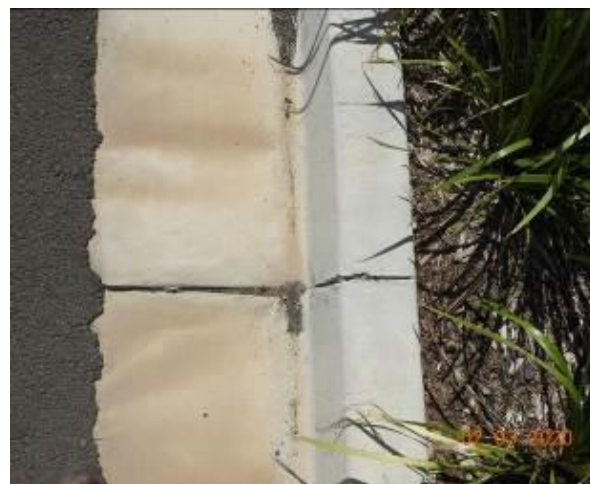
Figure 1983 – Loss of material through kerb and gutter

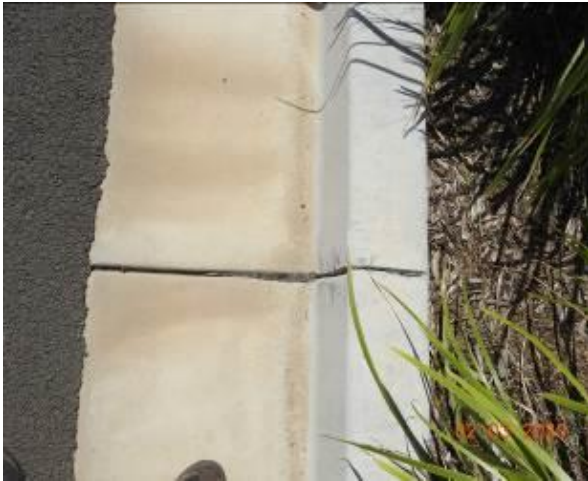
Figure 1984 – Crack propagation through kerb

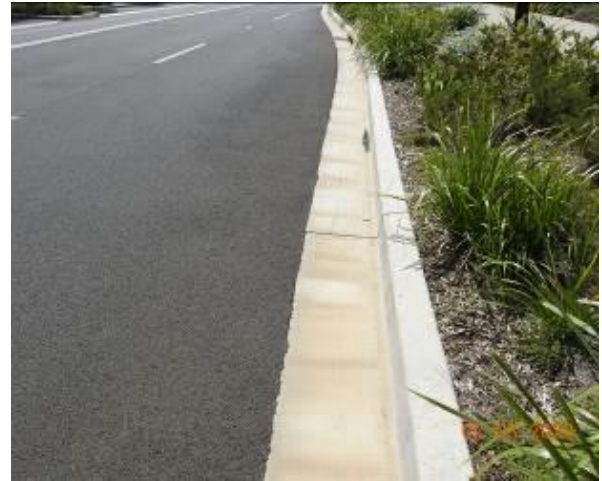
Figure 1985 – Crack propagation through kerb

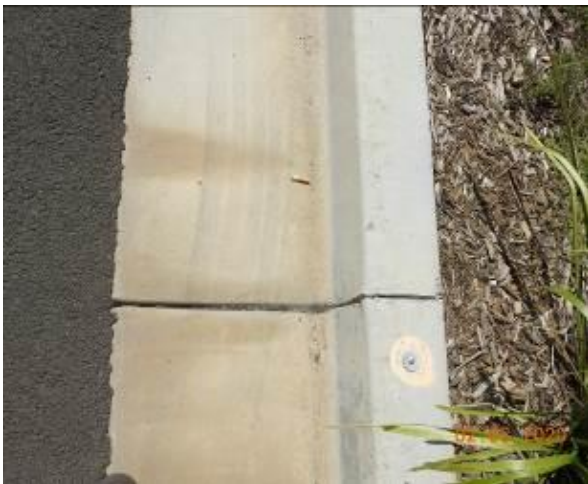
Figure 1986 – General Condition of kerb and gutter

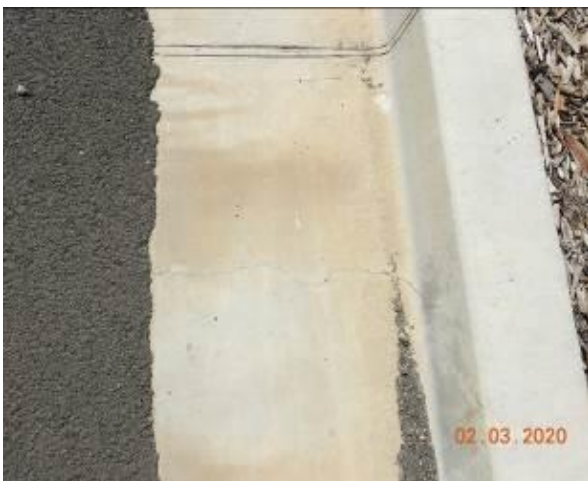
Figure 1988 – Crack propagation through kerb and gutter

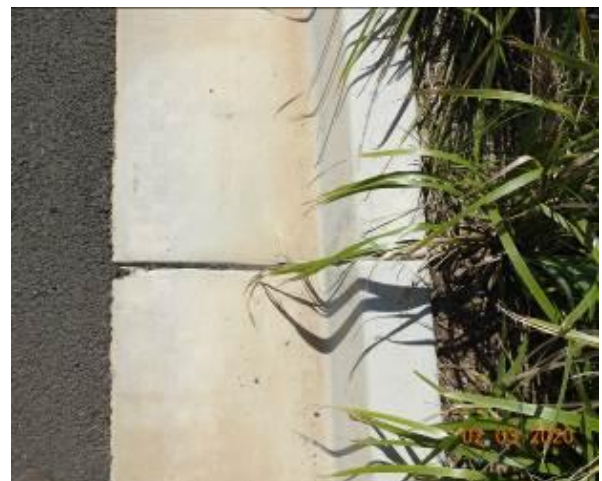
Figure 1989 – Crack propagation through kerb and gutter

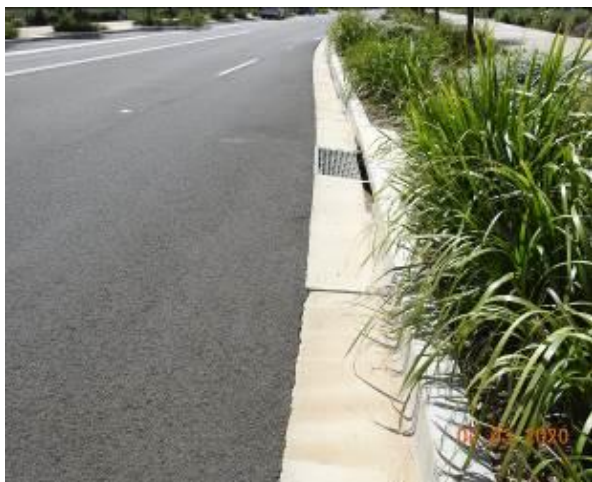
Figure 1990 – Loss of material through gutter

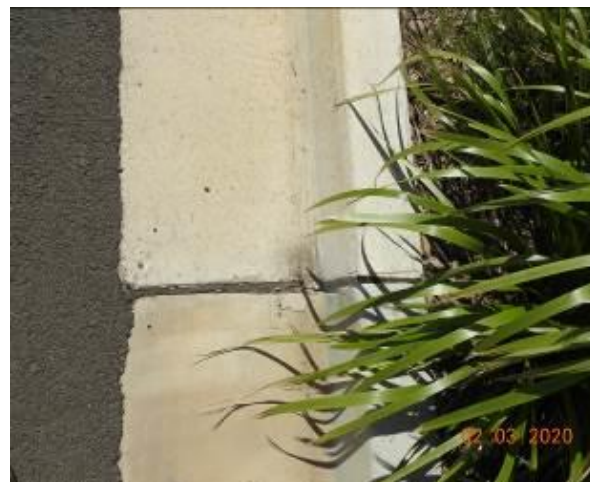
Figure 1991 – General Condition of kerb and gutter

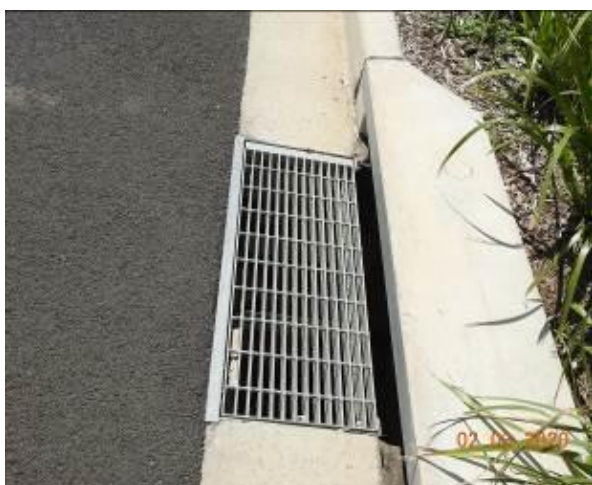
Figure 1992 – Loss of material through gutter

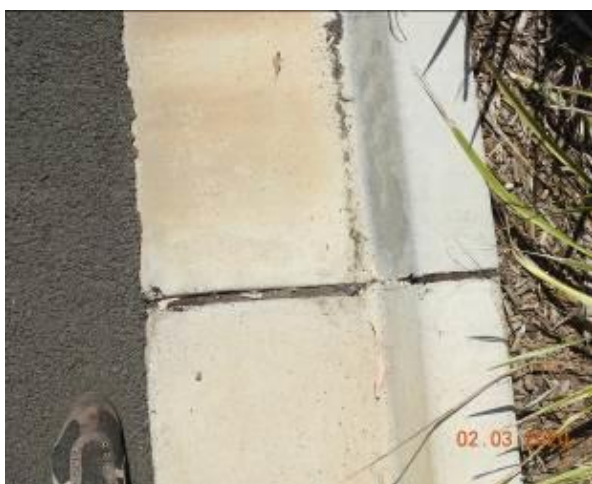
Figure 1994 – General Condition of kerb and gutter

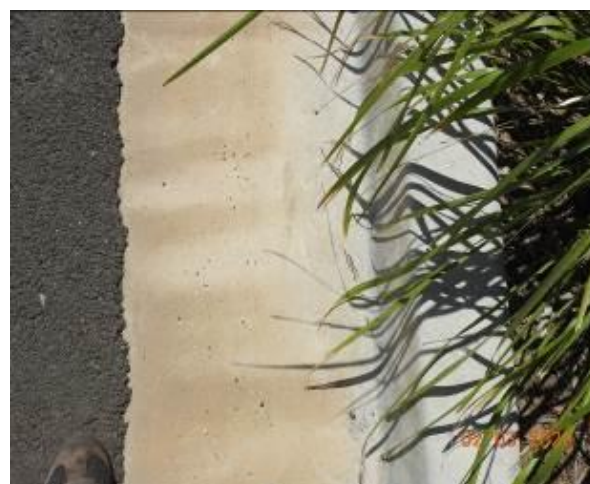
Figure 1995 – Loss of material through kerb and gutter

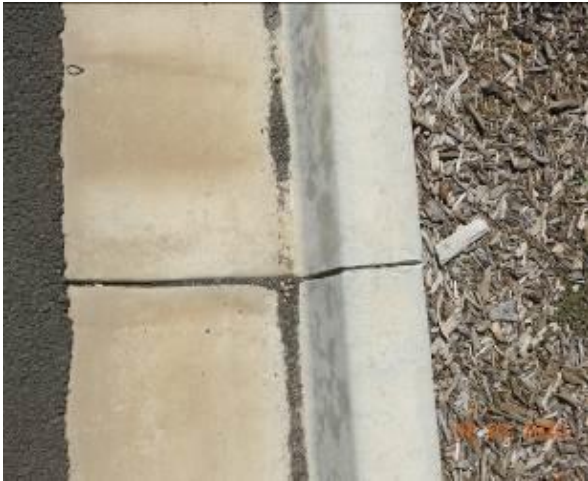
Figure 1996 – General Condition of kerb and gutter

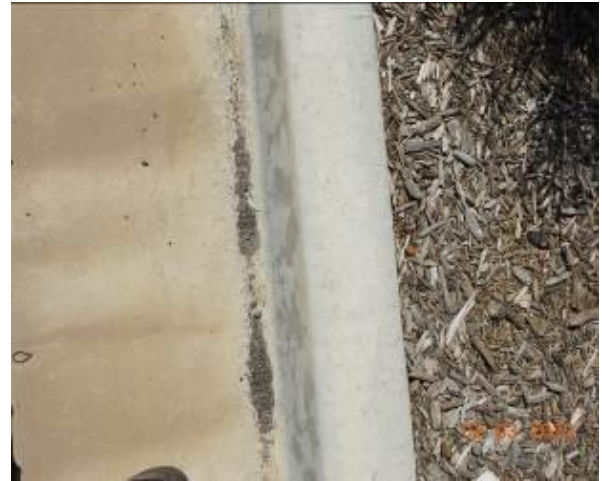
Figure 1997 – Loss of material through kerb and gutter

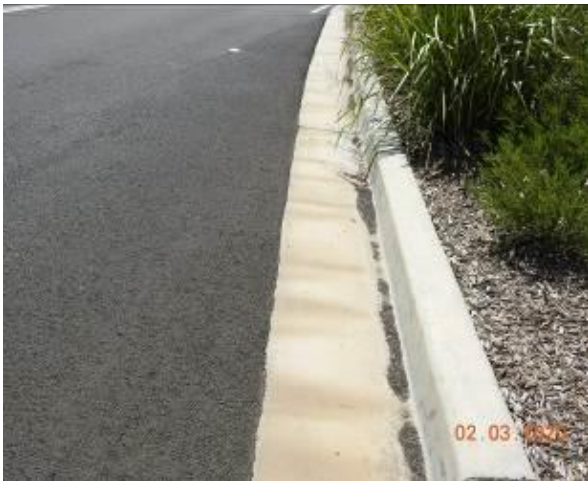
Figure 1998 – Crack propagation through kerb and gutter

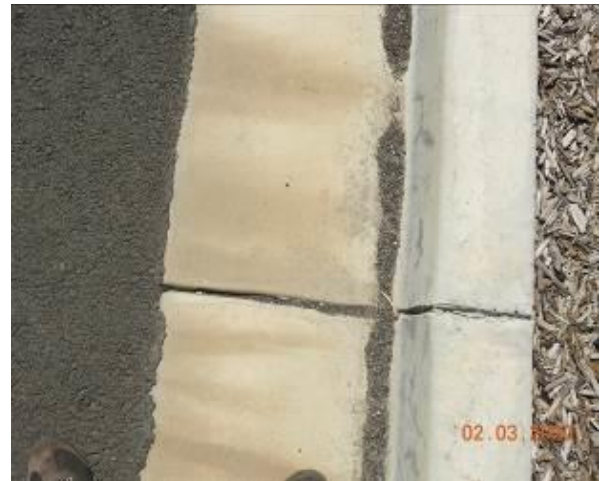
Figure 1999 – General Condition of kerb and gutter

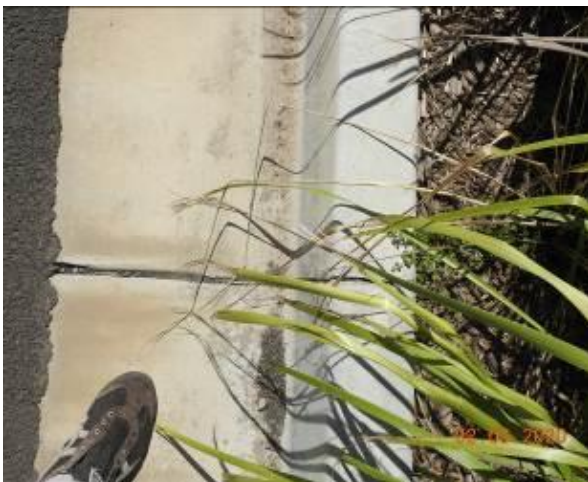
Figure 2000 – Crack propagation through kerb and gutter

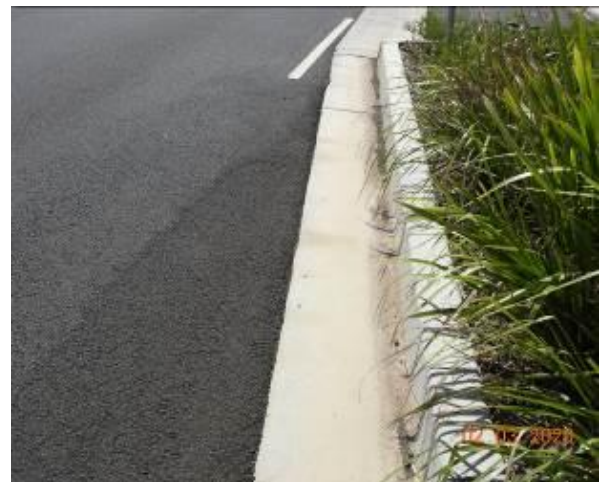
Figure 2001 – Crack propagation through kerb and gutter

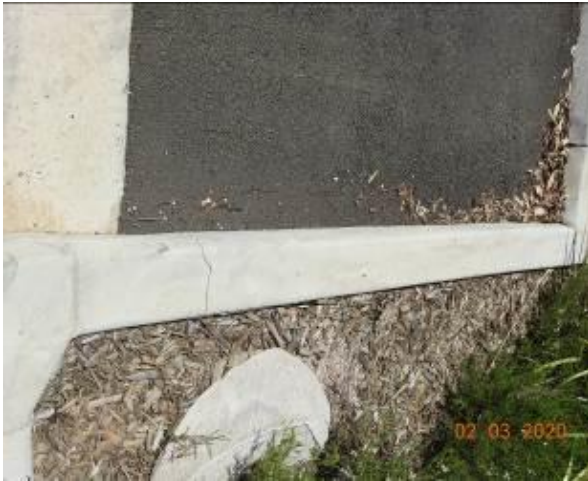
Figure 2002 – General Condition of kerb and gutter

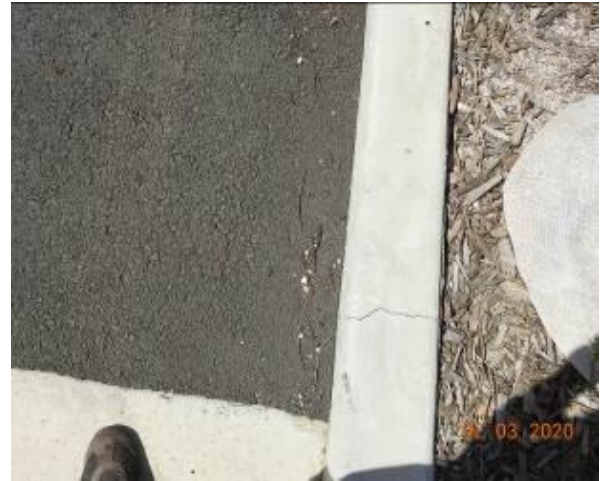
Figure 2003 – Crack propagation through kerb
