**1-15 AND 2-12 CONFERTA AVENUE,
ROUSE HILL NSW 2155
TALLAWONG STATION PRECINCT SOUTH
PRE-DILAPIDATION REPORT**

**DEICORP PROJECTS
(TALLAWONG STATION) PTY LTD**

Job No. 191294.0
24/03/2020

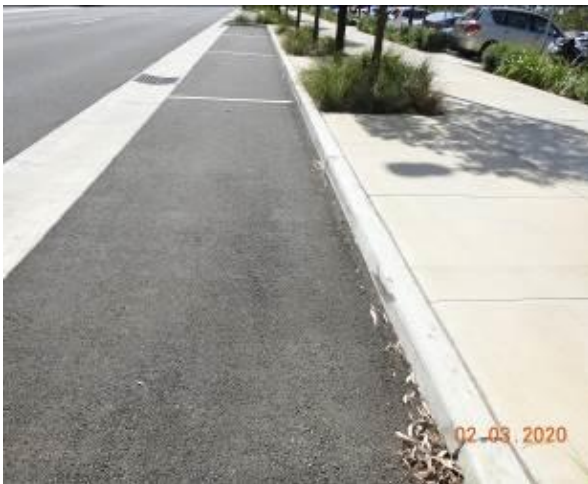
Figure 2004 – Crack propagation through kerb

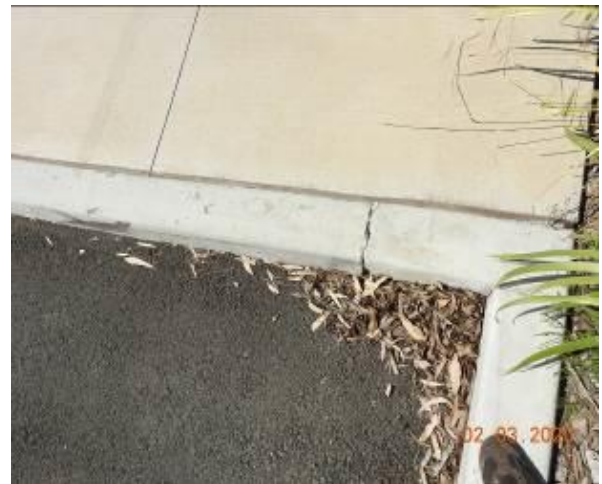
Figure 2005 – General Condition of kerb

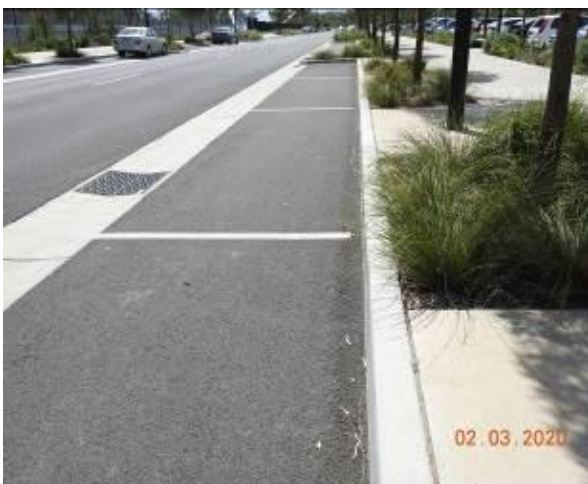
Figure 2006 – Crack propagation through kerb

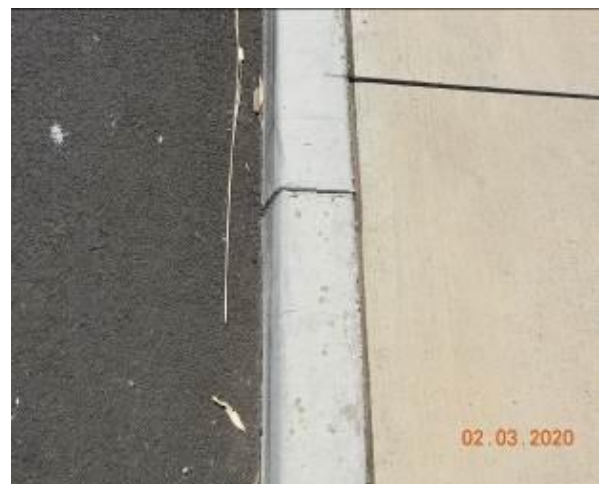
Figure 2007 – General Condition of kerb

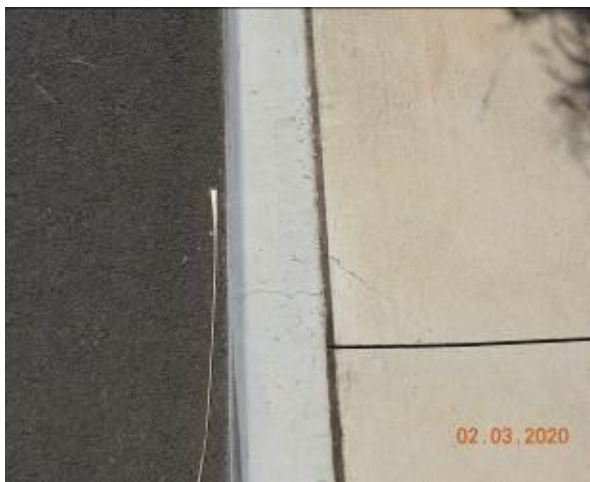
Figure 2008 – Crack propagation through kerb

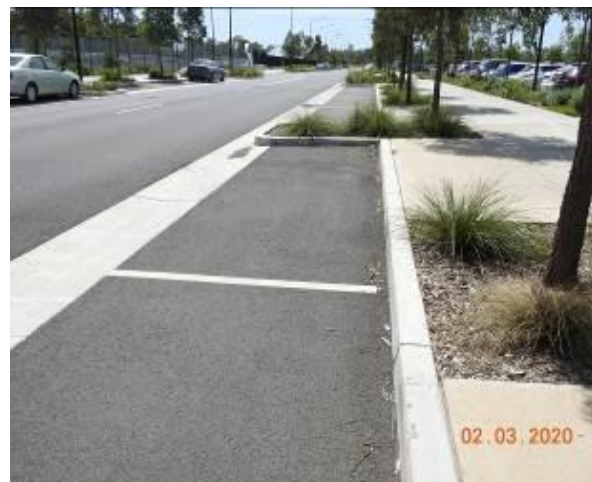
Figure 2009 – Crack propagation through kerb

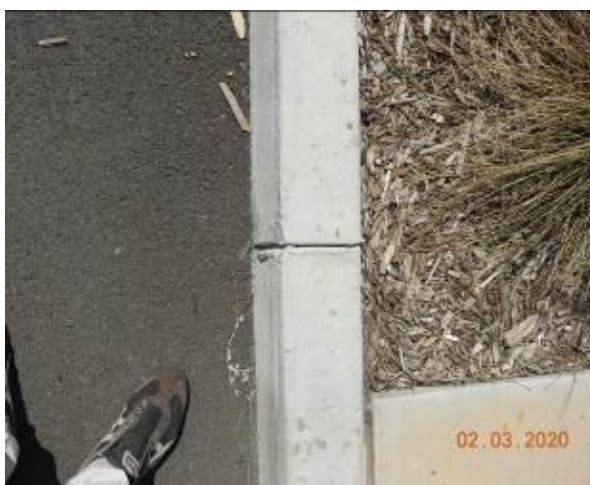
Figure 2010 – General Condition of kerb

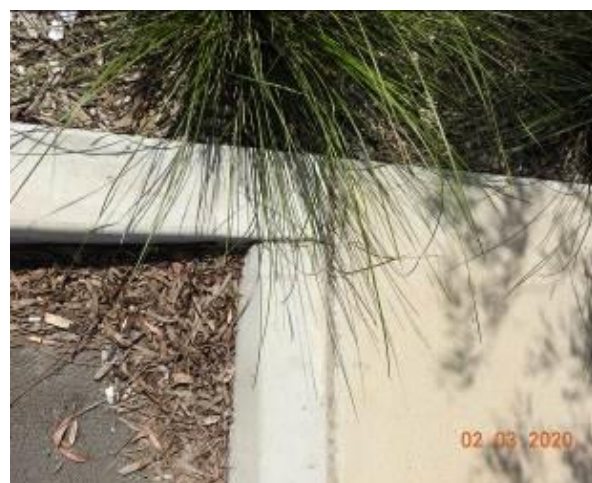
Figure 2013 – Crack propagation through kerb

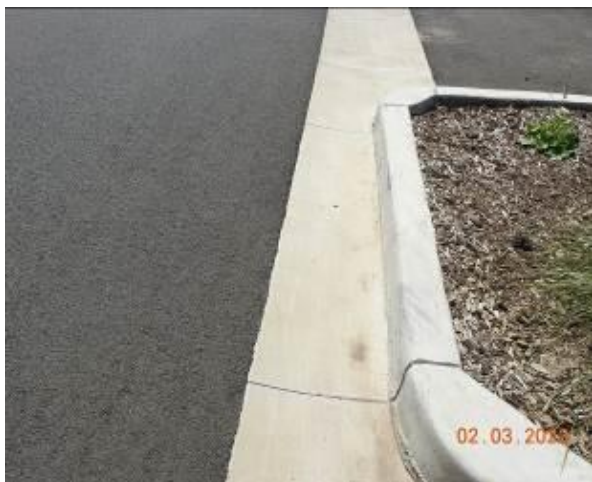
Figure 2014 – Crack propagation through kerb

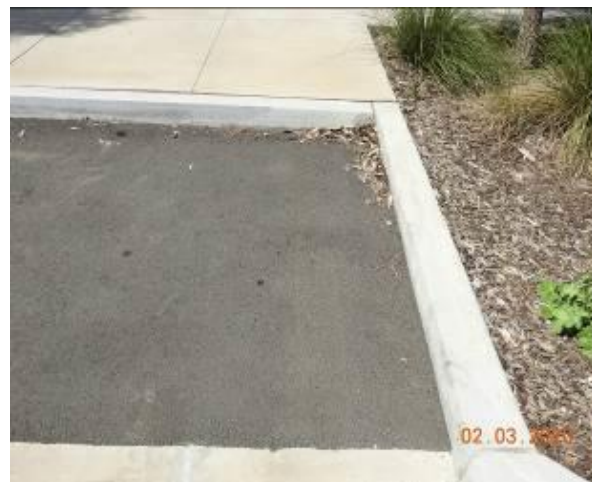
Figure 2015 – General Condition of kerb and gutter

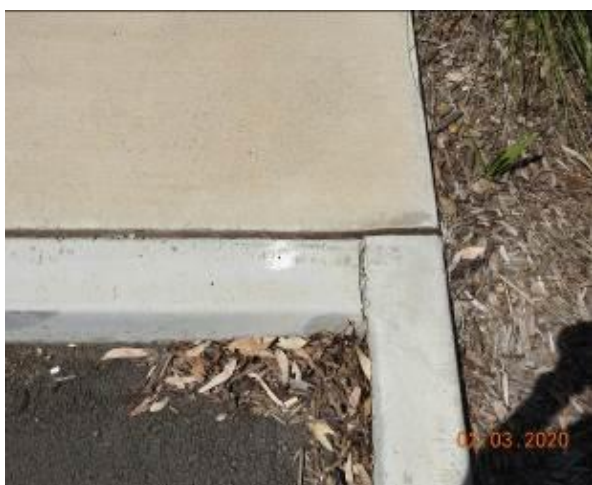
Figure 2016 – General Condition of kerb

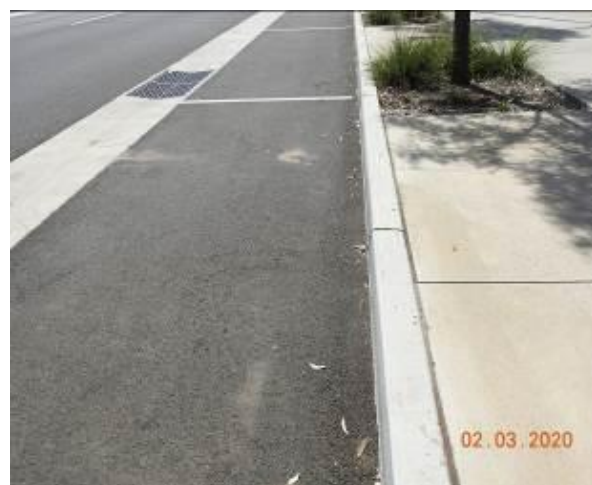
Figure 2017 – Crack propagation and loss of material through kerb

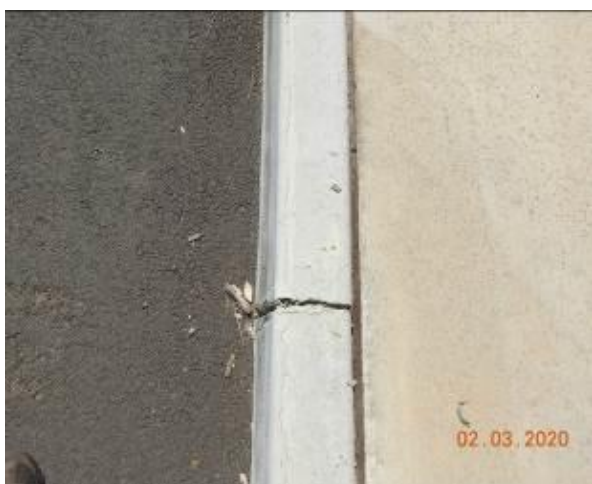
Figure 2018 – General Condition of kerb

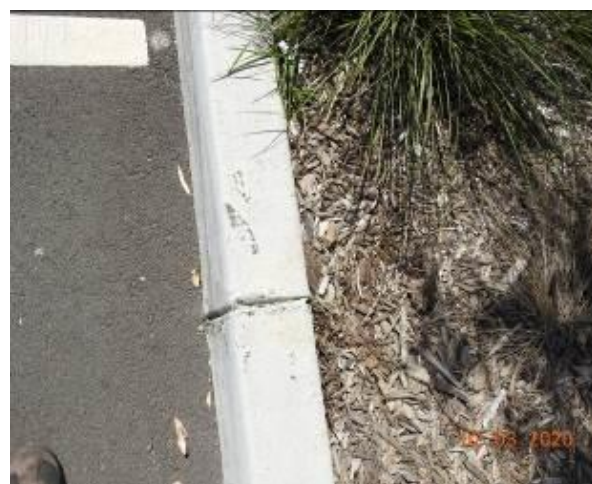
Figure 2019 – Loss of material through kerb

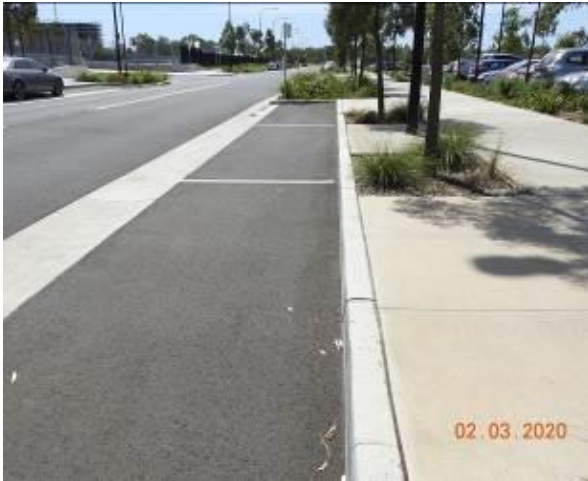
Figure 2020 – Loss of material through kerb

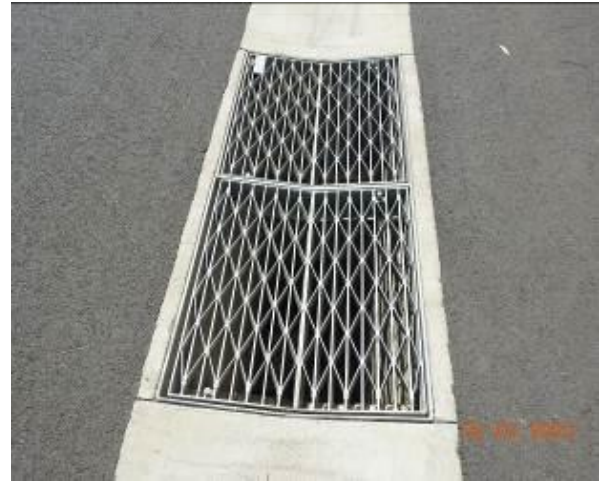
Figure 2021 – General Condition of kerb

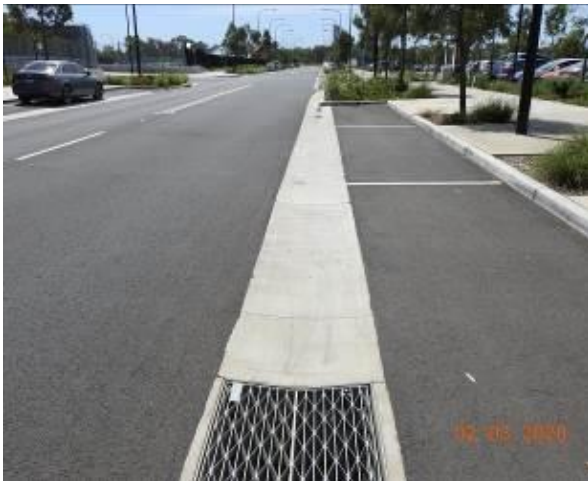
Figure 2022 – General Condition of stormwater inlet pit

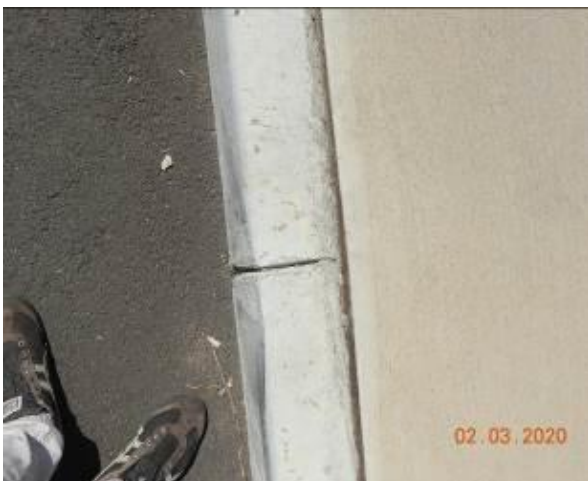
Figure 2024 – Crack propagation through kerb

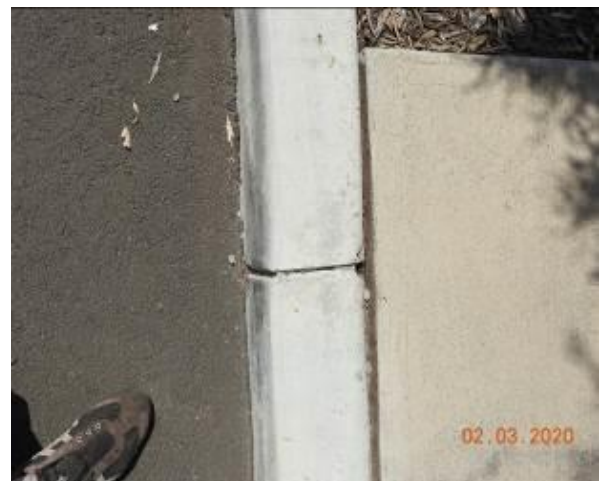
Figure 2025 – Crack propagation through kerb

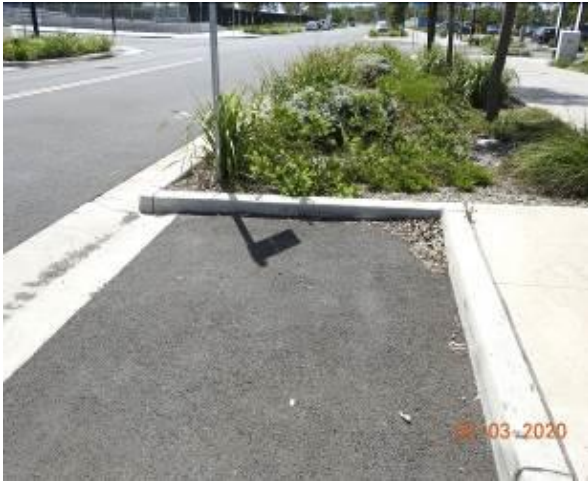
Figure 2026 – Crack propagation through kerb

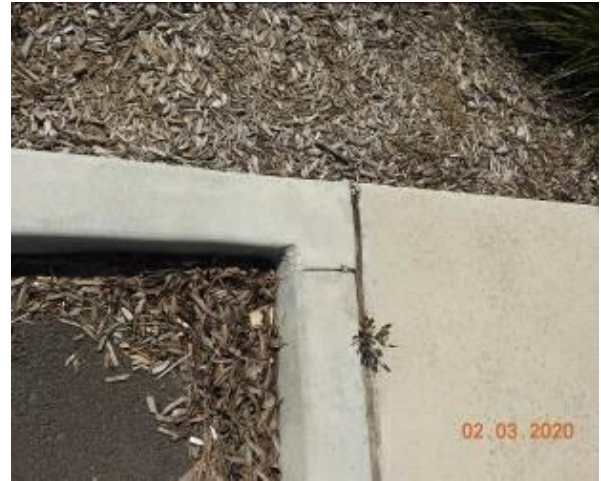
Figure 2027 – General Condition of kerb

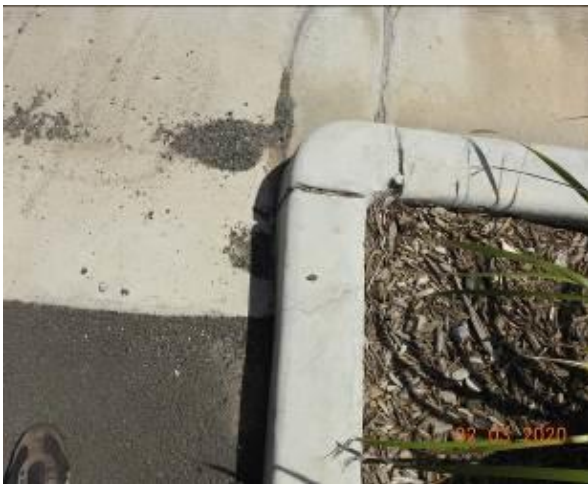
Figure 2028 – Crack propagation through kerb

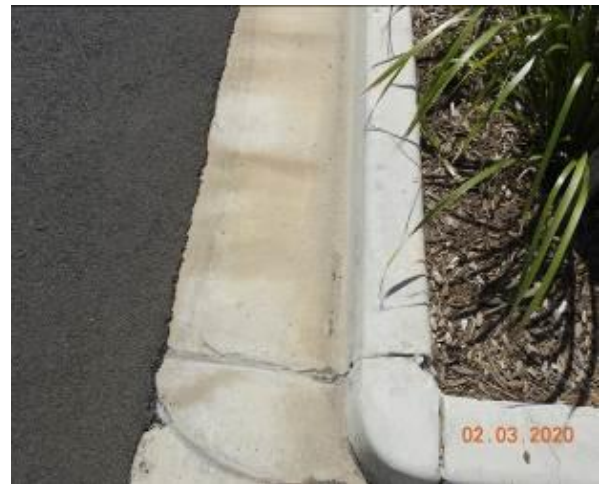
Figure 2029 – Crack propagation through kerb

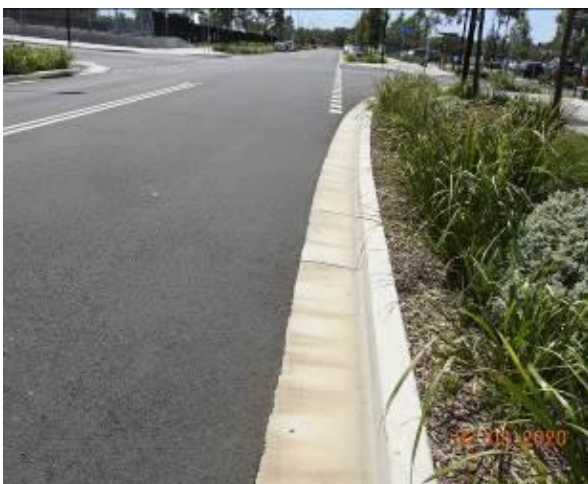
Figure 2030 – Loss of material through kerb

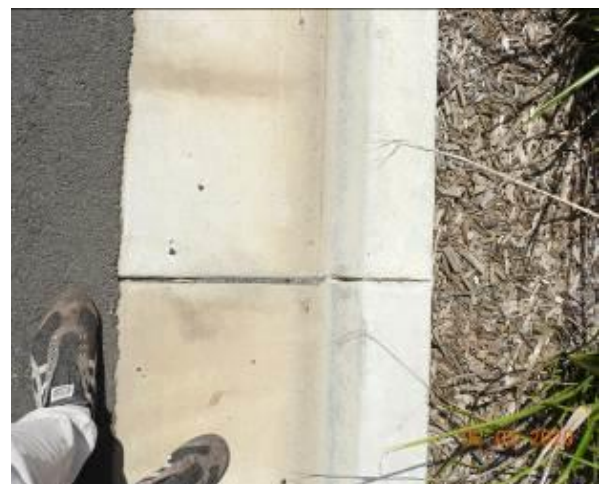
Figure 2032 – Crack propagation through kerb

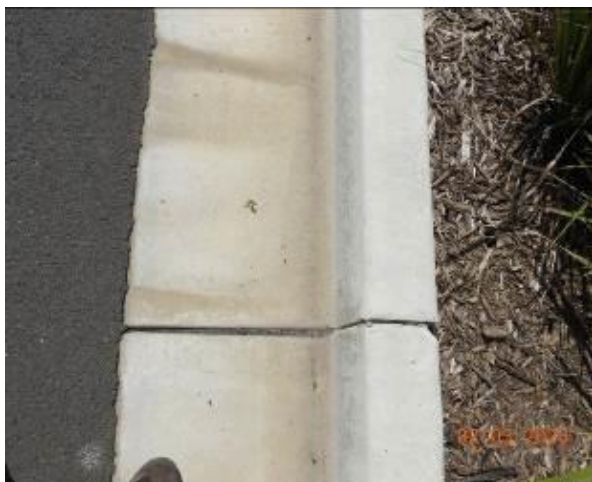
Figure 2033 – Crack propagation through kerb

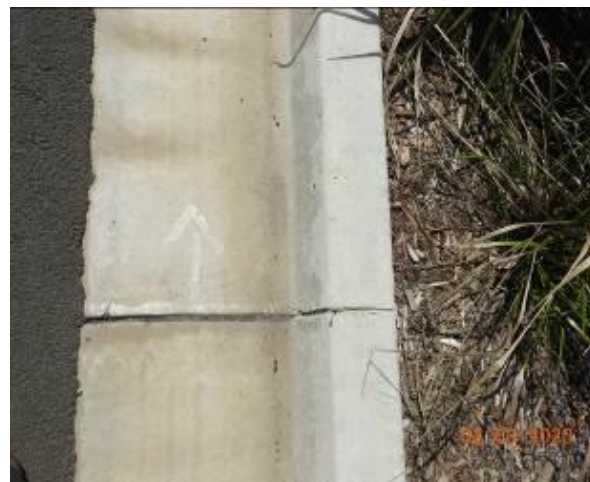
Figure 2034 – Crack propagation through kerb

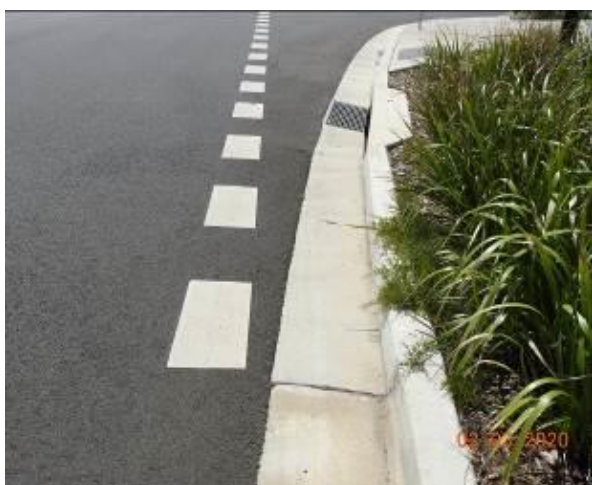
Figure 2035 – General Condition of kerb and gutter

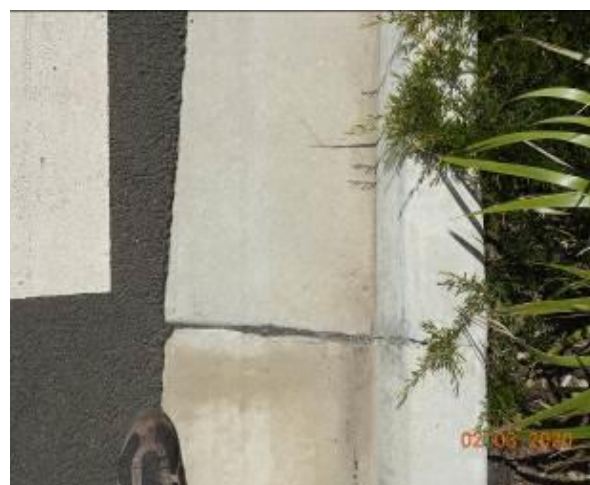
Figure 2036 – Crack propagation and loss of material through kerb and gutter

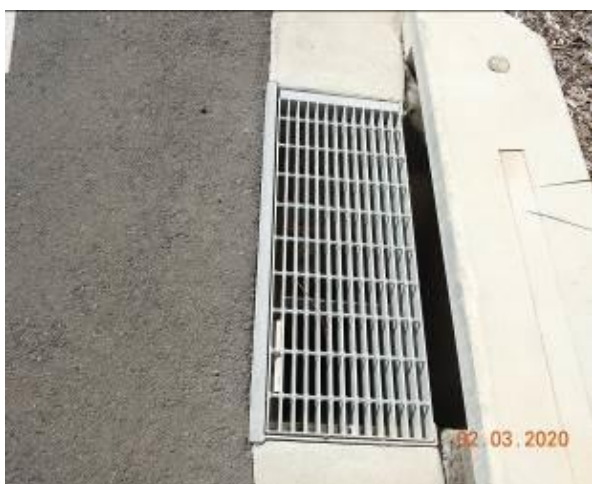
Figure 2037 – General Condition of stormwater inlet pit

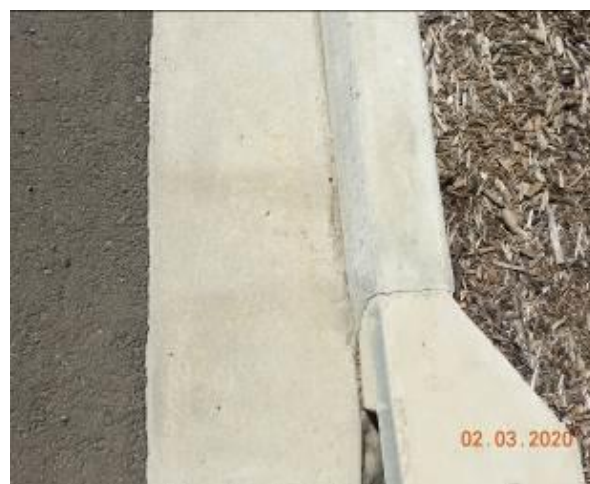
Figure 2038 – Crack propagation through stormwater inlet pit

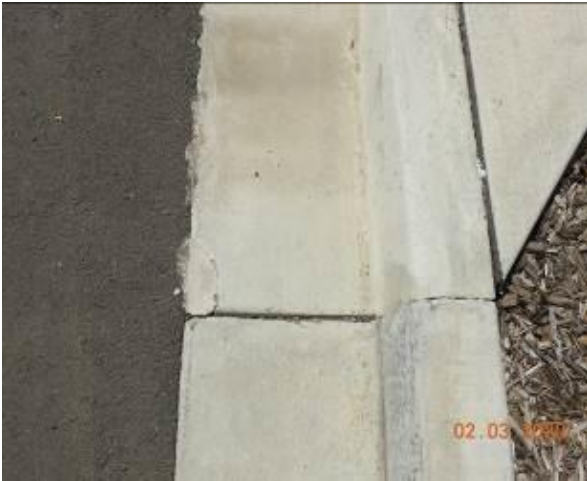
Figure 2039 – Crack propagation through gutter

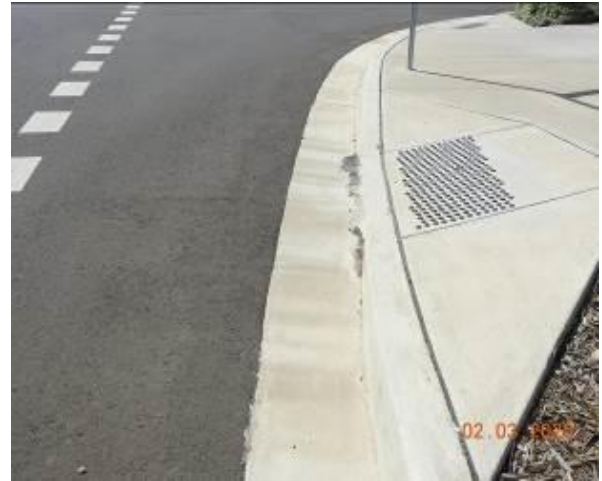
Figure 2040 – General Condition of layback and gutter

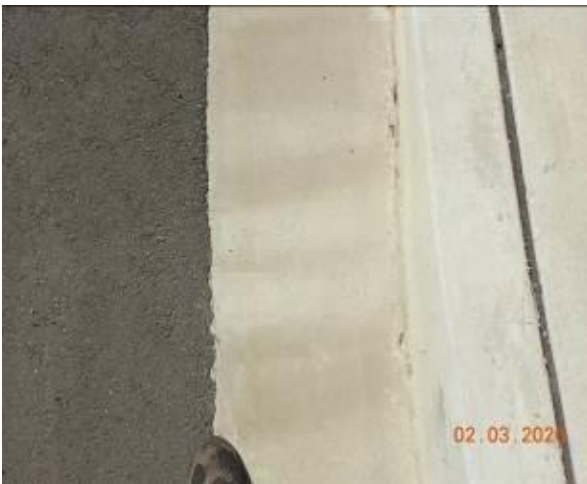
Figure 2041 – Crack propagation through layback and gutter

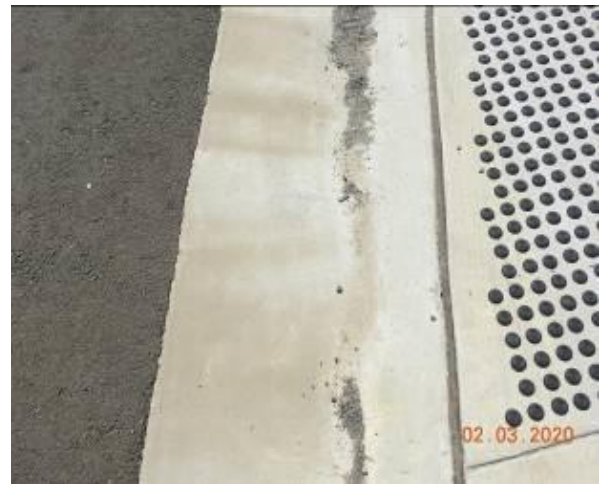
Figure 2042 – General Condition of layback and gutter

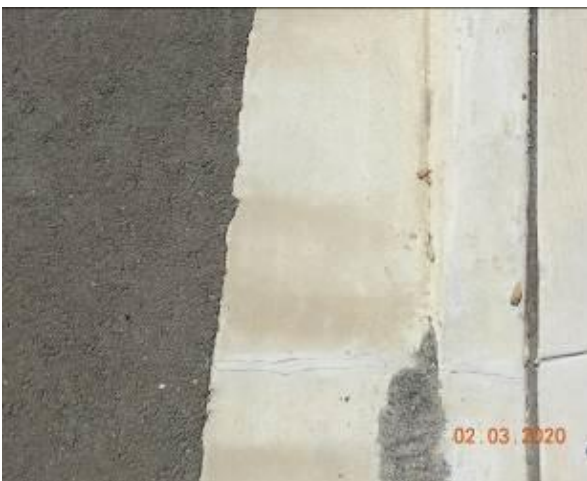
Figure 2043 – Evidence of patchwork through layback and gutter

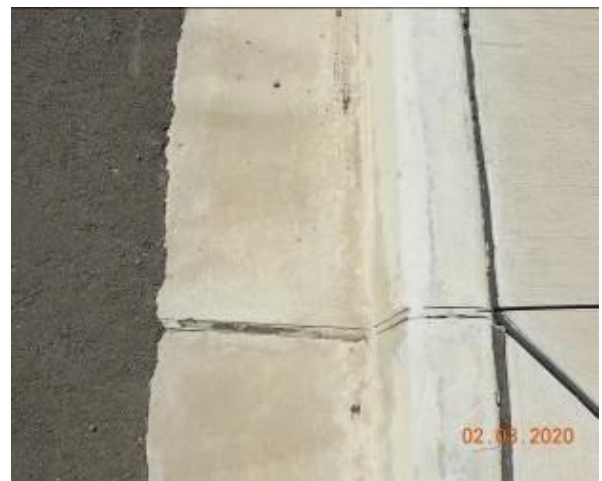
Figure 2044 – Loss of material through gutter

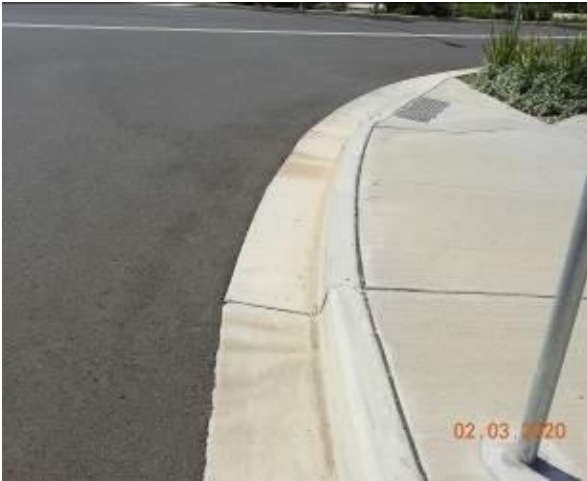
Figure 2045 – General Condition of kerb and gutter

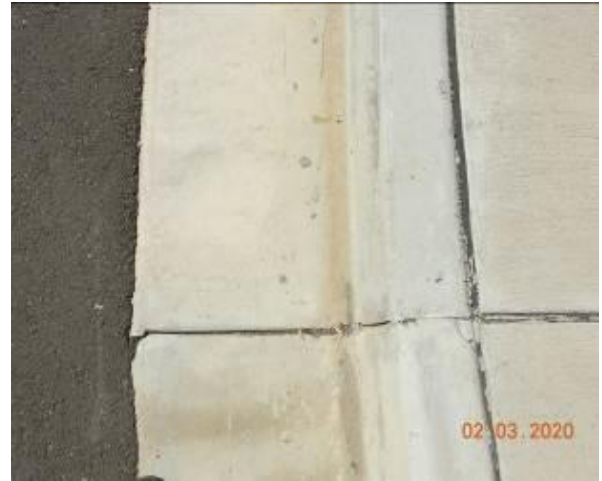
Figure 2046 – Loss of material through kerb and gutter

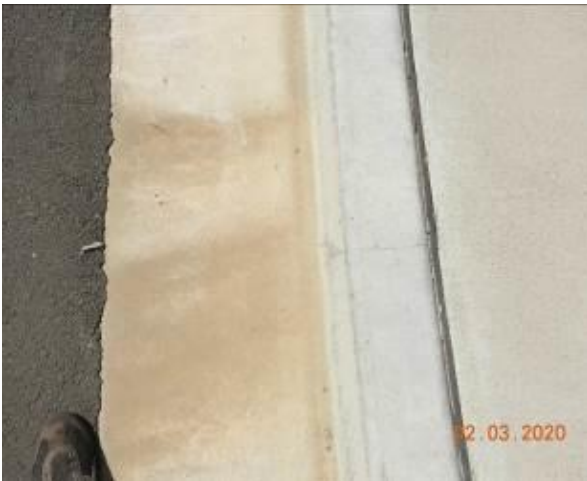
Figure 2047 – Crack propagation through kerb and gutter

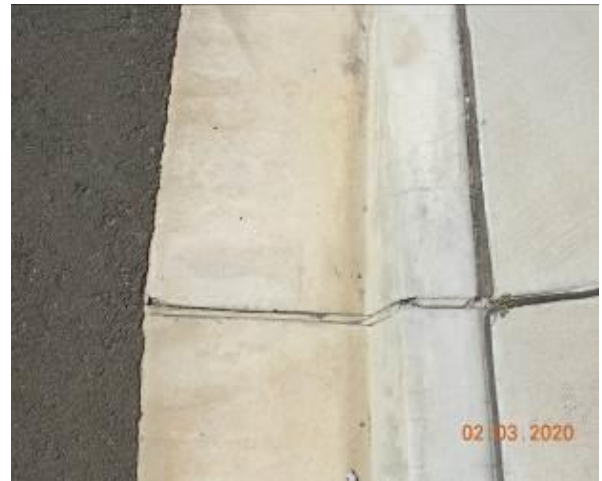
Figure 2048 – Loss of material through kerb and gutter

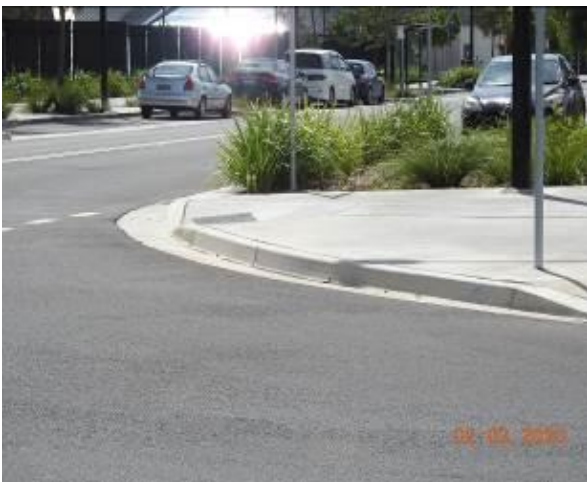
Figure 2049 – General Condition of kerb and gutter

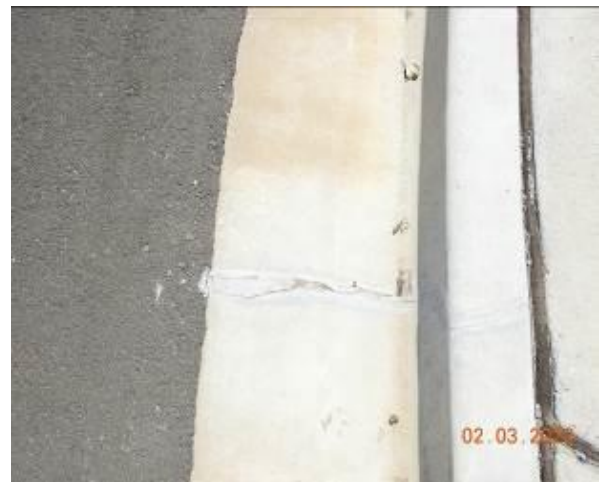
Figure 2050 – Crack propagation through kerb and gutter

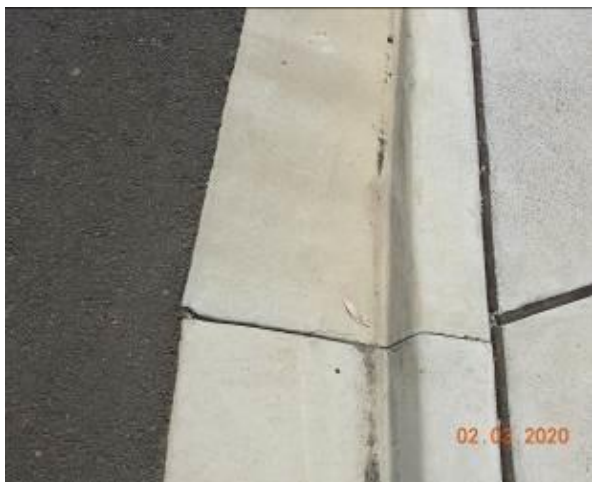
Figure 2051 – Loss of material through gutter

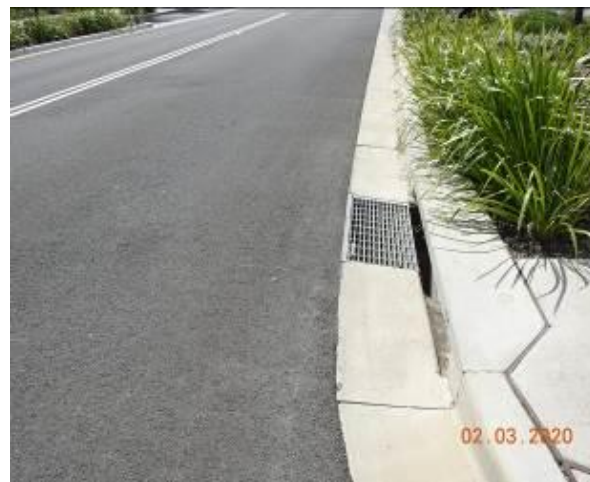
Figure 2052 – General Condition of kerb and gutter

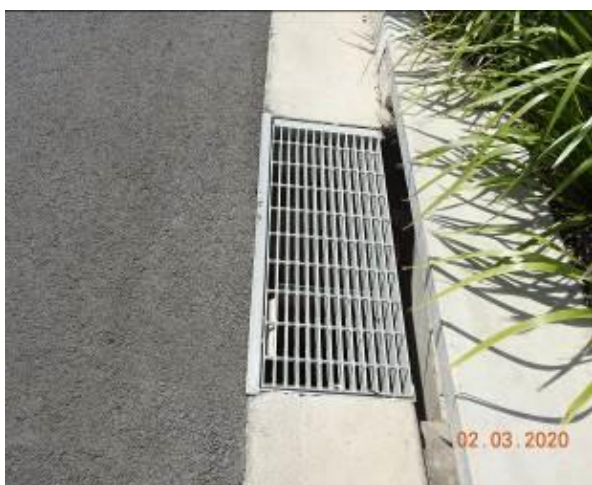
Figure 2053 – General Condition of stormwater inlet pit

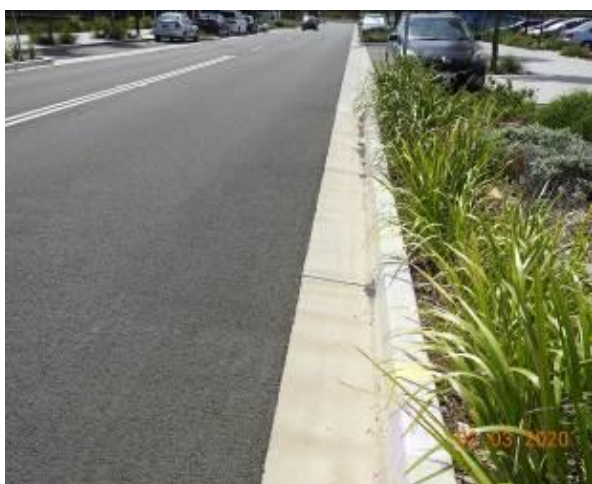
Figure 2055 – General Condition of kerb and gutter

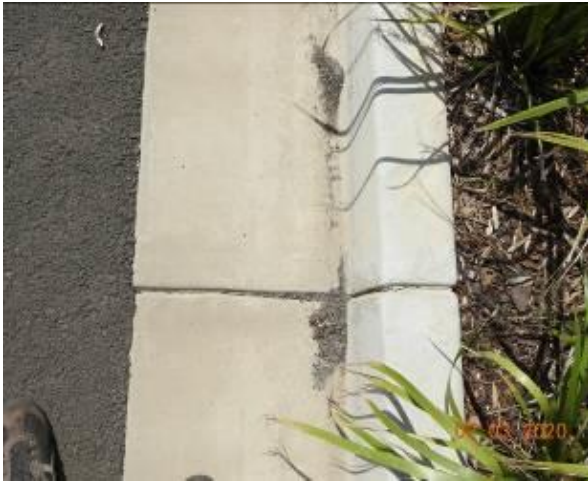
Figure 2057 – Crack propagation through kerb and gutter

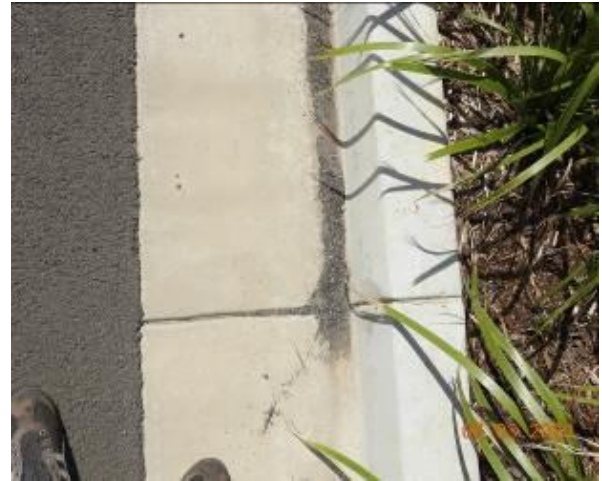
Figure 2058 – Crack propagation through kerb and gutter

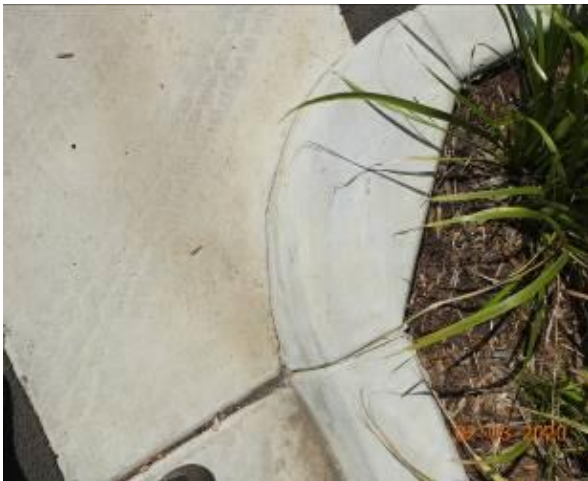
Figure 2059 – Crack propagation through kerb and gutter

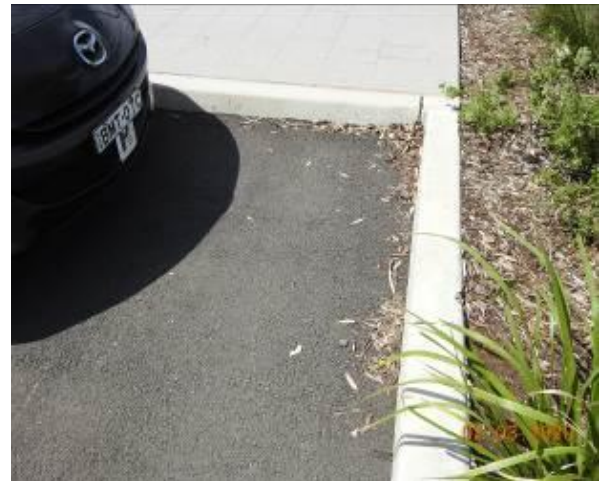
Figure 2060 – General Condition of kerb

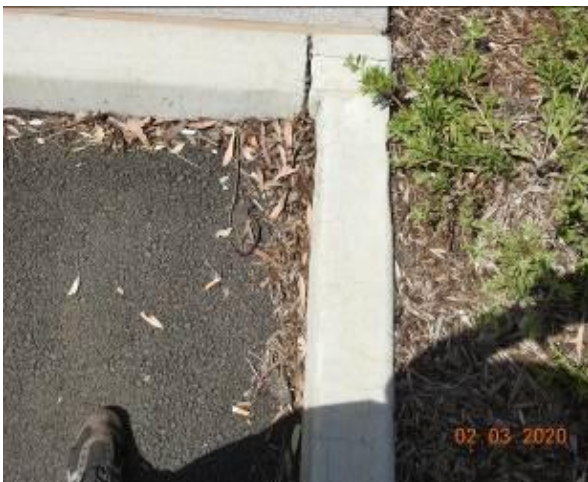
Figure 2061 – Crack propagation and Separation through kerb

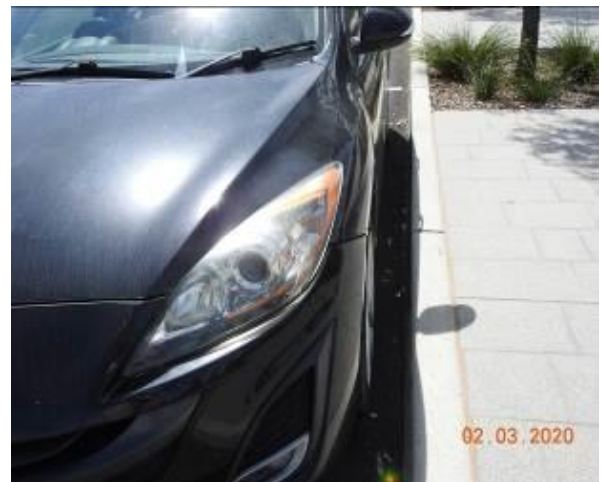
Figure 2062 – General Condition of kerb

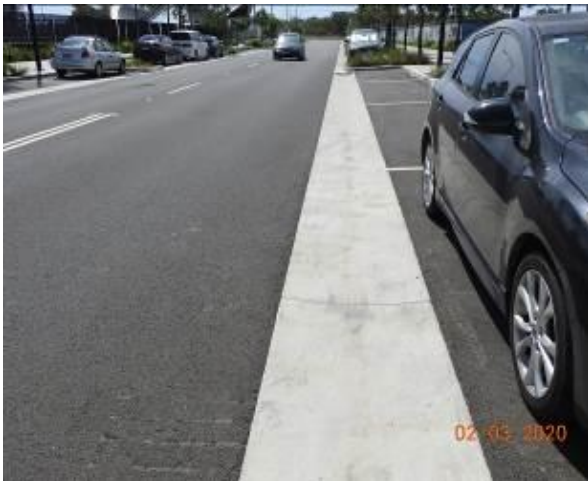
Figure 2063 – General Condition of gutter

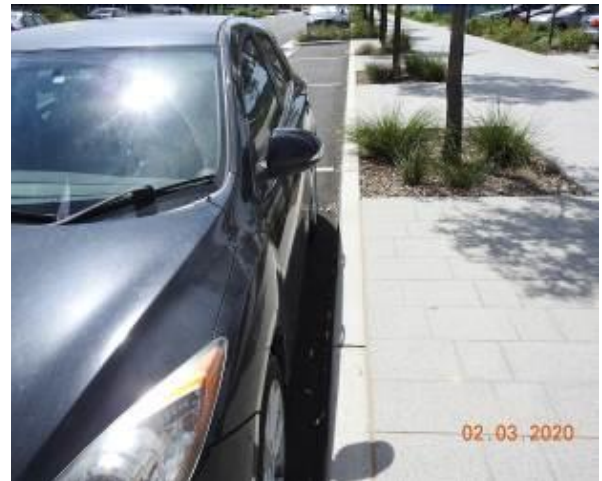
Figure 2064 – General Condition of kerb

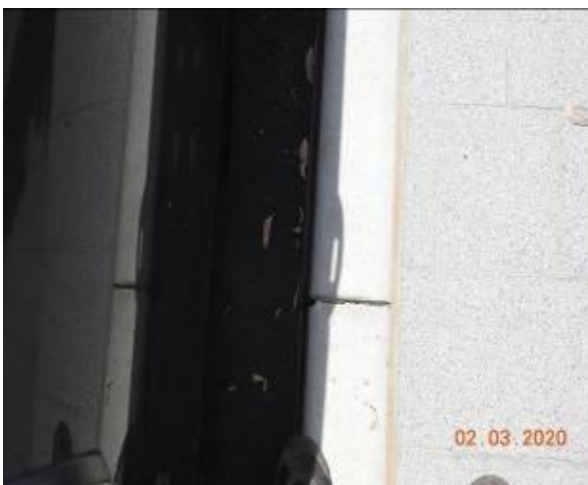
Figure 2065 – Crack propagation through kerb

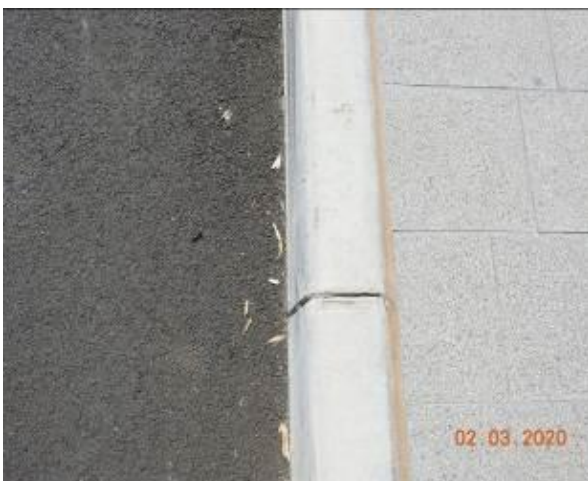
Figure 2067 – Crack propagation through kerb

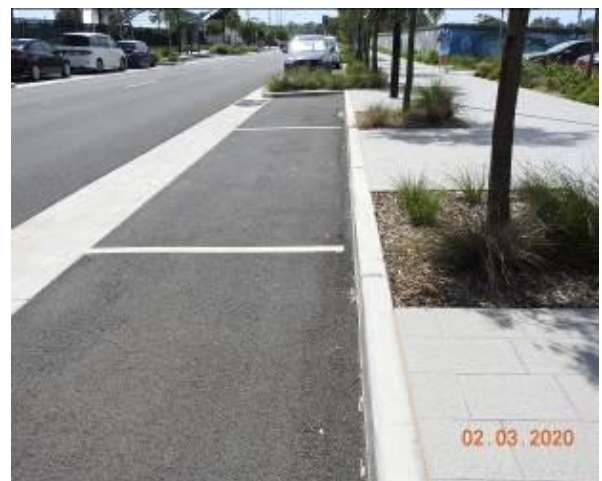
Figure 2068 – General Condition of kerb

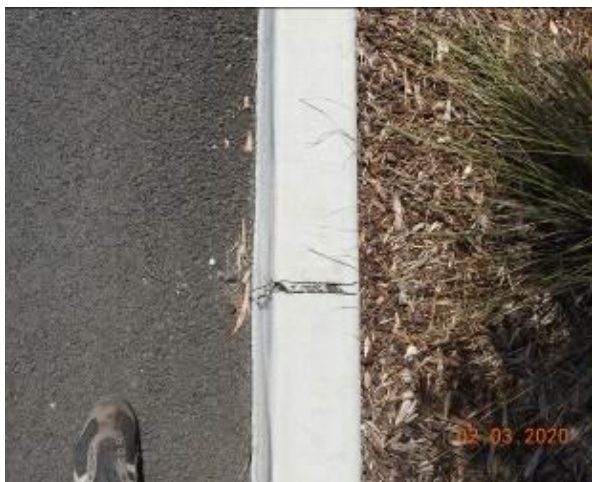
Figure 2069 – Crack propagation and loss of material through kerb

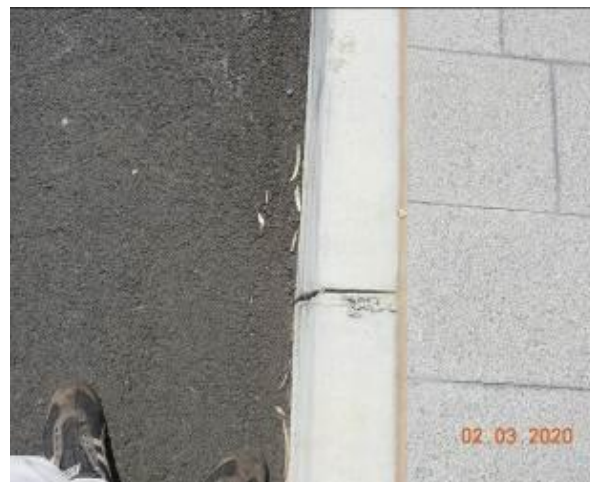
Figure 2070 – Crack propagation and loss of material through kerb

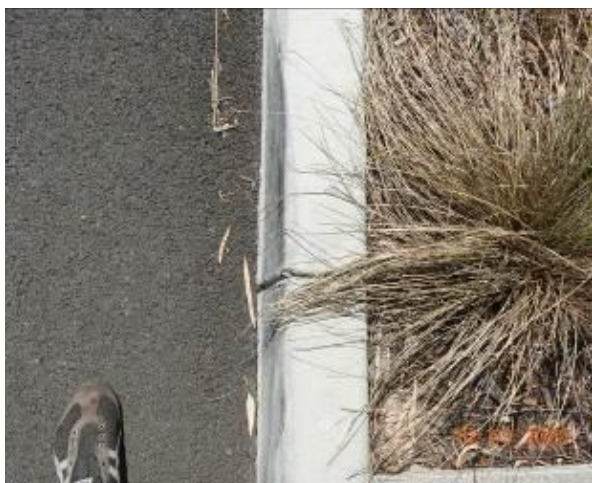
Figure 2071 – Loss of material through kerb

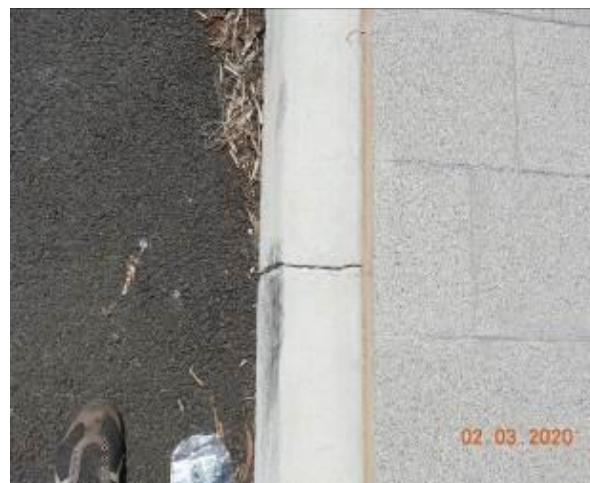
Figure 2072 – Crack propagation through kerb

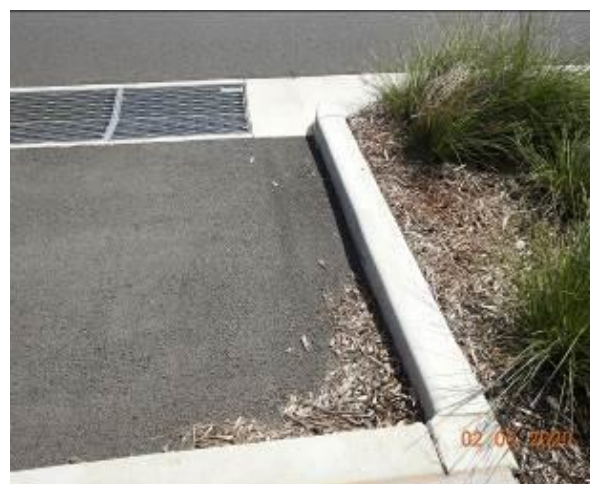
Figure 2073 – Crack propagation through kerb

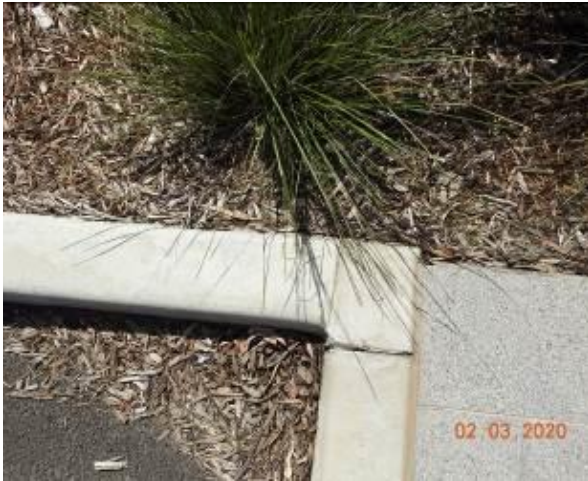
Figure 2074 – General Condition of kerb

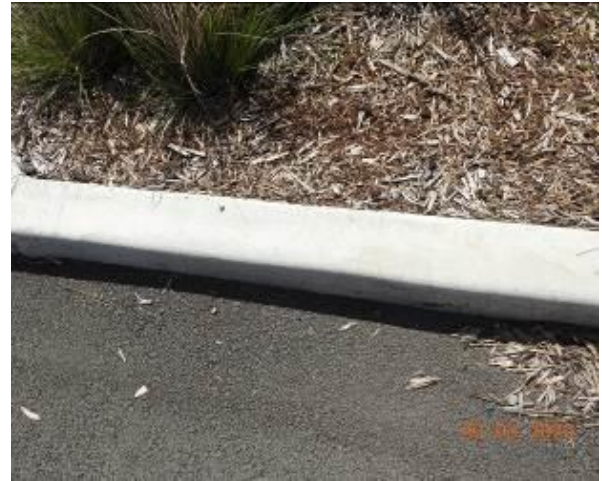
Figure 2075 – Crack propagation through kerb

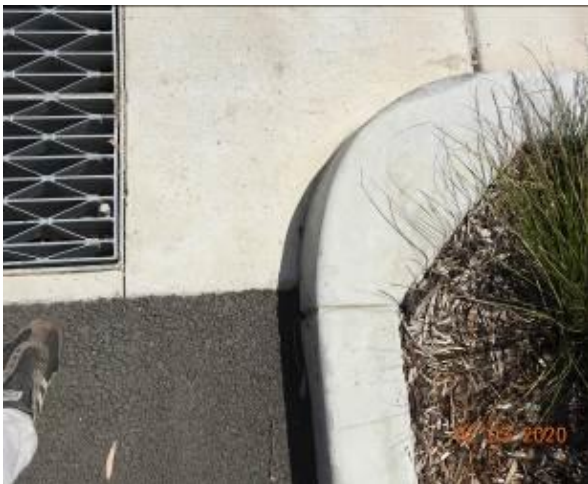
Figure 2076 – Crack propagation through kerb

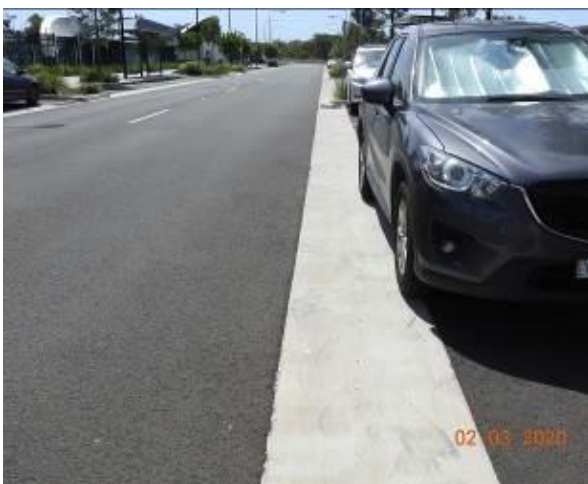
Figure 2078 – General Condition of kerb and gutter

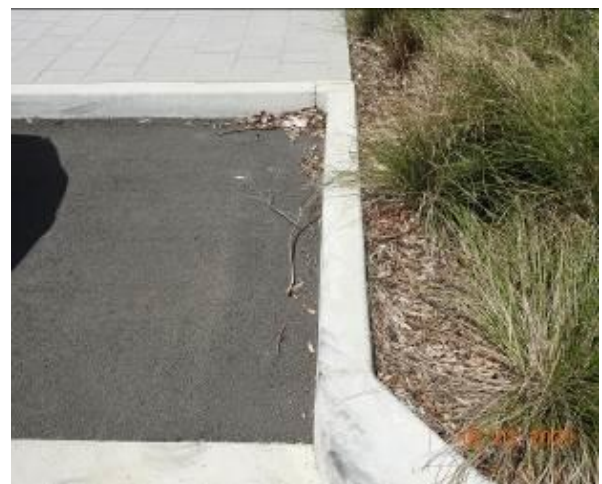
Figure 2079 – General Condition of gutter

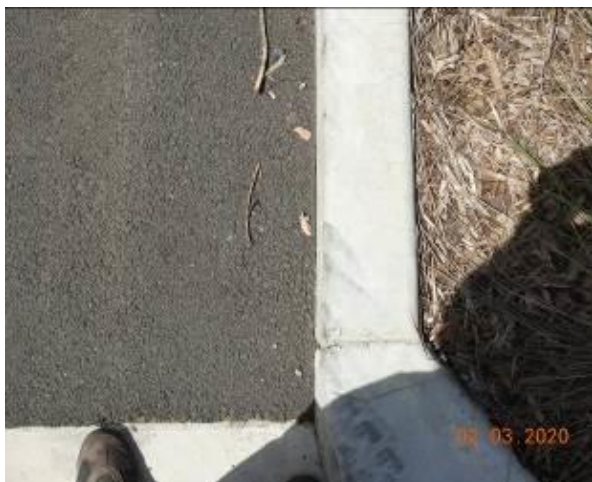
Figure 2080 – General Condition of kerb

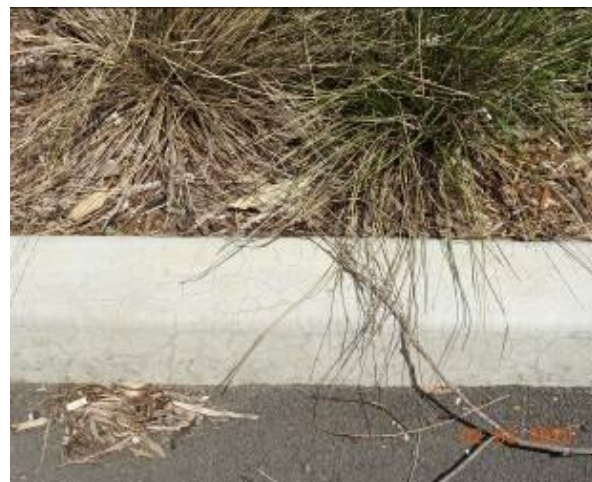
Figure 2081 – Loss of material through kerb

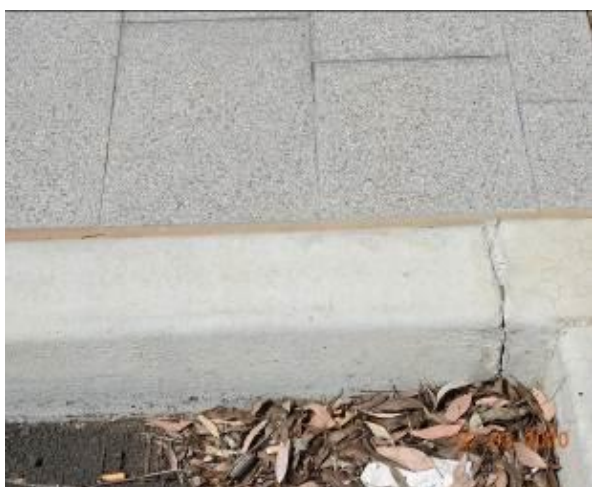
Figure 2082 – Crack propagation through kerb

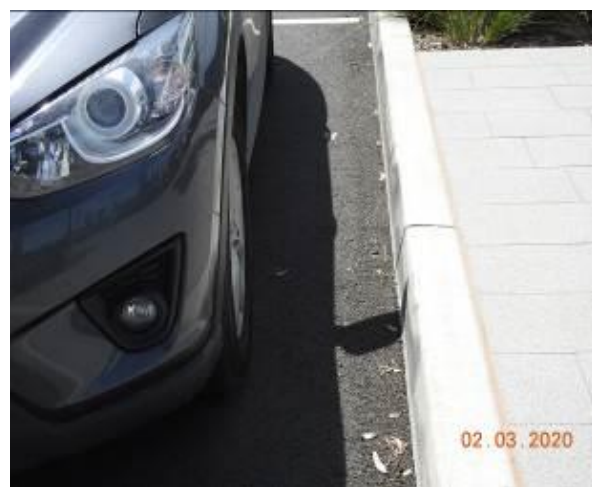
Figure 2083 – Separation through kerb

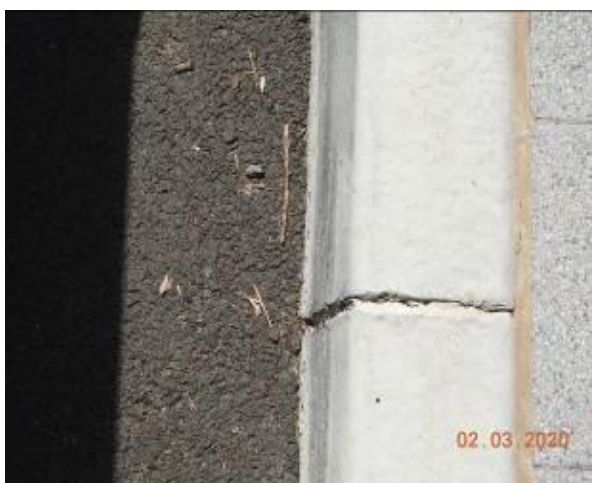
Figure 2084 – General Condition of kerb

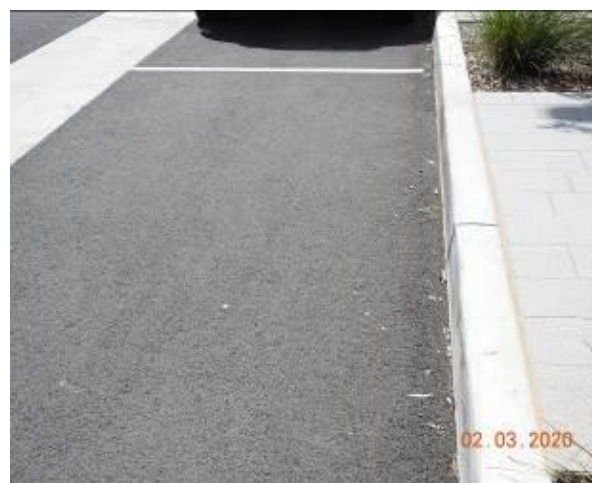
Figure 2085 – Crack propagation through kerb

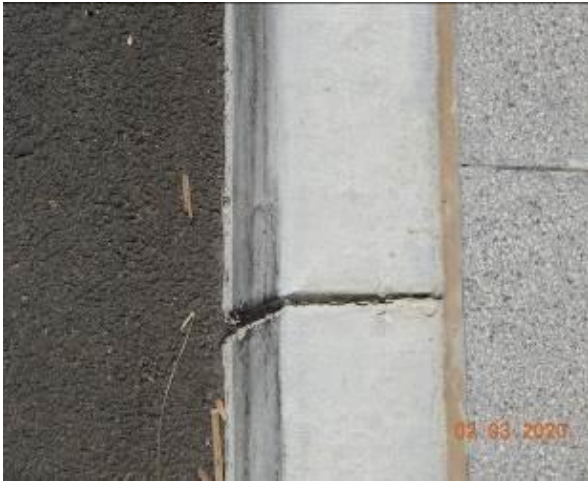
Figure 2086 – General Condition of kerb

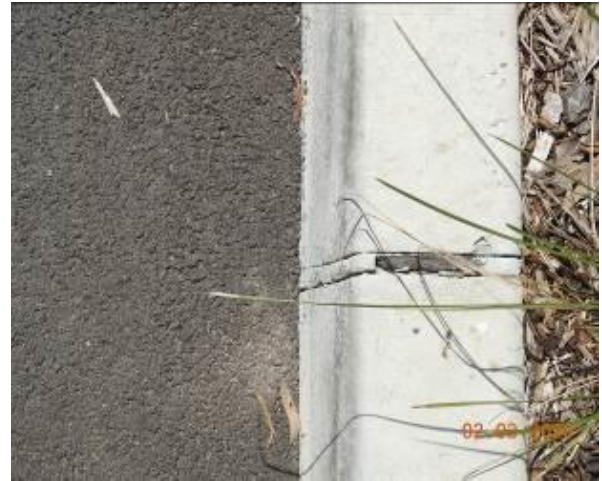
Figure 2087 – Crack propagation and loss of material through kerb

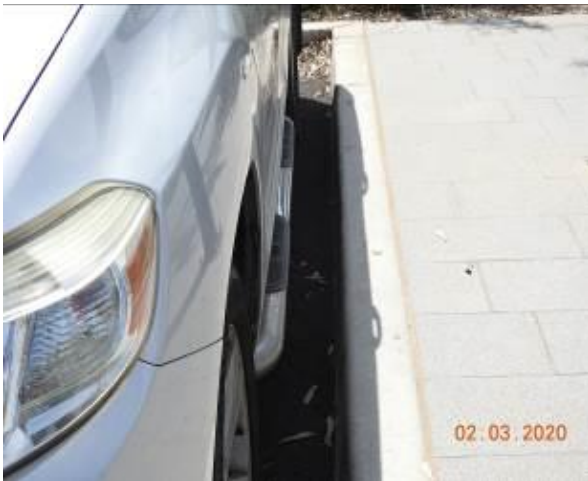
Figure 2088 – Crack propagation through kerb
