**1-15 AND 2-12 CONFERTA AVENUE,
ROUSE HILL NSW 2155
TALLAWONG STATION PRECINCT SOUTH
PRE-DILAPIDATION REPORT**

**DEICORP PROJECTS
(TALLAWONG STATION) PTY LTD**

Job No. 191294.0
24/03/2020

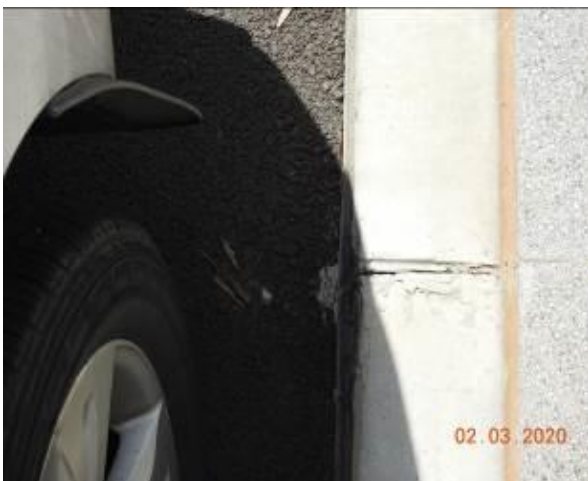
Figure 2090 – Crack propagation through kerb

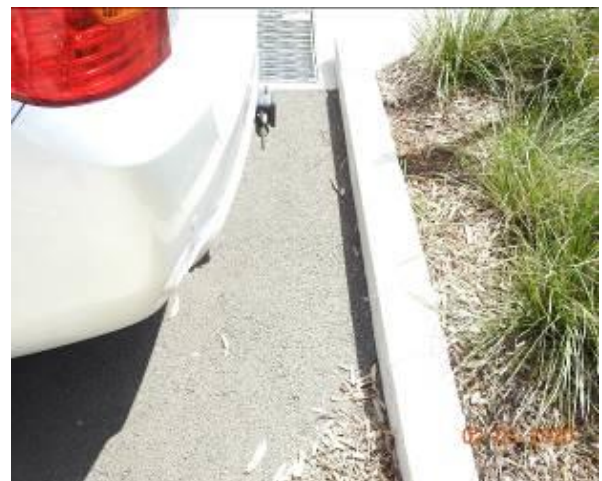
Figure 2091 – Crack propagation through kerb

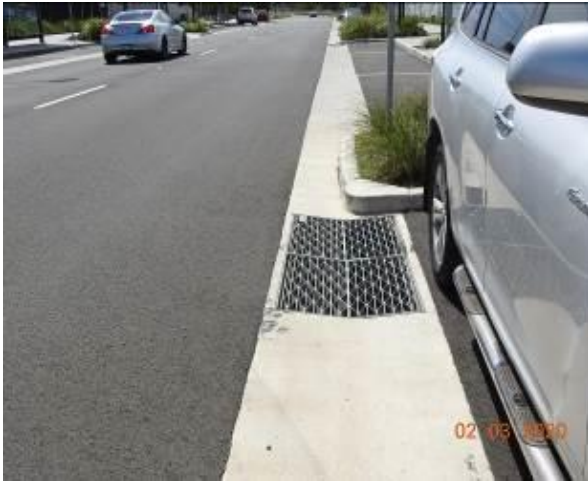
Figure 2092 – General Condition of kerb

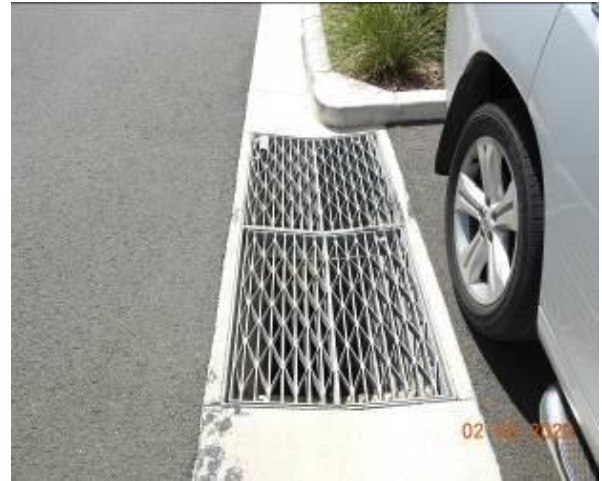
Figure 2093 – General Condition of gutter

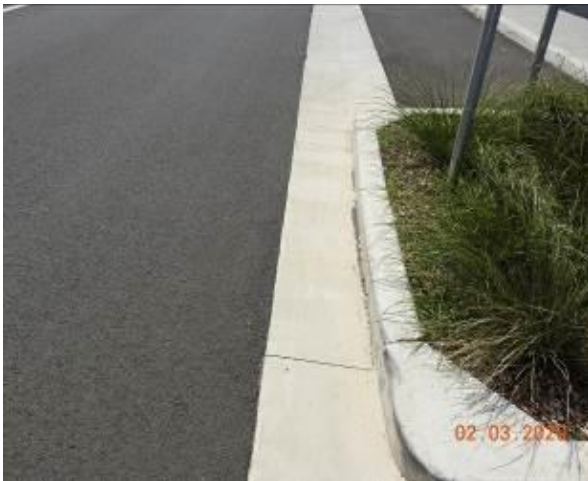
Figure 2094 – General Condition of stormwater inlet pit

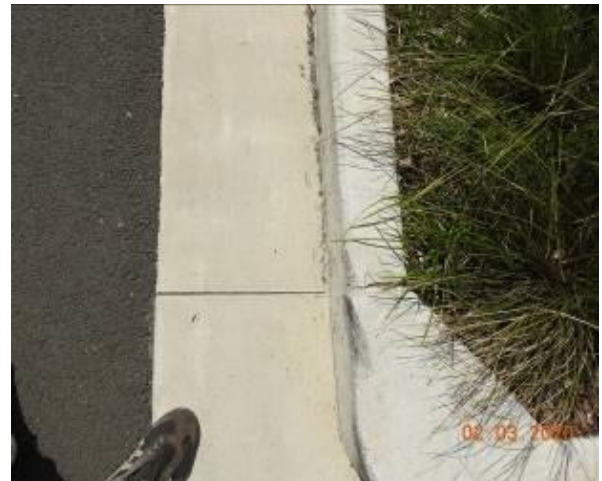
Figure 2095 – General Condition of kerb and gutter

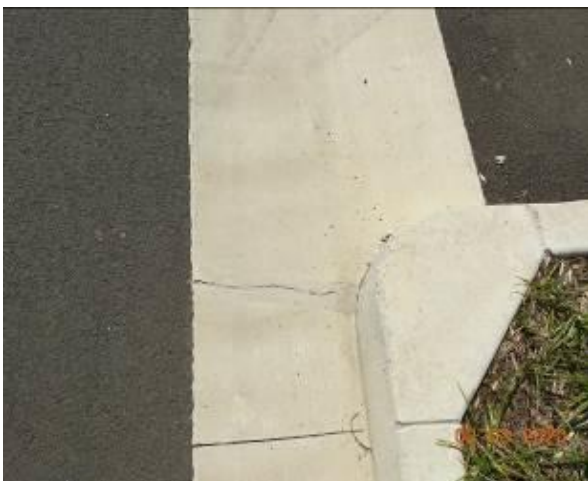
Figure 2096 – Crack propagation through kerb

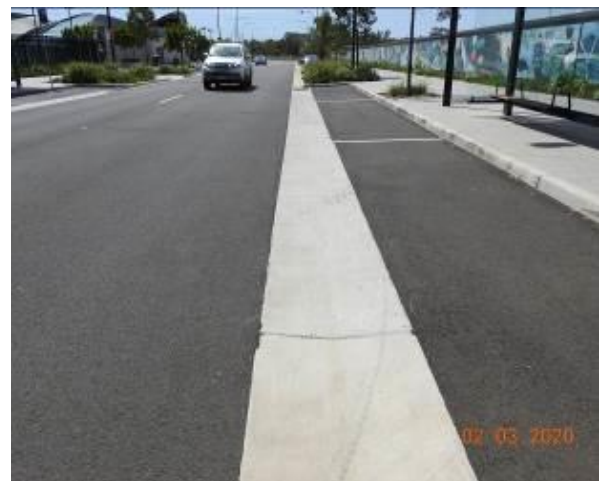
Figure 2097 – Crack propagation through gutter

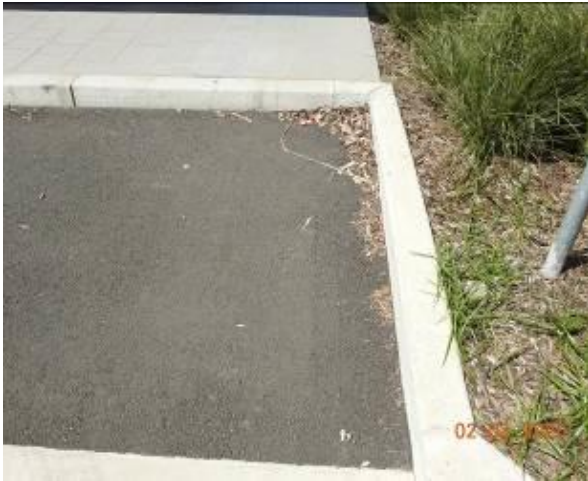
Figure 2098 – General Condition of gutter

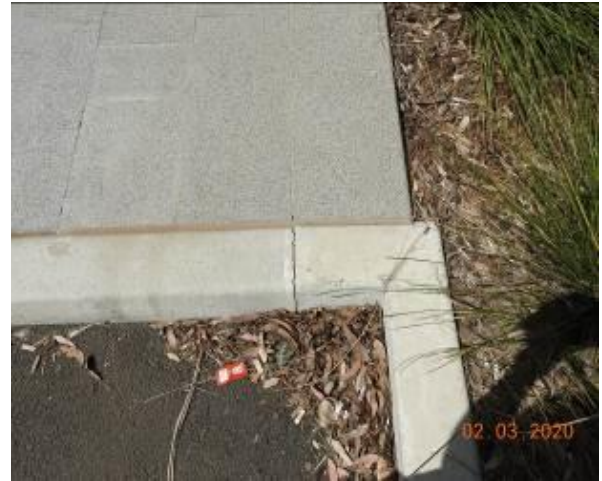
Figure 2099 – General Condition of kerb

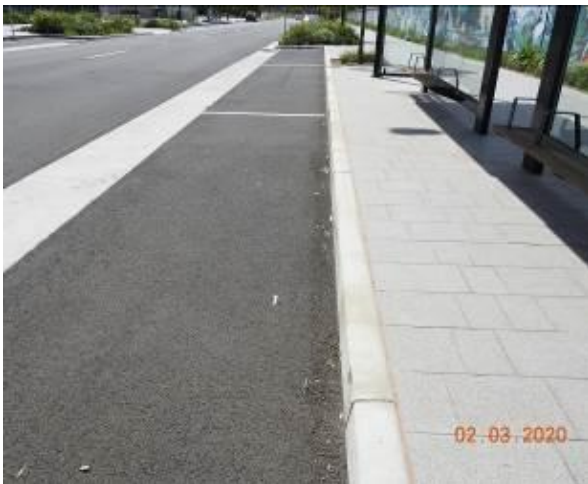
Figure 2100 – Separation through kerb

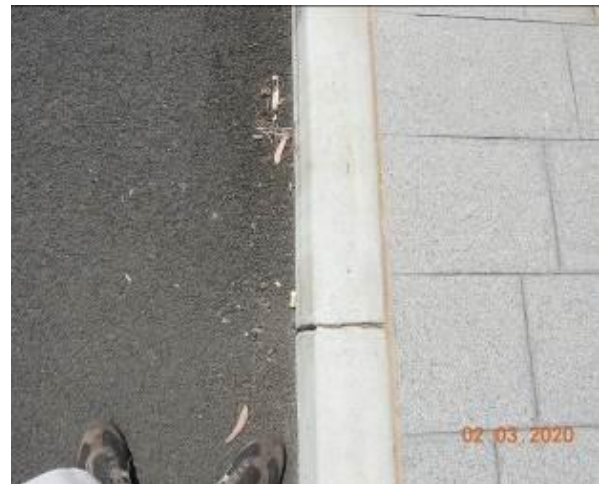
Figure 2101 – General Condition of kerb

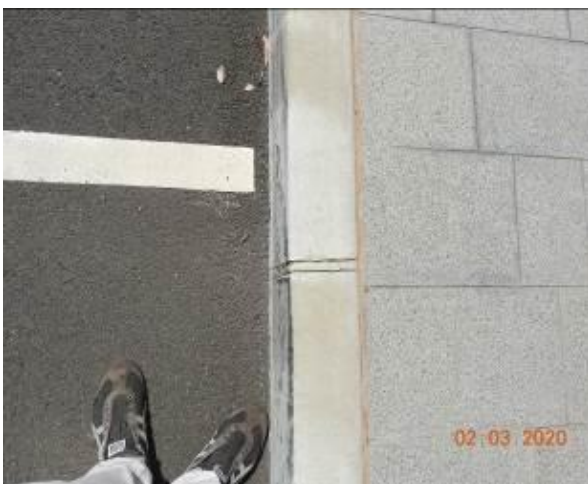
Figure 2102 – Crack propagation through kerb

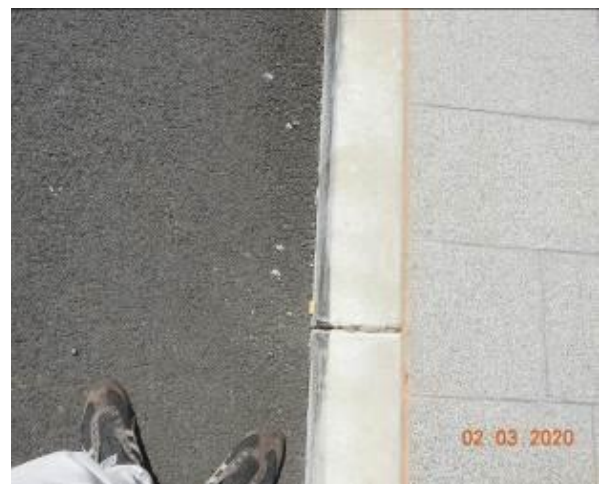
Figure 2103 – Crack propagation through kerb

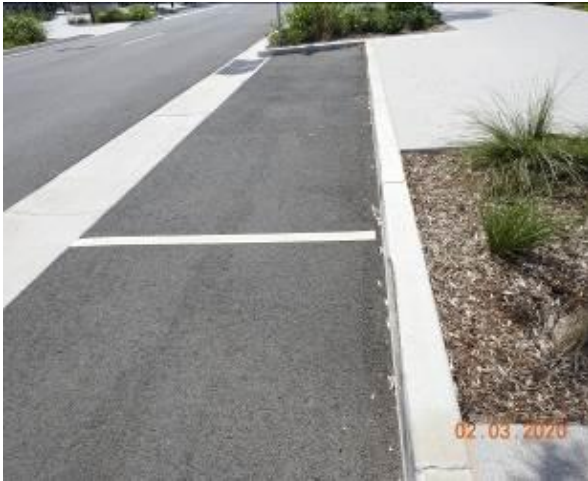
Figure 2104 – Crack propagation through kerb

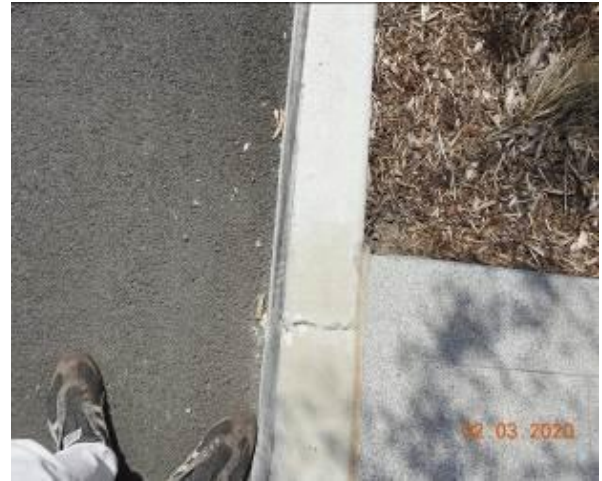
Figure 2105 – General Condition of kerb

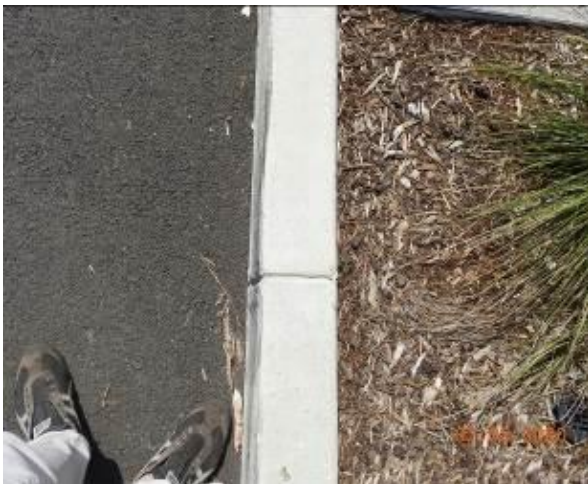
Figure 2106 – Crack propagation through kerb

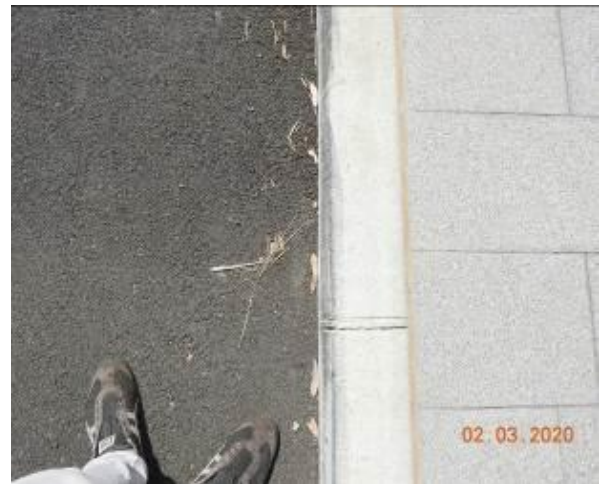
Figure 2107 – Crack propagation through kerb

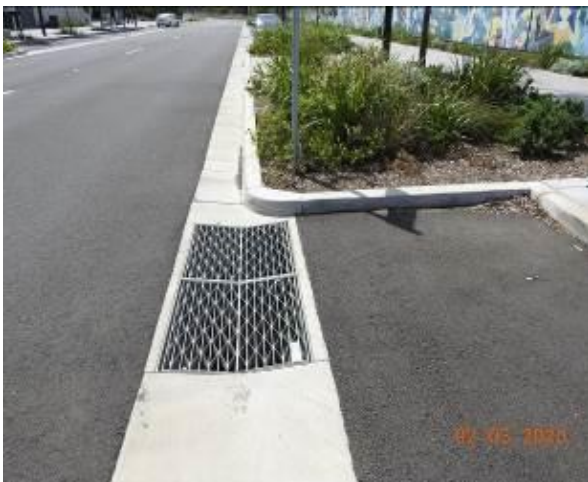
Figure 2108 – Crack propagation through kerb

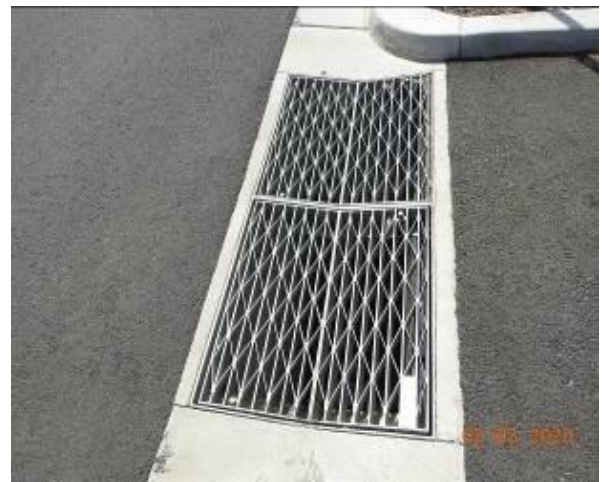
Figure 2109 – General Condition of gutter

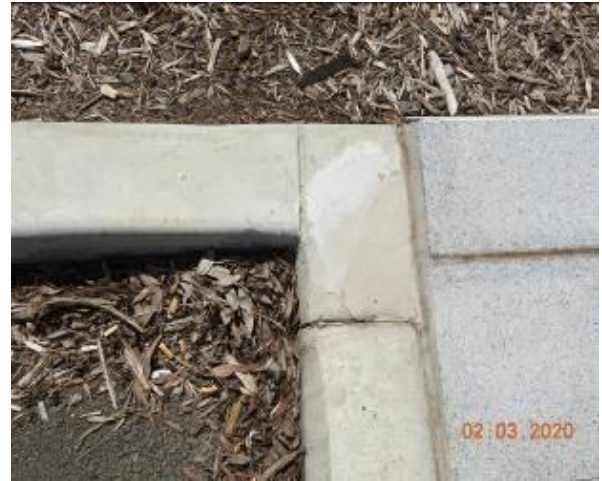
Figure 2111 – Crack propagation through kerb

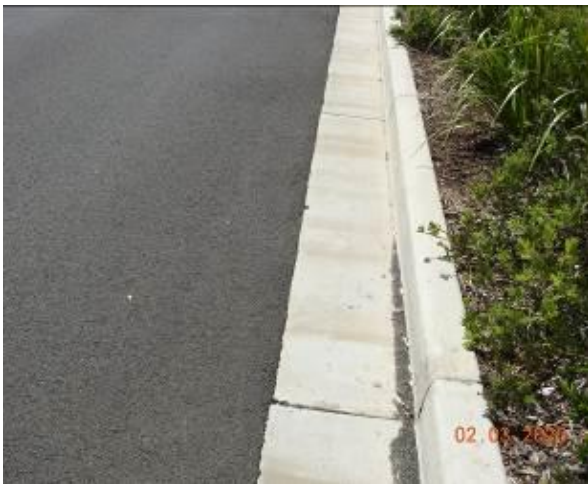
Figure 2112 – Crack propagation through kerb

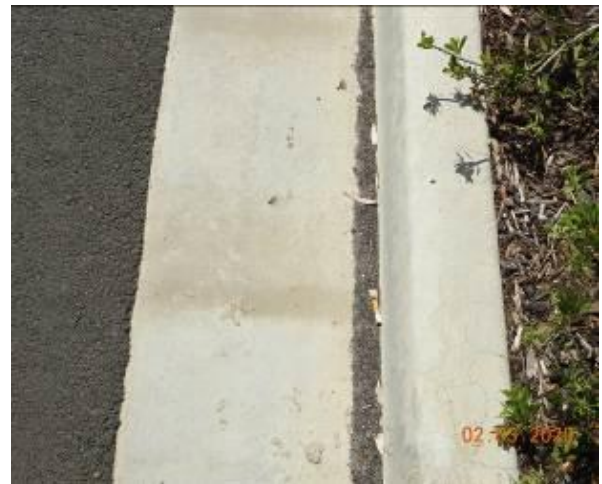
Figure 2114 – Crack propagation through kerb

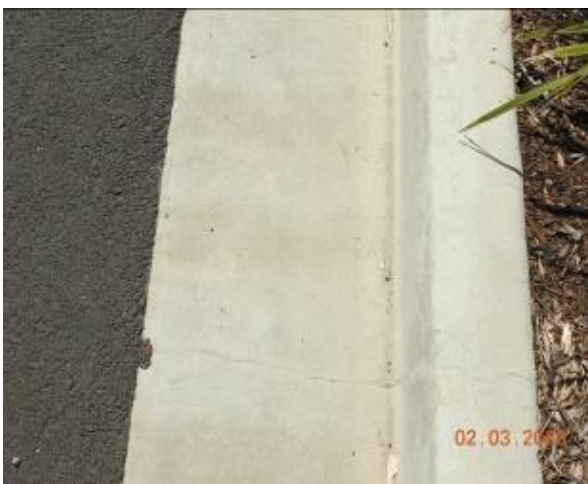
Figure 2115 – Crack propagation through kerb and gutter

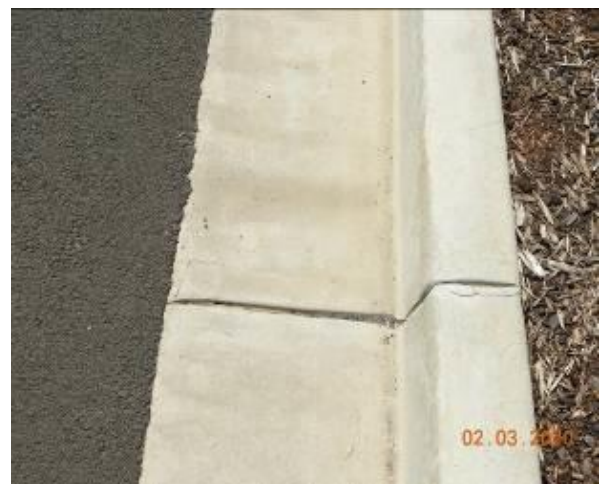
Figure 2116 – Crack propagation through kerb and gutter

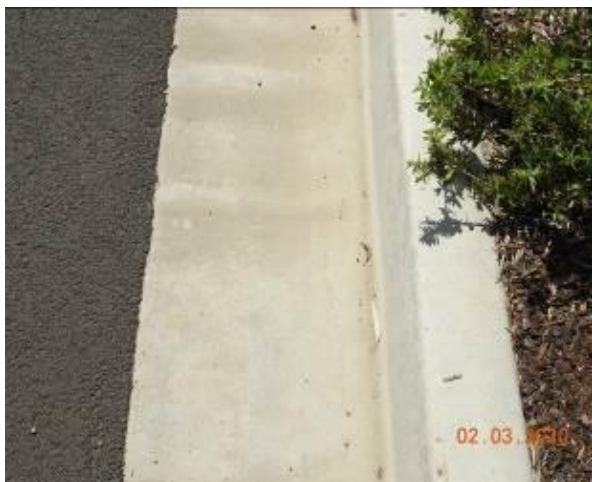
Figure 2117 – General Condition of kerb and gutter

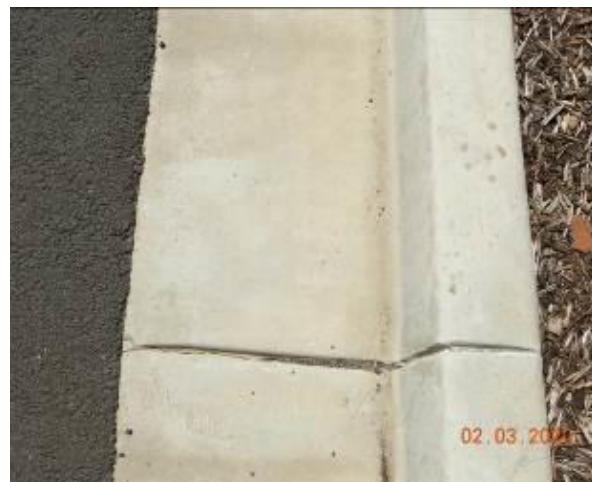
Figure 2118 – Crack propagation through kerb and gutter

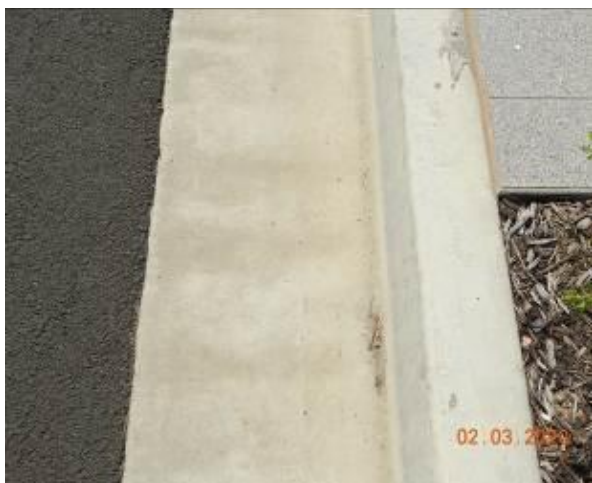
Figure 2119 – General Condition of kerb and gutter

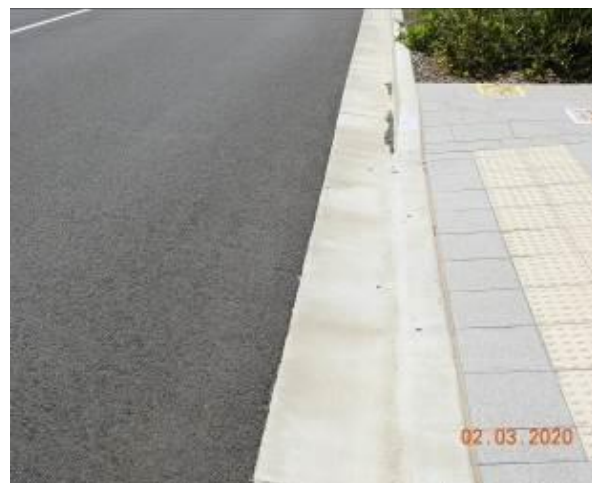
Figure 2120 – General Condition of layback and gutter

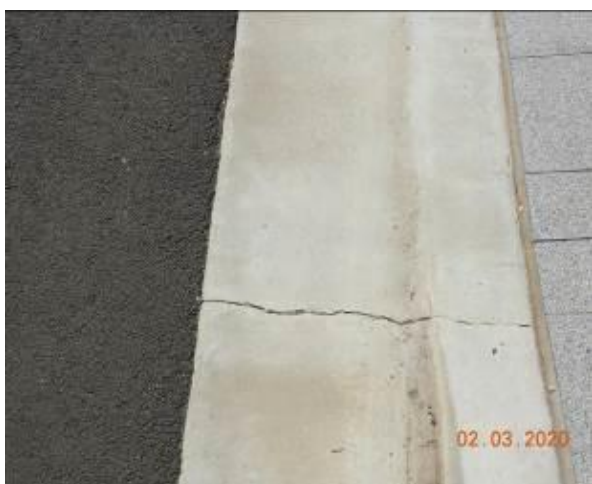
Figure 2121 – Crack propagation through layback and gutter

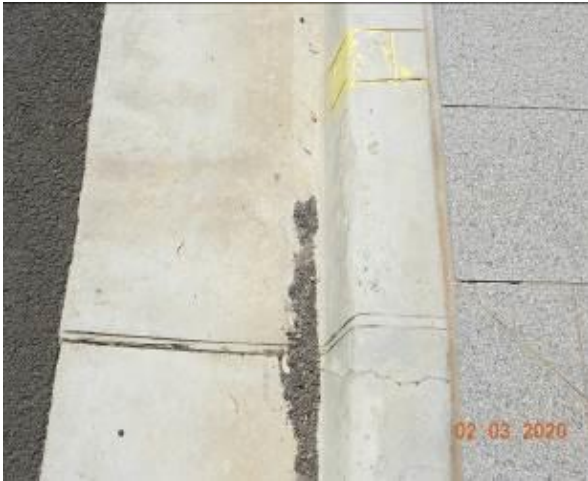
Figure 2123 – Crack propagation through kerb and gutter

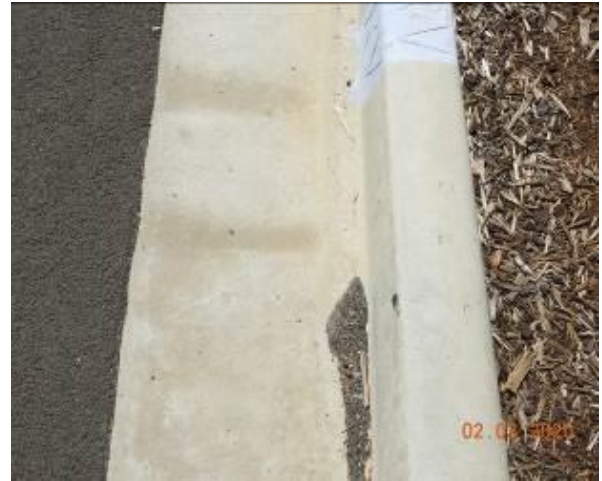
Figure 2124 – Crack propagation through kerb and gutter

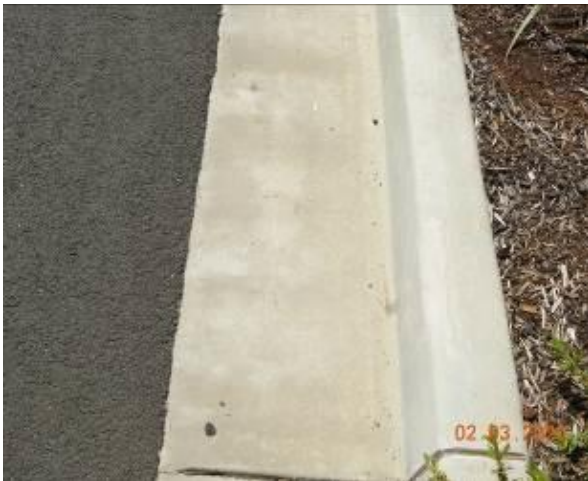
Figure 2125 – General Condition of kerb and gutter

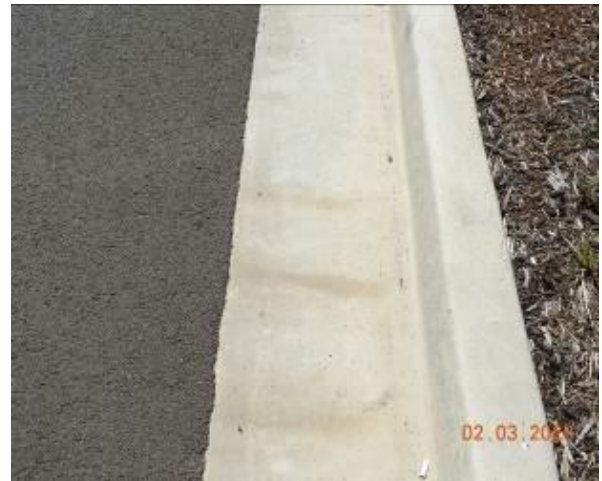
Figure 2126 – General Condition of kerb and gutter

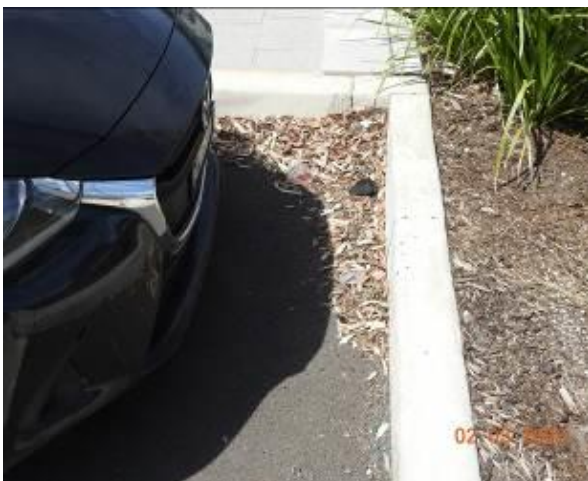
Figure 2127 – General Condition of kerb

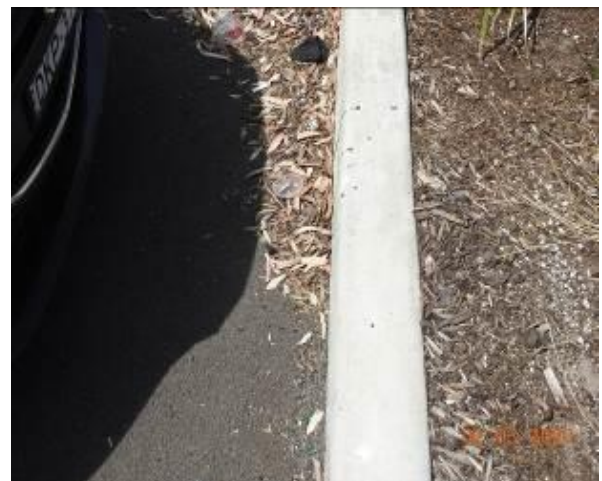
Figure 2128 – General Condition of kerb

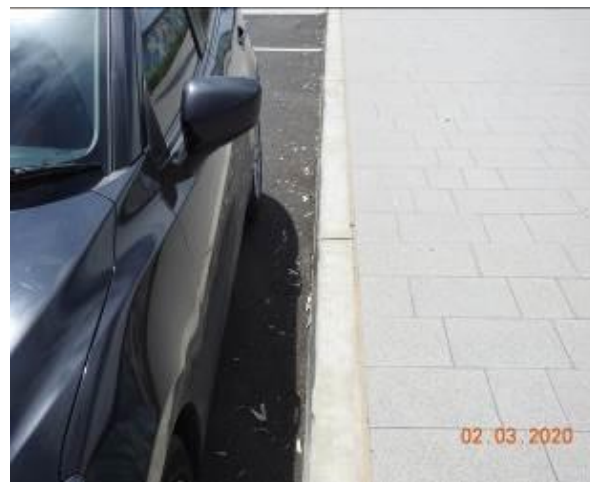
Figure 2130 – General Condition of kerb

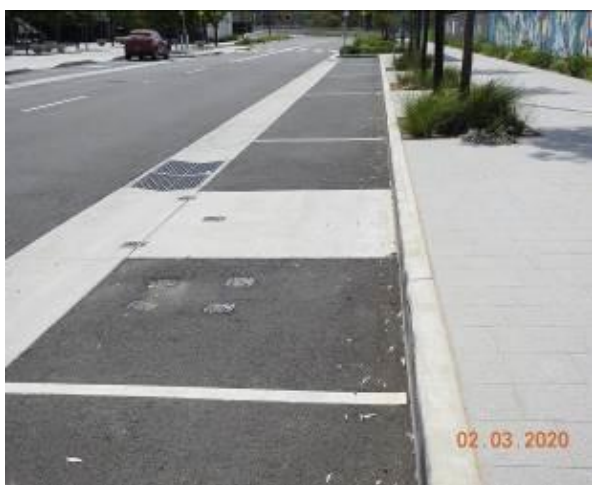
Figure 2131 – General Condition of kerb

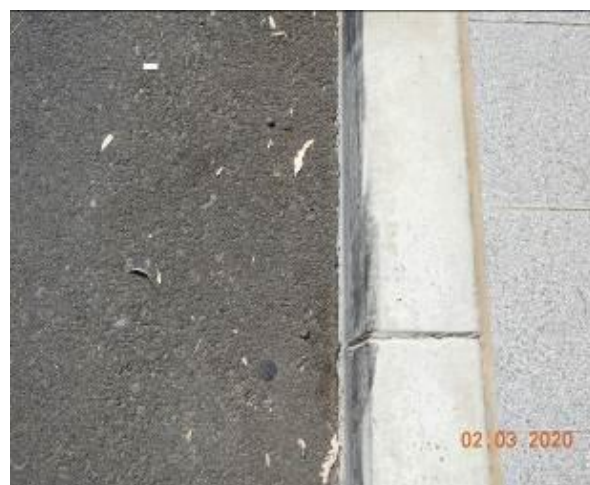
Figure 2132 – Crack propagation through kerb

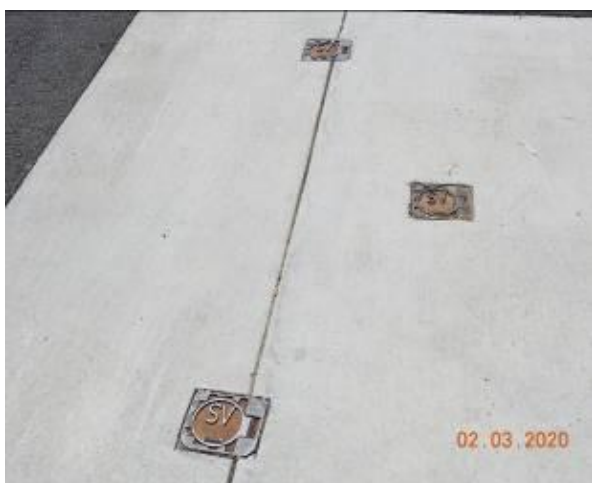
Figure 2133 – General Condition of service pit

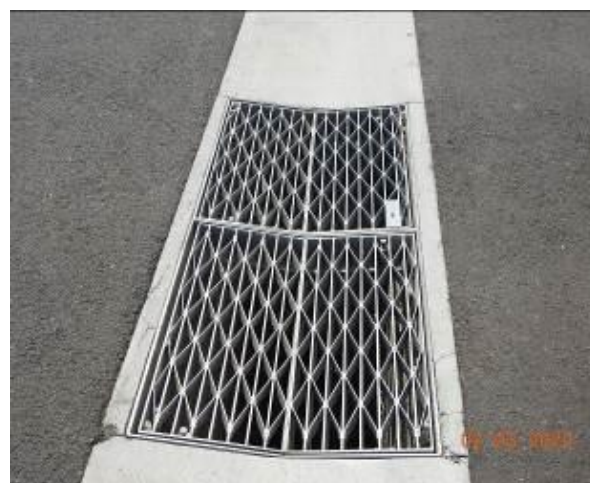
Figure 2134 – General Condition of stormwater inlet pit

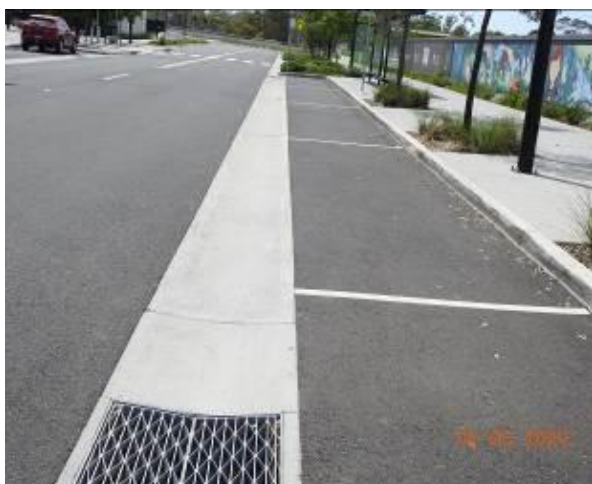
Figure 2135 – General Condition of gutter

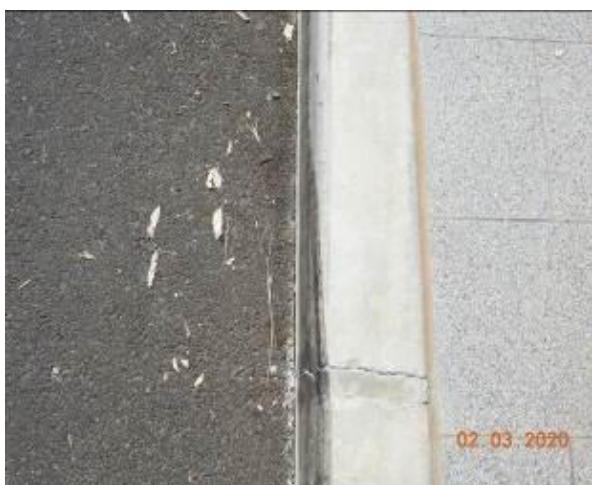
Figure 2137 – Crack propagation through kerb

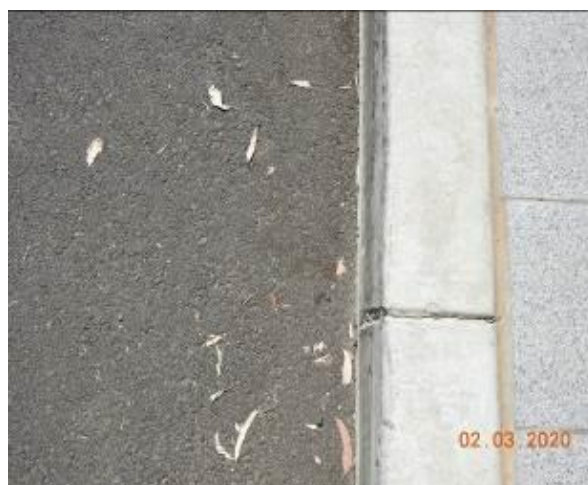
Figure 2138 – Crack propagation through kerb

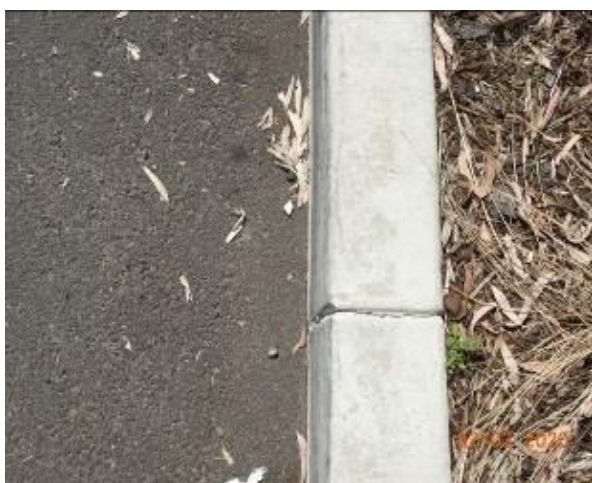
Figure 2139 – Crack propagation through kerb

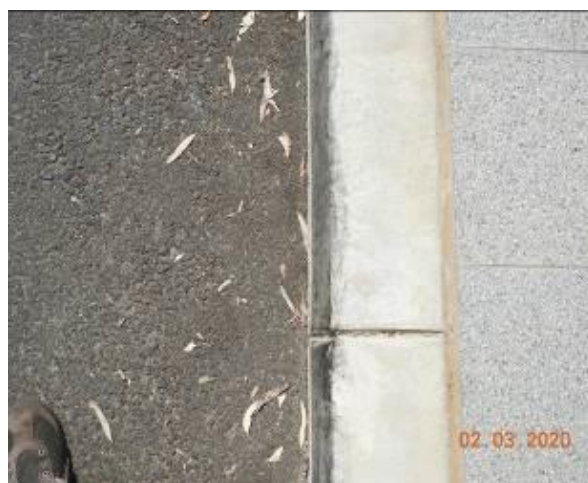
Figure 2140 – Crack propagation through kerb

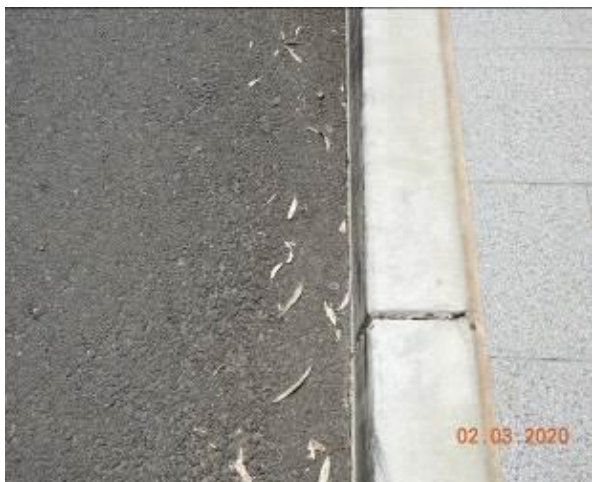
Figure 2141 – Crack propagation through kerb

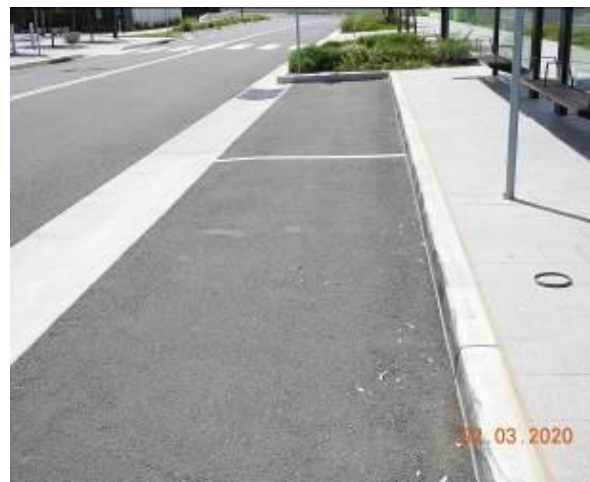
Figure 2142 – General Condition of kerb

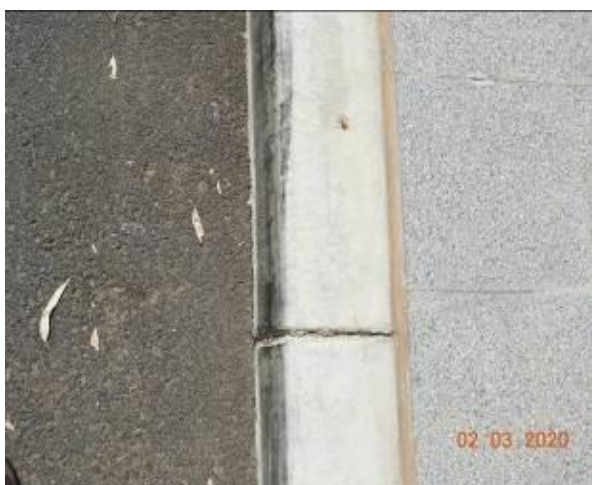
Figure 2143 – Crack propagation through kerb

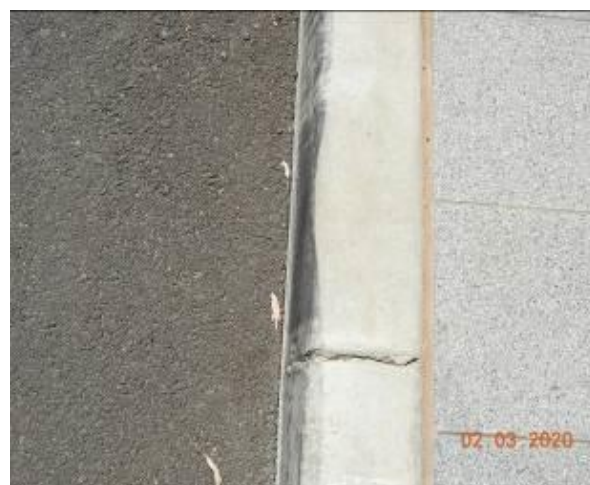
Figure 2144 – Crack propagation through kerb

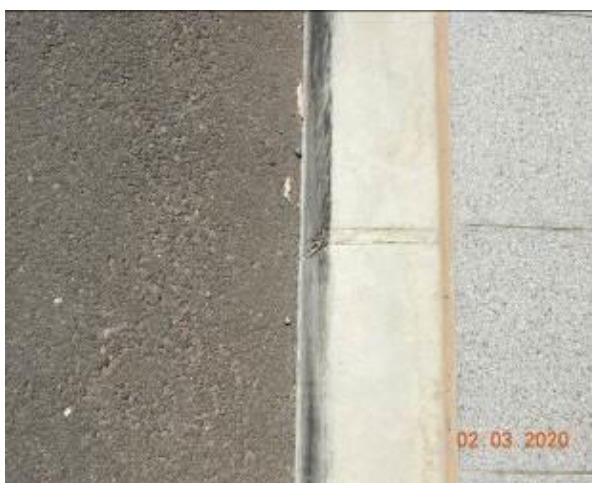
Figure 2145 – Crack propagation through kerb

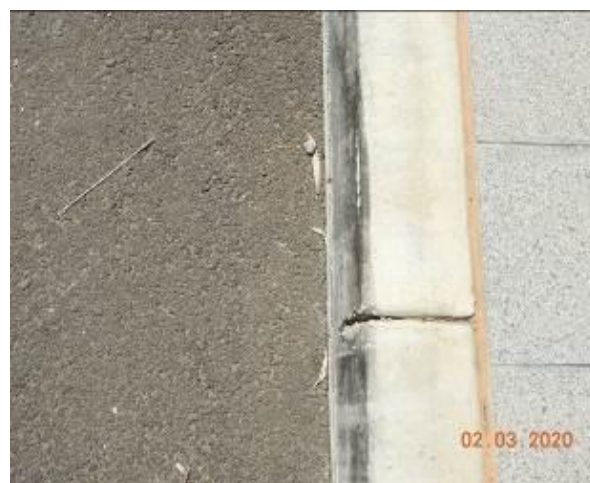
Figure 2146 – Crack propagation and loss of material through kerb

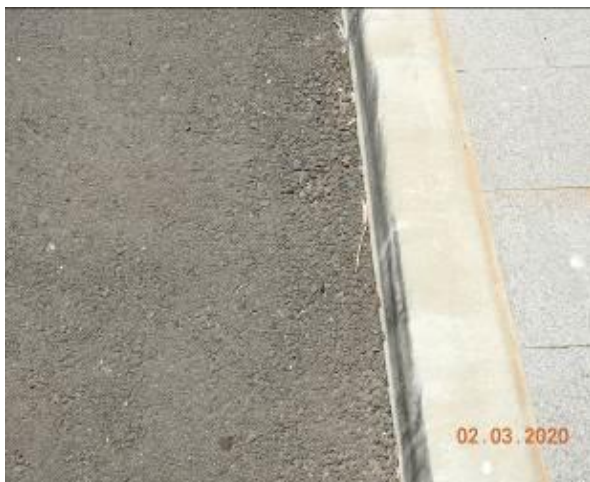
Figure 2147 – Crack propagation through kerb

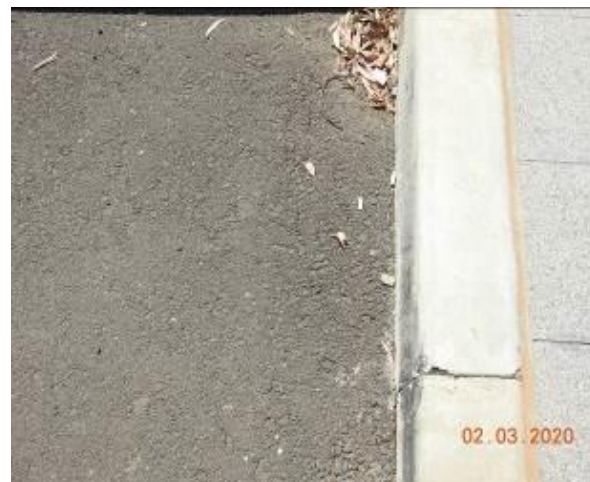
Figure 2148 – Crack propagation through kerb

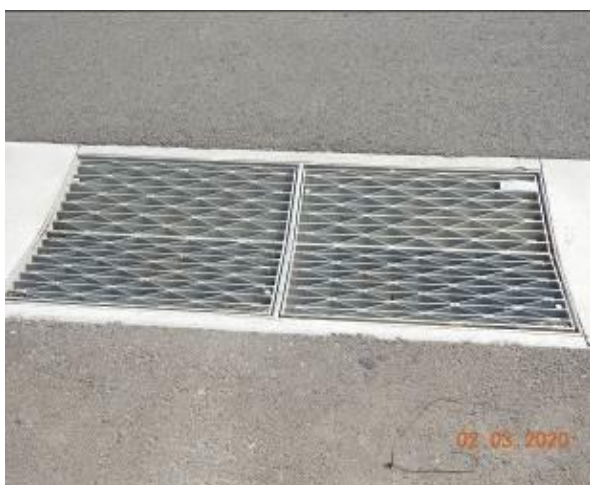
Figure 2149 – General Condition of stormwater inlet pit

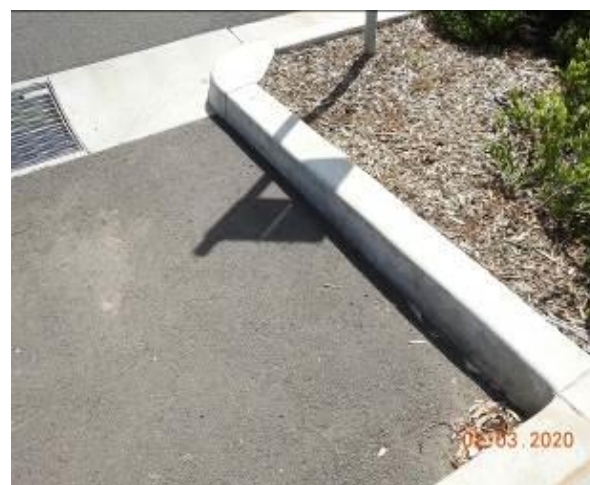
Figure 2150 – General Condition of kerb

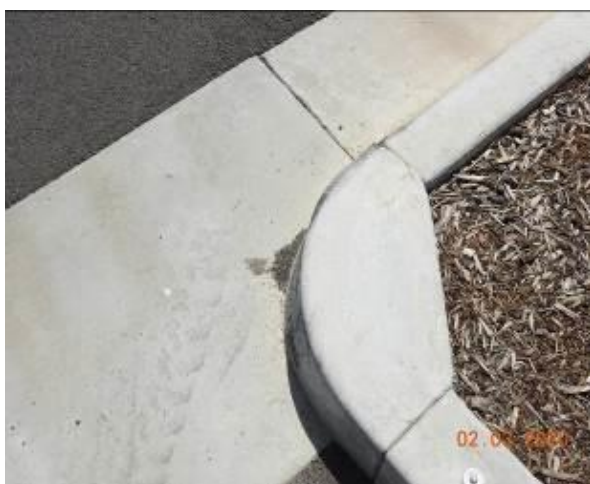
Figure 2151 – Crack propagation through kerb

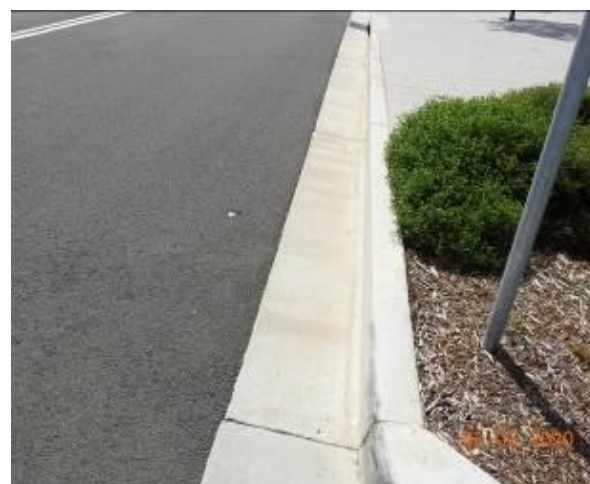
Figure 2152 – General Condition of kerb and gutter

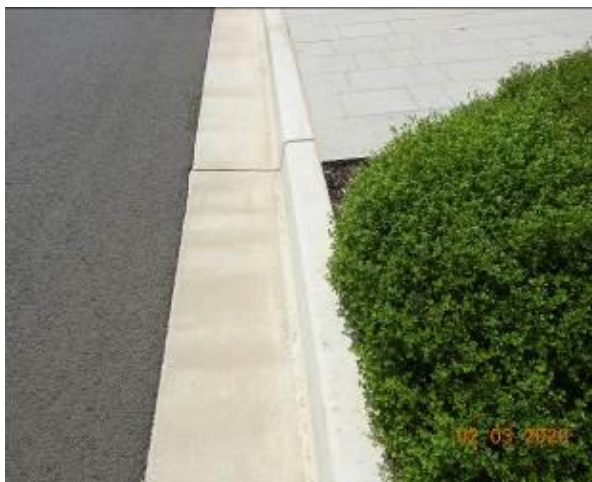
Figure 2153 – General Condition of kerb and gutter

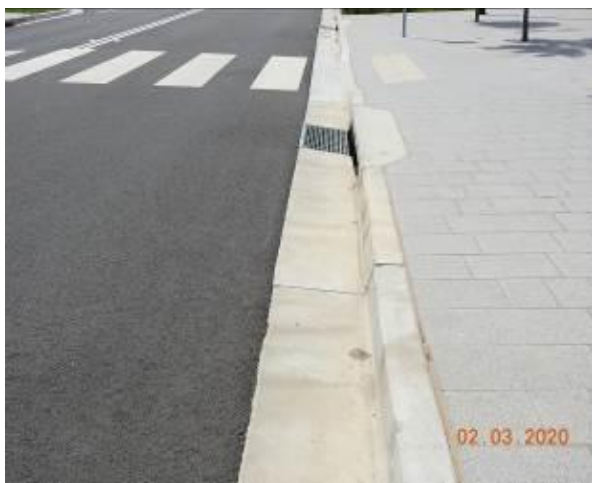
Figure 2154 – Crack propagation through kerb and gutter

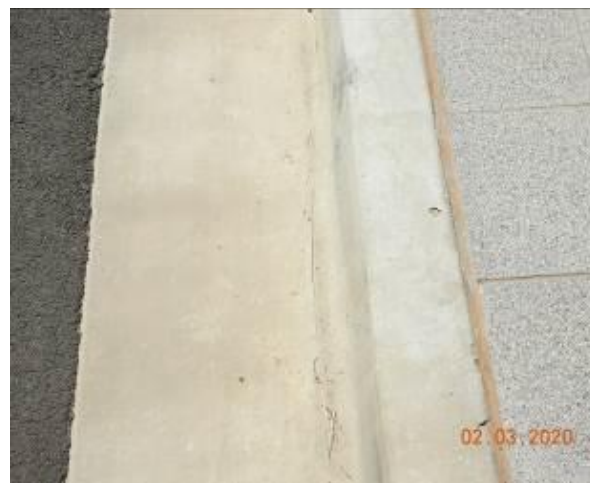
Figure 2155 – General Condition of kerb and gutter

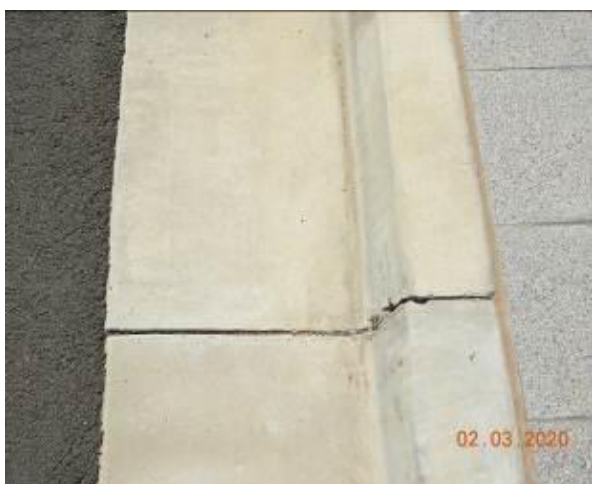
Figure 2156 – Crack propagation through kerb

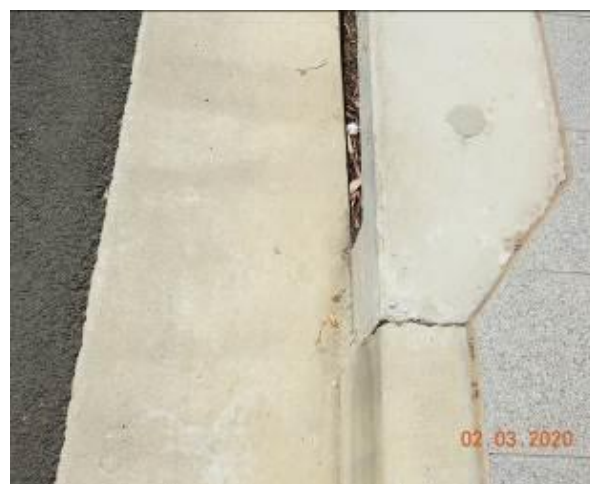
Figure 2157 – Loss of material through kerb and gutter

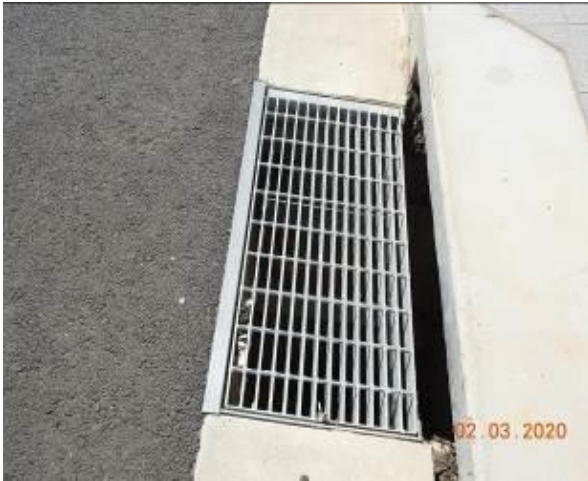
Figure 2158 – Crack propagation through kerb

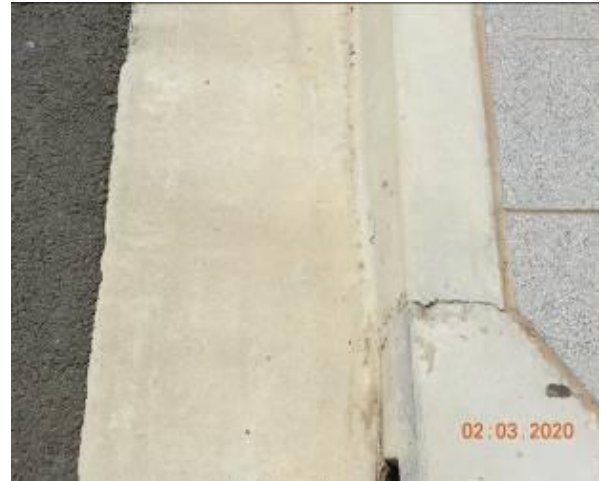
Figure 2159 – General Condition of stormwater inlet pit

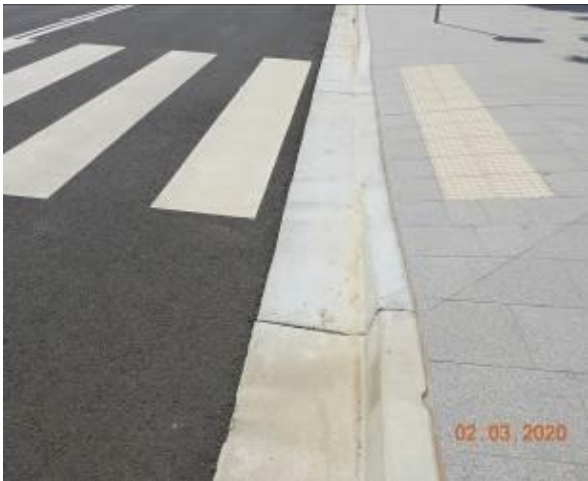
Figure 2160 – Crack propagation through kerb

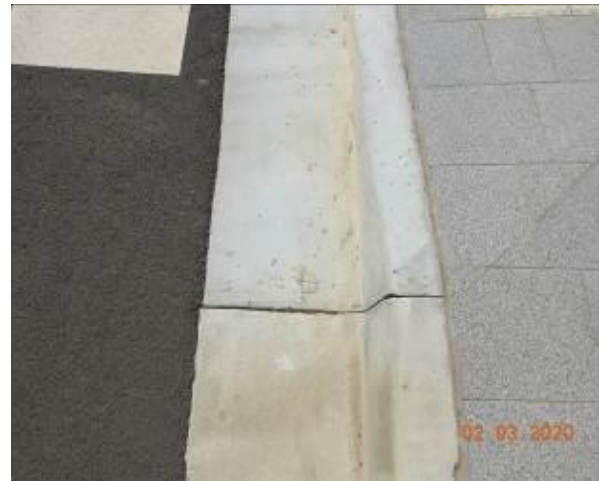
Figure 2161 – General Condition of layback and gutter

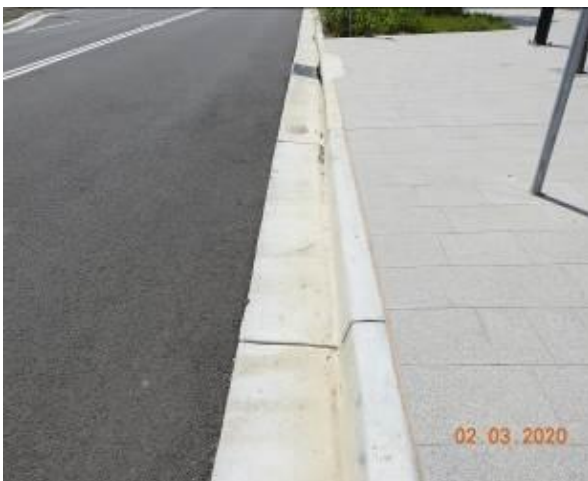
Figure 2162 – General Condition of kerb and gutter

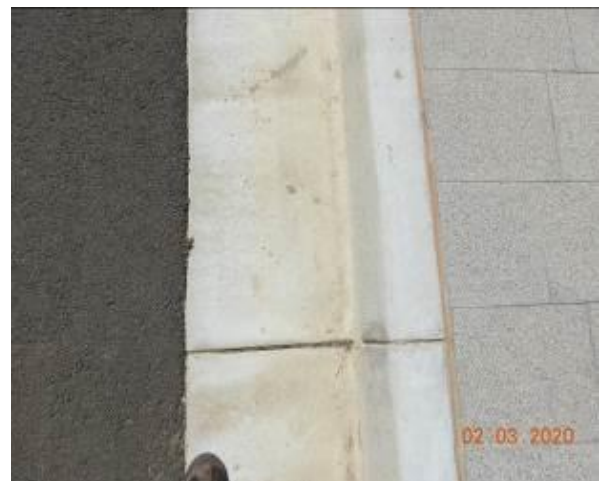
Figure 2163 – General Condition of kerb and gutter

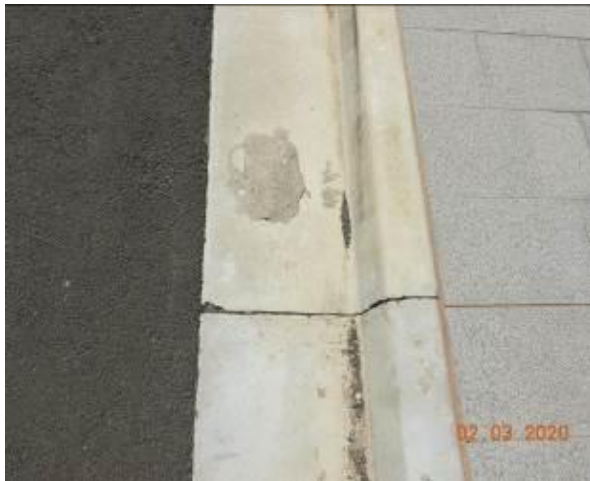
Figure 2164 – Crack propagation through kerb and gutter

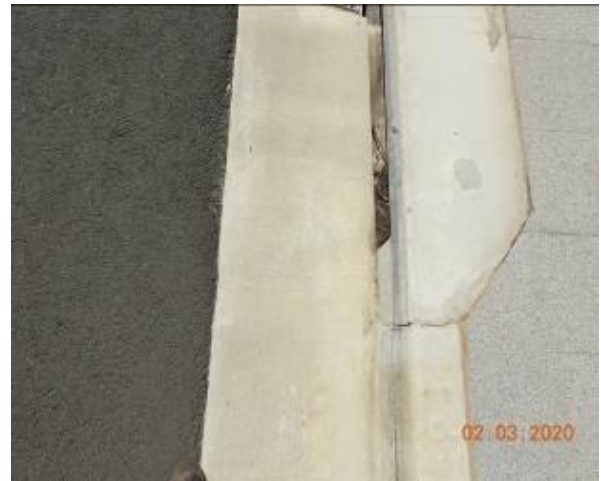
Figure 2165 – Crack propagation and loss of material through kerb and gutter

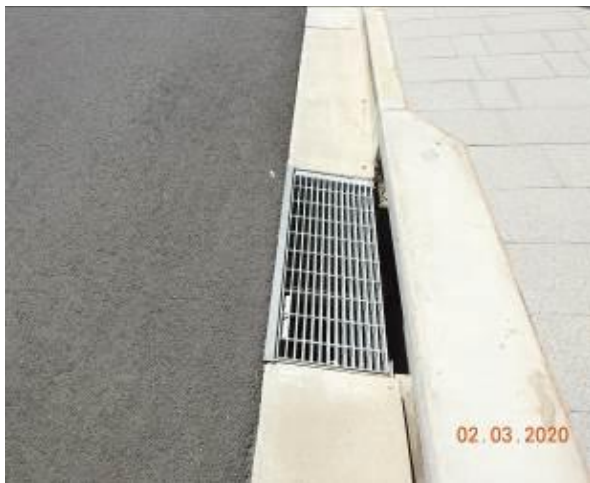
Figure 2166 – Crack propagation through kerb and gutter

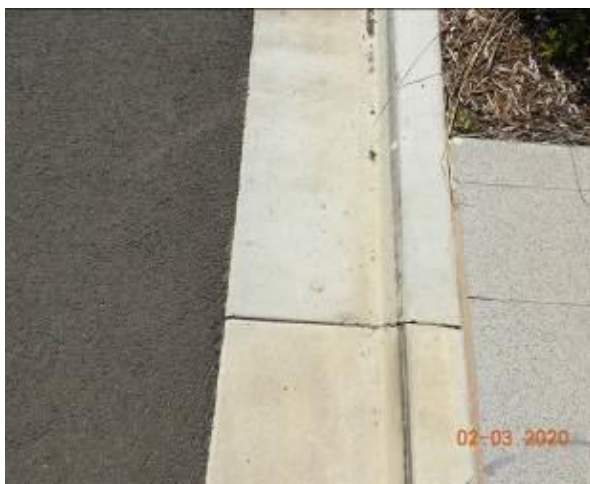
Figure 2168 – General Condition of kerb and gutter

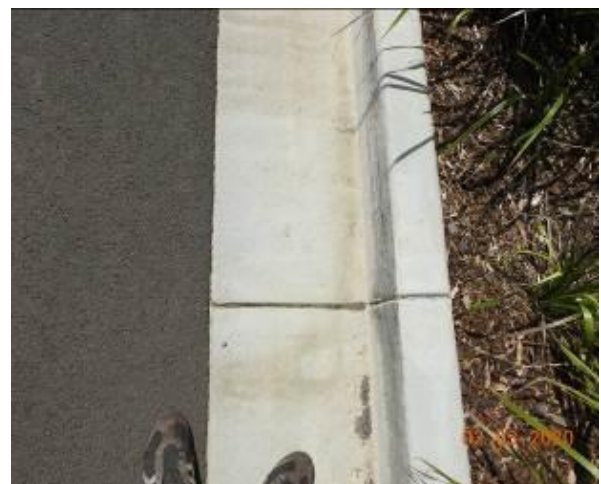
Figure 2169 – General Condition of kerb and gutter

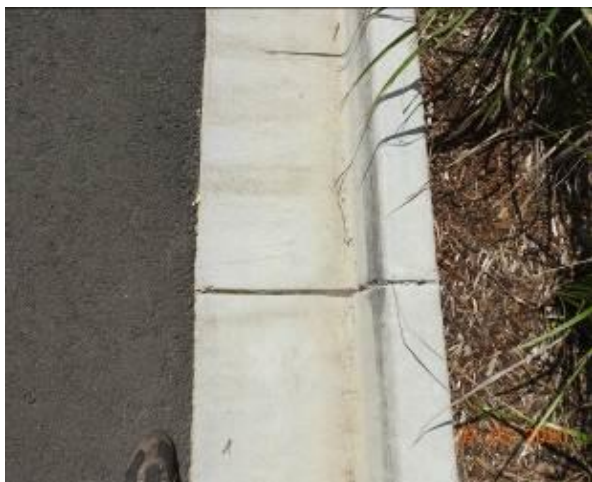
Figure 2170 – Crack propagation through kerb

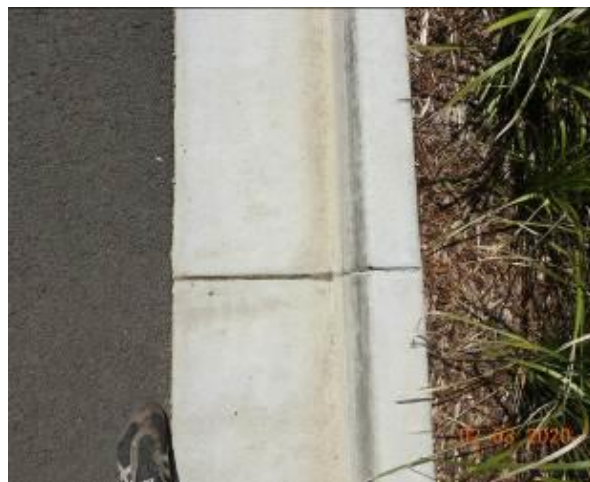
Figure 2171 – Crack propagation through kerb

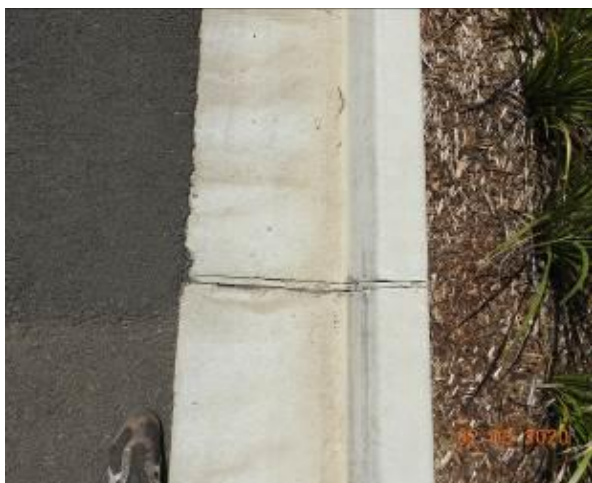
Figure 2172 – Crack propagation through kerb and gutter
