**1-15 AND 2-12 CONFERTA AVENUE,
ROUSE HILL NSW 2155
TALLAWONG STATION PRECINCT SOUTH
PRE-DILAPIDATION REPORT**

**DEICORP PROJECTS
(TALLAWONG STATION) PTY LTD**

Job No. 191294.0
24/03/2020

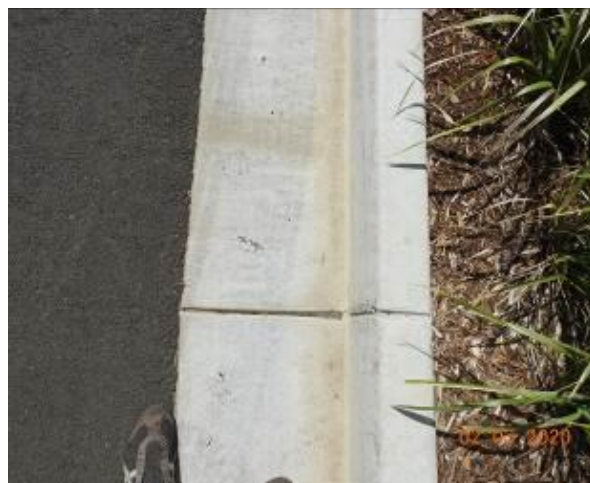
Figure 2173 – Crack propagation through kerb and gutter

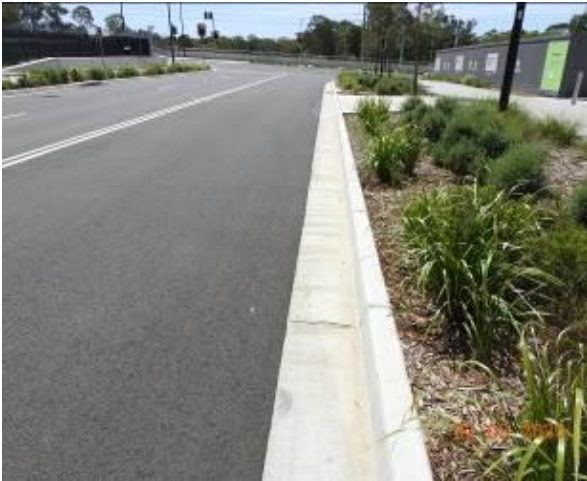
Figure 2176 – Crack propagation through kerb

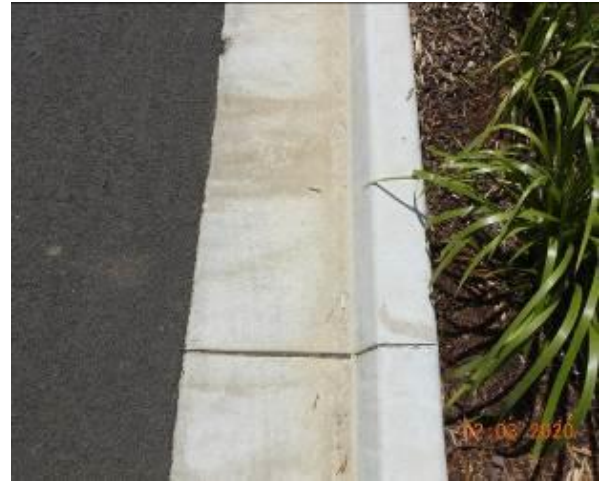
Figure 2177 – General Condition of kerb and gutter

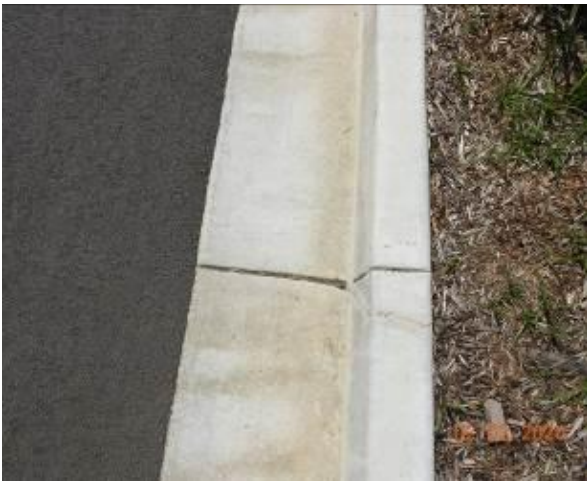
Figure 2178 – Crack propagation through kerb and gutter

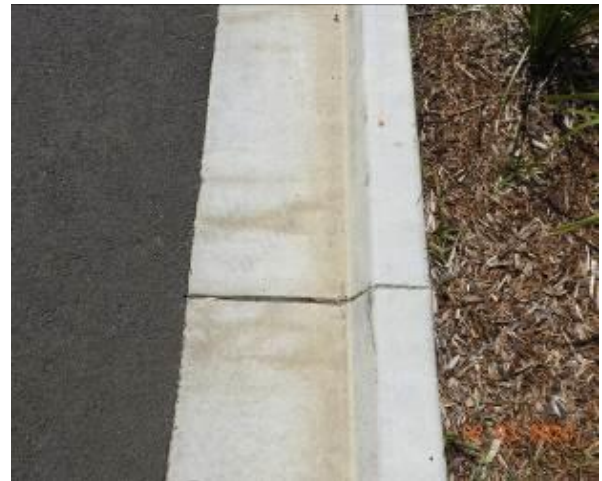
Figure 2179 – Crack propagation through kerb

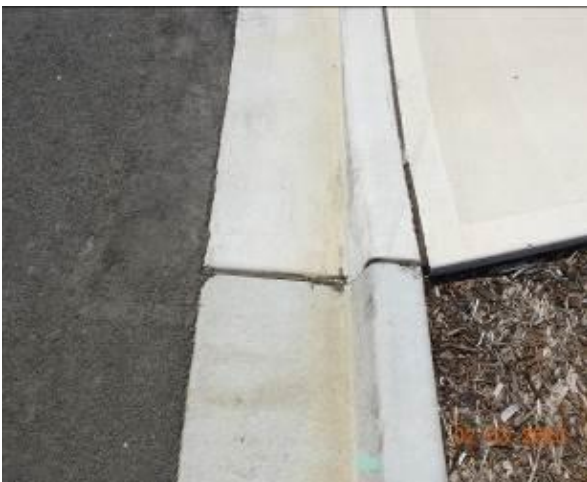
Figure 2180 – Crack propagation through kerb and gutter

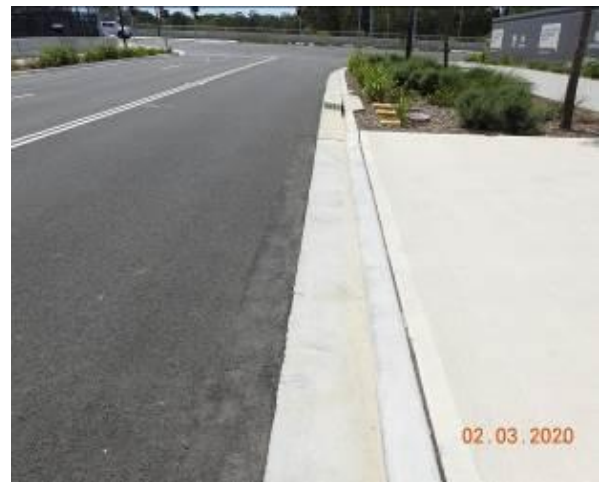
Figure 2181 – Crack propagation and loss of material through kerb and gutter

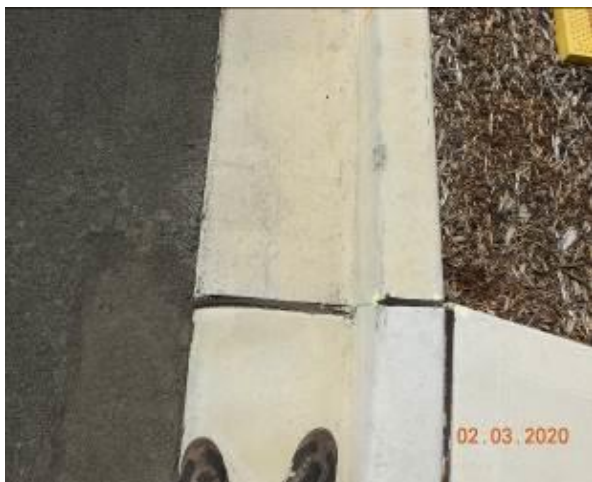
Figure 2182 – General Condition of layback and gutter

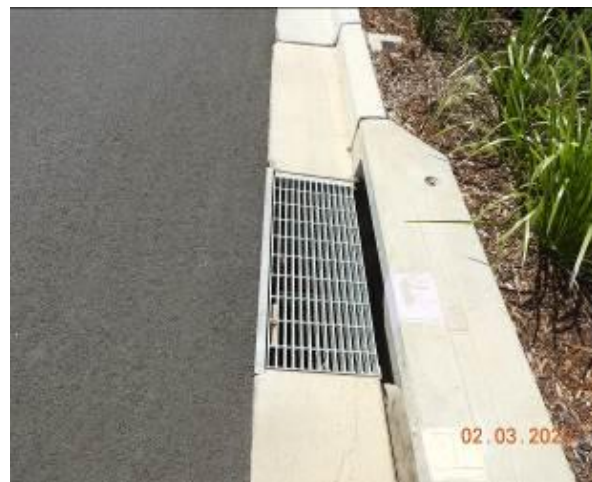
Figure 2183 – Crack propagation through kerb

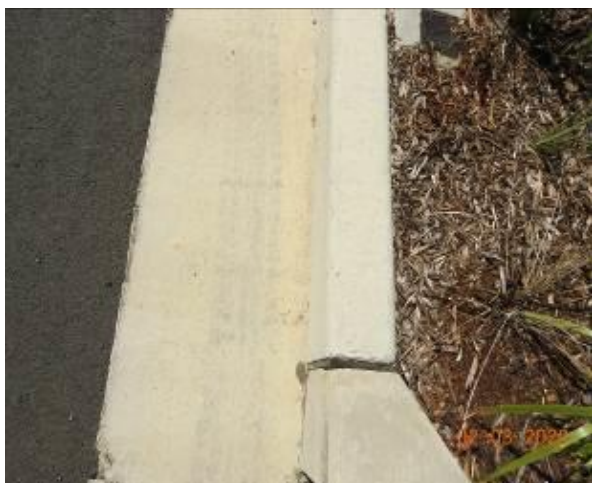
Figure 2184 – General Condition of stormwater inlet pit

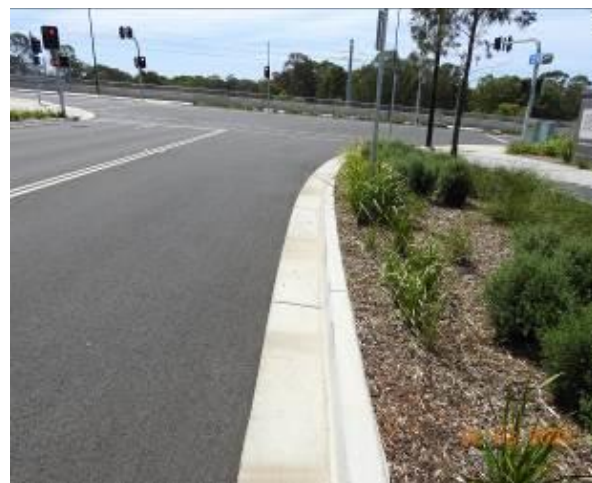
Figure 2185 – Crack propagation through kerb

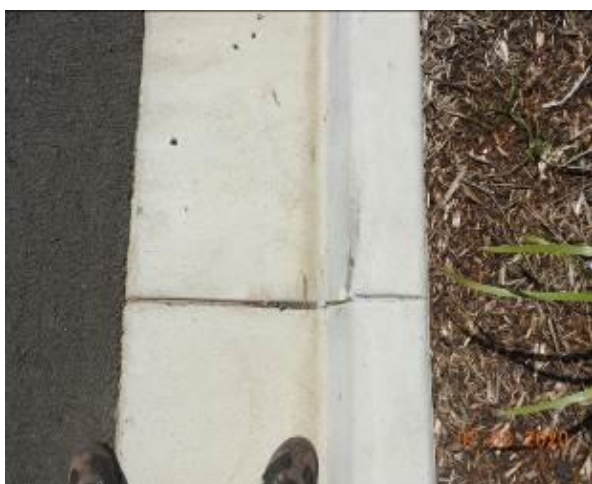
Figure 2186 – General Condition of kerb and gutter

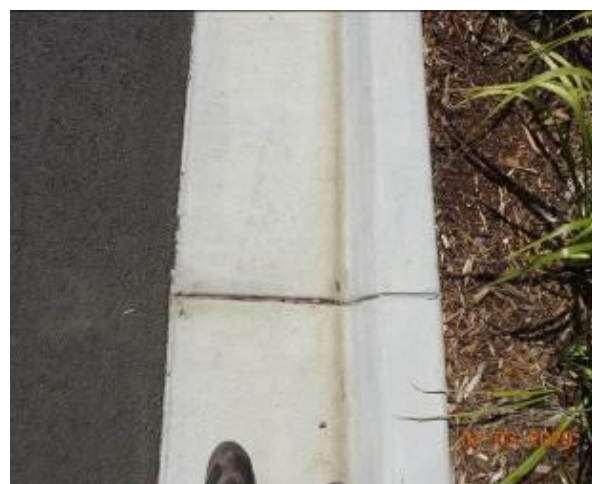
Figure 2187 – Crack propagation through kerb and gutter

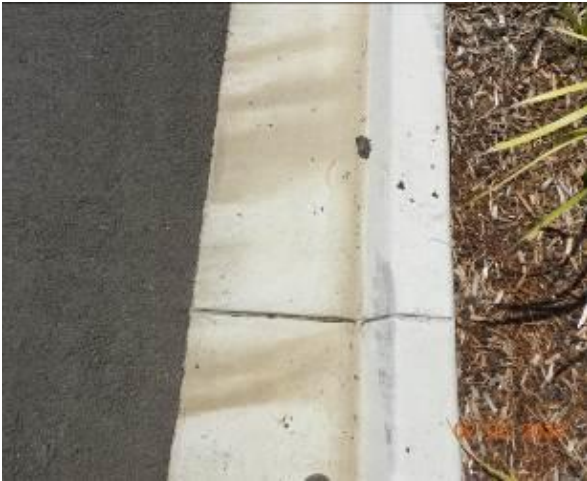
Figure 2188 – Crack propagation through kerb and gutter

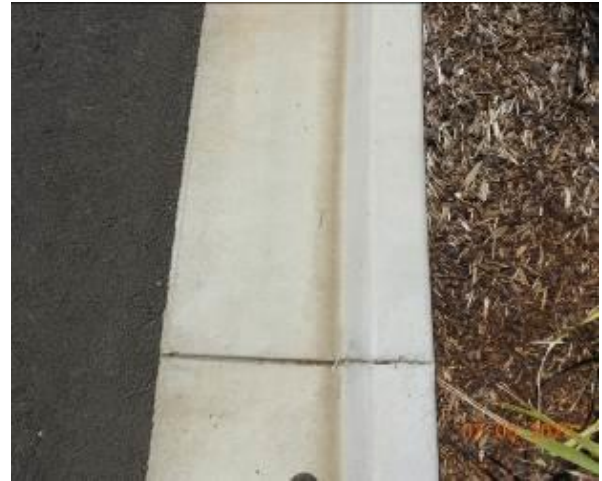
Figure 2189 – Crack propagation through kerb and gutter

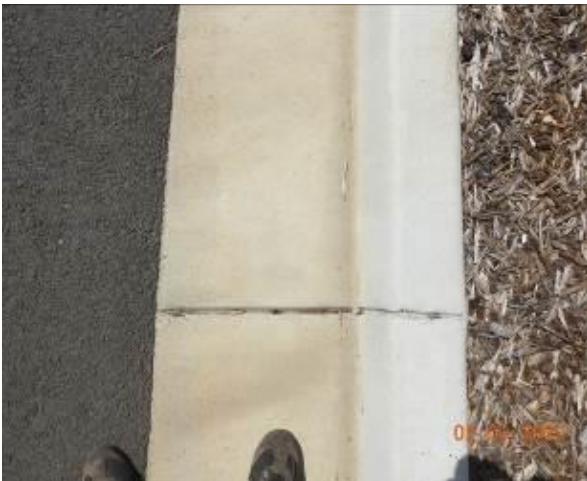
Figure 2190 – Crack propagation through kerb and gutter

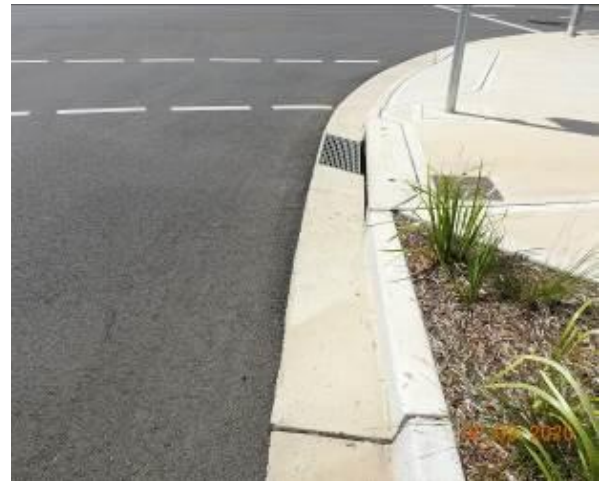
Figure 2191 – Crack propagation through kerb and gutter

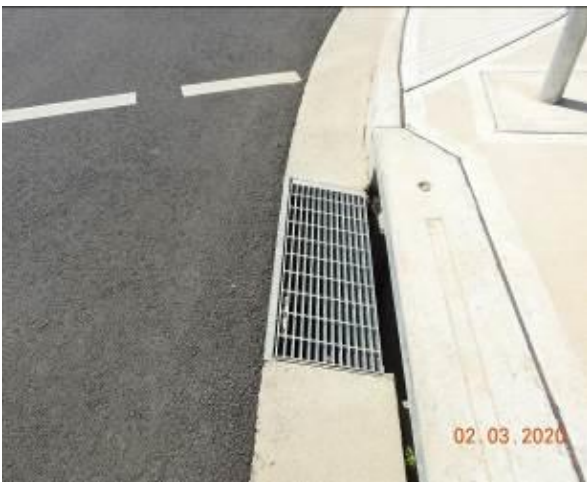
Figure 2192 – General Condition of kerb and gutter

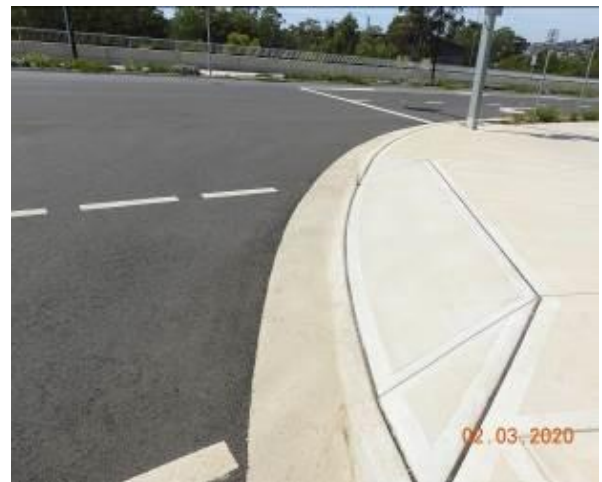
Figure 2194 – General Condition of layback and gutter

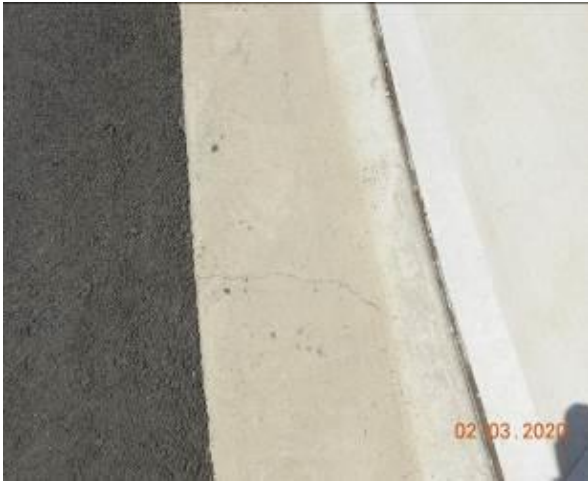
Figure 2195 – Crack propagation through layback and gutter

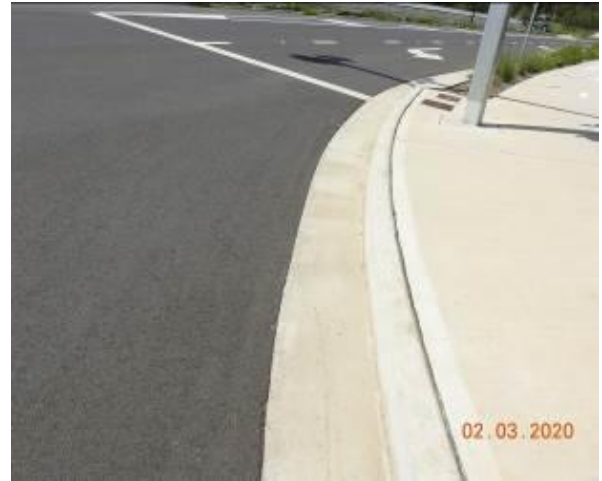
Figure 2196 – General Condition of layback and gutter

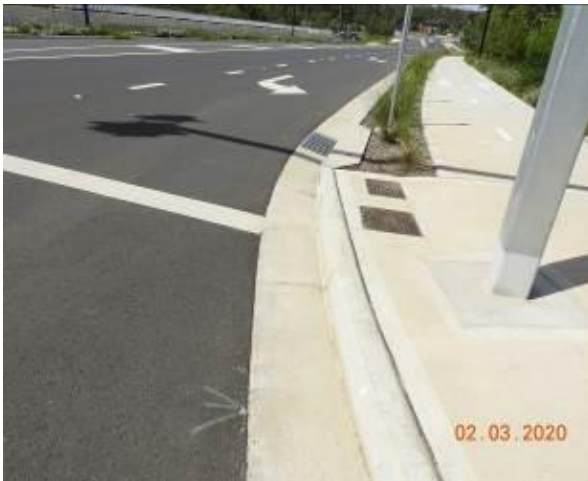
Figure 2197 – General Condition of layback and gutter

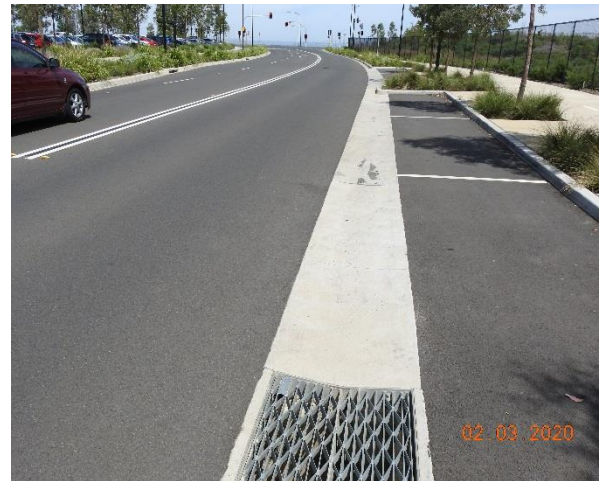
Figure 2198 – General Condition of gutter

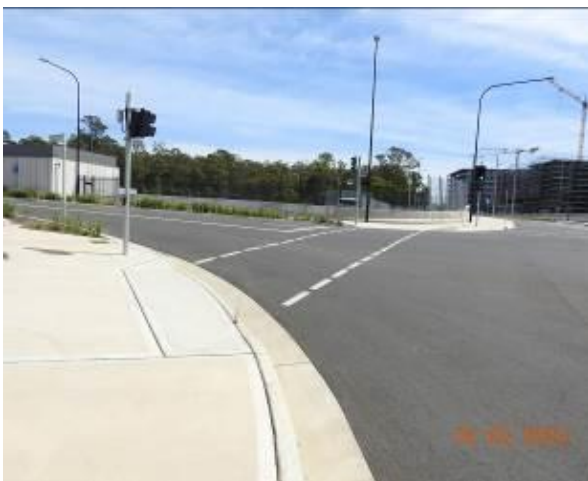
Figure 2199 – General Condition of road surface

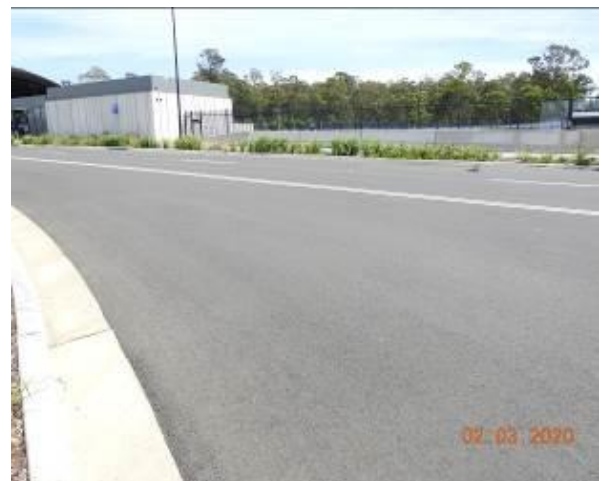
Figure 2200 – General Condition of road surface

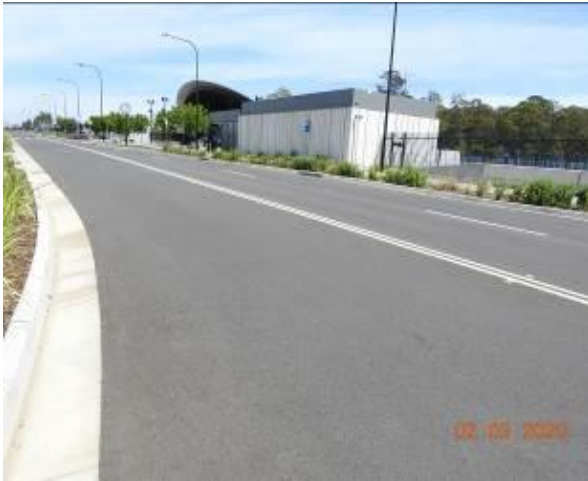
Figure 2201 – General Condition of road surface

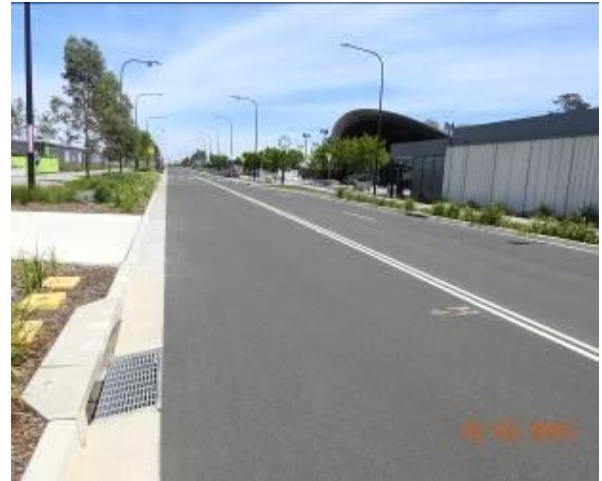
Figure 2202 – General Condition of road surface

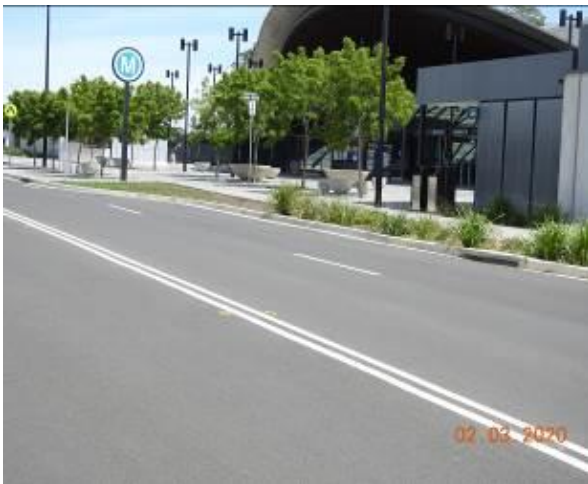
Figure 2203 – General Condition of road surface

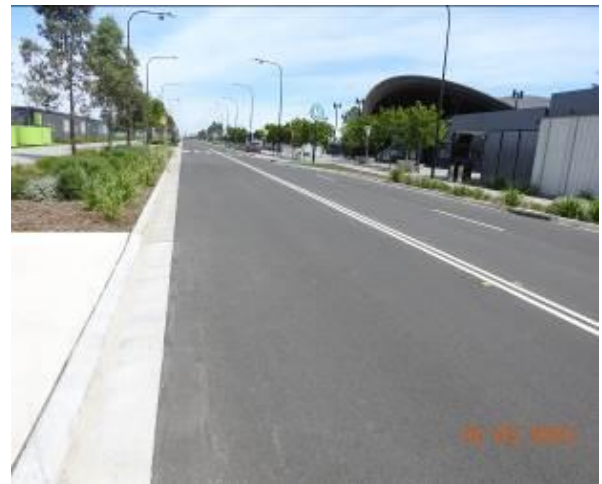
Figure 2204 – General Condition of road surface

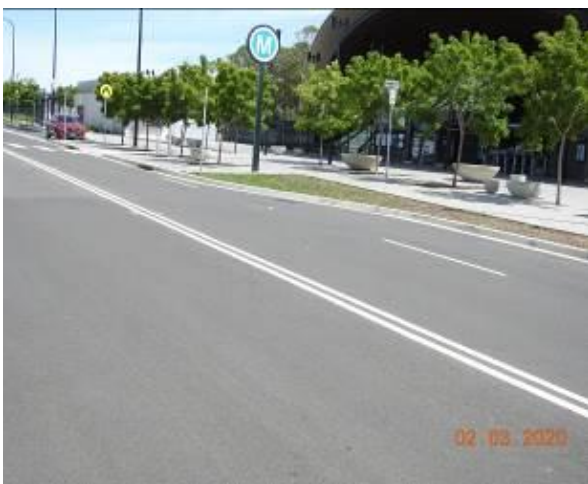
Figure 2205 – General Condition of road surface

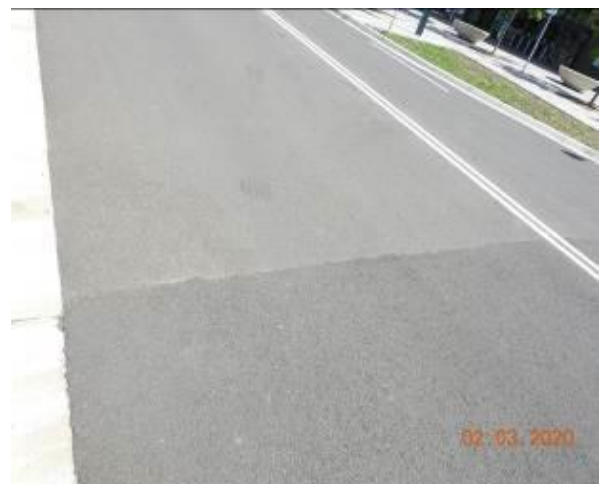
Figure 2206 – General Condition of road surface

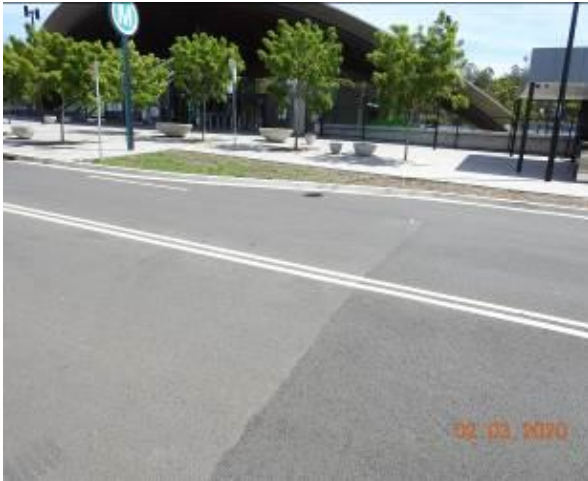
Figure 2207 – General Condition of road surface

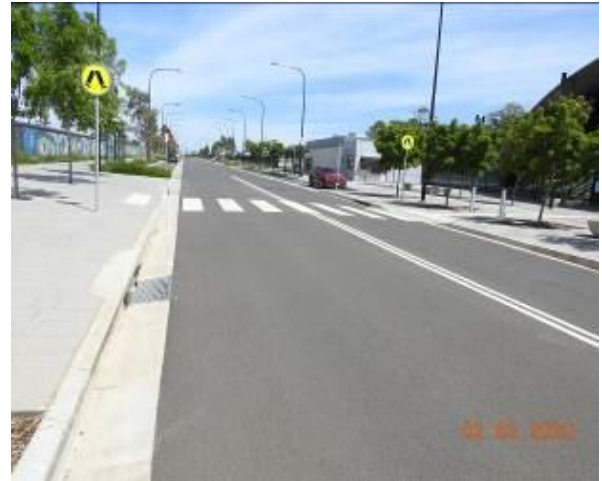
Figure 2208 – General Condition of road surface

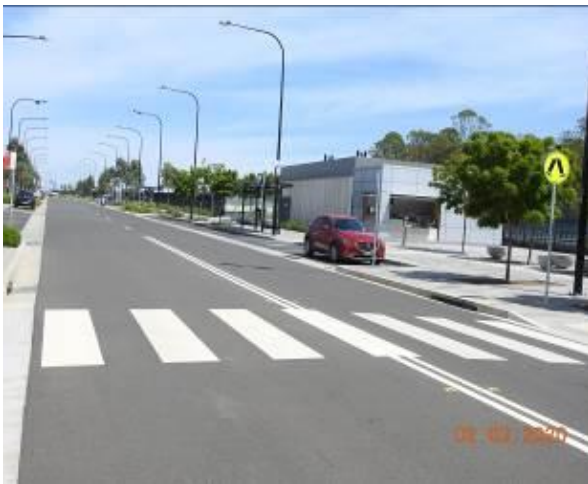
Figure 2209 – General Condition of road surface

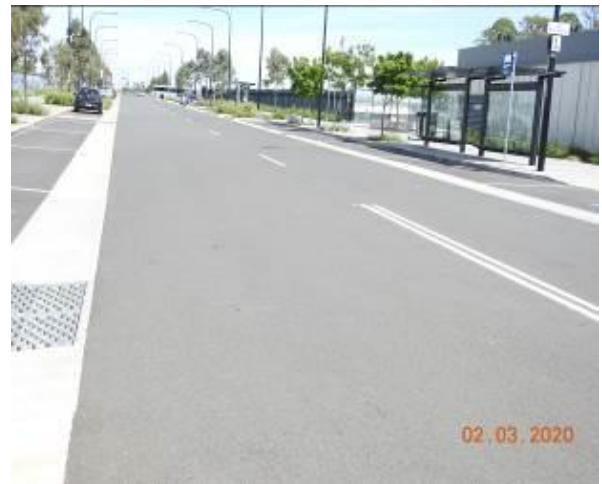
Figure 2210 – General Condition of road surface

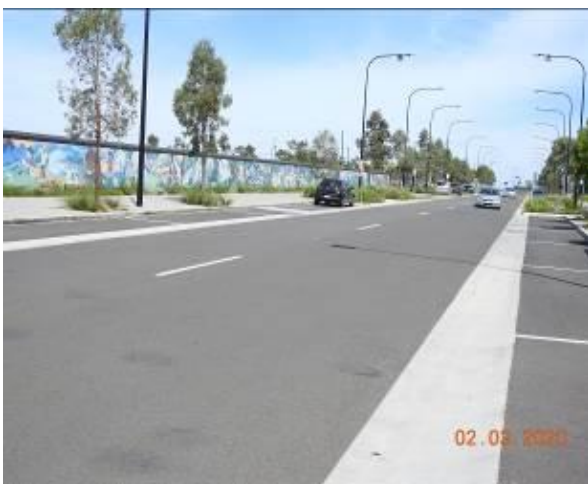
Figure 2211 – General Condition of road surface

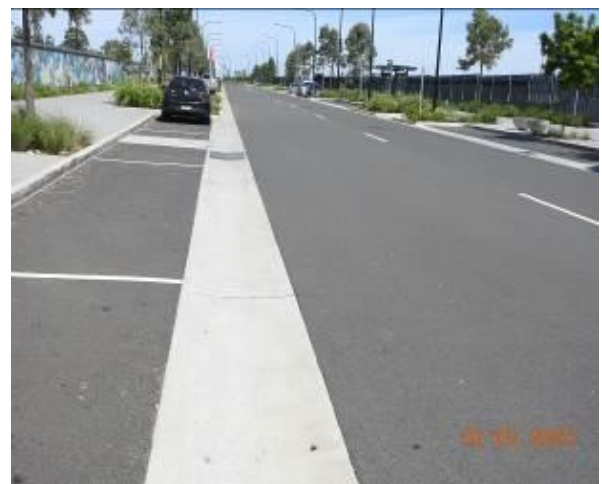
Figure 2212 – General Condition of road surface

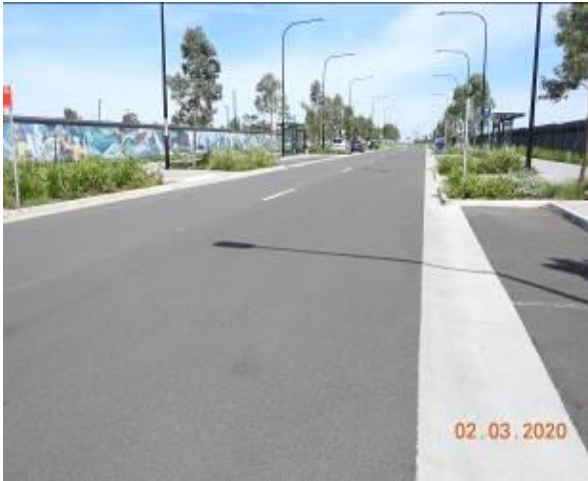
Figure 2213 – General Condition of road surface

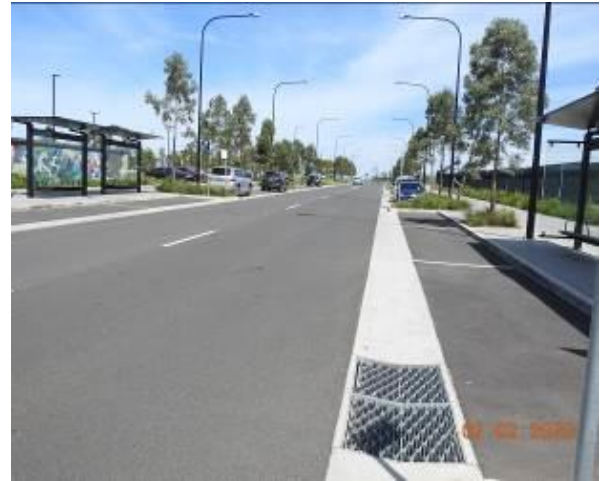
Figure 2214 – General Condition of road surface

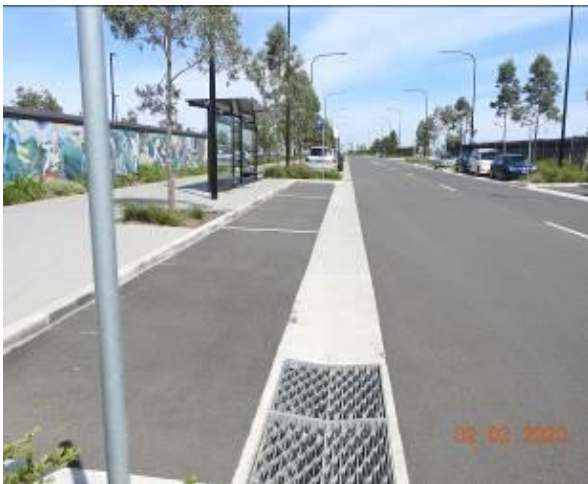
Figure 2215 – General Condition of road surface

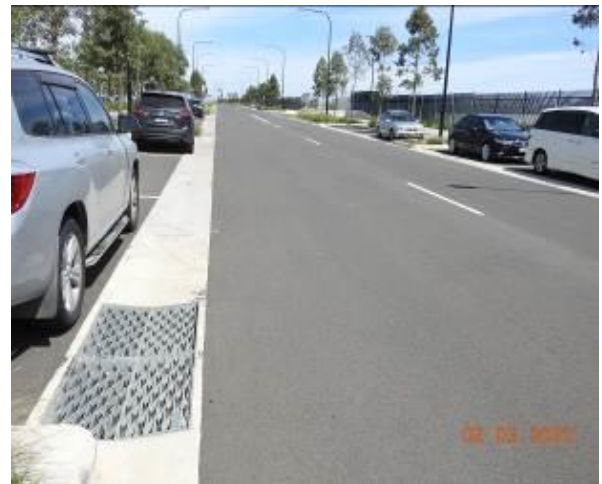
Figure 2216 – General Condition of road surface

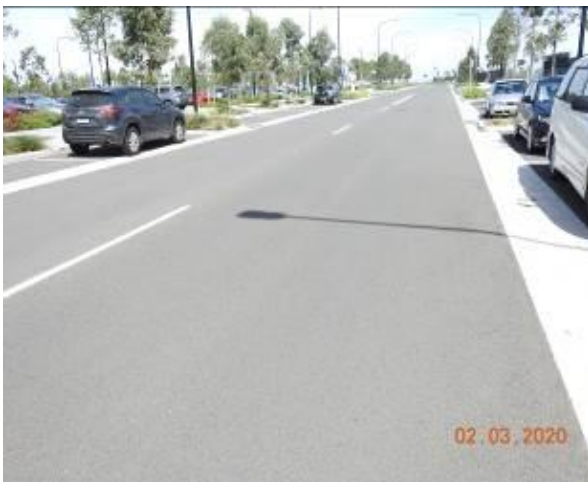
Figure 2217 – General Condition of road surface

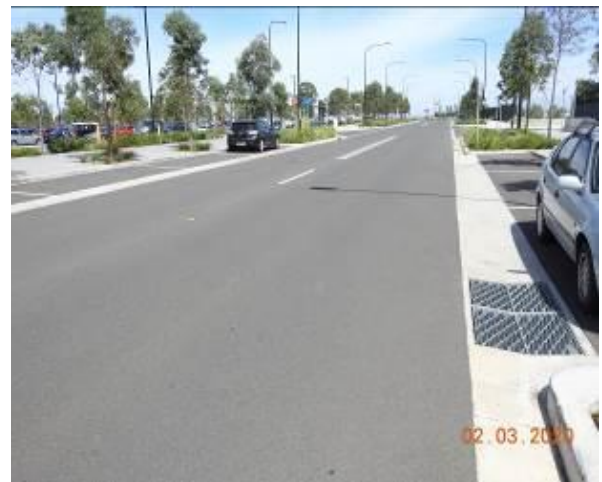
Figure 2218 – General Condition of road surface

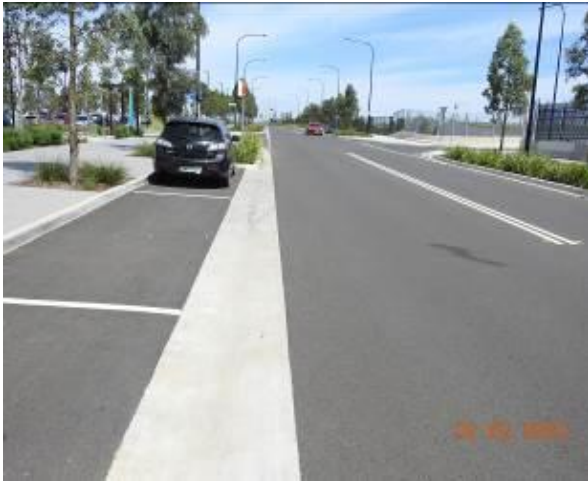
Figure 2219 – General Condition of road surface

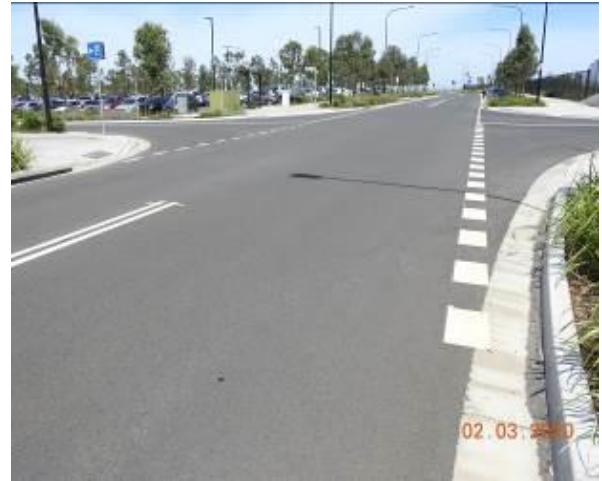
Figure 2220 – General Condition of road surface

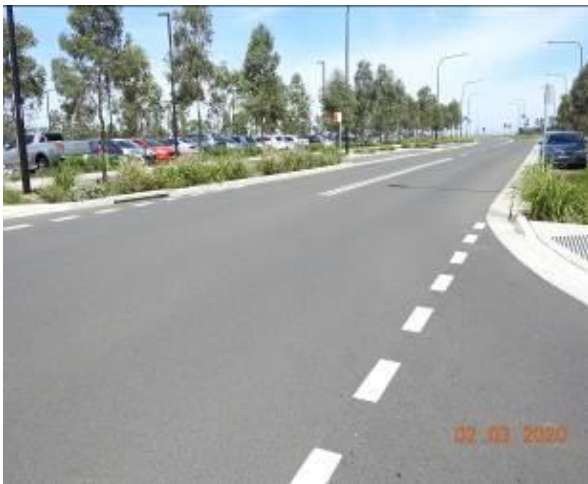
Figure 2221 – General Condition of road surface

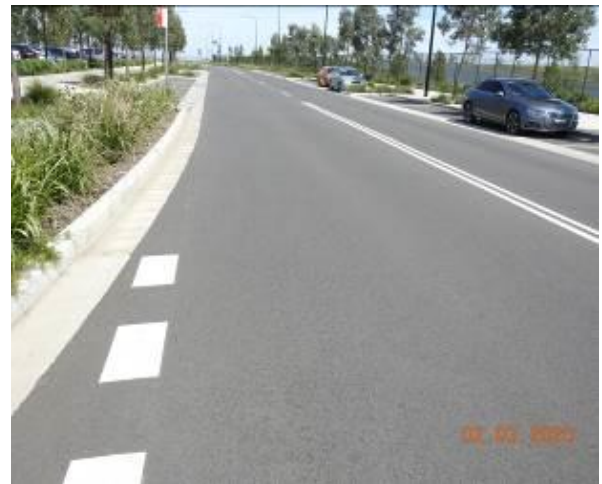
Figure 2222 – General Condition of road surface

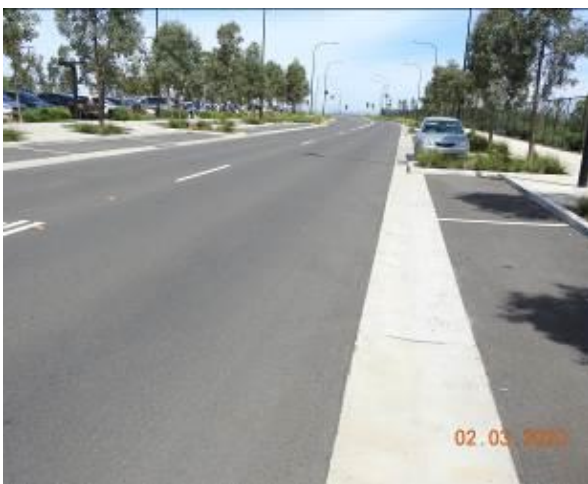
Figure 2223 – General Condition of road surface

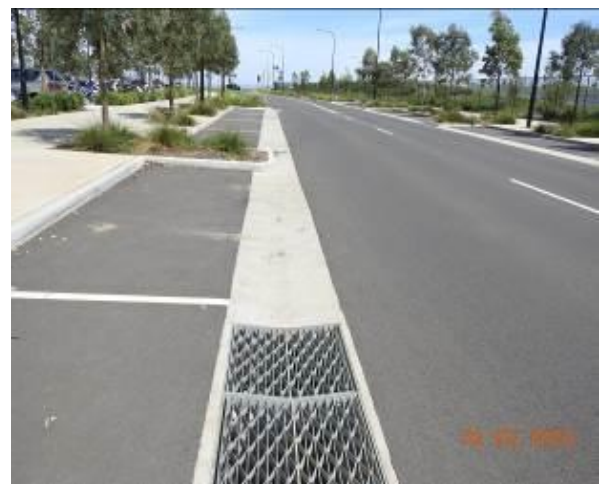
Figure 2224 – General Condition of road surface

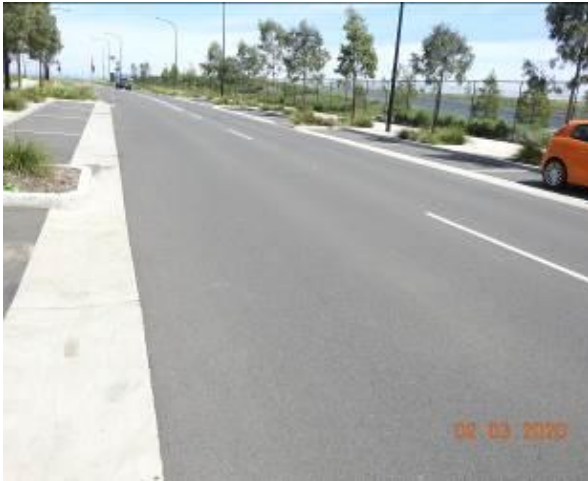
Figure 2225 – General Condition of road surface

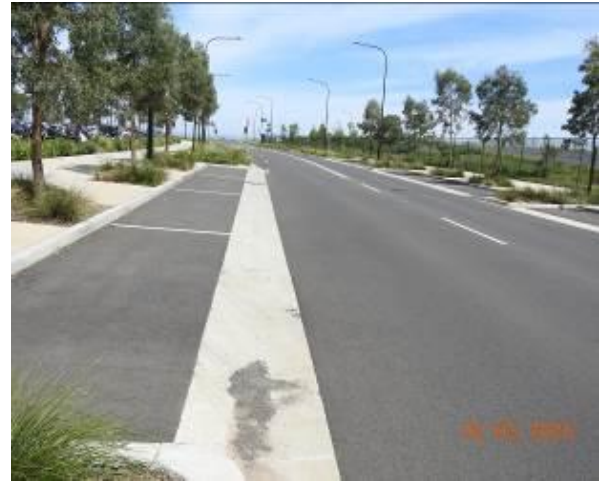
Figure 2226 – General Condition of road surface

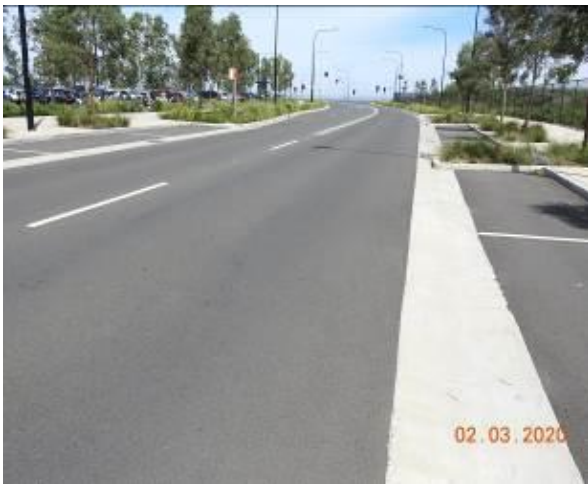
Figure 2227 – General Condition of road surface

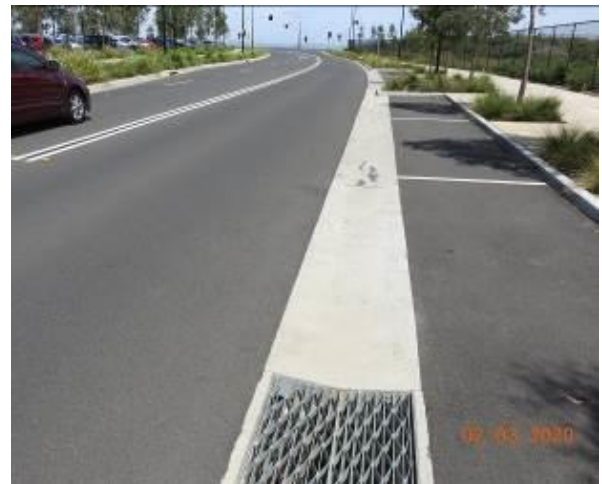
Figure 2228 – General Condition of road surface

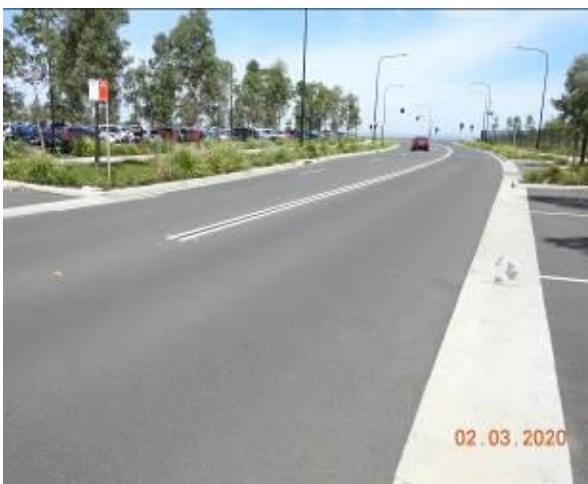
Figure 2229 – General Condition of road surface

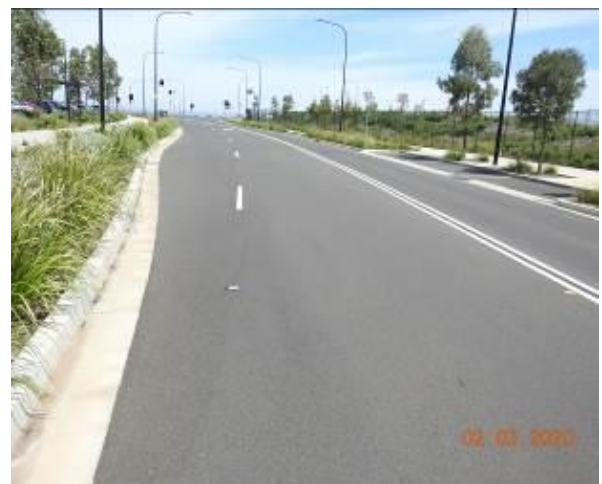
Figure 2230 – General Condition of road surface

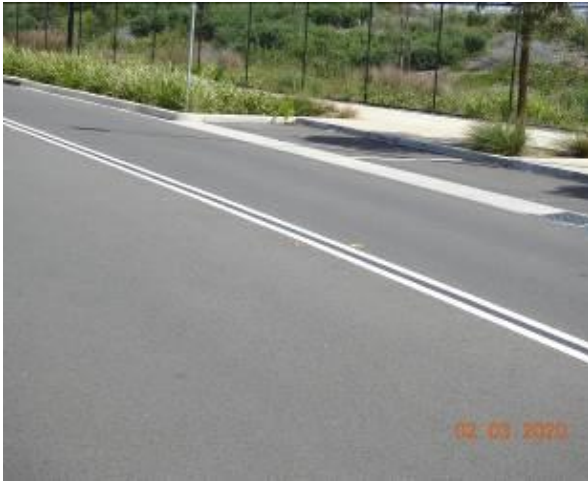
Figure 2231 – General Condition of road surface

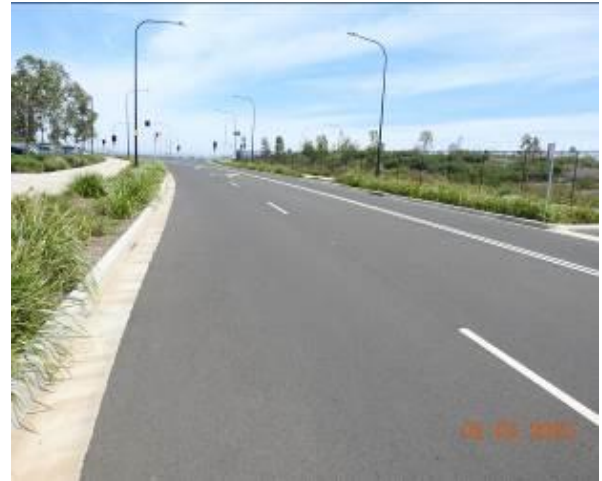
Figure 2232 – General Condition of road surface

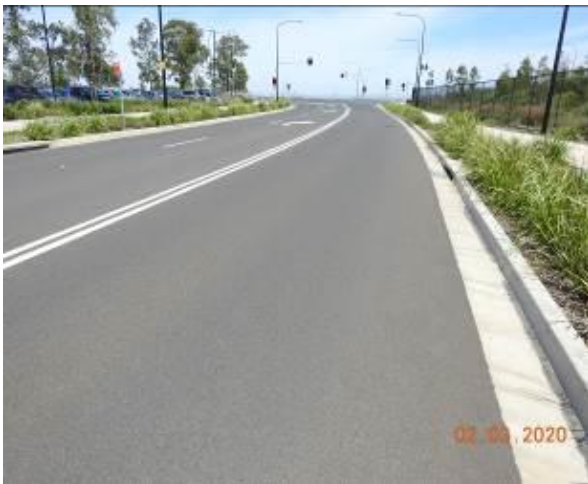
Figure 2233 – General Condition of road surface

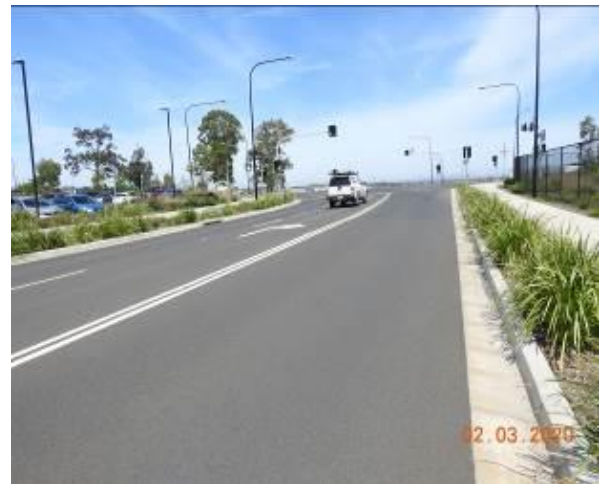
Figure 2234 – General Condition of road surface

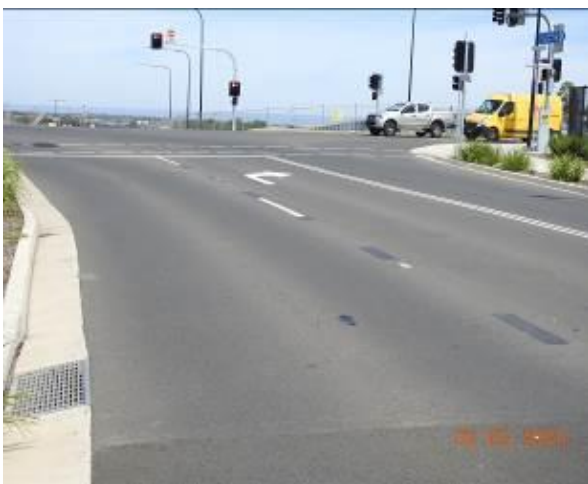
Figure 2235 – General Condition of road surface

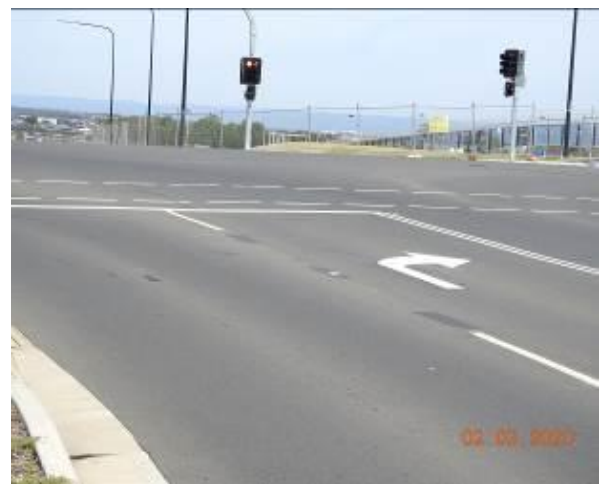
Figure 2236 – General Condition of road surface

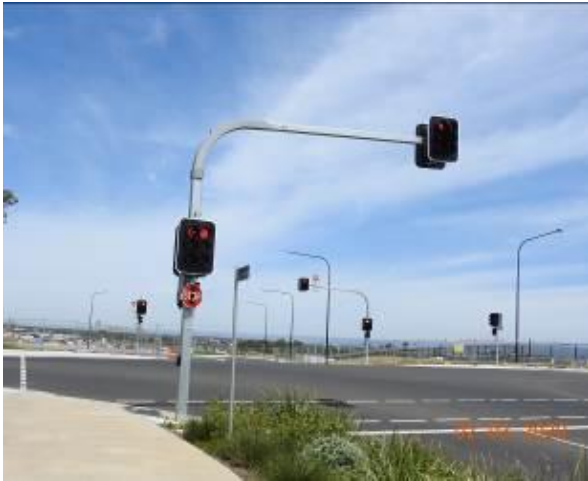
Figure 2237 – General Condition of street sign / traffic light

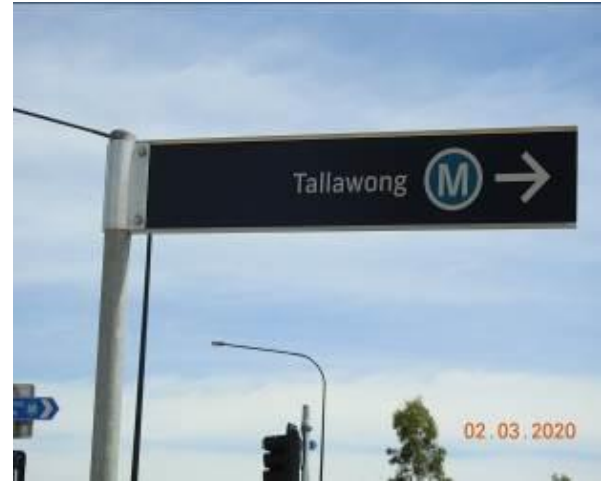
Figure 2238 – General Condition of street sign

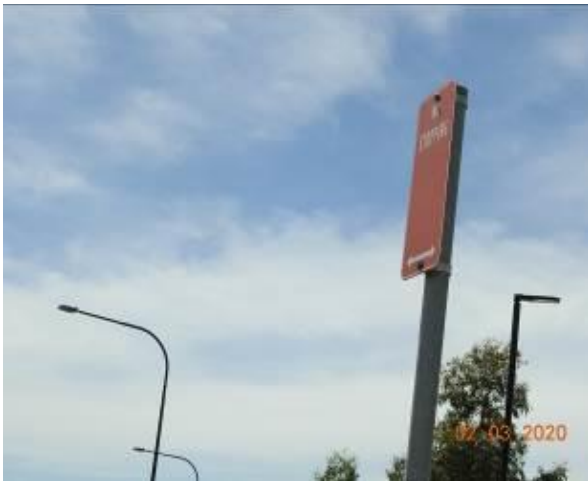
Figure 2239 – General Condition of street sign

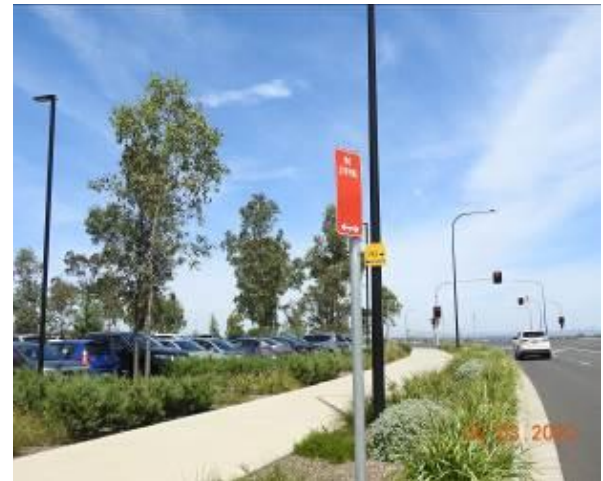
Figure 2240 – General Condition of street sign

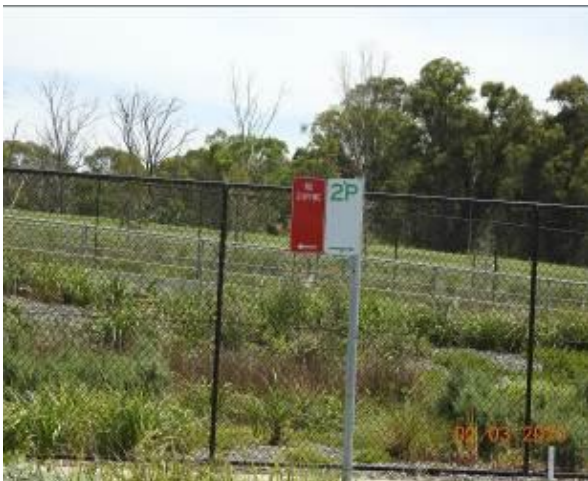
Figure 2241 – General Condition of street sign

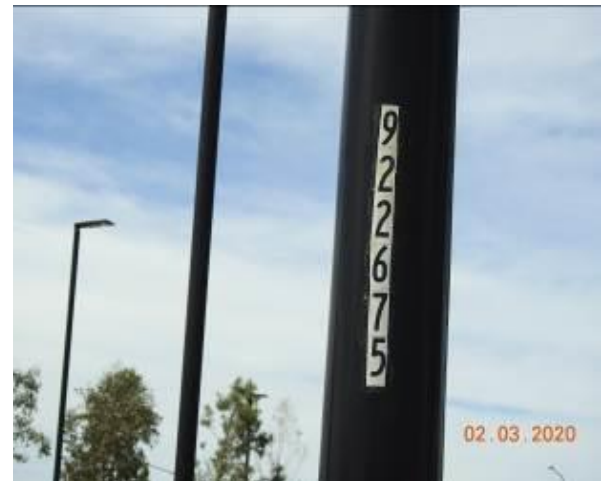
Figure 2242 – General Condition of lamp post
Identification No.922675

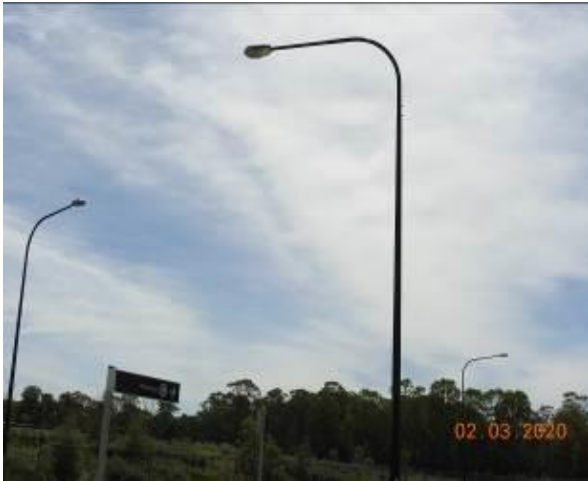
Figure 2243 – General Condition of lamp post

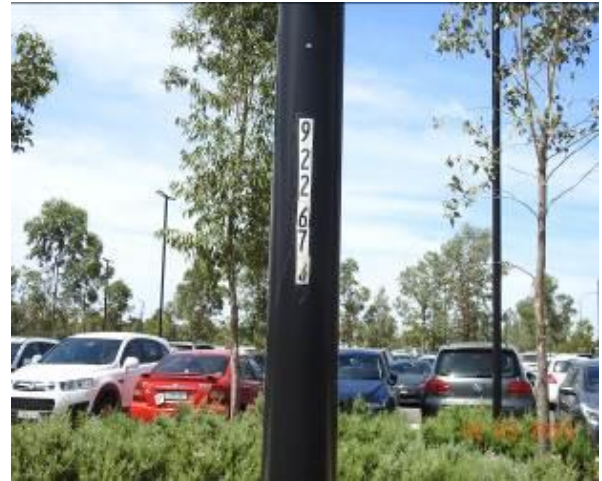
Figure 2244 – General Condition of lamp post
Identification No.922678

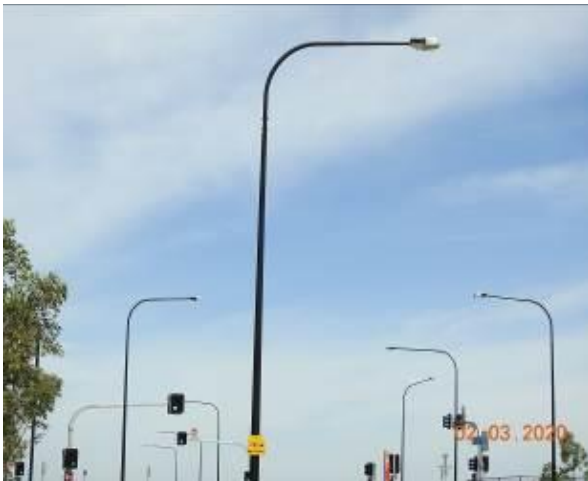
Figure 2245 – General Condition of lamp post

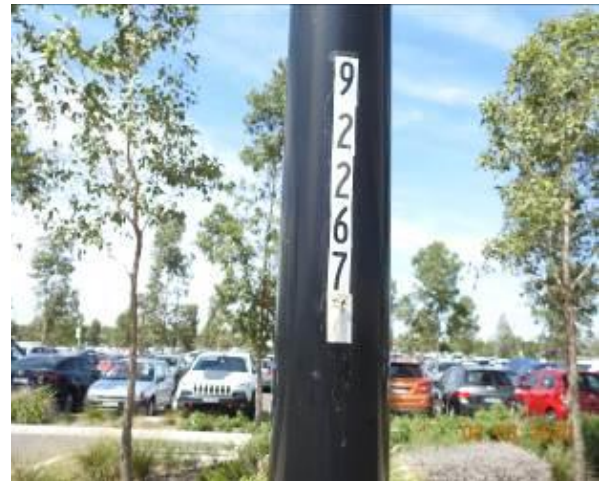
Figure 2246 – General Condition of lamp post
Identification No.922677

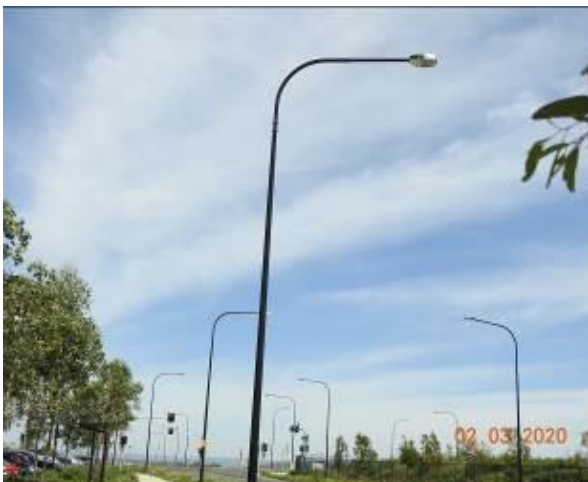
Figure 2247 – General Condition of lamp post

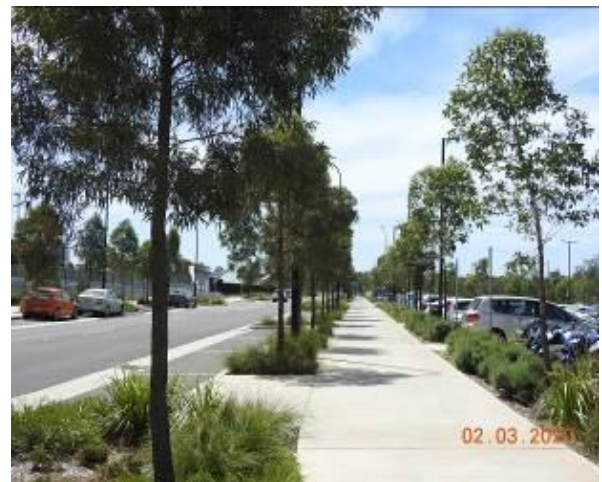
Figure 2248 – General Condition of plantation

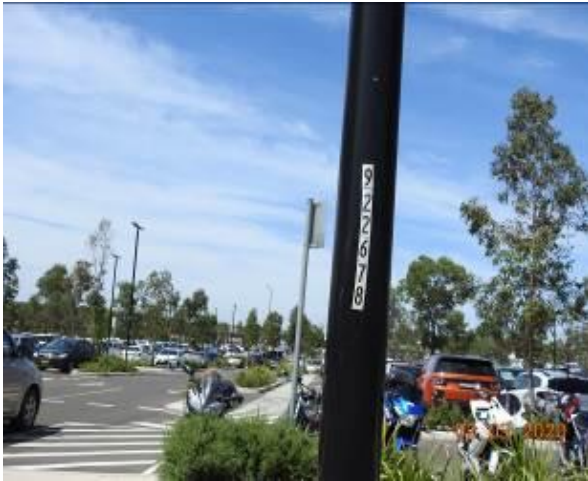
Figure 2249 – General Condition of lamp post
Identification No.922678

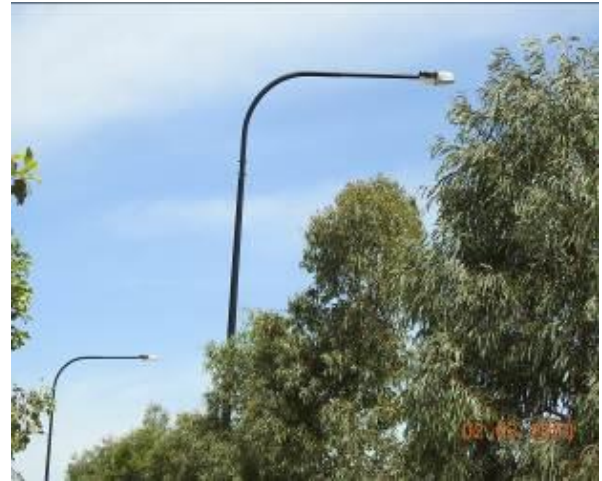
Figure 2250 – General Condition of lamp post

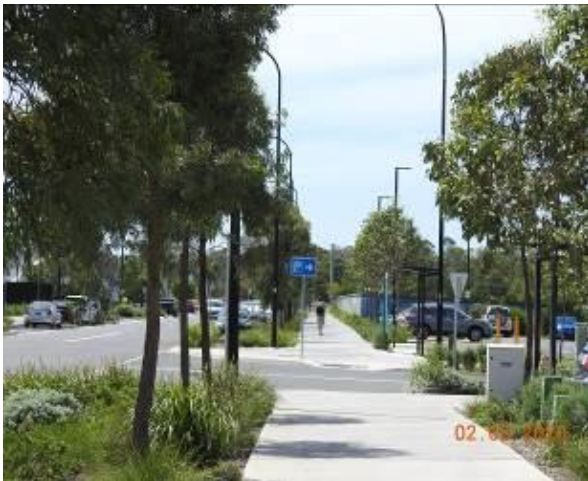
Figure 2251 – General Condition of street sign /
plantation

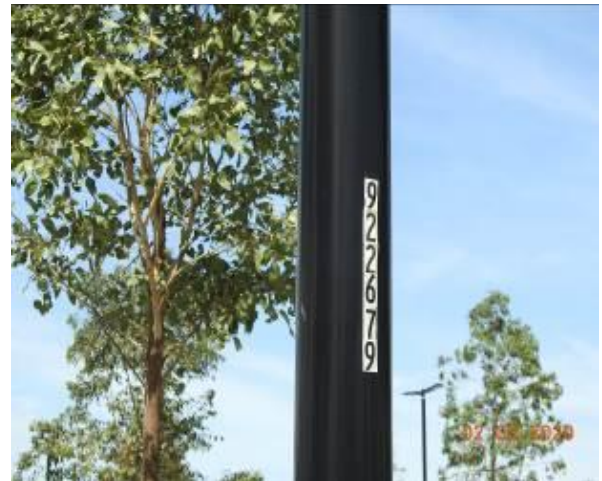
Figure 2252 – General Condition of lamp post
Identification No.922679
