**1-15 AND 2-12 CONFERTA AVENUE,
ROUSE HILL NSW 2155
TALLAWONG STATION PRECINCT SOUTH
PRE-DILAPIDATION REPORT**

**DEICORP PROJECTS
(TALLAWONG STATION) PTY LTD**

Job No. 191294.0
24/03/2020

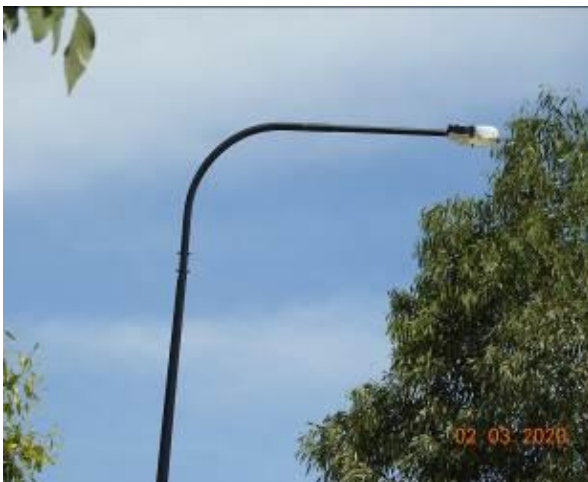
Figure 2253 – General Condition of lamp post

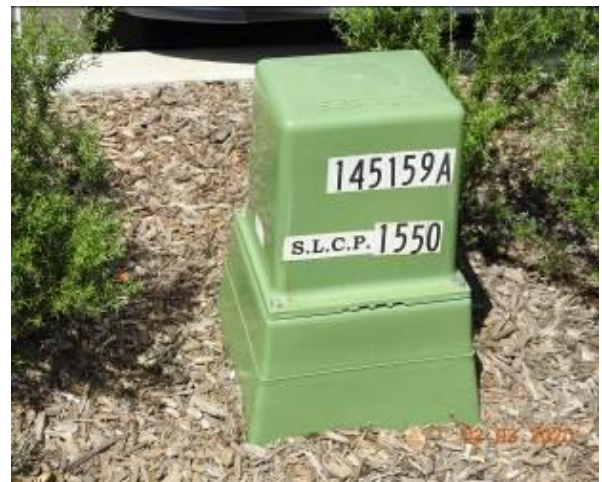
Figure 2254 – General Condition of electricity box
Identification No.145159A / S.L.C.P.1550

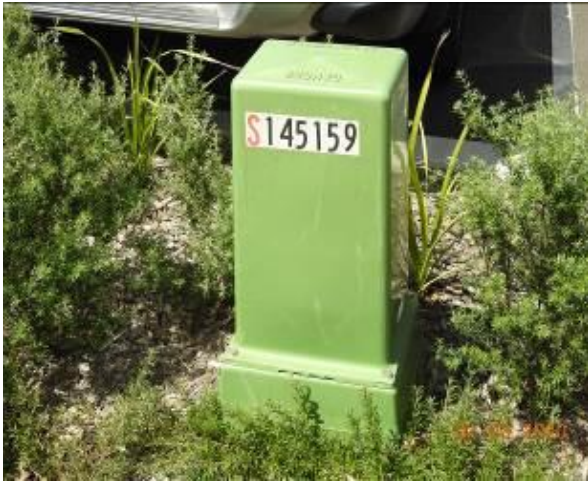
Figure 2255 – General Condition of electricity box
Identification No. S145159

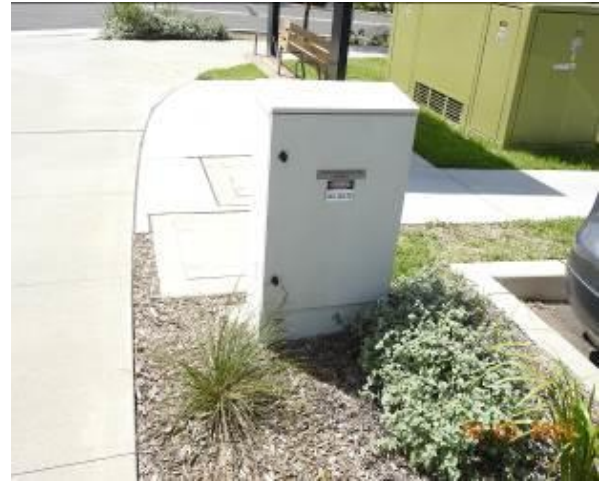
Figure 2256 – General Condition of electricity box

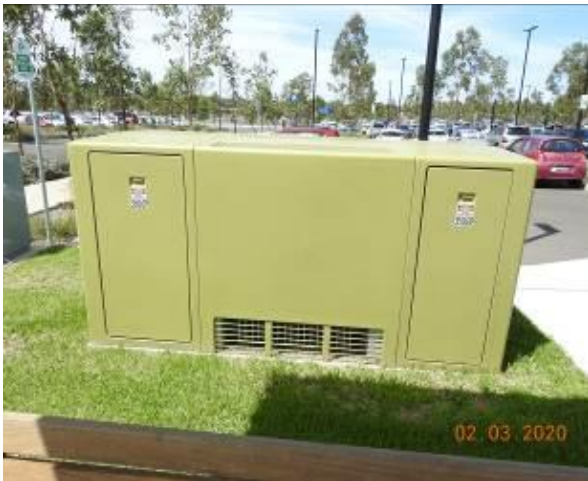
Figure 2257 – General Condition of electricity sub-
station Identification No. 35069

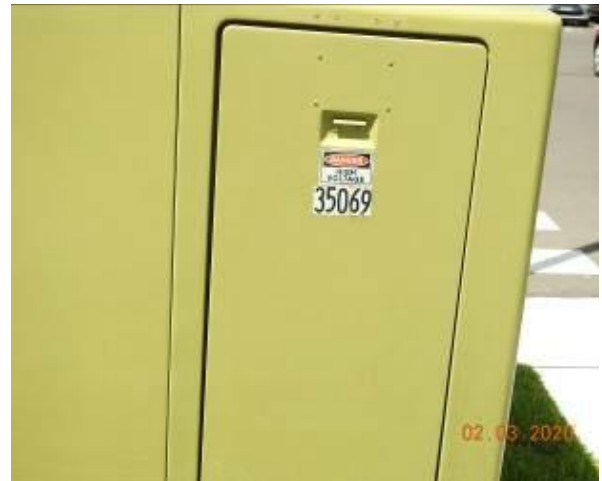
Figure 2258 – General Condition of electricity sub-
station Identification No. 35069

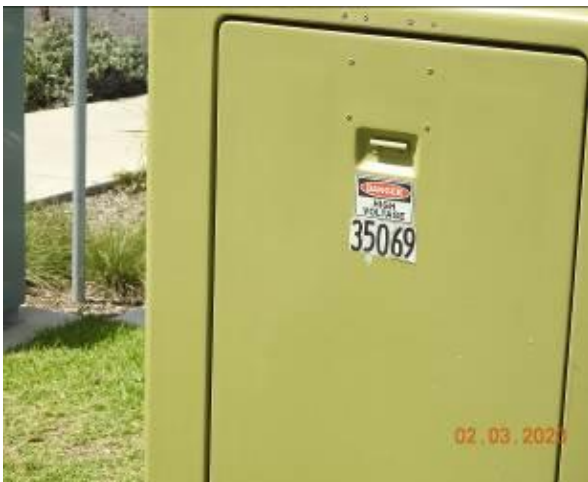
Figure 2259 – General Condition of electricity sub-
station Identification No. 35069

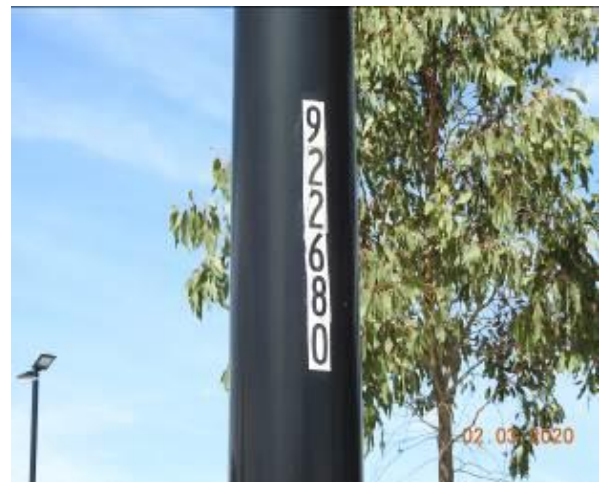
Figure 2260 – General Condition of lamp post
Identification No. 922680

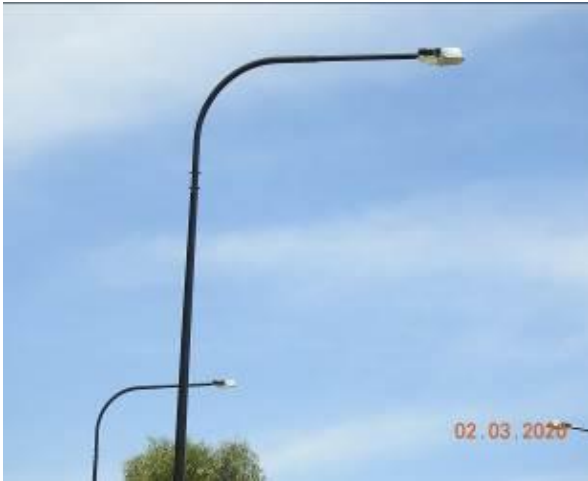
Figure 2261 – General Condition of lamp post

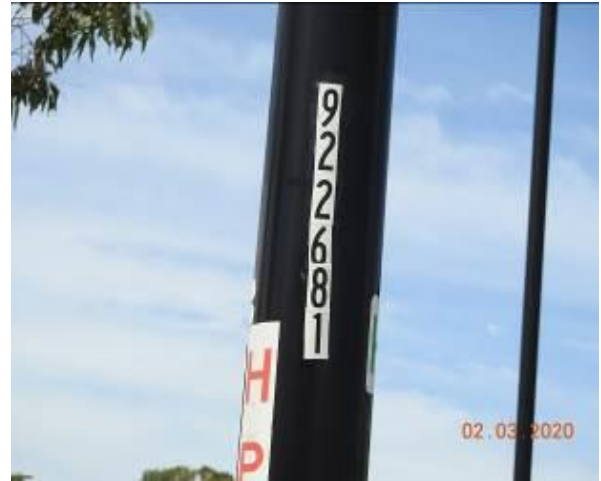
Figure 2262 – General Condition of lamp post
Identification No. 922681

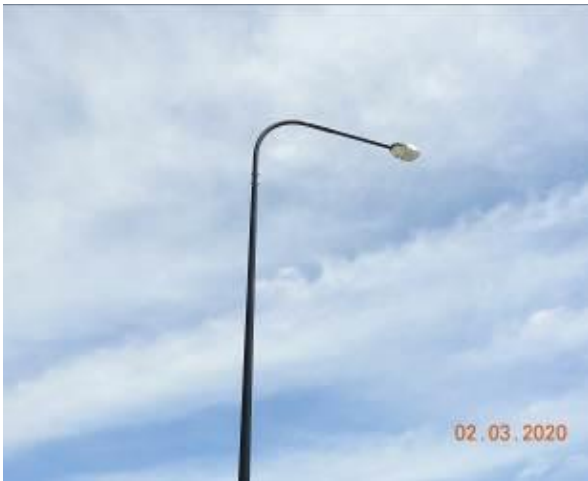
Figure 2263 – General Condition of lamp post

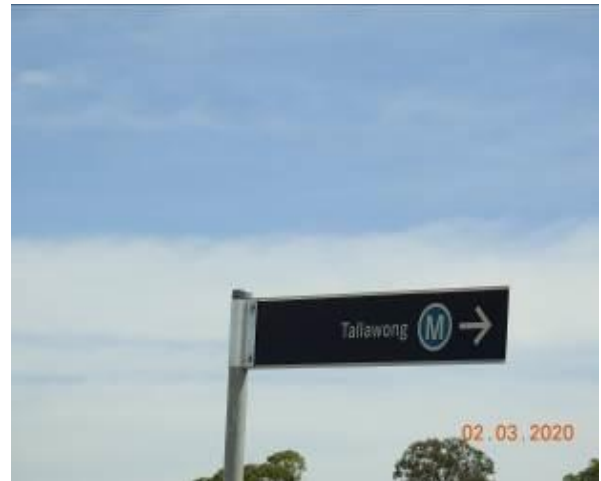
Figure 2264 – General Condition of street sign

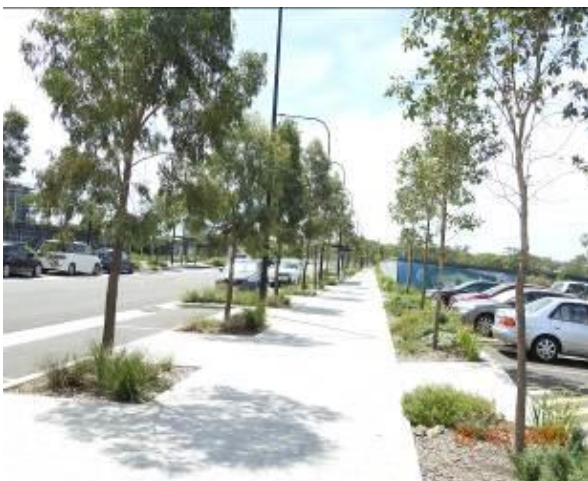
Figure 2265 – General Condition of plantation

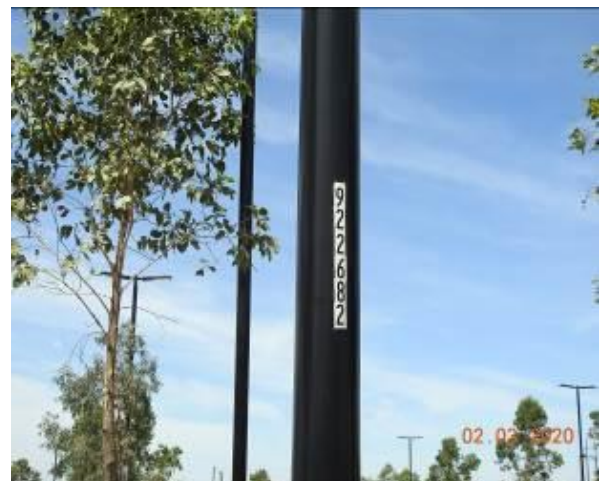
Figure 2266 – General Condition of lamp post
Identification No. 922682

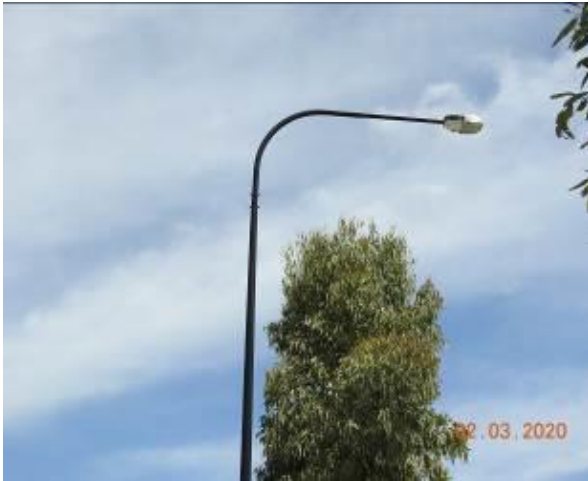
Figure 2267 – General Condition of lamp post

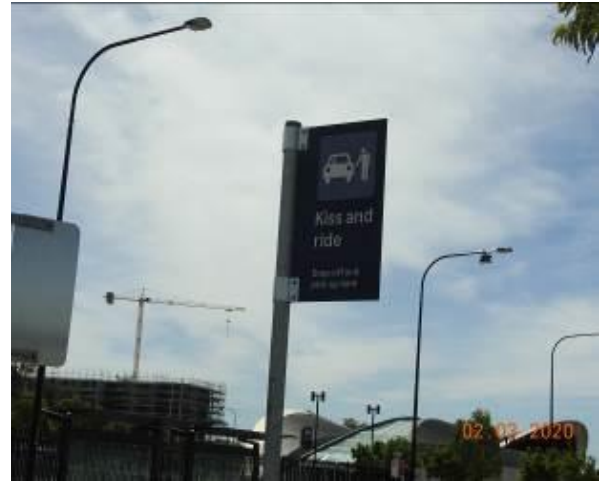
Figure 2268 – General Condition of street sign

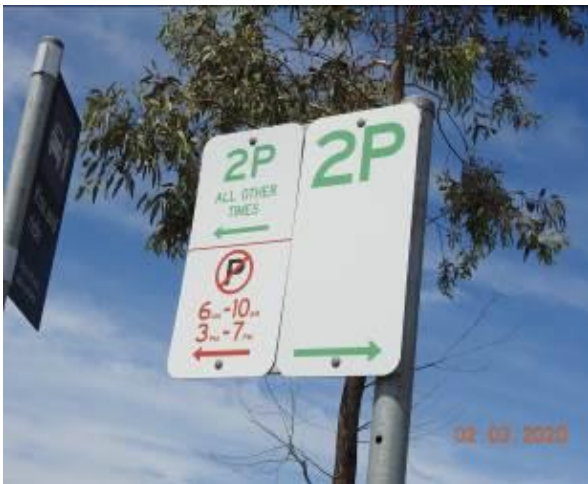
Figure 2269 – General Condition of street sign

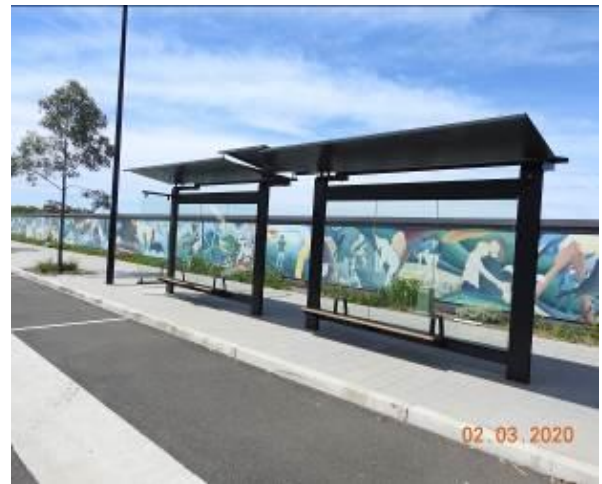
Figure 2270 – General Condition of bus stop public bench

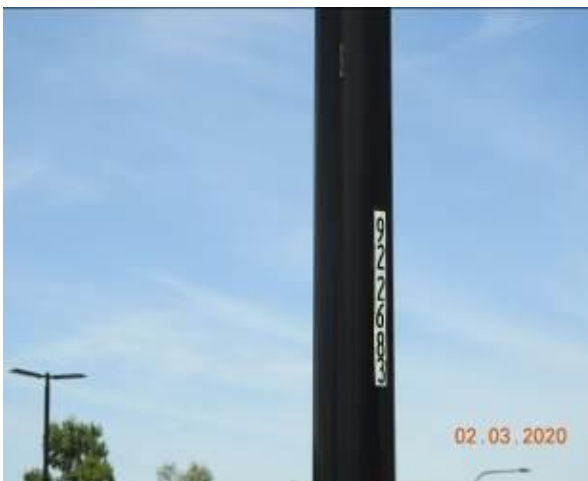
Figure 2271 – General Condition of lamp post
Identification No. 922683

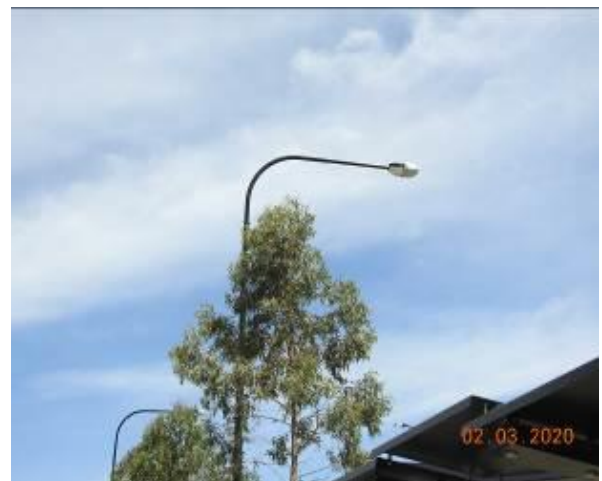
Figure 2272 – General Condition of lamp post

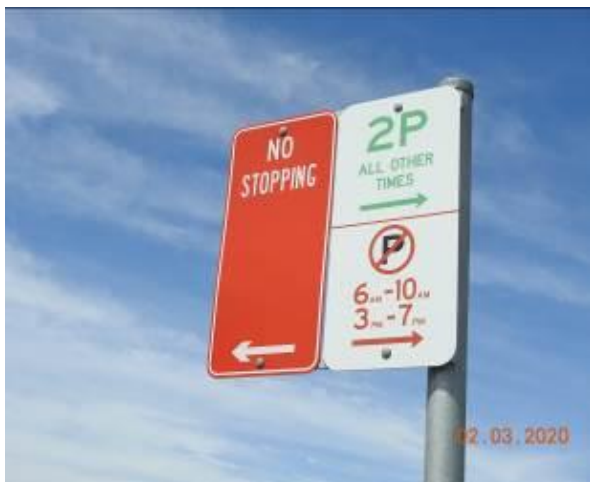
Figure 2273 – General Condition of street sign

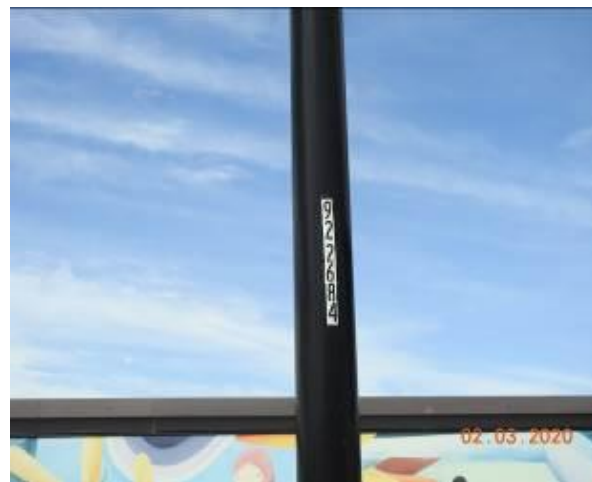
Figure 2274 – General Condition of lamp post
Identification No. 922684

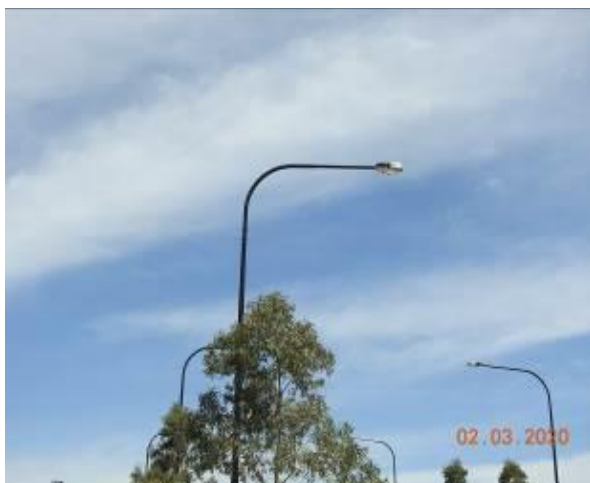
Figure 2275 – General Condition of lamp post

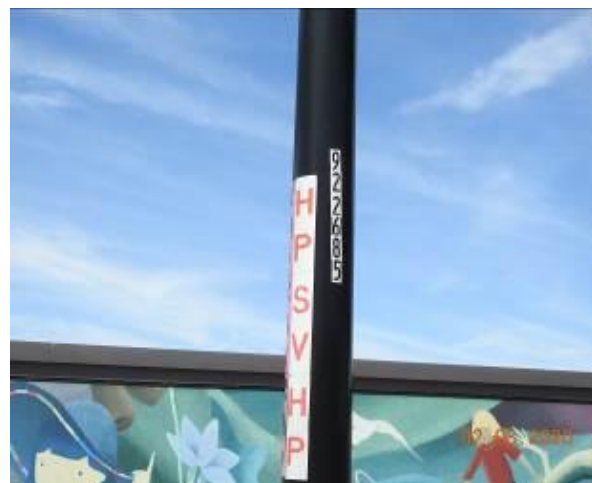
Figure 2276 – General Condition of lamp post
Identification No. 922685

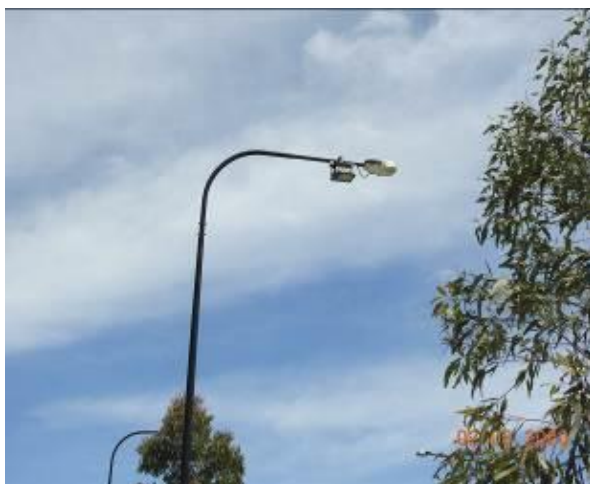
Figure 2277 – General Condition of lamp post

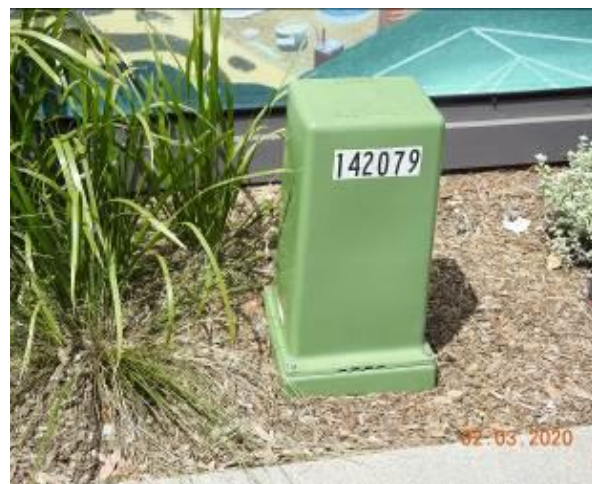
Figure 2278 – General Condition of electricity box
Identification No. 142079

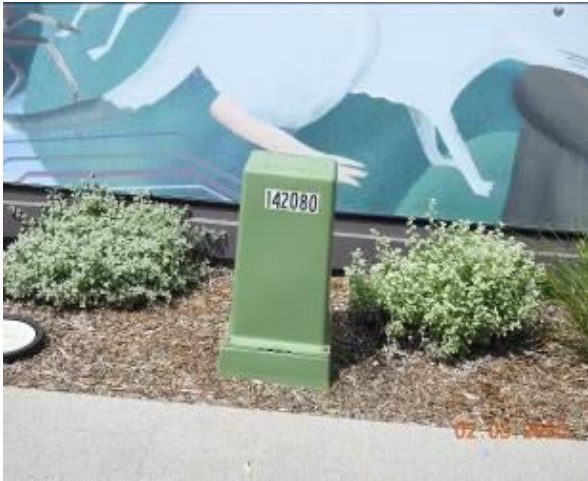
Figure 2279 – General Condition of electricity box
Identification No. 142079

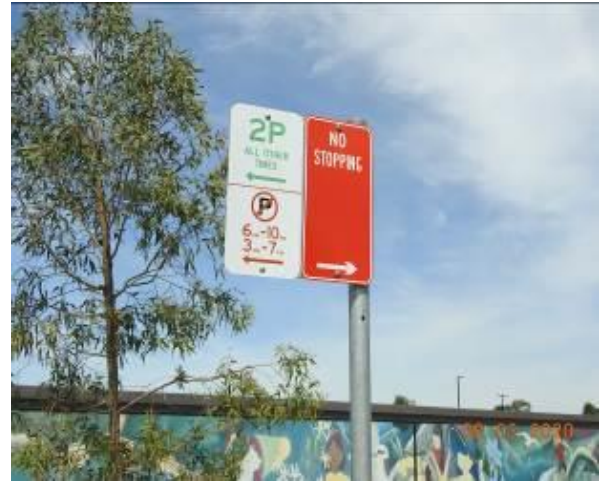
Figure 2280 – General Condition of street sign

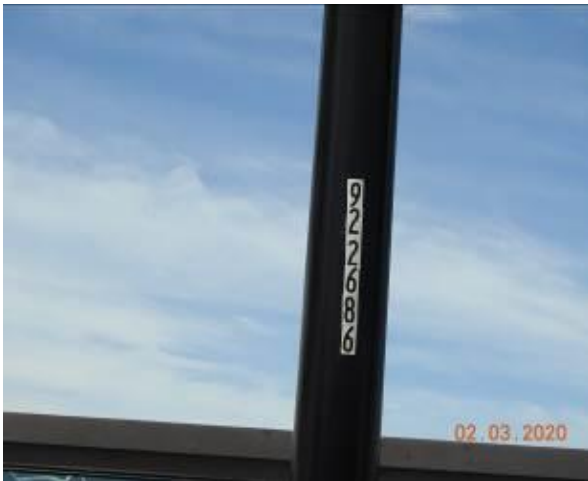
Figure 2281 – General Condition of lamp post
Identification No. 922686

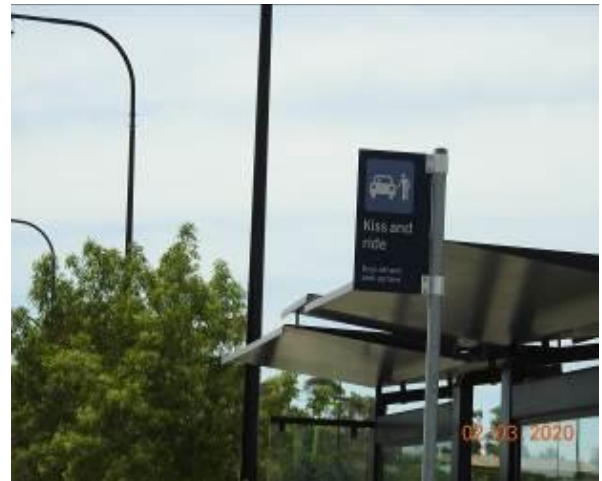
Figure 2282 – General Condition of street sign

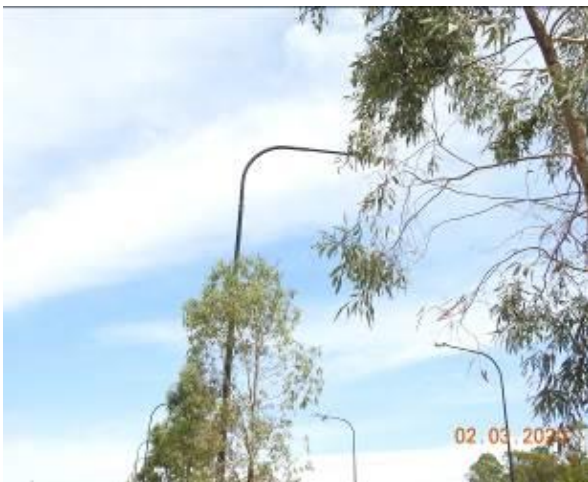
Figure 2283 – General Condition of lamp post

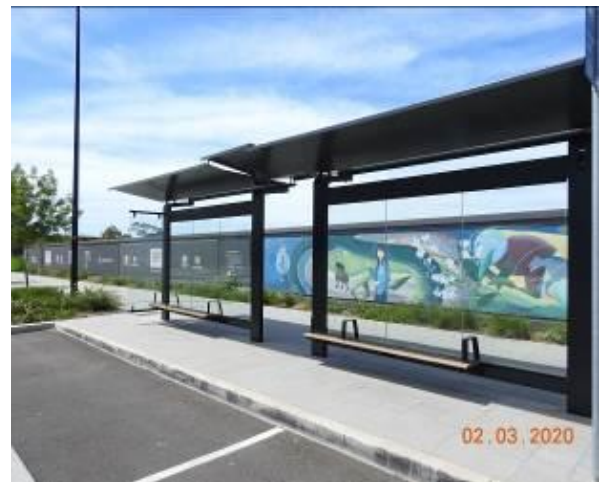
Figure 2284 – General Condition of bus stop public bench

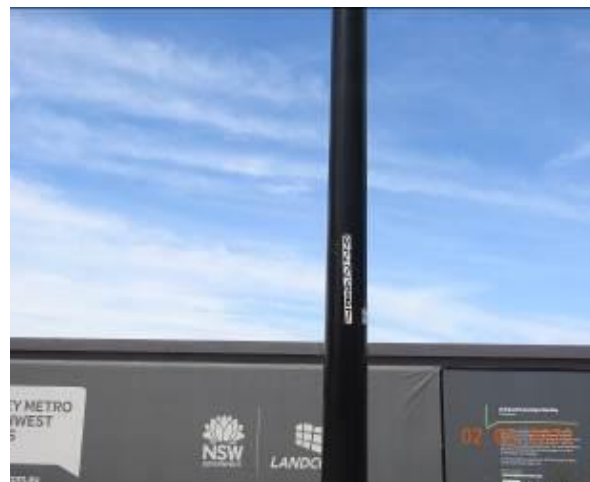
Figure 2286 – General Condition of lamp post
Identification No. 922687

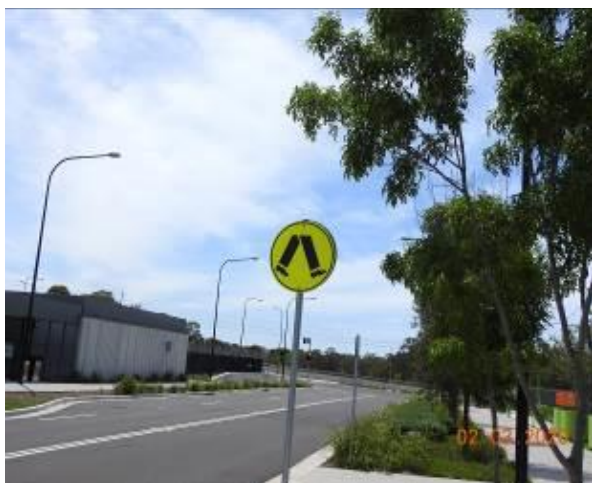
Figure 2287 – General Condition of street sign

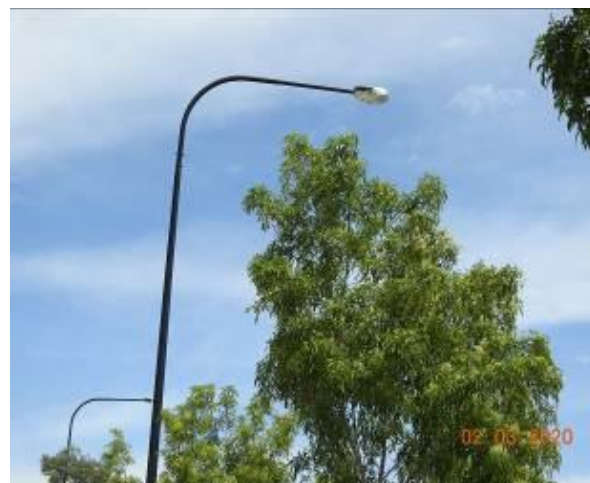
Figure 2288 – General Condition of lamp post

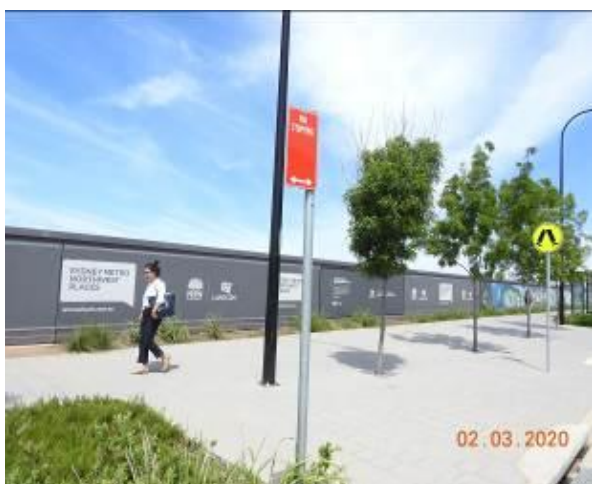
Figure 2289 – General Condition of street sign

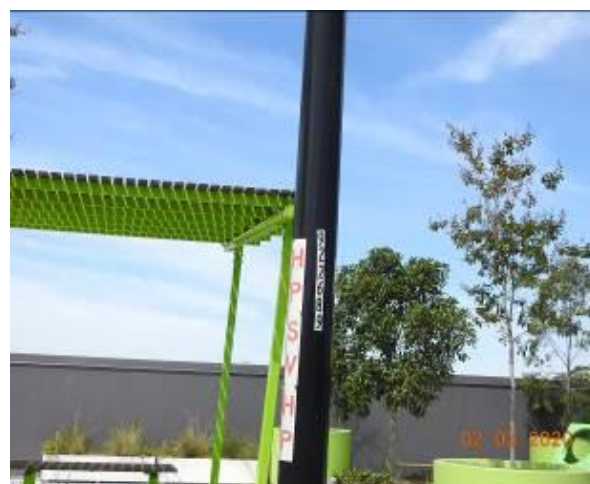
Figure 2290 – General Condition of lamp post
Identification No. 922689

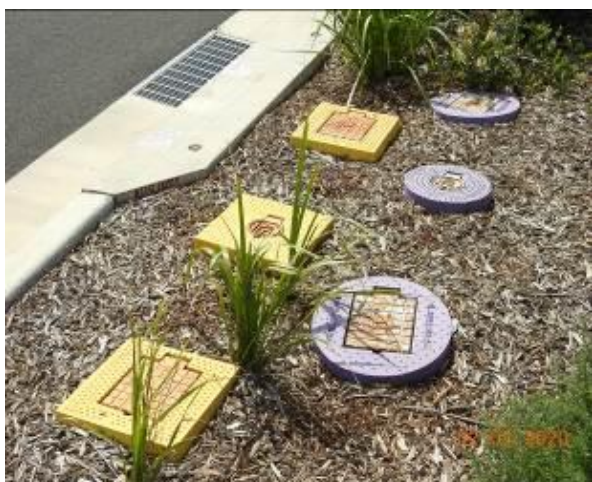
Figure 2291 – General Condition of service pit

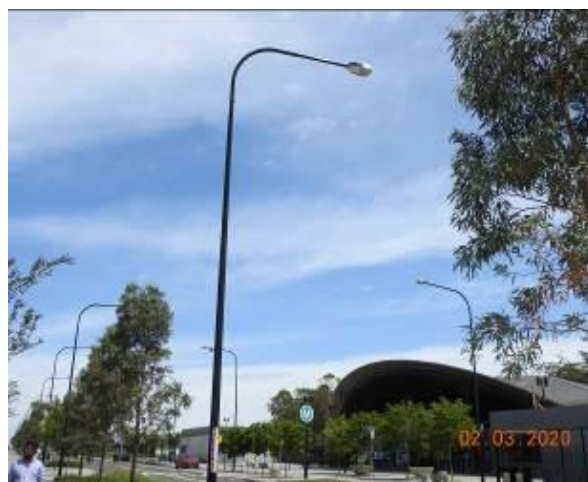
Figure 2292 – General Condition of lamp post

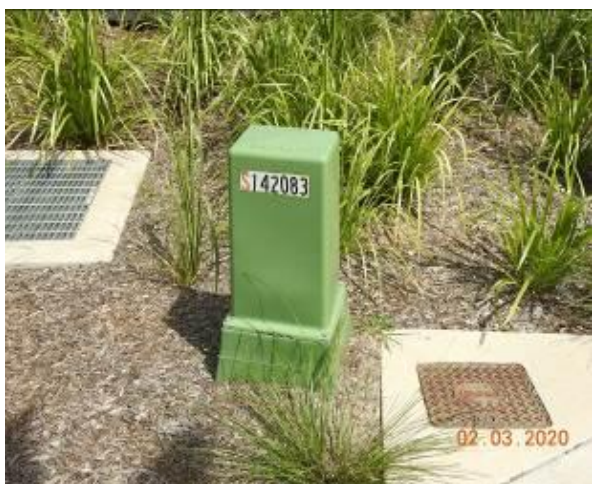
Figure 2293 – General Condition of electricity box
Identification No. 142083

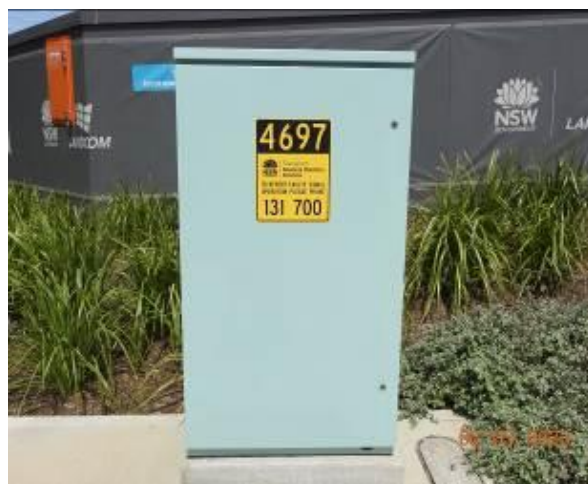
Figure 2294 – General Condition of electricity box
Identification No. 4697

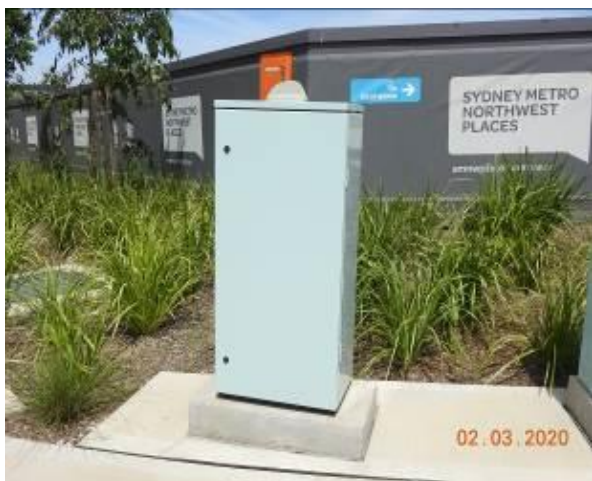
Figure 2295 – General Condition of electricity box

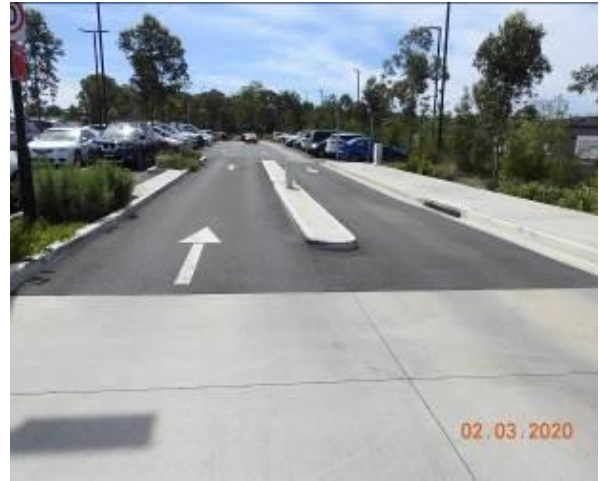
Figure 2297 – General Condition of driveway pavement

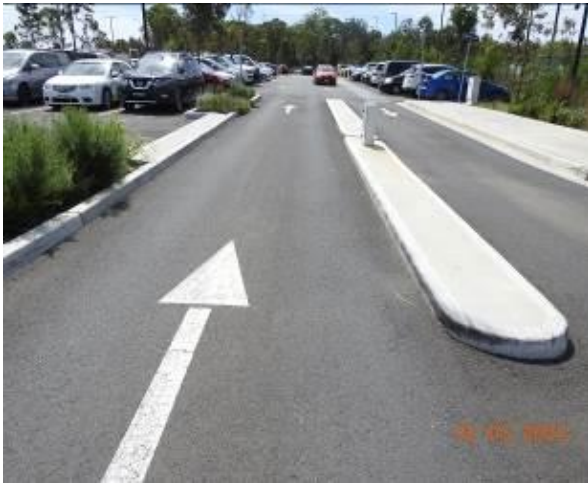
Figure 2298 – General Condition of carpark pavement

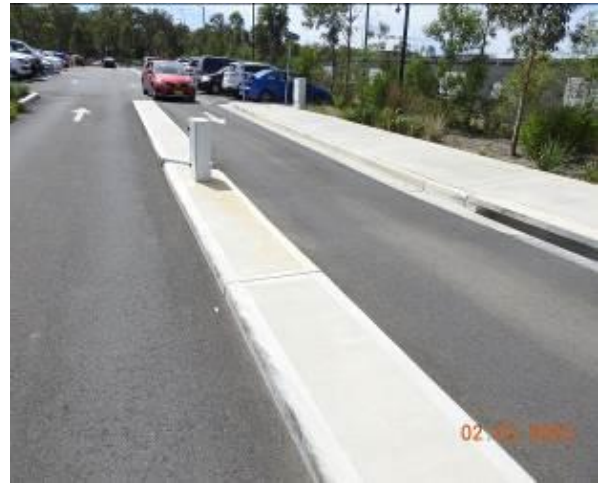
Figure 2299 – General Condition of carpark pavement

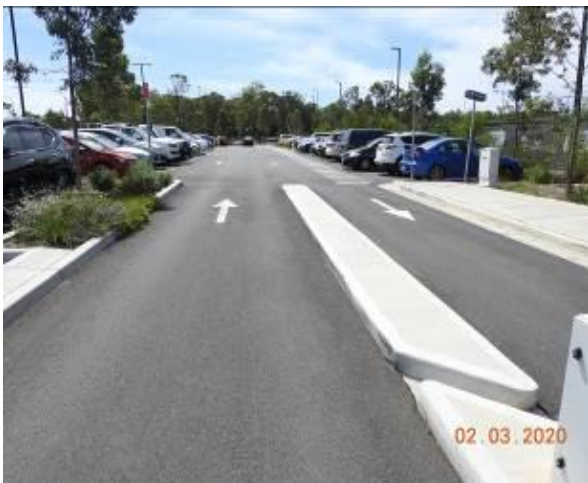
Figure 2300 – General Condition of carpark pavement

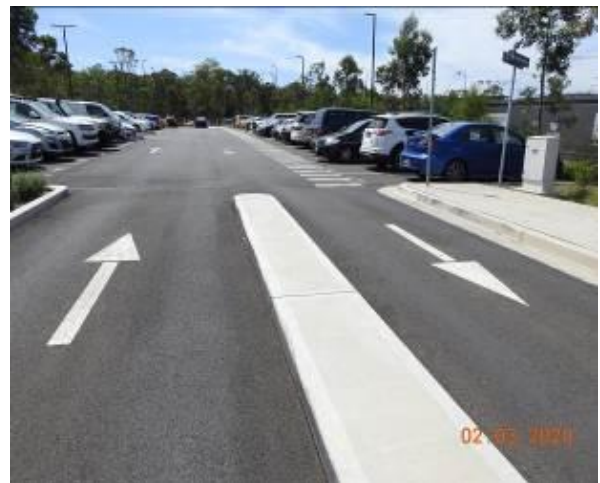
Figure 2301 – General Condition of carpark pavement

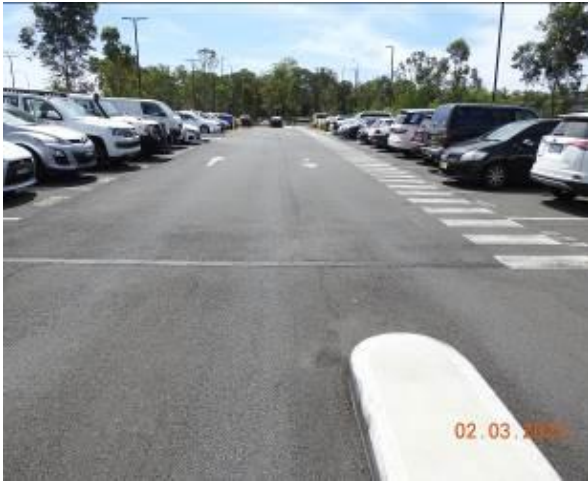
Figure 2302 – General Condition of carpark pavement

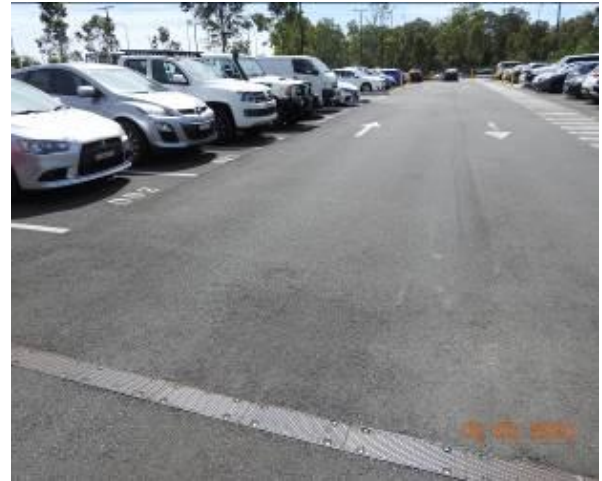
Figure 2303 – General Condition of carpark pavement

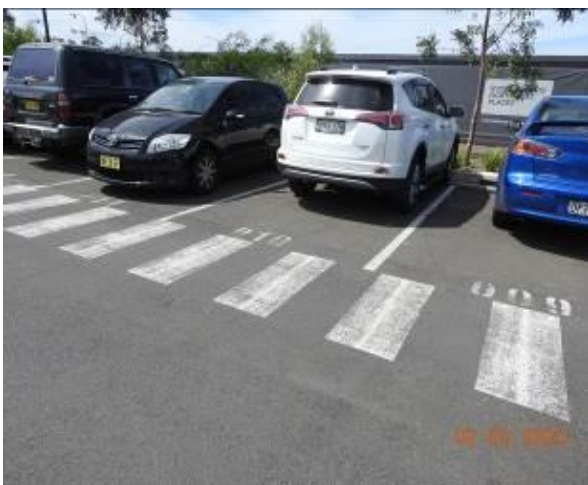
Figure 2304 – General Condition of carpark pavement

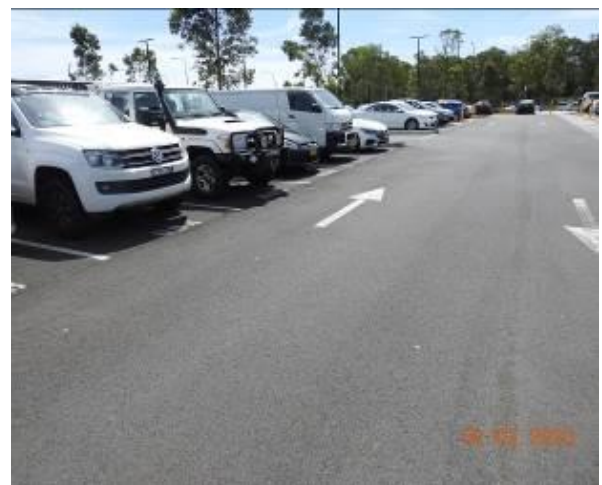
Figure 2305 – General Condition of carpark pavement

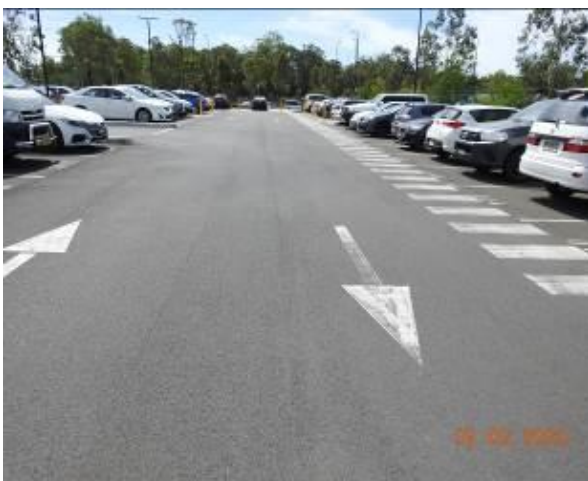
Figure 2306 – General Condition of carpark pavement

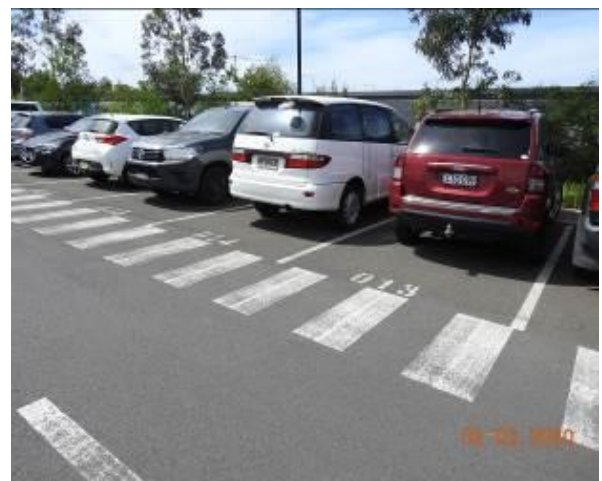
Figure 2307 – General Condition of carpark pavement

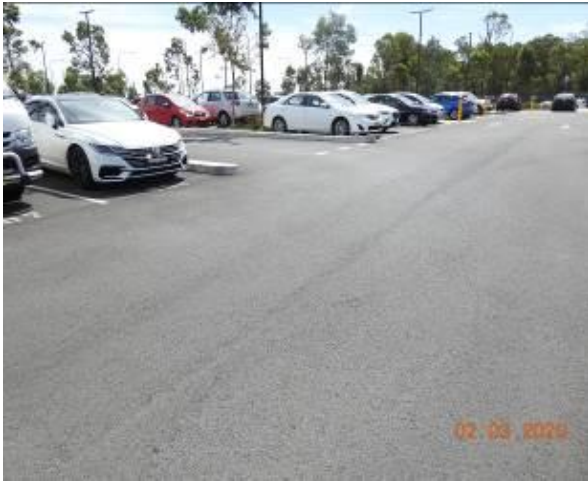
Figure 2308 – General Condition of carpark pavement

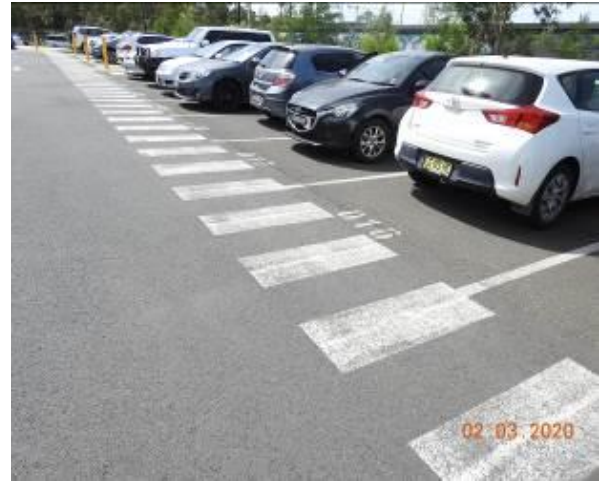
Figure 2309 – General Condition of carpark pavement

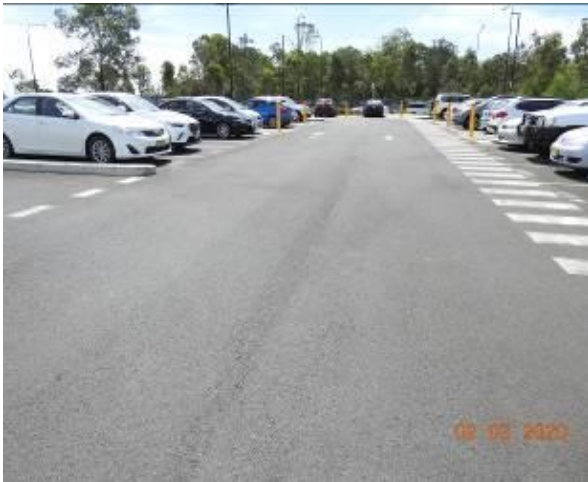
Figure 2310 – General Condition of carpark pavement

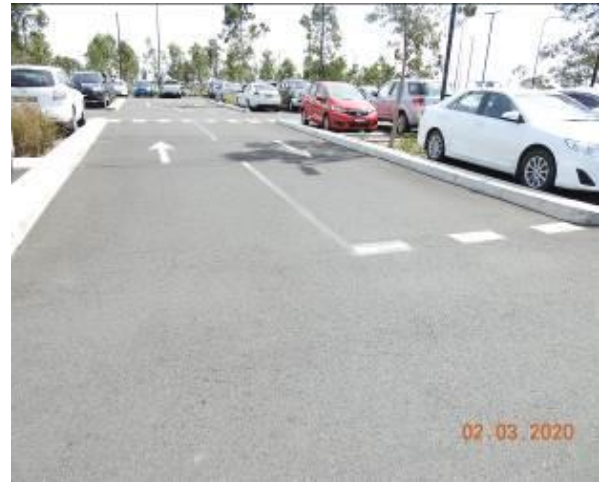
Figure 2311 – General Condition of carpark pavement

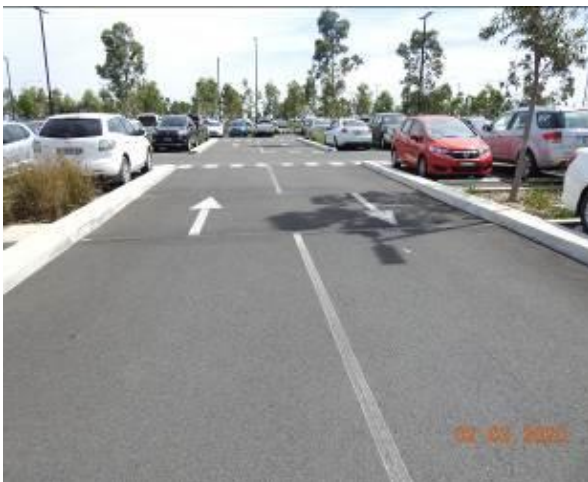
Figure 2312 – General Condition of carpark pavement

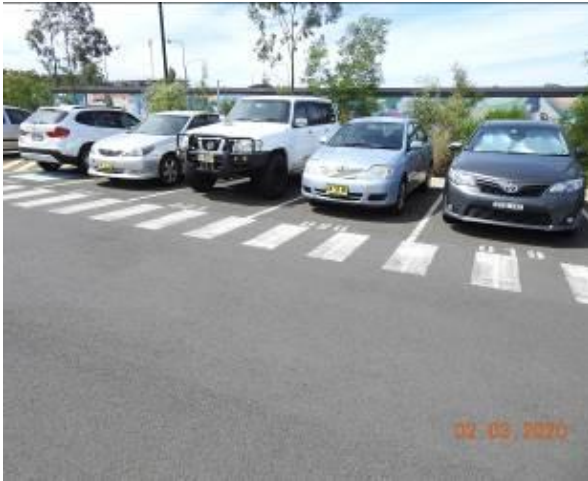
Figure 2313 – General Condition of carpark pavement

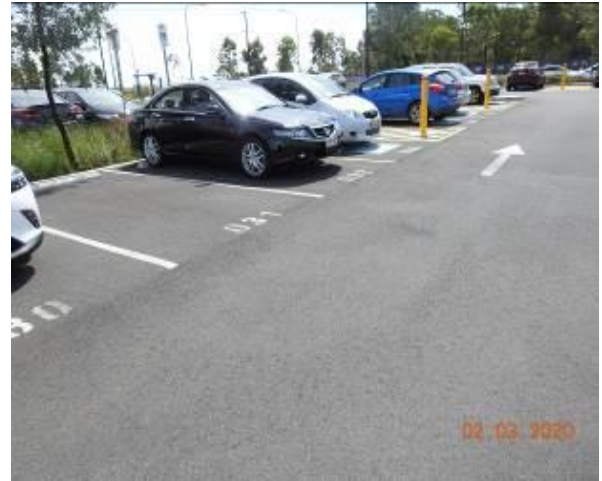
Figure 2314 – General Condition of carpark pavement

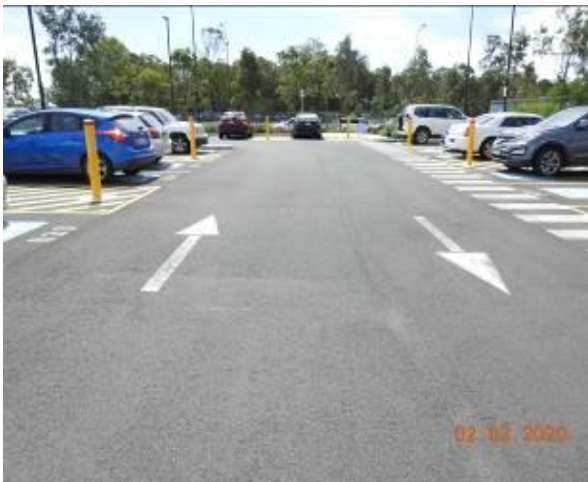
Figure 2315 – General Condition of carpark pavement

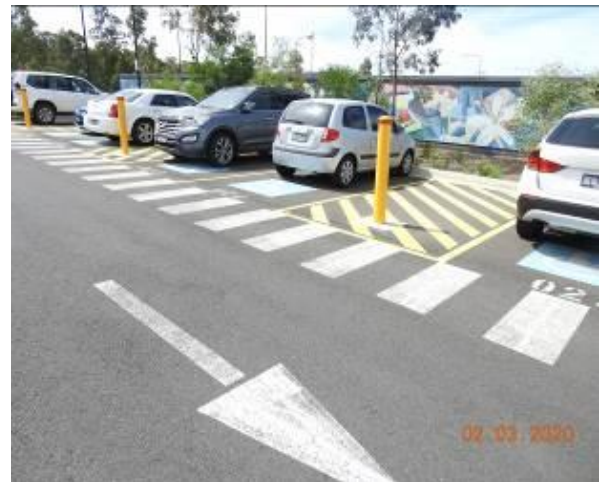
Figure 2316 – General Condition of carpark pavement

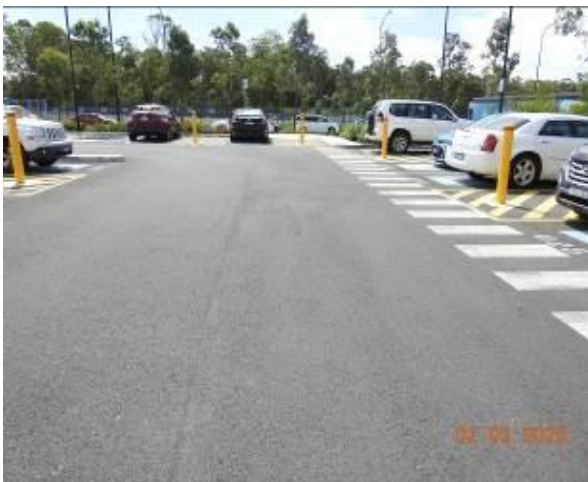
Figure 2317 – General Condition of carpark pavement

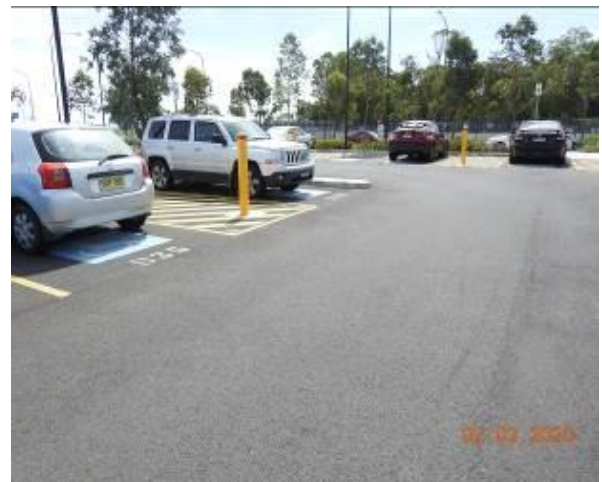
Figure 2318 – General Condition of carpark pavement

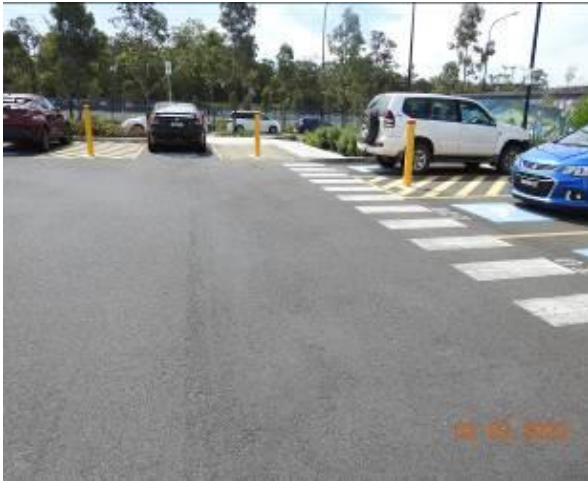
Figure 2319 – General Condition of carpark pavement

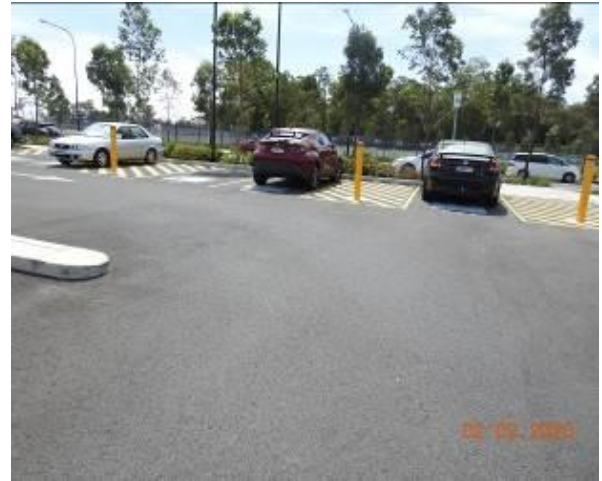
Figure 2320 – General Condition of carpark pavement

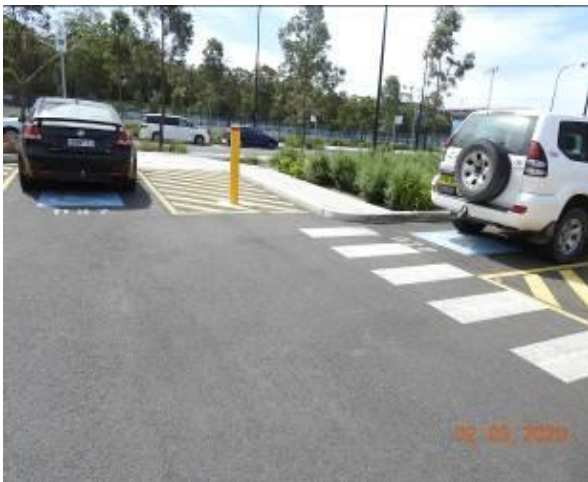
Figure 2321 – General Condition of carpark pavement

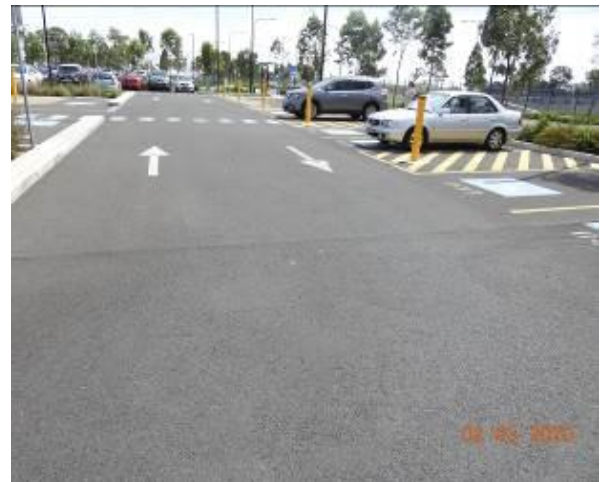
Figure 2322 – General Condition of carpark pavement

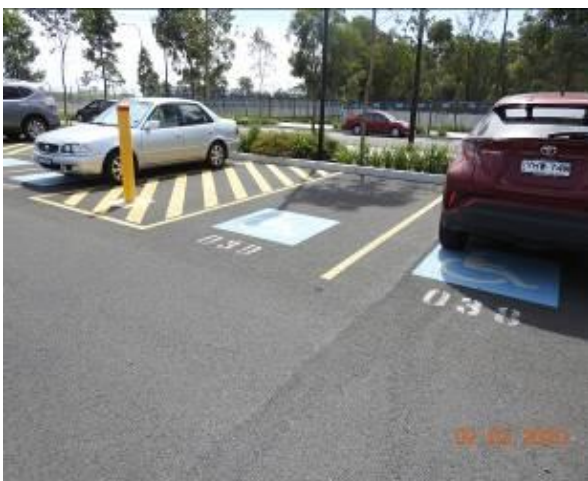
Figure 2323 – General Condition of carpark pavement

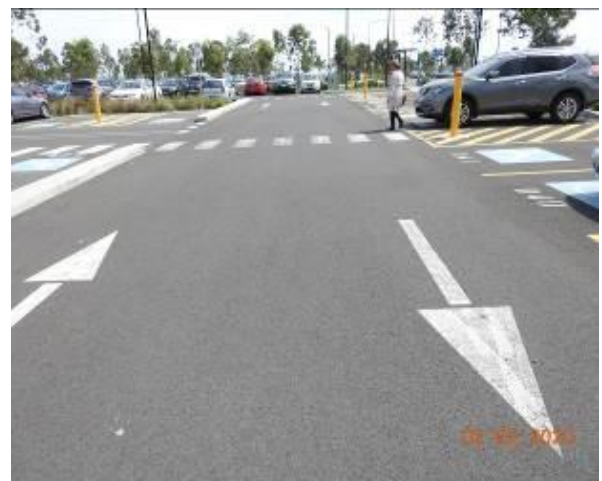
Figure 2324 – General Condition of carpark pavement

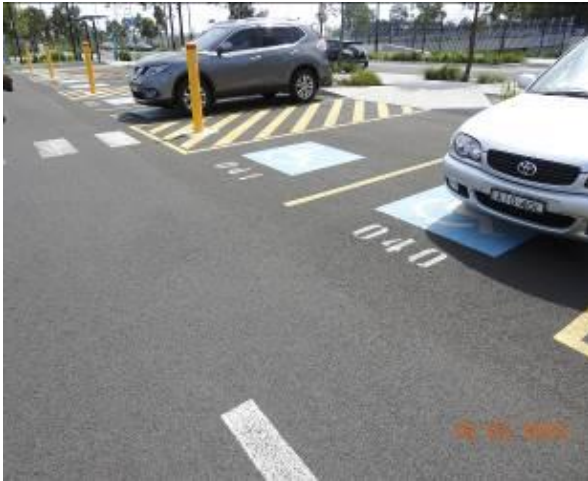
Figure 2325 – General Condition of carpark pavement

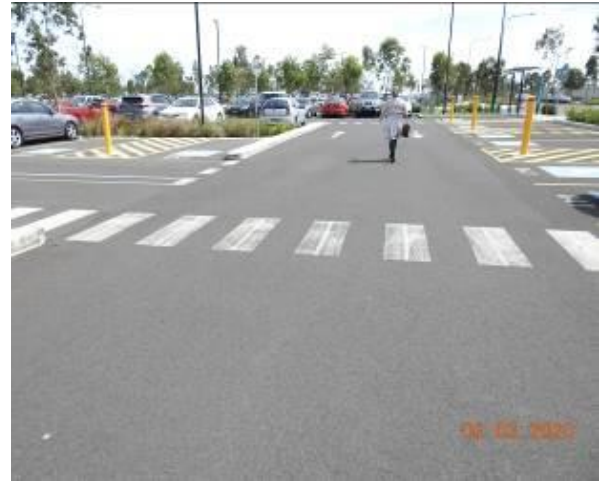
Figure 2326 – General Condition of carpark pavement

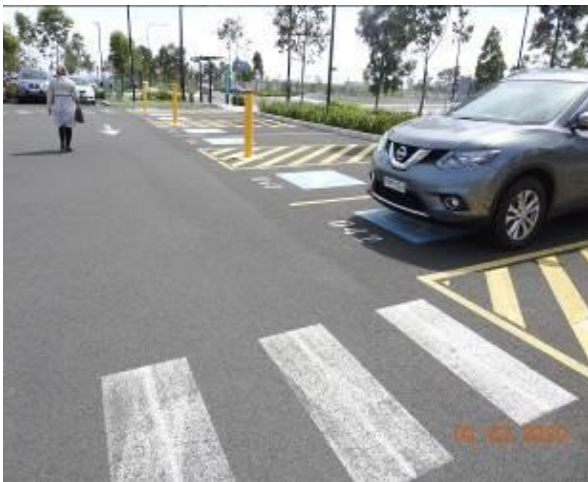
Figure 2327 – General Condition of carpark pavement

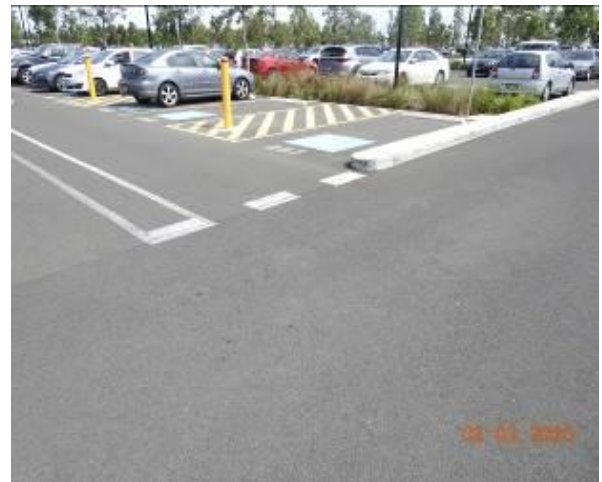
Figure 2328 – General Condition of carpark pavement

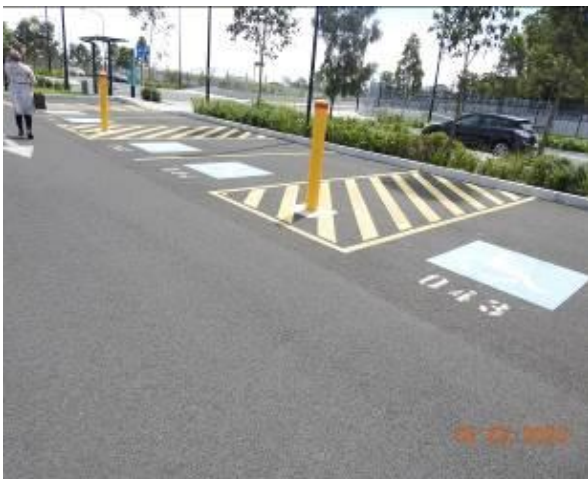
Figure 2329 – General Condition of carpark pavement

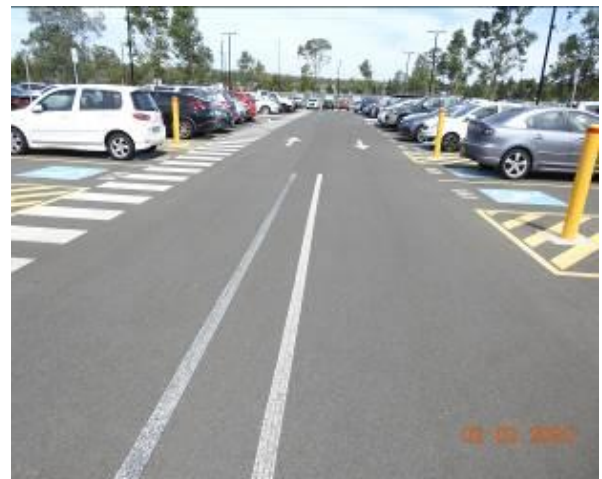
Figure 2330 – General Condition of carpark pavement

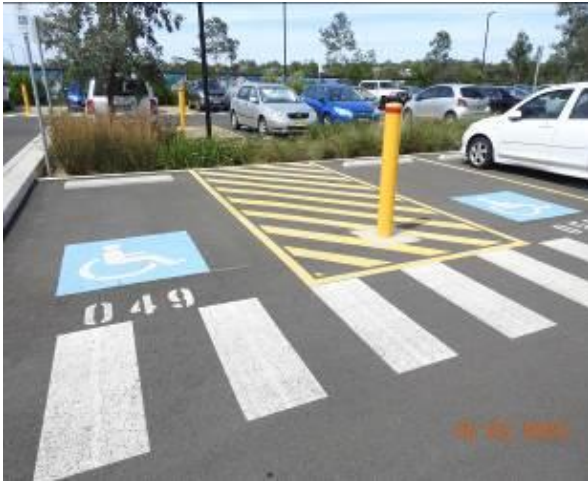
Figure 2331 – General Condition of carpark pavement
