**1-15 AND 2-12 CONFERTA AVENUE,
ROUSE HILL NSW 2155
TALLAWONG STATION PRECINCT SOUTH
PRE-DILAPIDATION REPORT**

**DEICORP PROJECTS
(TALLAWONG STATION) PTY LTD**

Job No. 191294.0
24/03/2020

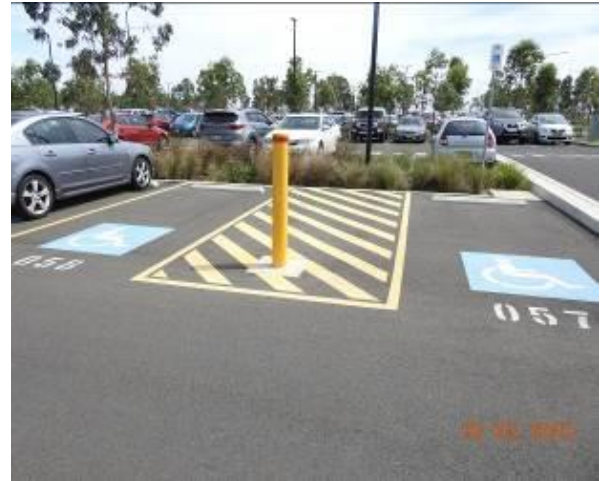
Figure 2332 – General Condition of carpark pavement

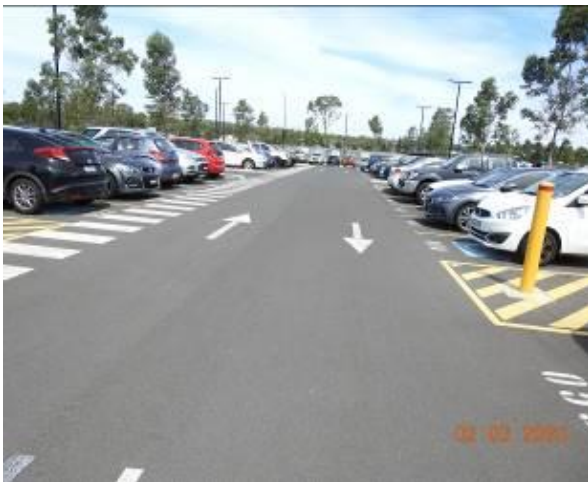
Figure 2333 – General Condition of carpark pavement

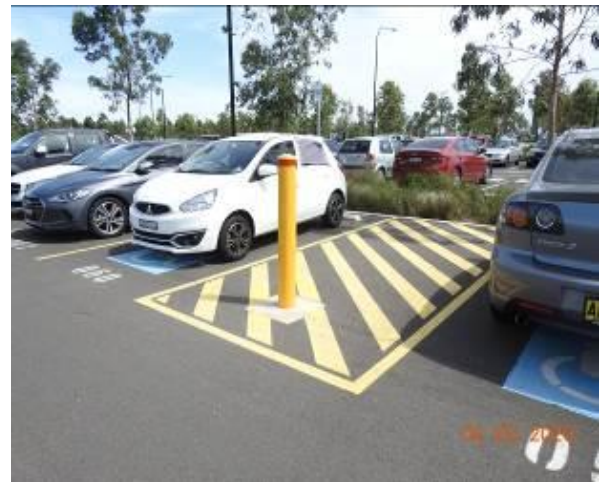
Figure 2334 – General Condition of carpark pavement

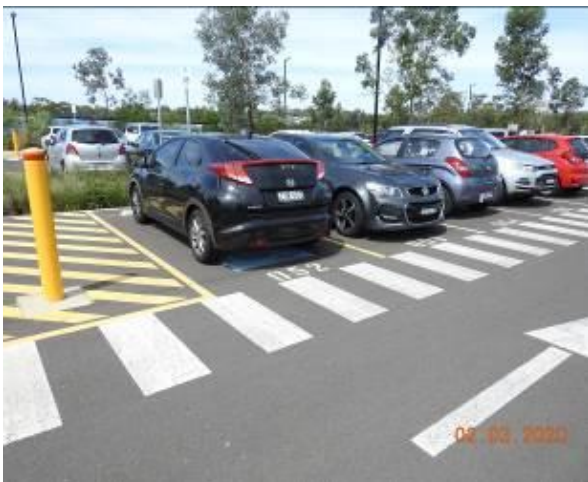
Figure 2335 – General Condition of carpark pavement

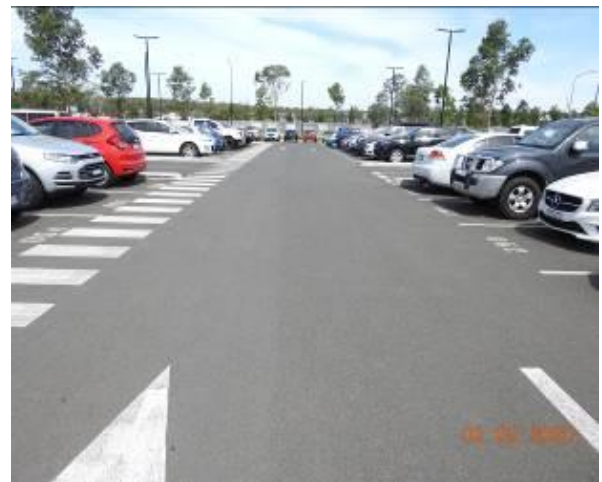
Figure 2336 – General Condition of carpark pavement

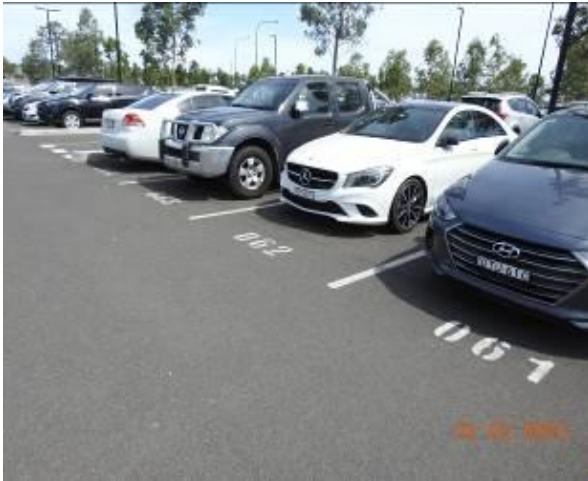
Figure 2337 – General Condition of carpark pavement

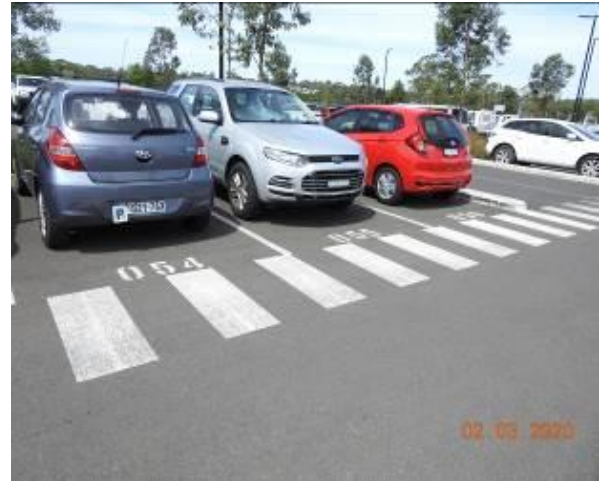
Figure 2338 – General Condition of carpark pavement

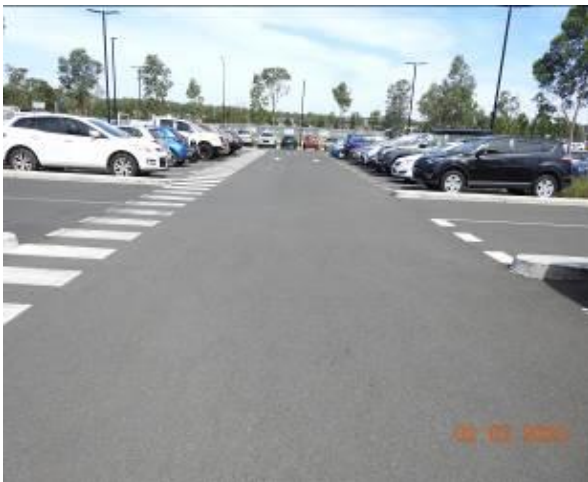
Figure 2339 – General Condition of carpark pavement

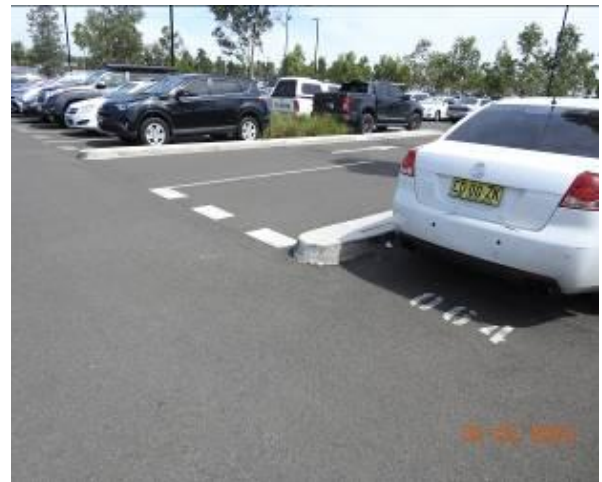
Figure 2340 – General Condition of carpark pavement

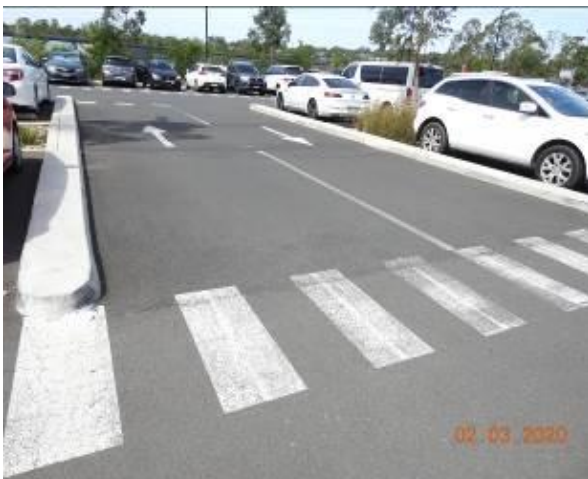
Figure 2341 – General Condition of carpark pavement

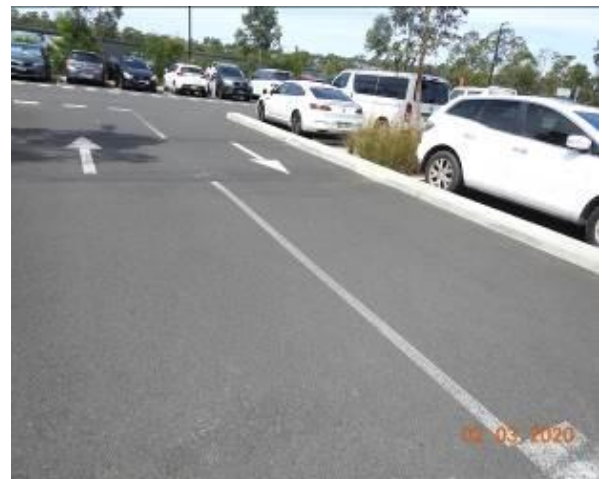
Figure 2342 – General Condition of carpark pavement

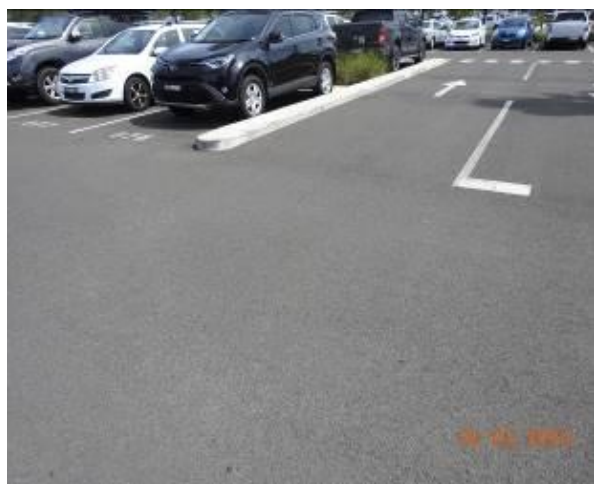
Figure 2343 – General Condition of carpark pavement

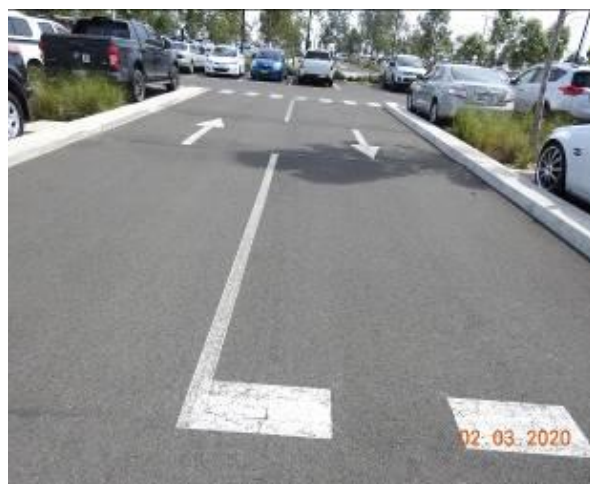
Figure 2344 – General Condition of carpark pavement

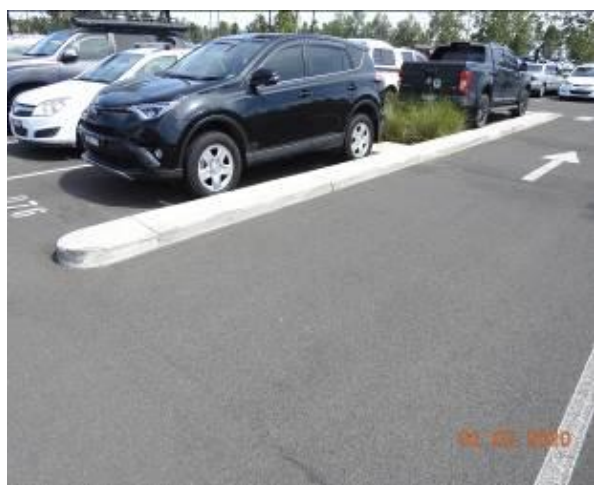
Figure 2345 – General Condition of carpark pavement

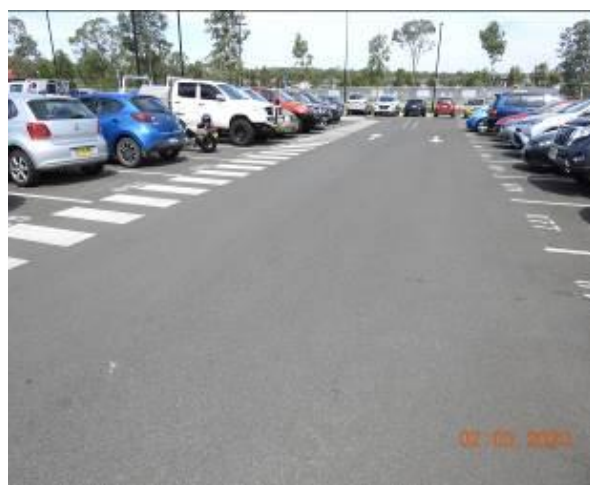
Figure 2346 – General Condition of carpark pavement

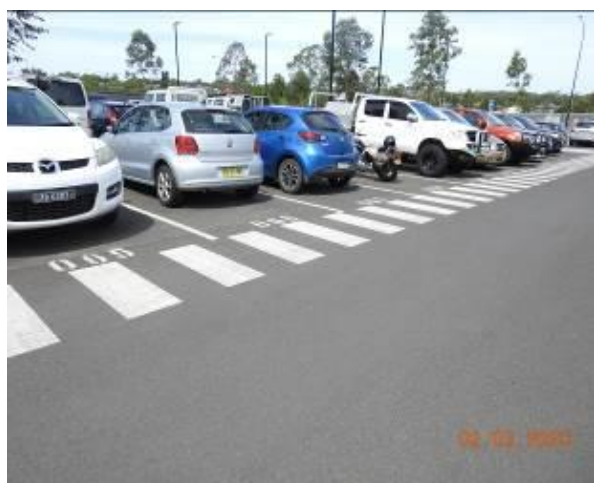
Figure 2347 – General Condition of carpark pavement

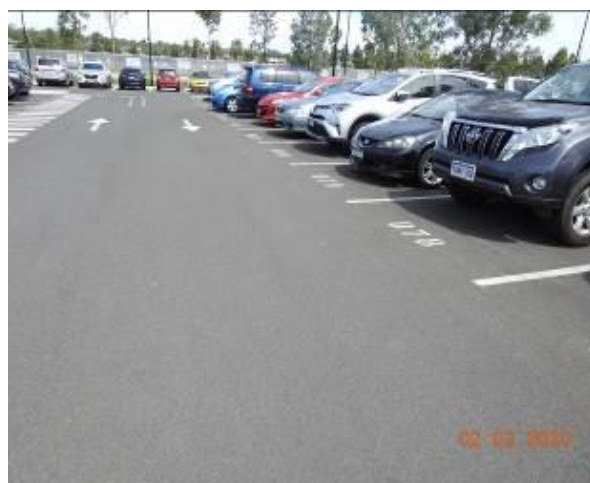
Figure 2348 – General Condition of carpark pavement

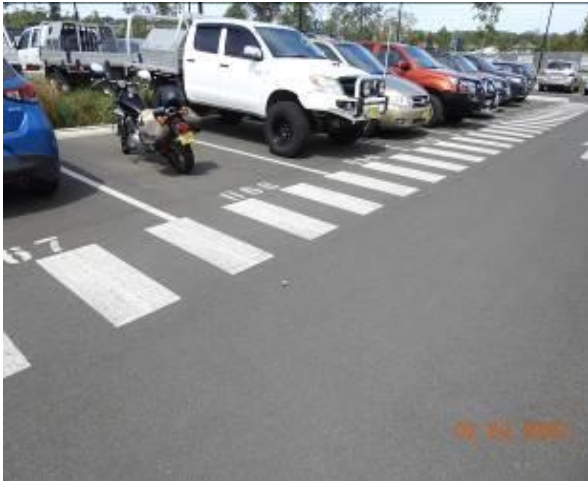
Figure 2349 – General Condition of carpark pavement

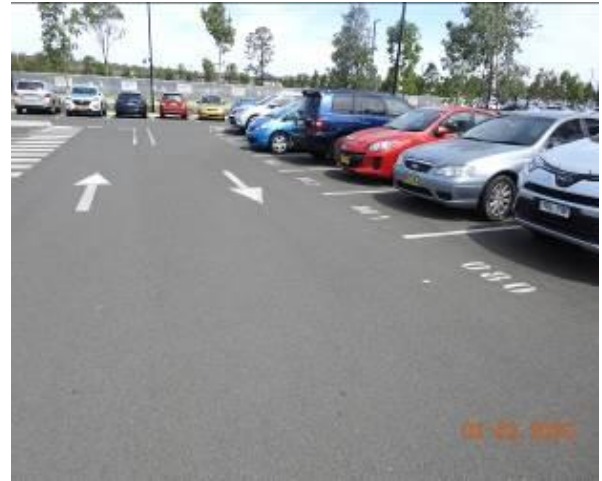
Figure 2350 – General Condition of carpark pavement

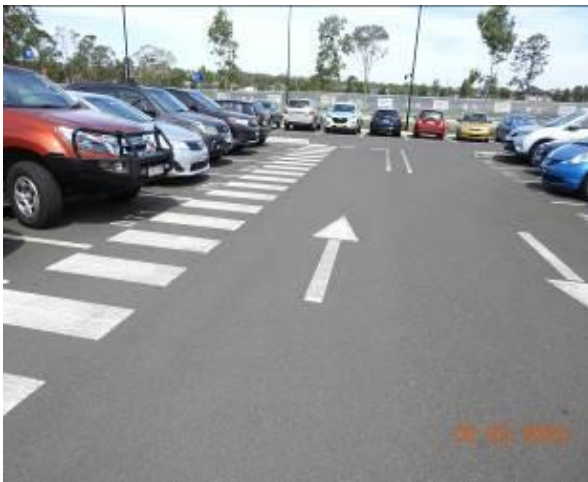
Figure 2351 – General Condition of carpark pavement

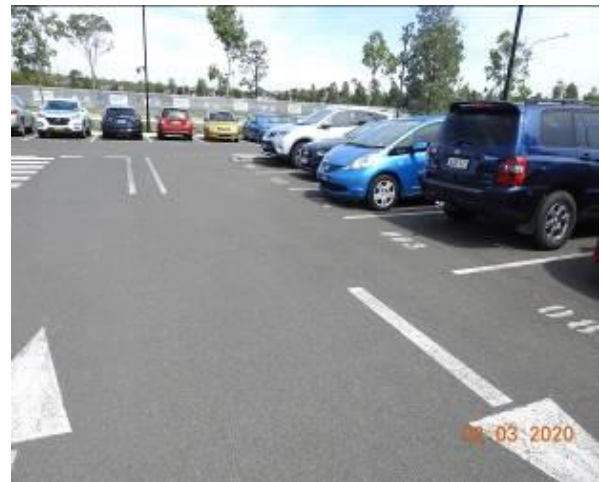
Figure 2353 – General Condition of carpark pavement

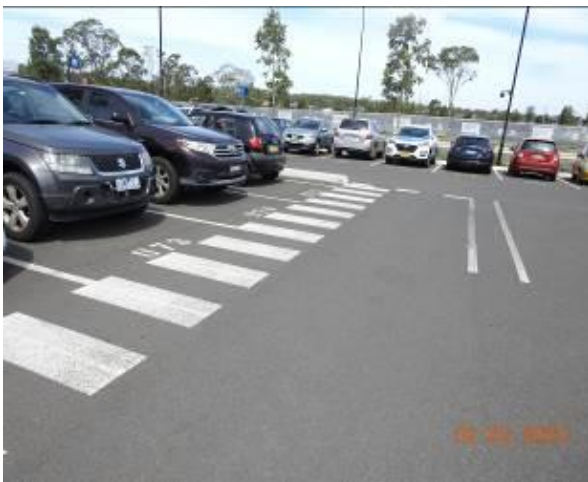
Figure 2354 – General Condition of carpark pavement

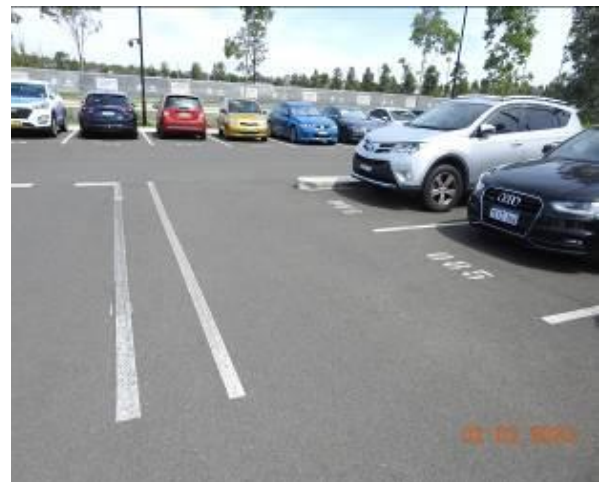
Figure 2355 – General Condition of carpark pavement

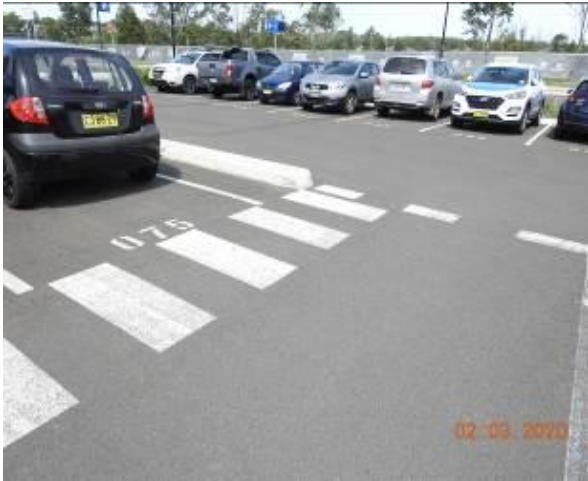
Figure 2356 – General Condition of carpark pavement

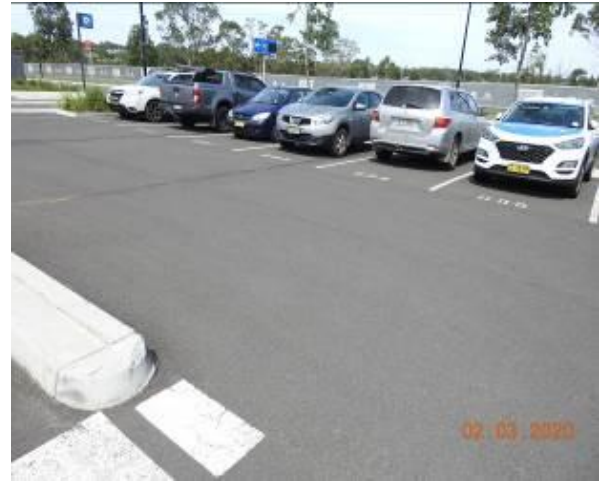
Figure 2357 – General Condition of carpark pavement

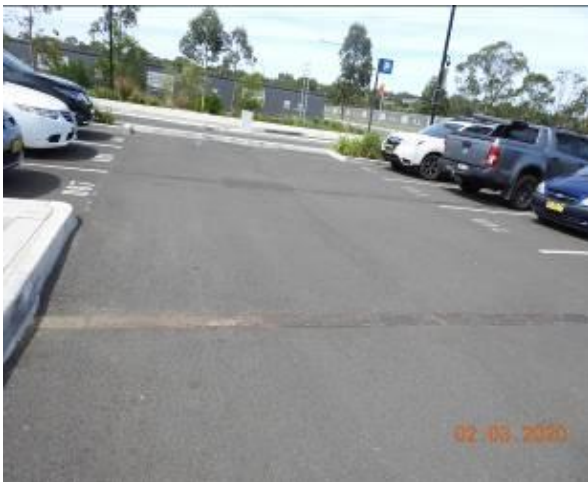
Figure 2358 – General Condition of carpark pavement

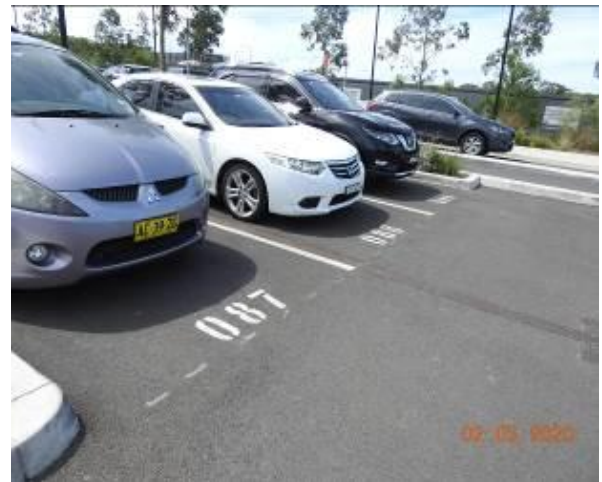
Figure 2359 – General Condition of carpark pavement

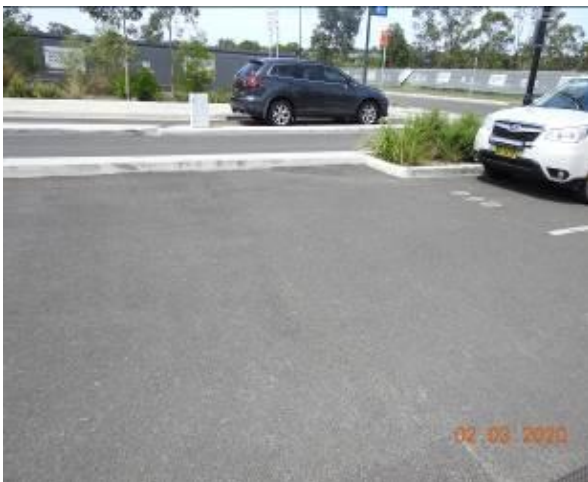
Figure 2360 – General Condition of carpark pavement

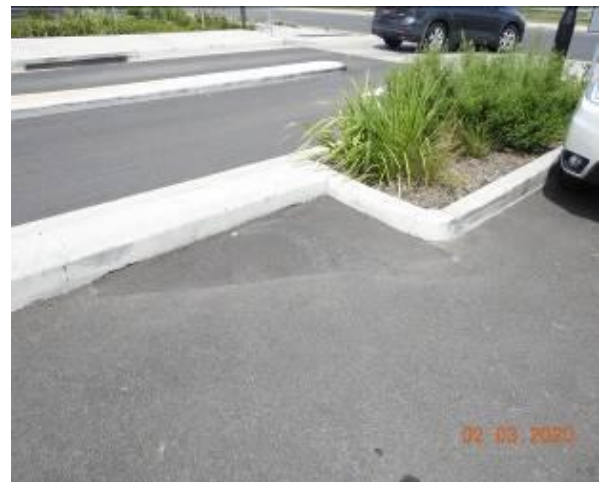
Figure 2361 – Crack propagation through carpark pavement

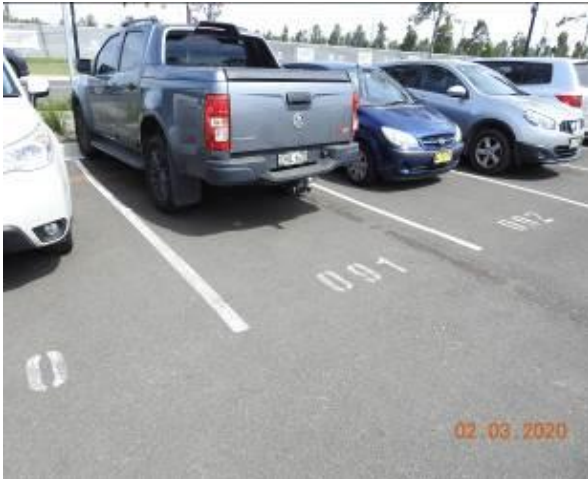
Figure 2362 – General Condition of carpark pavement

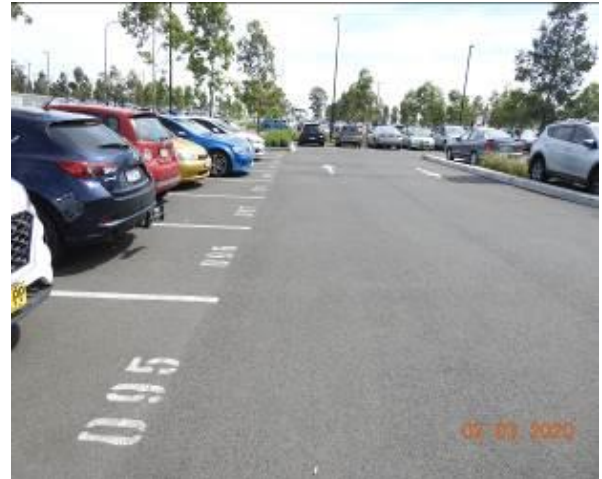
Figure 2363 – General Condition of carpark pavement

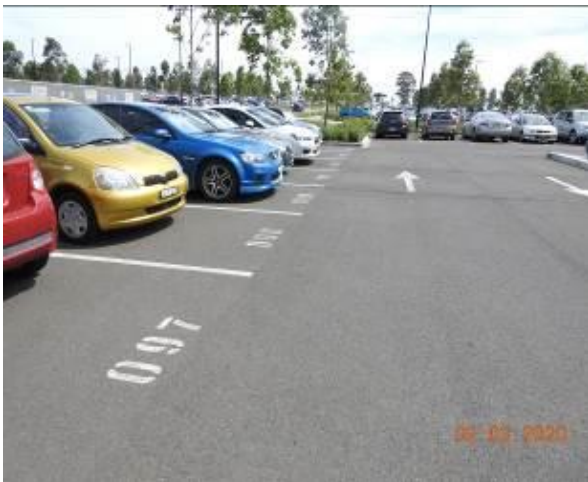
Figure 2364 – General Condition of carpark pavement

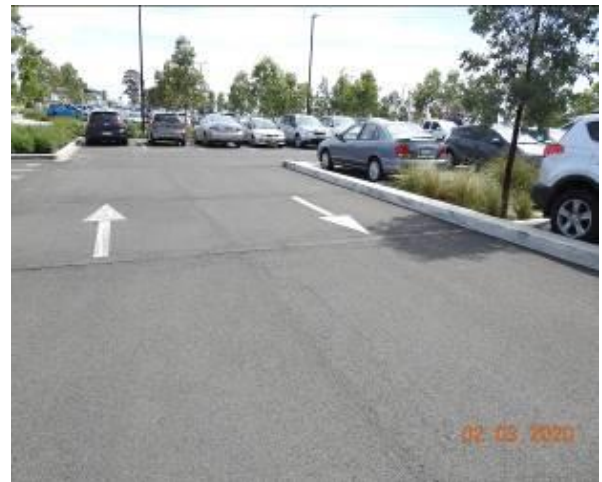
Figure 2365 – General Condition of carpark pavement

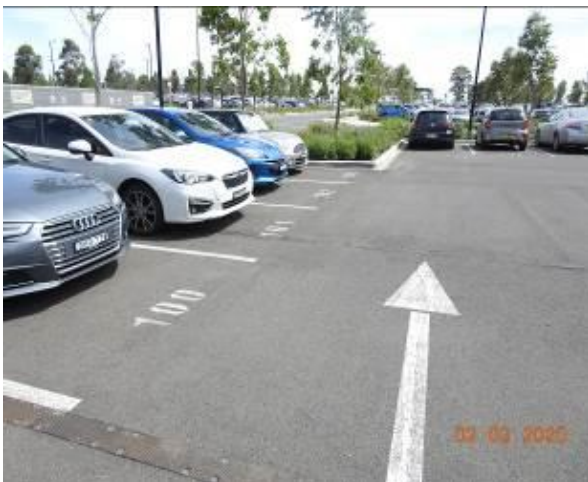
Figure 2366 – General Condition of carpark pavement

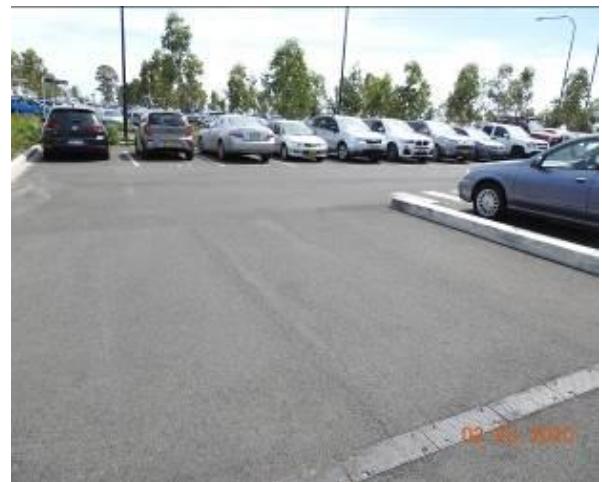
Figure 2367 – General Condition of carpark pavement

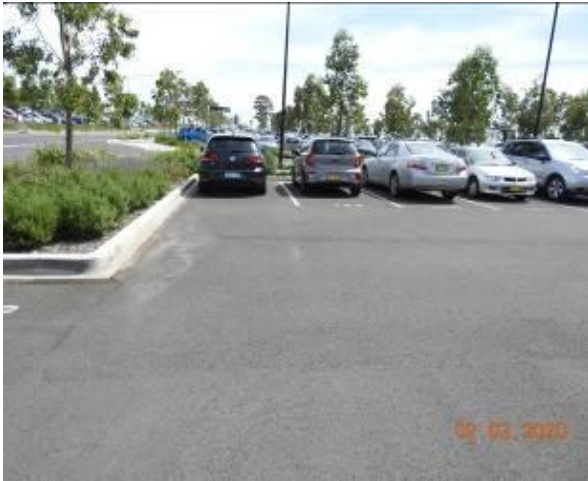
Figure 2368 – General Condition of carpark pavement

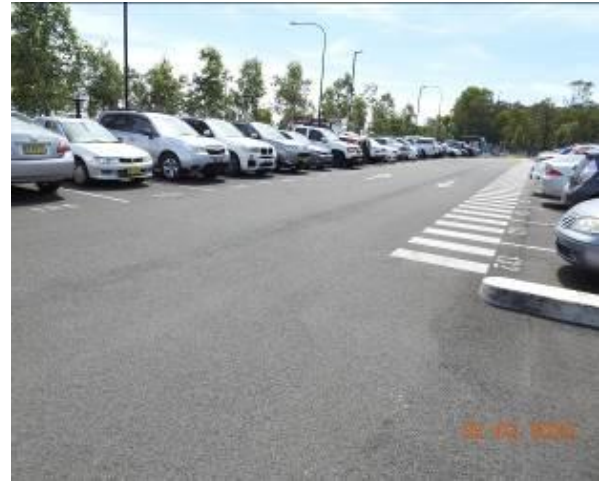
Figure 2369 – General Condition of carpark pavement

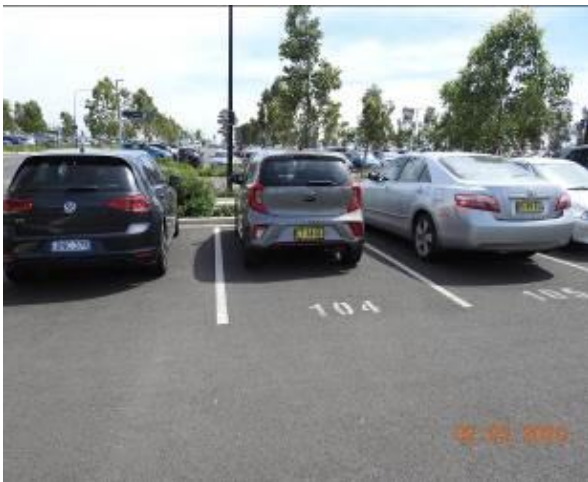
Figure 2370 – General Condition of carpark pavement

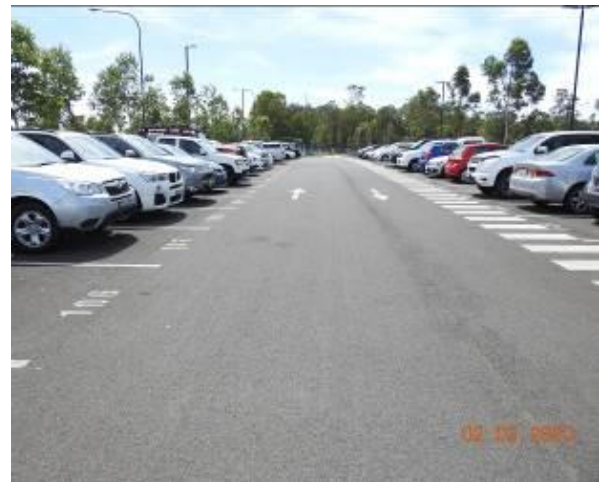
Figure 2371 – General Condition of carpark pavement

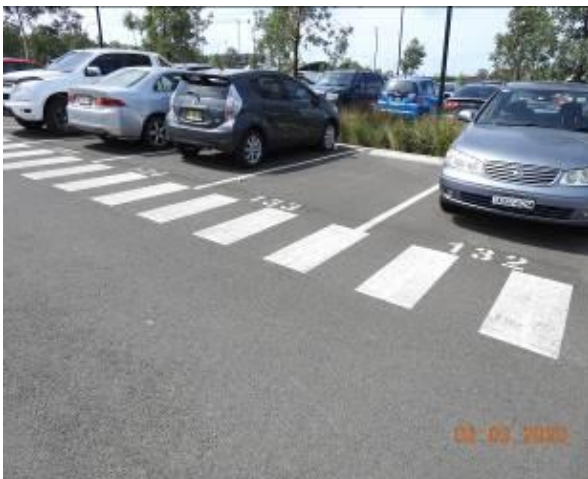
Figure 2372 – General Condition of carpark pavement

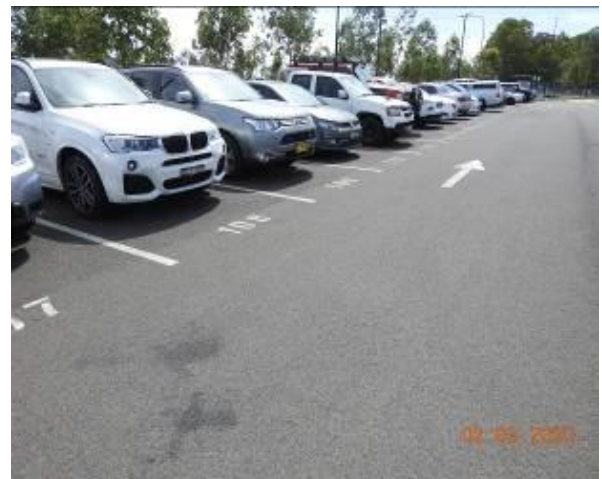
Figure 2373 – General Condition of carpark pavement

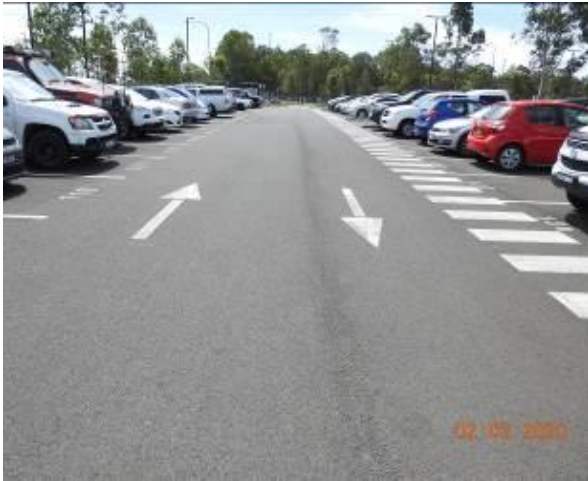
Figure 2374 – General Condition of carpark pavement

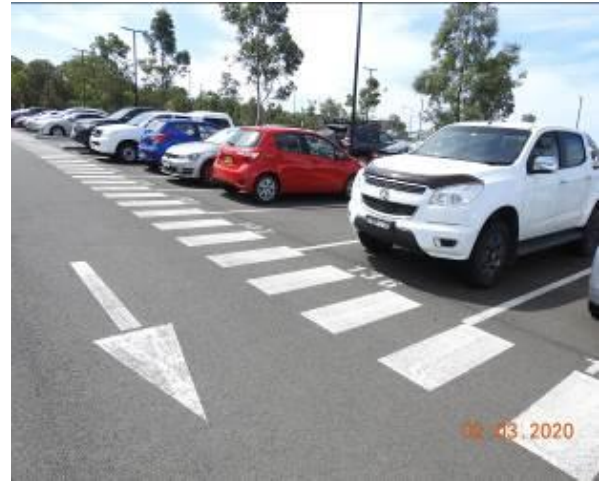
Figure 2375 – General Condition of carpark pavement

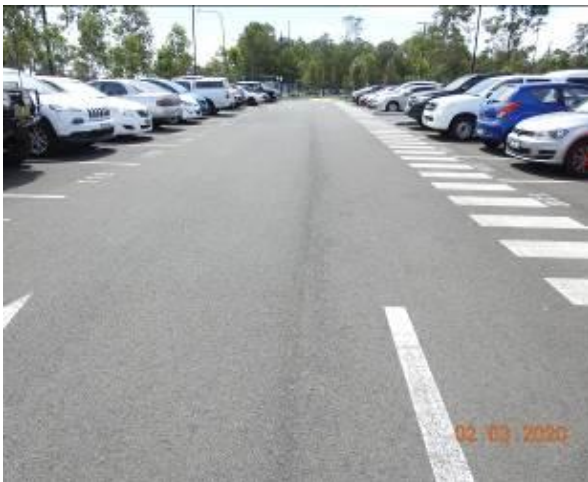
Figure 2376 – General Condition of carpark pavement

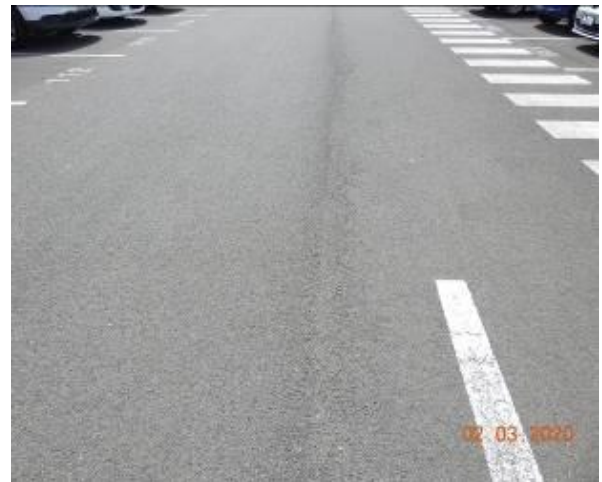
Figure 2377 – Loss of material through carpark pavement

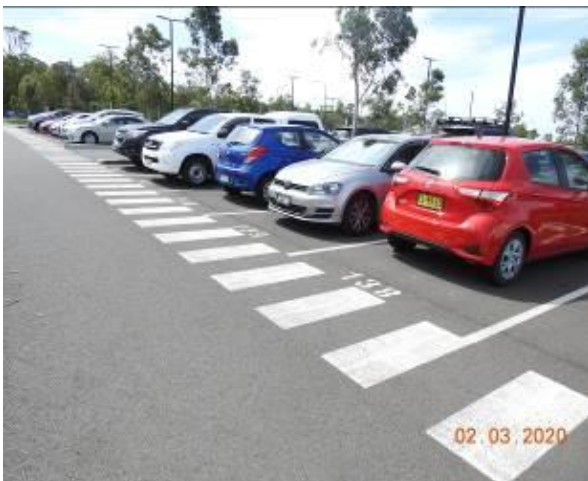
Figure 2378 – General Condition of carpark pavement

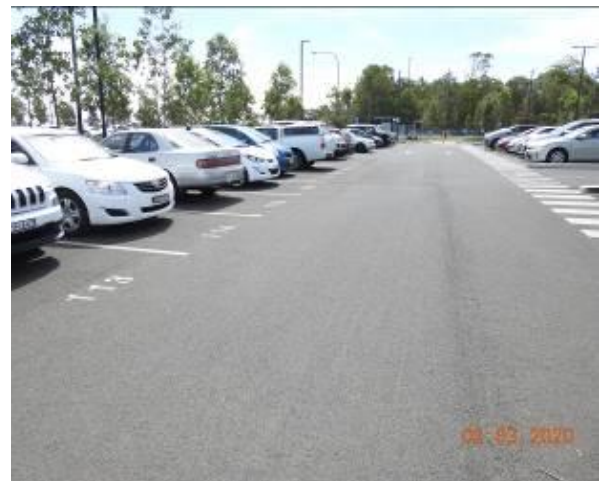
Figure 2379 – General Condition of carpark pavement

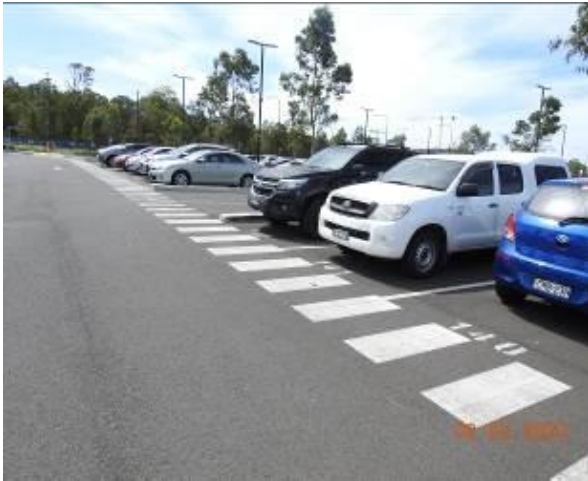
Figure 2380 – General Condition of carpark pavement

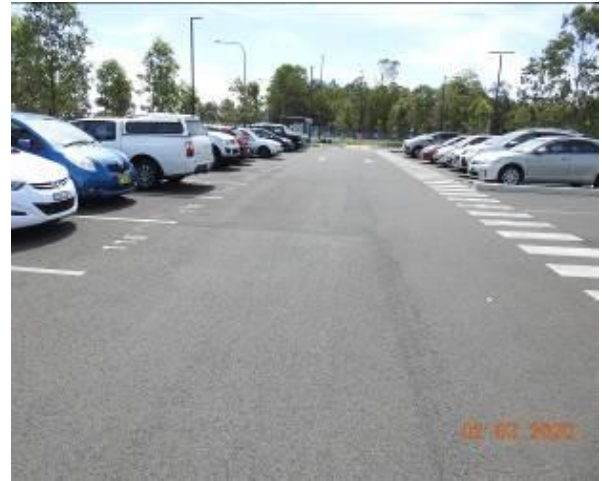
Figure 2381 – General Condition of carpark pavement

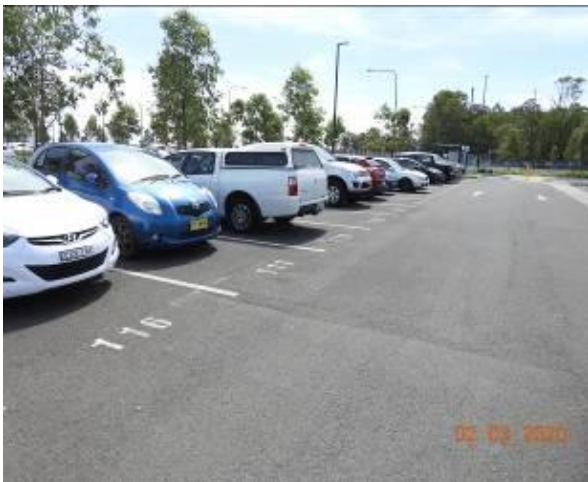
Figure 2382 – General Condition of carpark pavement

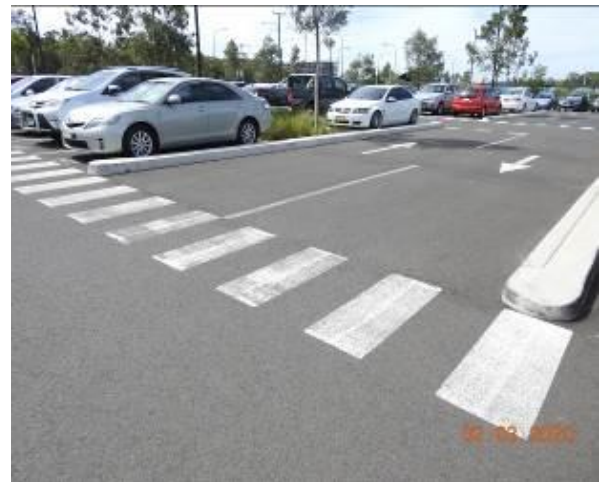
Figure 2383 – General Condition of carpark pavement

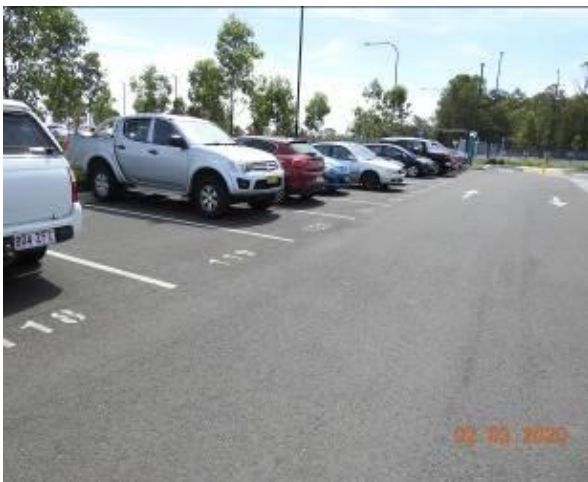
Figure 2384 – General Condition of carpark pavement

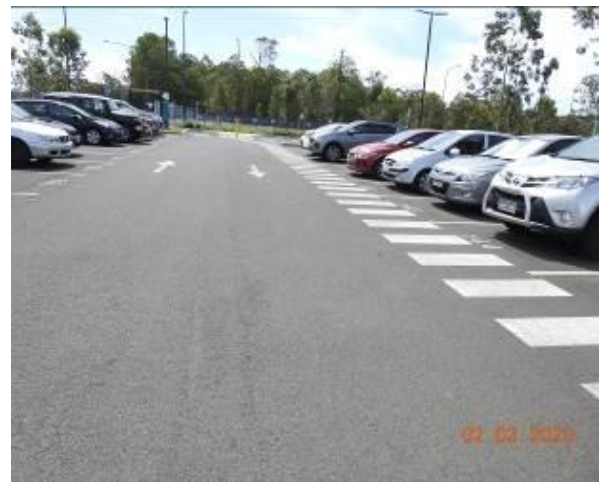
Figure 2385 – General Condition of carpark pavement

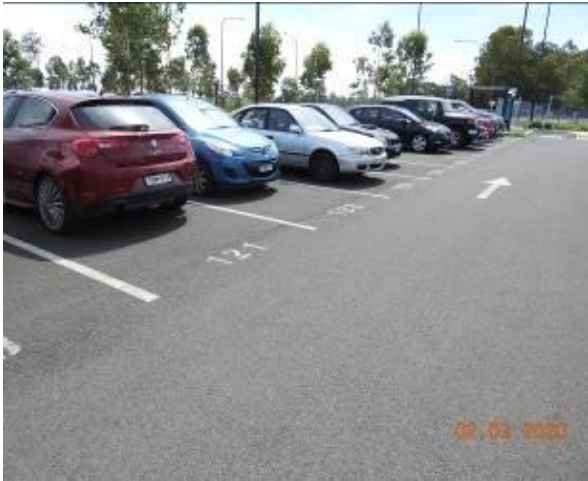
Figure 2386 – General Condition of carpark pavement

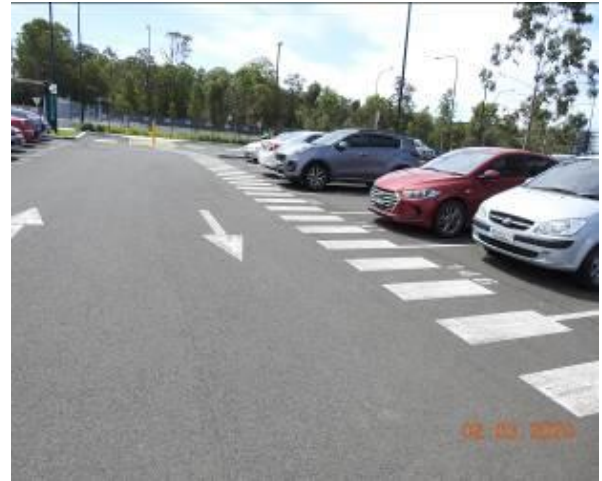
Figure 2387 – General Condition of carpark pavement

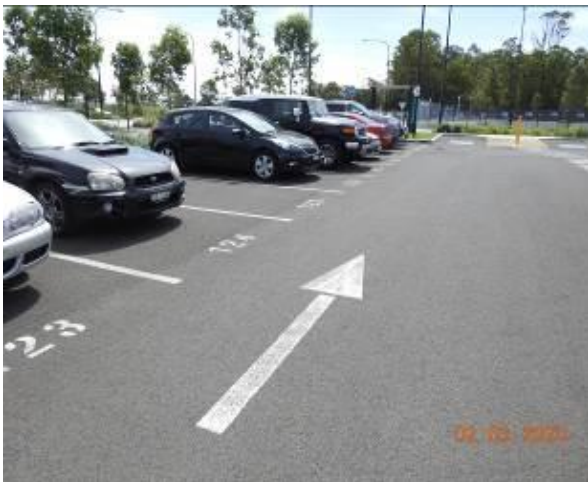
Figure 2388 – General Condition of carpark pavement

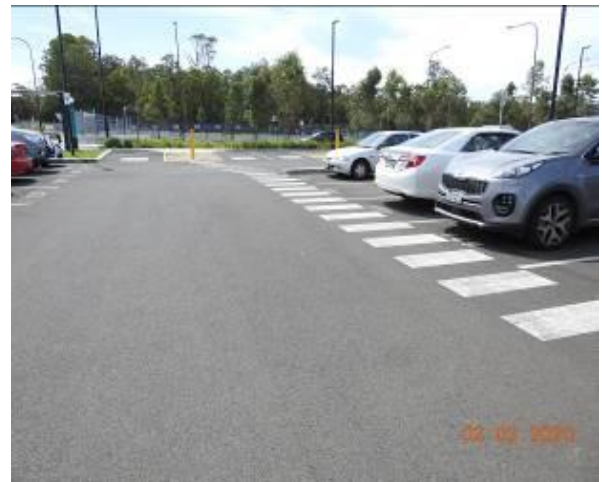
Figure 2389 – General Condition of carpark pavement

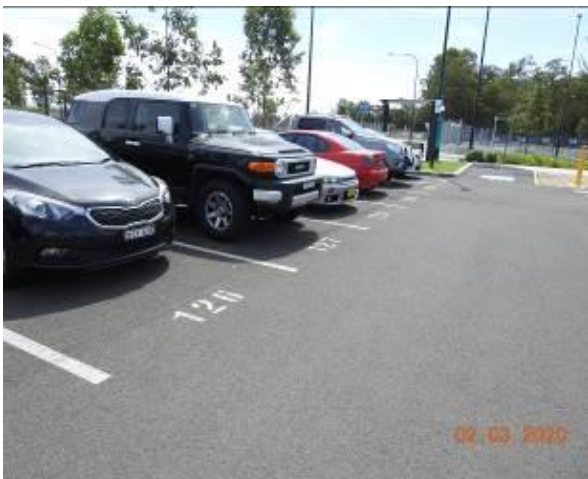
Figure 2390 – General Condition of carpark pavement

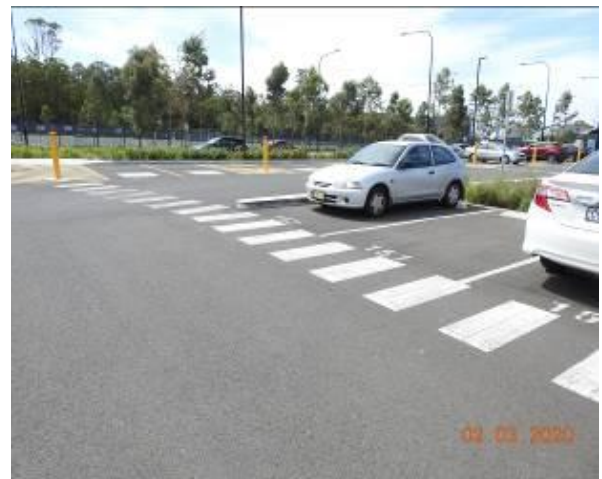
Figure 2391 – General Condition of carpark pavement

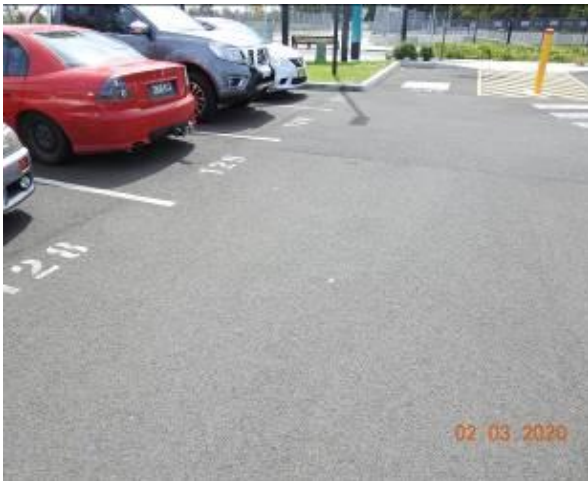
Figure 2392 – General Condition of carpark pavement

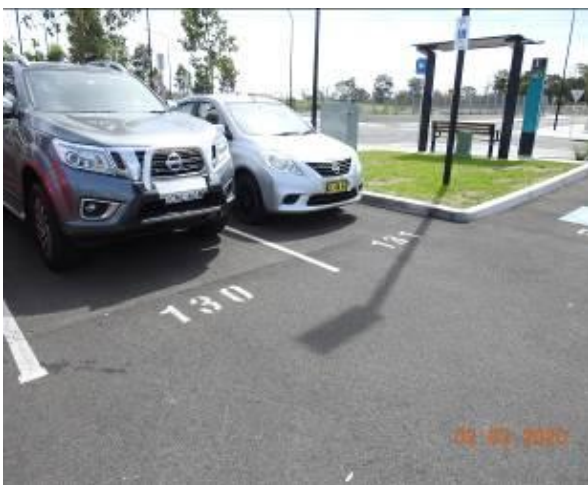
Figure 2393 – General Condition of carpark pavement

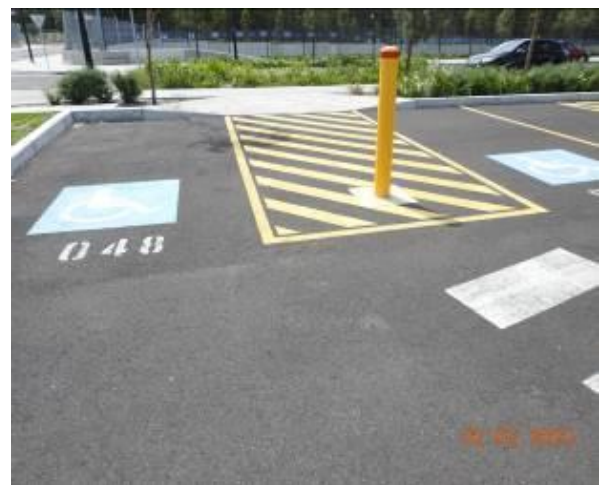
Figure 2394 – General Condition of carpark pavement

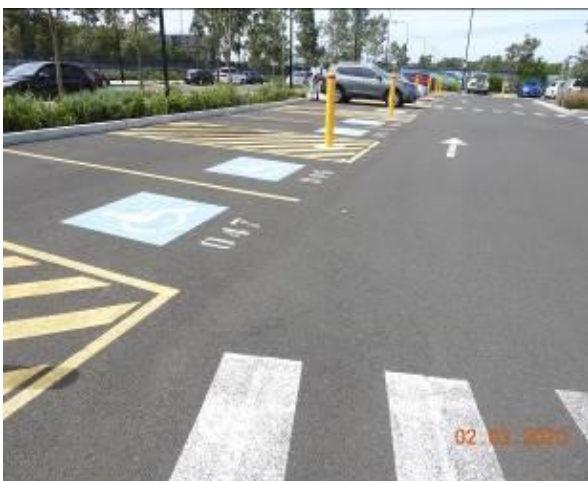
Figure 2395 – General Condition of carpark pavement

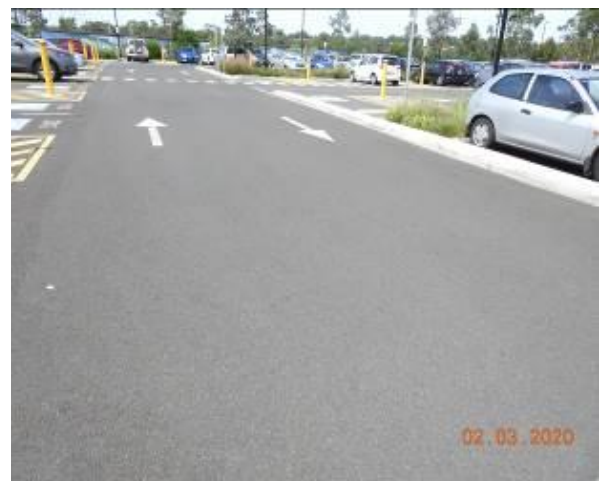
Figure 2396 – General Condition of carpark pavement

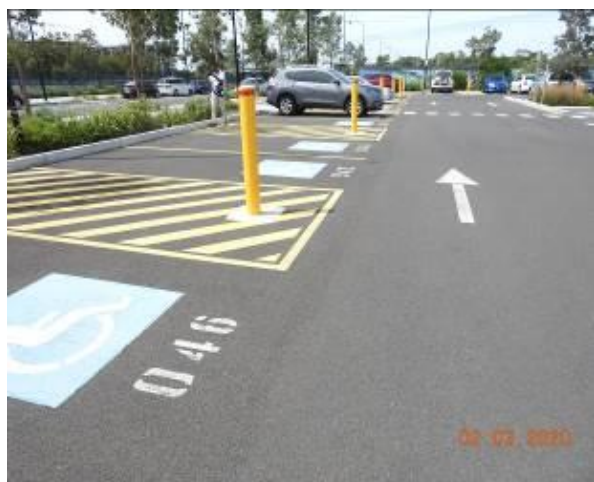
Figure 2397 – General Condition of carpark pavement

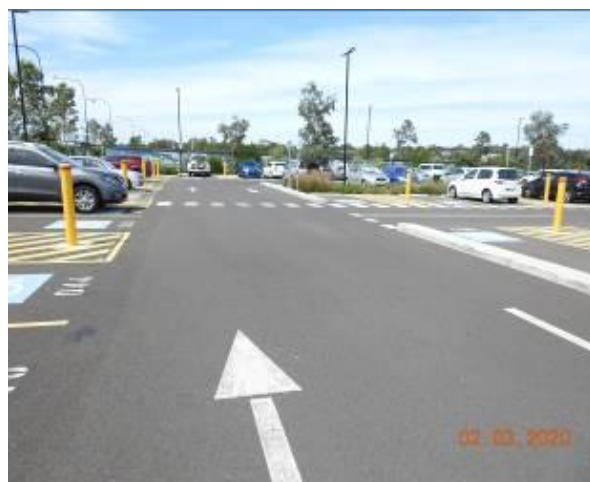
Figure 2398 – General Condition of carpark pavement

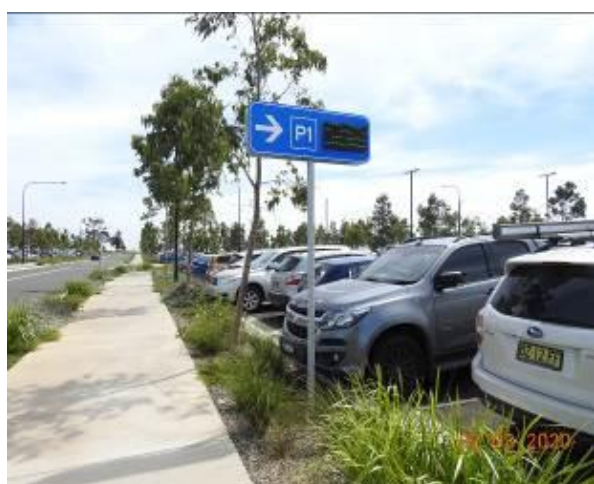
Figure 2399 – General Condition of carpark pavement

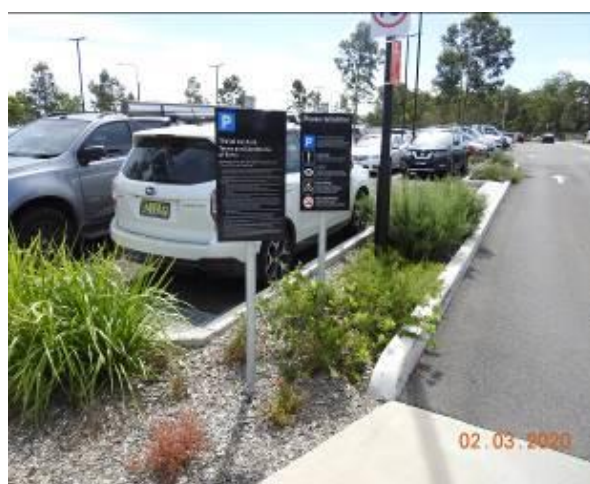
Figure 2400 – General Condition of street sign

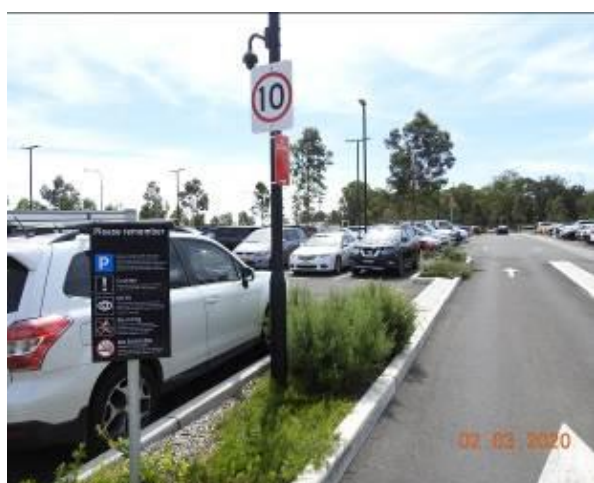
Figure 2401 – General Condition of street sign

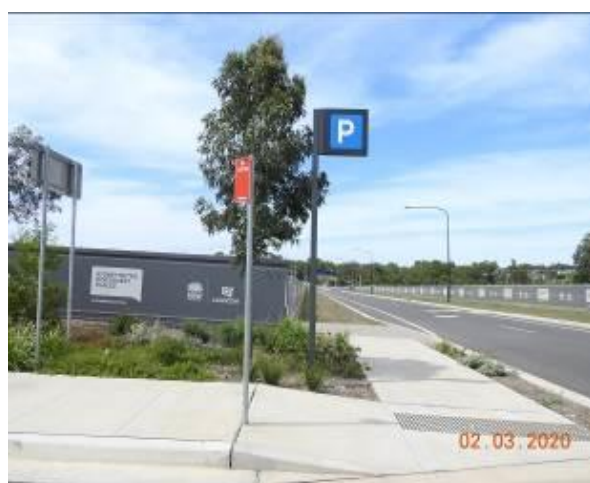
Figure 2402 – General Condition of street sign

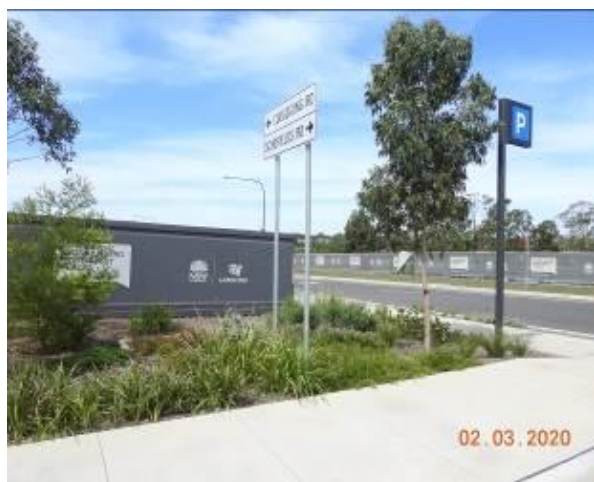
Figure 2403 – General Condition of street sign

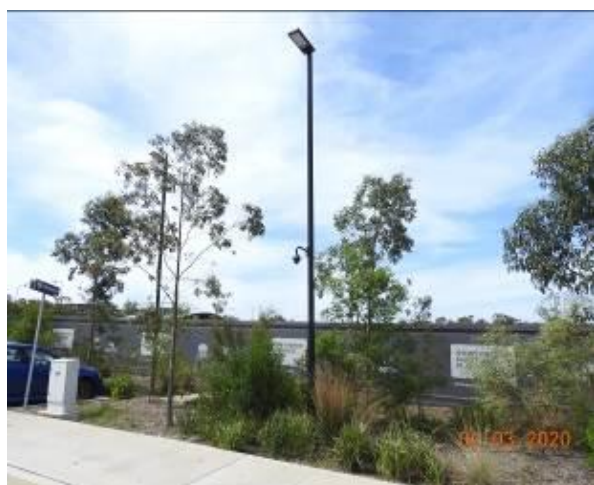
Figure 2405 – General Condition of electricity box

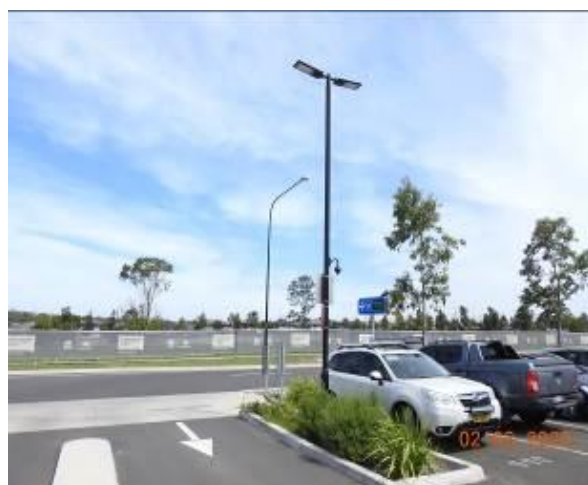
Figure 2406 – General Condition of lamp post

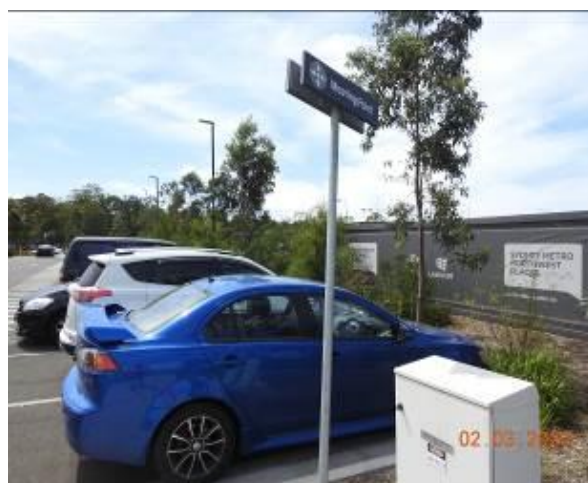
Figure 2408 – General Condition of electricity box

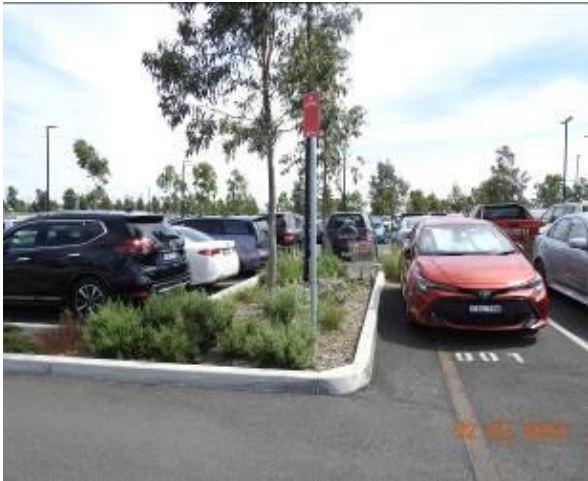
Figure 2409 – General Condition of street sign

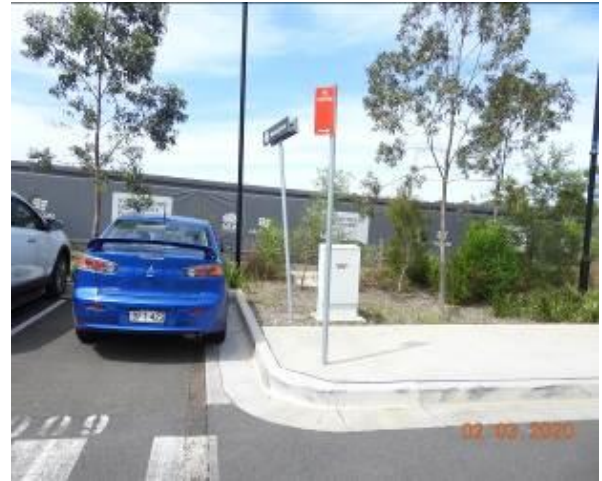
Figure 2410 – General Condition of street sign

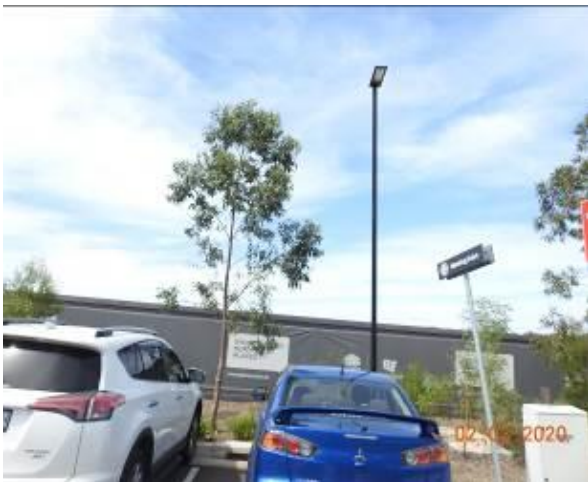
Figure 2411 – General Condition of street sign
