**1-15 AND 2-12 CONFERTA AVENUE,
ROUSE HILL NSW 2155
TALLAWONG STATION PRECINCT SOUTH
PRE-DILAPIDATION REPORT**

**DEICORP PROJECTS
(TALLAWONG STATION) PTY LTD**

Job No. 191294.0
24/03/2020

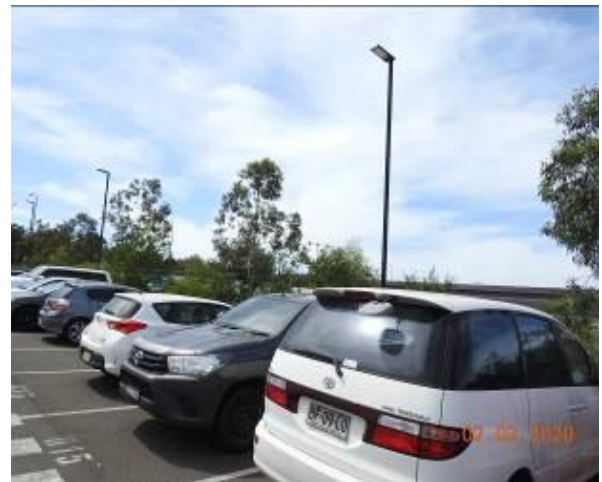
Figure 2412 – General Condition of lamp post

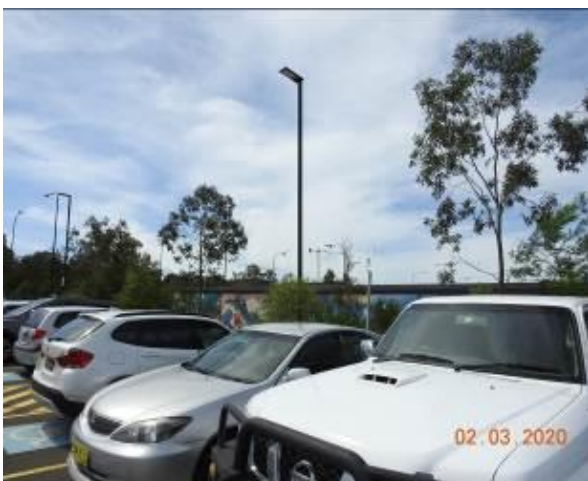
Figure 2413 – General Condition of lamp post

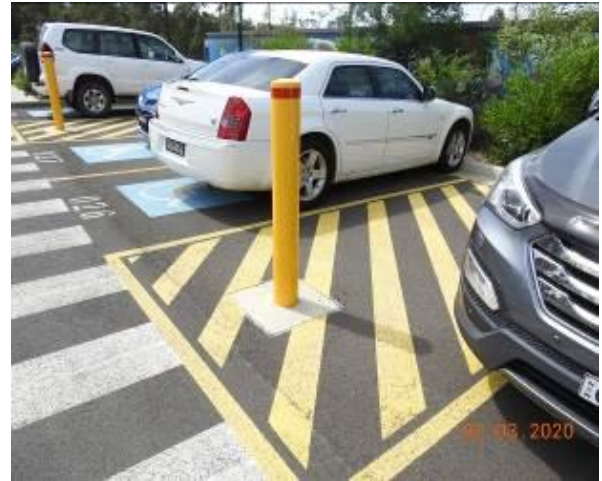
Figure 2416 – General Condition of traffic bollard

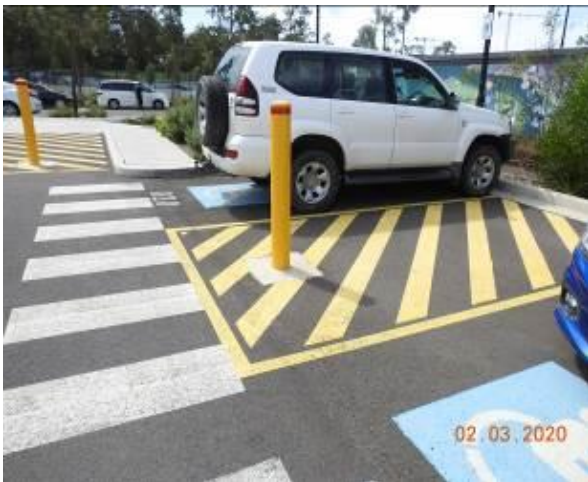
Figure 2417 – General Condition of traffic bollard

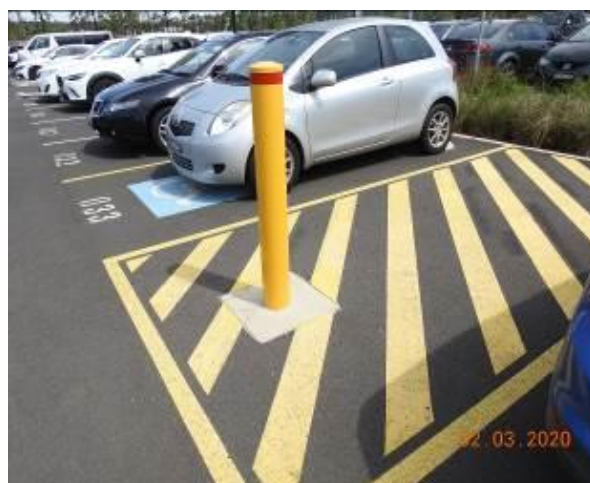
Figure 2426 – General Condition of traffic bollard

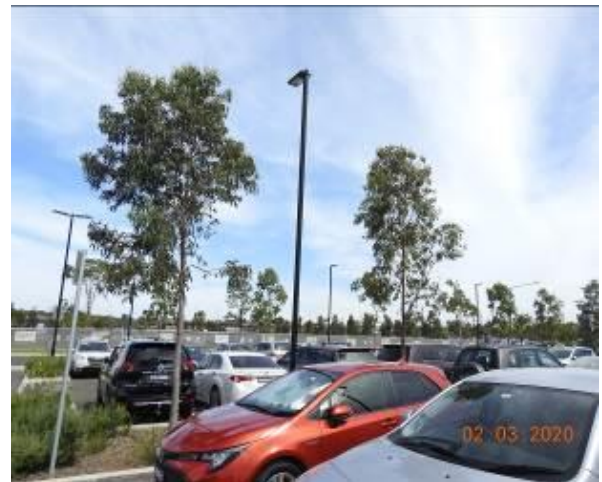
Figure 2430 – General Condition of lamp post

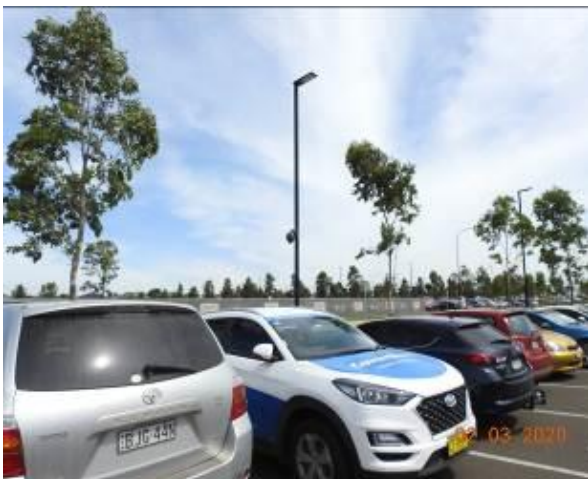
Figure 2431 – General Condition of lamp post

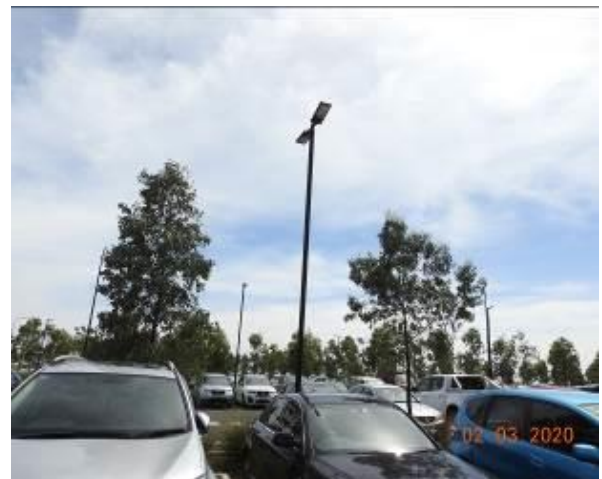
Figure 2433 – General Condition of lamp post

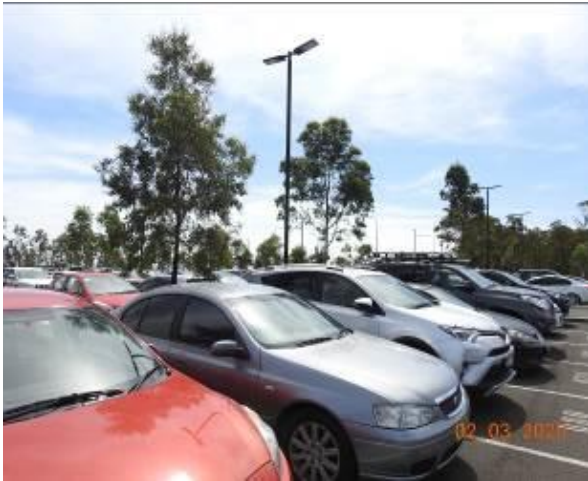
Figure 2434 – General Condition of lamp post

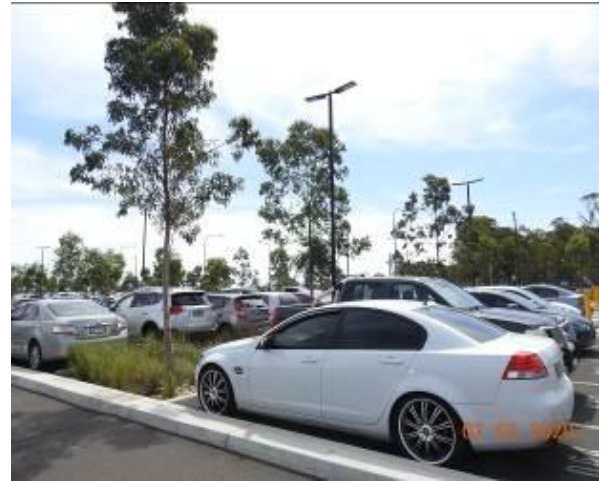
Figure 2435 – General Condition of lamp post

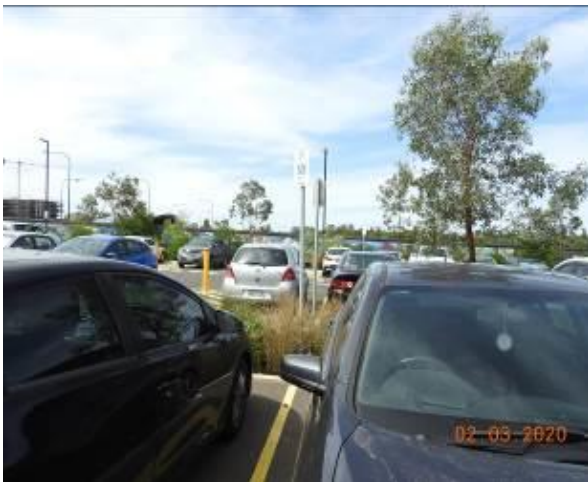
Figure 2436 – General Condition of street sign

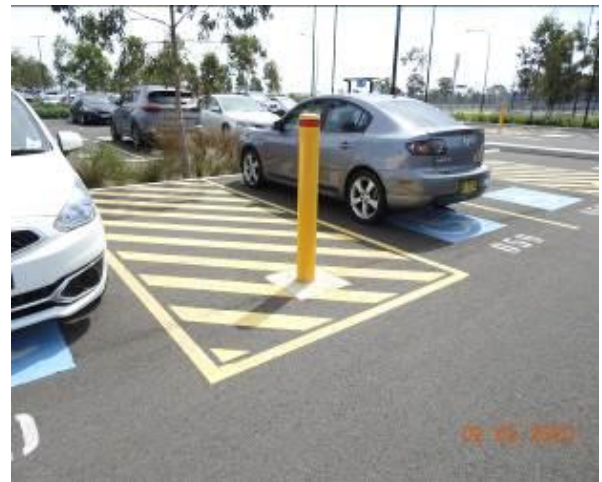
Figure 2437 – General Condition of traffic bollard

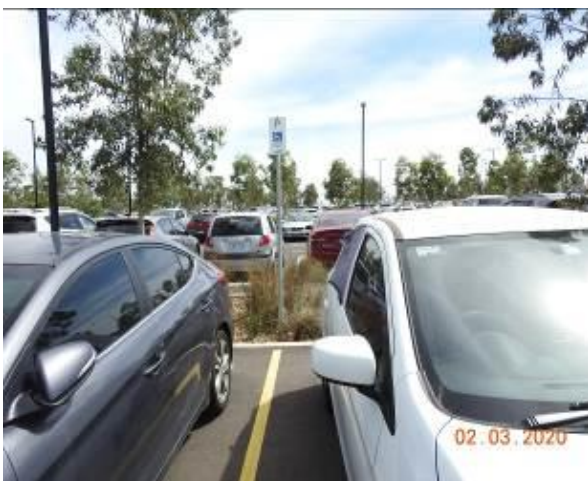
Figure 2438 – General Condition of street sign

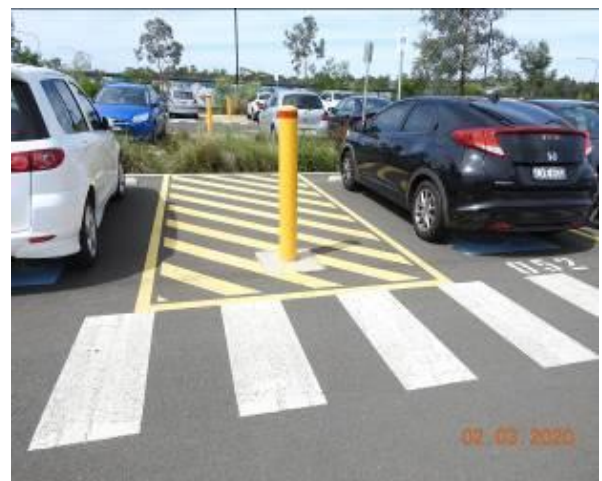
Figure 2439 – General Condition of traffic bollard

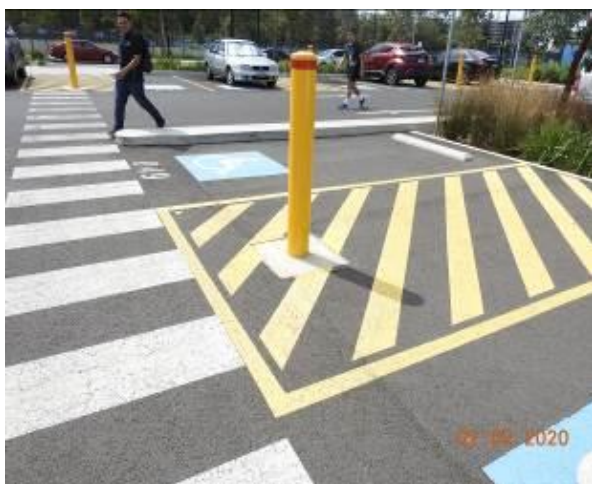
Figure 2440 – General Condition of traffic bollard

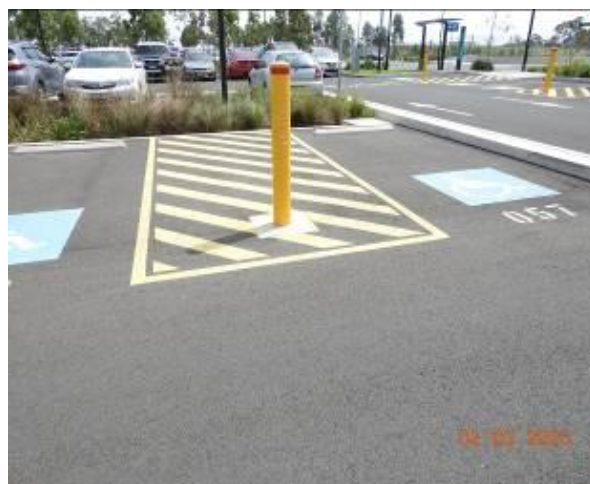
Figure 2441 – General Condition of traffic bollard

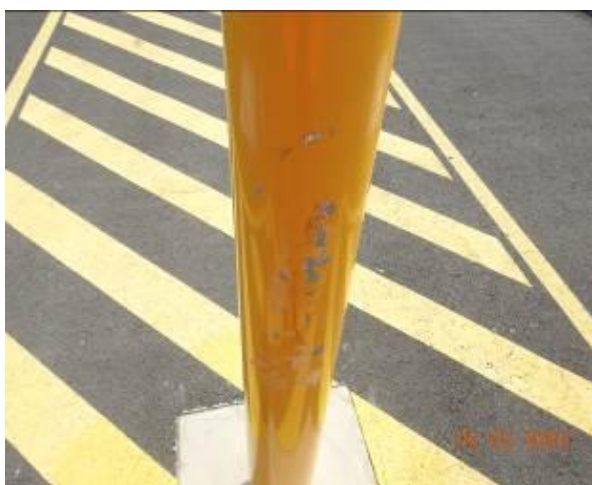
Figure 2442 – Physical damage traffic bollard

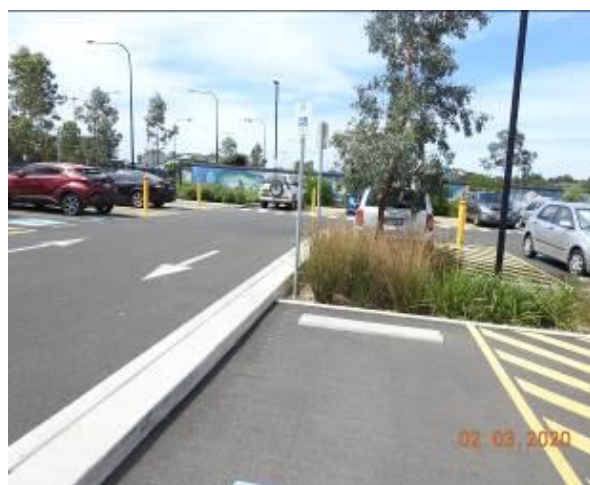
Figure 2443 – General Condition of street sign

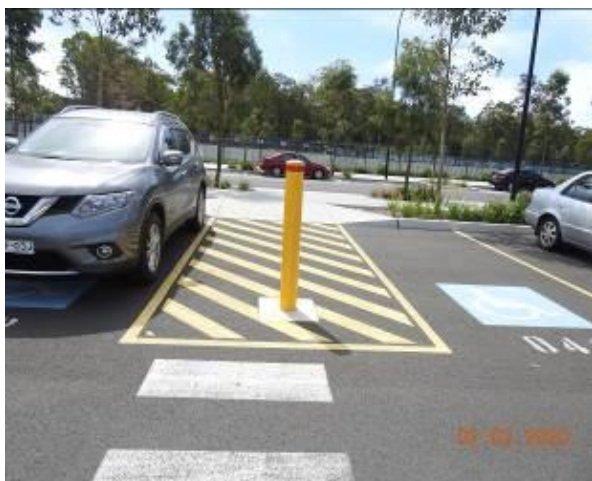
Figure 2444 – General Condition of traffic bollard

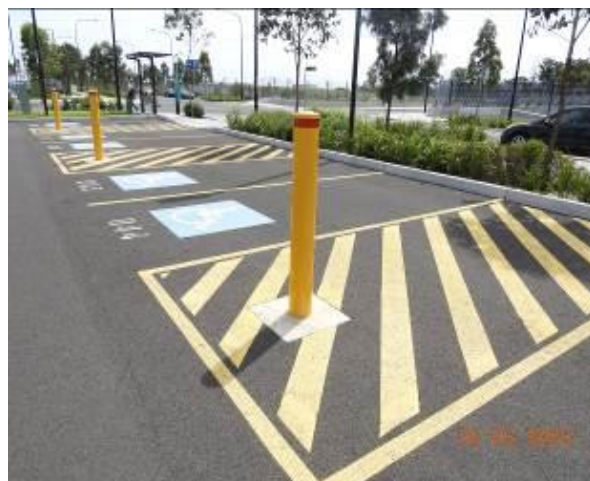
Figure 2445 – General Condition of traffic bollard

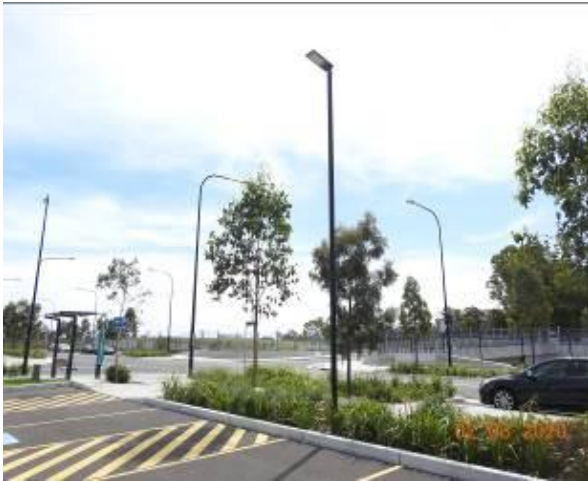
Figure 2446 – General Condition of lamp post

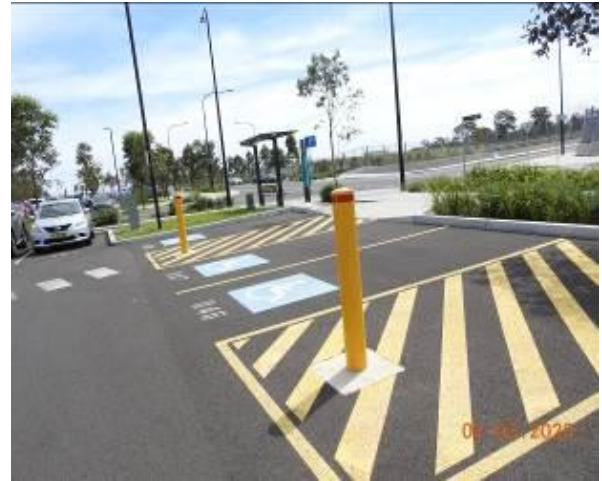
Figure 2447 – General Condition of traffic bollard

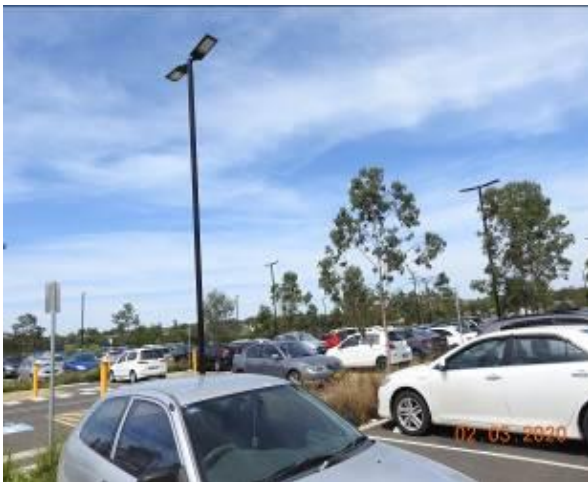
Figure 2448 – General Condition of lamp post

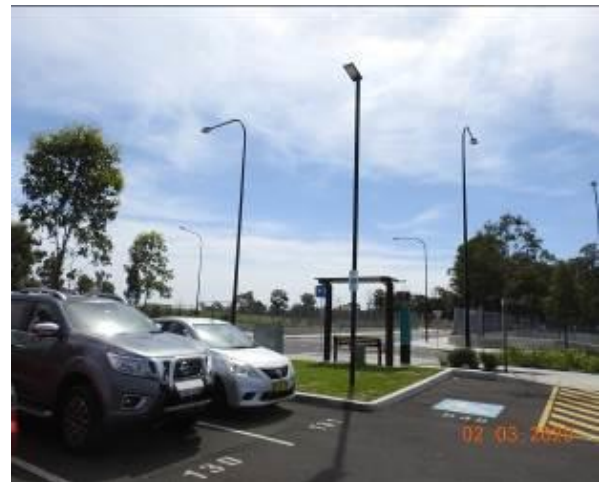
Figure 2449 – General Condition of lamp post

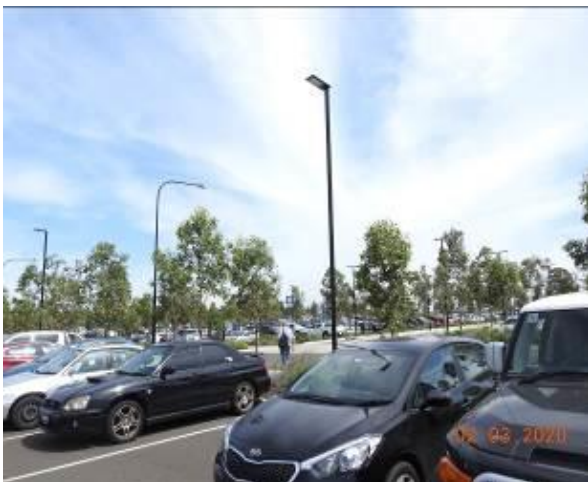
Figure 2450 – General Condition of lamp post

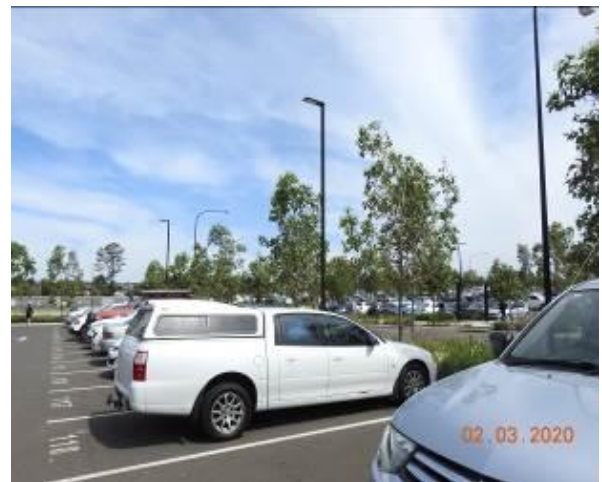
Figure 2451 – General Condition of lamp post

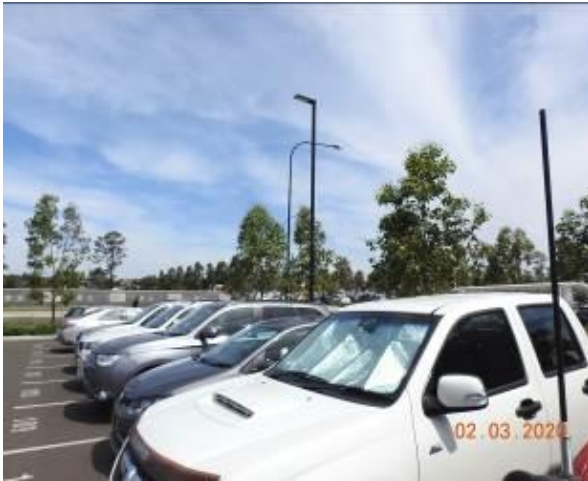
Figure 2452 – General Condition of lamp post

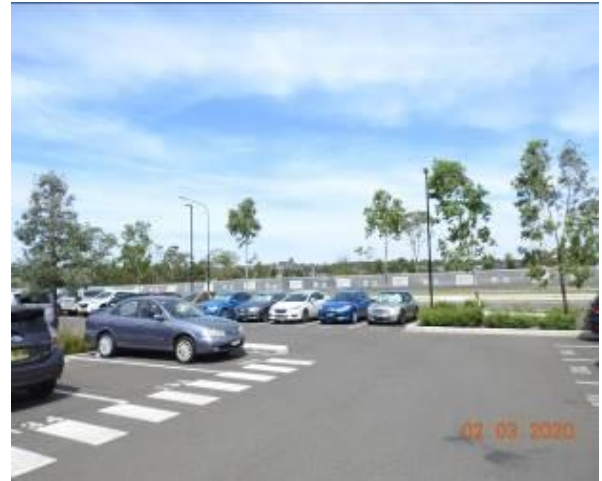
Figure 2453 – General Condition of lamp post

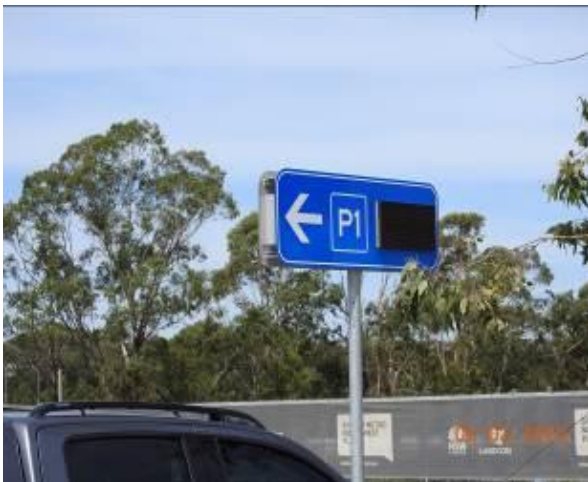
Figure 2454 – General Condition of street sign

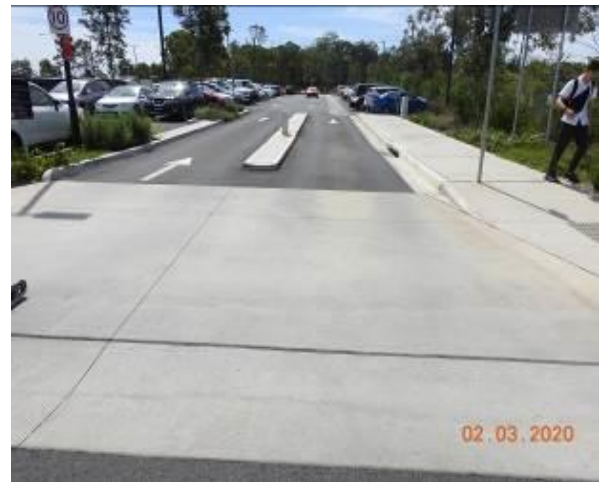
Figure 2455 – General Condition of layback

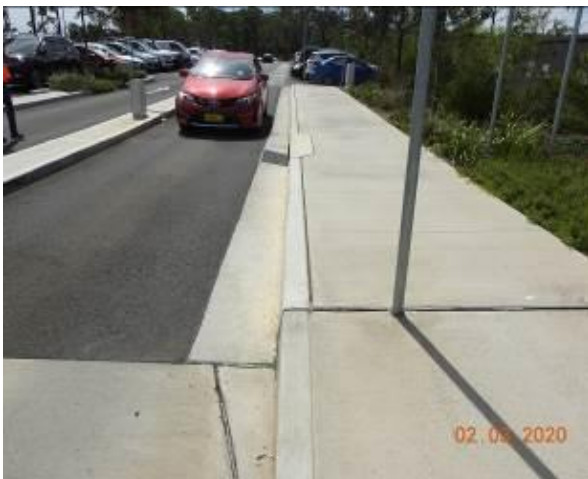
Figure 2456 – General Condition of kerb and gutter

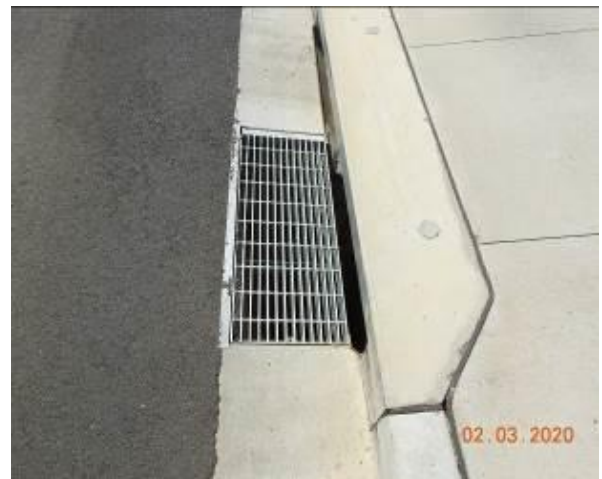
Figure 2457 – General Condition of stormwater inlet pit

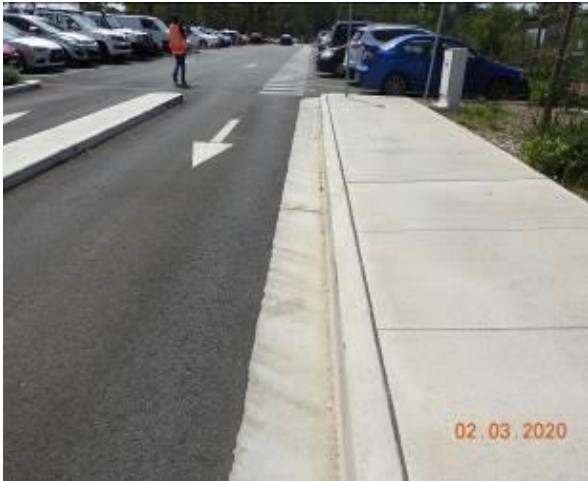
Figure 2458 – General Condition of kerb, gutter and footpath pavement

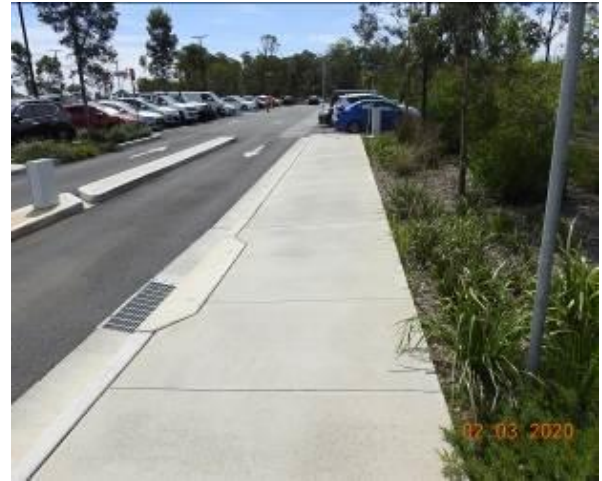
Figure 2459 – General Condition of footpath pavement

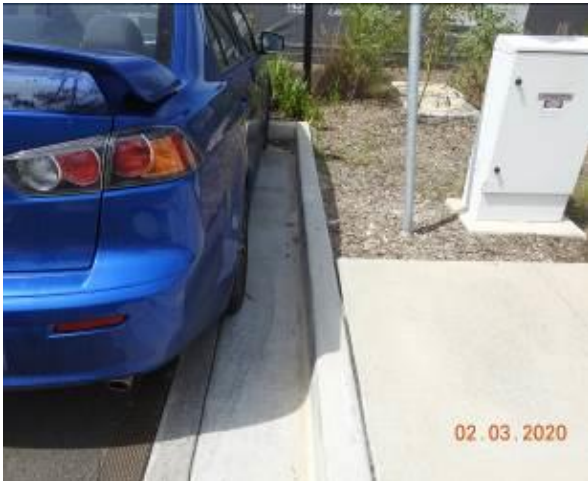
Figure 2460 – General Condition of kerb and gutter

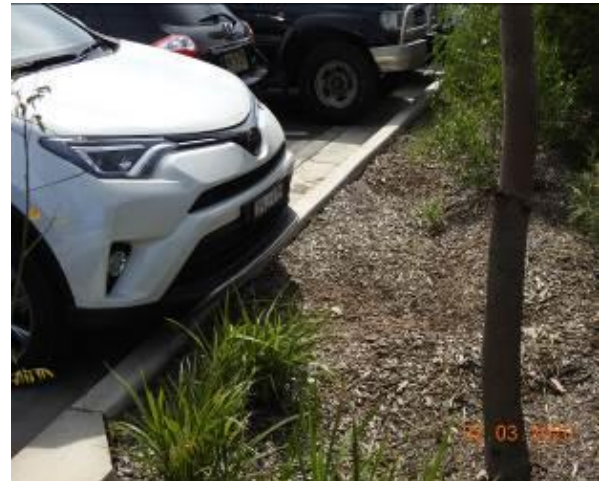
Figure 2461 – General Condition of kerb

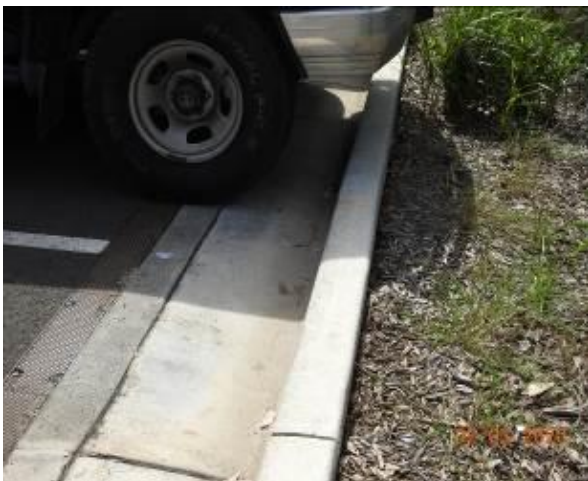
Figure 2462 – General Condition of kerb and gutter

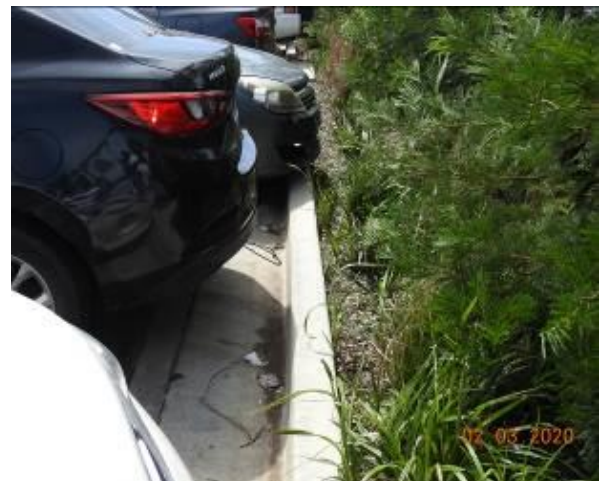
Figure 2463 – General Condition of kerb and gutter

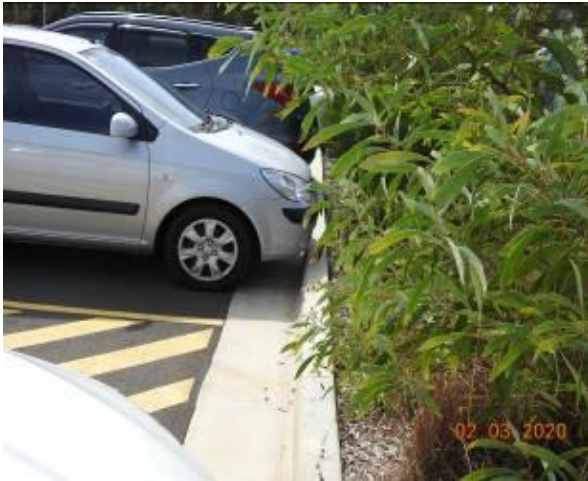
Figure 2464 – General Condition of kerb and gutter

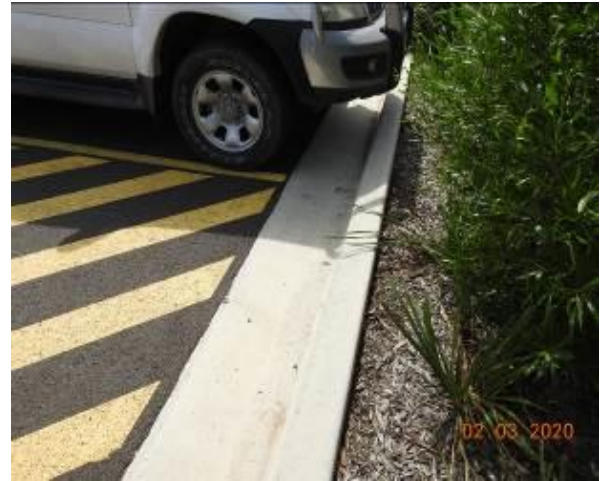
Figure 2465 – General Condition of kerb and gutter

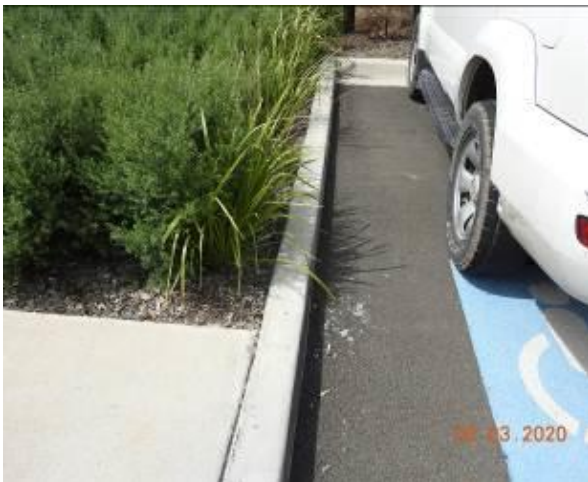
Figure 2466 – General Condition of kerb

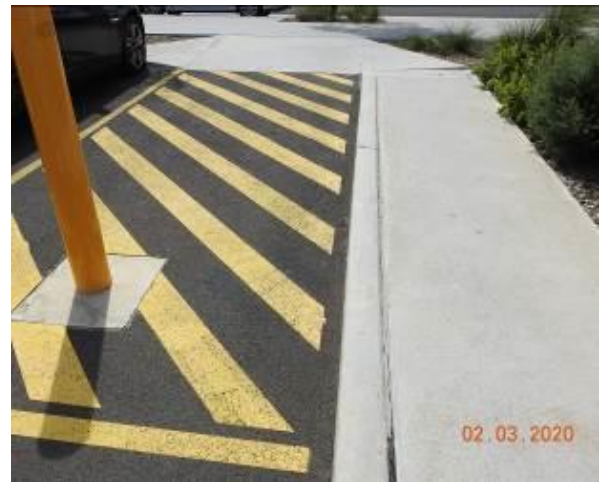
Figure 2467 – Crack propagation through footpath pavement

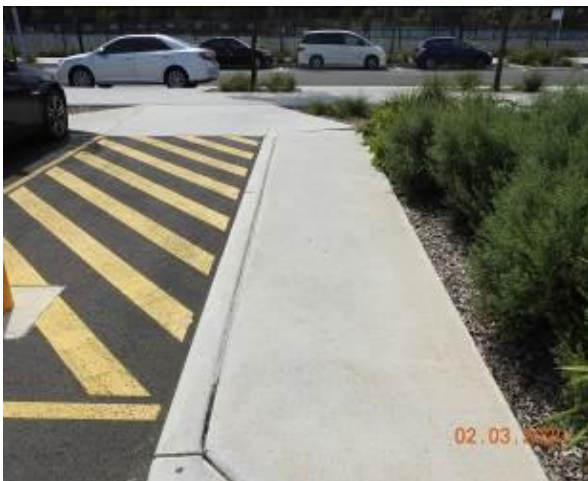
Figure 2468 – Crack propagation through footpath pavement

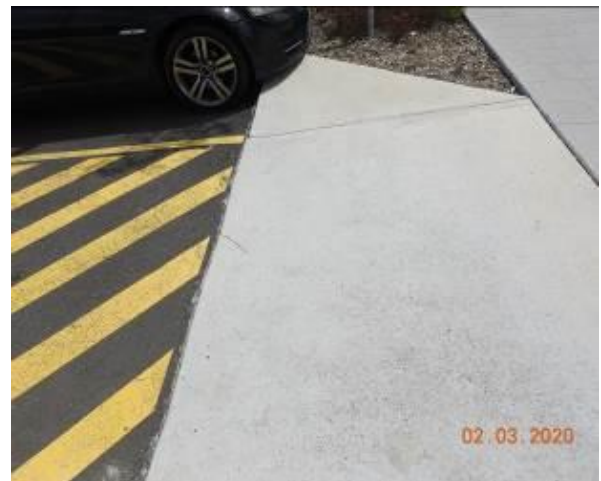
Figure 2469 – General Condition of footpath pavement

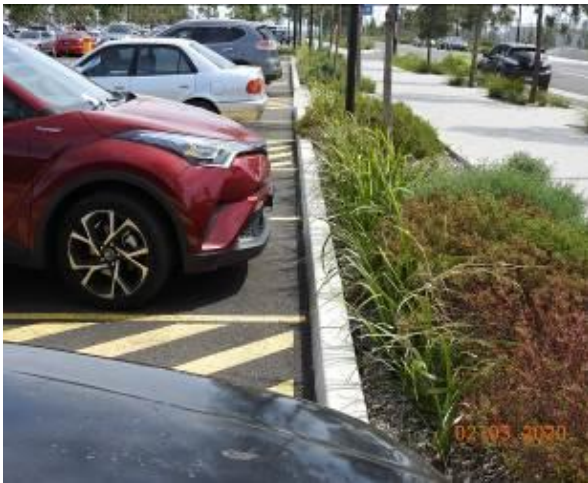
Figure 2470 – General Condition of kerb and gutter

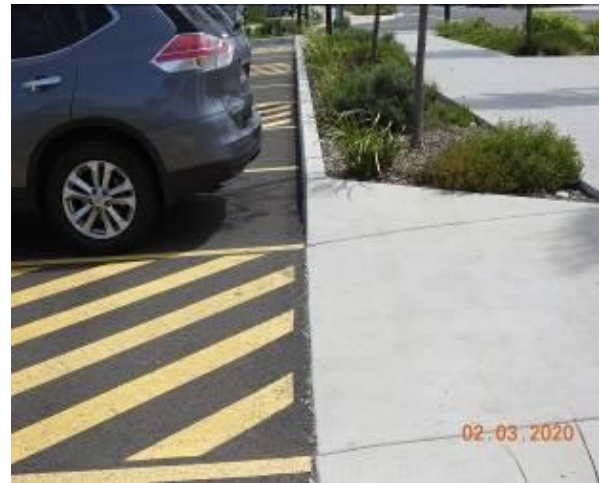
Figure 2471 – General Condition of layback and gutter

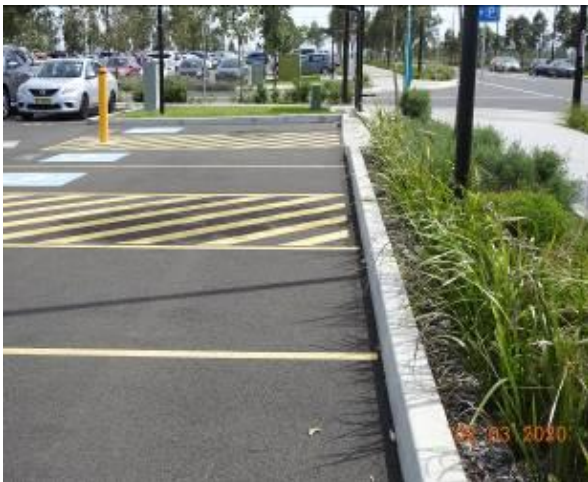
Figure 2472 – General Condition of kerb

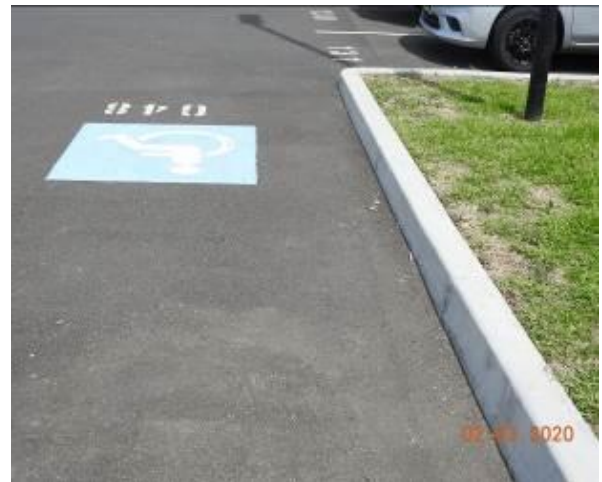
Figure 2473 – General Condition of kerb

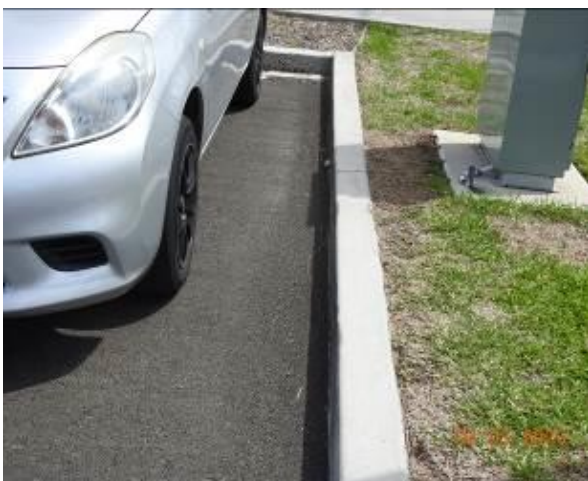
Figure 2474 – General Condition of kerb

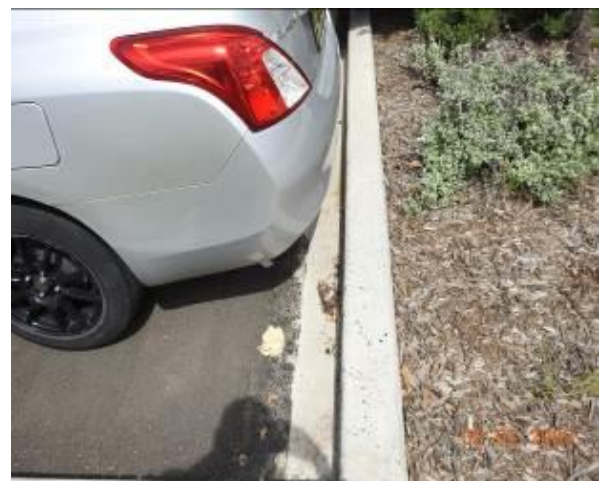
Figure 2475 – General Condition of kerb and gutter

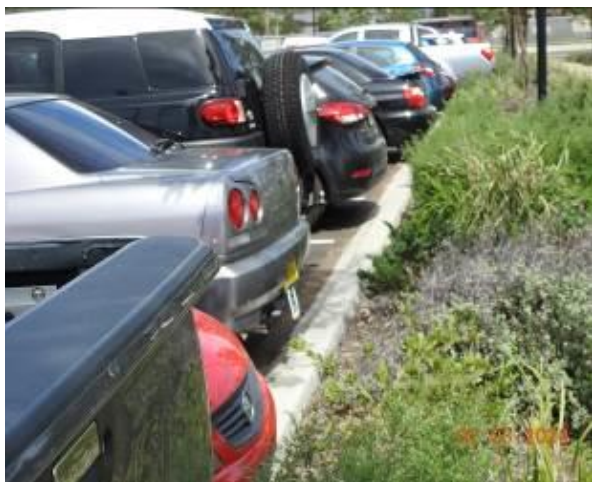
Figure 2476 – General Condition of kerb

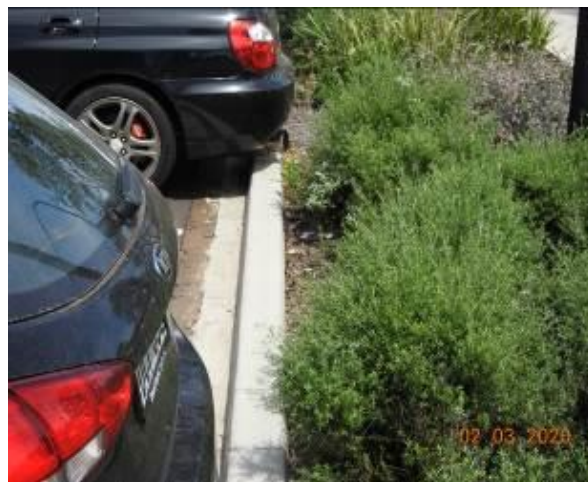
Figure 2477 – General Condition of kerb and gutter

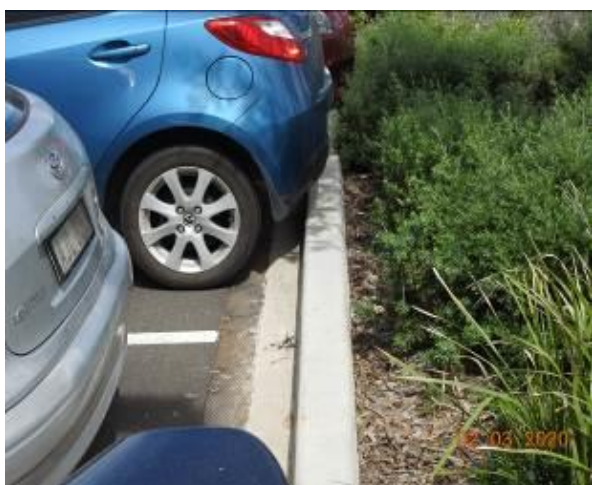
Figure 2478 – General Condition of kerb and gutter

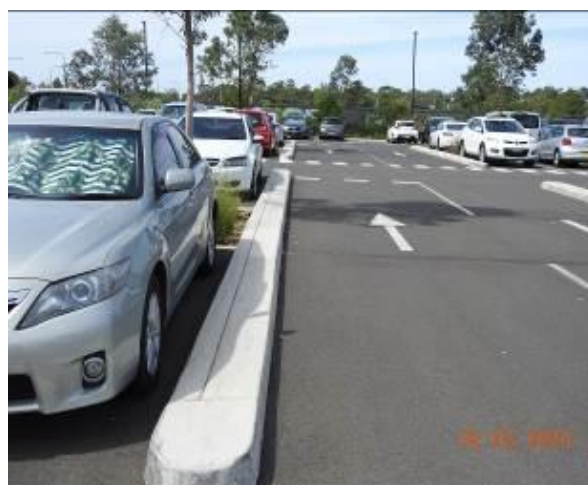
Figure 2479 – General Condition of traffic island kerb

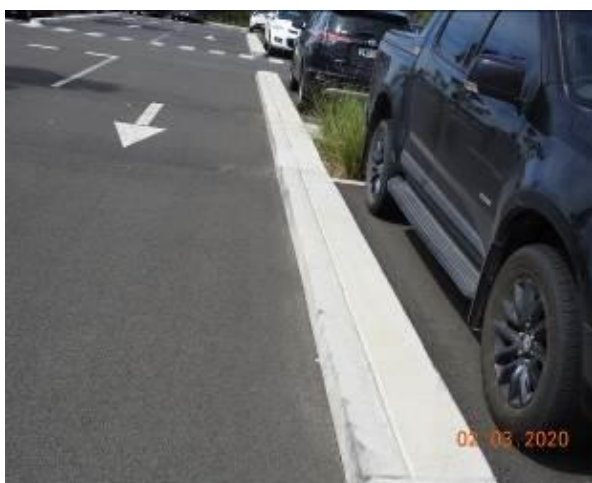
Figure 2480 – General Condition of traffic island kerb

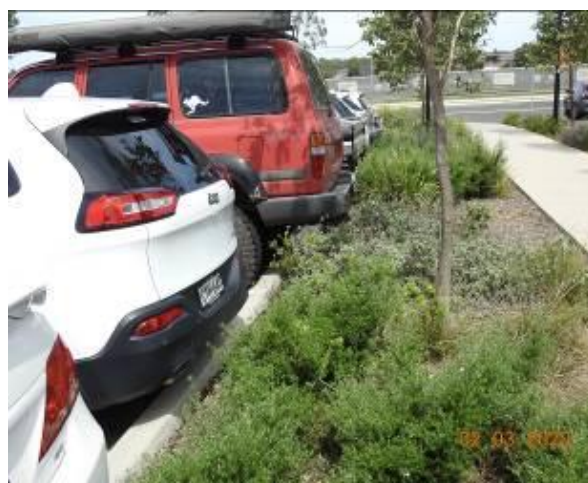
Figure 2481 – General Condition of kerb

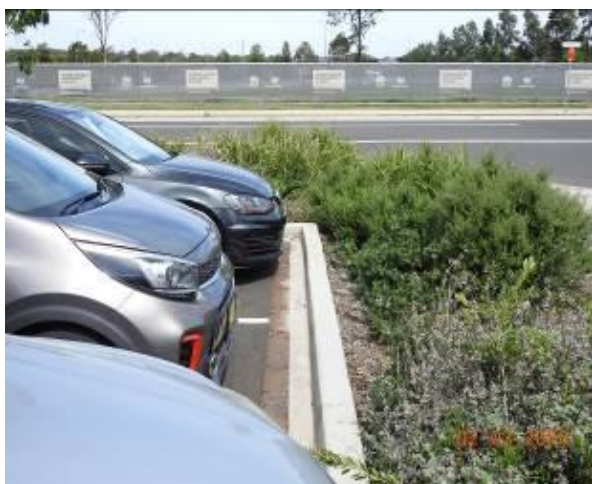
Figure 2482 – General Condition of kerb and gutter

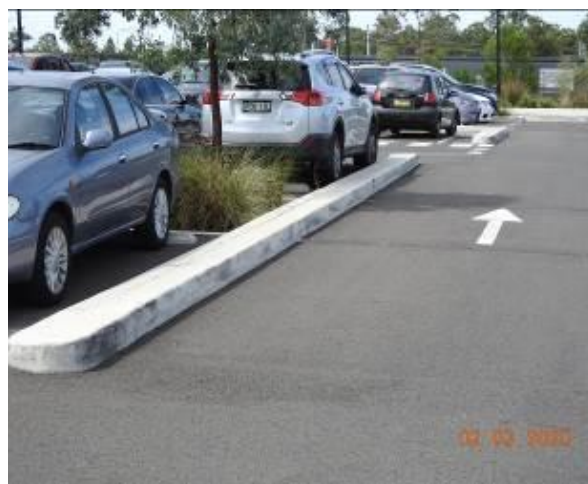
Figure 2483 – General Condition of traffic island kerb

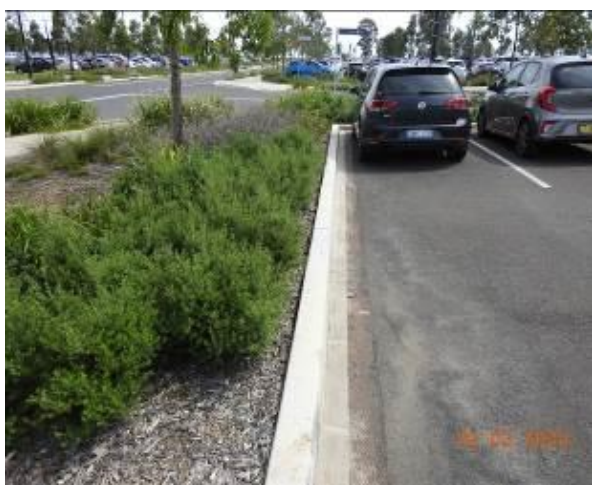
Figure 2484 – General Condition of kerb and gutter

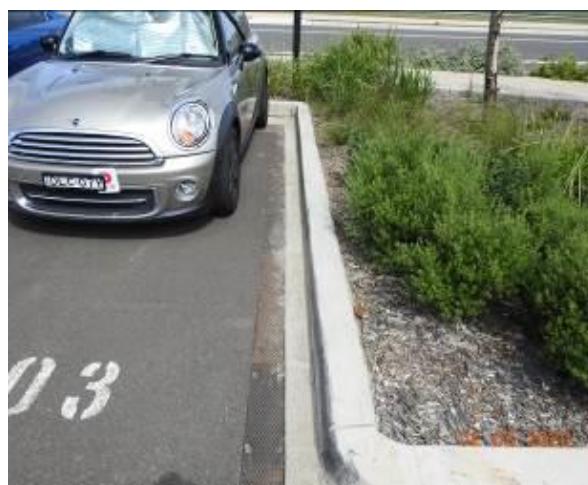
Figure 2485 – General Condition of kerb and gutter

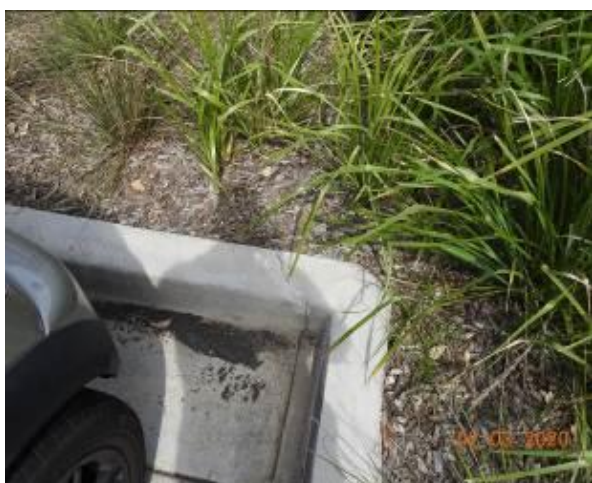
Figure 2486 – Crack propagation through kerb

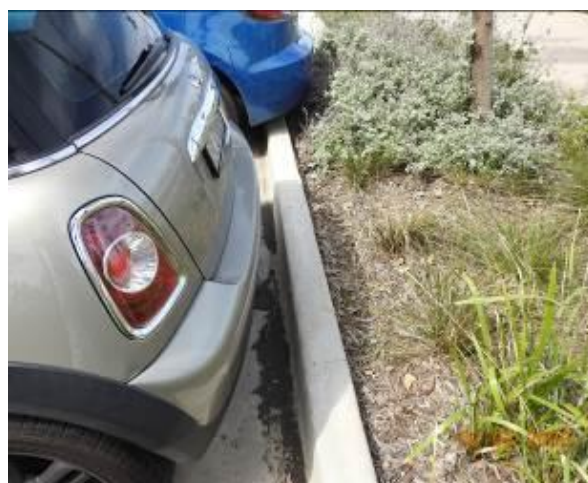
Figure 2487 – General Condition of kerb and gutter

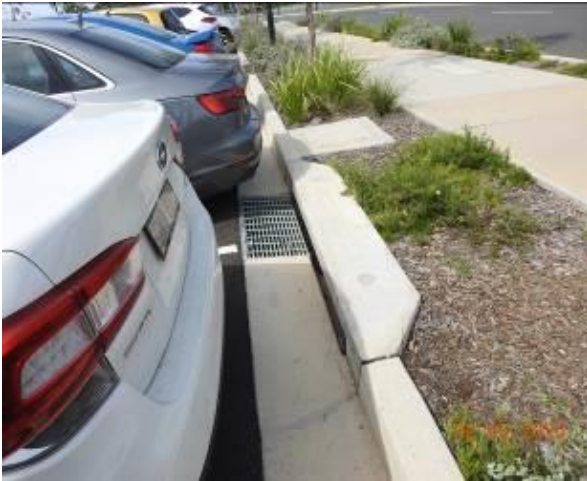
Figure 2488 – General Condition of kerb and gutter

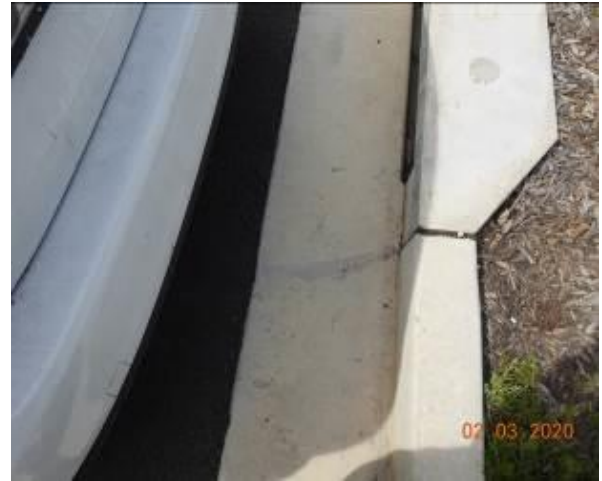
Figure 2489 – Crack propagation through gutter

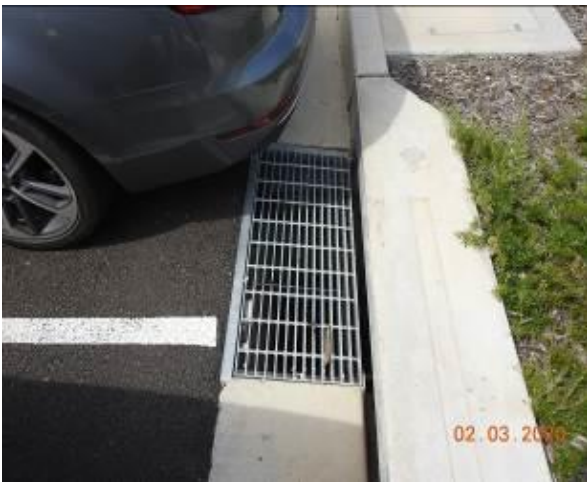
Figure 2490 – General Condition of stormwater inlet pit

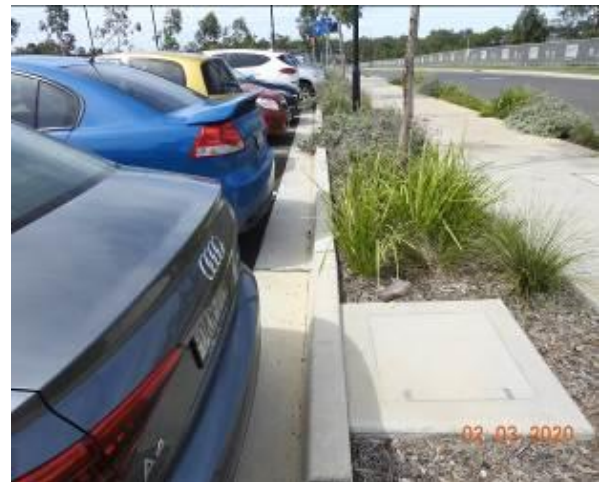
Figure 2491 – General Condition of kerb and gutter

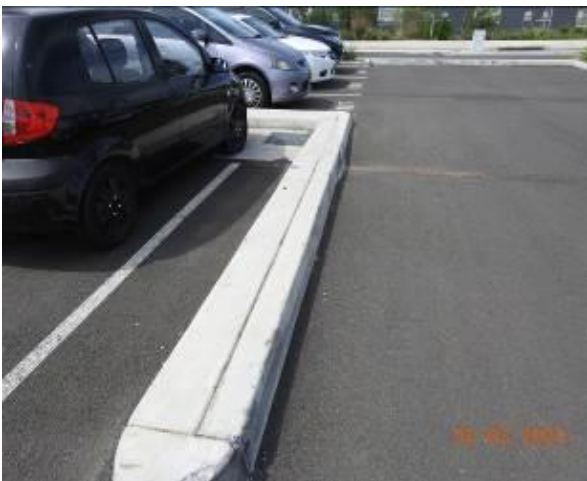
Figure 2492 – General Condition of traffic island kerb

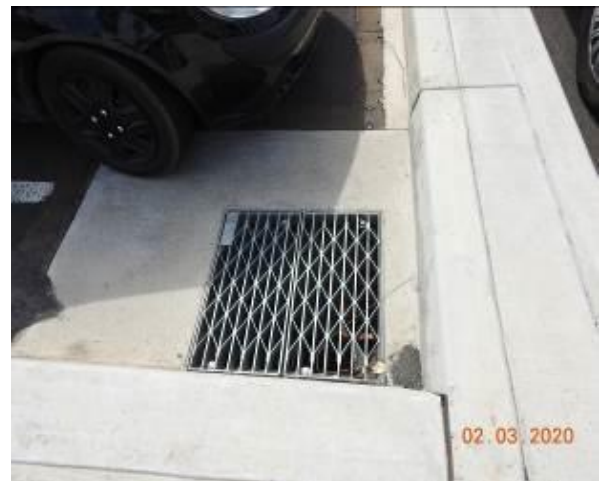
Figure 2493 – General Condition of stormwater inlet pit

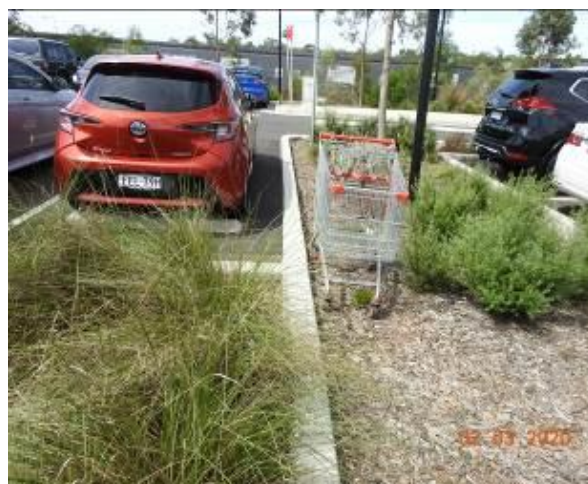
Figure 2495 – General Condition of kerb

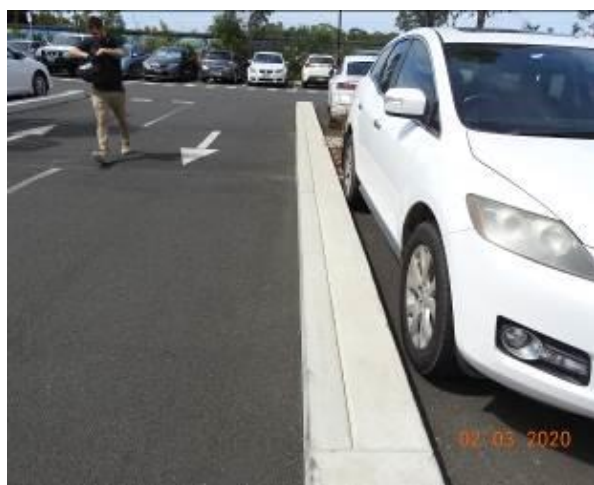
Figure 2496 – General Condition of traffic island kerb

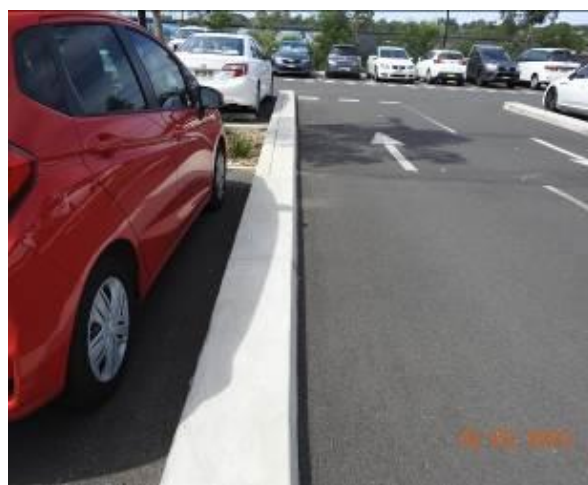
Figure 2497 – General Condition of traffic island kerb

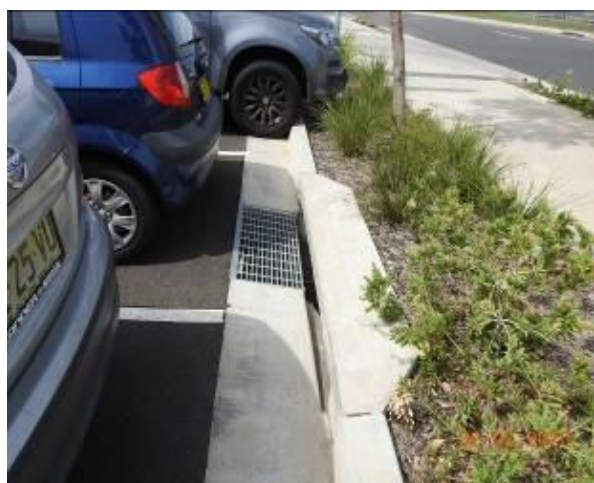
Figure 2498 – General Condition of kerb and gutter

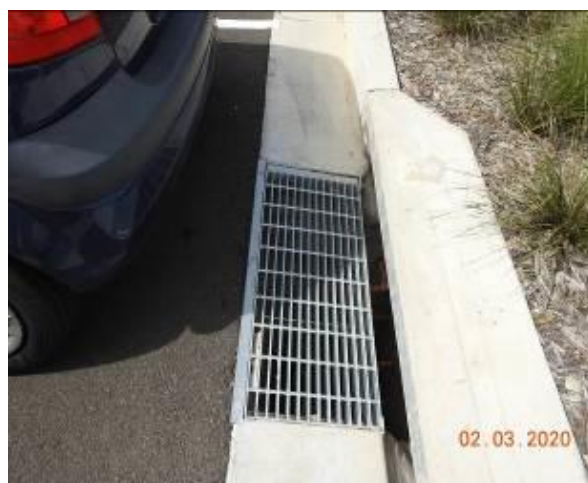
Figure 2499 – General Condition of stormwater inlet pit

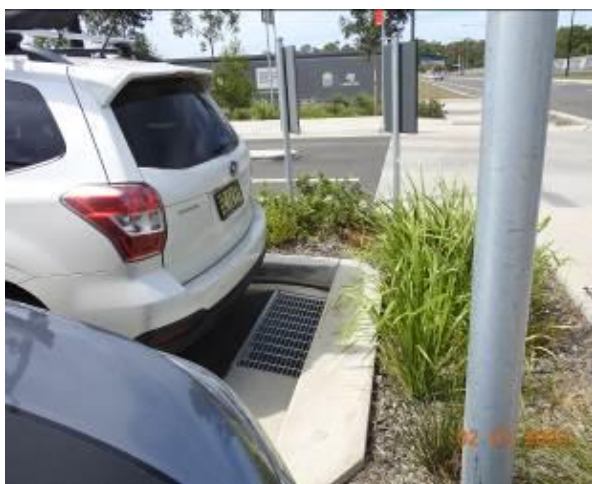
Figure 2500 – General Condition of kerb and gutter

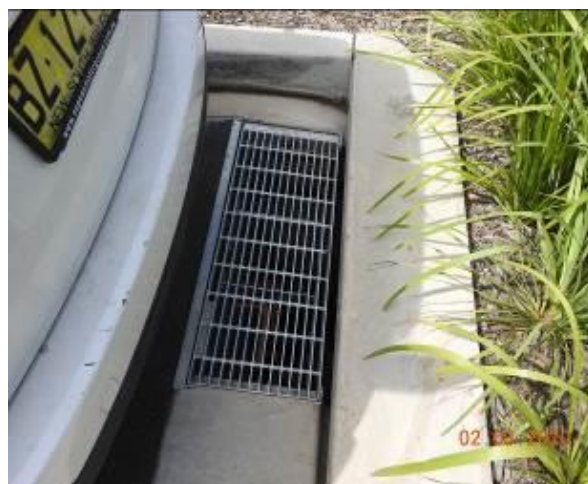
Figure 2501 – General Condition of stormwater inlet pit

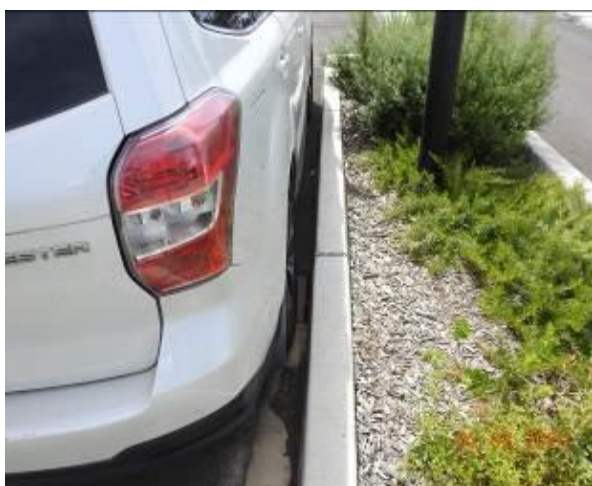
Figure 2502 – General Condition of kerb

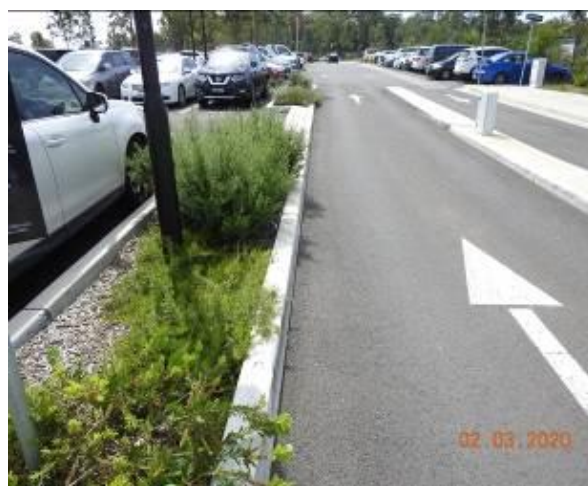
Figure 2503 – General Condition of kerb
