**1-15 AND 2-12 CONFERTA AVENUE,
ROUSE HILL NSW 2155
TALLAWONG STATION PRECINCT SOUTH
PRE-DILAPIDATION REPORT**

**DEICORP PROJECTS
(TALLAWONG STATION) PTY LTD**

Job No. 191294.0
24/03/2020

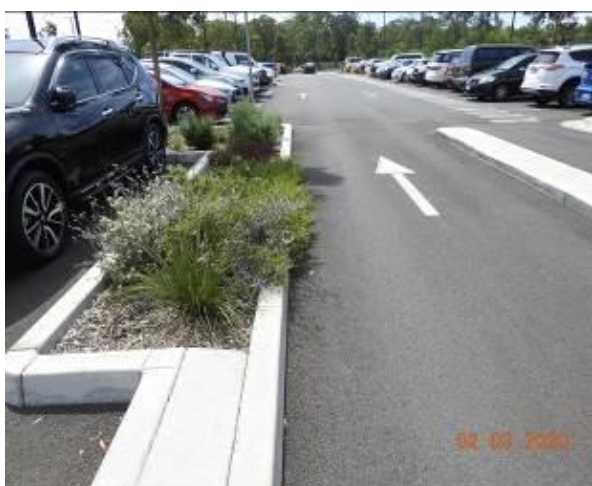
Figure 2504 – General Condition of traffic island kerb

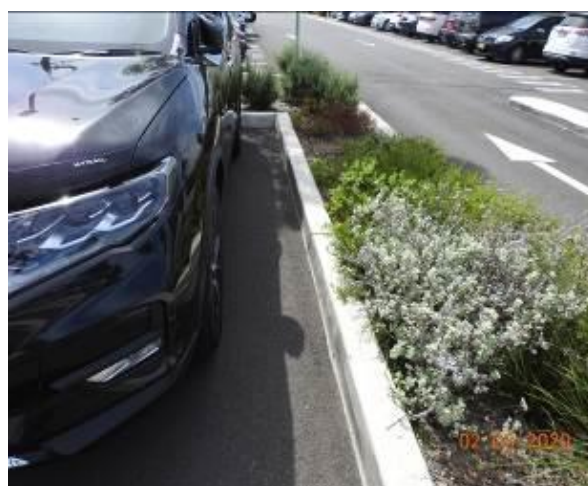
Figure 2505 – General Condition of kerb

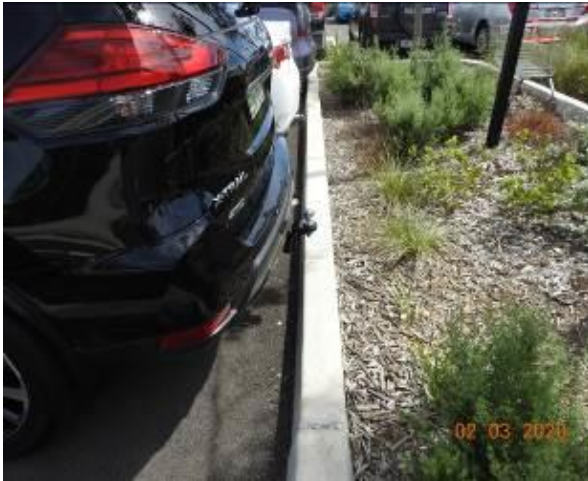
Figure 2506 – General Condition of kerb

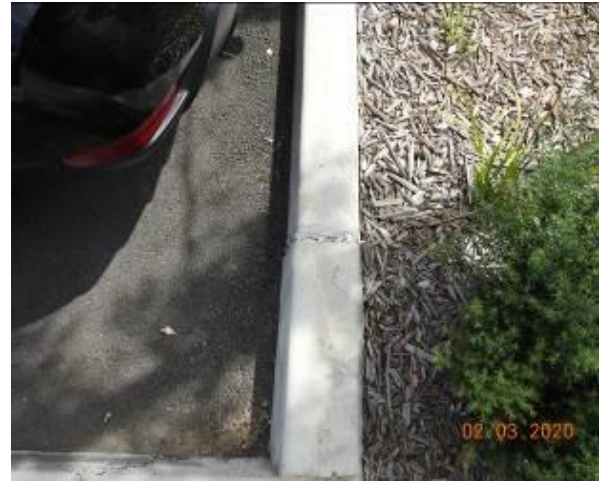
Figure 2507 – Crack propagation and loss of material through kerb

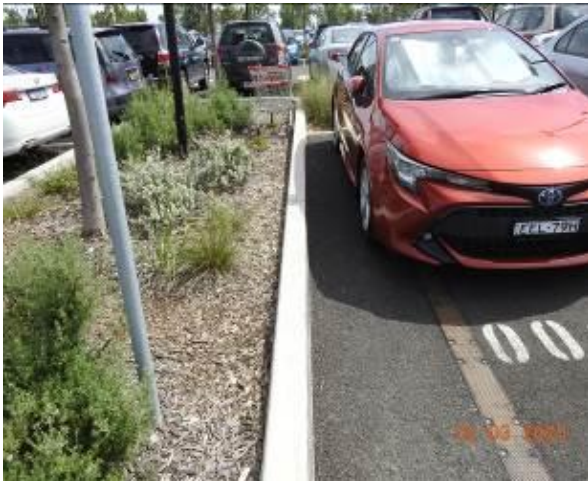
Figure 2508 – General Condition of kerb

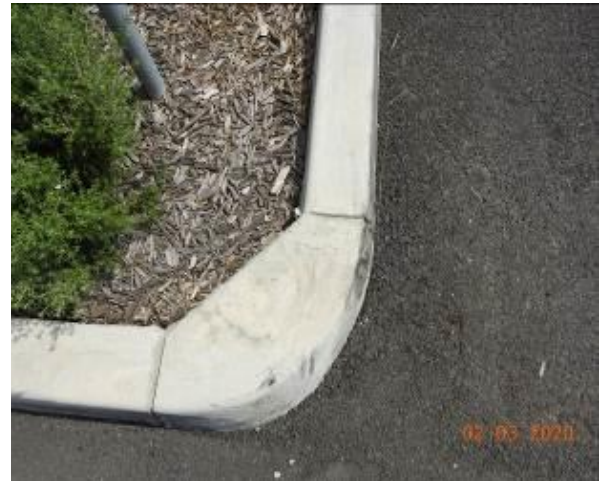
Figure 2509 – Crack propagation through kerb

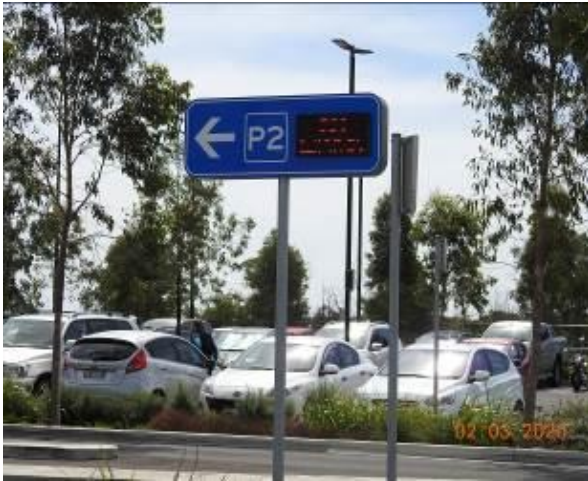
Figure 2510 – The following images display condition of Carpark 2

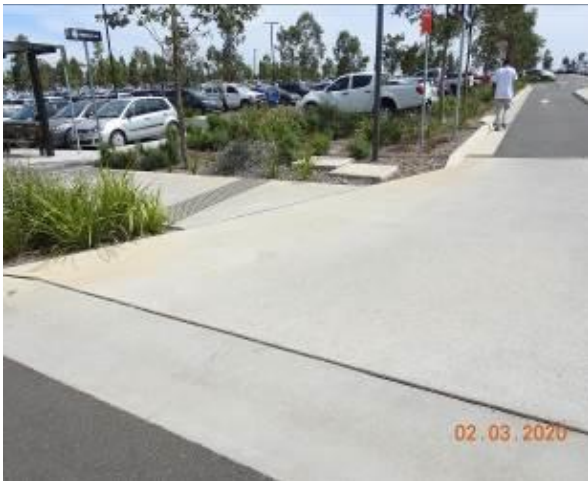
Figure 2512 – Crack propagation through layback and gutter

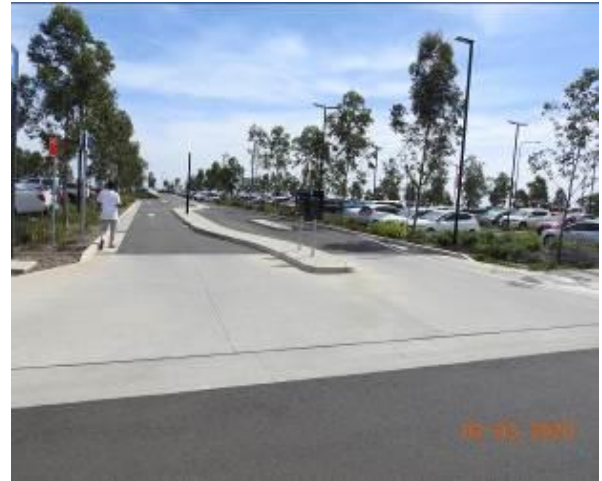
Figure 2514 – General Condition of driveway pavement

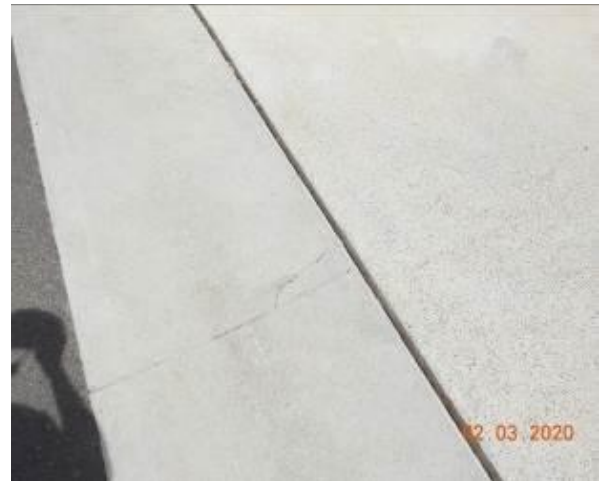
Figure 2511 – General Condition of driveway pavement

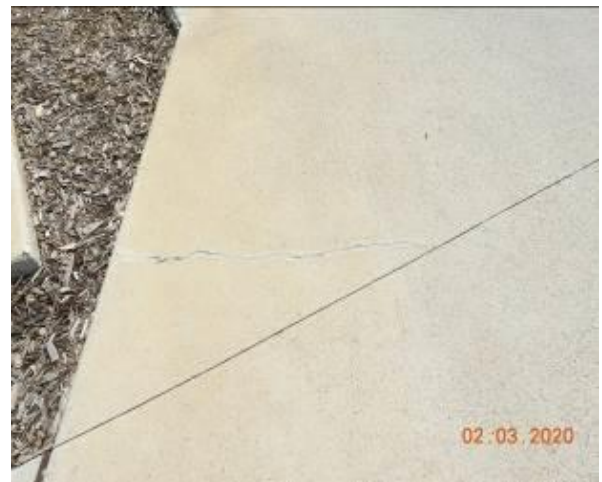
Figure 2513 – Crack propagation through layback and gutter

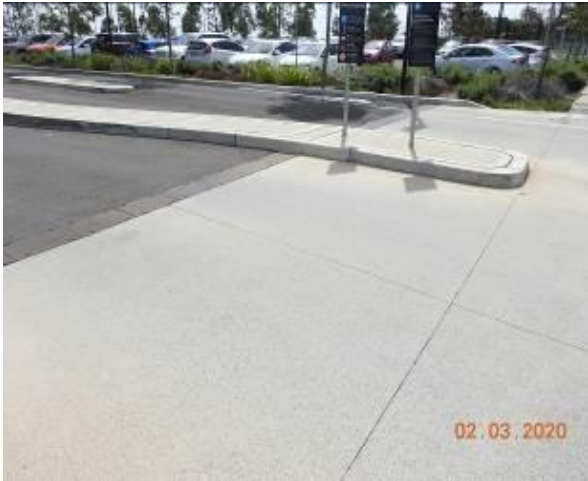
Figure 2515 – Crack propagation through driveway pavement

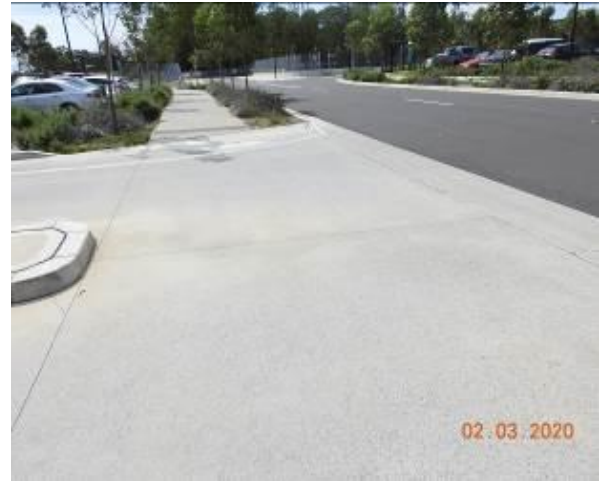
Figure 2516 – General Condition of driveway pavement

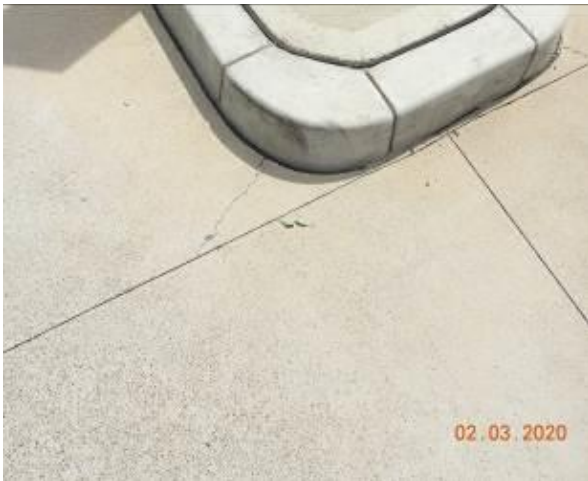
Figure 2517 – General Condition of driveway pavement

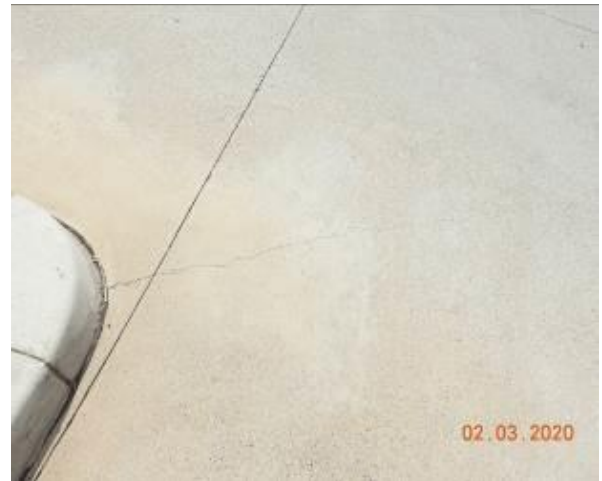
Figure 2518 – Crack propagation through driveway pavement

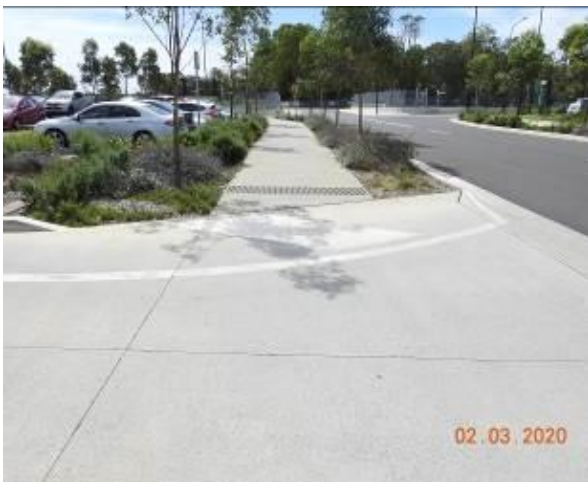
Figure 2519 – Crack propagation through driveway pavement

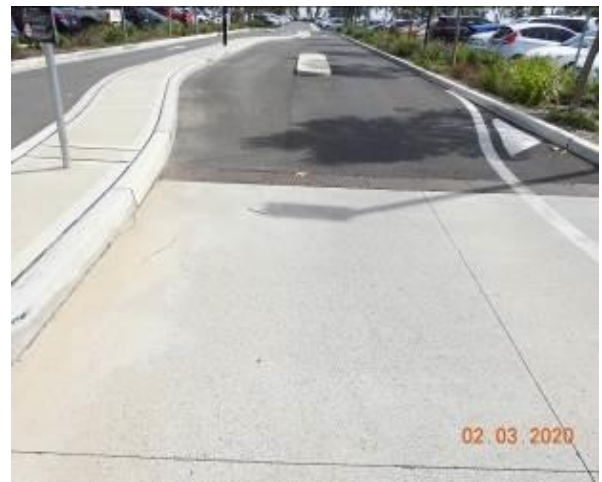
Figure 2520 – General Condition of driveway pavement

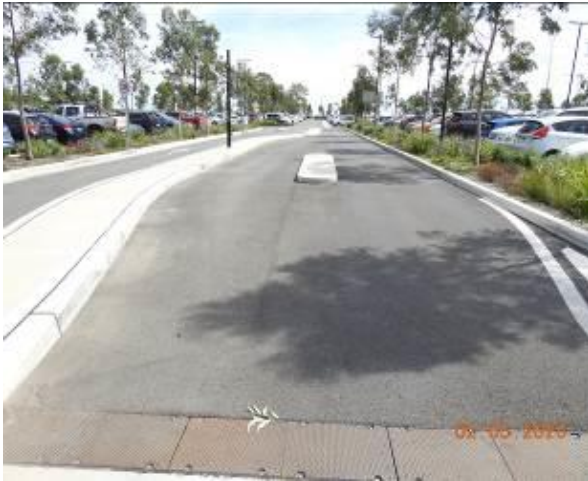
Figure 2521 – General Condition of driveway pavement

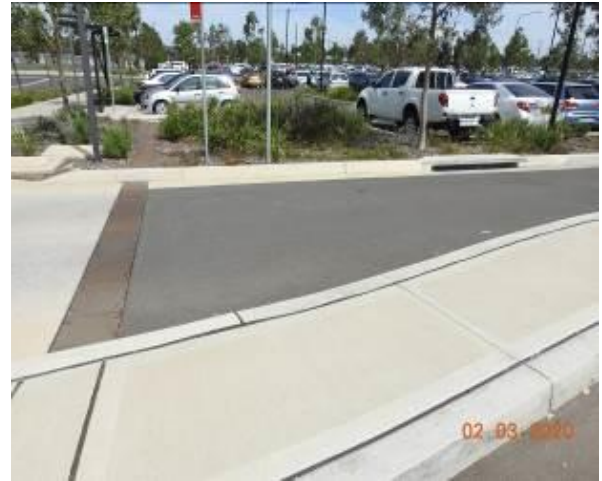
Figure 2522 – General Condition of carpark pavement

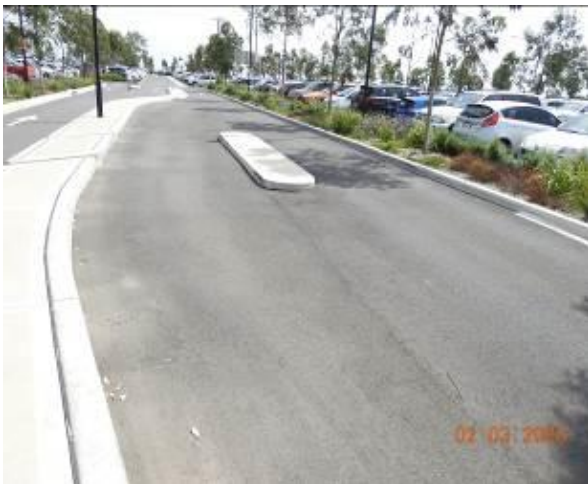
Figure 2523 – General Condition of carpark pavement

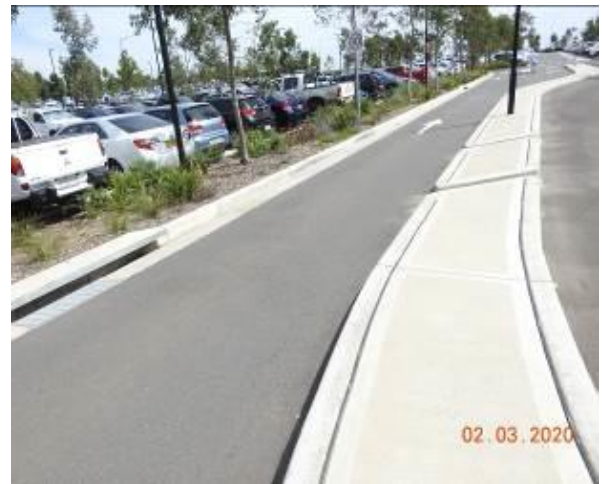
Figure 2524 – General Condition of carpark pavement

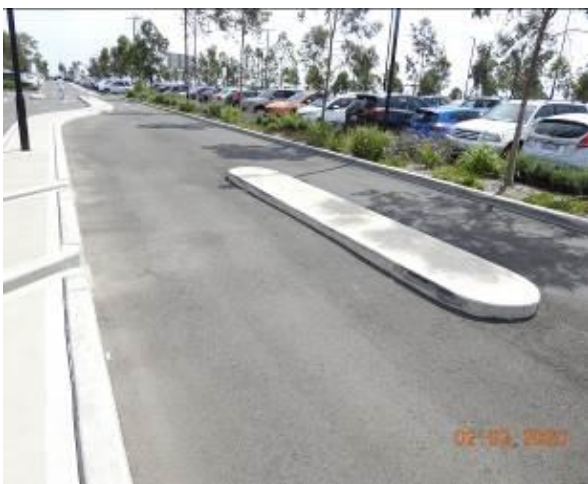
Figure 2525 – General Condition of carpark pavement

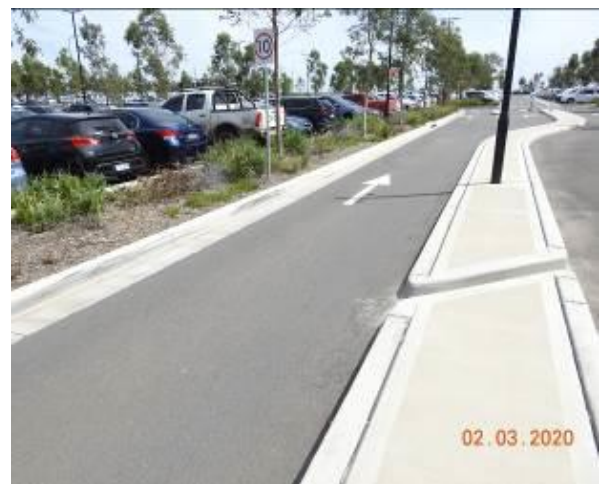
Figure 2526 – General Condition of carpark pavement

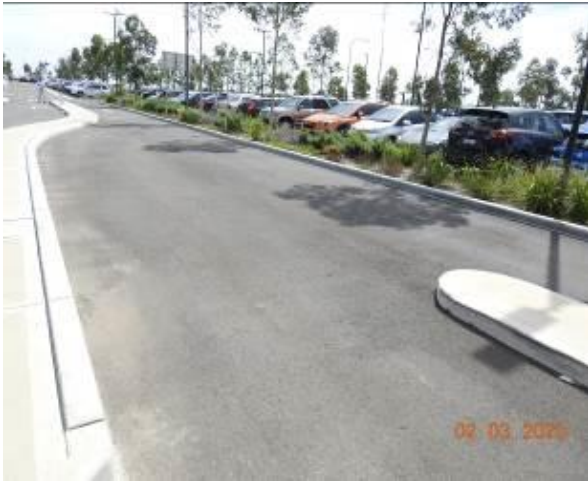
Figure 2527 – General Condition of carpark pavement

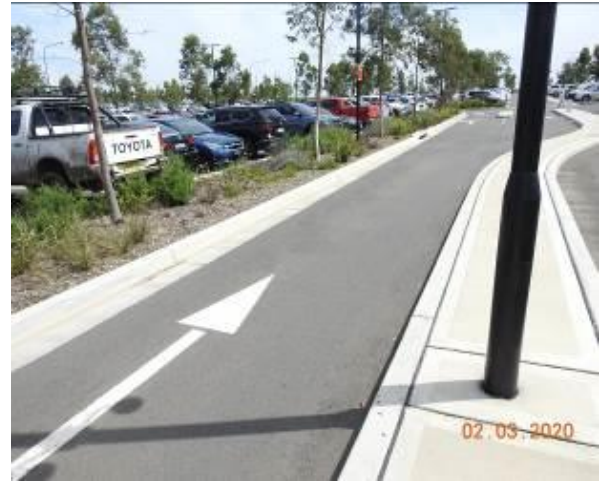
Figure 2528 – General Condition of carpark pavement

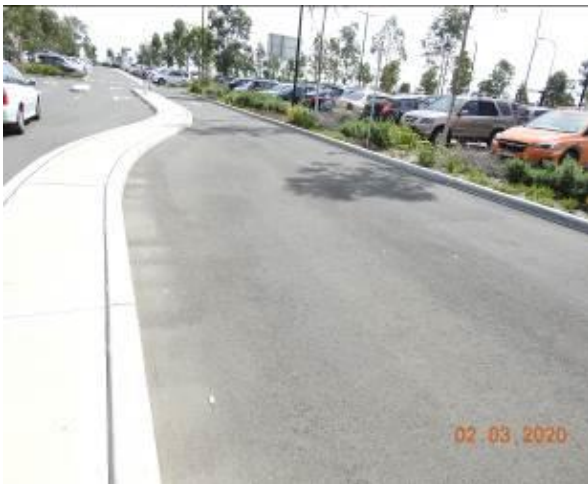
Figure 2529 – General Condition of carpark pavement

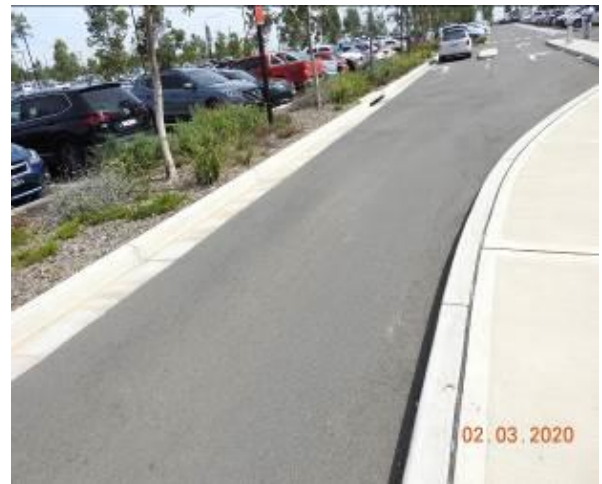
Figure 2530 – General Condition of carpark pavement

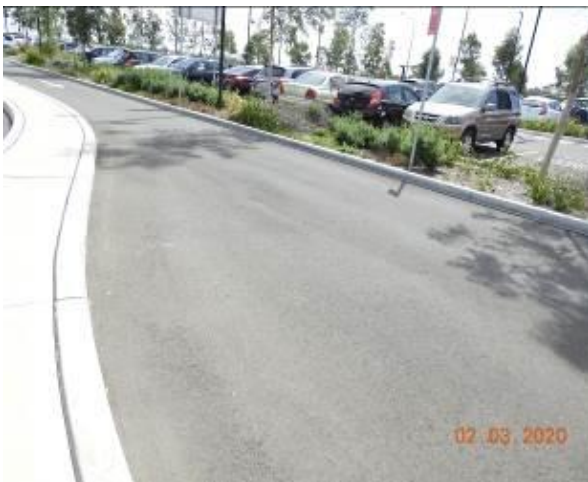
Figure 2531 – General Condition of carpark pavement

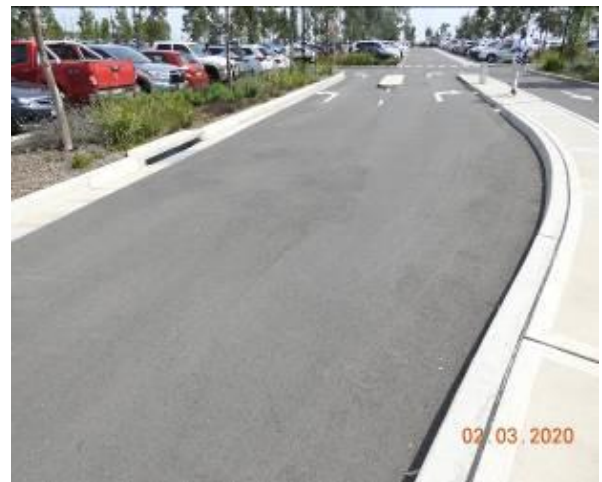
Figure 2532 – General Condition of carpark pavement

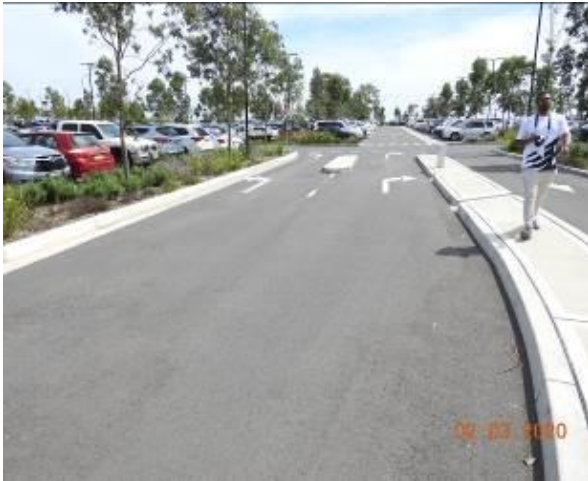
Figure 2533 – General Condition of carpark pavement

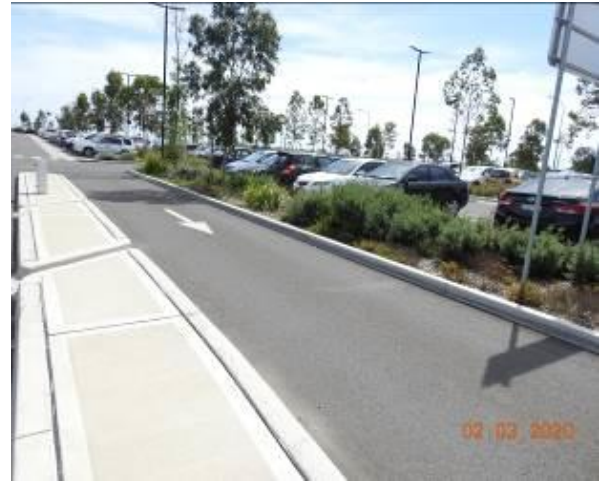
Figure 2534 – General Condition of carpark pavement

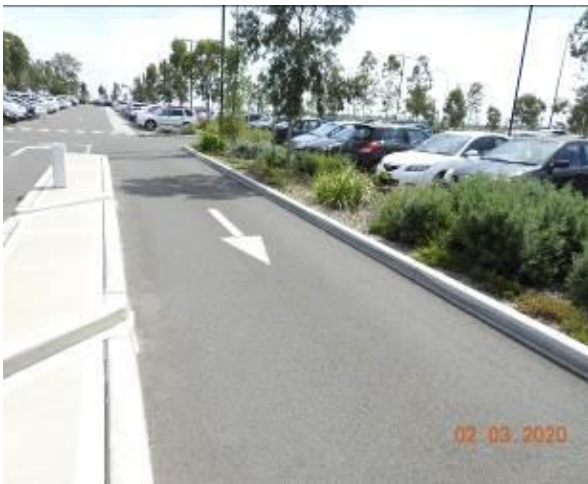
Figure 2535 – General Condition of carpark pavement

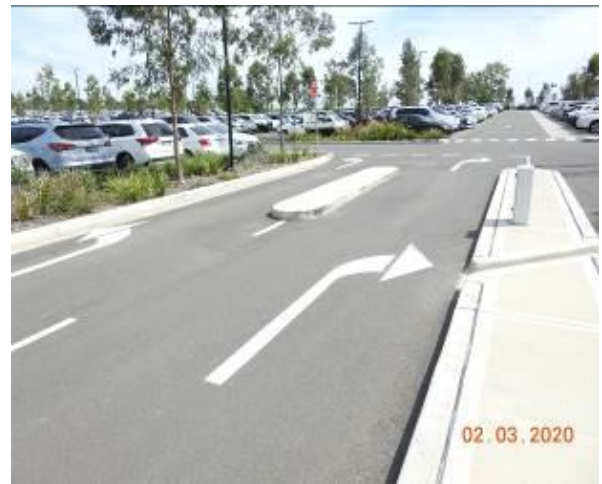
Figure 2536 – General Condition of carpark pavement

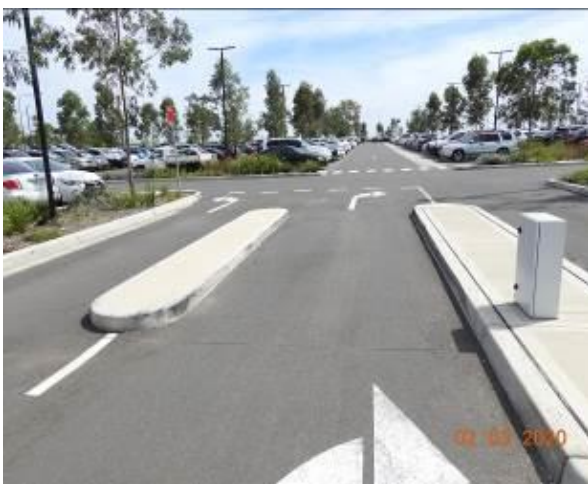
Figure 2537 – General Condition of carpark pavement

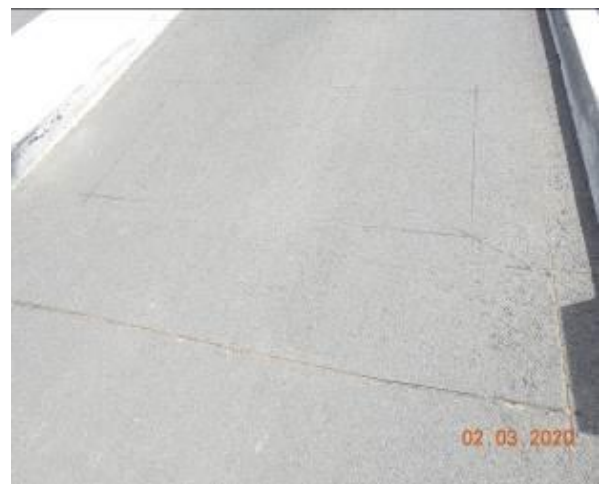
Figure 2538 – General Condition of carpark pavement

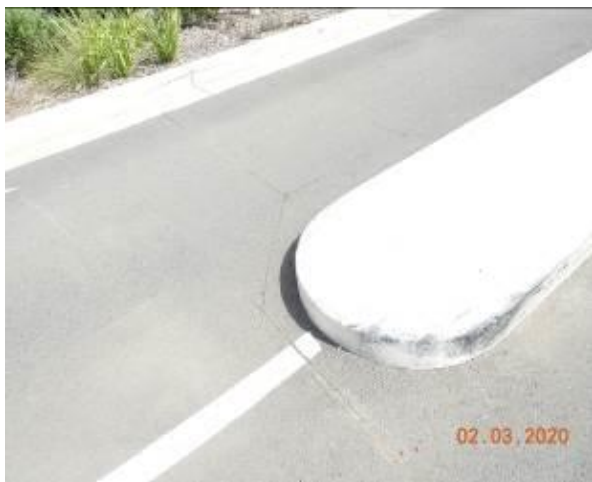
Figure 2539 – General Condition of carpark pavement

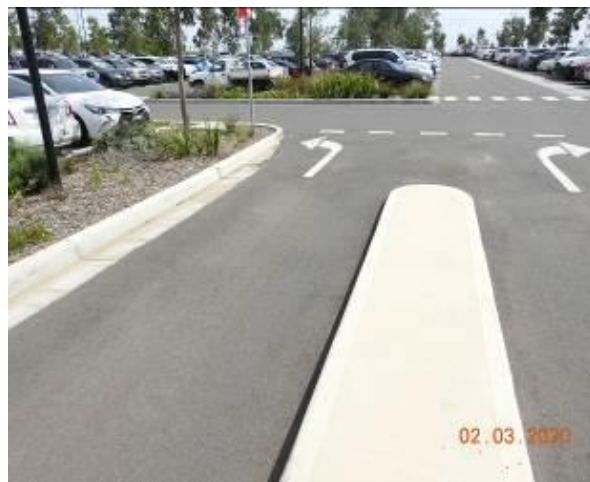
Figure 2540 – General Condition of carpark pavement

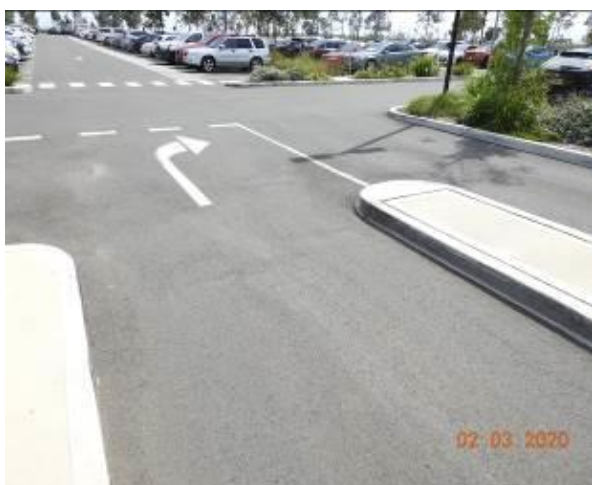
Figure 2541 – General Condition of carpark pavement

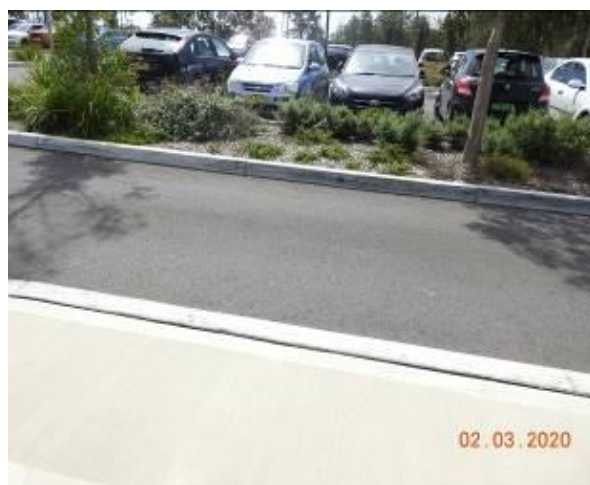
Figure 2542 – General Condition of carpark pavement

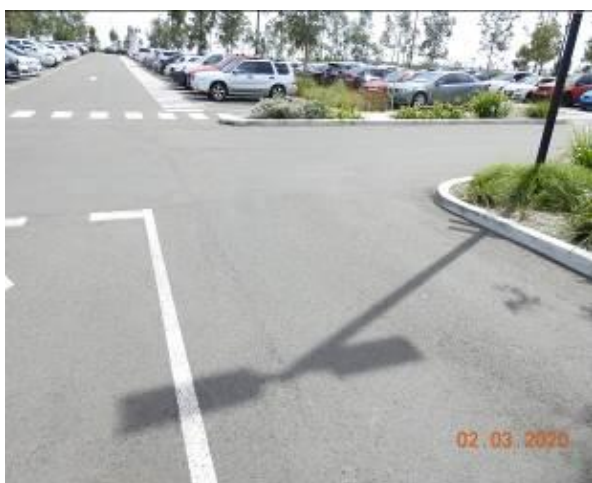
Figure 2543 – General Condition of carpark pavement

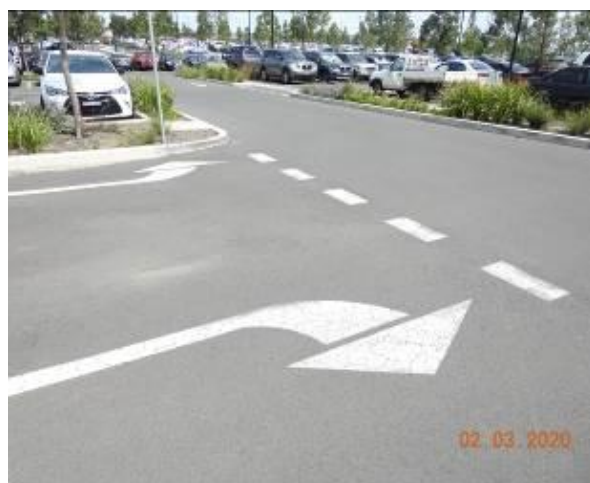
Figure 2544 – General Condition of carpark pavement

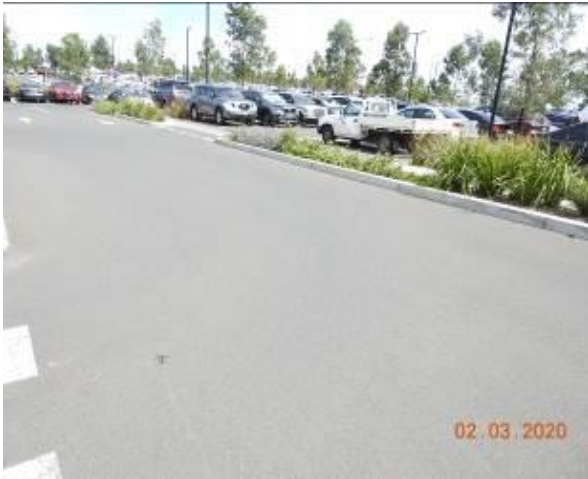
Figure 2545 – General Condition of carpark pavement

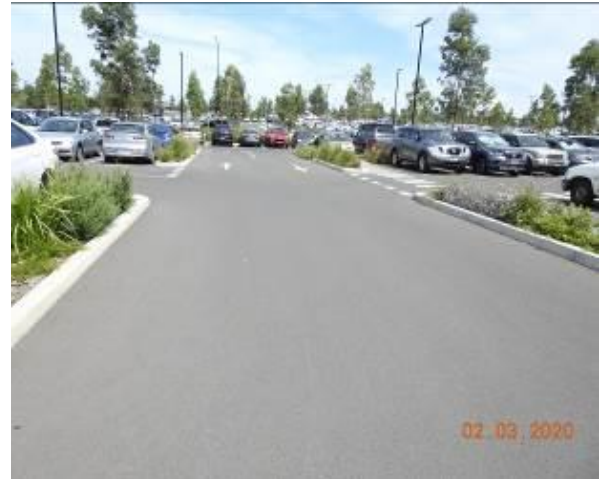
Figure 2546 – General Condition of carpark pavement

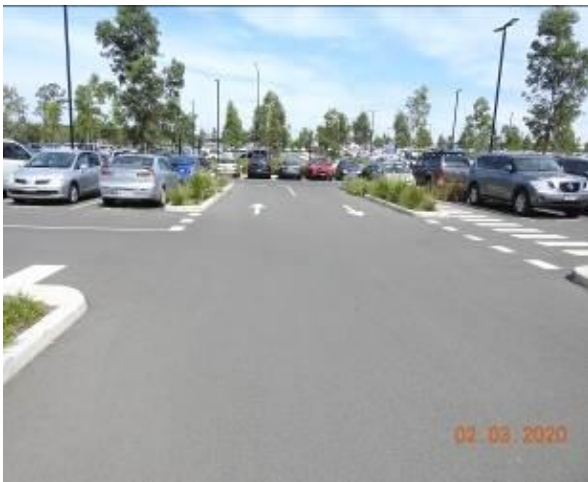
Figure 2547 – General Condition of carpark pavement

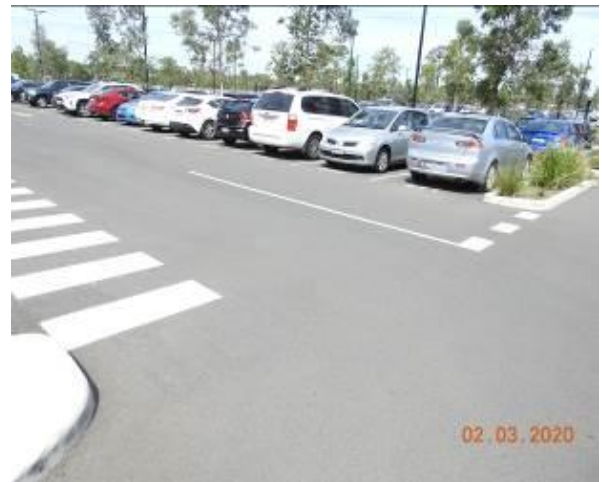
Figure 2548 – General Condition of carpark pavement

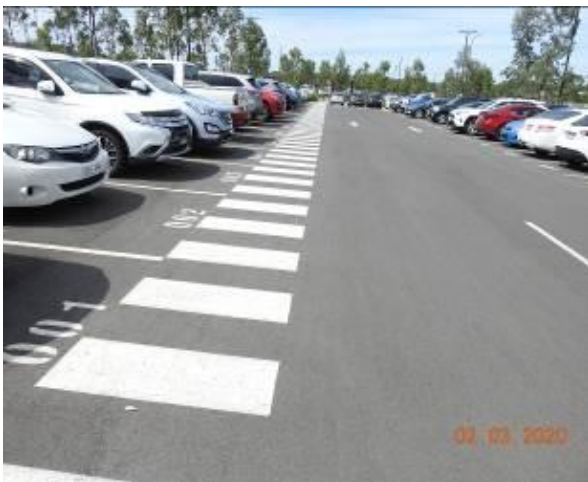
Figure 2549 – General Condition of carpark pavement

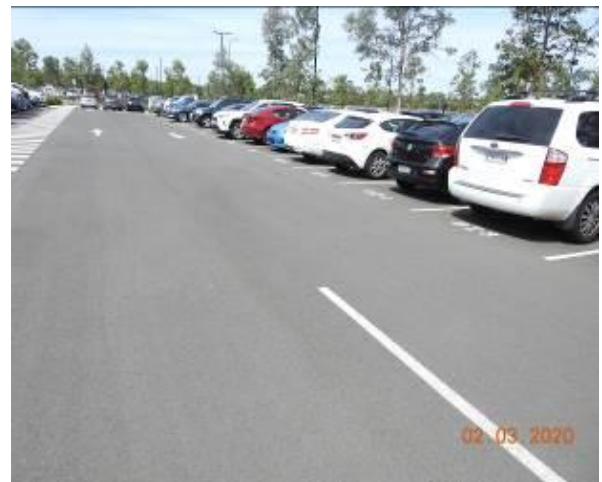
Figure 2550 – General Condition of carpark pavement

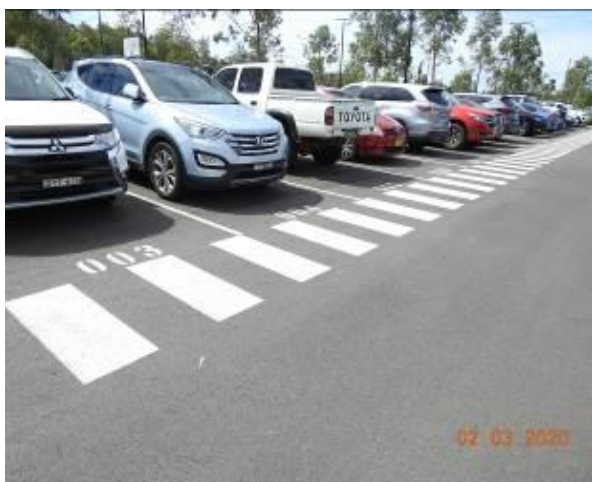
Figure 2552 – General Condition of carpark pavement

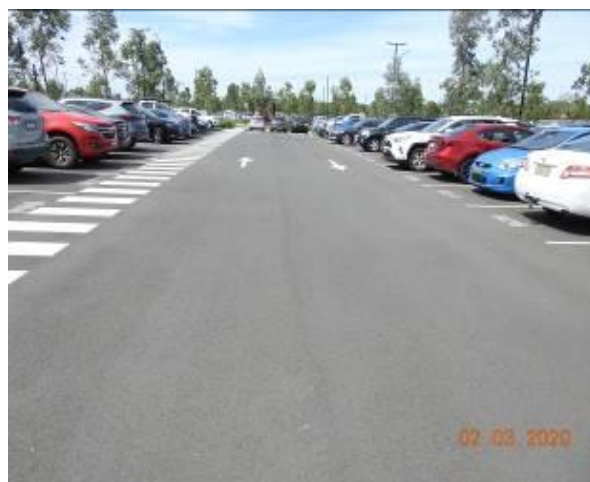
Figure 2553 – General Condition of carpark pavement

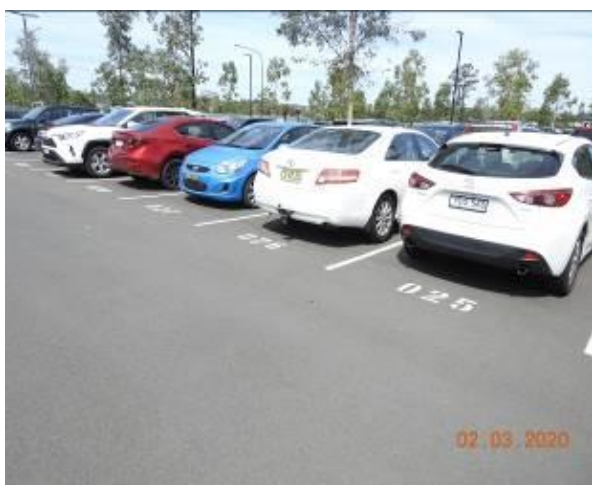
Figure 2554 – General Condition of carpark pavement

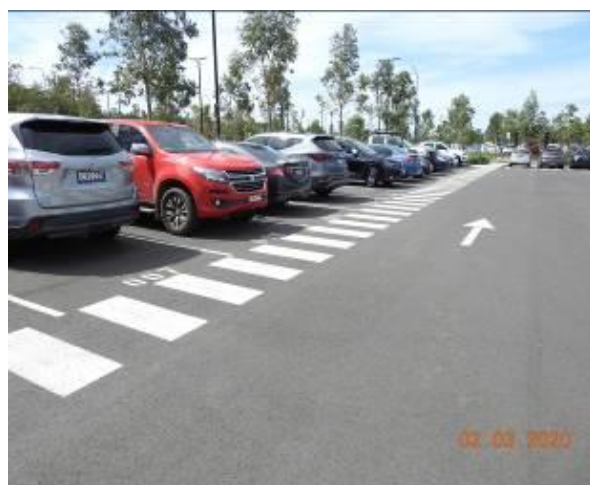
Figure 2555 – General Condition of carpark pavement

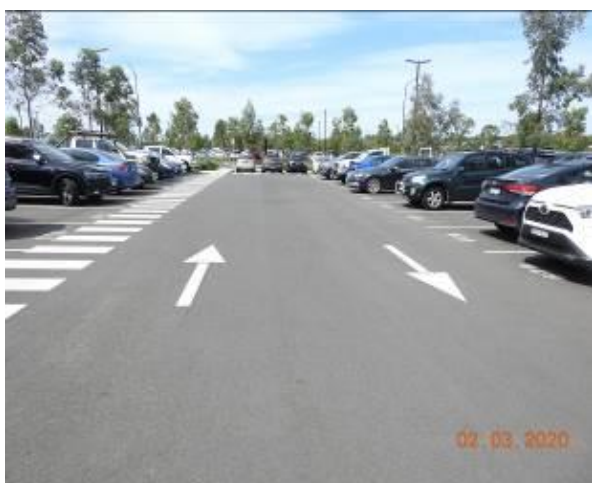
Figure 2556 – General Condition of carpark pavement

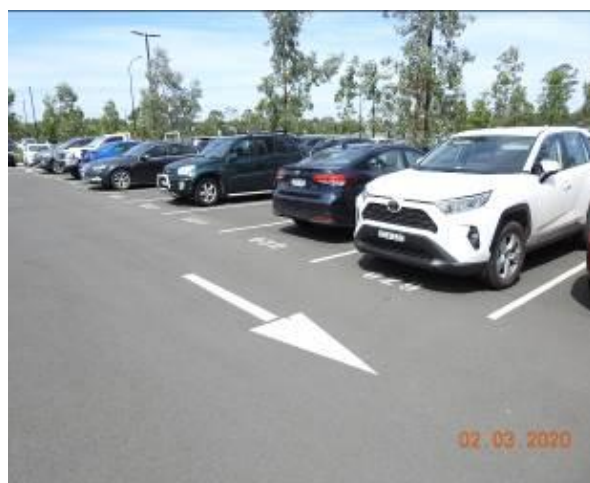
Figure 2557 – General Condition of carpark pavement

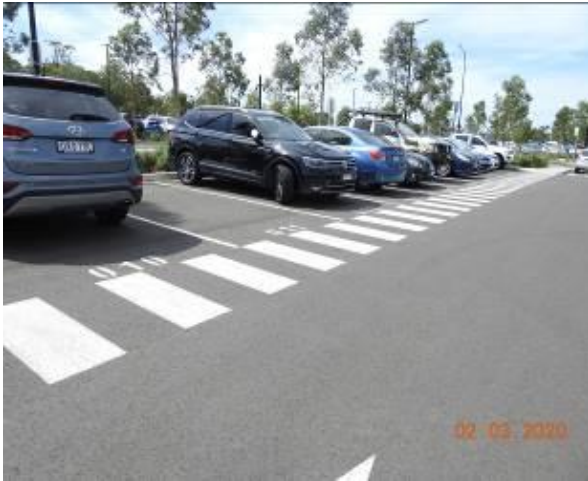
Figure 2558 – General Condition of carpark pavement

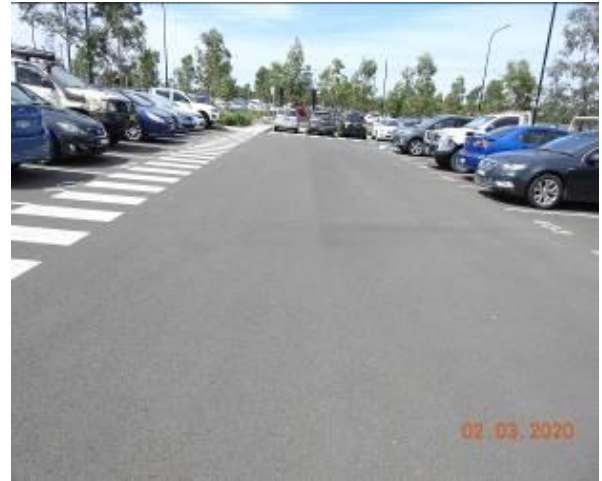
Figure 2559 – General Condition of carpark pavement

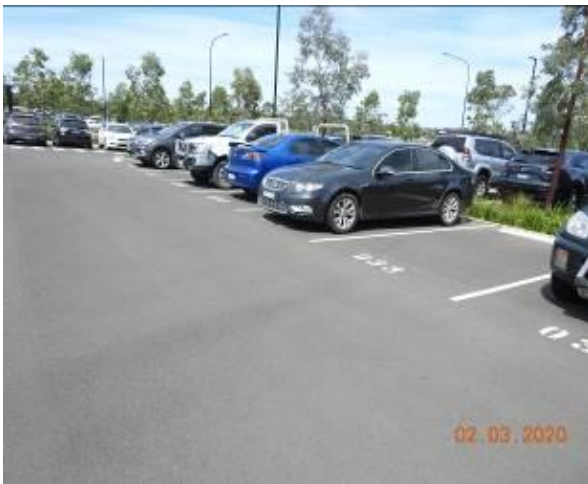
Figure 2560 – General Condition of carpark pavement

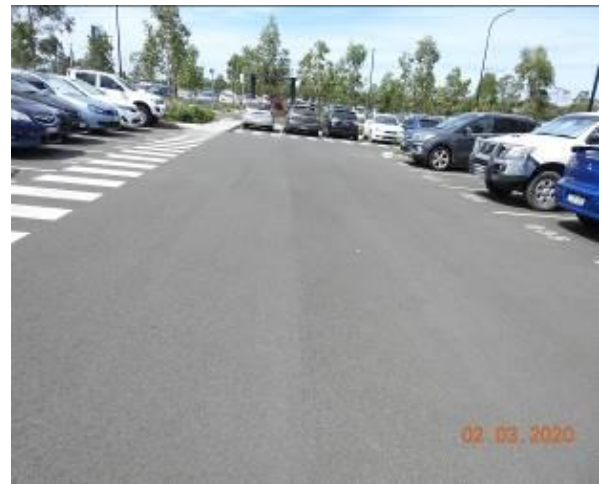
Figure 2561 – General Condition of carpark pavement

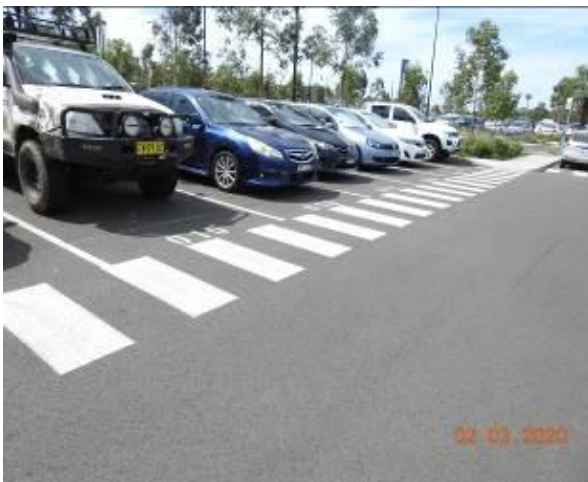
Figure 2562 – General Condition of carpark pavement

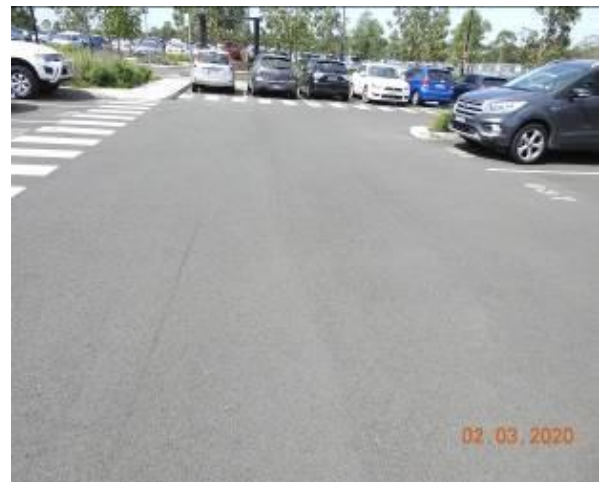
Figure 2563 – General Condition of carpark pavement

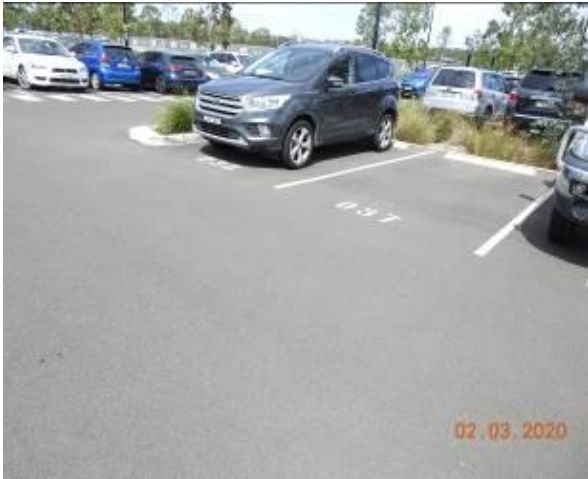
Figure 2564 – General Condition of carpark pavement

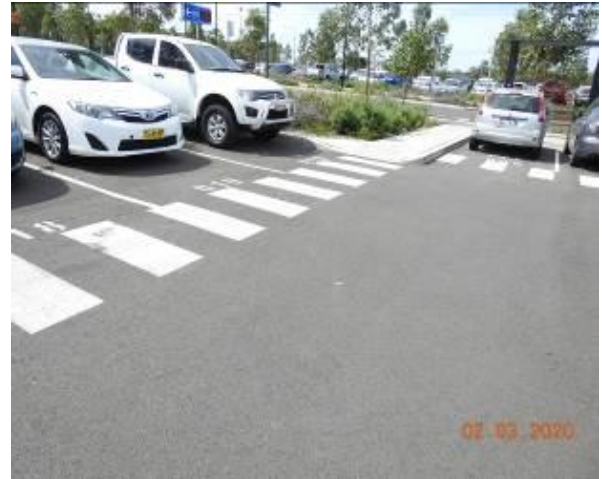
Figure 2565 – General Condition of carpark pavement

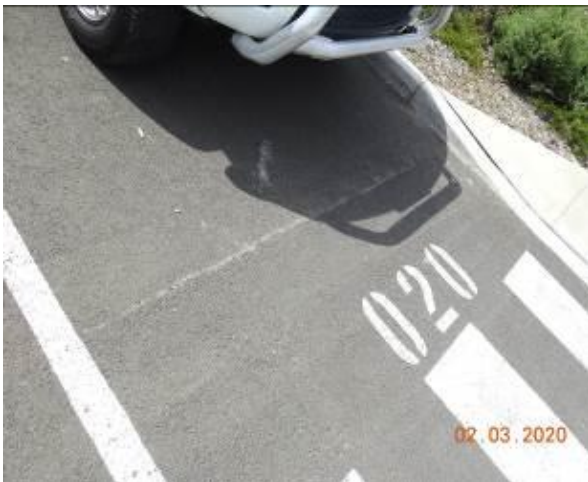
Figure 2566 – Crack propagation through carpark pavement

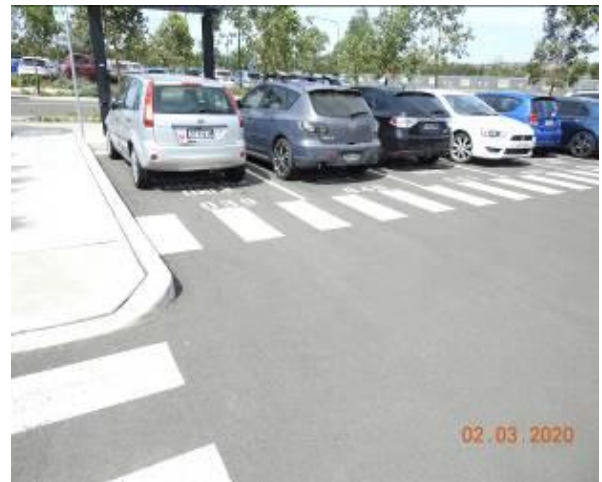
Figure 2567 – General Condition of carpark pavement

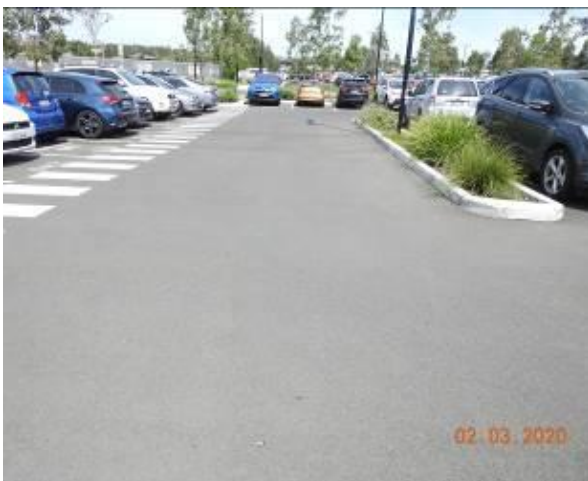
Figure 2568 – General Condition of carpark pavement

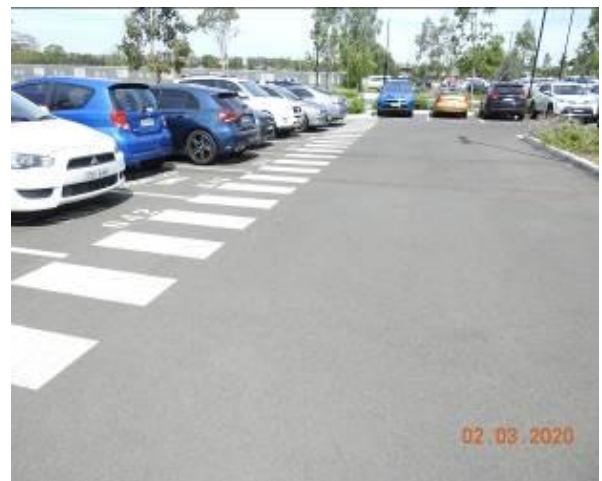
Figure 2569 – General Condition of carpark pavement

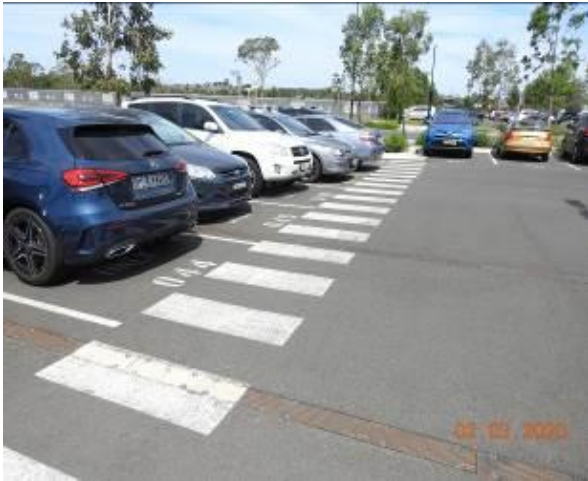
Figure 2570 – General Condition of carpark pavement

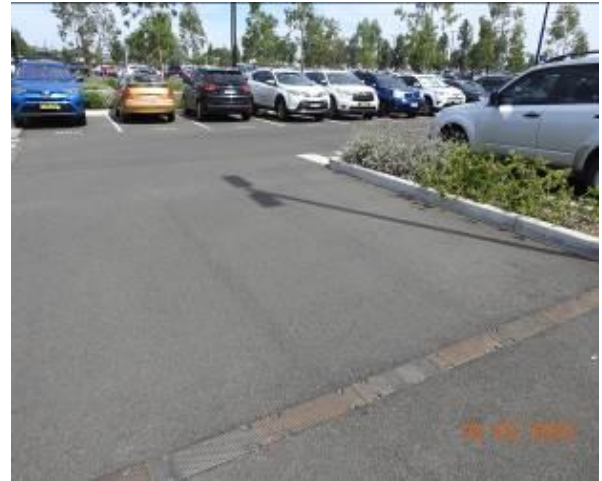
Figure 2571 – General Condition of carpark pavement

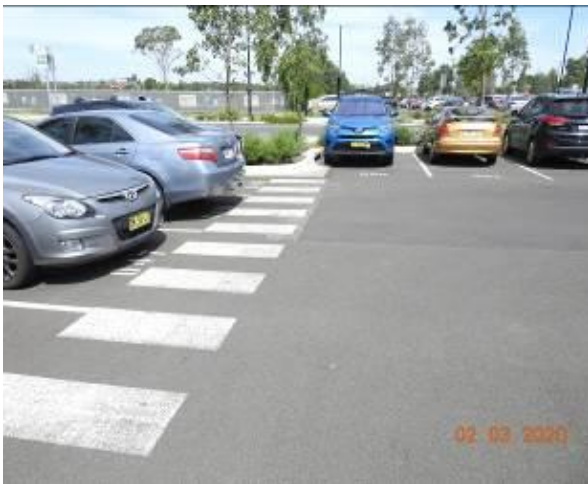
Figure 2572 – General Condition of carpark pavement

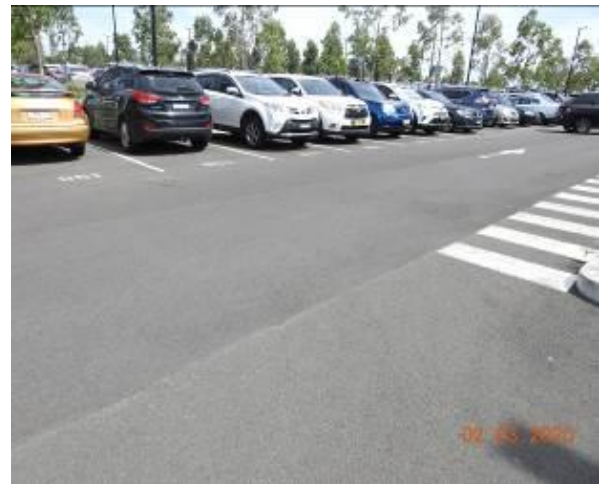
Figure 2573 – General Condition of carpark pavement

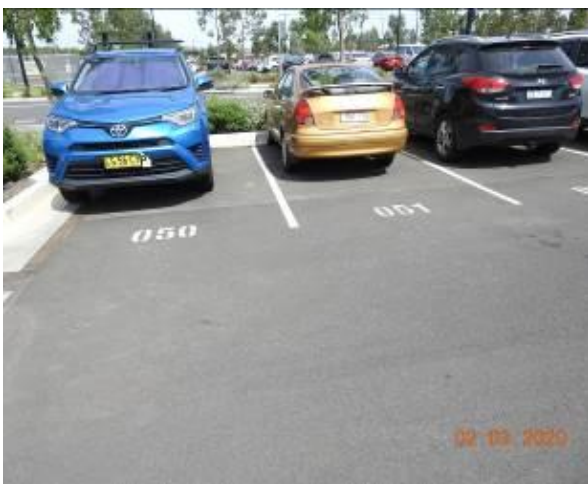
Figure 2574 – General Condition of carpark pavement

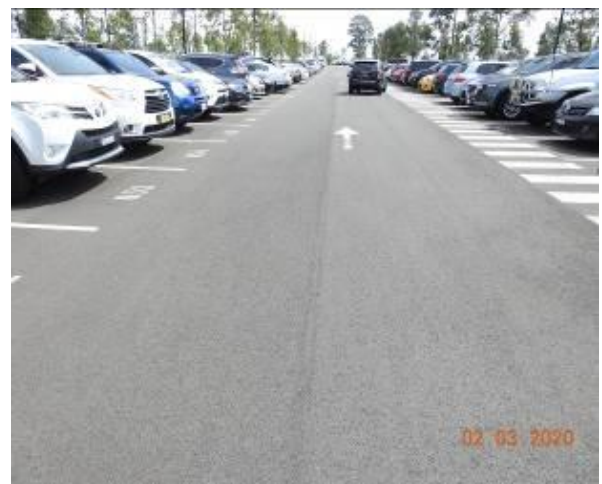
Figure 2575 – General Condition of carpark pavement

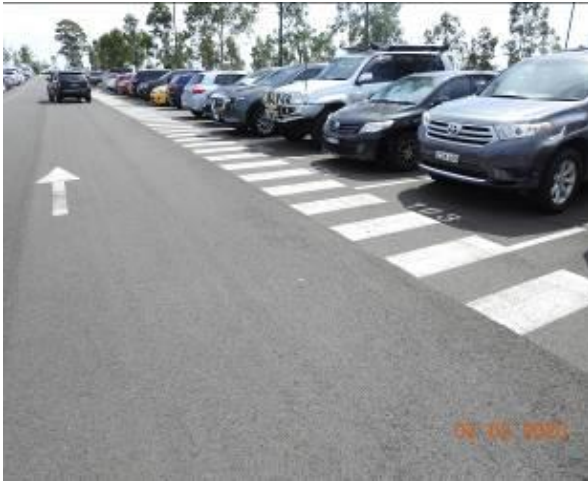
Figure 2576 – General Condition of carpark pavement

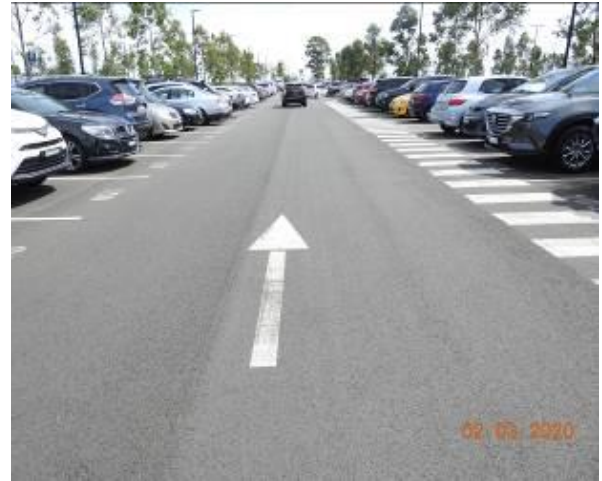
Figure 2577 – General Condition of carpark pavement

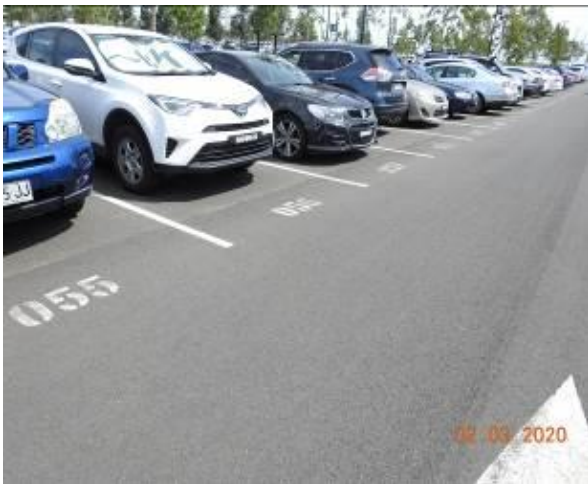
Figure 2578 – General Condition of carpark pavement

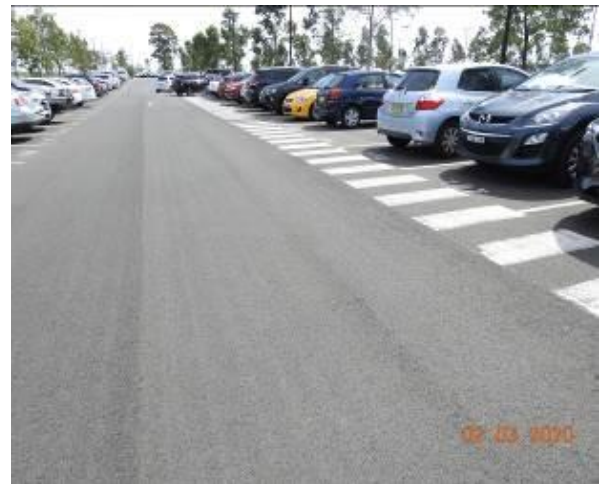
Figure 2579 – General Condition of carpark pavement

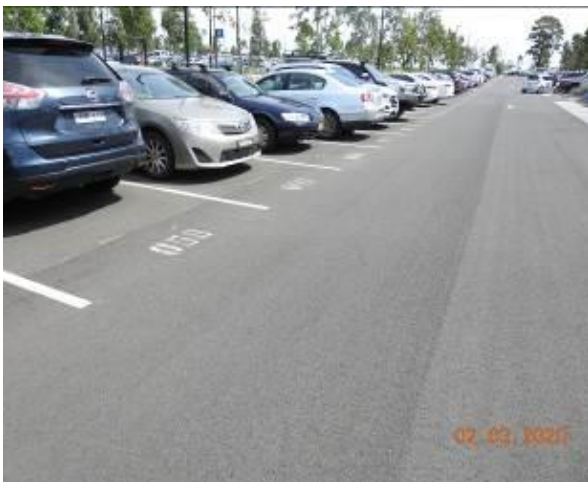
Figure 2580 – General Condition of carpark pavement

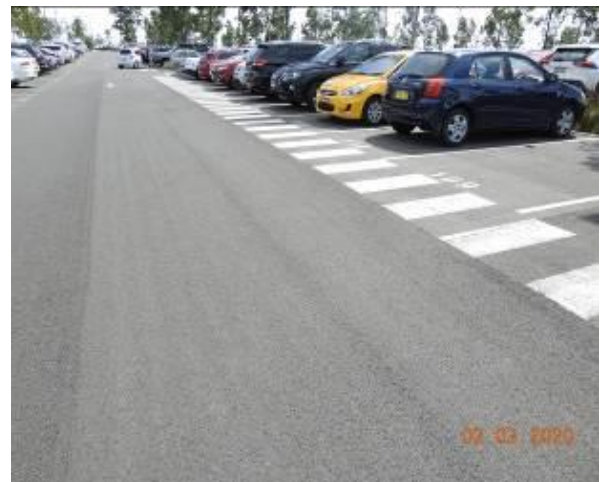
Figure 2581 – General Condition of carpark pavement
