**1-15 AND 2-12 CONFERTA AVENUE,
ROUSE HILL NSW 2155
TALLAWONG STATION PRECINCT SOUTH
PRE-DILAPIDATION REPORT**

**DEICORP PROJECTS
(TALLAWONG STATION) PTY LTD**

Job No. 191294.0
24/03/2020

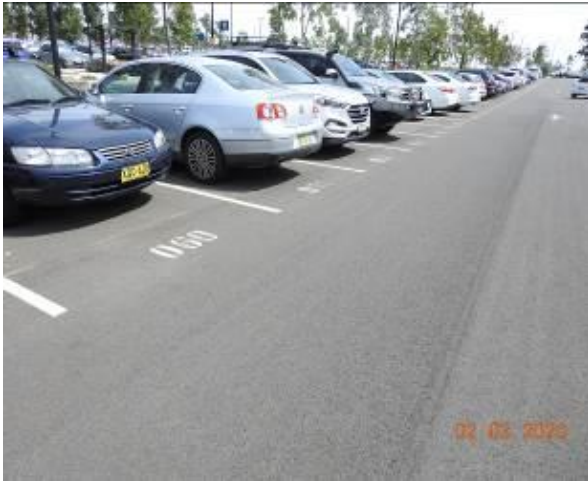
Figure 2582 – General Condition of carpark pavement

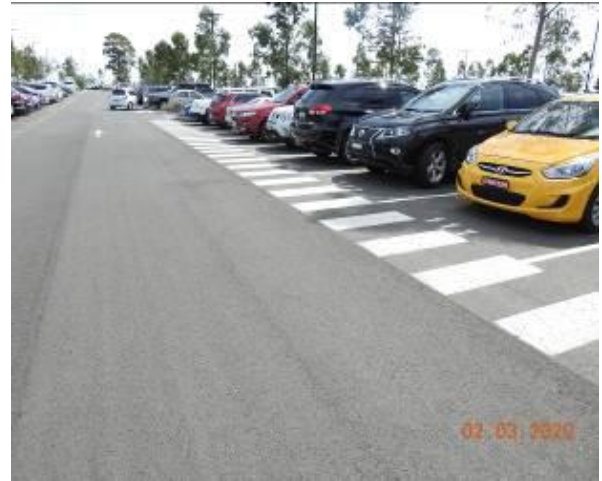
Figure 2583 – General Condition of carpark pavement

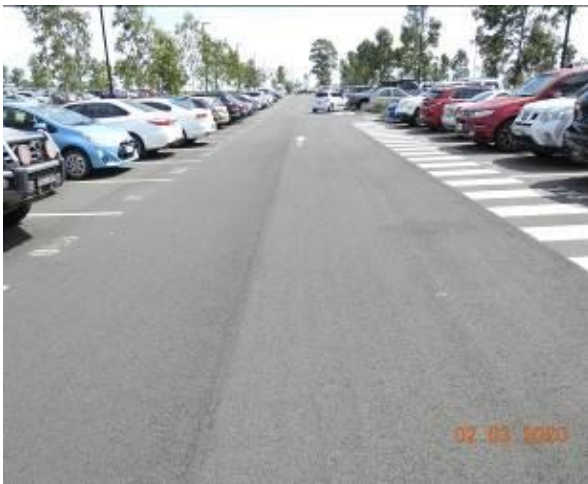
Figure 2584 – General Condition of carpark pavement

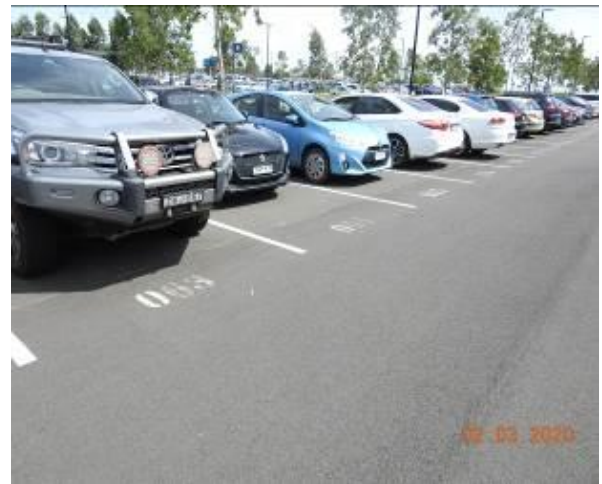
Figure 2585 – General Condition of carpark pavement

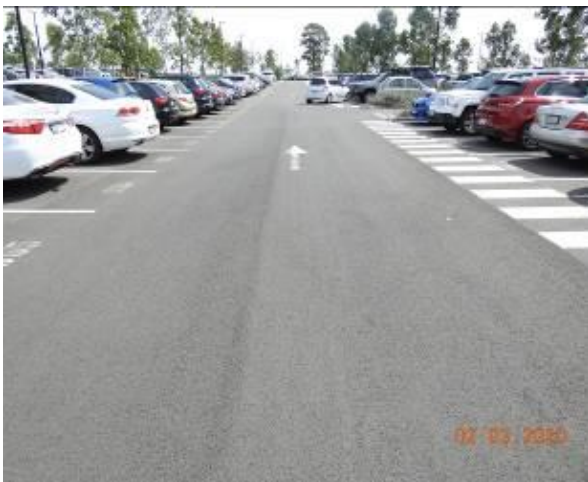
Figure 2586 – General Condition of carpark pavement

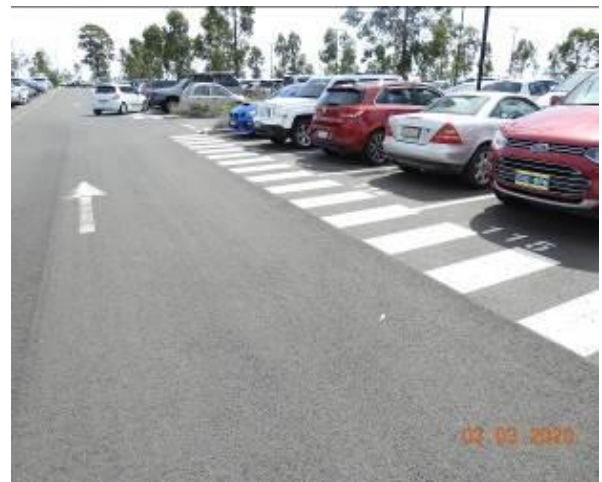
Figure 2587 – General Condition of carpark pavement

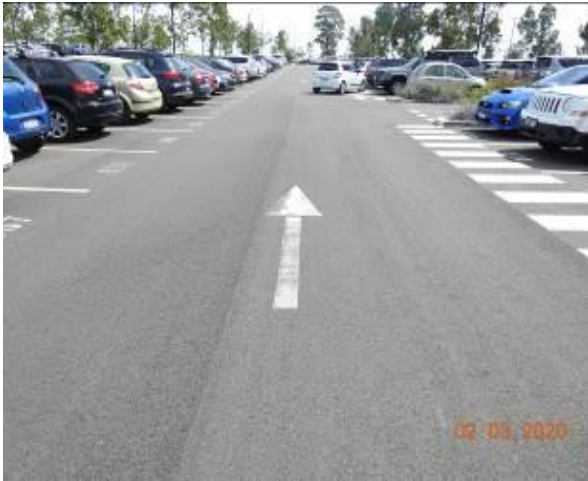
Figure 2588 – General Condition of carpark pavement

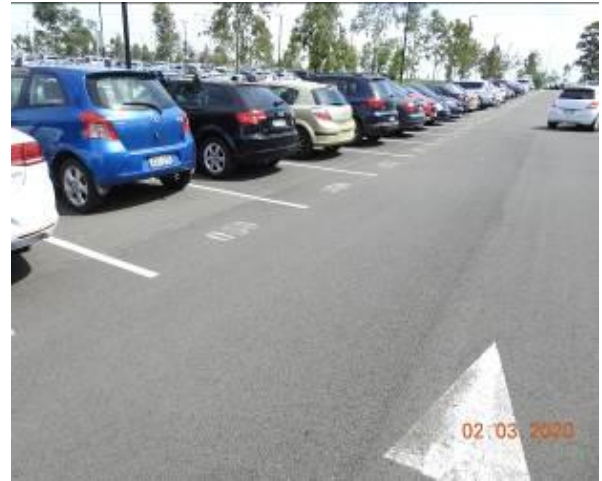
Figure 2589 – General Condition of carpark pavement

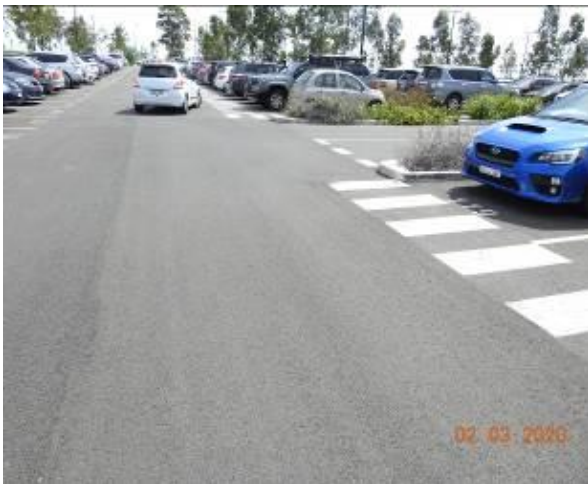
Figure 2590 – General Condition of carpark pavement

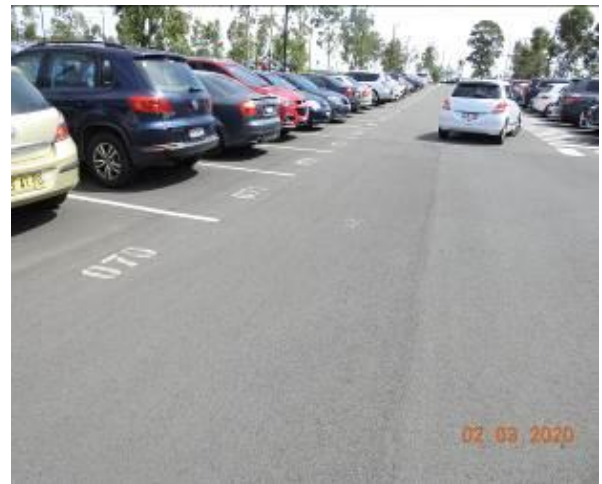
Figure 2591 – General Condition of carpark pavement

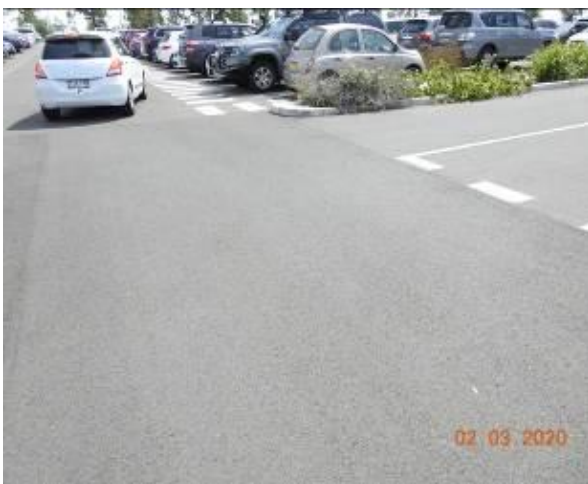
Figure 2592 – General Condition of carpark pavement

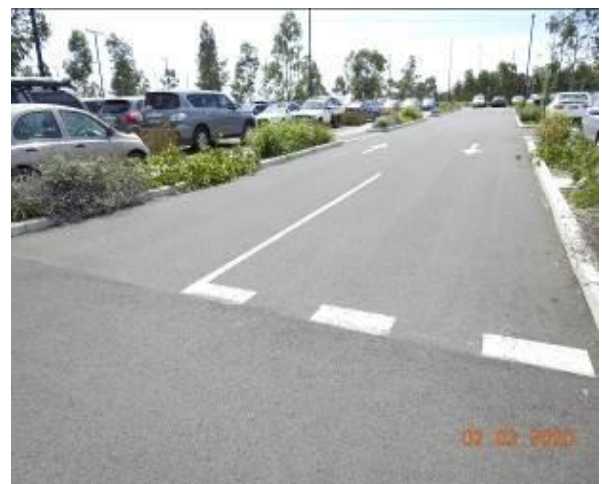
Figure 2593 – General Condition of carpark pavement

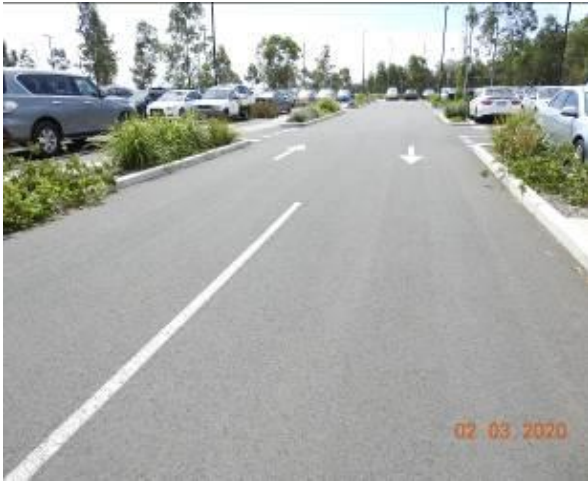
Figure 2594 – General Condition of carpark pavement

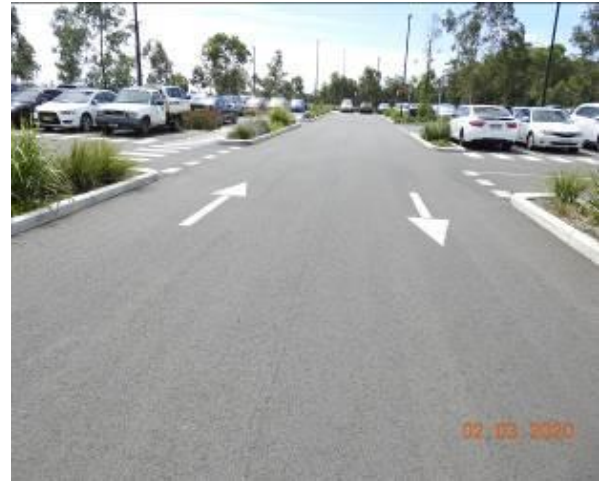
Figure 2595 – General Condition of carpark pavement

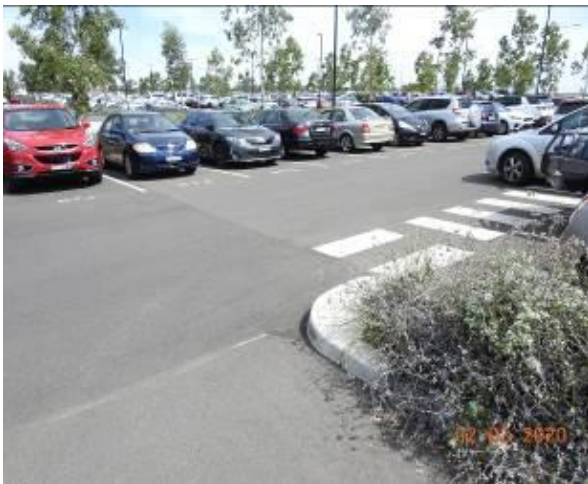
Figure 2596 – General Condition of carpark pavement

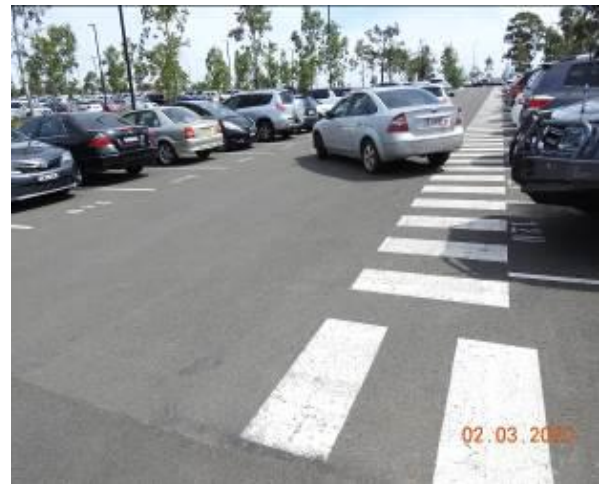
Figure 2597 – General Condition of carpark pavement

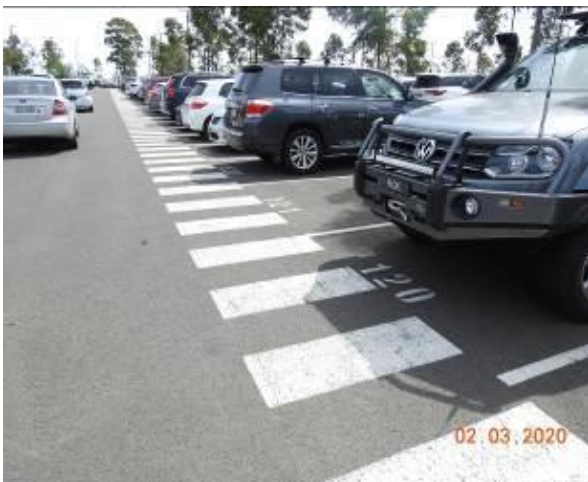
Figure 2598 – General Condition of carpark pavement

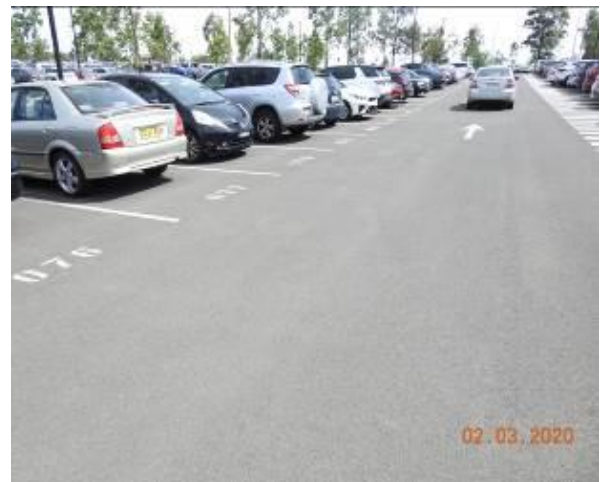
Figure 2599 – General Condition of carpark pavement

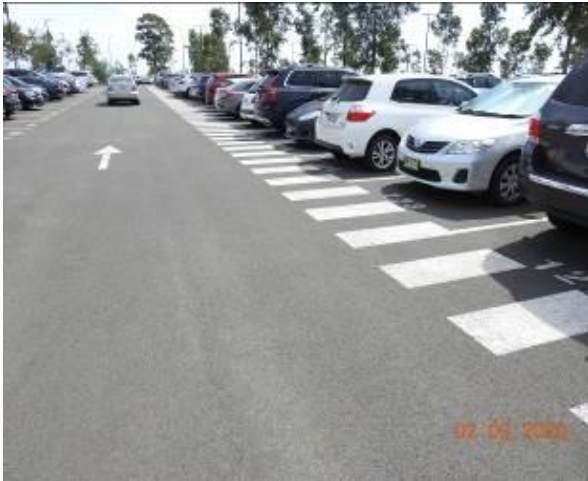
Figure 2600 – General Condition of carpark pavement

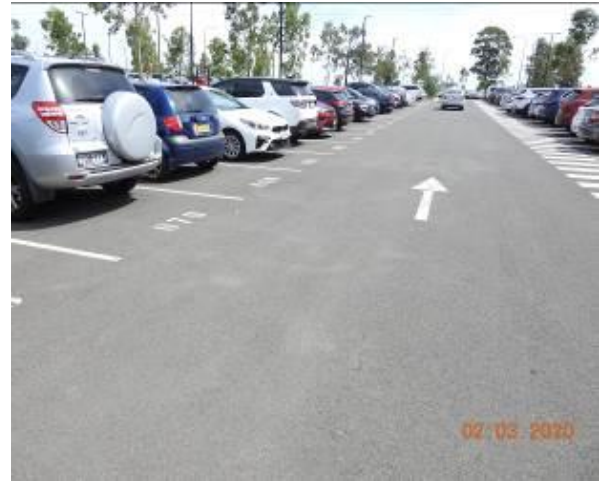
Figure 2601 – General Condition of carpark pavement

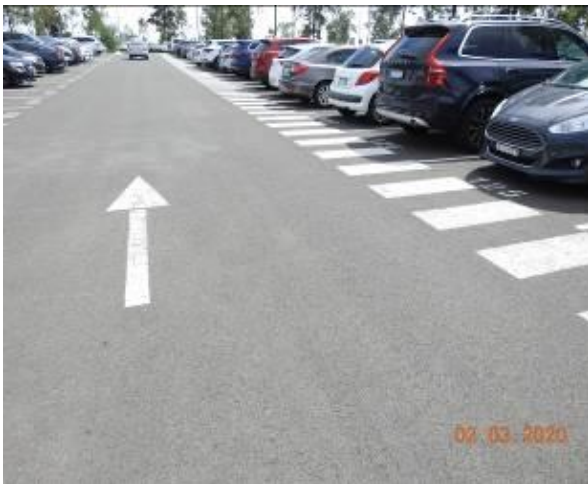
Figure 2602 – General Condition of carpark pavement

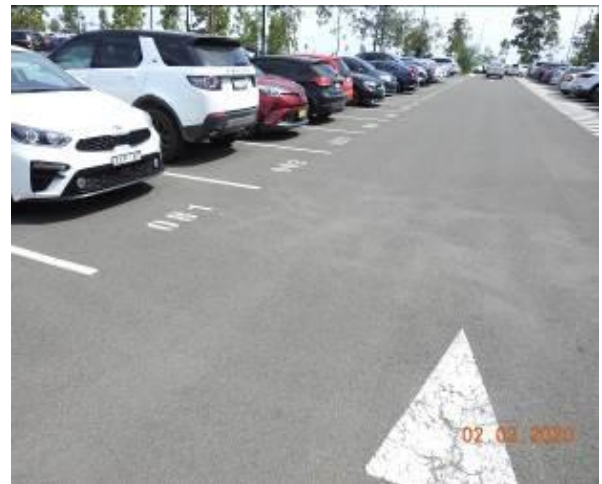
Figure 2603 – General Condition of carpark pavement

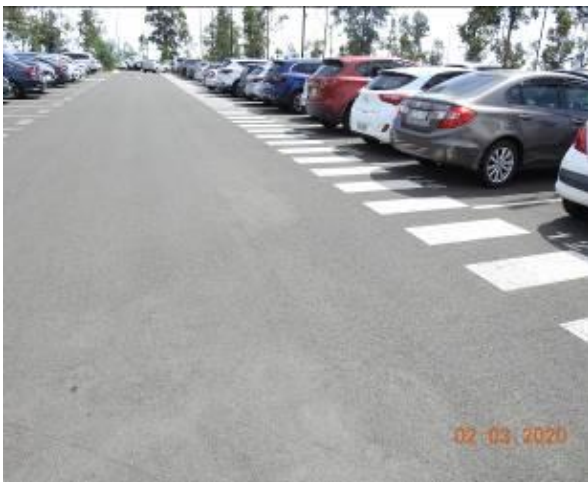
Figure 2604 – General Condition of carpark pavement

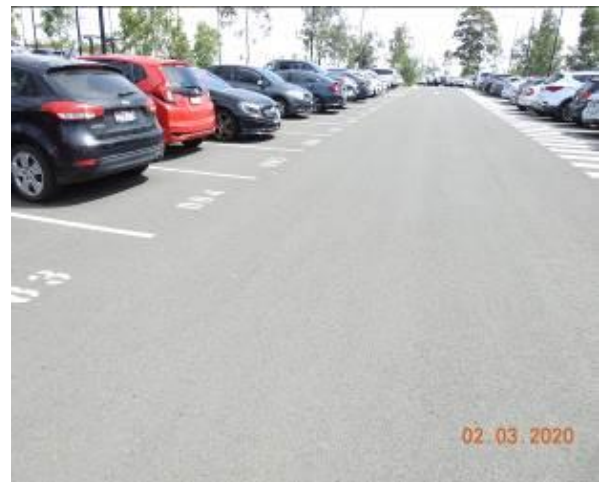
Figure 2605 – General Condition of carpark pavement

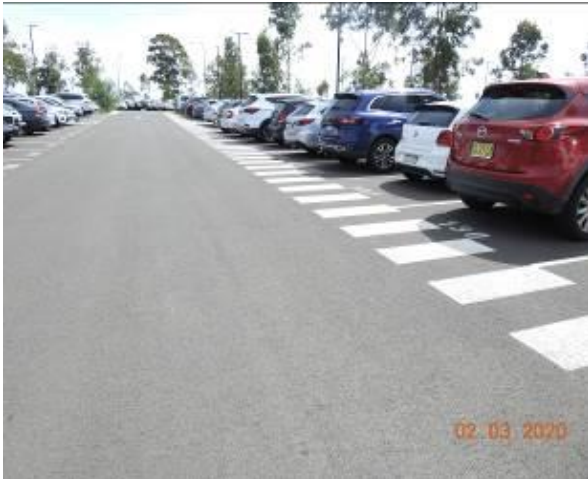
Figure 2606 – General Condition of carpark pavement

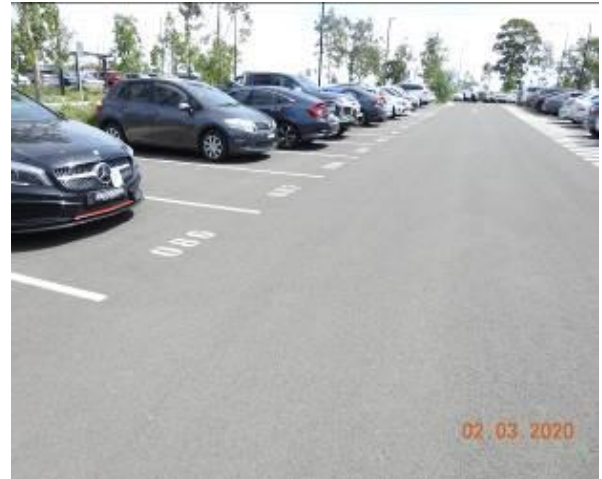
Figure 2607 – General Condition of carpark pavement

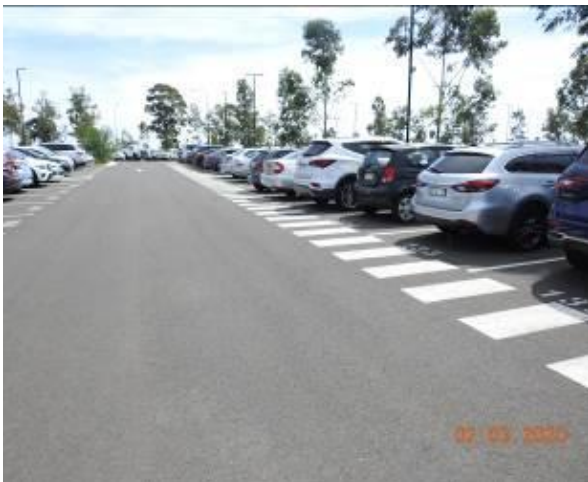
Figure 2608 – General Condition of carpark pavement

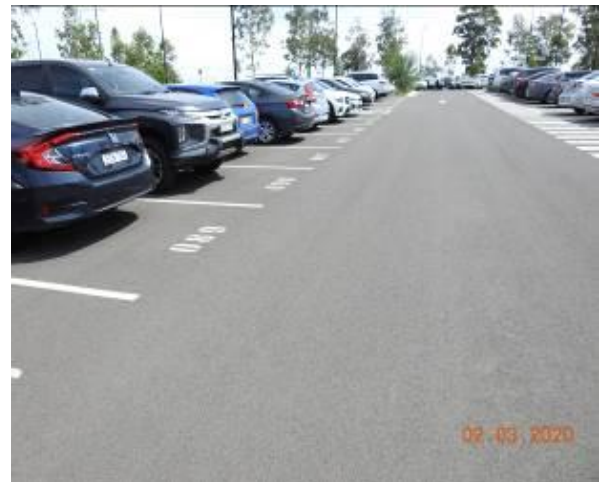
Figure 2609 – General Condition of carpark pavement

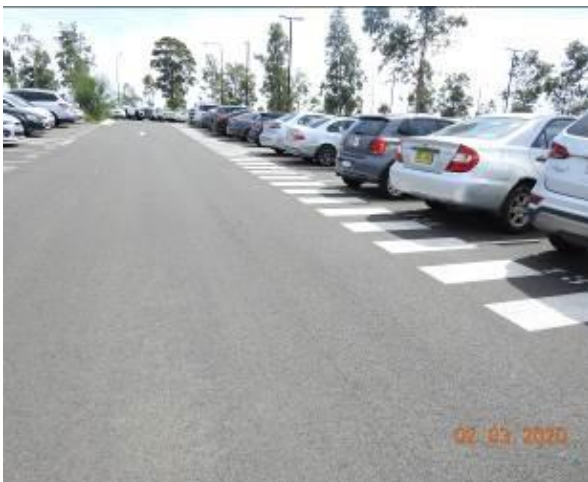
Figure 2610 – General Condition of carpark pavement

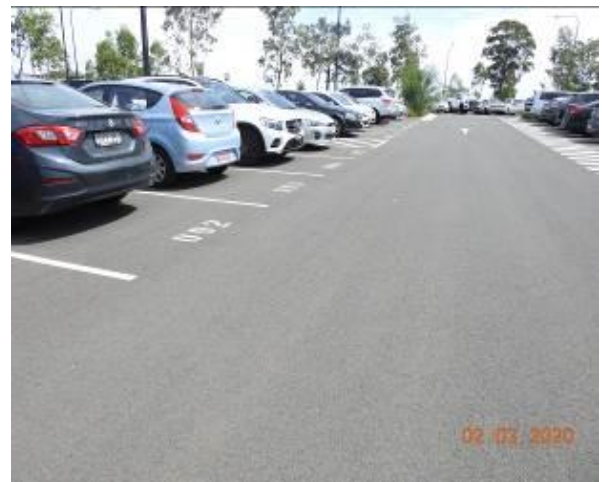
Figure 2611 – General Condition of carpark pavement

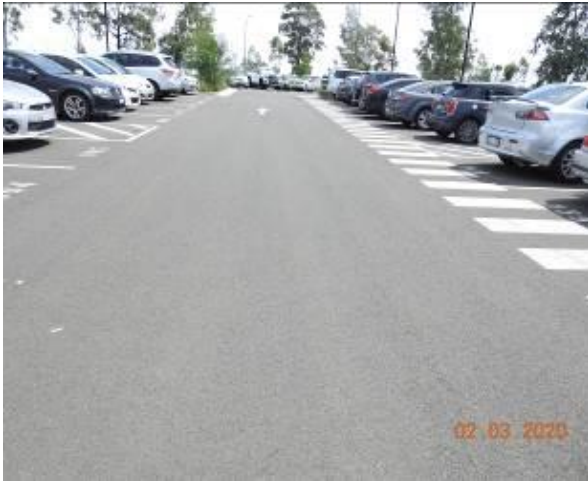
Figure 2612 – General Condition of carpark pavement

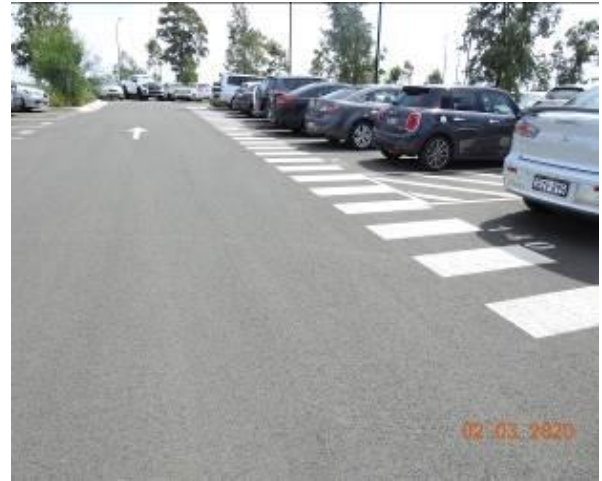
Figure 2613 – General Condition of carpark pavement

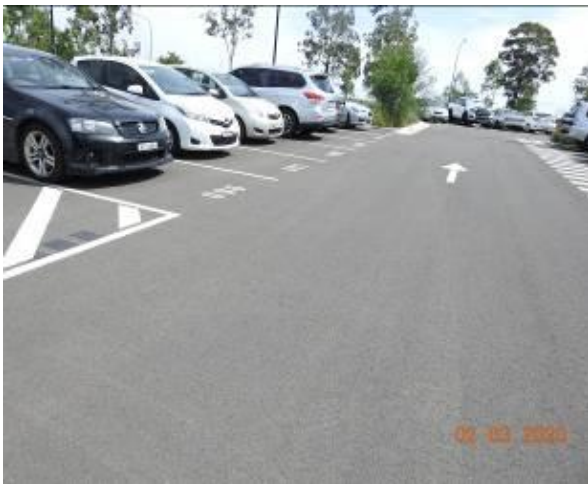
Figure 2614 – General Condition of carpark pavement

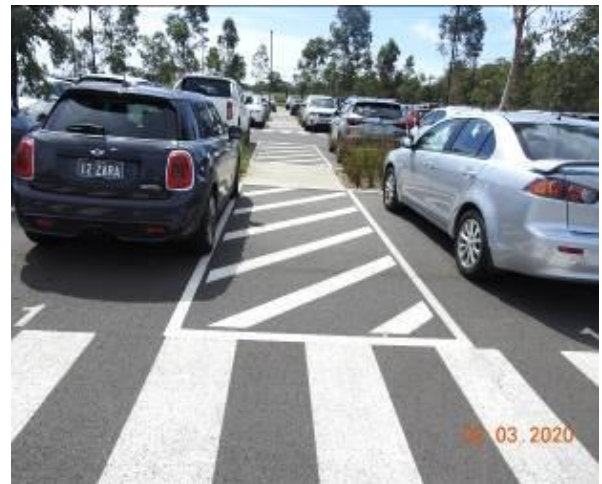
Figure 2615 – General Condition of carpark pavement

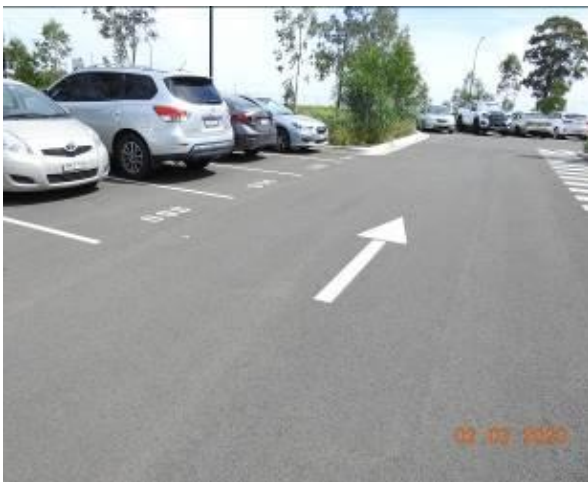
Figure 2616 – General Condition of carpark pavement

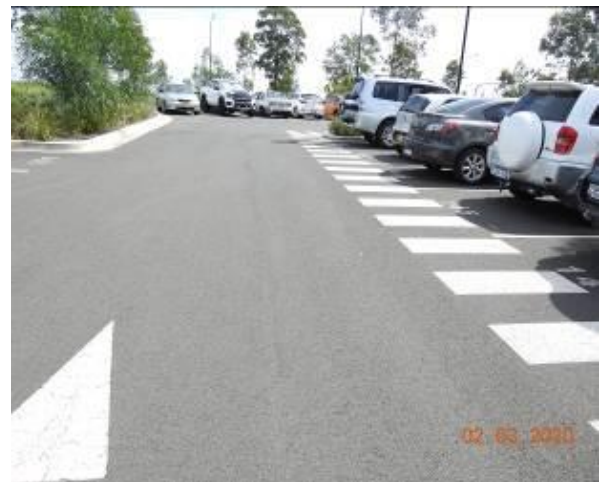
Figure 2617 – General Condition of carpark pavement

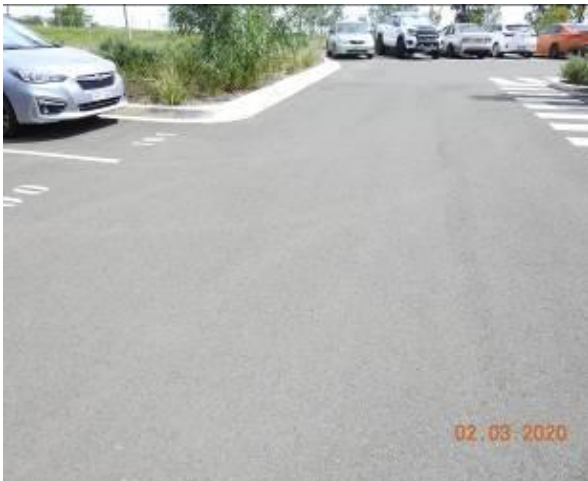
Figure 2618 – General Condition of carpark pavement

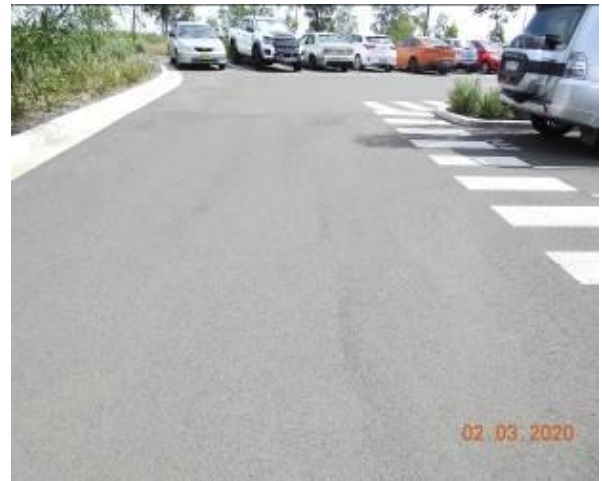
Figure 2619 – General Condition of carpark pavement

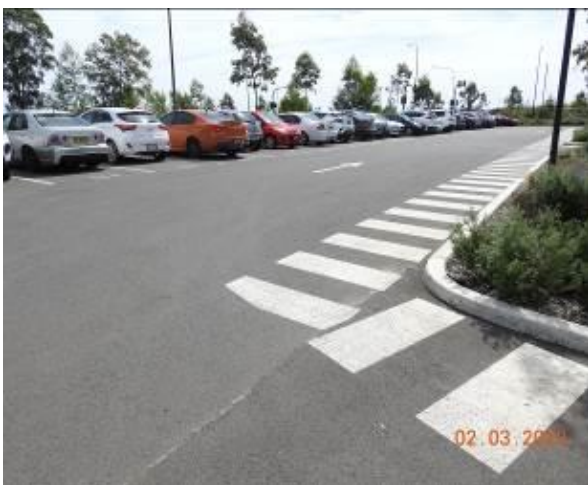
Figure 2620 – Crack propagation through carpark pavement

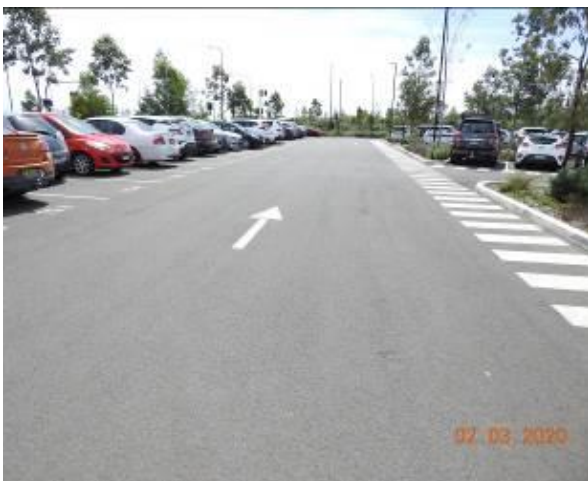
Figure 2622 – General Condition of carpark pavement

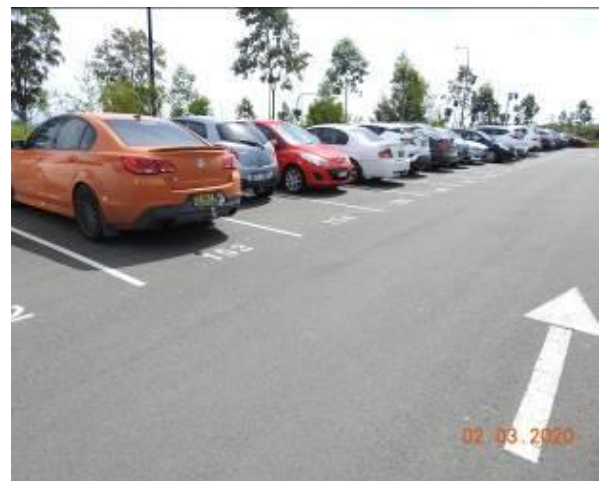
Figure 2623 – General Condition of carpark pavement

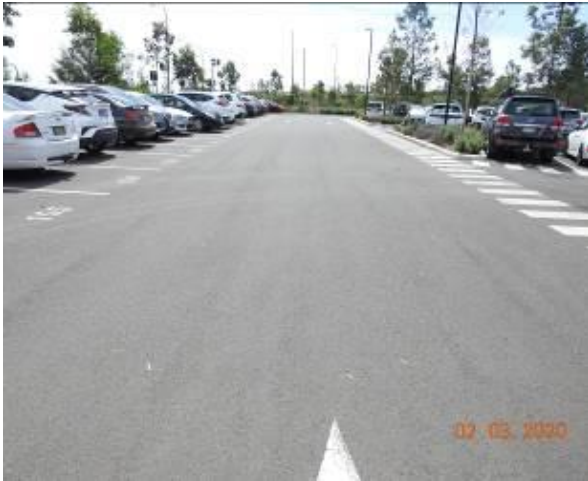
Figure 2624 – General Condition of carpark pavement

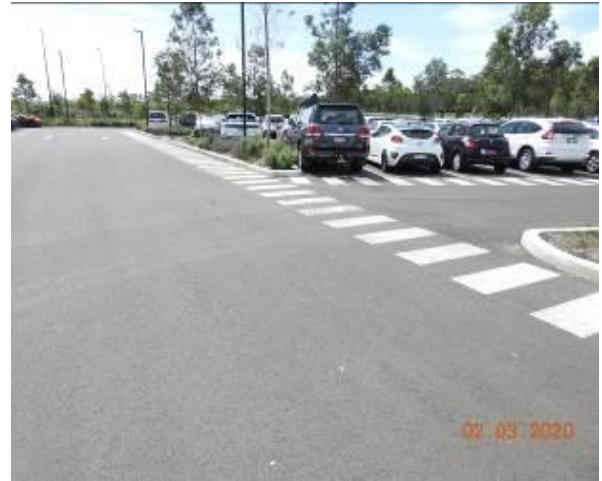
Figure 2625 – General Condition of carpark pavement

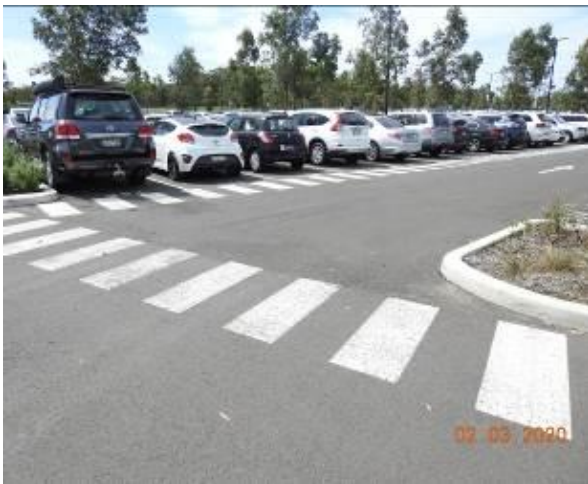
Figure 2626 – General Condition of carpark pavement

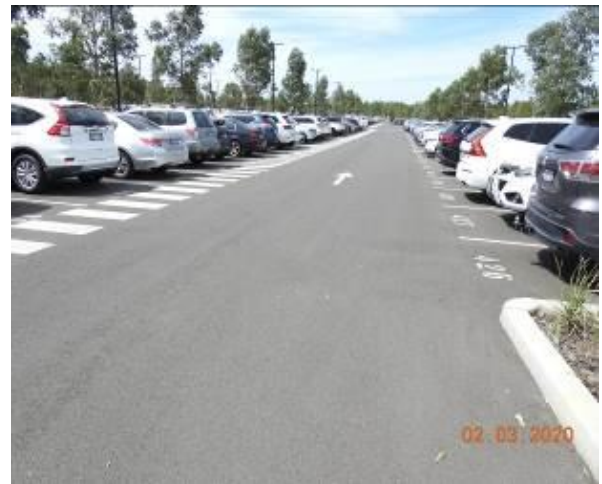
Figure 2627 – General Condition of carpark pavement

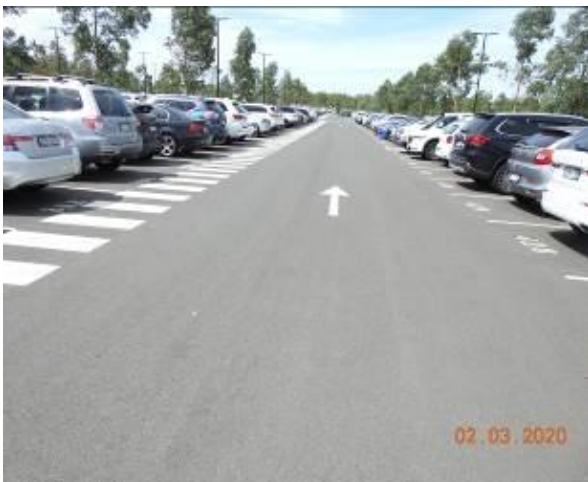
Figure 2628 – General Condition of carpark pavement

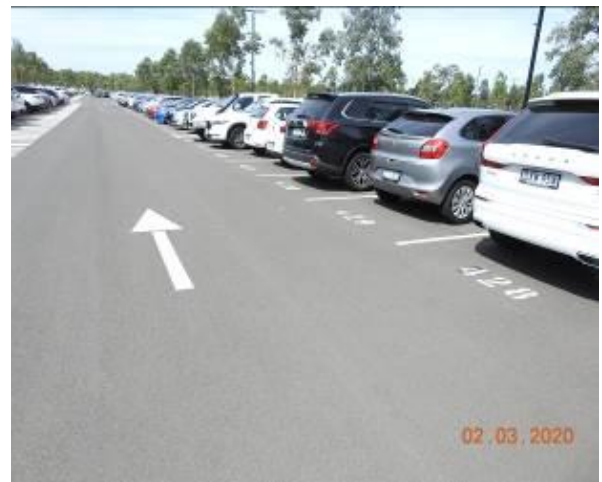
Figure 2629 – General Condition of carpark pavement

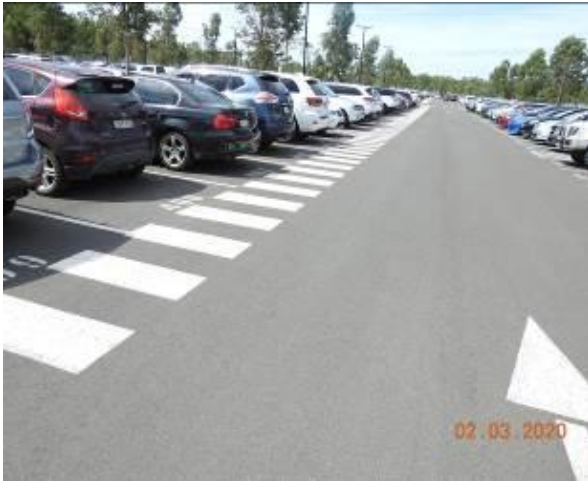
Figure 2630 – General Condition of carpark pavement

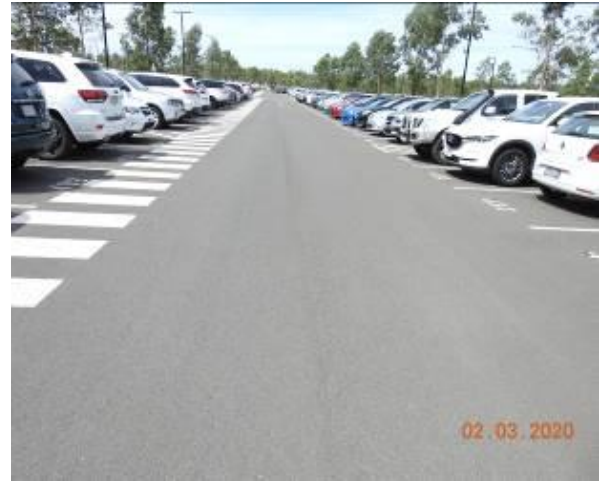
Figure 2631 – General Condition of carpark pavement

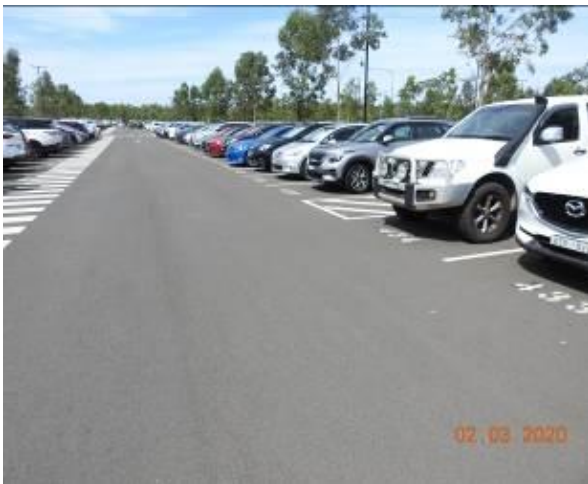
Figure 2632 – General Condition of carpark pavement

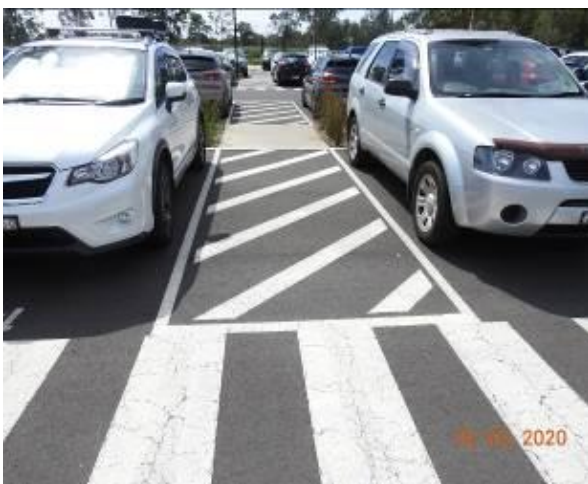
Figure 2633 – General Condition of carpark pavement

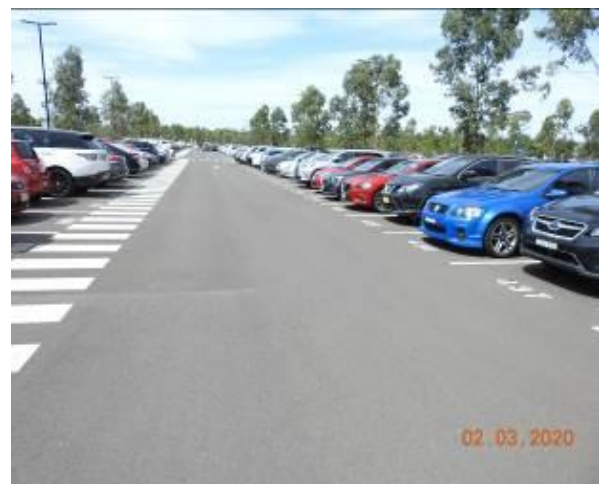
Figure 2634 – General Condition of carpark pavement

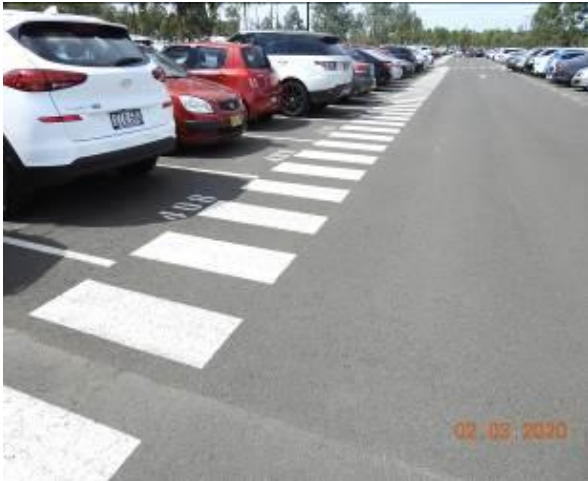
Figure 2635 – General Condition of carpark pavement

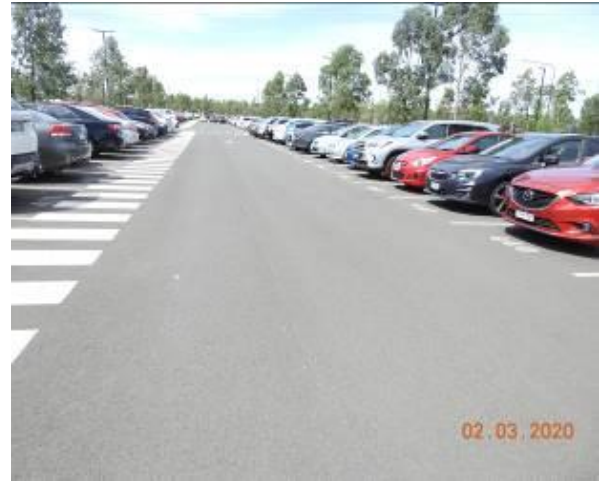
Figure 2636 – General Condition of carpark pavement

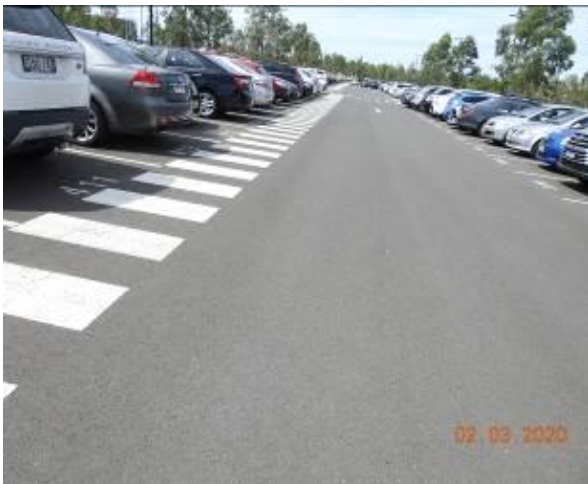
Figure 2637 – General Condition of carpark pavement

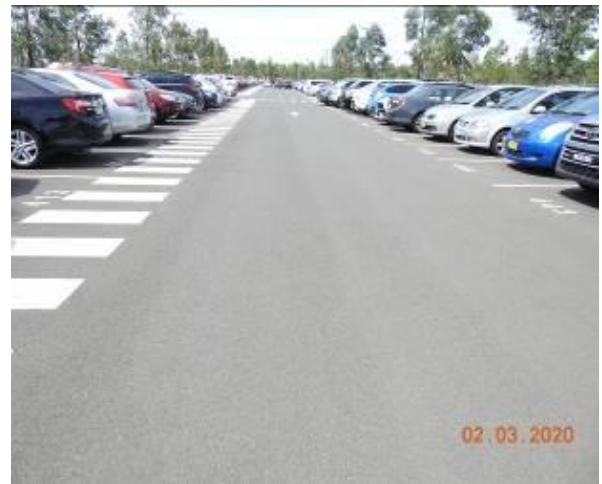
Figure 2638 – General Condition of carpark pavement

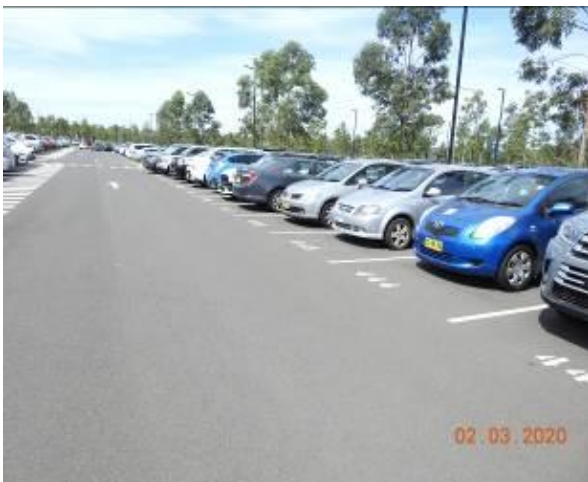
Figure 2639 – General Condition of carpark pavement

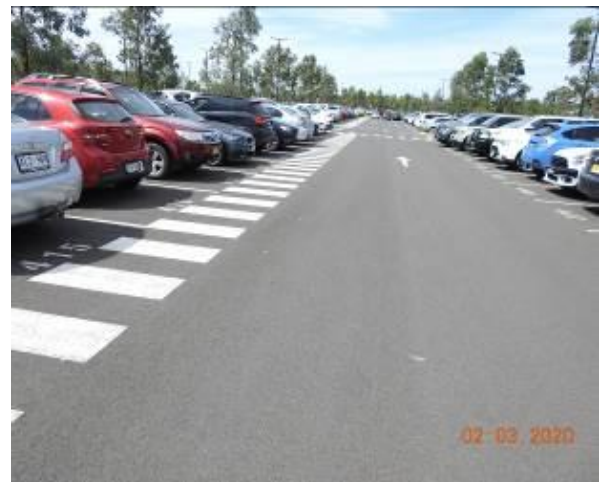
Figure 2640 – General Condition of carpark pavement

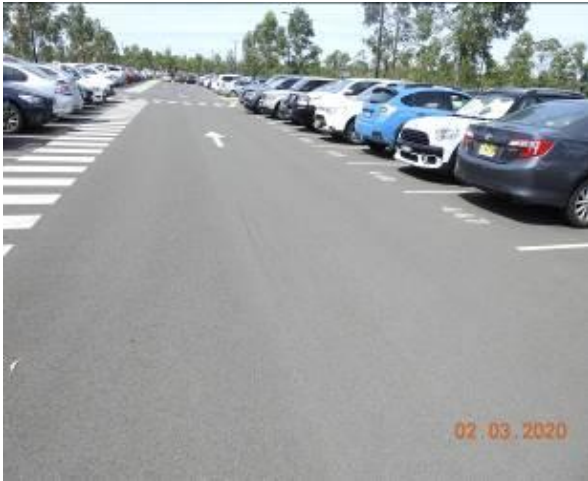
Figure 2641 – General Condition of carpark pavement

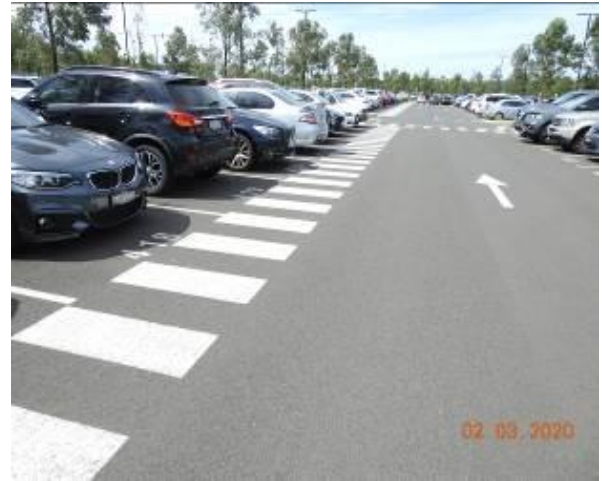
Figure 2642 – General Condition of carpark pavement

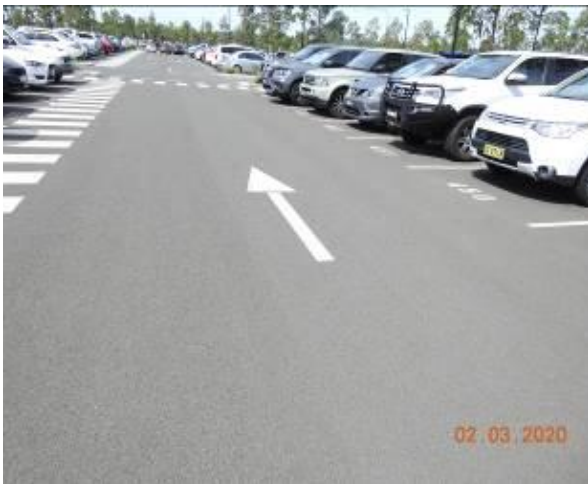
Figure 2643 – General Condition of carpark pavement

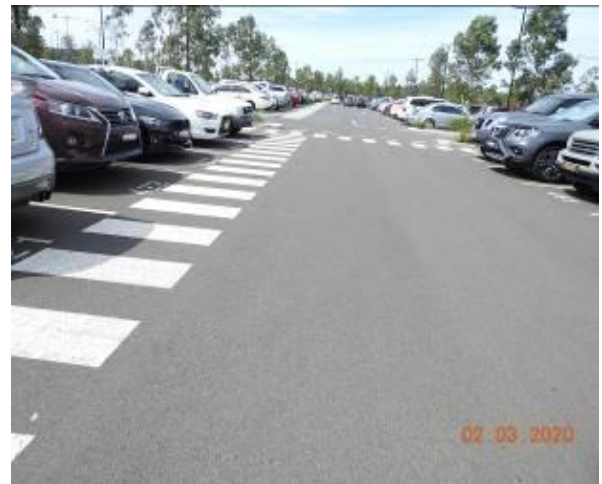
Figure 2644 – General Condition of carpark pavement

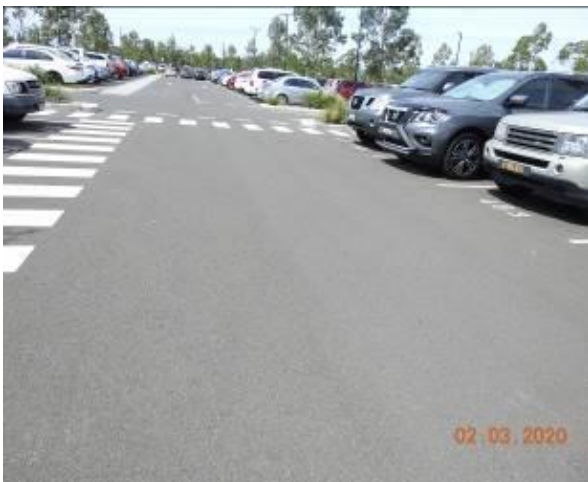
Figure 2645 – General Condition of carpark pavement

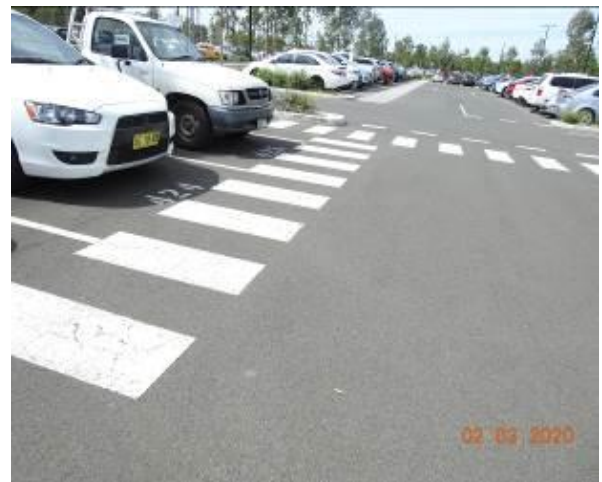
Figure 2646 – General Condition of carpark pavement

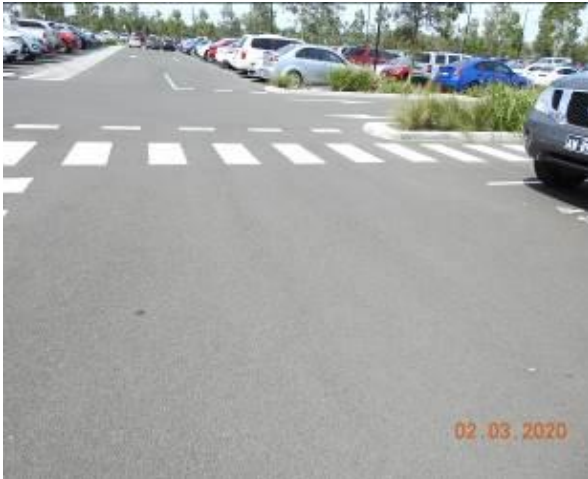
Figure 2647 – Crack propagation through carpark pavement

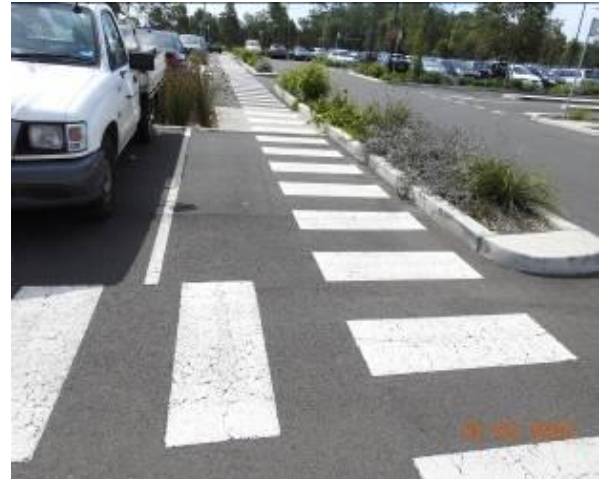
Figure 2648 – General Condition of carpark pavement

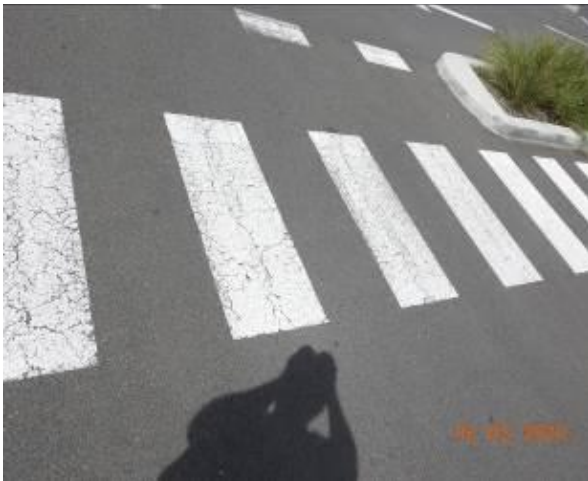
Figure 2649 – Crack propagation through carpark pavement

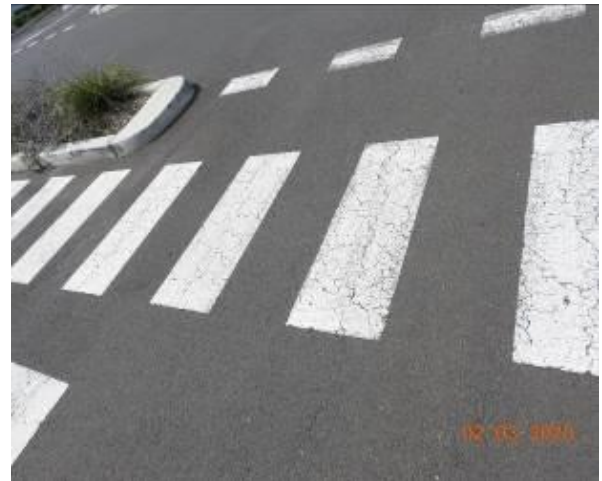
Figure 2650 – Crack propagation through carpark pavement

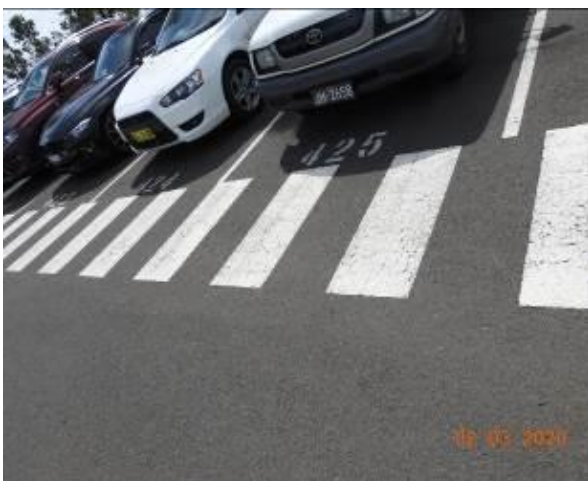
Figure 2651 – Crack propagation through carpark pavement

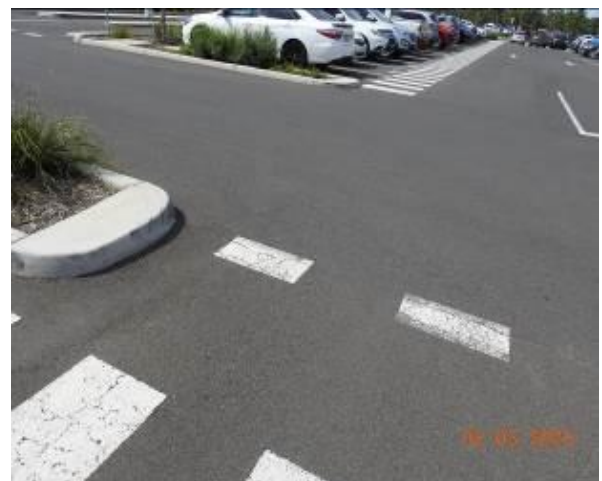
Figure 2652 – Crack propagation through carpark pavement

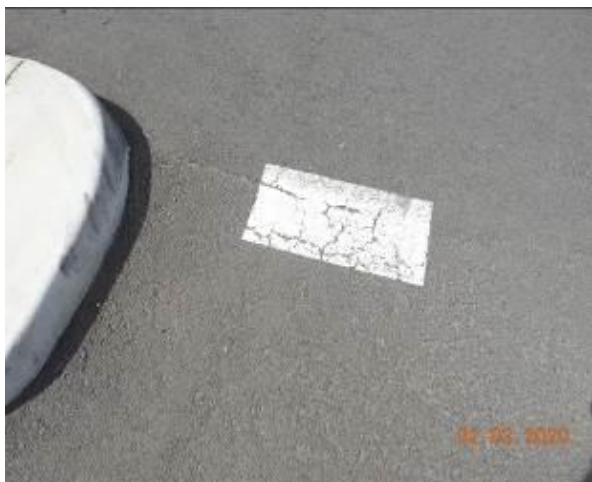
Figure 2653 – Crack propagation through carpark pavement

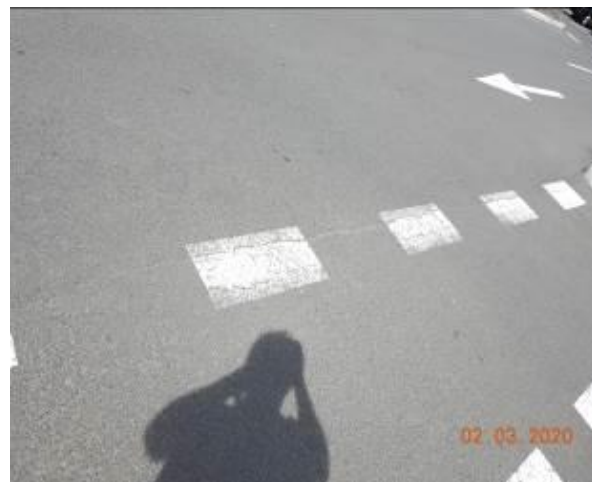
Figure 2654 – Crack propagation through carpark pavement

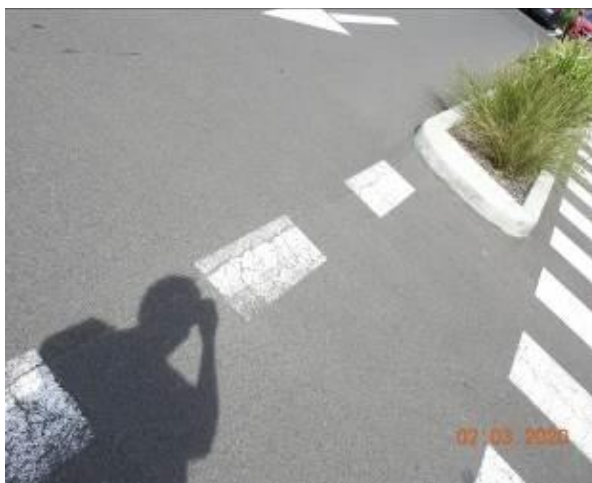
Figure 2655 – Crack propagation through carpark pavement

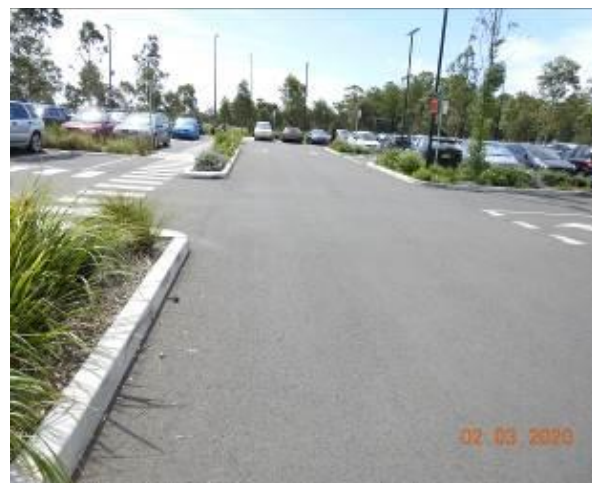
Figure 2656 – Crack propagation through carpark pavement

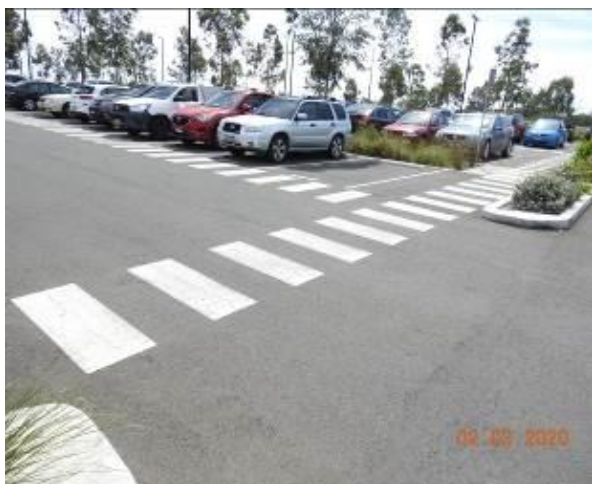
Figure 2657 – General Condition of carpark pavement

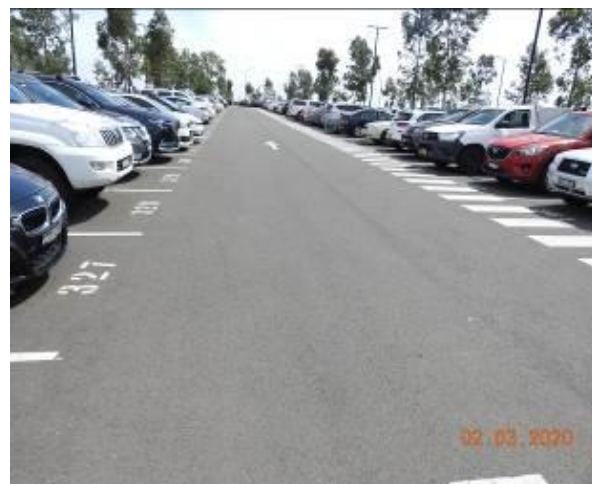
Figure 2658 – General Condition of carpark pavement

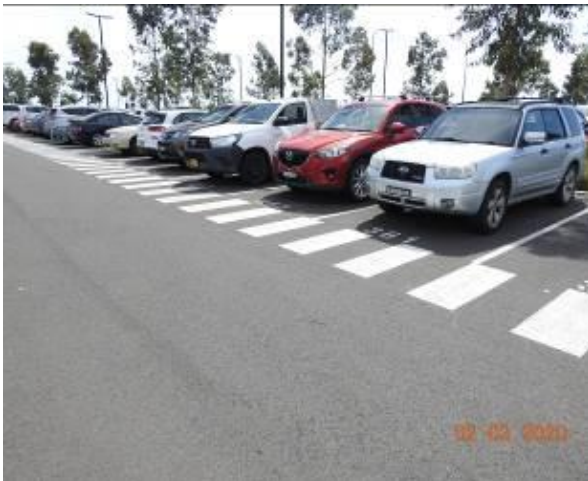
Figure 2659 – General Condition of carpark pavement
