**1-15 AND 2-12 CONFERTA AVENUE,
ROUSE HILL NSW 2155
TALLAWONG STATION PRECINCT SOUTH
PRE-DILAPIDATION REPORT**

**DEICORP PROJECTS
(TALLAWONG STATION) PTY LTD**

Job No. 191294.0
24/03/2020

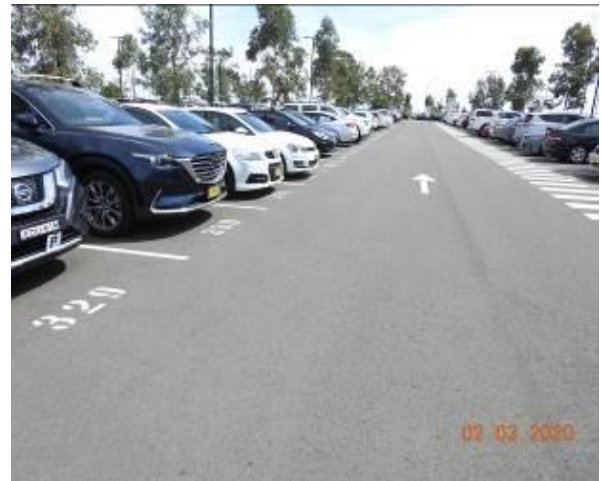
Figure 2660 – General Condition of carpark pavement

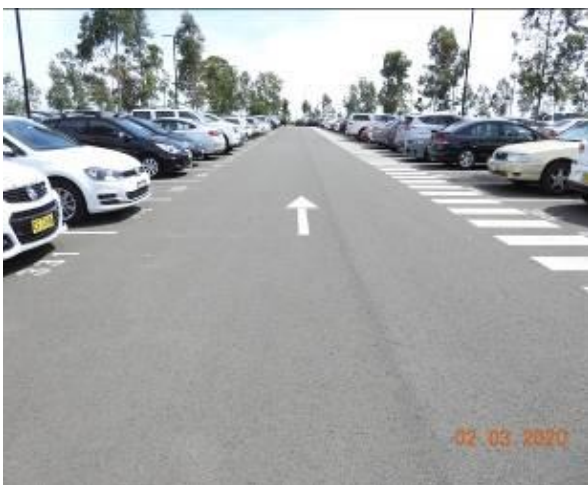
Figure 2661 – General Condition of carpark pavement

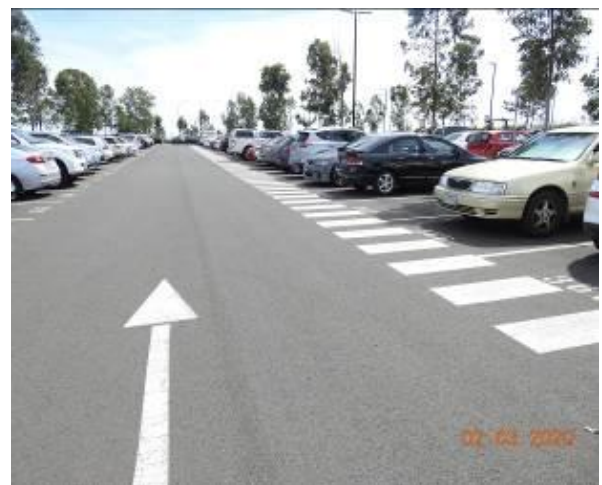
Figure 2662 – General Condition of carpark pavement

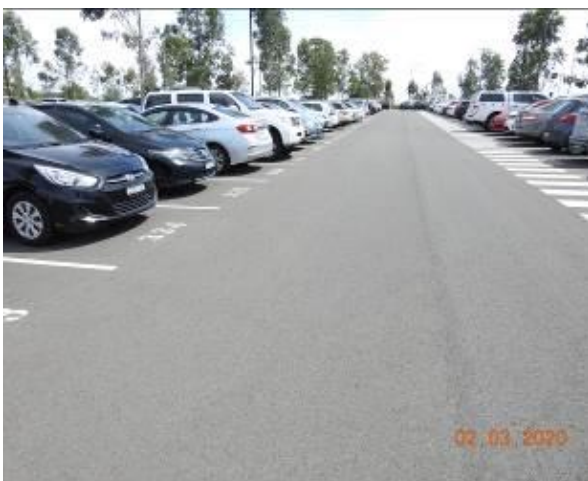
Figure 2663 – General Condition of carpark pavement

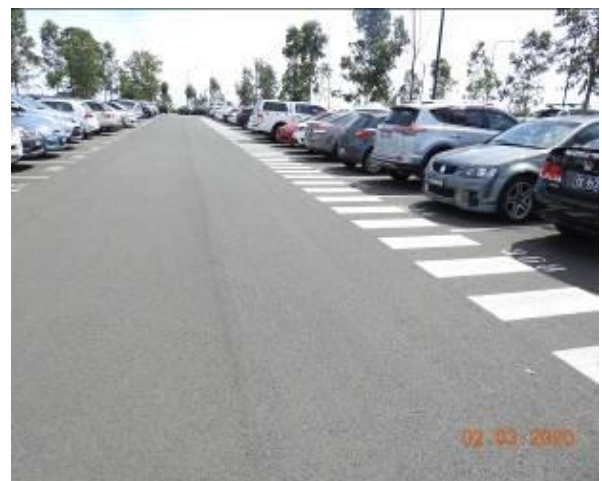
Figure 2664 – General Condition of carpark pavement

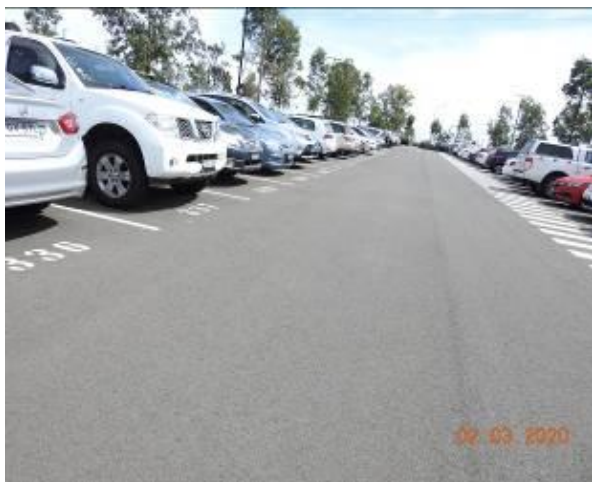
Figure 2665 – General Condition of carpark pavement

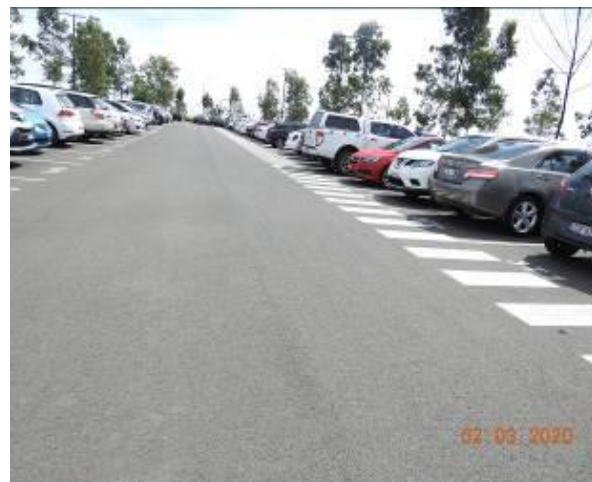
Figure 2666 – General Condition of carpark pavement

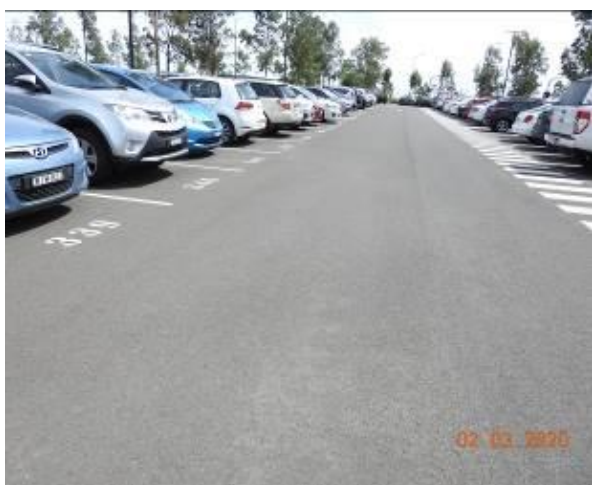
Figure 2667 – General Condition of carpark pavement

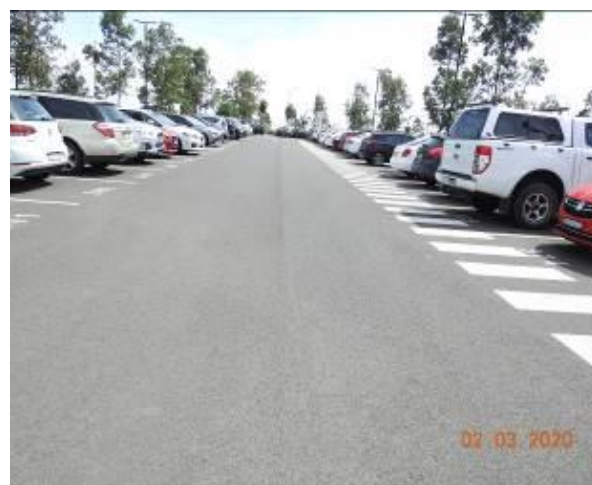
Figure 2668 – General Condition of carpark pavement

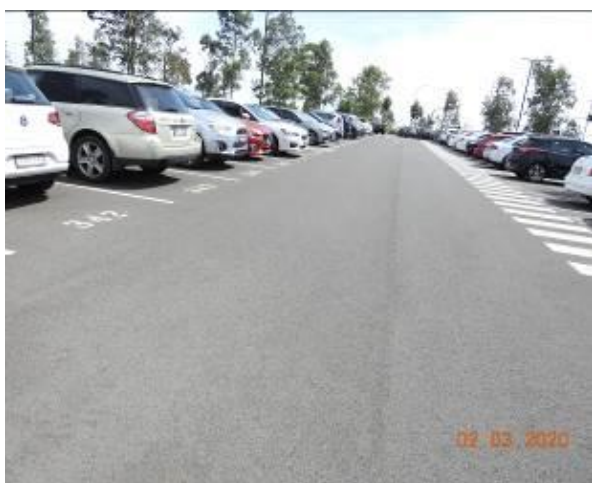
Figure 2669 – General Condition of carpark pavement

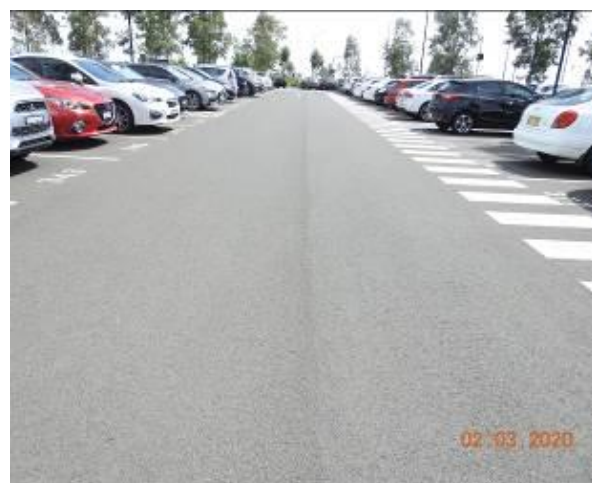
Figure 2670 – General Condition of carpark pavement

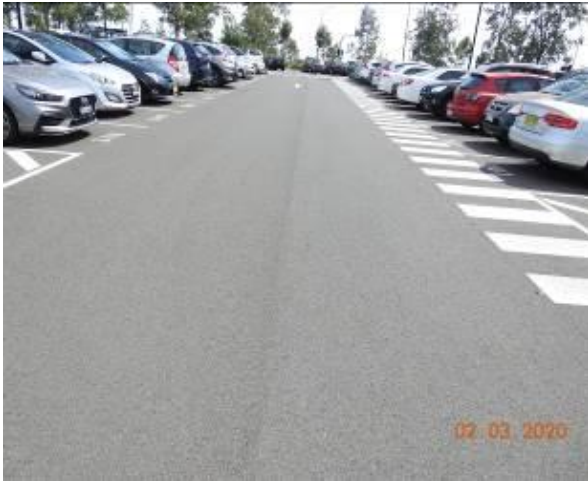
Figure 2671 – General Condition of carpark pavement

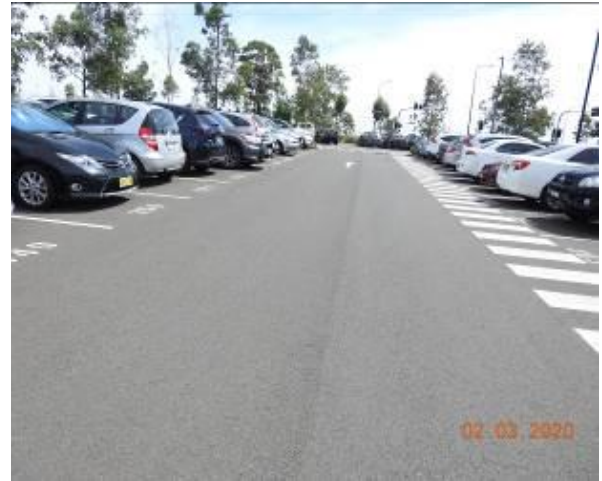
Figure 2672 – General Condition of carpark pavement

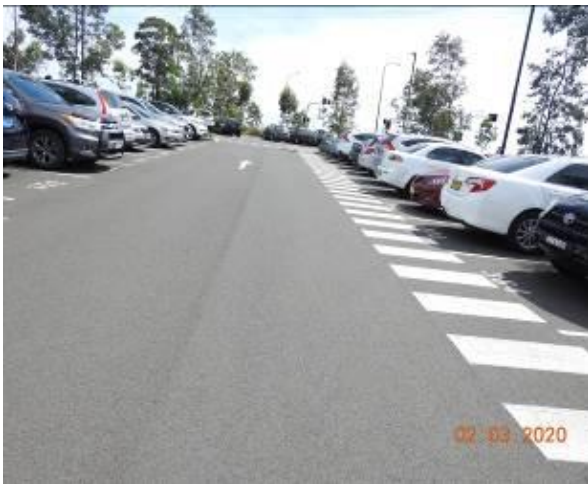
Figure 2673 – General Condition of carpark pavement

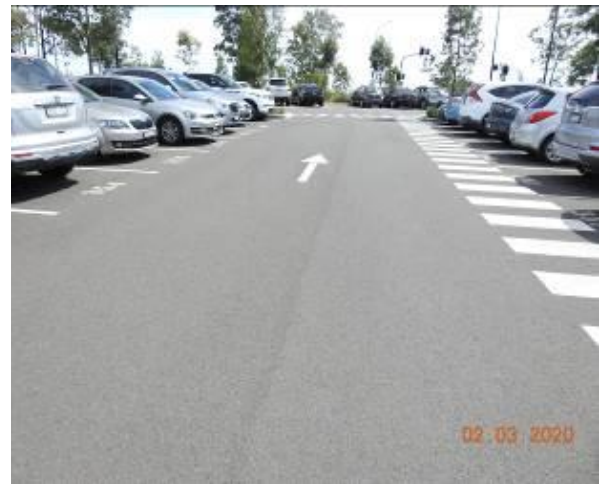
Figure 2674 – General Condition of carpark pavement

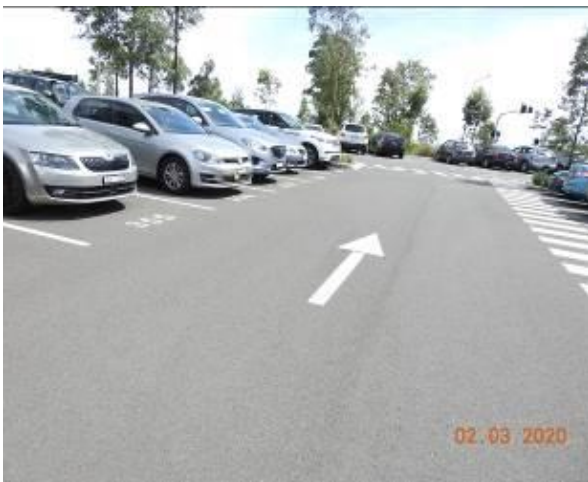
Figure 2675 – General Condition of carpark pavement

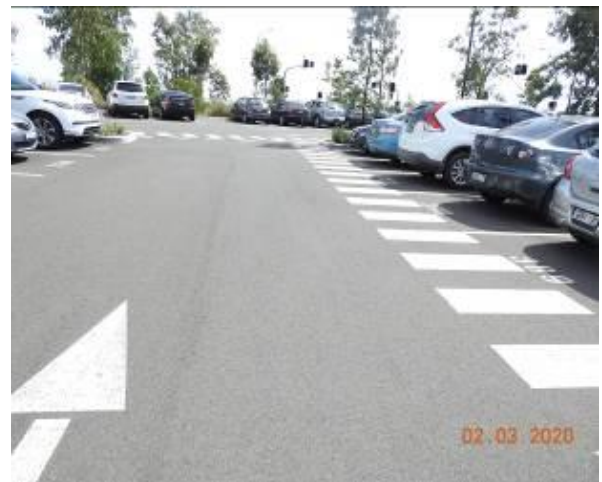
Figure 2676 – General Condition of carpark pavement

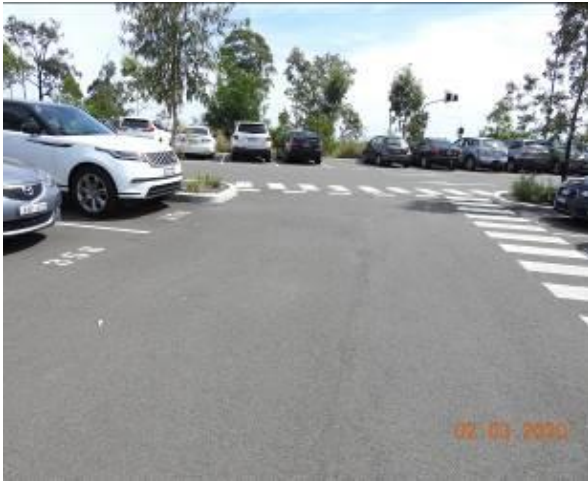
Figure 2677 – General Condition of carpark pavement

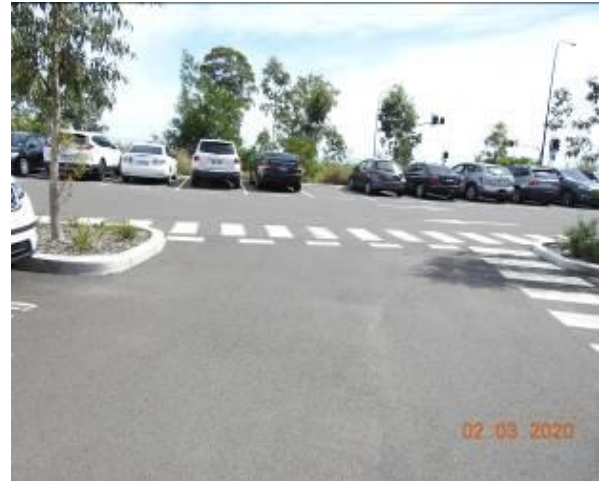
Figure 2678 – General Condition of carpark pavement

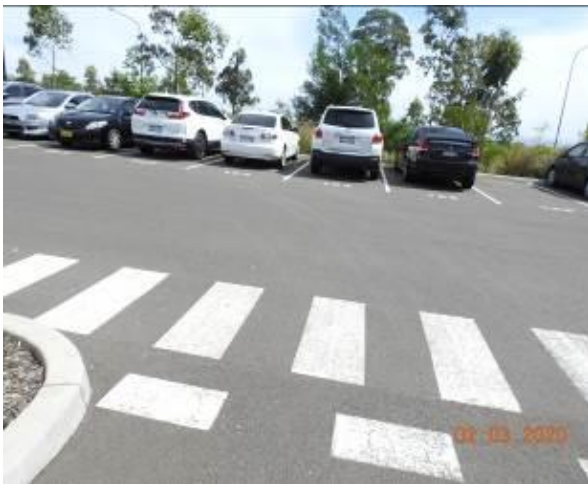
Figure 2679 – General Condition of carpark pavement

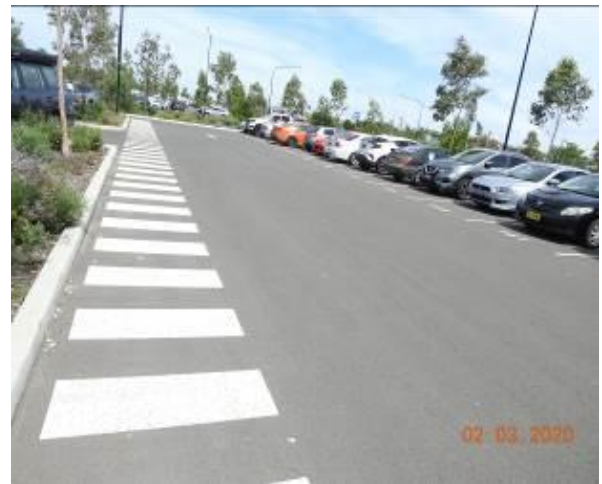
Figure 2680 – General Condition of carpark pavement

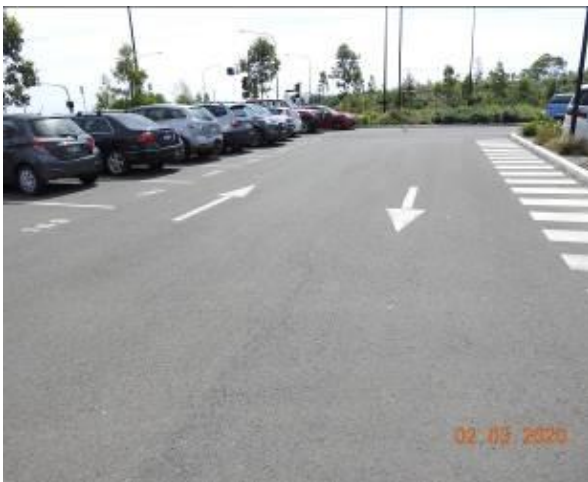
Figure 2681 – General Condition of carpark pavement

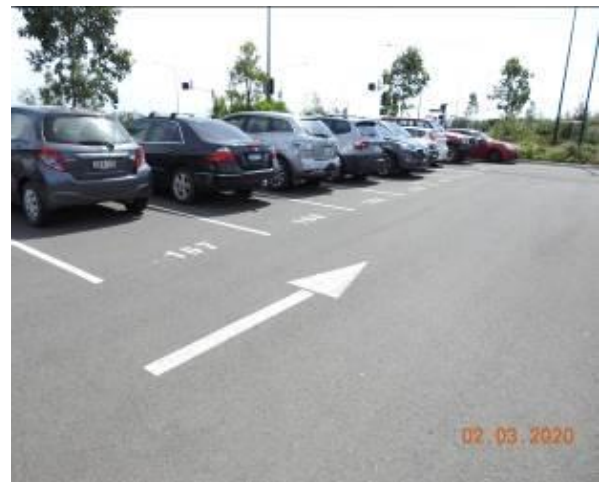
Figure 2682 – General Condition of carpark pavement

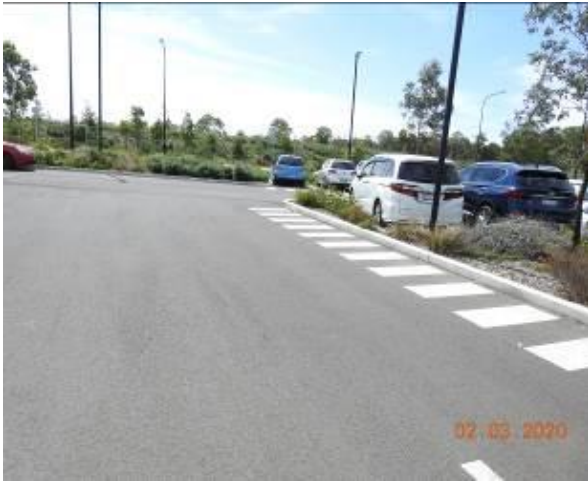
Figure 2683 – General Condition of carpark pavement

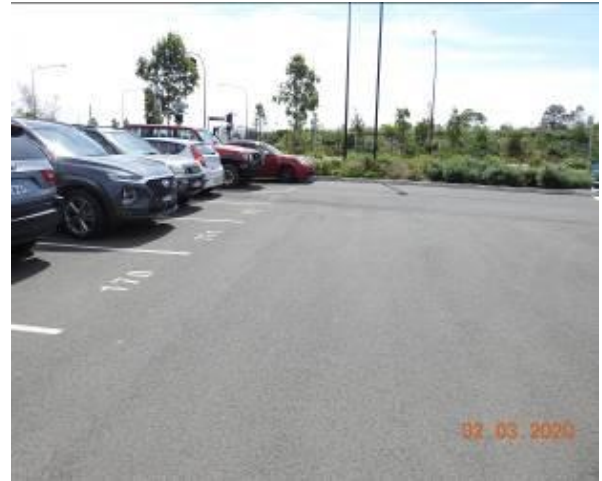
Figure 2684 – General Condition of carpark pavement

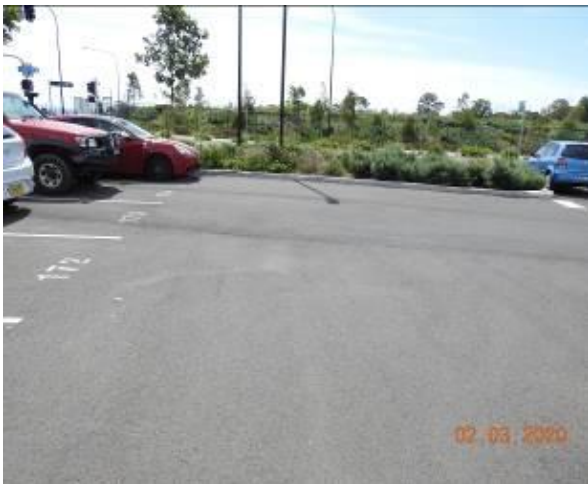
Figure 2685 – General Condition of carpark pavement

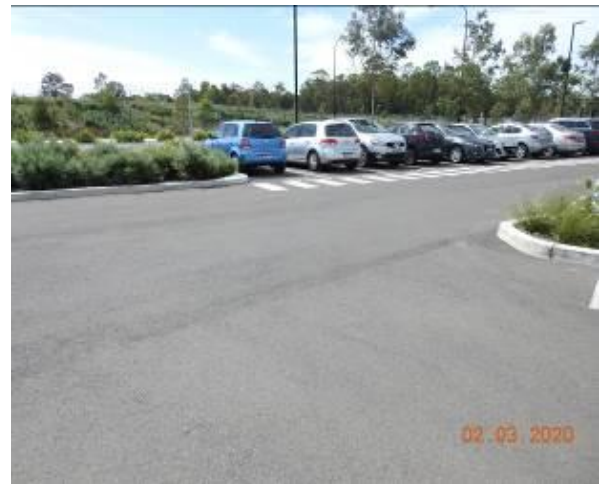
Figure 2686 – General Condition of carpark pavement

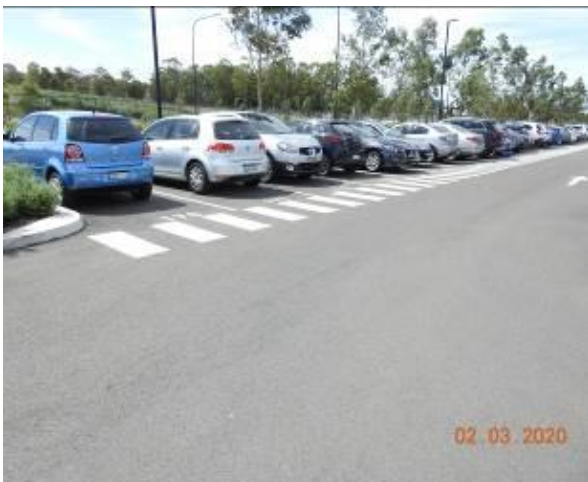
Figure 2687 – General Condition of carpark pavement

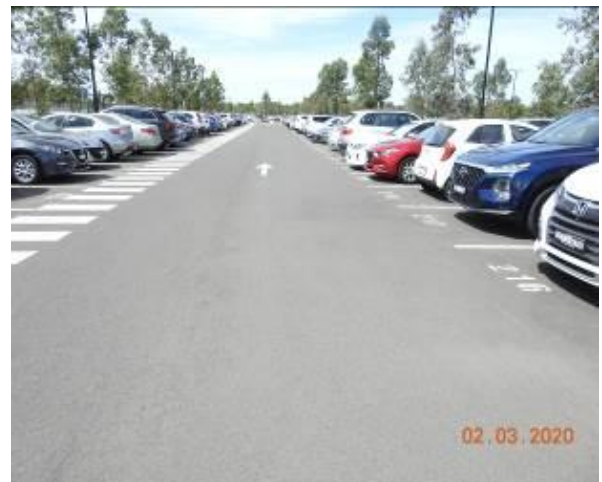
Figure 2688 – General Condition of carpark pavement

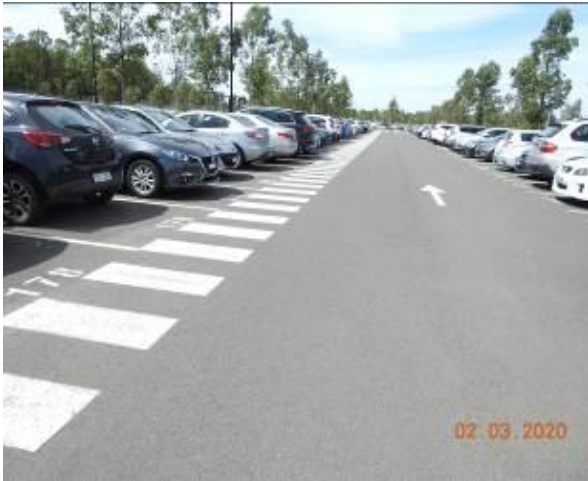
Figure 2689 – General Condition of carpark pavement

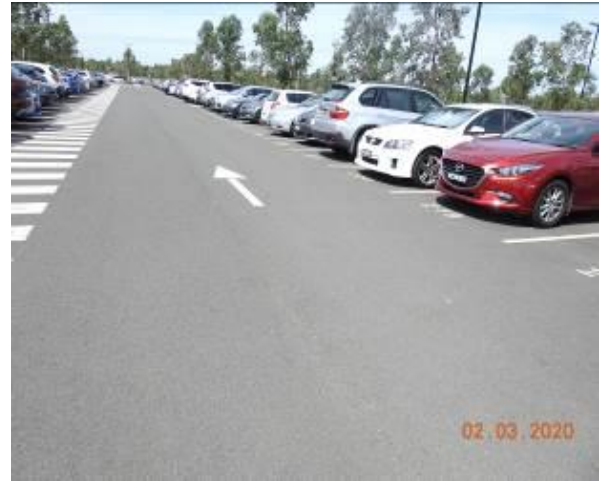
Figure 2690 – General Condition of carpark pavement

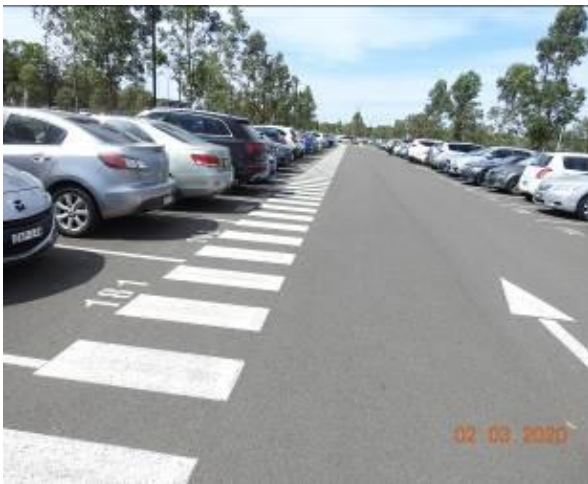
Figure 2691 – General Condition of carpark pavement

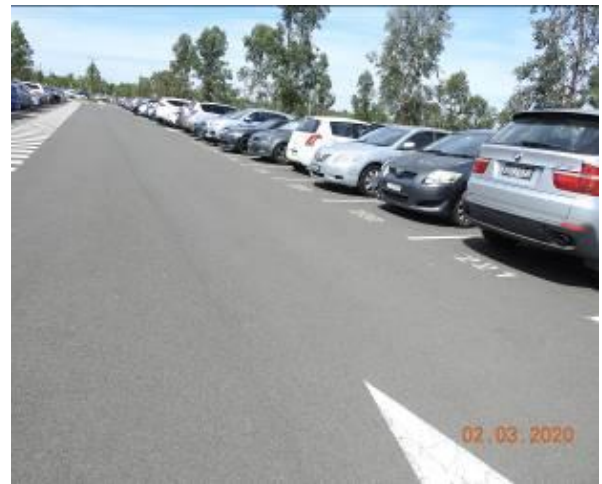
Figure 2692 – General Condition of carpark pavement

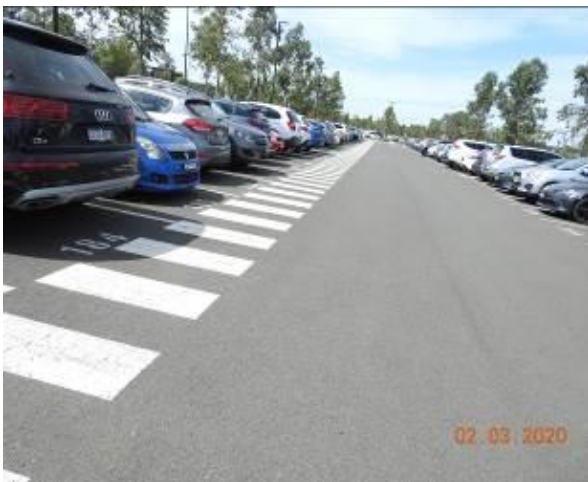
Figure 2693 – General Condition of carpark pavement

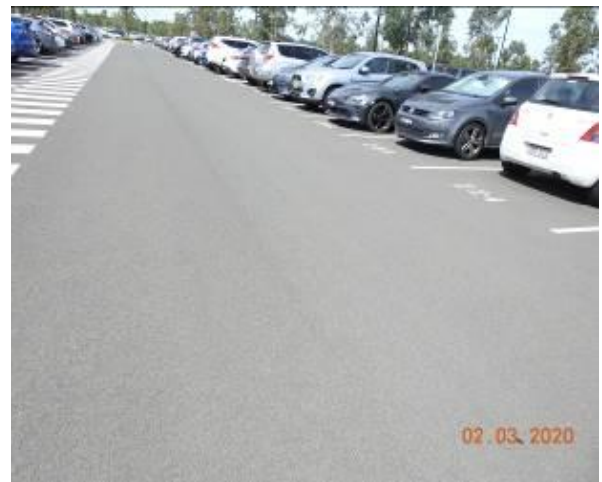
Figure 2694 – General Condition of carpark pavement

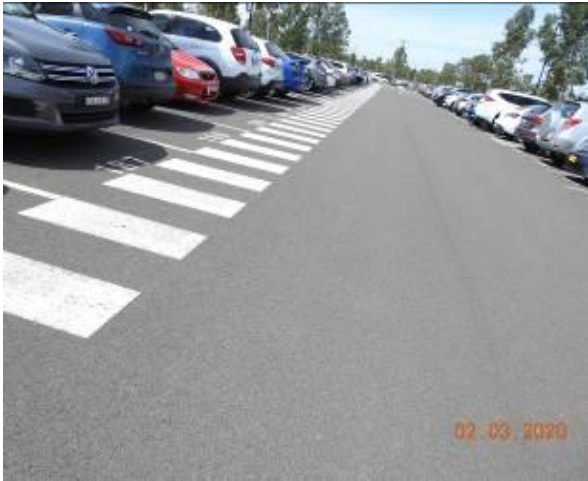
Figure 2695 – General Condition of carpark pavement

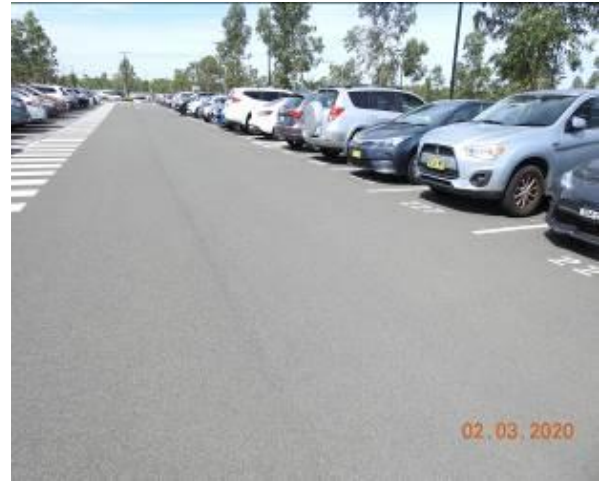
Figure 2696 – General Condition of carpark pavement

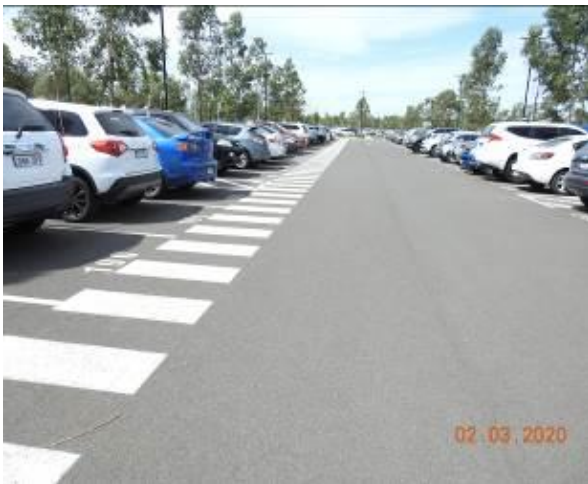
Figure 2697 – General Condition of carpark pavement

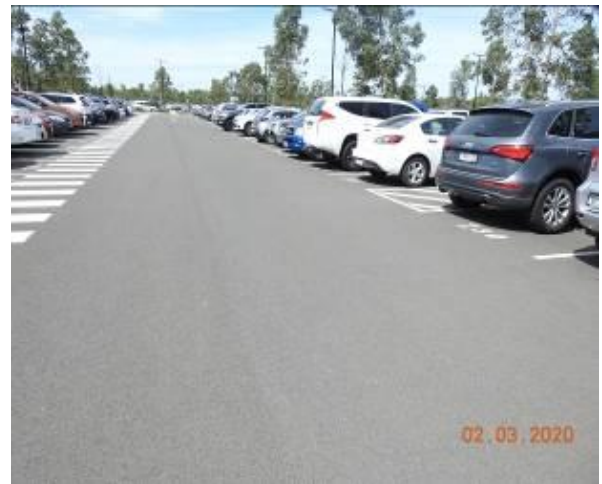
Figure 2698 – General Condition of carpark pavement

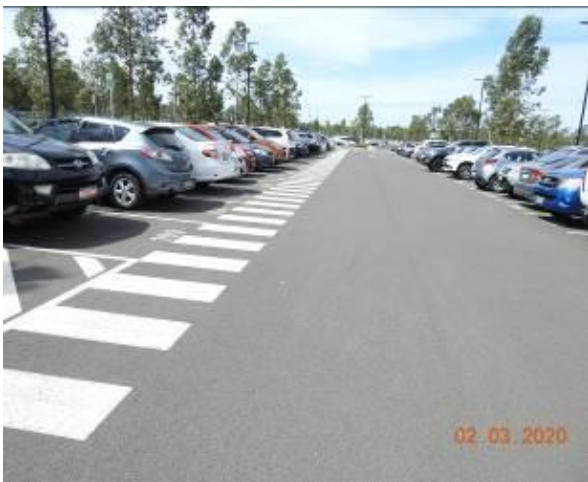
Figure 2699 – General Condition of carpark pavement

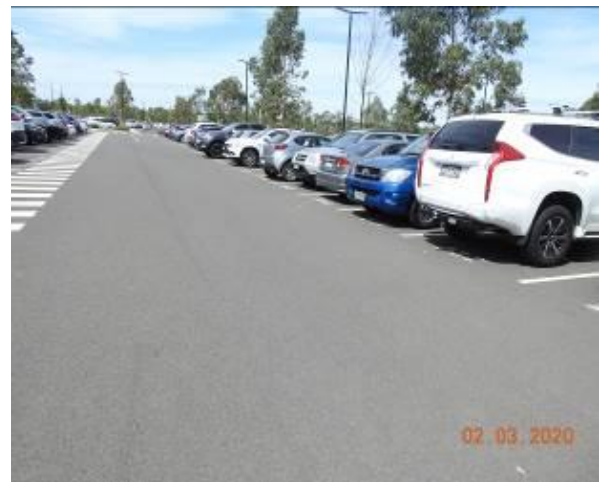
Figure 2700 – General Condition of carpark pavement

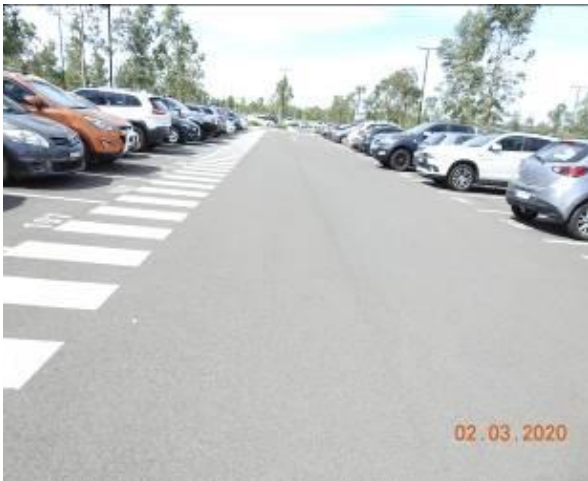
Figure 2701 – General Condition of carpark pavement

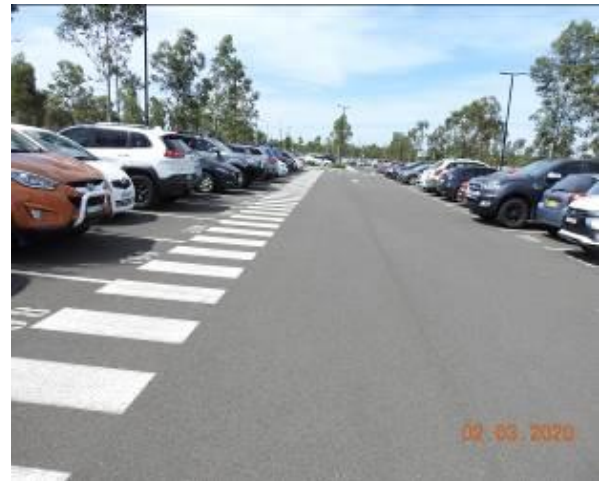
Figure 2702 – General Condition of carpark pavement

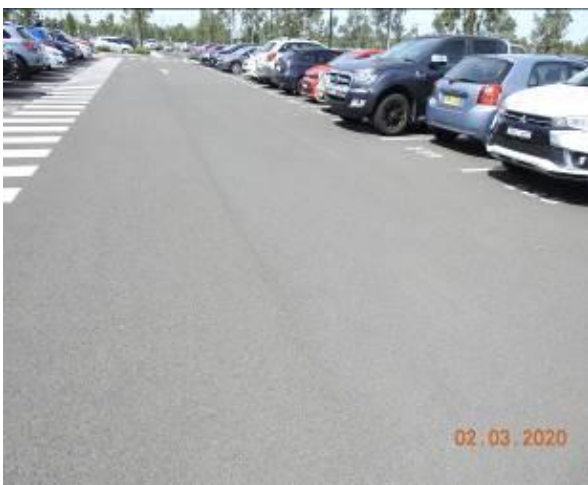
Figure 2703 – General Condition of carpark pavement

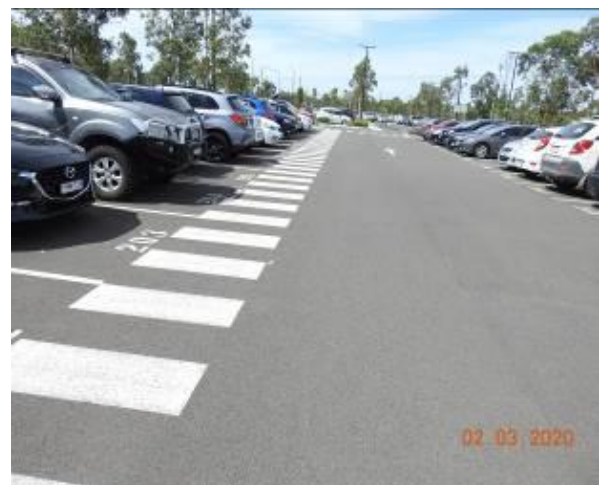
Figure 2704 – General Condition of carpark pavement

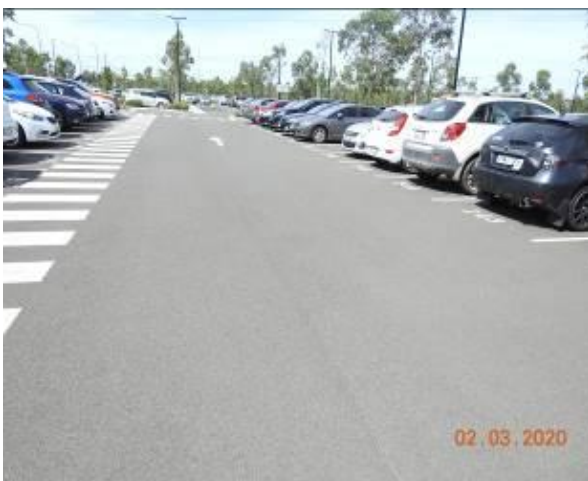
Figure 2705 – General Condition of carpark pavement

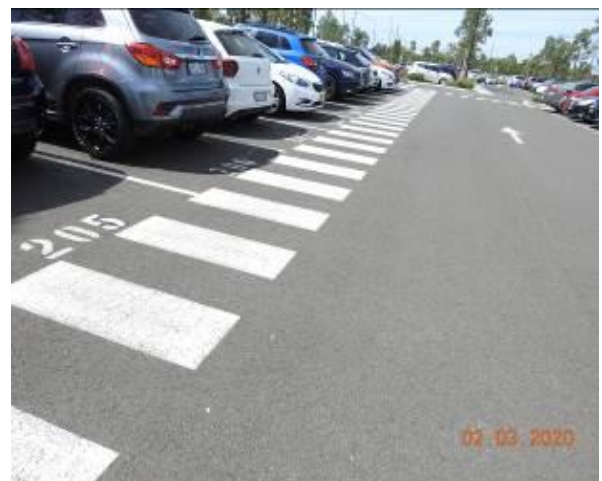
Figure 2706 – Crack propagation through carpark pavement

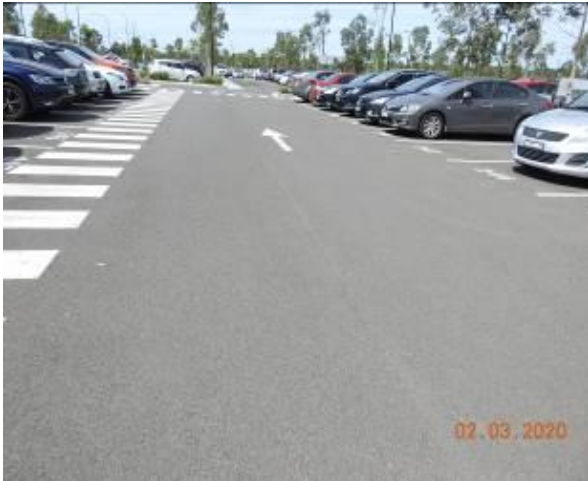
Figure 2707 – General Condition of carpark pavement

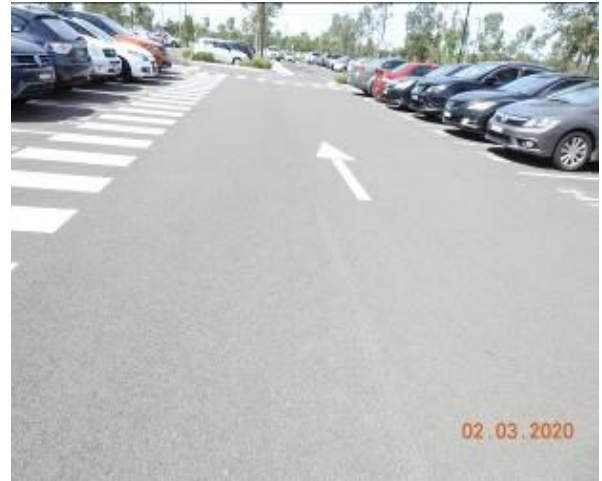
Figure 2708 – General Condition of carpark pavement

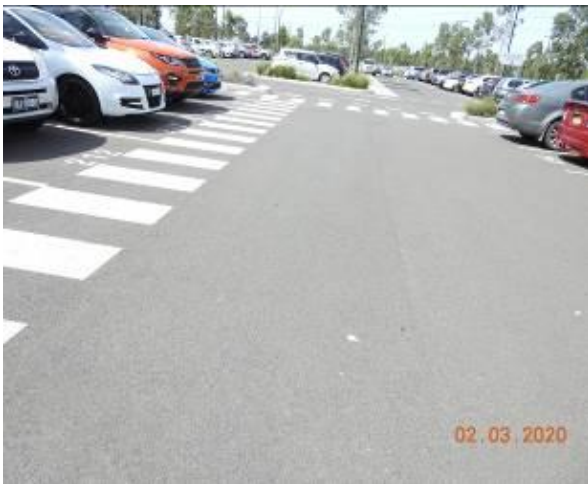
Figure 2709 – General Condition of carpark pavement

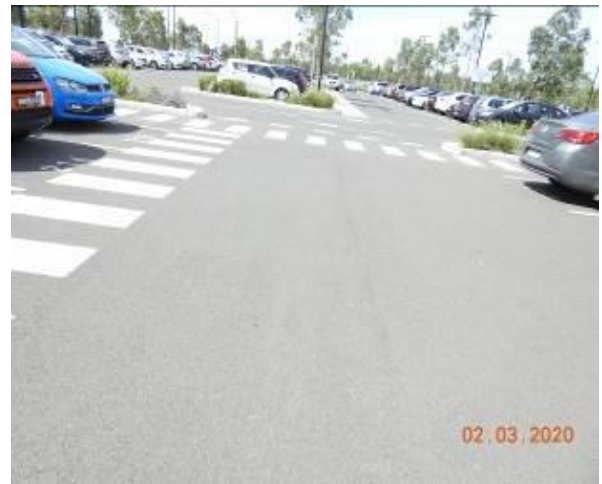
Figure 2710 – General Condition of carpark pavement

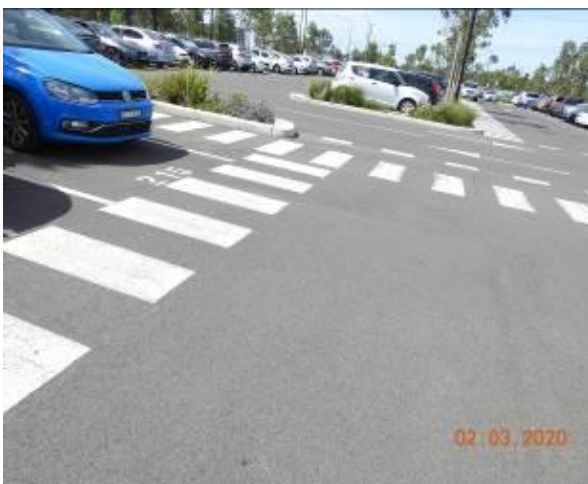
Figure 2711 – General Condition of carpark pavement

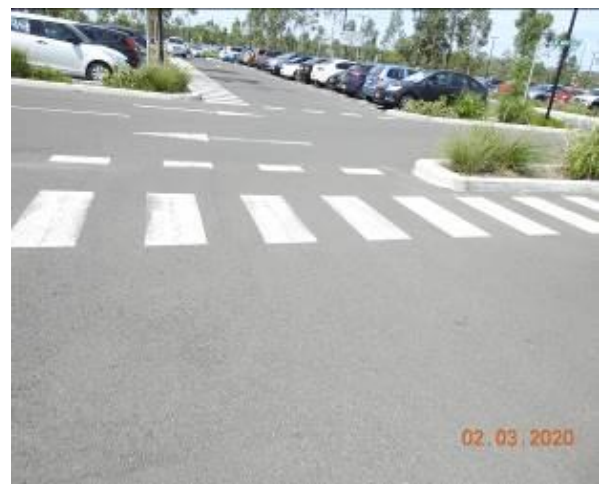
Figure 2713 – General Condition of carpark pavement

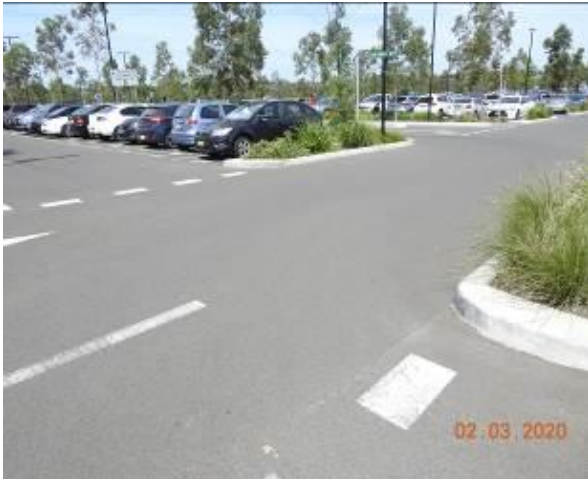
Figure 2714 – General Condition of carpark pavement

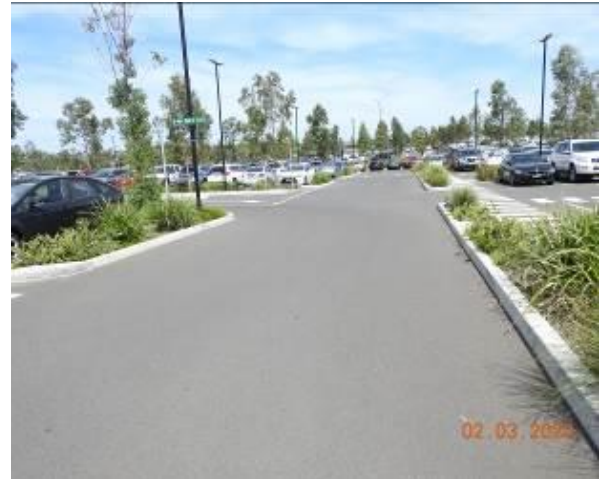
Figure 2715 – General Condition of carpark pavement

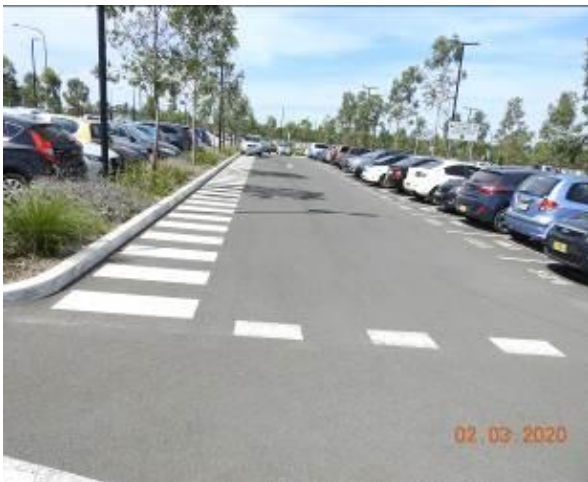
Figure 2716 – General Condition of carpark pavement

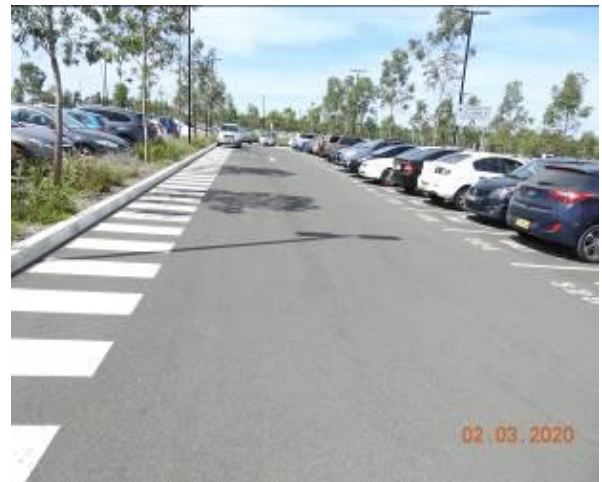
Figure 2717 – General Condition of carpark pavement

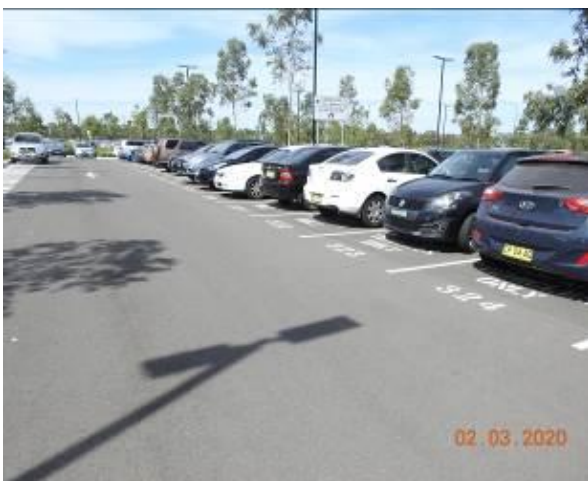
Figure 2718 – General Condition of carpark pavement

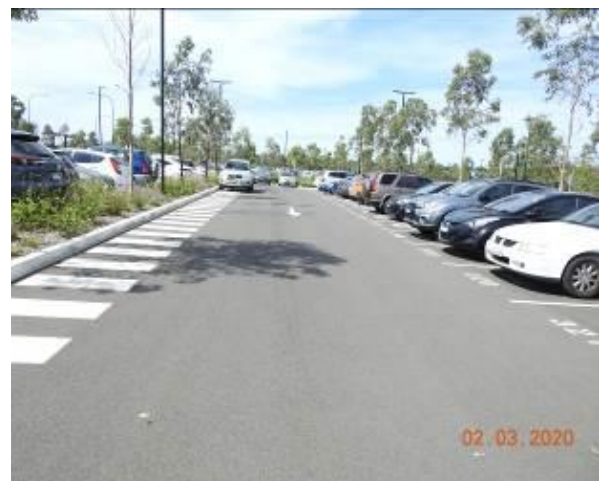
Figure 2719 – General Condition of carpark pavement

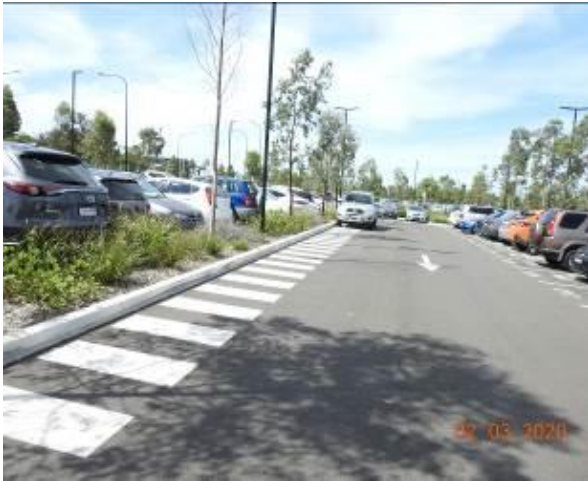
Figure 2720 – General Condition of carpark pavement

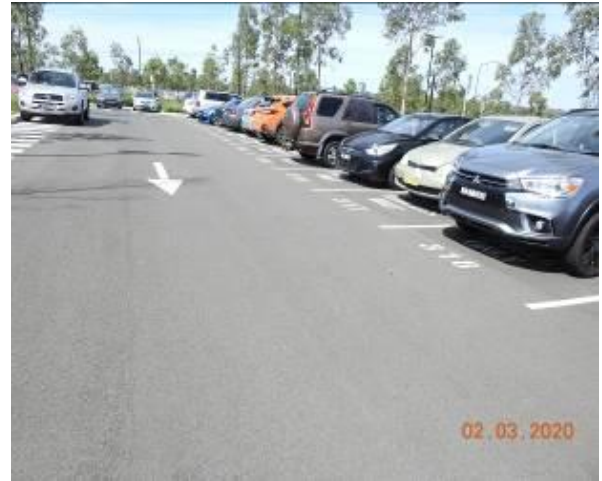
Figure 2721 – General Condition of carpark pavement

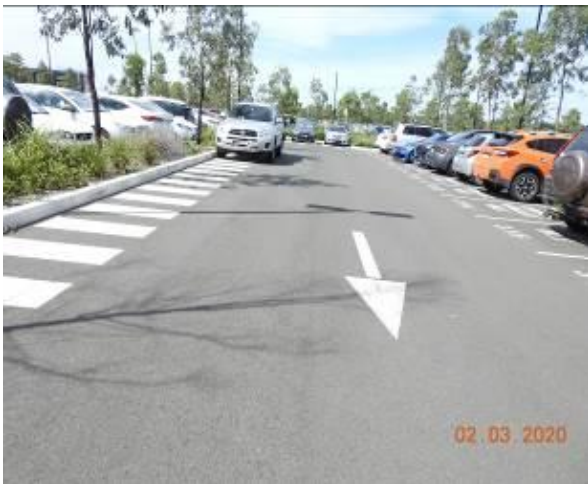
Figure 2722 – General Condition of carpark pavement

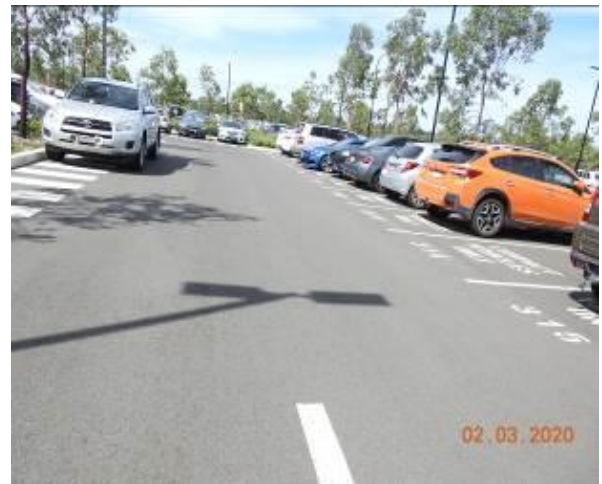
Figure 2723 – General Condition of carpark pavement

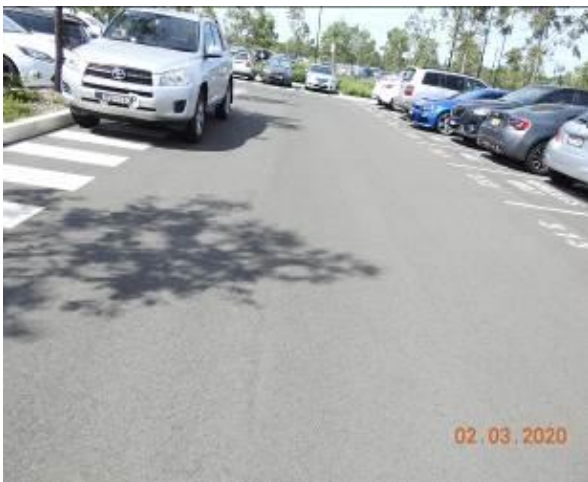
Figure 2724 – General Condition of carpark pavement

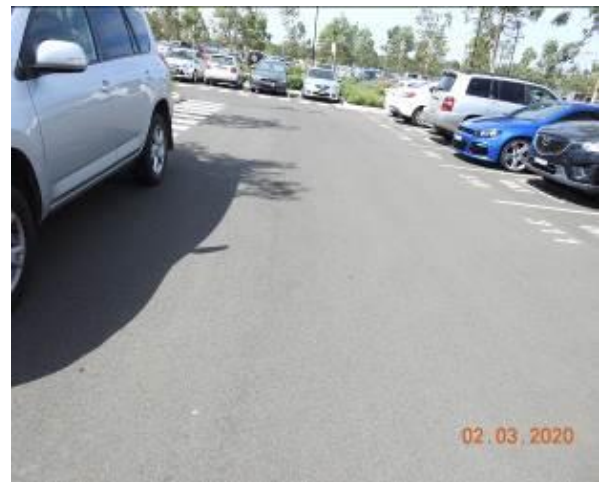
Figure 2725 – General Condition of carpark pavement

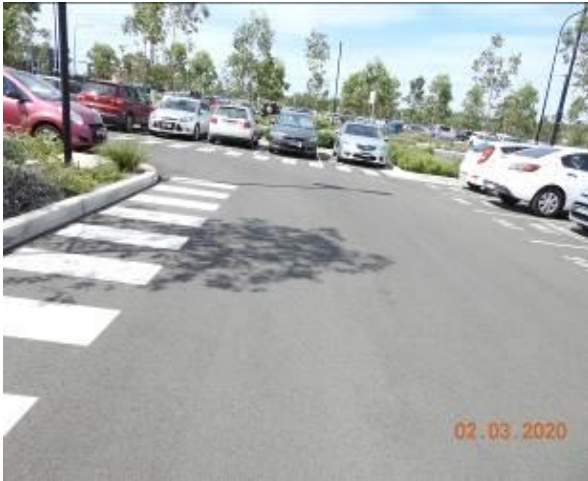
Figure 2726 – General Condition of carpark pavement

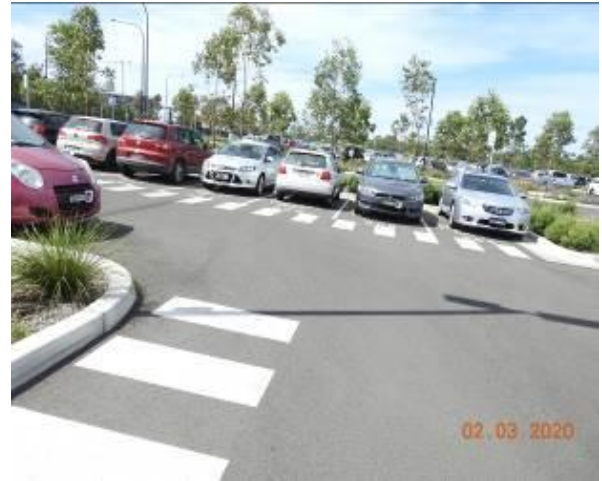
Figure 2727 – General Condition of carpark pavement

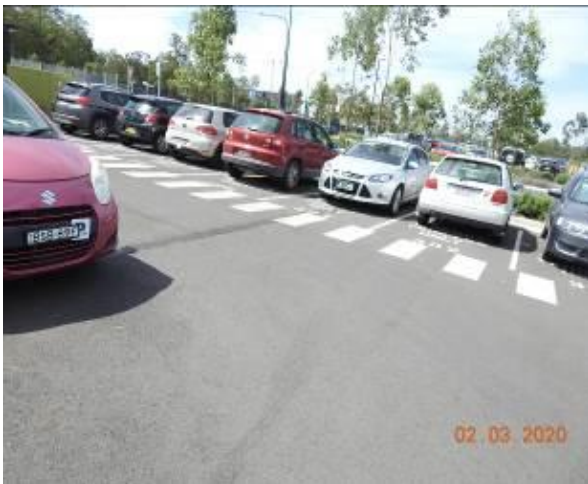
Figure 2728 – General Condition of carpark pavement

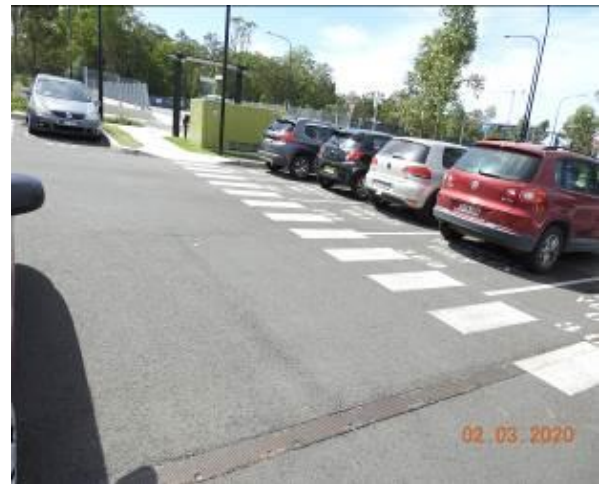
Figure 2729 – General Condition of carpark pavement

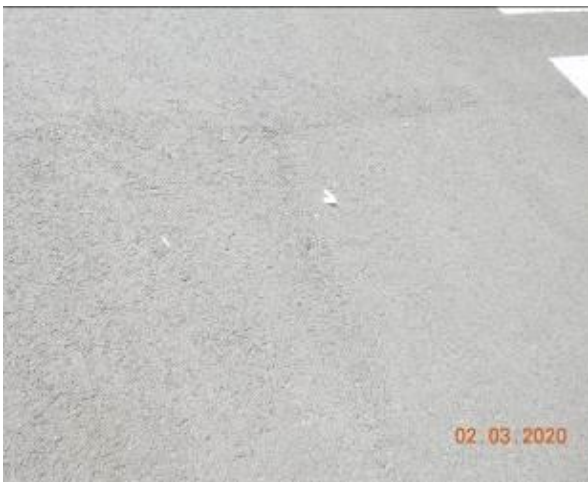
Figure 2730 – Crack propagation through carpark pavement

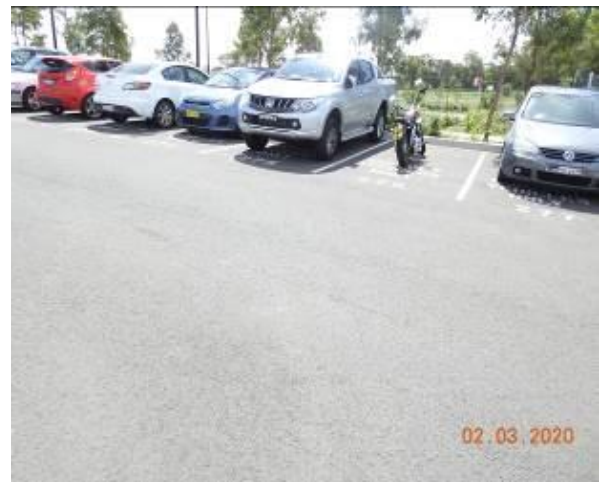
Figure 2731 – General Condition of carpark pavement

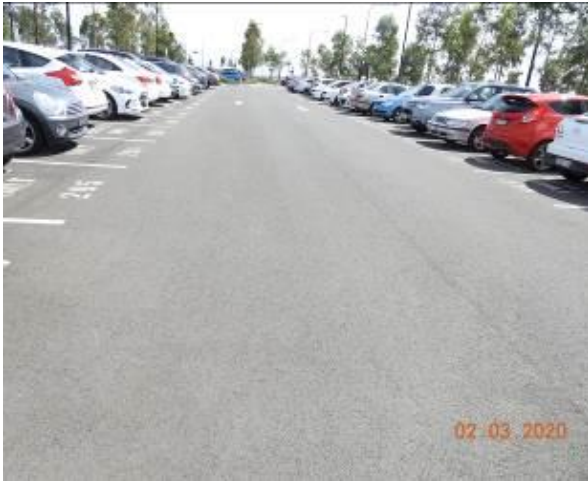
Figure 2732 – General Condition of carpark pavement

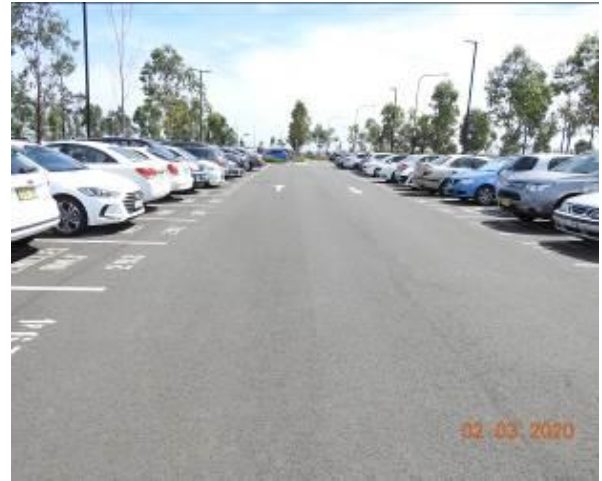
Figure 2733 – General Condition of carpark pavement

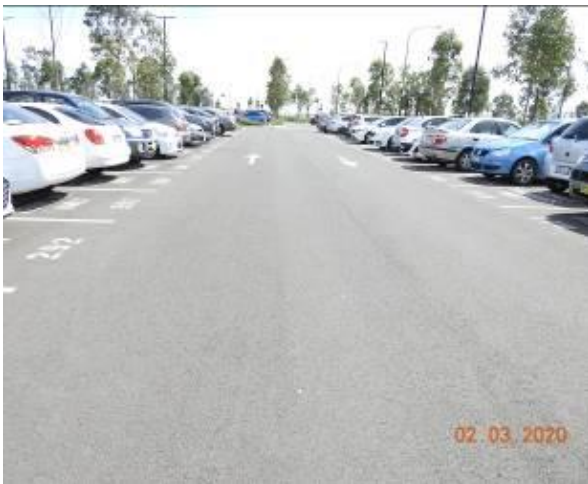
Figure 2734 – General Condition of carpark pavement

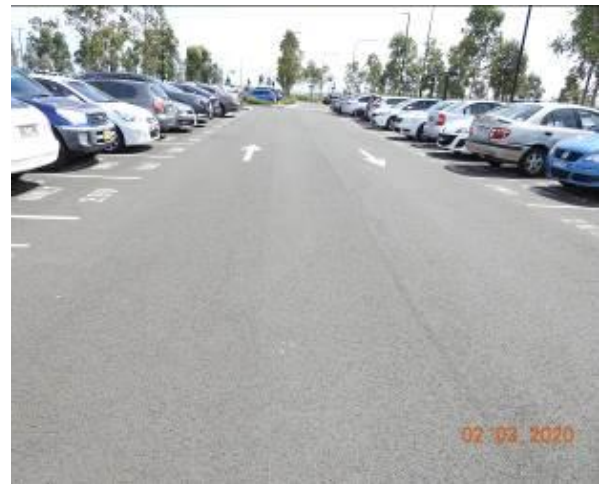
Figure 2735 – General Condition of carpark pavement

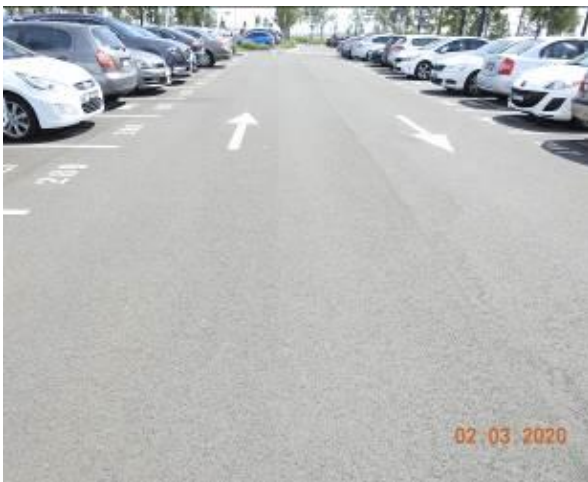
Figure 2736 – General Condition of carpark pavement

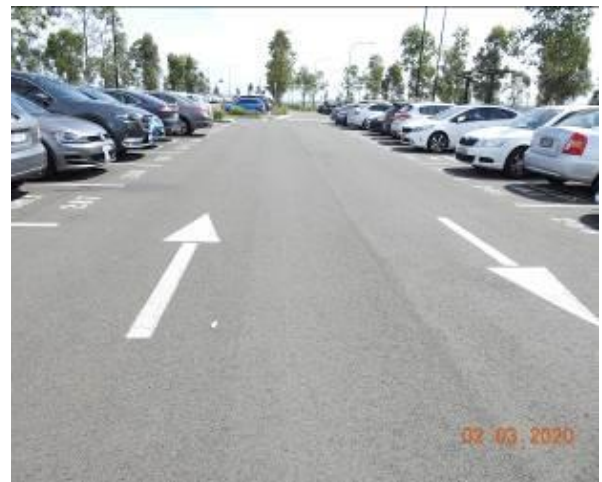
Figure 2737 – General Condition of carpark pavement
