**1-15 AND 2-12 CONFERTA AVENUE,
ROUSE HILL NSW 2155
TALLAWONG STATION PRECINCT SOUTH
PRE-DILAPIDATION REPORT**

**DEICORP PROJECTS
(TALLAWONG STATION) PTY LTD**

Job No. 191294.0
24/03/2020

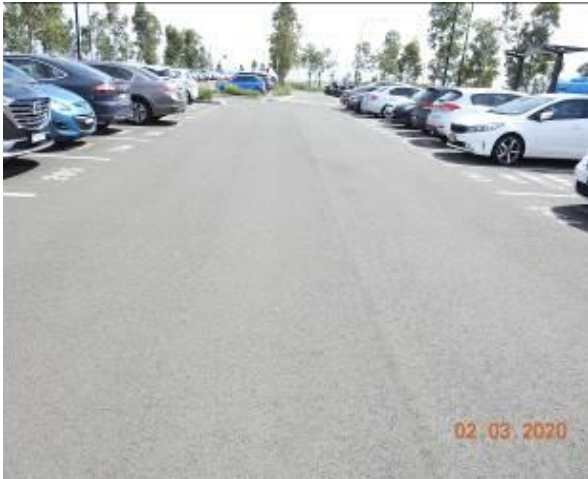
Figure 2738 – General Condition of carpark pavement

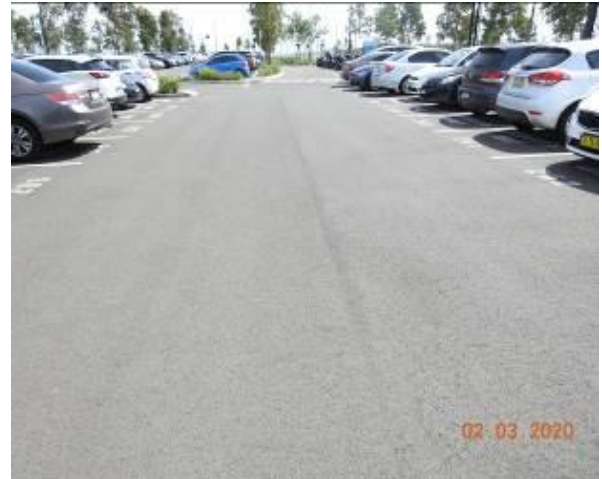
Figure 2739 – General Condition of carpark pavement

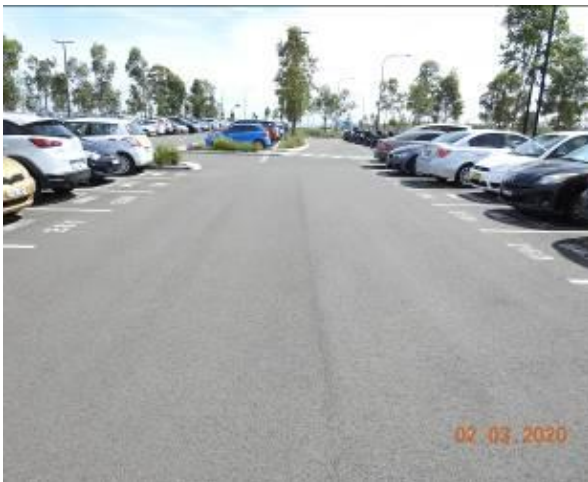
Figure 2740 – General Condition of carpark pavement

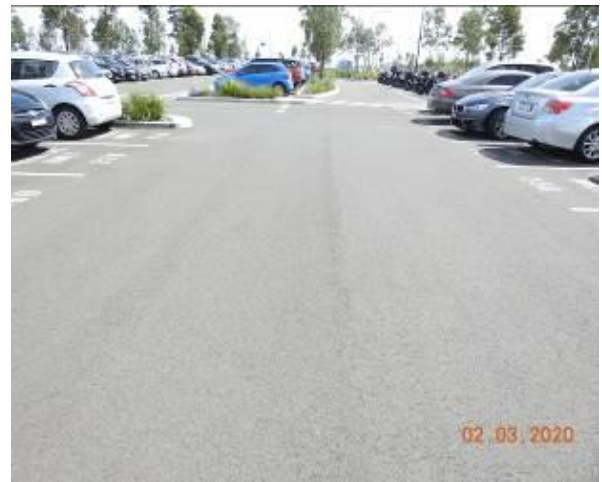
Figure 2741 – General Condition of carpark pavement

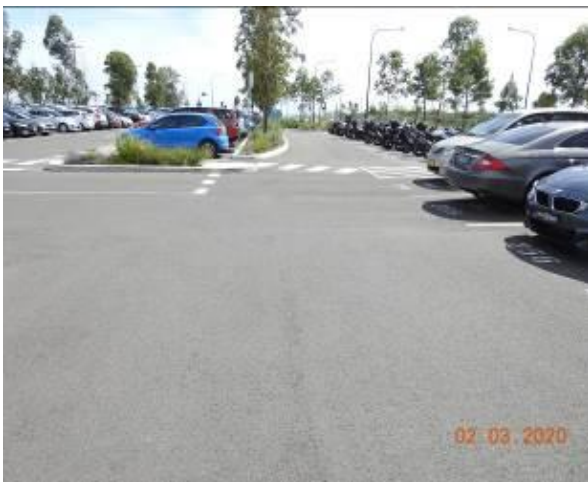
Figure 2742 – General Condition of carpark pavement

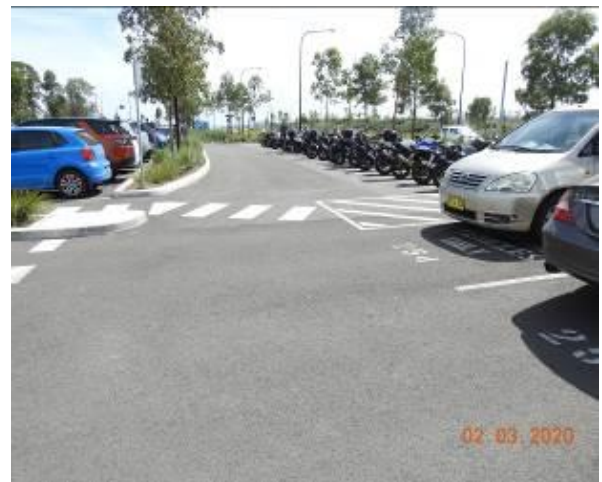
Figure 2743 – General Condition of carpark pavement

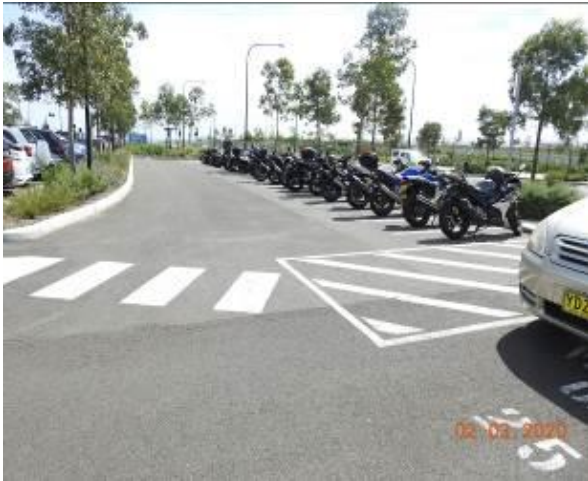
Figure 2744 – General Condition of carpark pavement

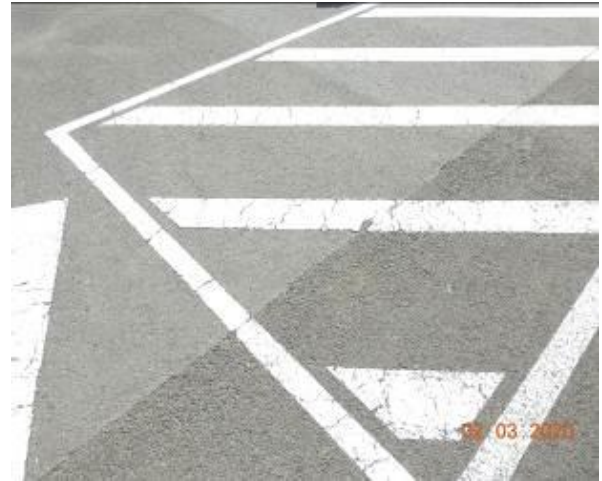
Figure 2745 – Crack propagation through carpark pavement

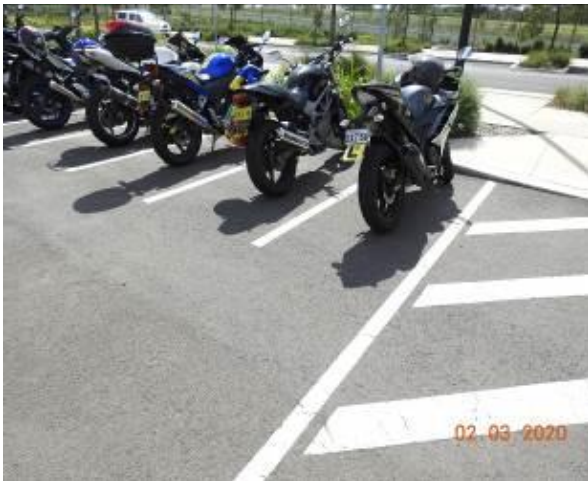
Figure 2746 – General Condition of carpark pavement

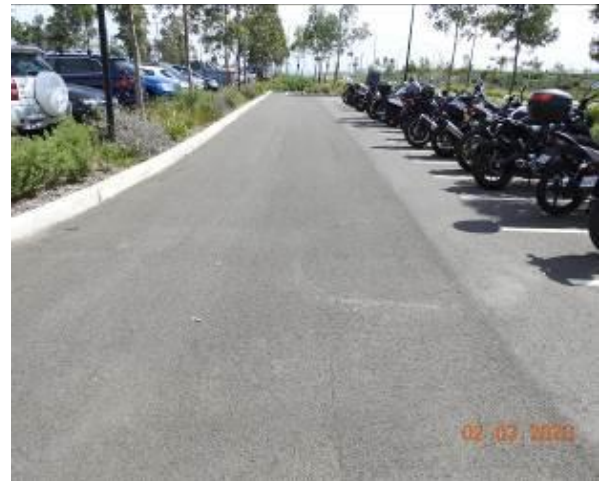
Figure 2747 – Crack propagation through carpark pavement

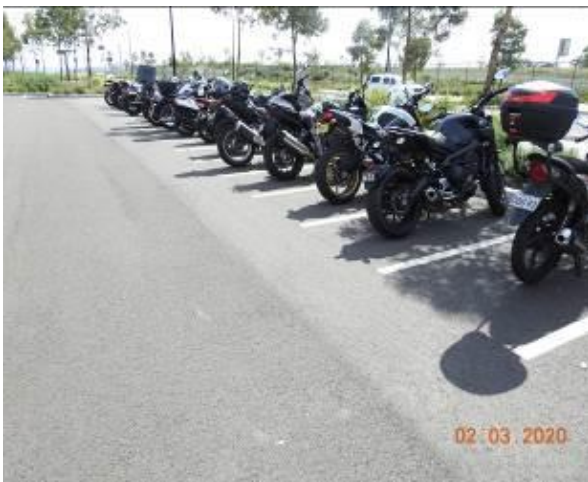
Figure 2748 – General Condition of carpark pavement

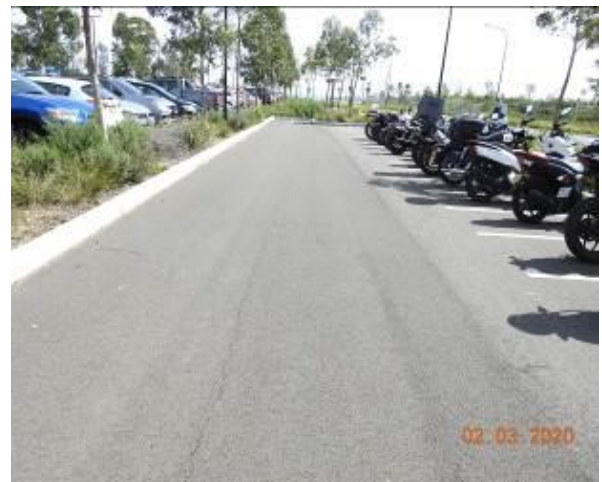
Figure 2749 – Crack propagation through carpark pavement

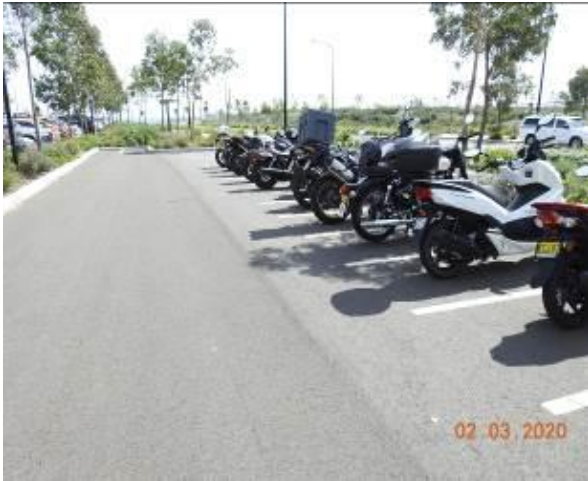
Figure 2750 – General Condition of carpark pavement

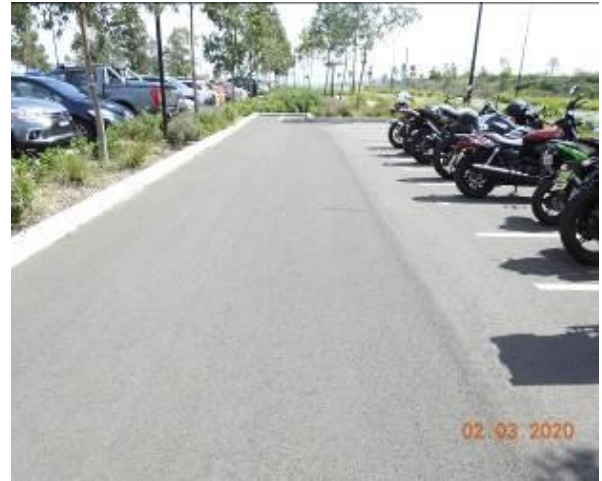
Figure 2751 – General Condition of carpark pavement

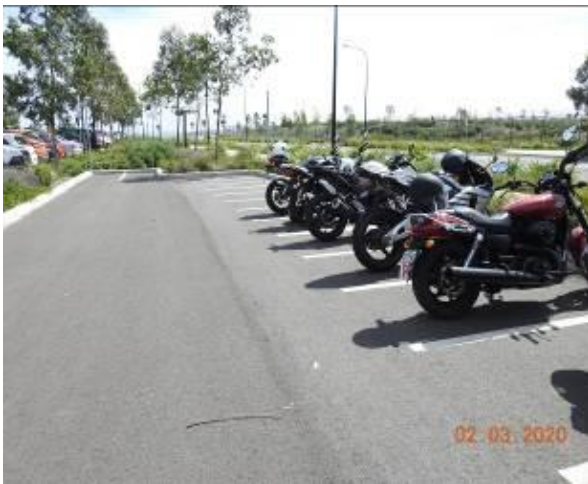
Figure 2752 – General Condition of carpark pavement

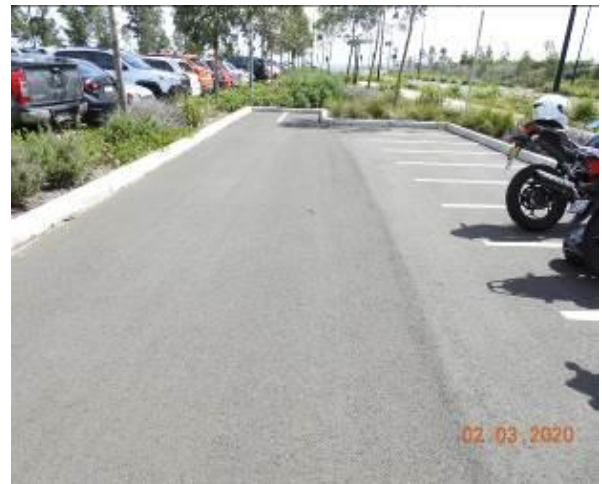
Figure 2753 – General Condition of carpark pavement

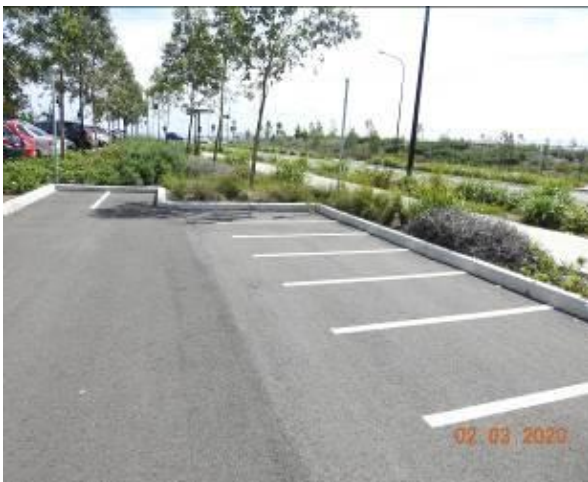
Figure 2754 – General Condition of carpark pavement

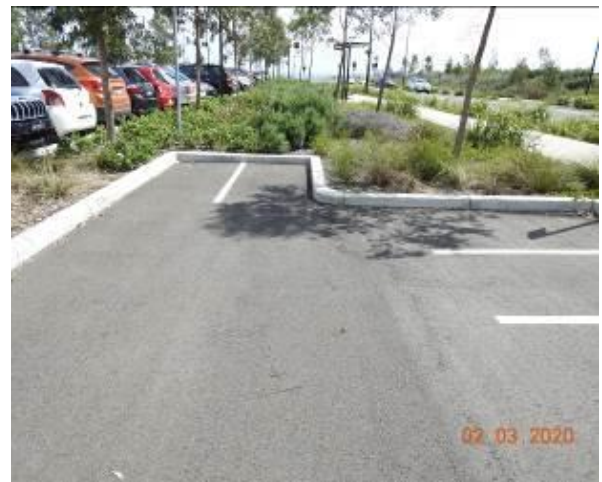
Figure 2755 – General Condition of carpark pavement

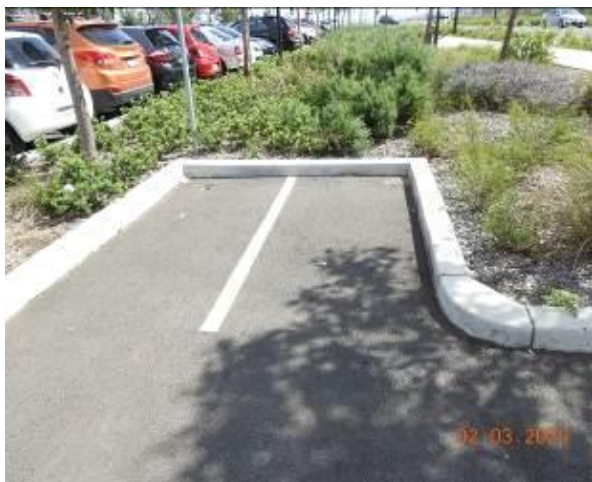
Figure 2756 – General Condition of carpark pavement

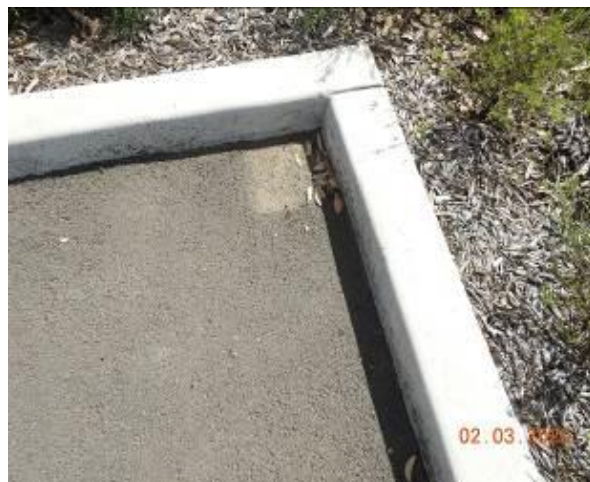
Figure 2757 – Loss of material through carpark pavement

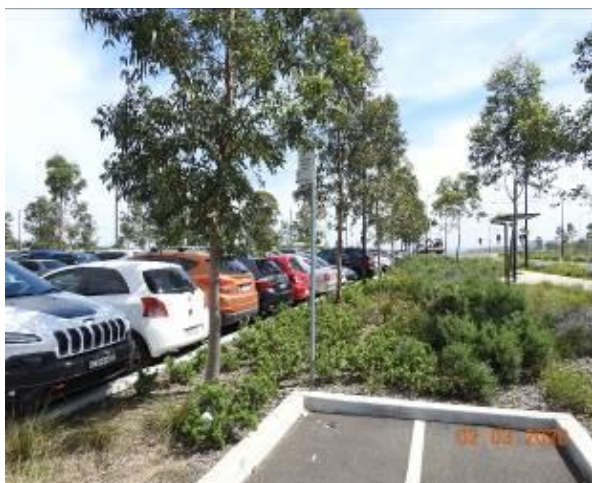
Figure 2758 – General Condition of street sign

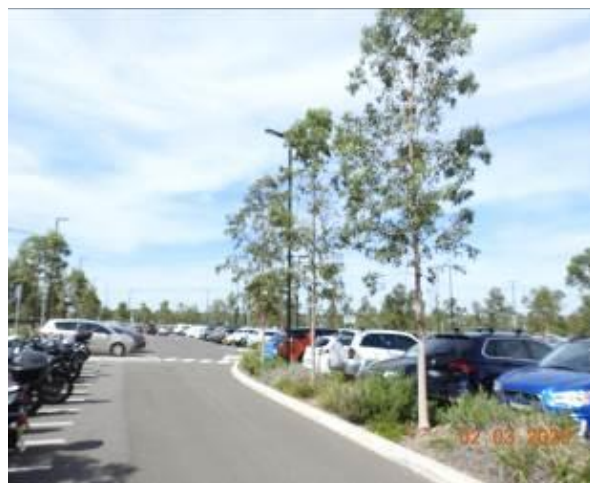
Figure 2759 – General Condition of lamp post

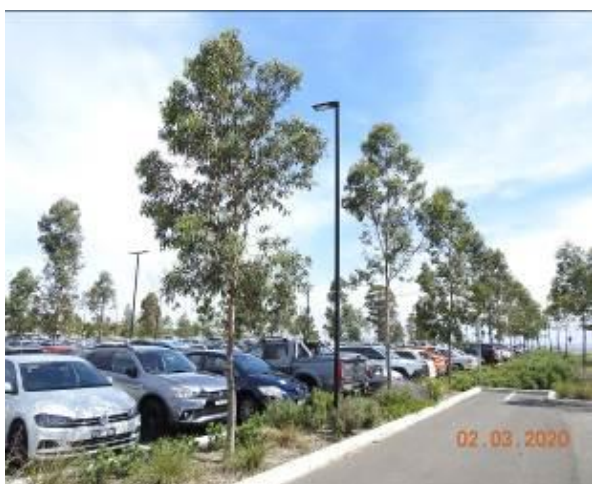
Figure 2760 – General Condition of lamp post

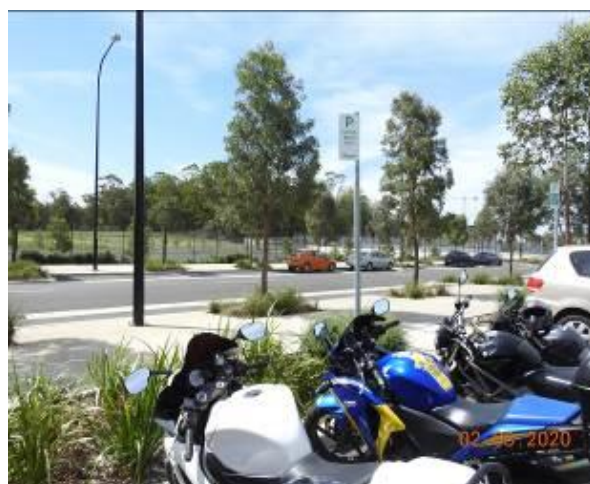
Figure 2761 – General Condition of street sign

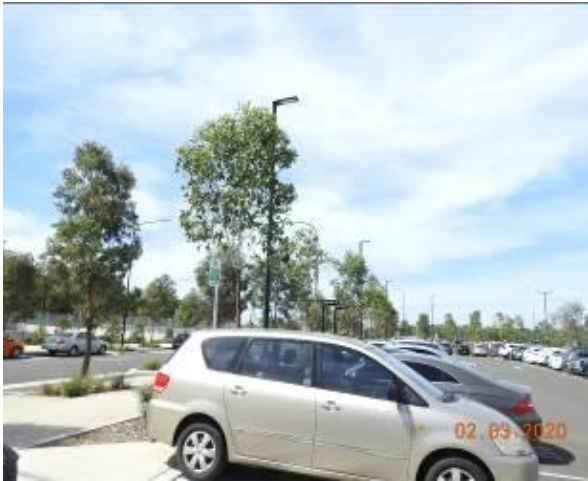
Figure 2762 – General Condition of lamp post

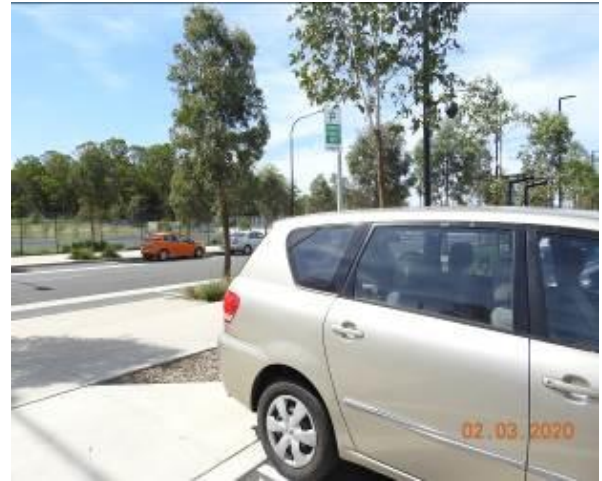
Figure 2763 – General Condition of street sign

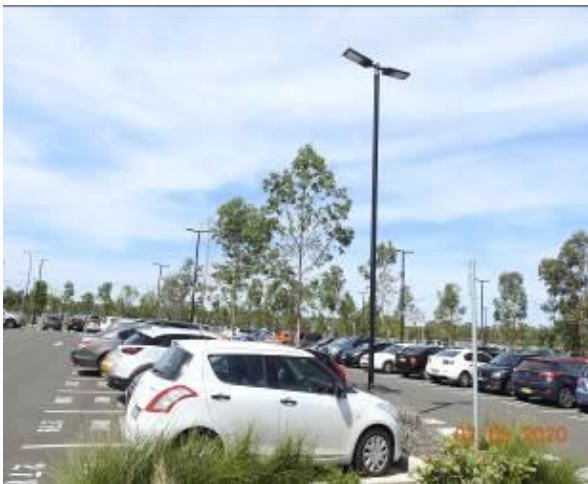
Figure 2764 – General Condition of lamp post

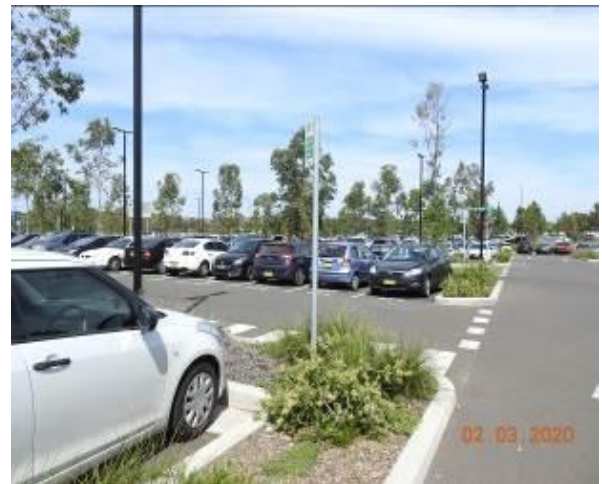
Figure 2765 – General Condition of street sign

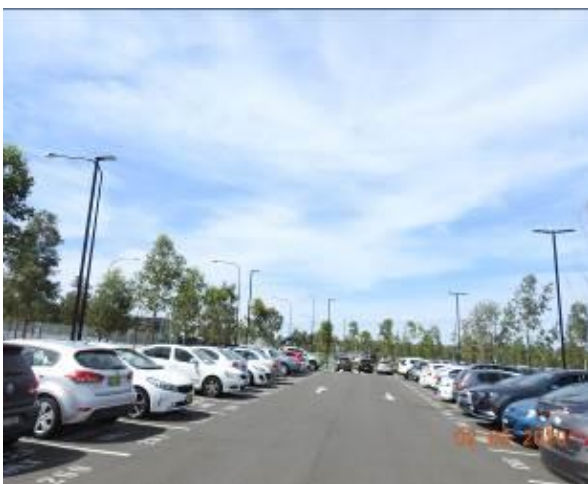
Figure 2766 – General Condition of lamp post

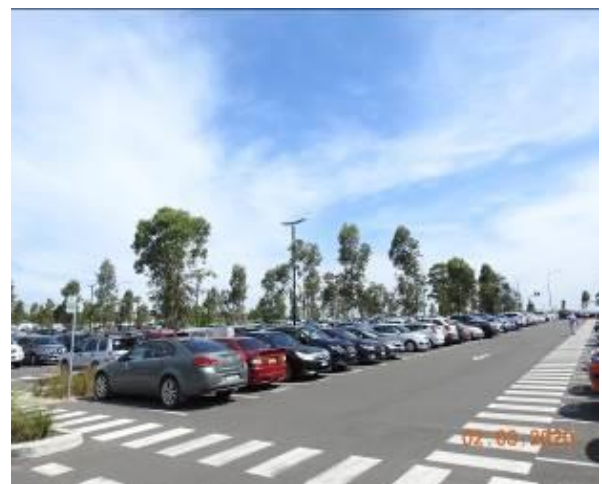
Figure 2767 – General Condition of lamp post

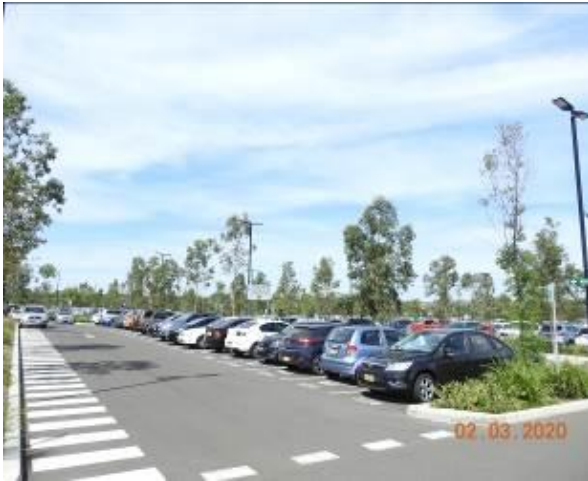
Figure 2768 – General Condition of plantation

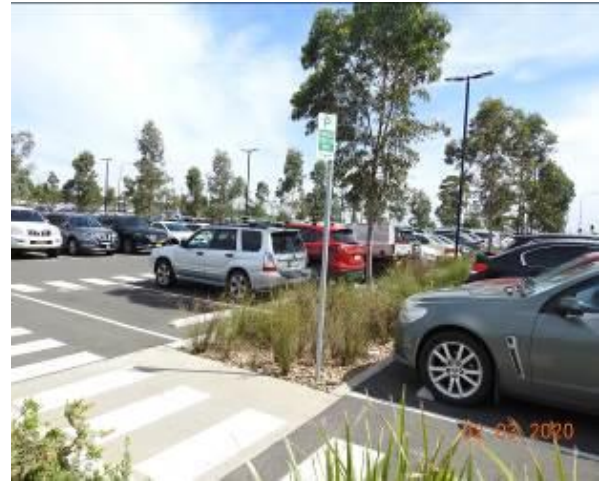
Figure 2769 – General Condition of street sign

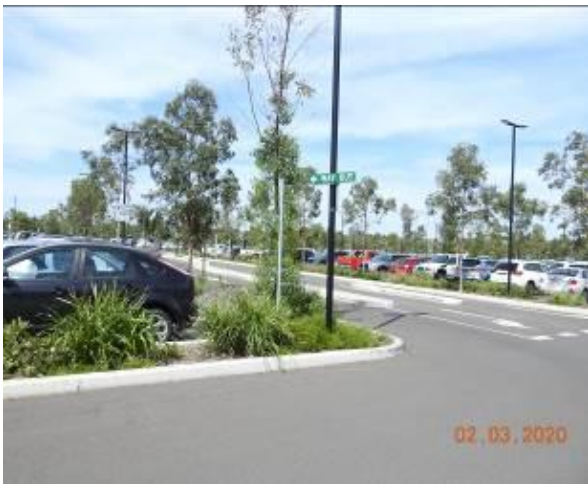
Figure 2770 – General Condition of street sign

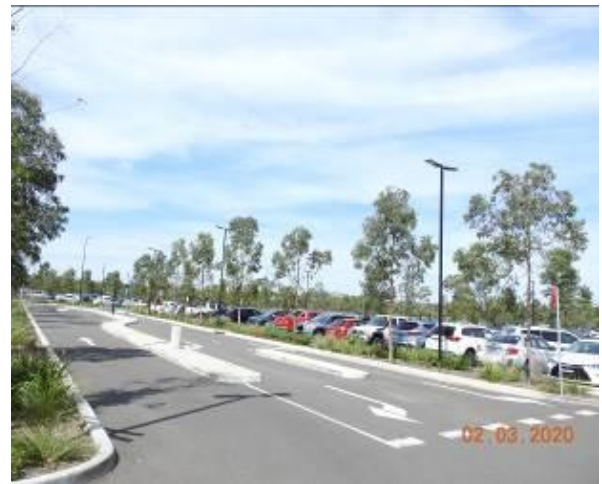
Figure 2771 – General Condition of lamp post

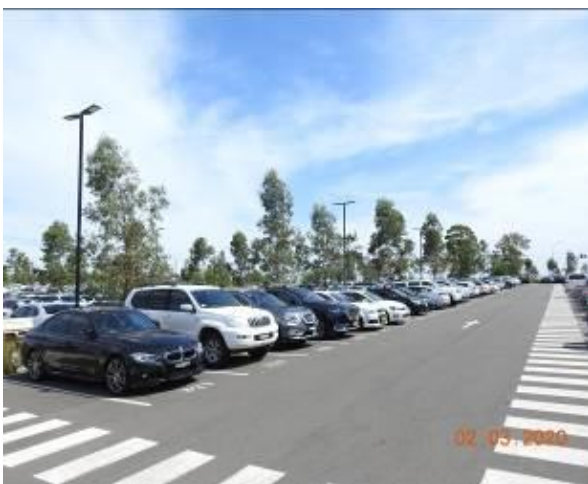
Figure 2772 – General Condition of lamp post

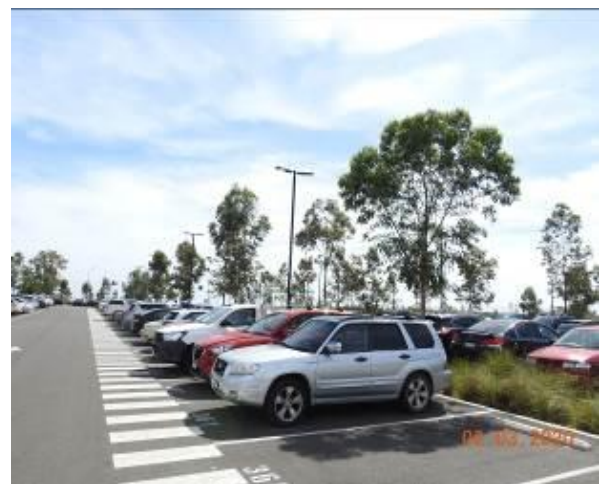
Figure 2773 – General Condition of lamp post

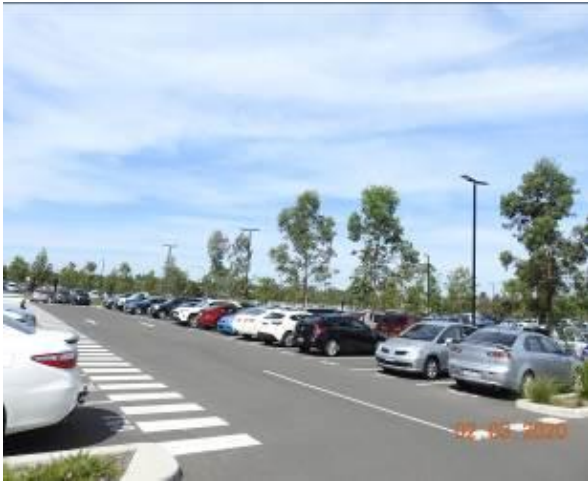
Figure 2774 – General Condition of lamp post

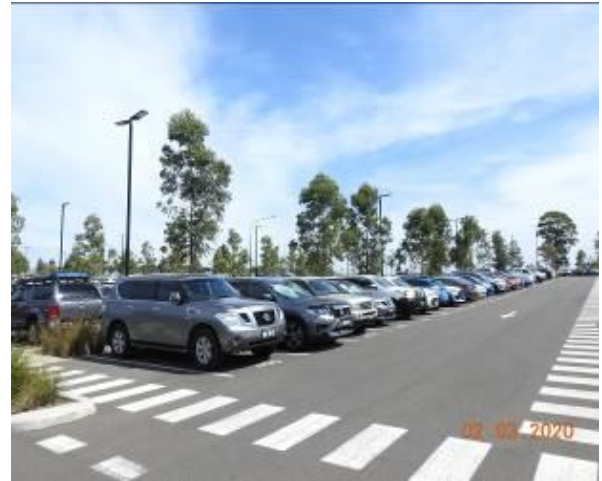
Figure 2775 – General Condition of lamp post /
plantation

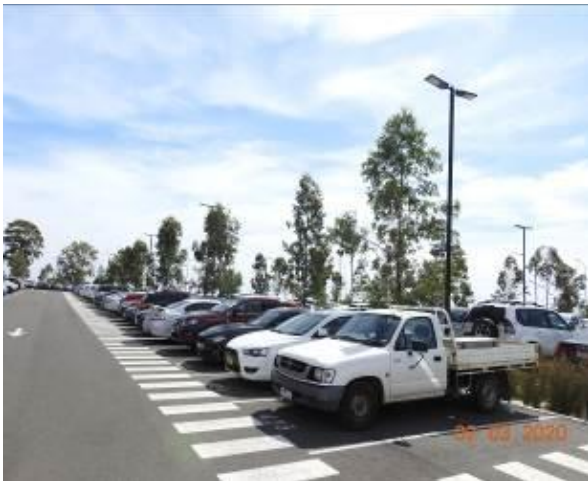
Figure 2776 – General Condition of lamp post /
plantation

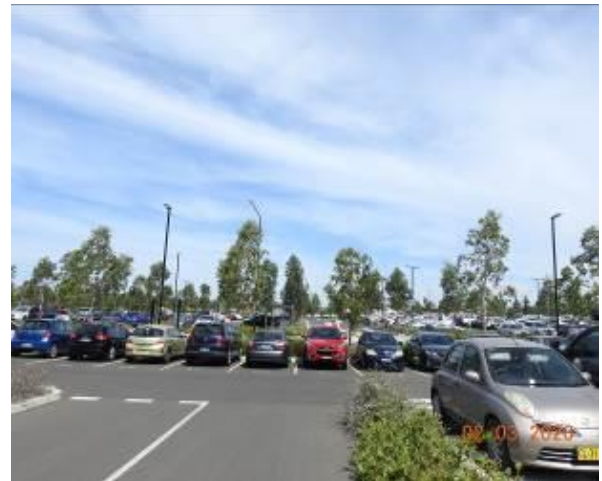
Figure 2777 – General Condition of lamp post /
plantation

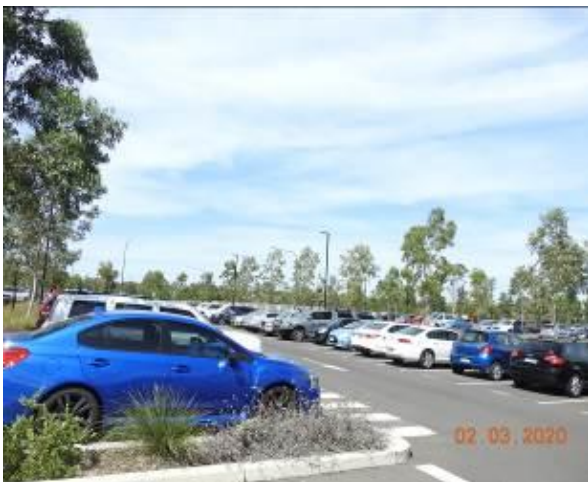
Figure 2778 – General Condition of lamp post /
plantation

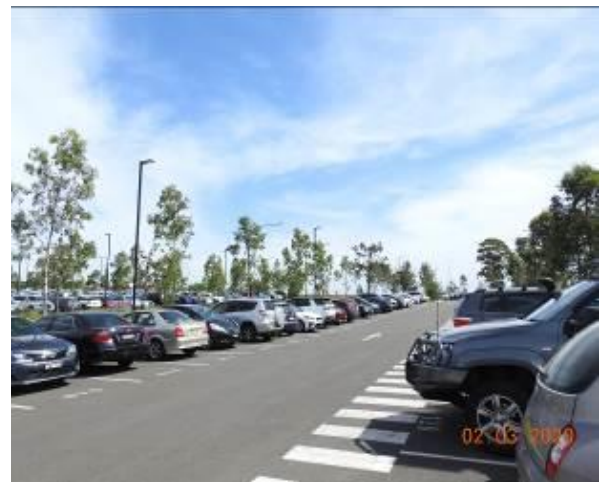
Figure 2779 – General Condition of lamp post /
plantation

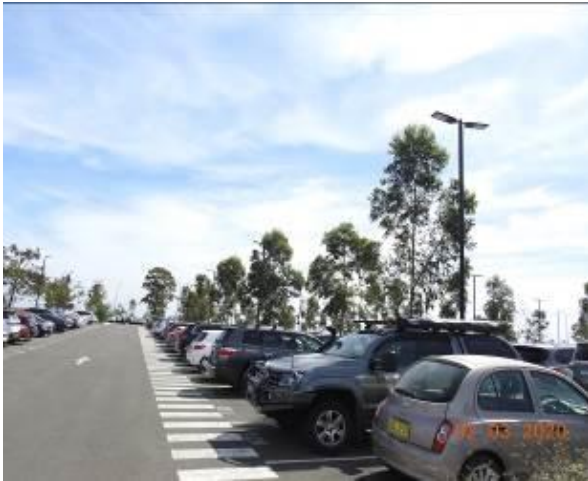
Figure 2780 – General Condition of lamp post / plantation

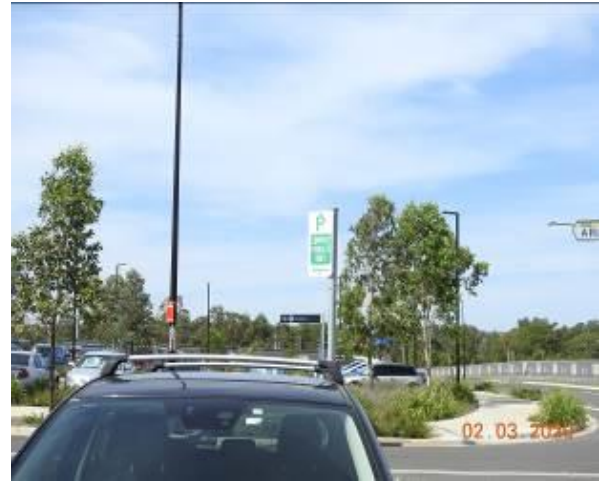
Figure 2781 – General Condition of street sign

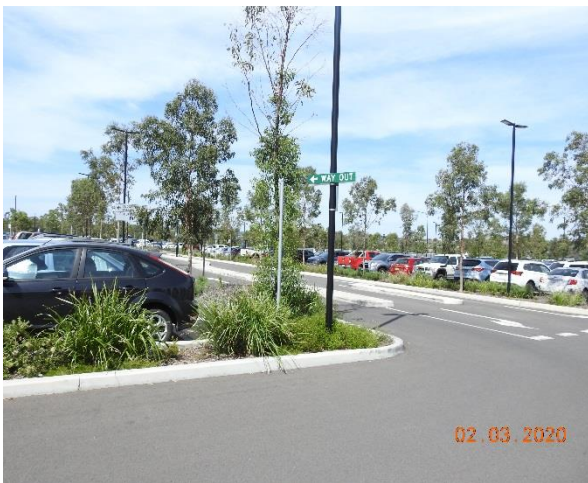
Figure 2782 – General Condition of lamp post / plantation

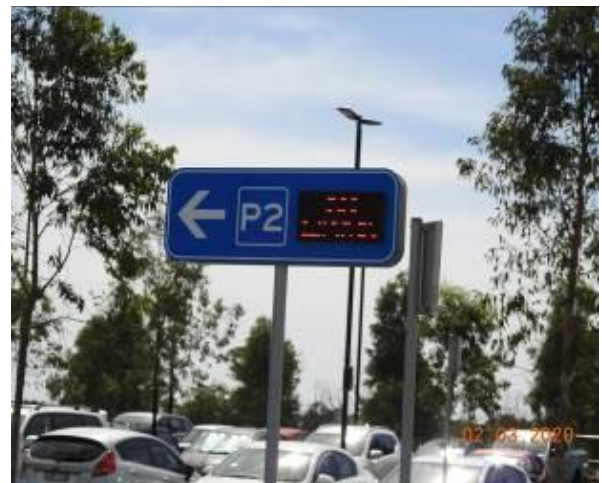
Figure 2783 – General Condition of street sign

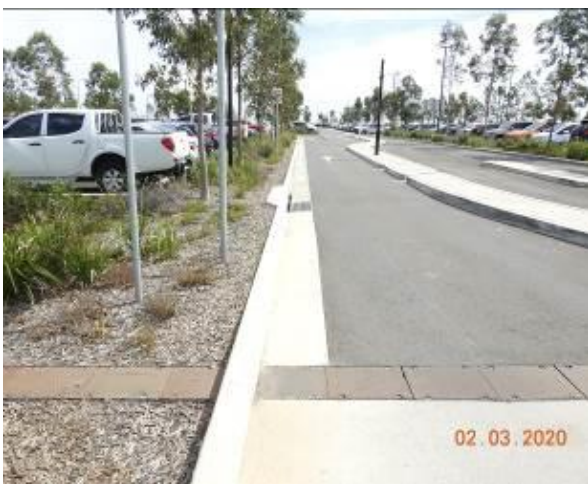
Figure 2784 – General Condition of kerb and gutter

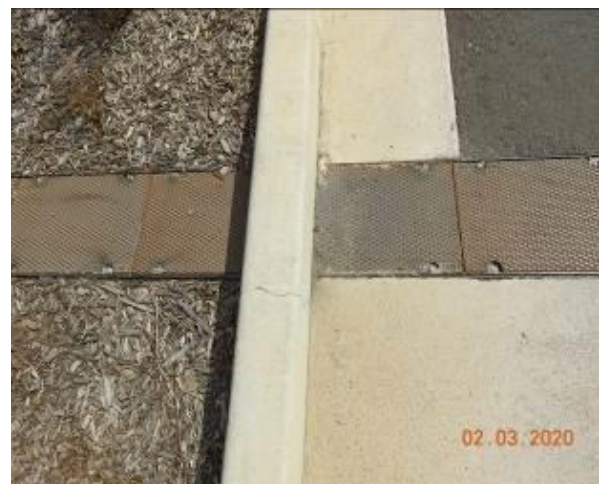
Figure 2785 – Crack propagation through kerb

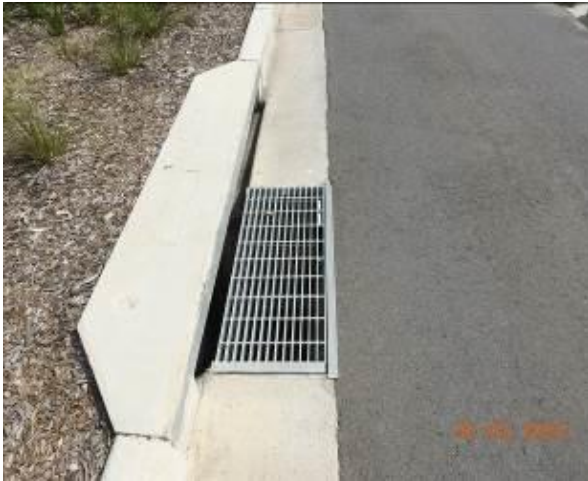
Figure 2786 – General Condition of stormwater inlet pit

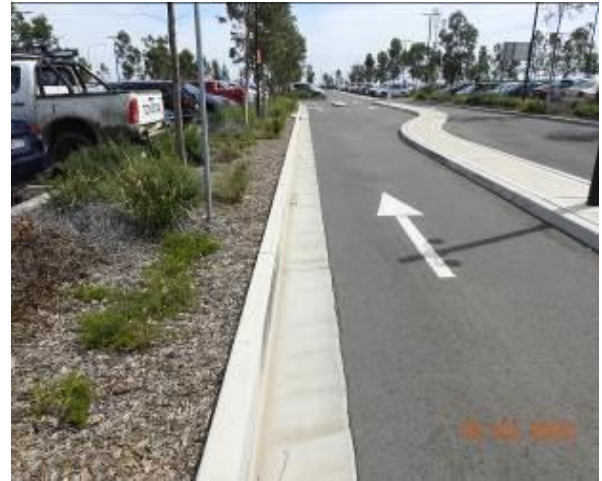
Figure 2787 – General Condition of kerb and gutter

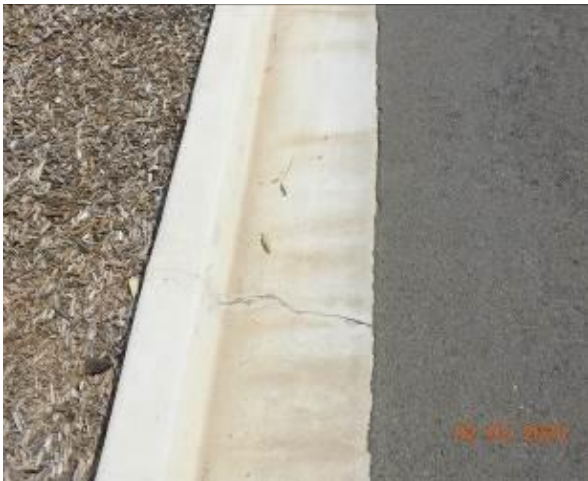
Figure 2788 – Crack propagation through kerb and gutter

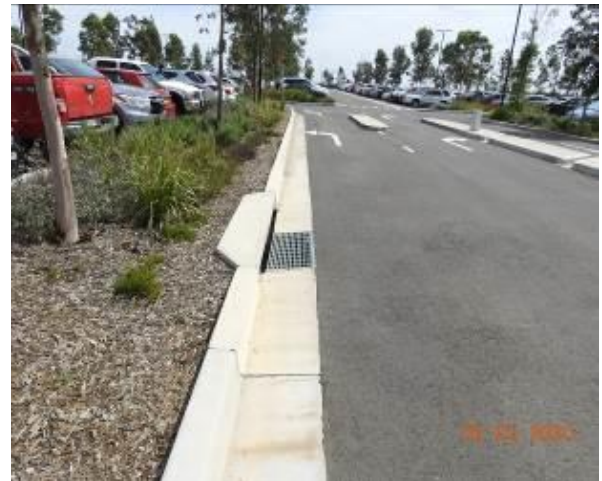
Figure 2789 – General Condition of kerb and gutter

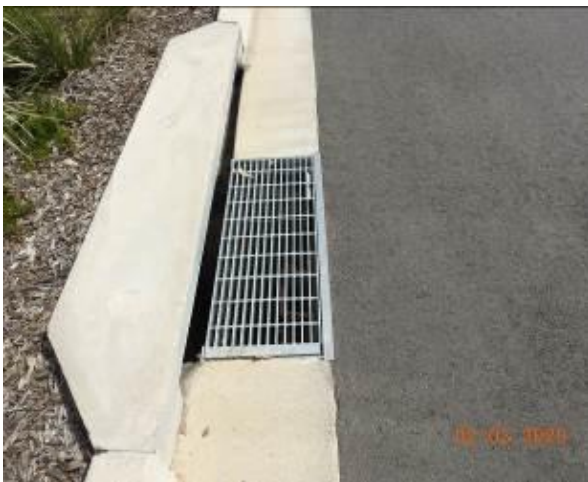
Figure 2790 – General Condition of stormwater inlet pit

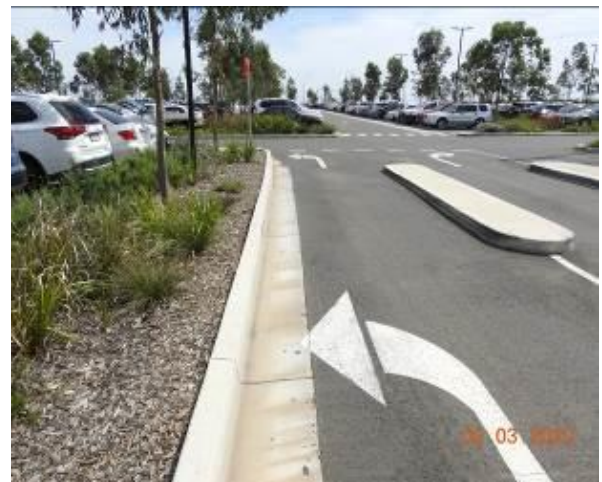
Figure 2791 – General Condition of kerb and gutter

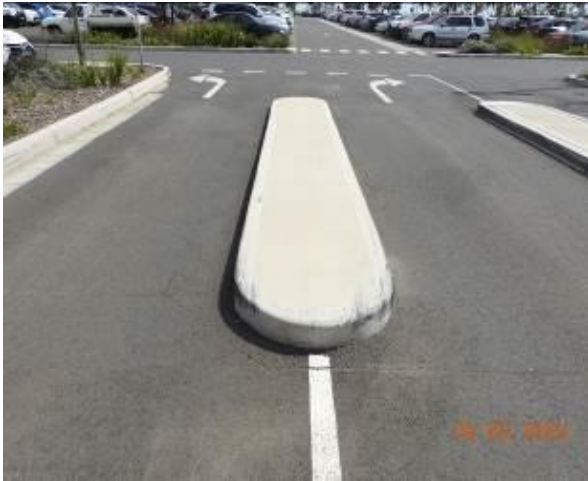
Figure 2792 – General Condition of traffic island kerb

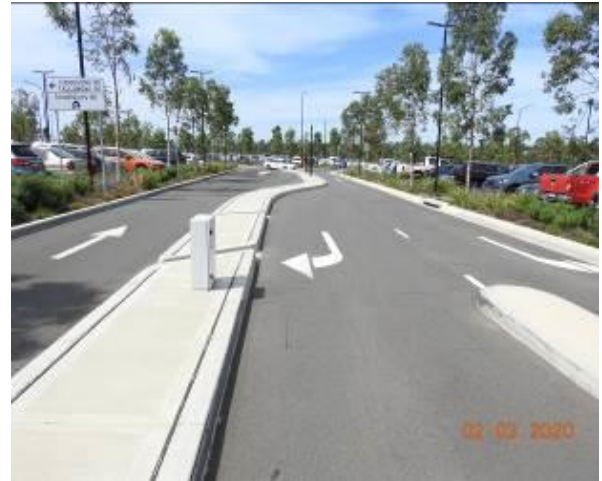
Figure 2793 – General Condition of traffic island kerb and footpath pavement

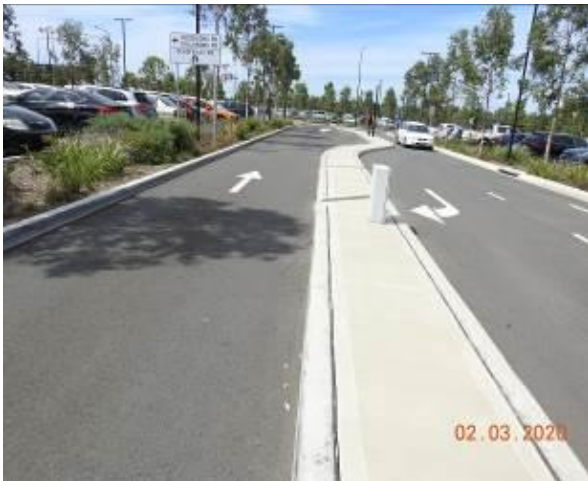
Figure 2794 – General Condition of traffic island kerb and footpath pavement

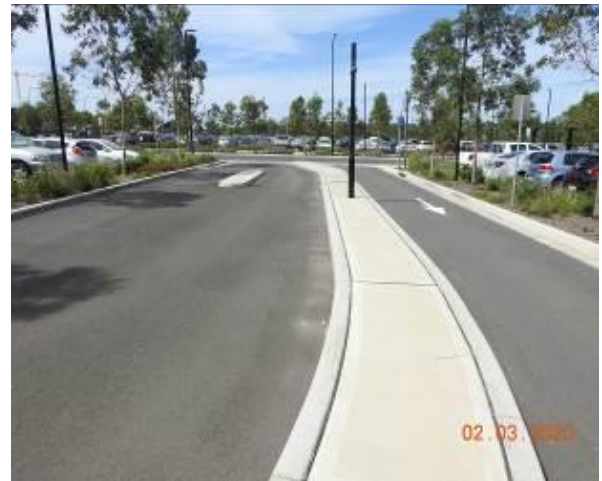
Figure 2795 – General Condition of traffic island kerb and footpath pavement

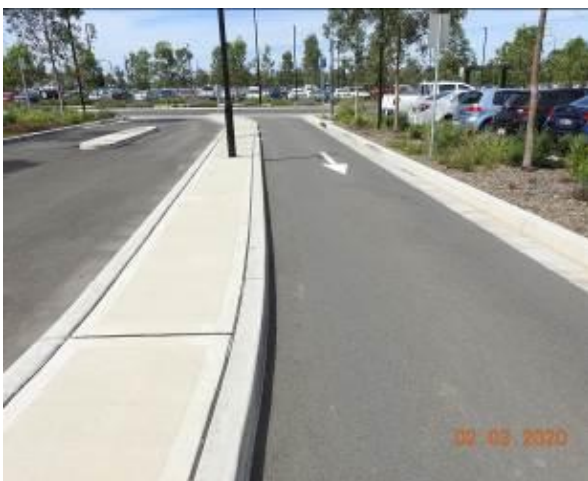
Figure 2796 – General Condition of traffic island kerb and footpath pavement

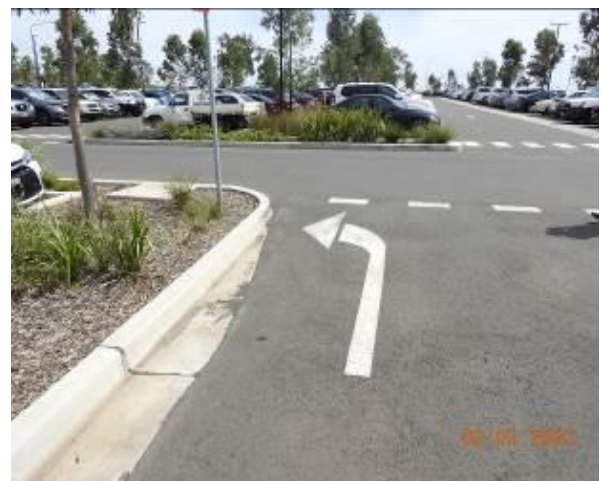
Figure 2797 – General Condition of kerb and gutter

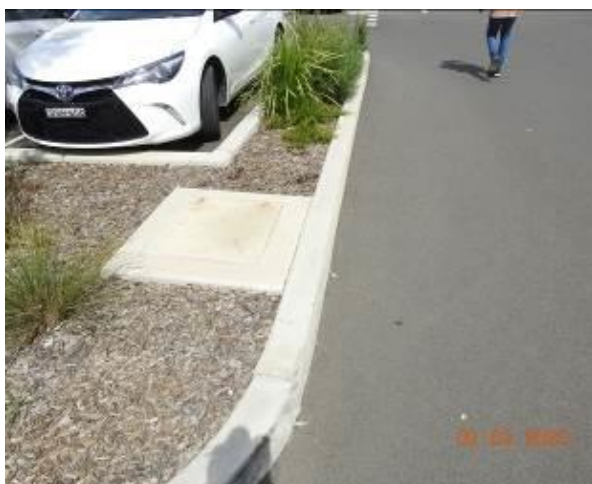
Figure 2798 – General Condition of kerb

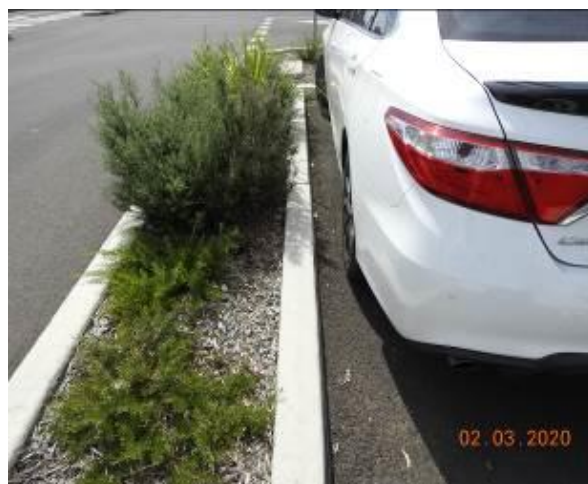
Figure 2799 – General Condition of kerb

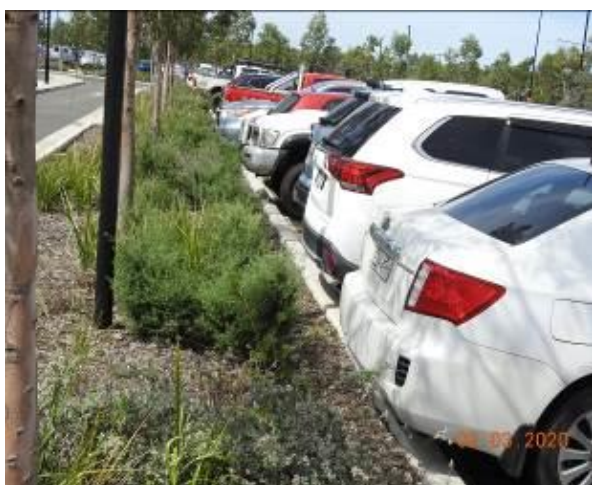
Figure 2800 – General Condition of kerb

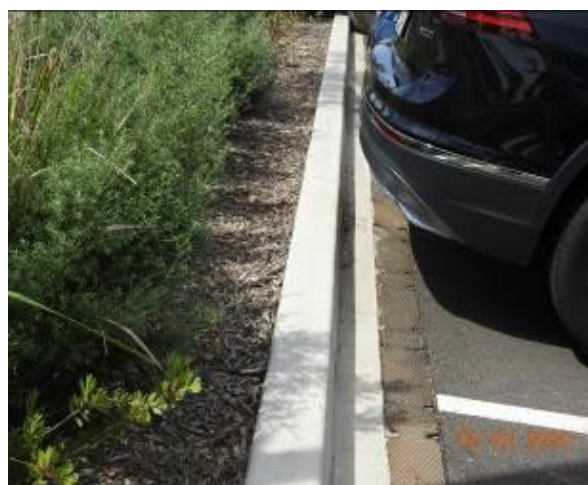
Figure 2801 – General Condition of kerb and gutter

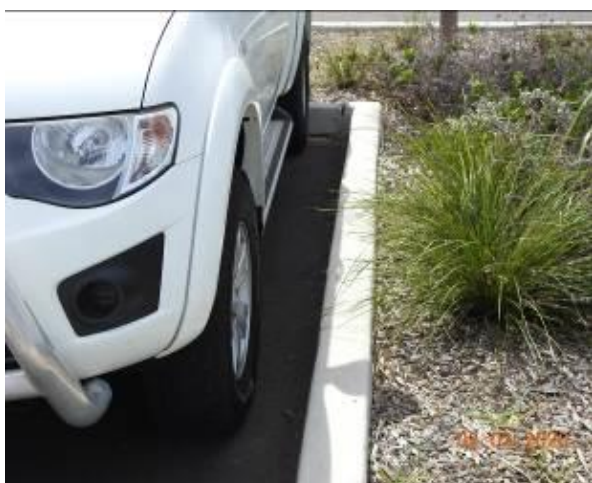
Figure 2802 – General Condition of kerb

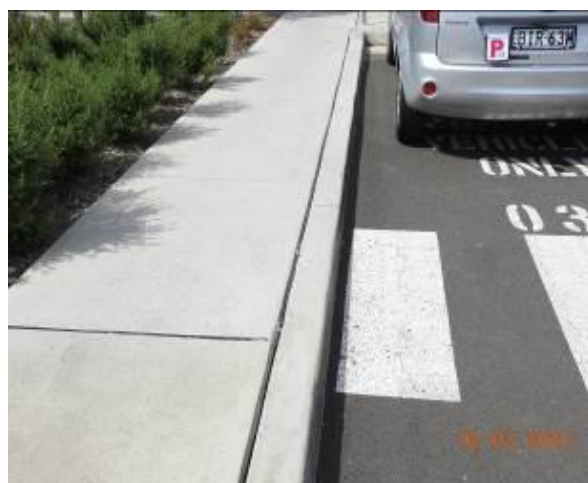
Figure 2803 – General Condition of kerb and footpath pavement

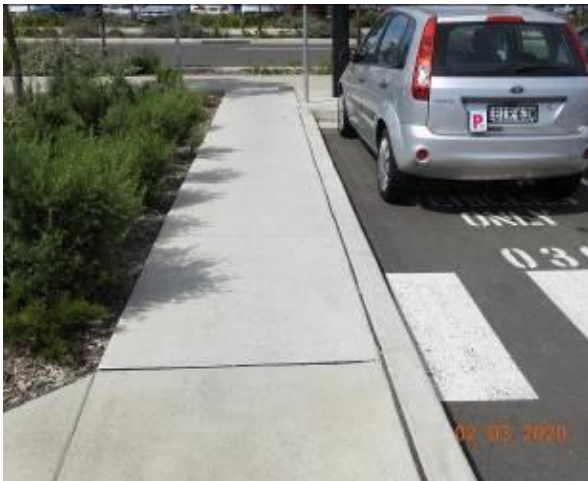
Figure 2804 – General Condition of kerb and footpath pavement

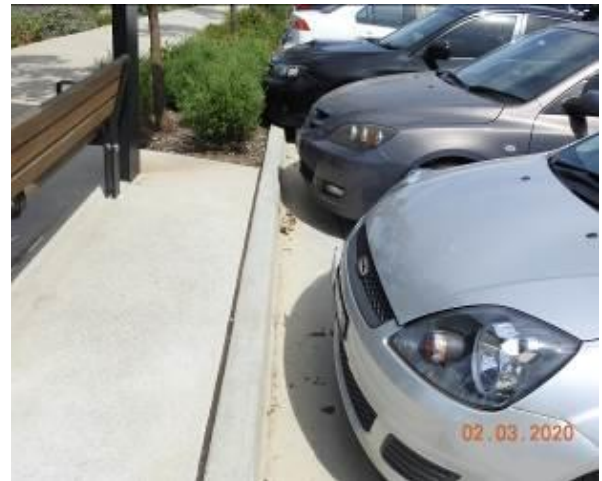
Figure 2805 – General Condition of kerb, gutter and footpath pavement

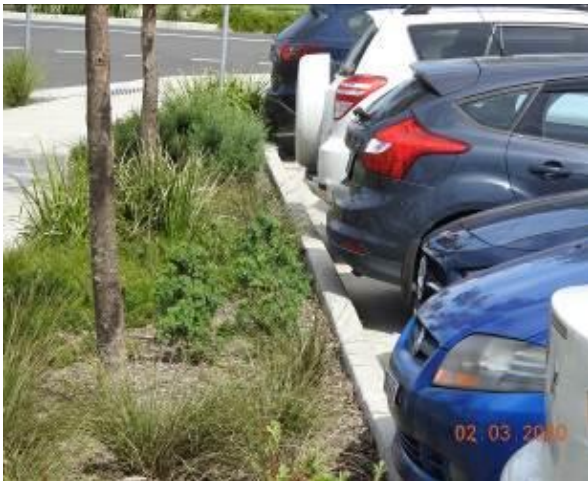
Figure 2806 – General Condition of kerb

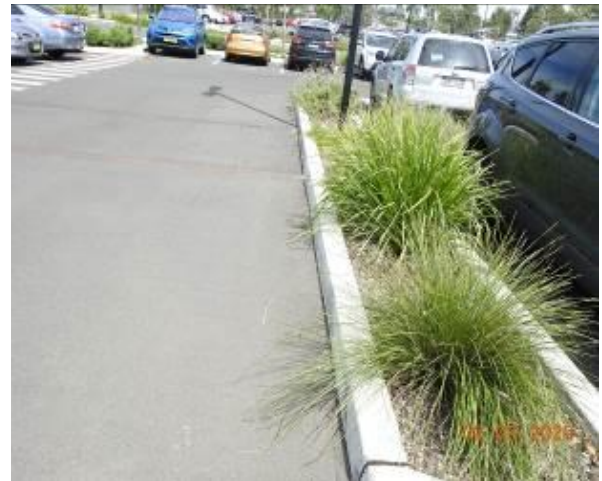
Figure 2807 – General Condition of kerb

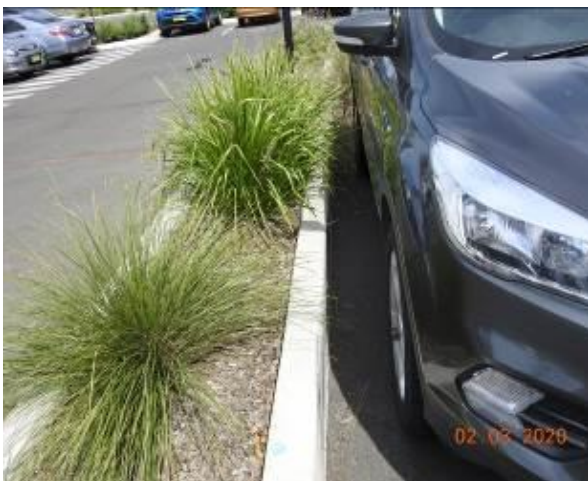
Figure 2808 – General Condition of kerb

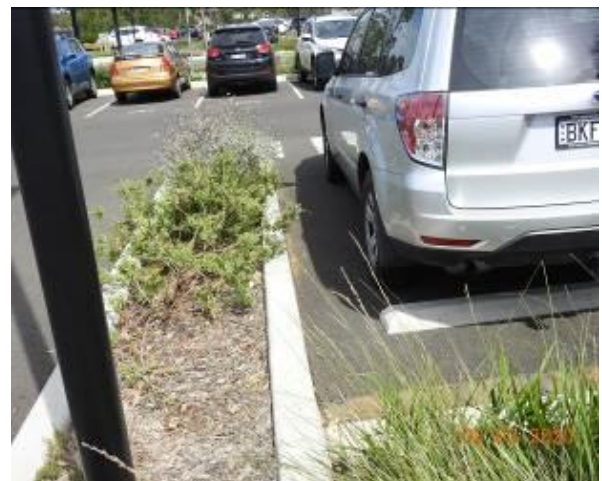
Figure 2809 – General Condition of kerb

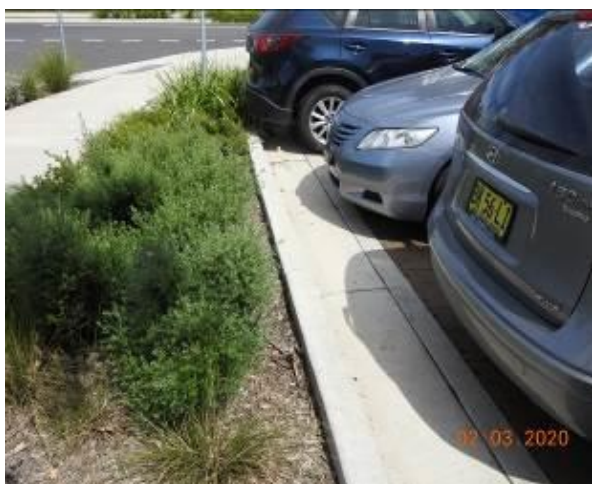
Figure 2810 – General Condition of kerb and footpath pavement

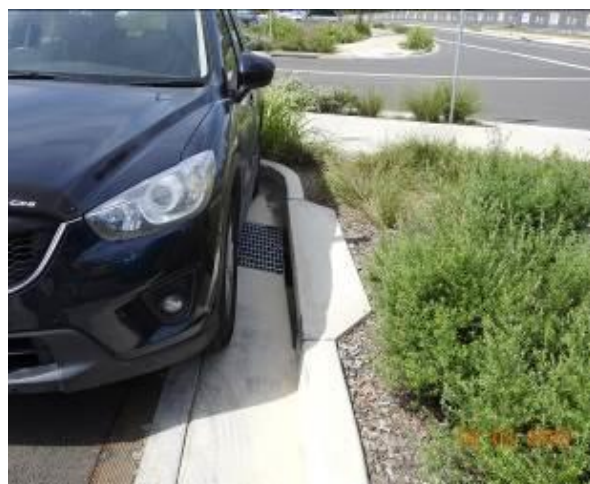
Figure 2811 – General Condition of kerb and gutter

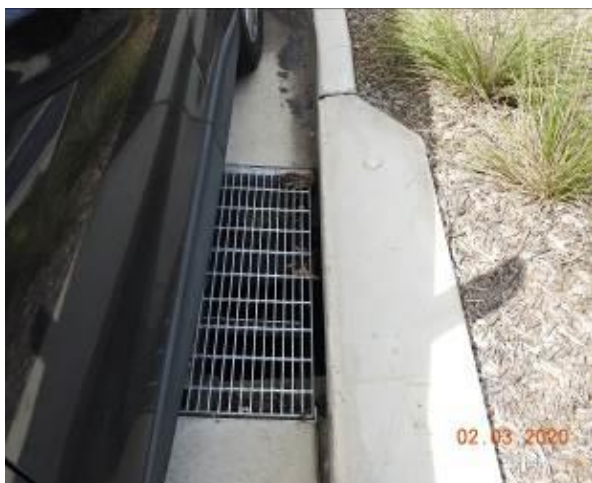
Figure 2812 – General Condition of stormwater inlet pit

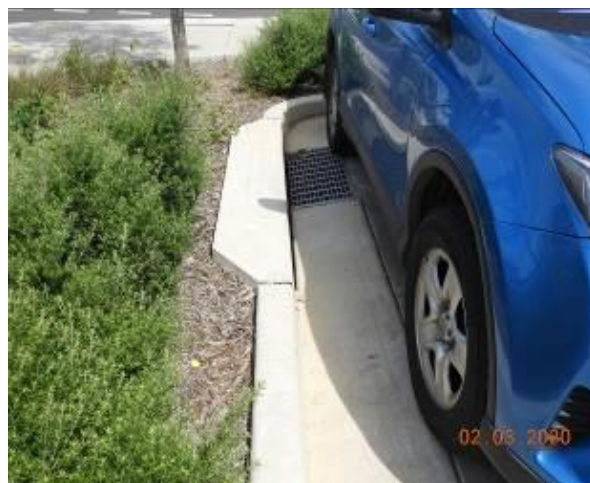
Figure 2813 – General Condition of kerb and gutter

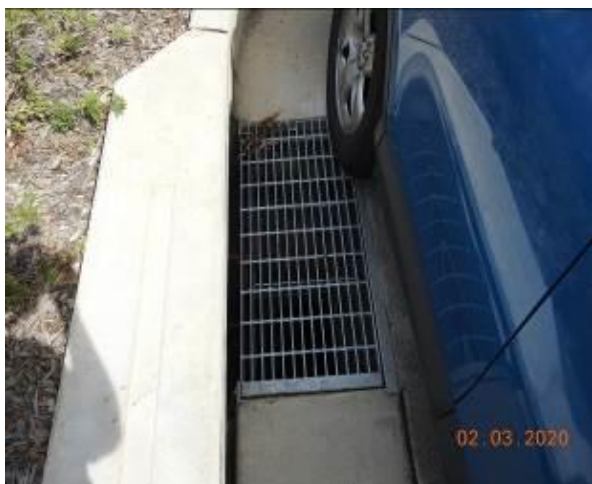
Figure 2814 – General Condition of stormwater inlet pit
