**1-15 AND 2-12 CONFERTA AVENUE,
ROUSE HILL NSW 2155
TALLAWONG STATION PRECINCT SOUTH
PRE-DILAPIDATION REPORT**

**DEICORP PROJECTS
(TALLAWONG STATION) PTY LTD**

Job No. 191294.0
24/03/2020

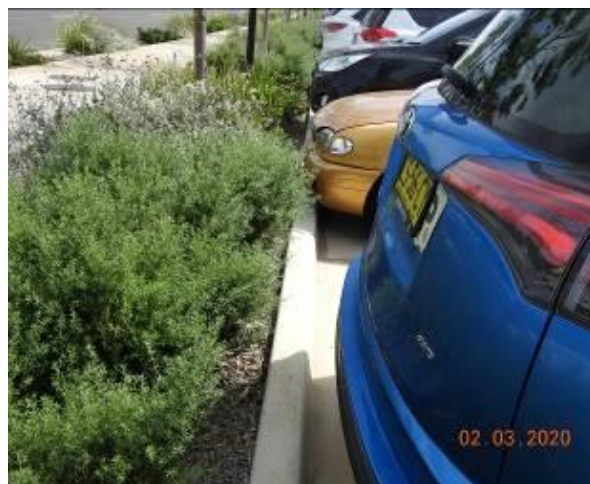
Figure 2815 – General Condition of kerb and gutter

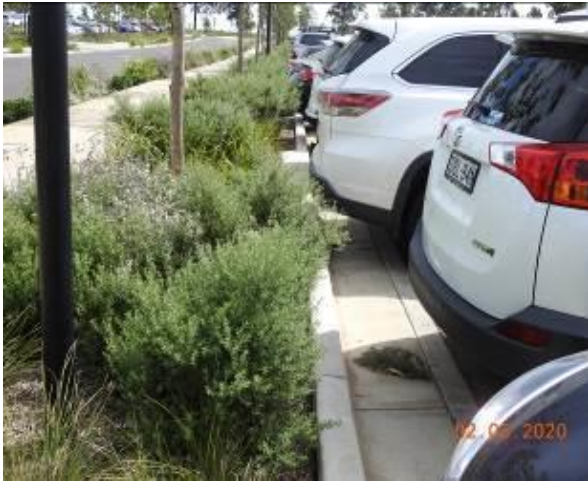
Figure 2816 – General Condition of kerb and gutter

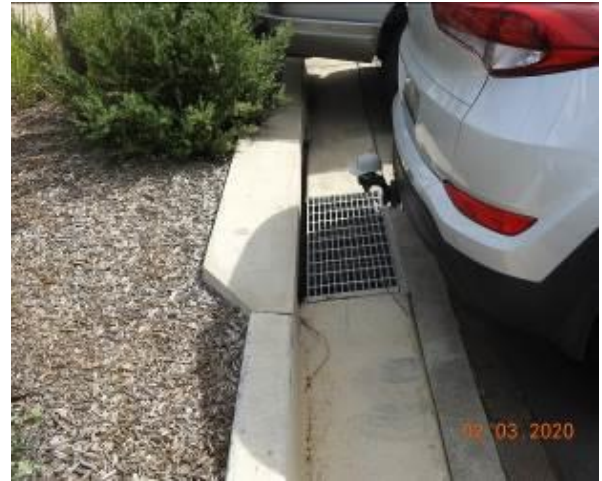
Figure 2817 – General Condition of kerb and gutter

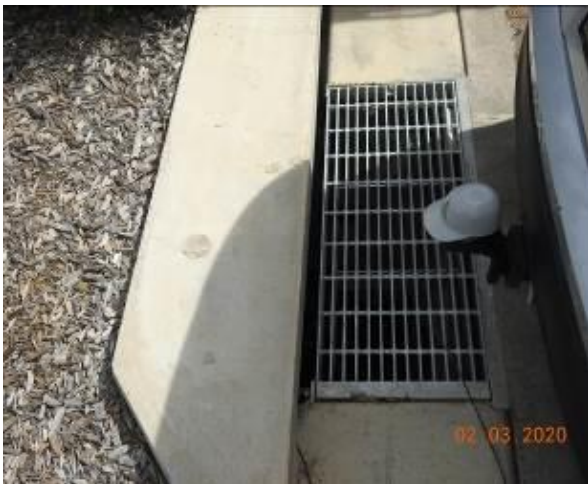
Figure 2818 – General Condition of stormwater inlet pit

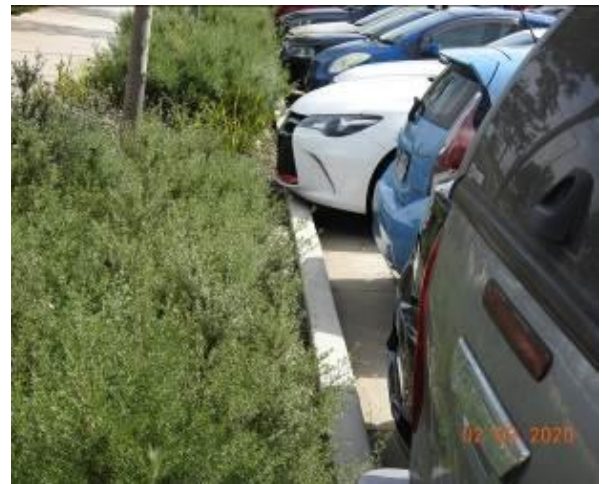
Figure 2819 – General Condition of kerb

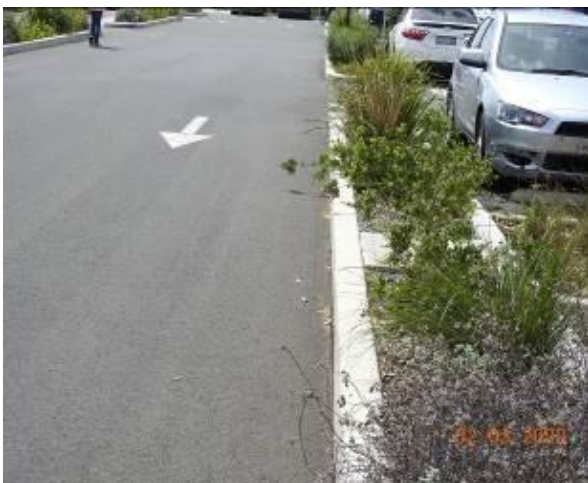
Figure 2820 – General Condition of kerb

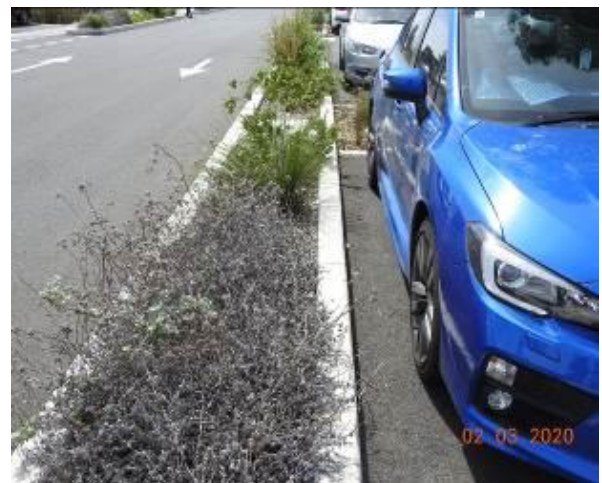
Figure 2821 – General Condition of kerb

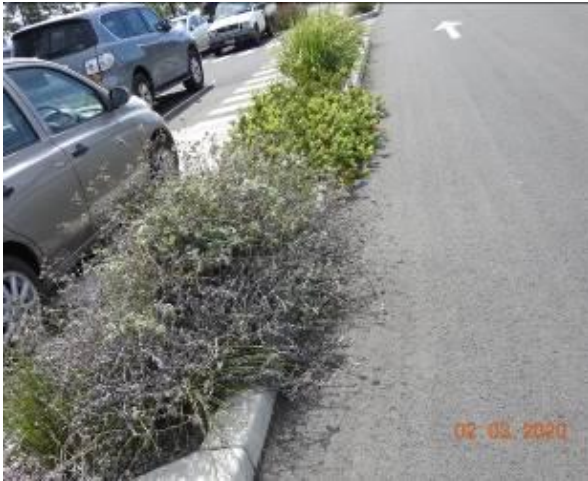
Figure 2822 – General Condition of kerb

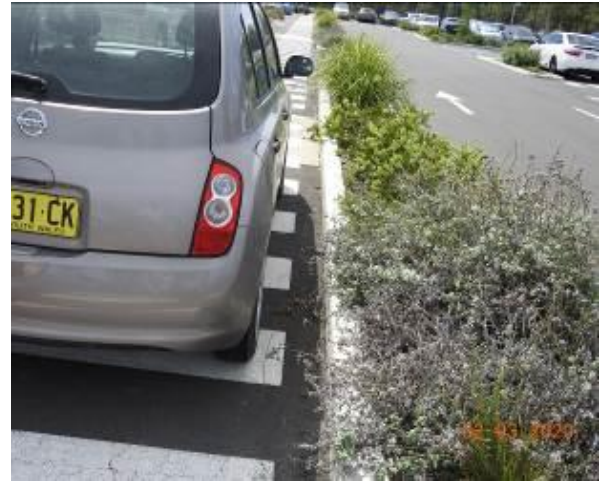
Figure 2823 – General Condition of kerb

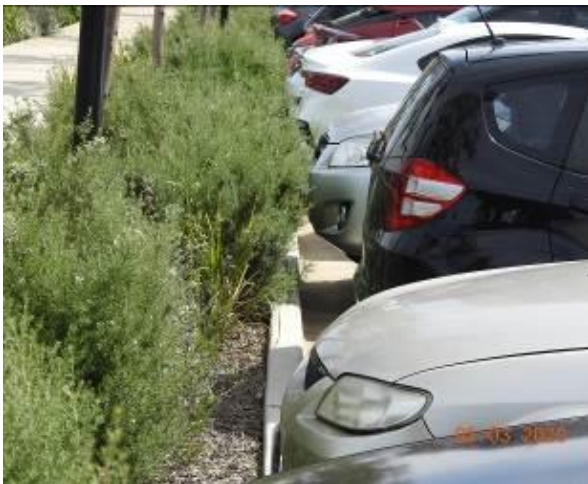
Figure 2824 – General Condition of kerb and gutter

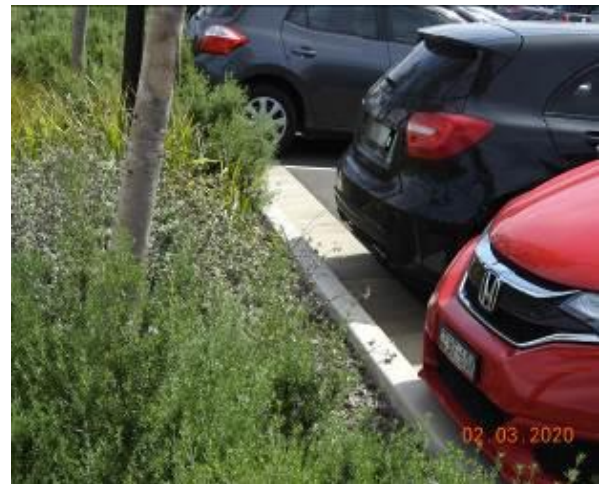
Figure 2825 – General Condition of kerb and gutter

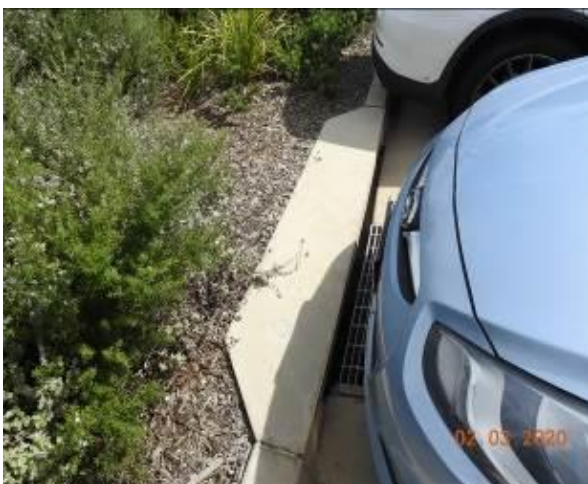
Figure 2826 – General Condition of kerb and gutter

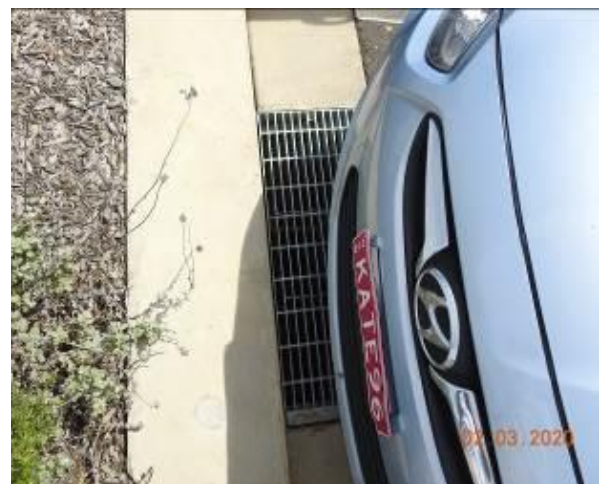
Figure 2827 – General Condition of stormwater inlet pit

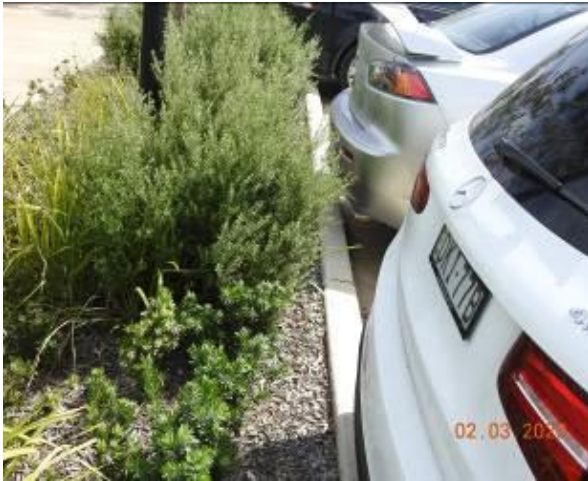
Figure 2828 – General Condition of kerb and gutter

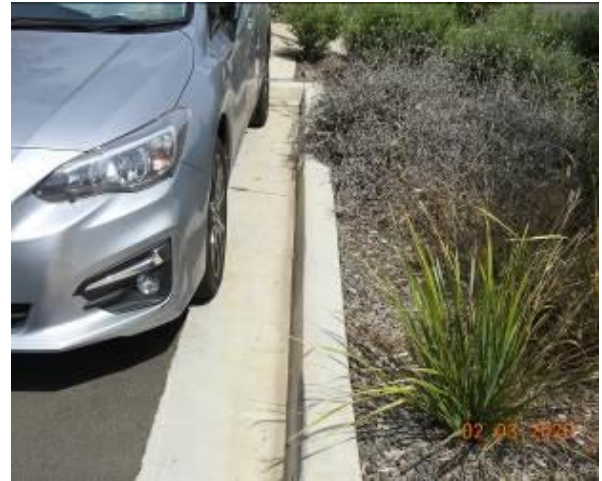
Figure 2829 – General Condition of kerb and gutter

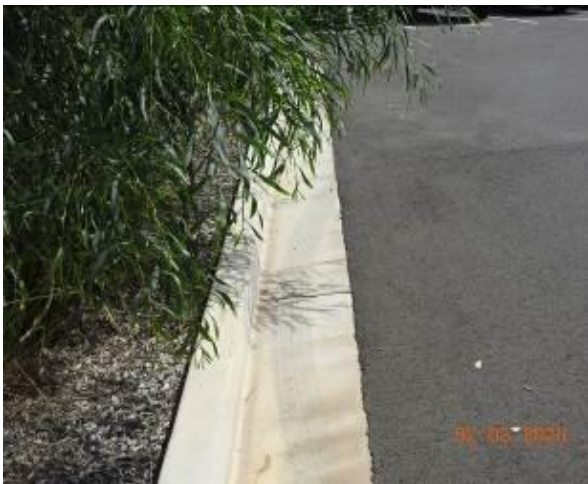
Figure 2830 – General Condition of kerb and gutter

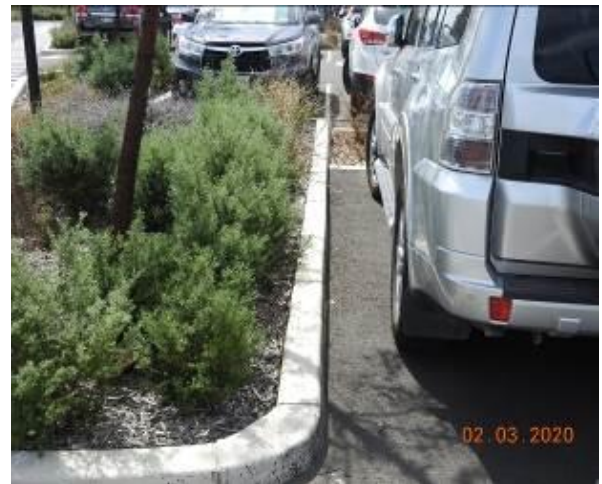
Figure 2831 – General Condition of kerb

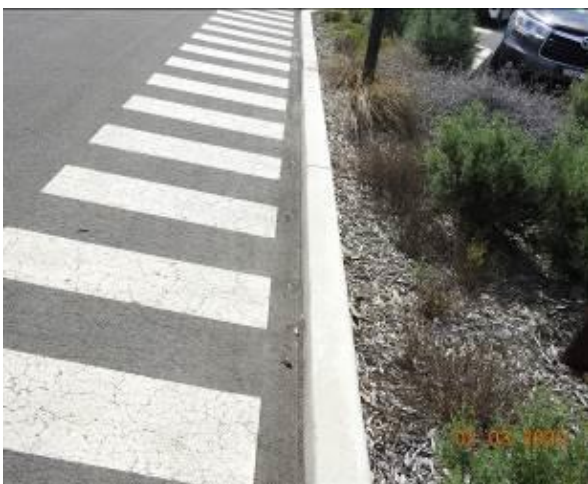
Figure 2832 – General Condition of kerb

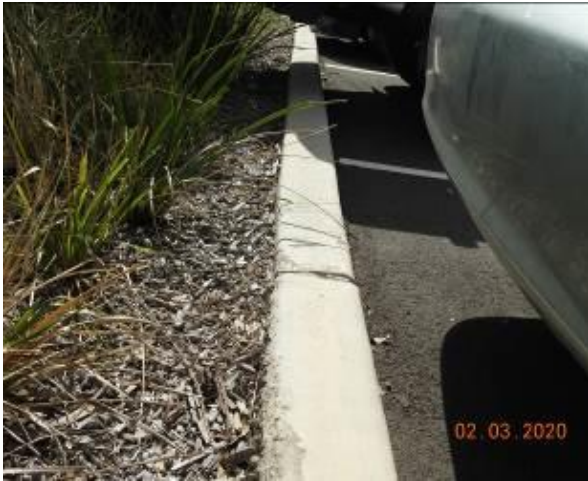
Figure 2834 – Loss of material through kerb

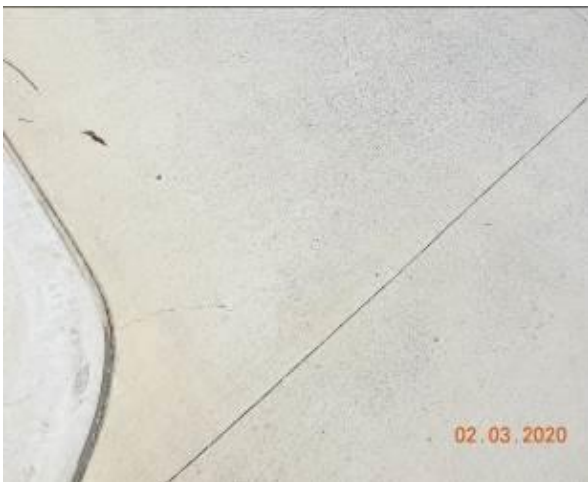
Figure 2860 – Crack propagation through driveway pavement

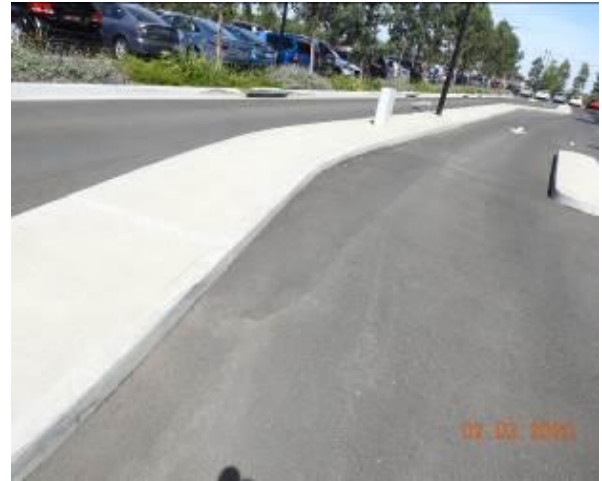
Figure 2863 – Evidence of patchwork through carpark pavement

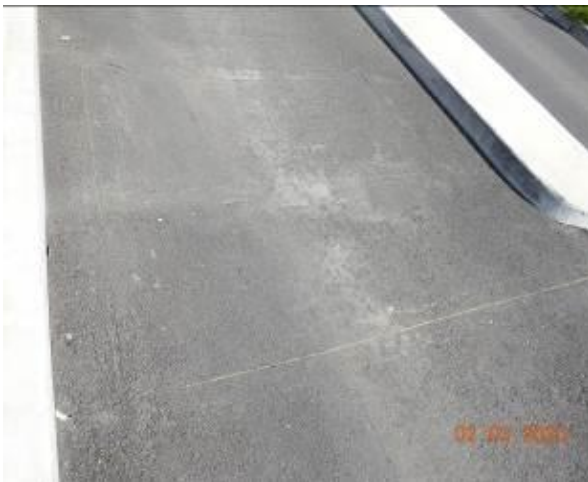
Figure 2870 – Crack propagation through carpark pavement

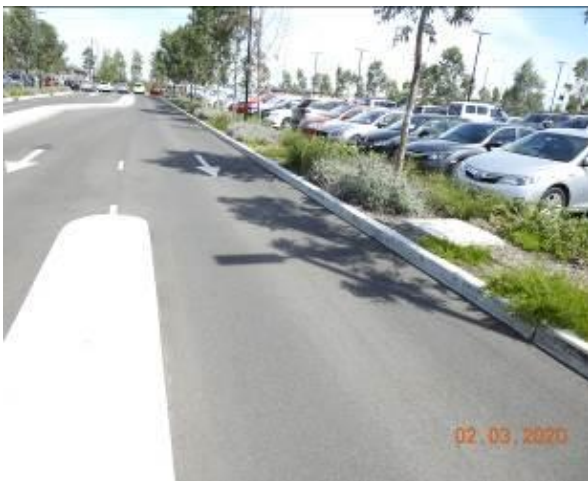
Figure 2872 – General Condition of carpark pavement

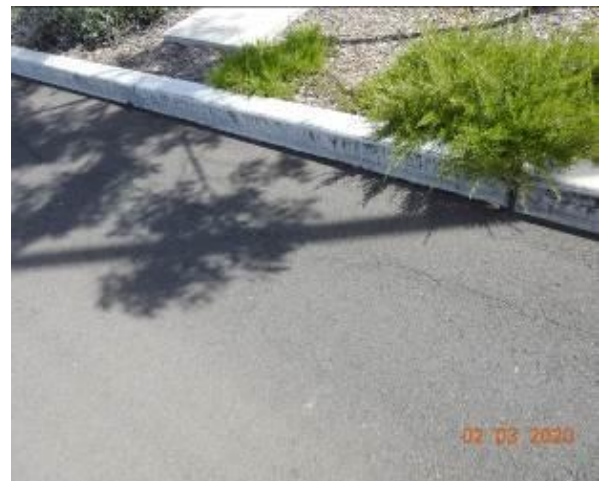
Figure 2873 – General Condition of carpark pavement

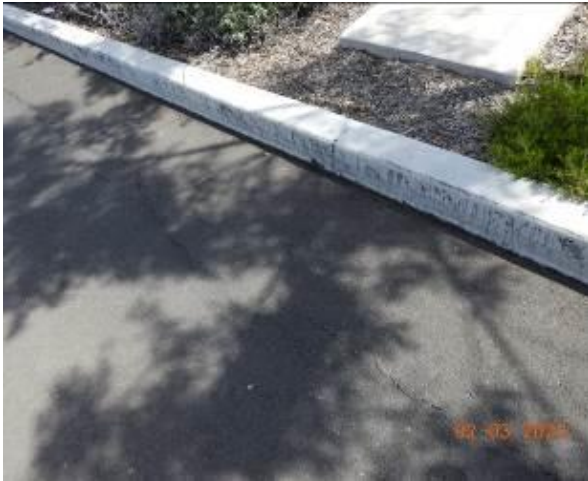
Figure 2874 – Crack propagation through carpark pavement

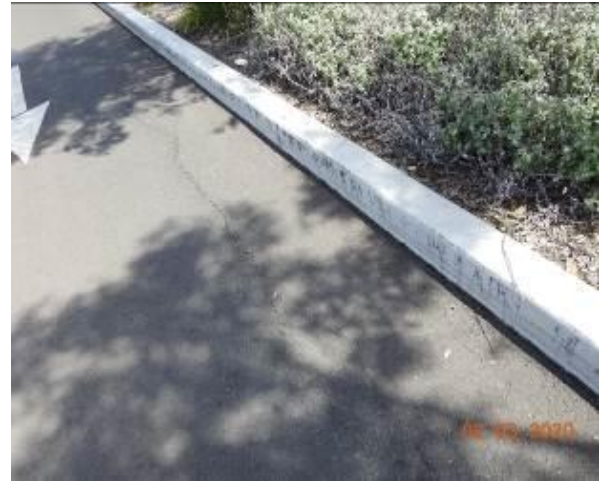
Figure 2875 – Crack propagation through carpark pavement

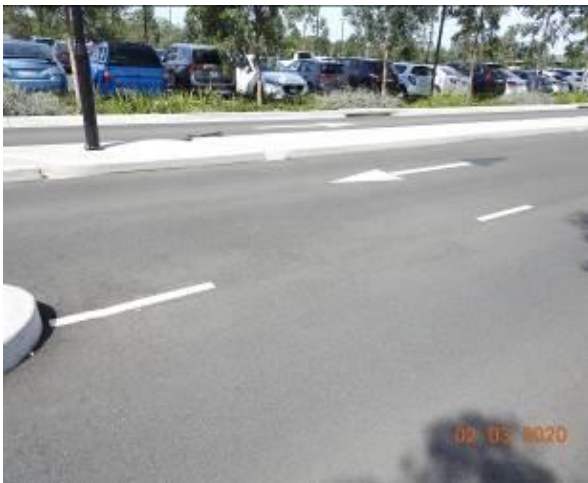
Figure 2876 – General Condition of carpark pavement

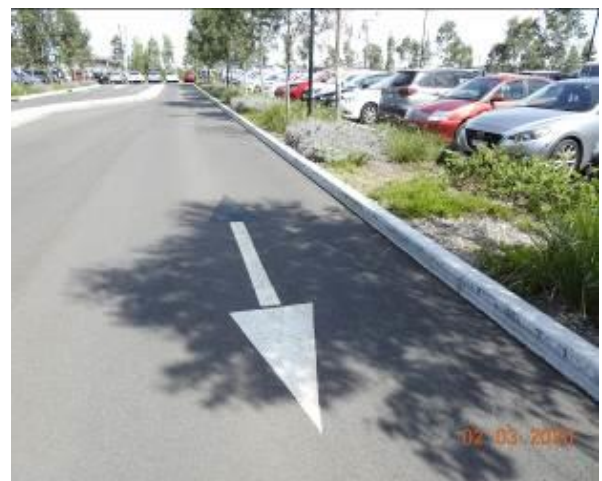
Figure 2879 – General Condition of carpark pavement

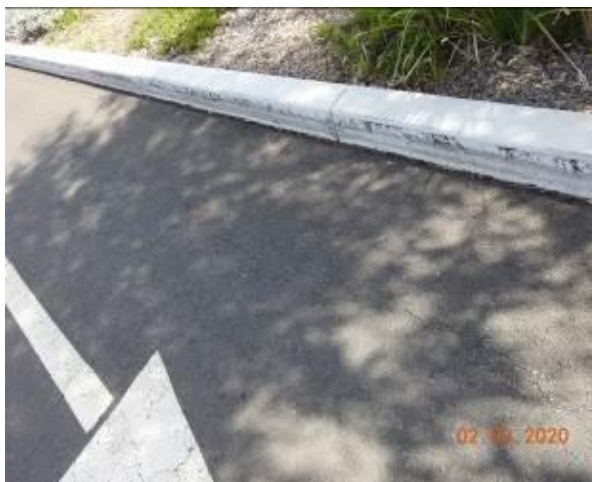
Figure 2880 – Crack propagation through carpark pavement

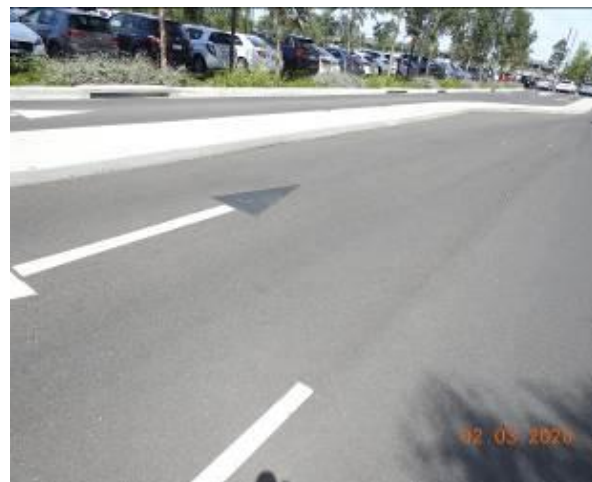
Figure 2881 – General Condition of carpark pavement

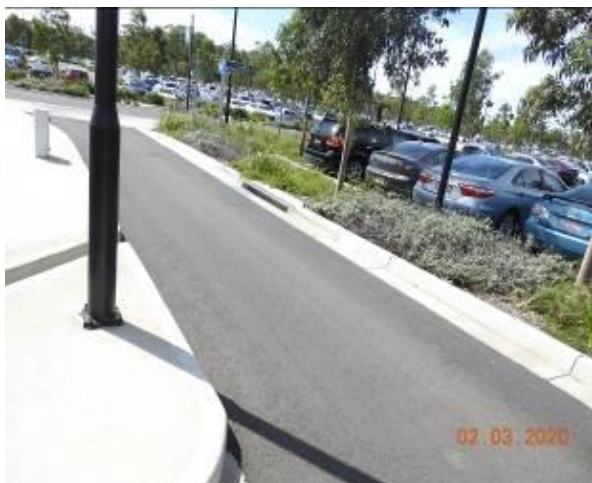
Figure 2882 – Crack propagation through carpark pavement

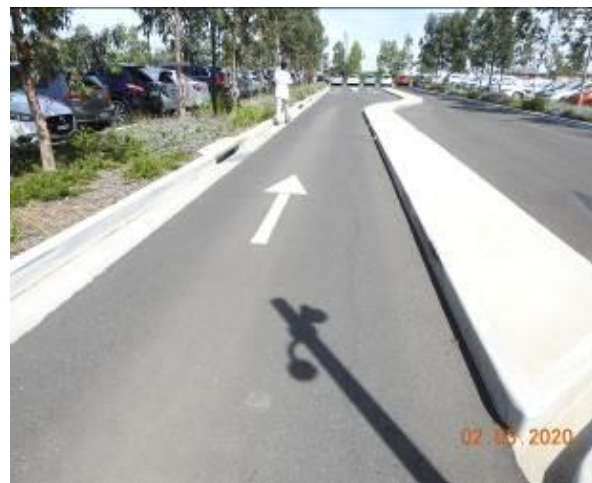
Figure 2883 – Crack propagation through carpark pavement

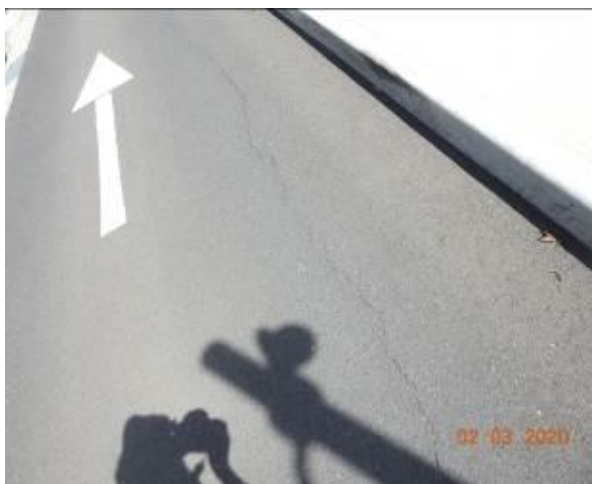
Figure 2884 – Crack propagation through carpark pavement

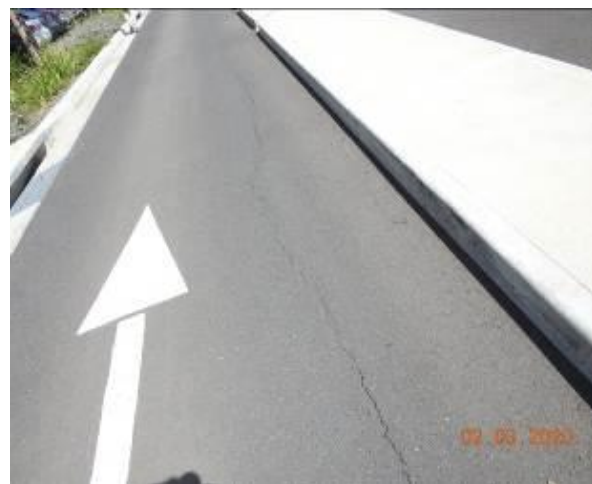
Figure 2885 – Crack propagation through carpark pavement

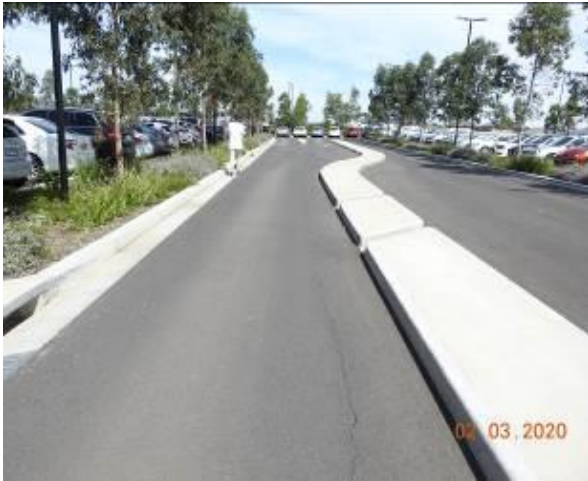
Figure 2886 – Crack propagation through carpark pavement

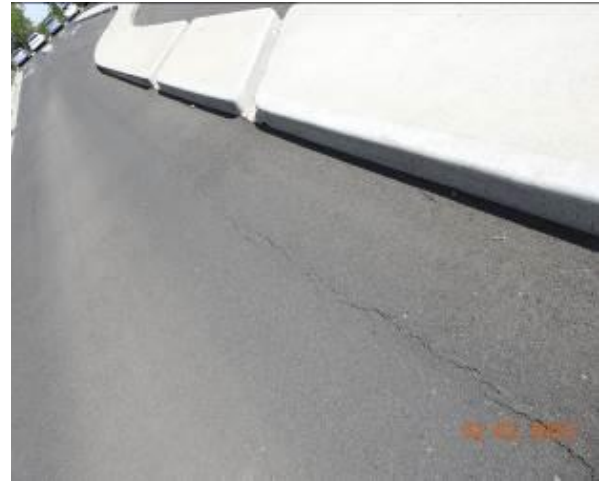
Figure 2887 – Crack propagation through carpark pavement

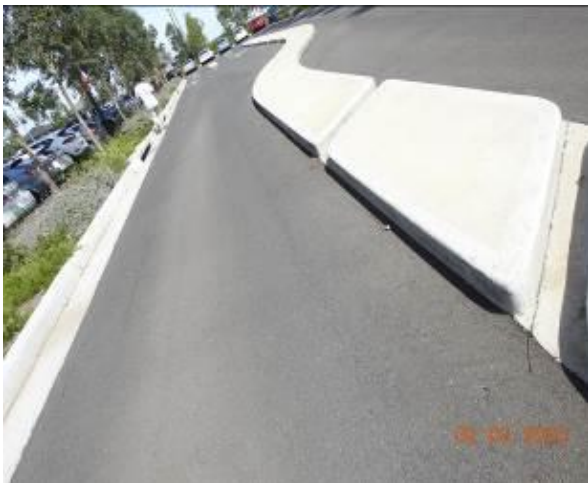
Figure 2888 – Crack propagation through carpark pavement

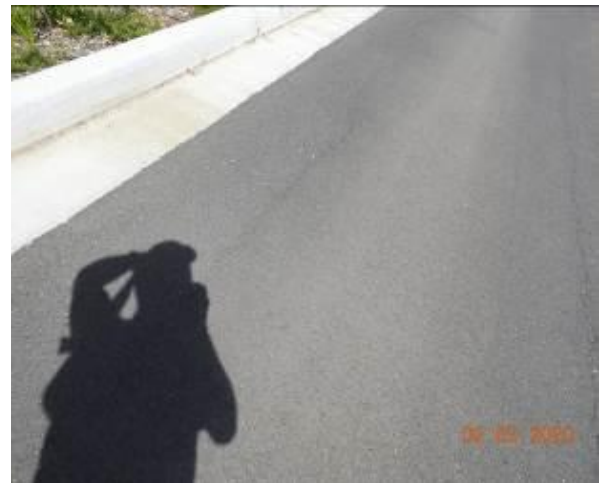
Figure 2889 – Crack propagation through carpark pavement

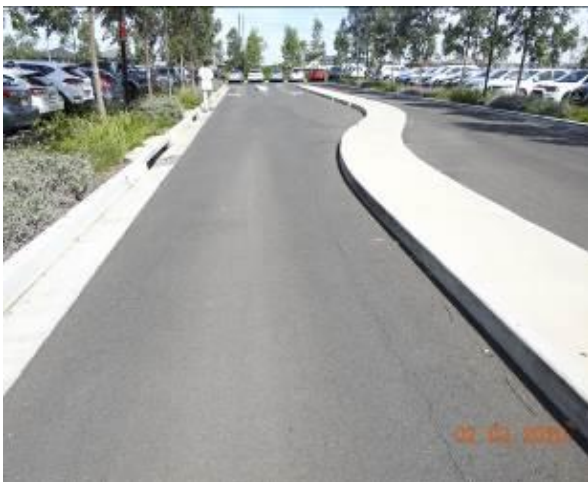
Figure 2890 – Crack propagation through carpark pavement

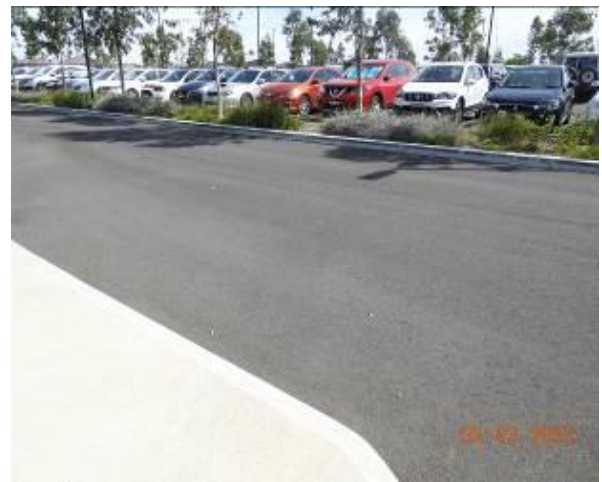
Figure 2891 – General Condition of carpark pavement

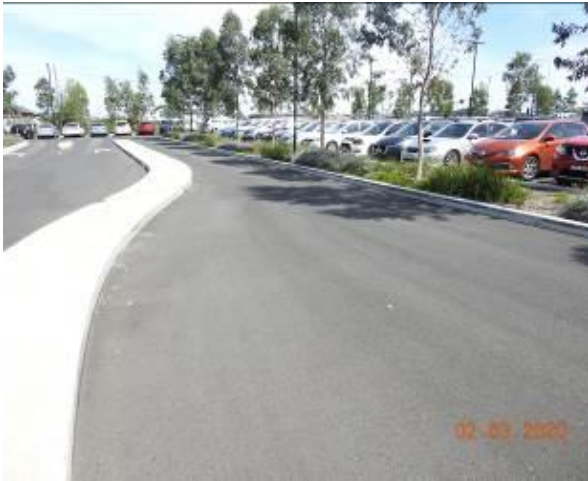
Figure 2892 – General Condition of carpark pavement

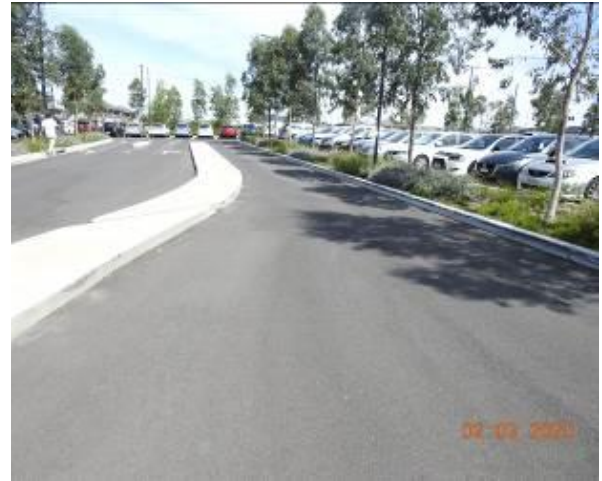
Figure 2893 – General Condition of carpark pavement

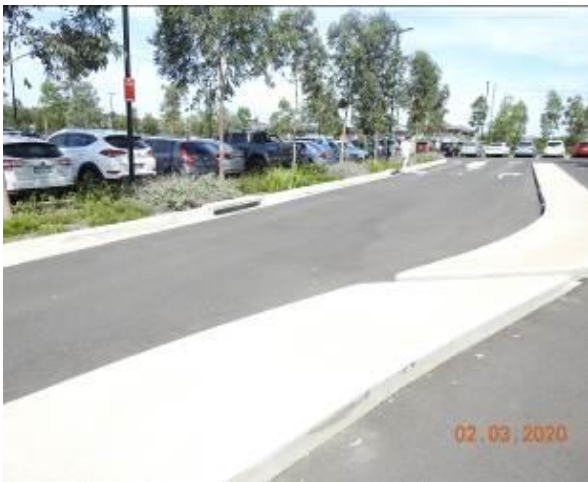
Figure 2894 – General Condition of carpark pavement

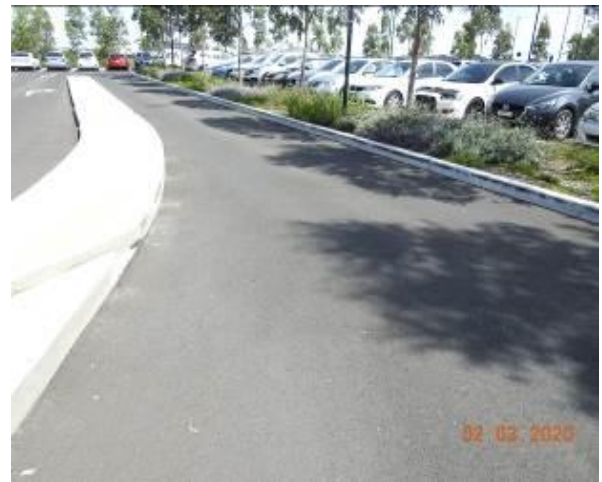
Figure 2895 – General Condition of carpark pavement

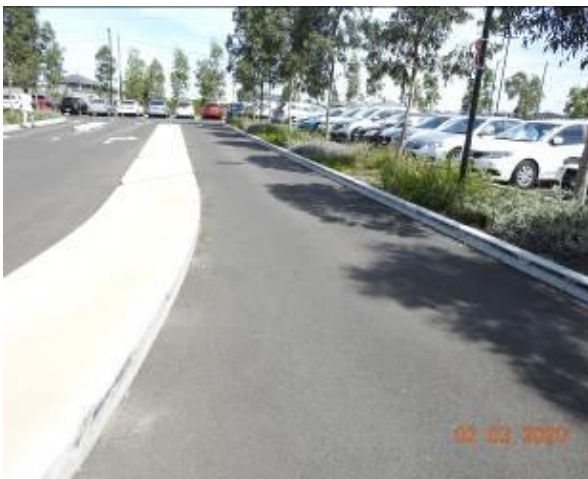
Figure 2896 – General Condition of carpark pavement

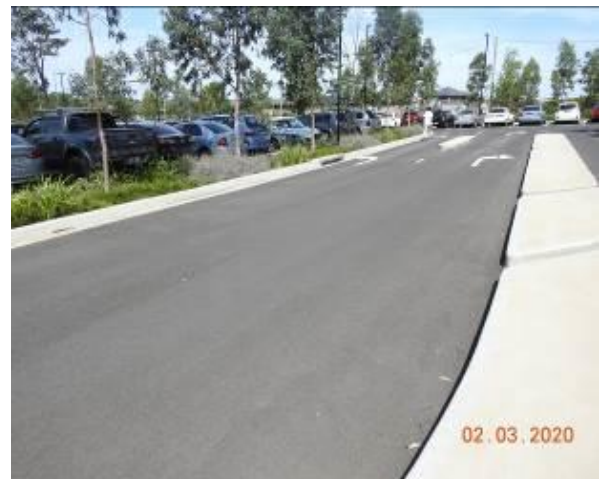
Figure 2897 – General Condition of carpark pavement

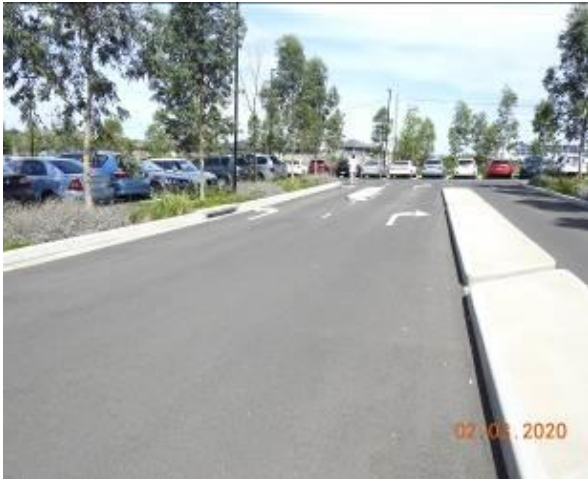
Figure 2898 – General Condition of carpark pavement

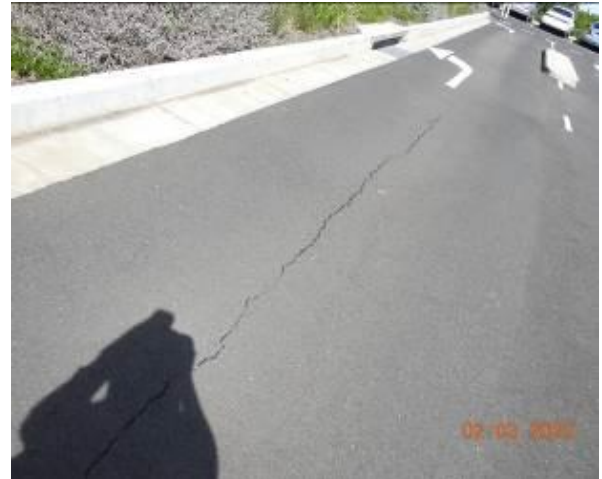
Figure 2899 – Crack propagation through carpark pavement

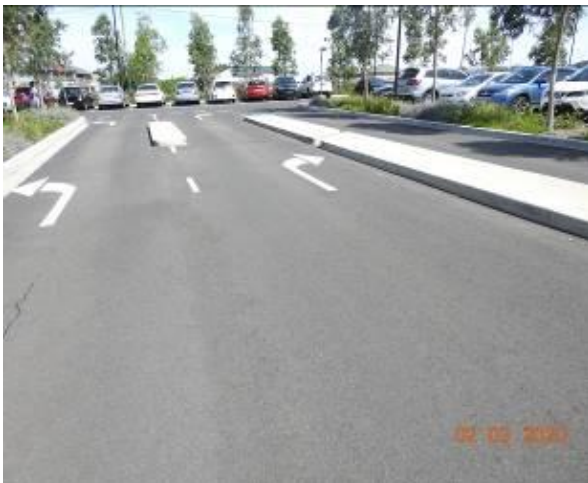
Figure 2900 – General Condition of carpark pavement

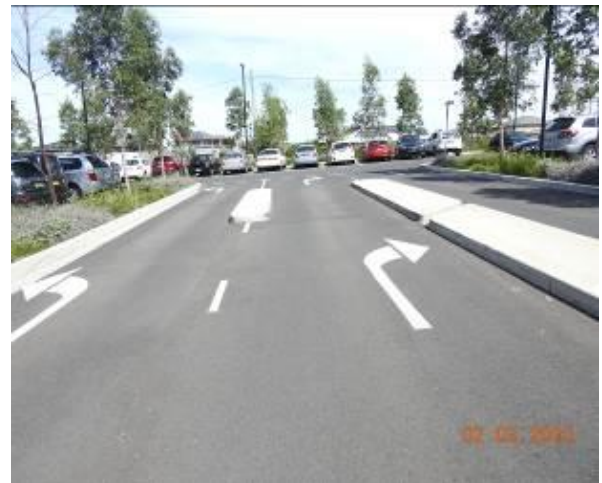
Figure 2901 – General Condition of carpark pavement

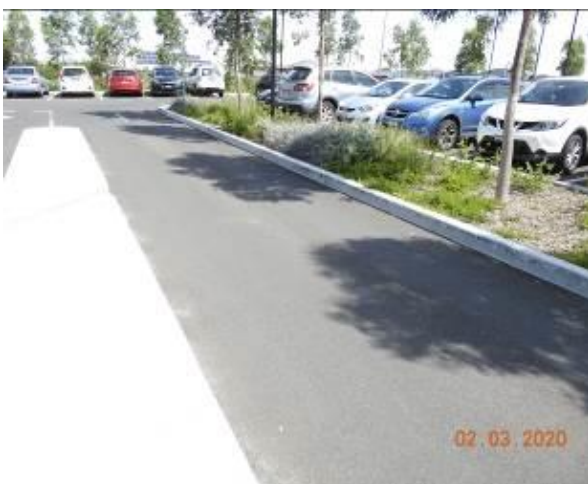
Figure 2902 – General Condition of carpark pavement

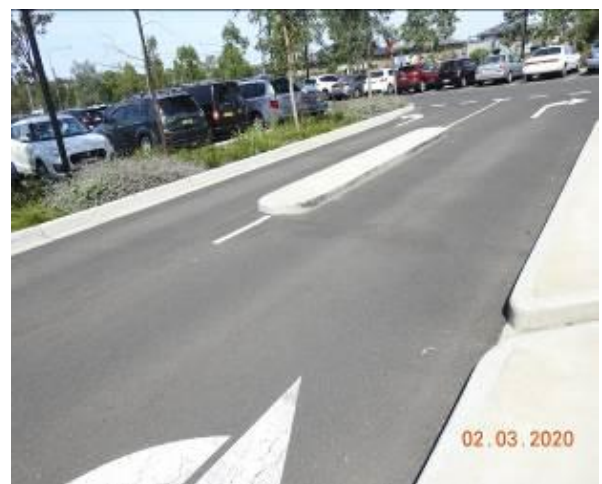
Figure 2903 – General Condition of carpark pavement

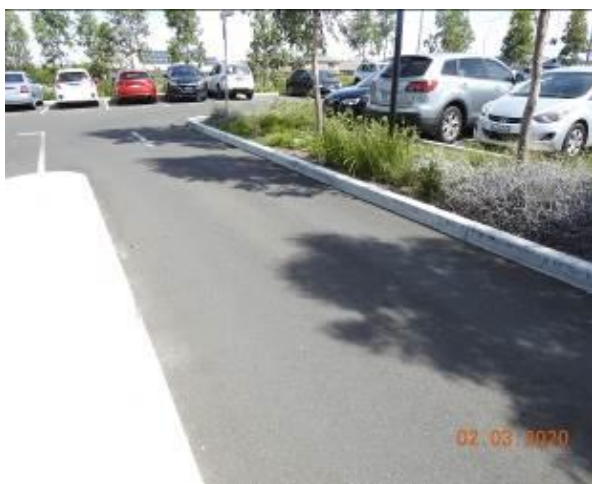
Figure 2904 – General Condition of carpark pavement

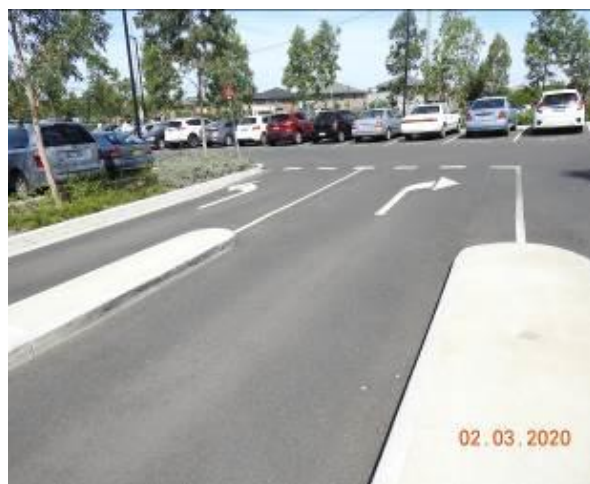
Figure 2905 – General Condition of carpark pavement

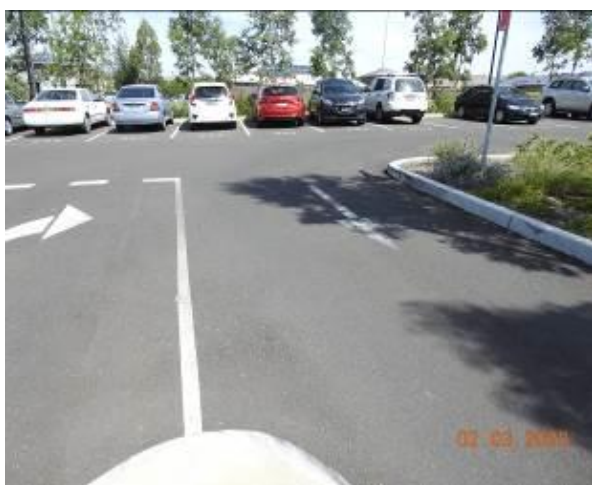
Figure 2906 – General Condition of carpark pavement

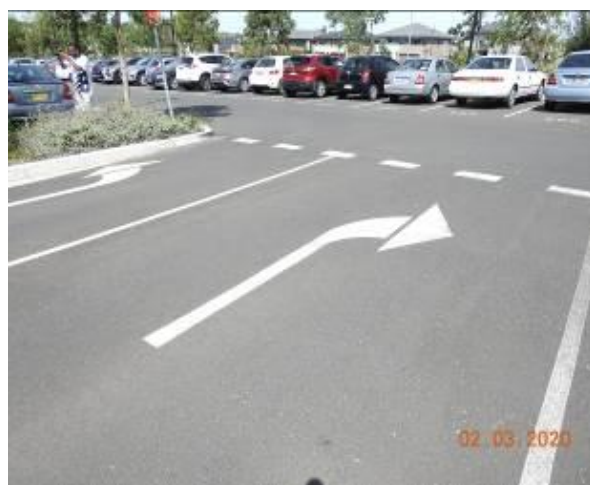
Figure 2907 – General Condition of carpark pavement

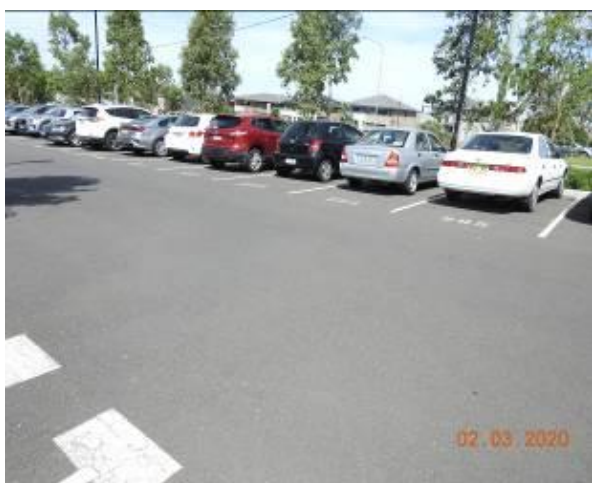
Figure 2908 – General Condition of carpark pavement

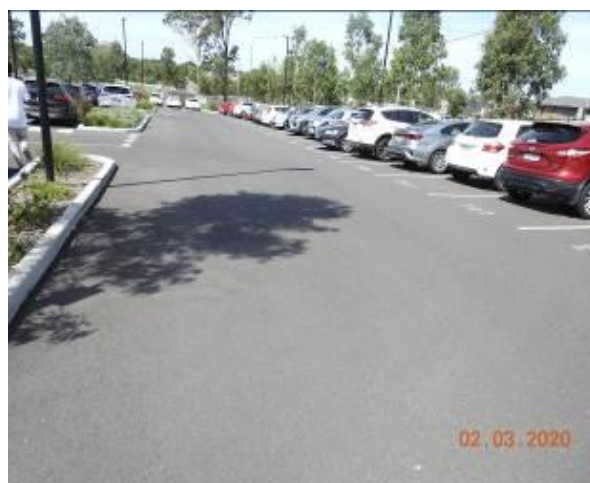
Figure 2909 – General Condition of carpark pavement

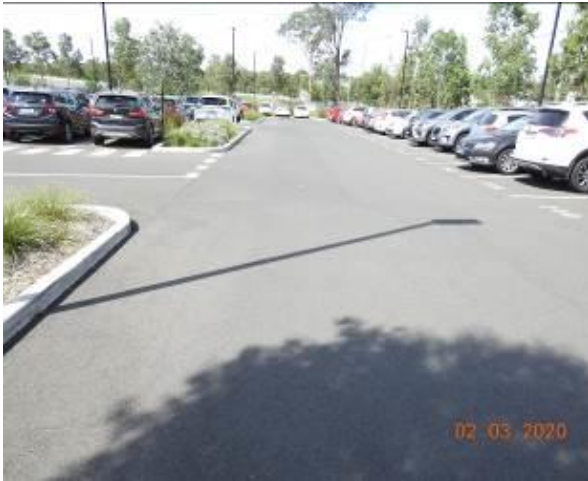
Figure 2910 – General Condition of carpark pavement

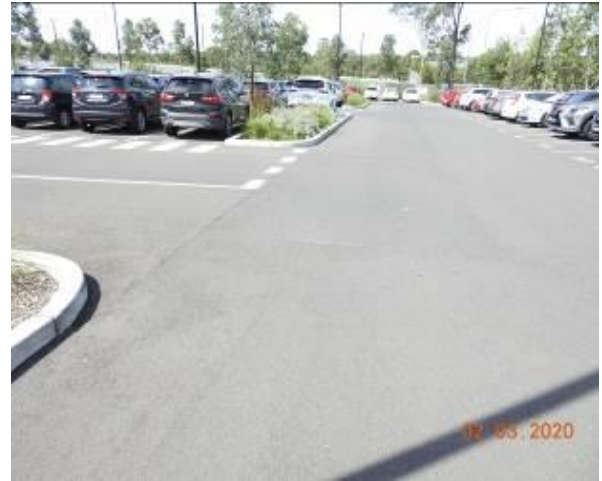
Figure 2911 – General Condition of carpark pavement

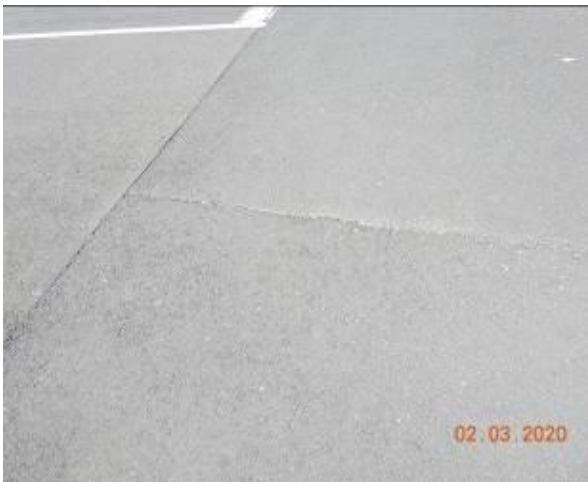
Figure 2912 – Crack propagation through carpark pavement

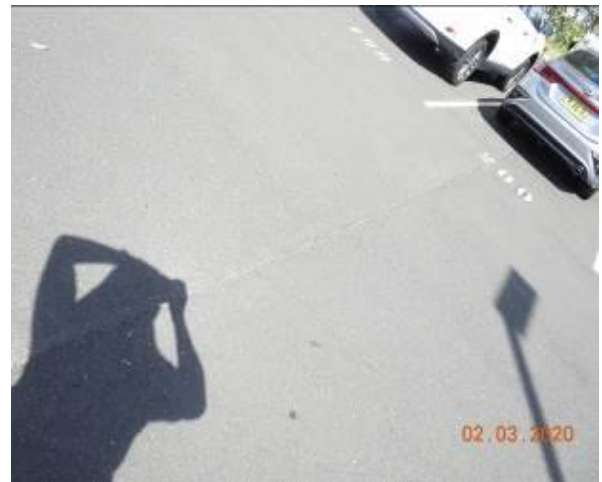
Figure 2913 – Crack propagation through carpark pavement

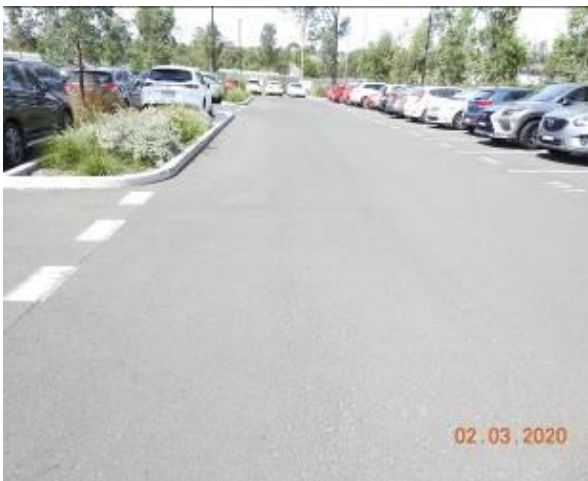
Figure 2914 – General Condition of carpark pavement

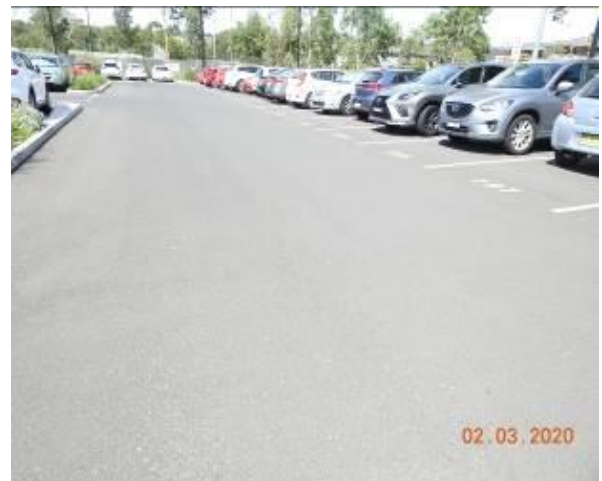
Figure 2915 – General Condition of carpark pavement

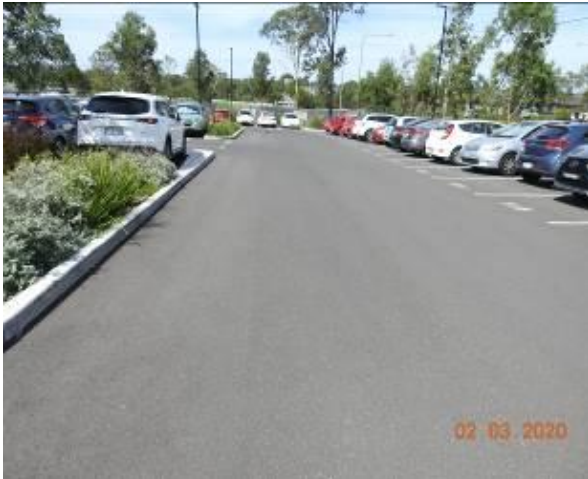
Figure 2916 – General Condition of carpark pavement

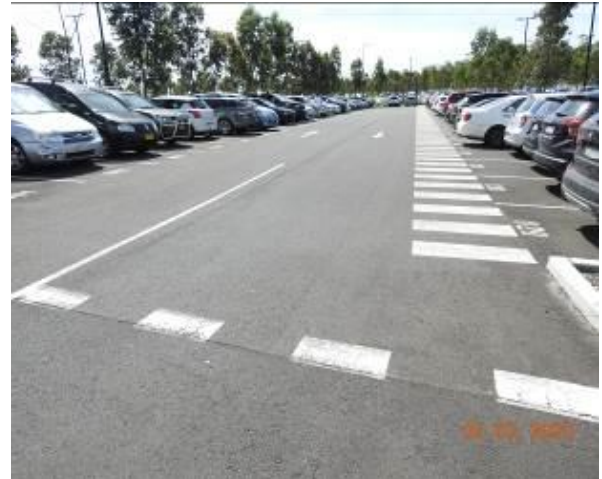
Figure 2917 – General Condition of carpark pavement

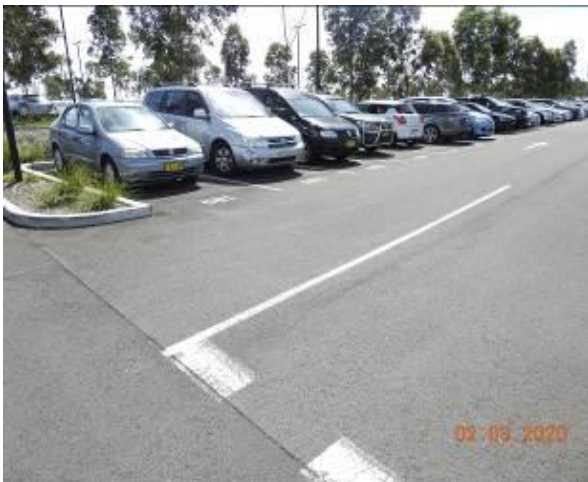
Figure 2918 – General Condition of carpark pavement

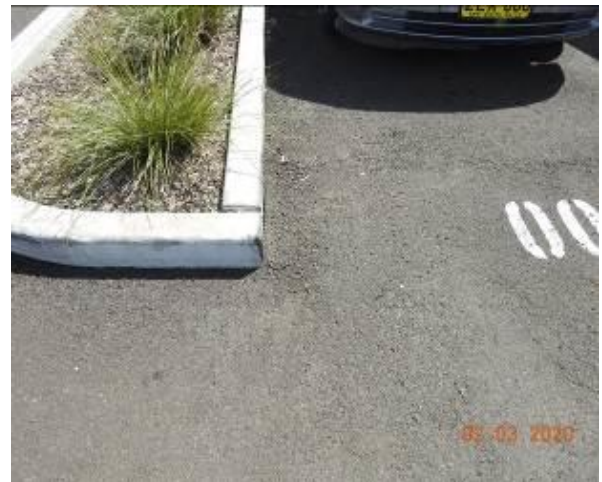
Figure 2919 – Loss of material through carpark pavement

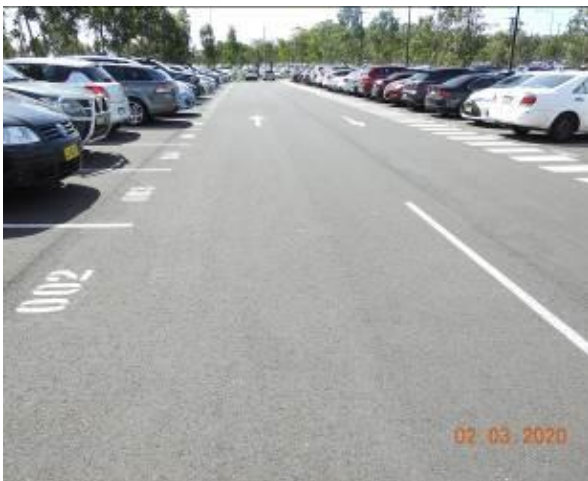
Figure 2920 – General Condition of carpark pavement

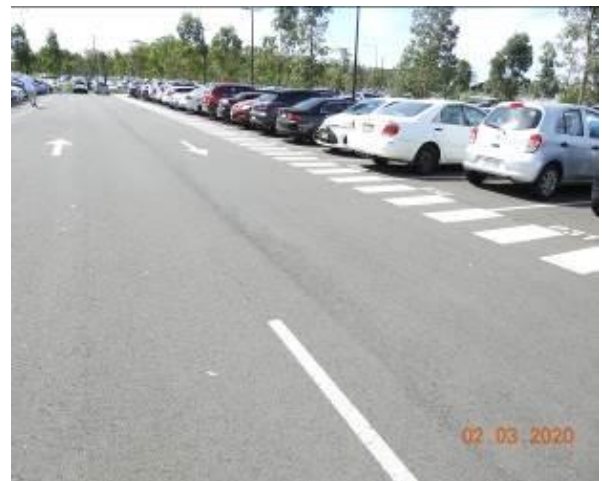
Figure 2921 – General Condition of carpark pavement

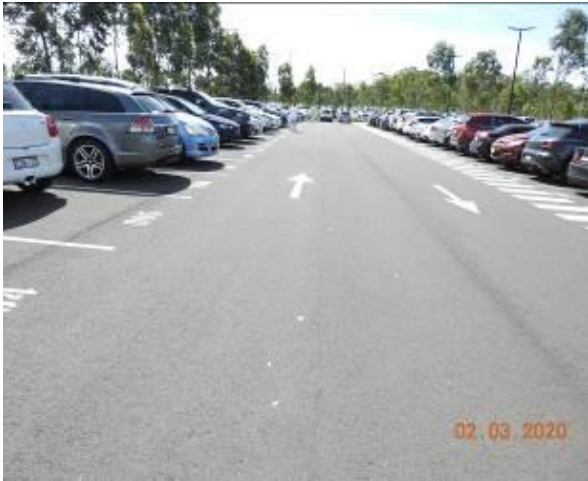
Figure 2922 – General Condition of carpark pavement

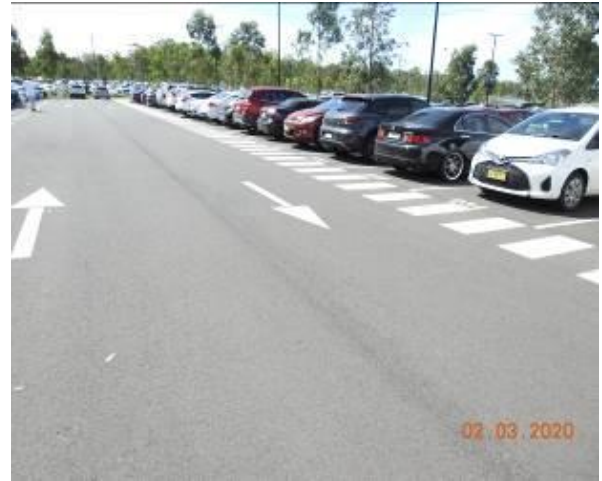
Figure 2923 – General Condition of carpark pavement

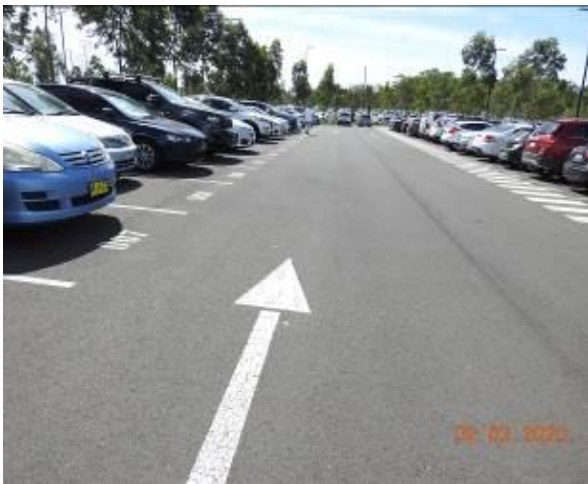
Figure 2924 – General Condition of carpark pavement

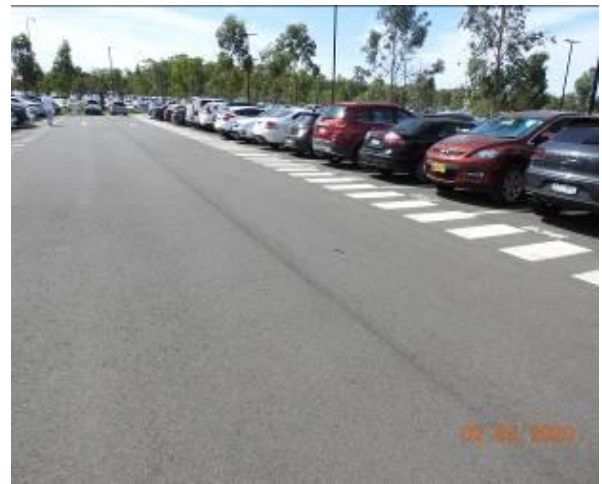
Figure 2925 – General Condition of carpark pavement

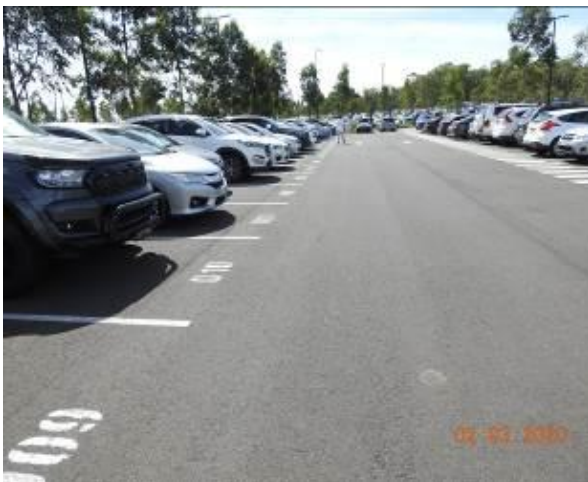
Figure 2926 – General Condition of carpark pavement

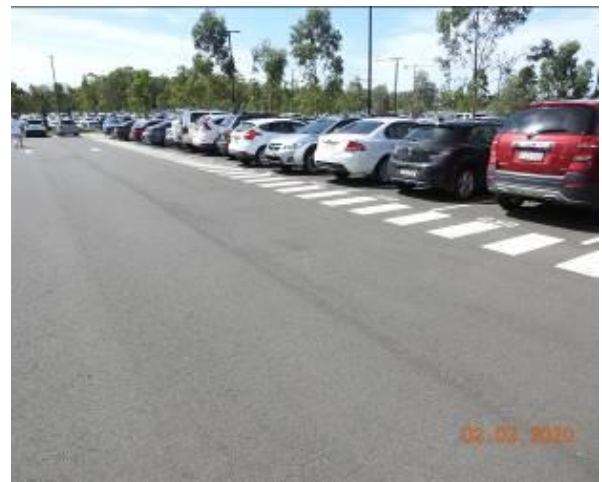
Figure 2927 – General Condition of carpark pavement

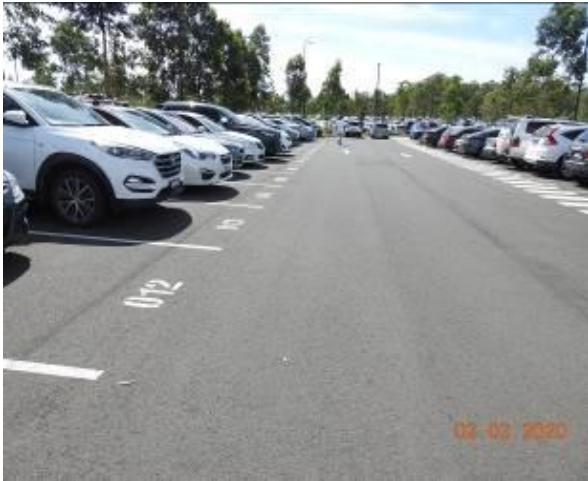
Figure 2928 – General Condition of carpark pavement
