**1-15 AND 2-12 CONFERTA AVENUE,
ROUSE HILL NSW 2155
TALLAWONG STATION PRECINCT SOUTH
PRE-DILAPIDATION REPORT**

**DEICORP PROJECTS
(TALLAWONG STATION) PTY LTD**

Job No. 191294.0
24/03/2020

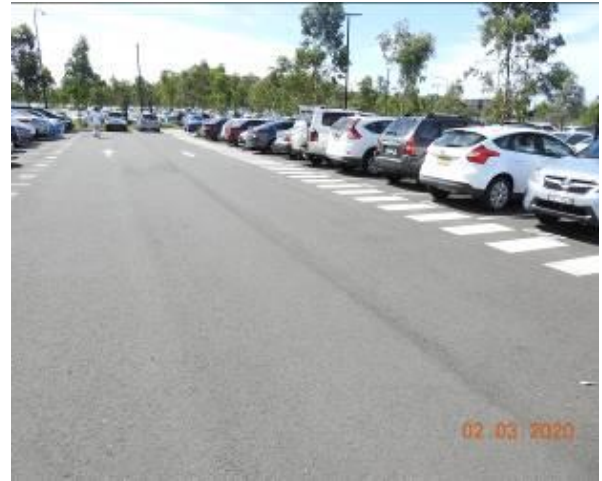
Figure 2929 – General Condition of carpark pavement

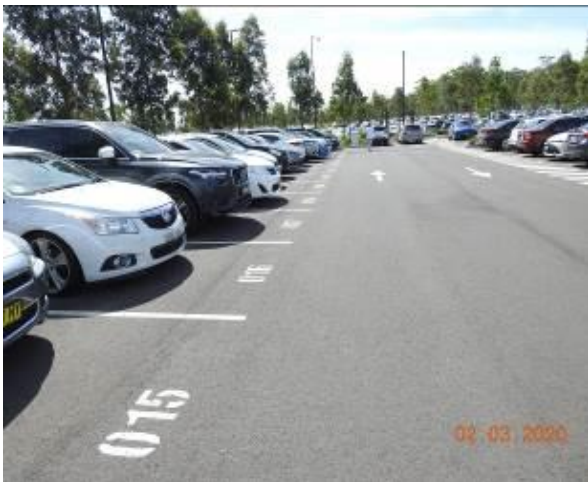
Figure 2930 – General Condition of carpark pavement

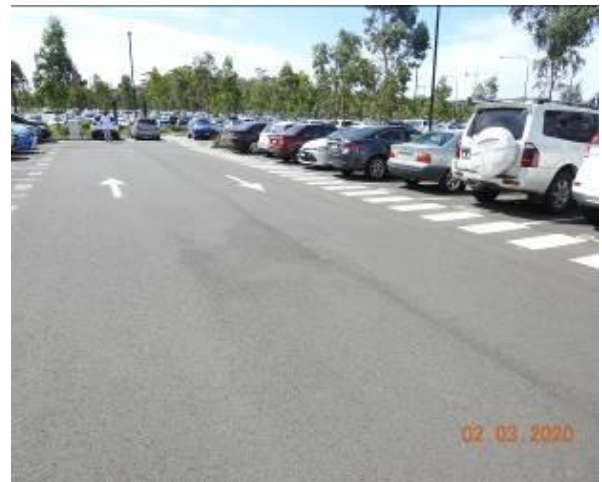
Figure 2931 – General Condition of carpark pavement

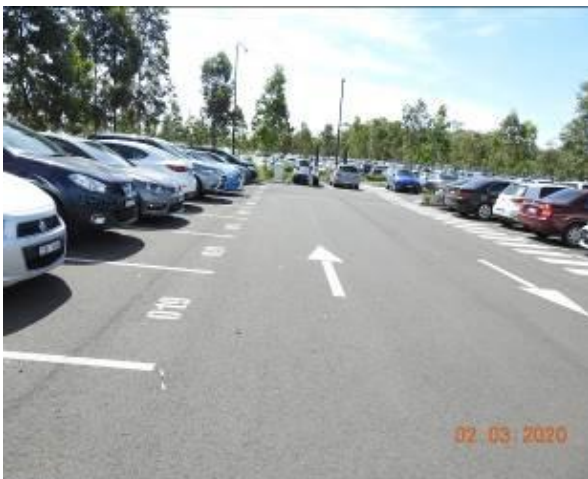
Figure 2932 – General Condition of carpark pavement

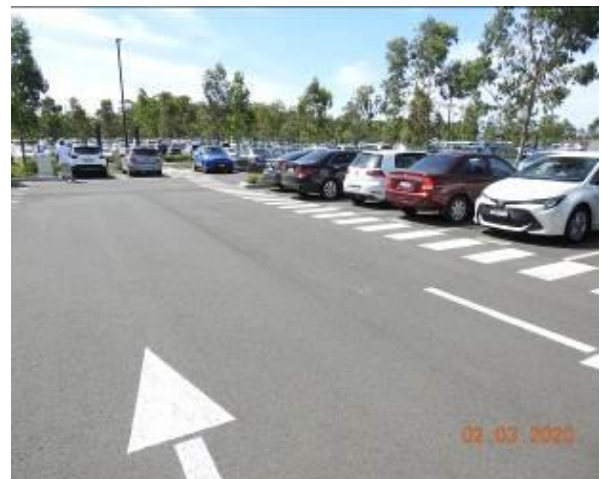
Figure 2933 – General Condition of carpark pavement

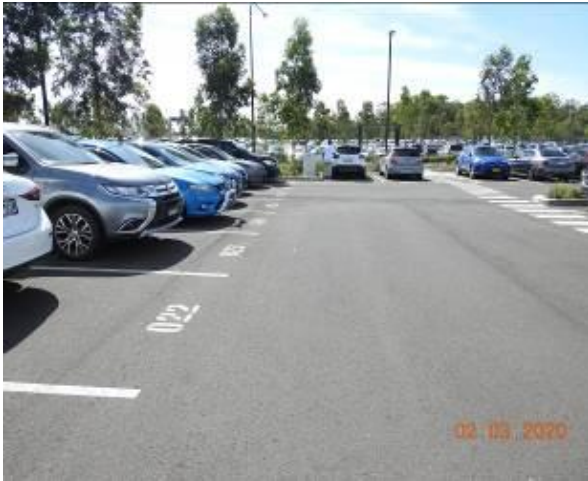
Figure 2934 – General Condition of carpark pavement

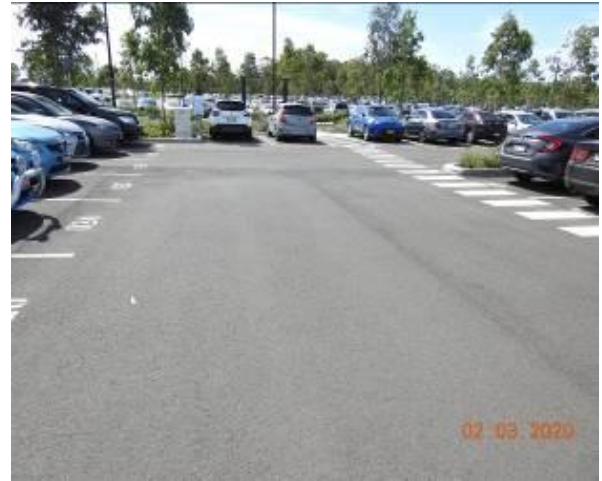
Figure 2935 – General Condition of carpark pavement

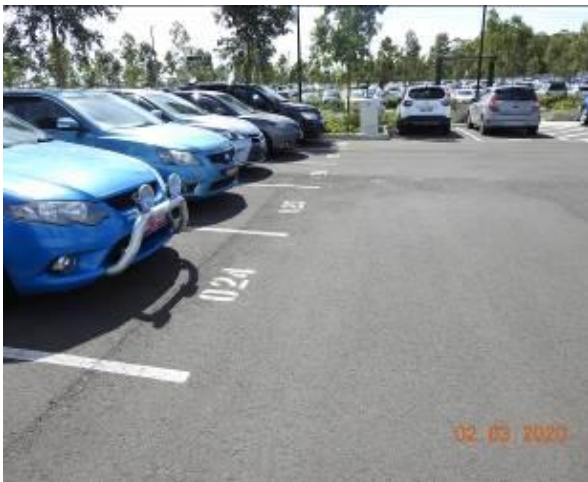
Figure 2936 – General Condition of carpark pavement

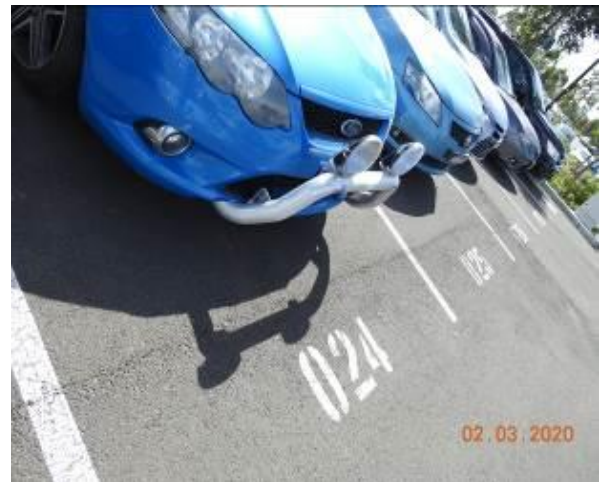
Figure 2937 – Crack propagation through carpark pavement

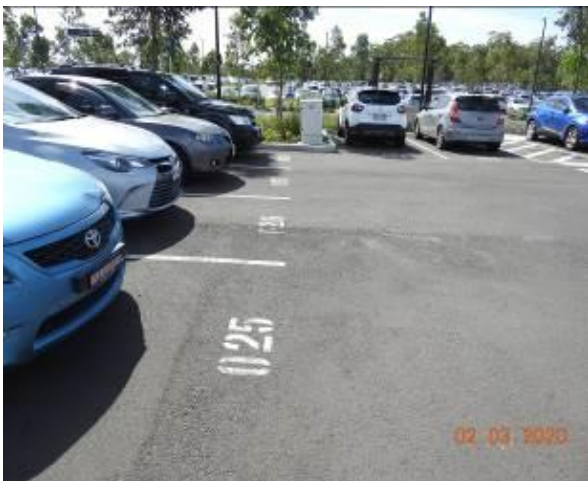
Figure 2938 – General Condition of carpark pavement

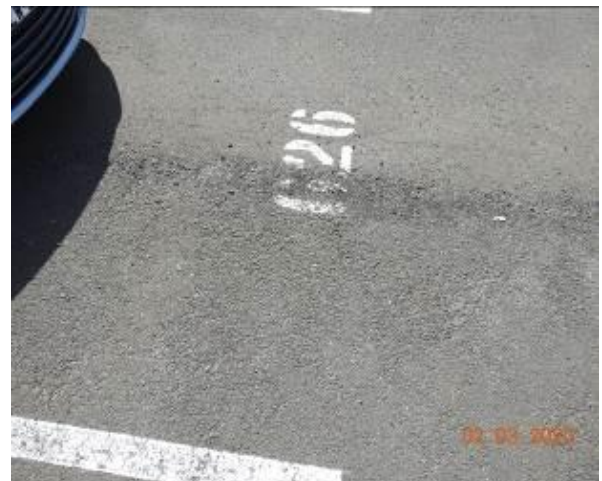
Figure 2939 – Loss of material through carpark pavement

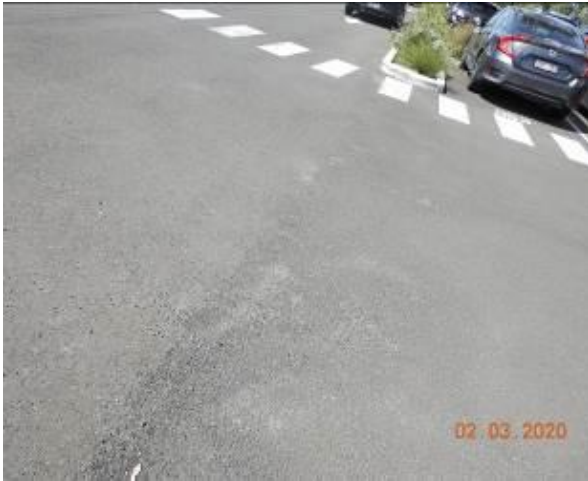
Figure 2940 – General Condition of carpark pavement

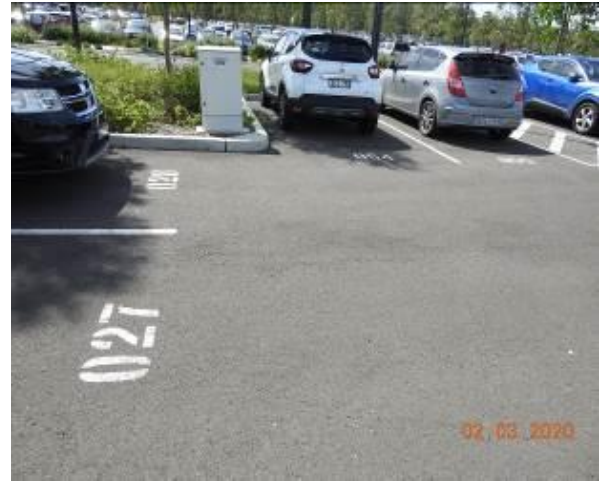
Figure 2941 – General Condition of carpark pavement

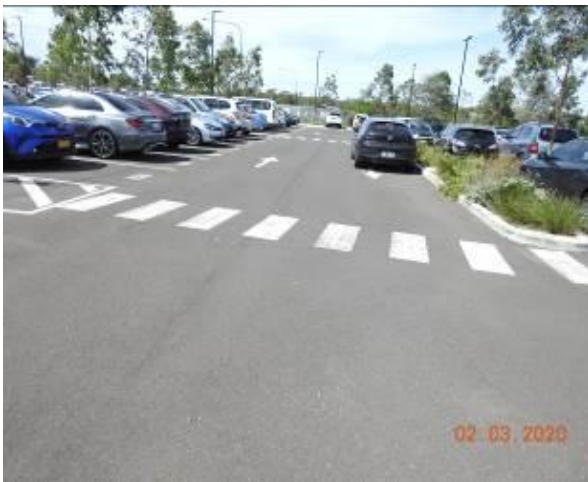
Figure 2942 – General Condition of carpark pavement

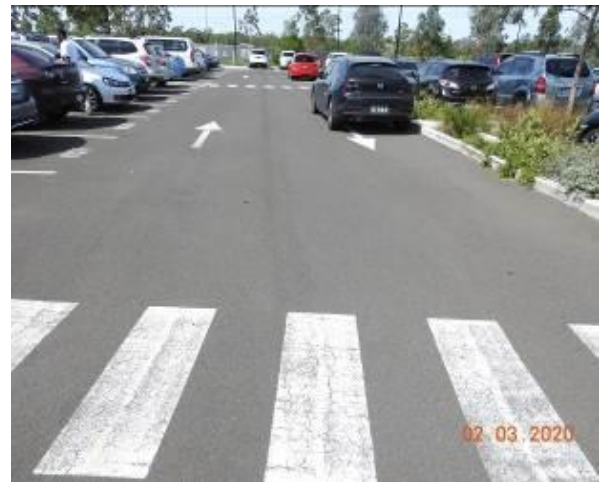
Figure 2943 – General Condition of carpark pavement

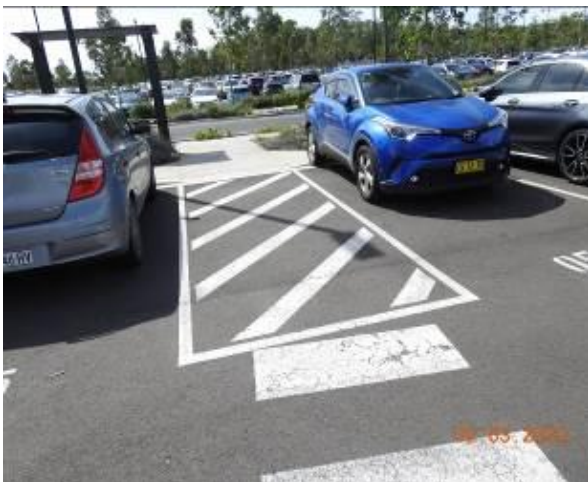
Figure 2944 – General Condition of carpark pavement

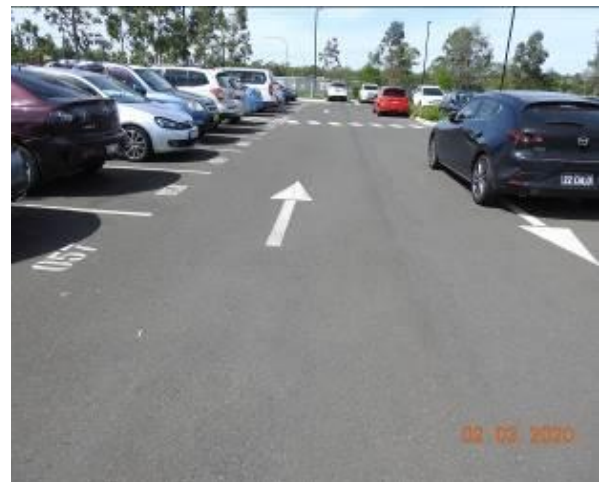
Figure 2945 – General Condition of carpark pavement

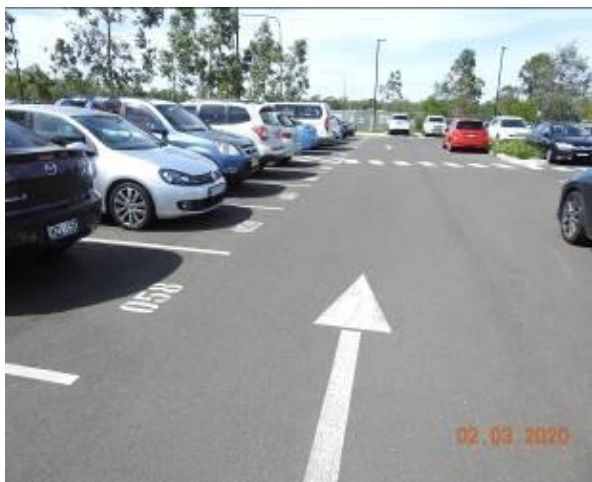
Figure 2946 – General Condition of carpark pavement

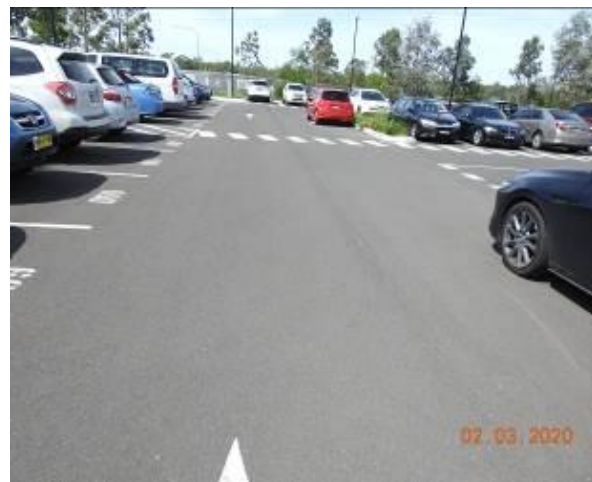
Figure 2947 – General Condition of carpark pavement

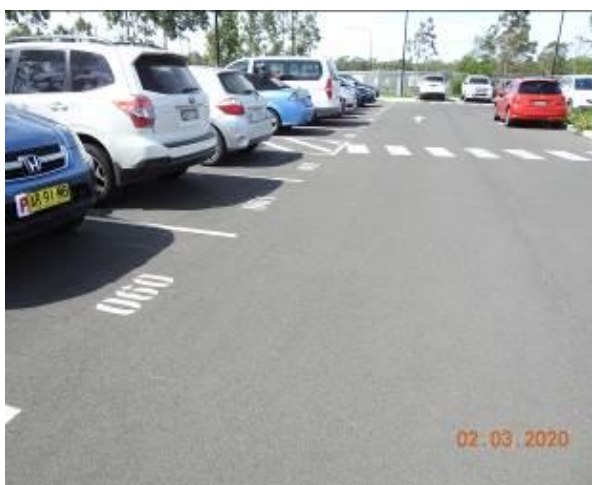
Figure 2948 – General Condition of carpark pavement

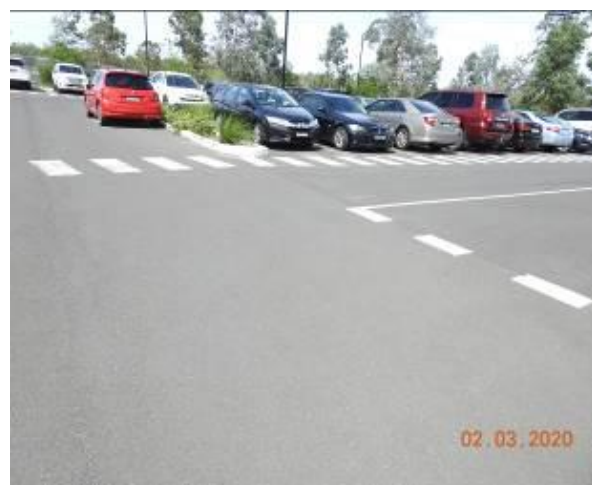
Figure 2949 – General Condition of carpark pavement

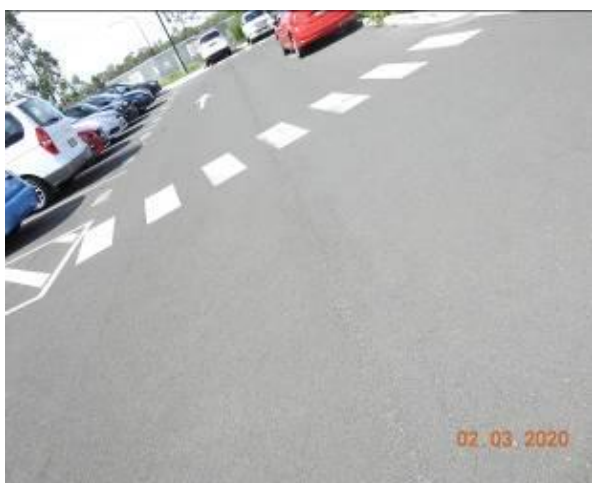
Figure 2950 – Crack propagation through carpark pavement

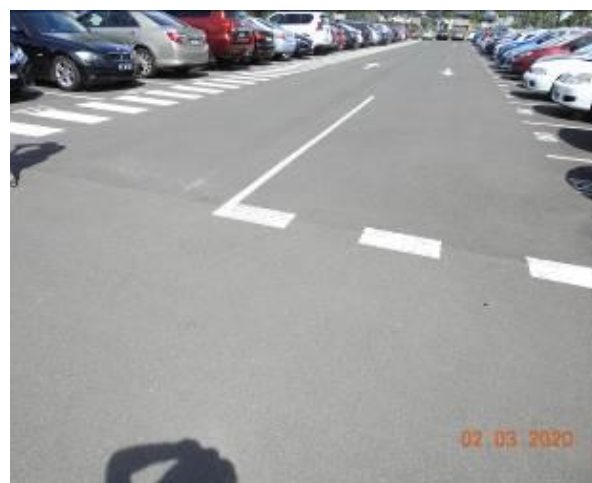
Figure 2951 – General Condition of carpark pavement

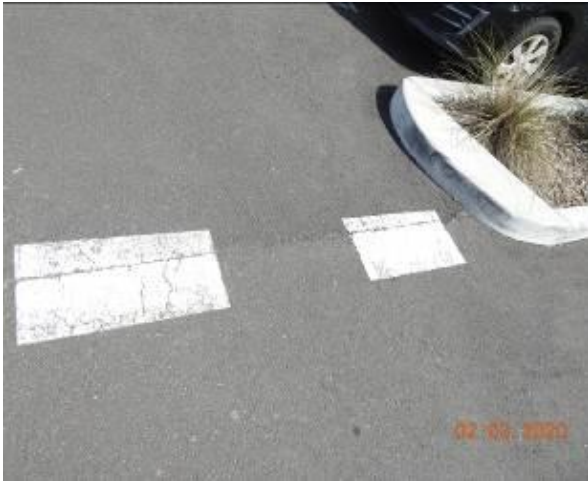
Figure 2952 – Crack propagation through carpark pavement

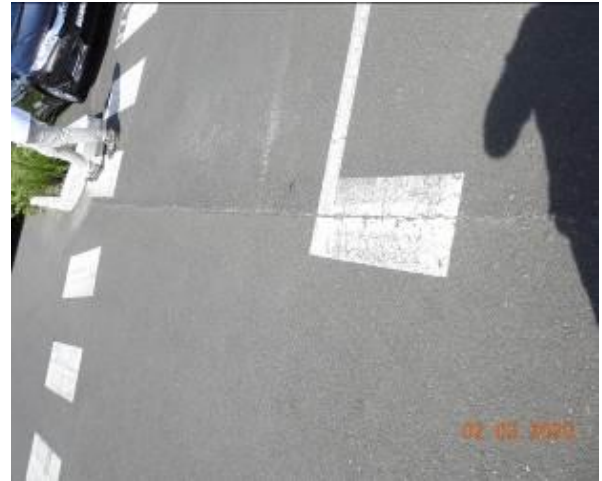
Figure 2953 – Crack propagation through carpark pavement

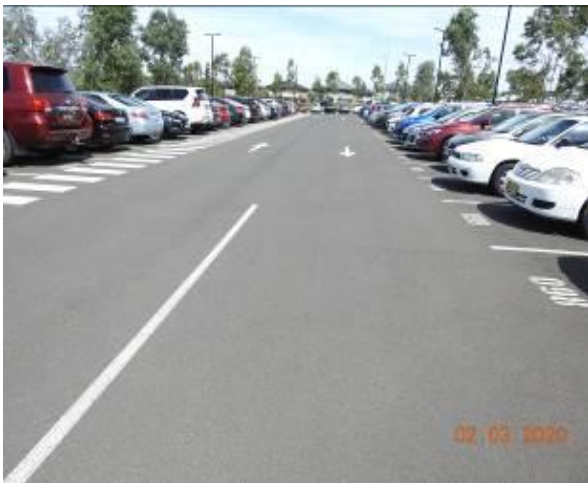
Figure 2954 – General Condition of carpark pavement

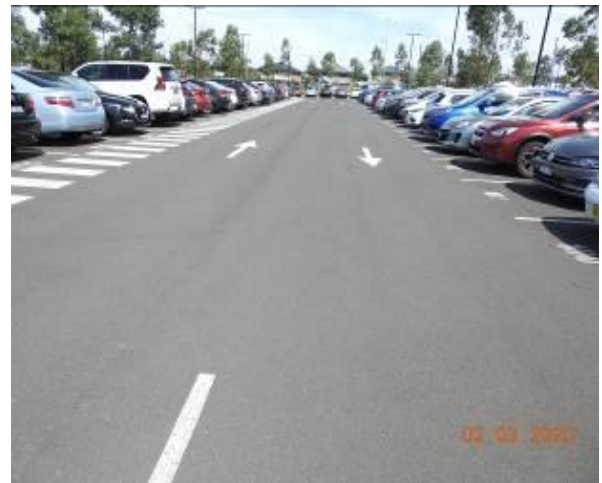
Figure 2955 – General Condition of carpark pavement

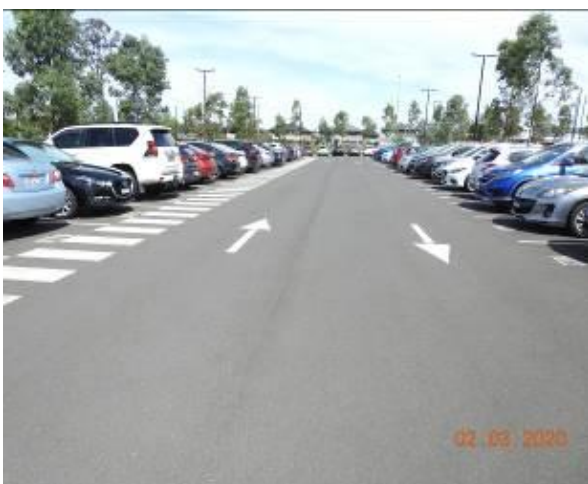
Figure 2956 – General Condition of carpark pavement

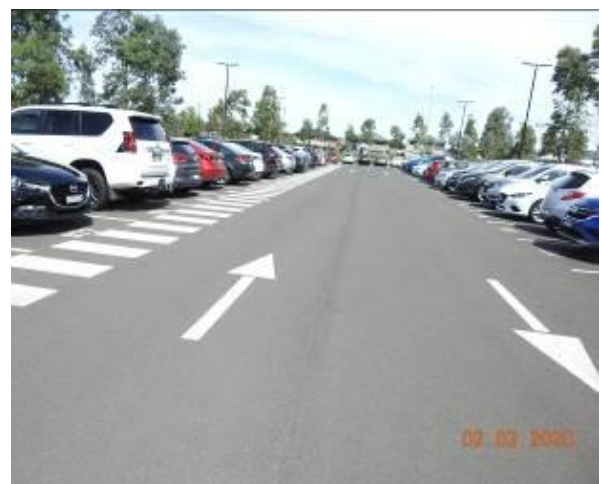
Figure 2957 – General Condition of carpark pavement

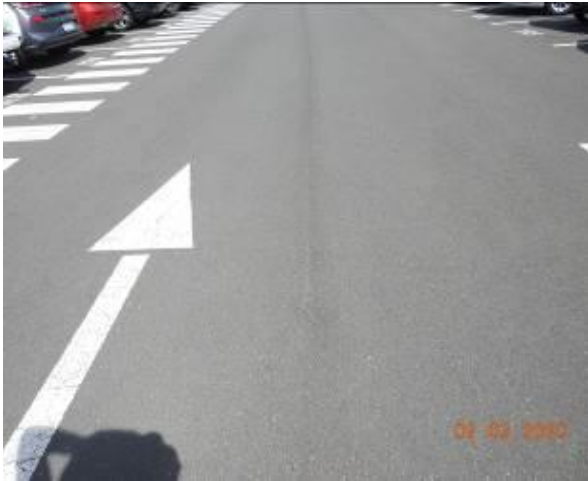
Figure 2958 – Crack propagation through carpark pavement

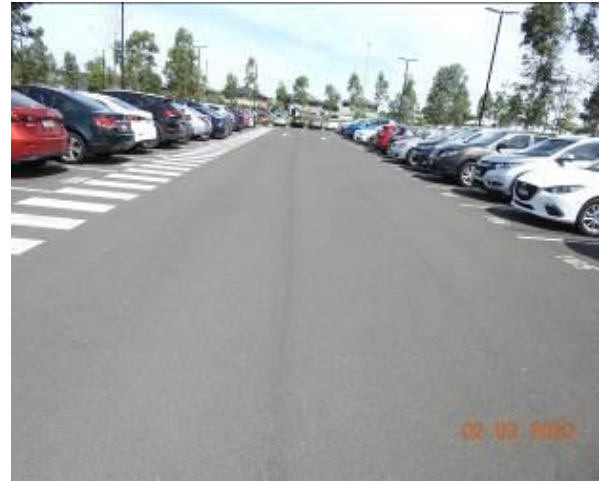
Figure 2959 – Crack propagation through carpark pavement

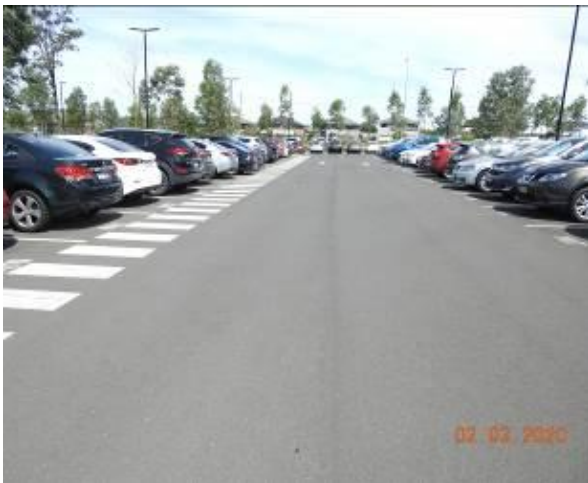
Figure 2960 – General Condition of carpark pavement

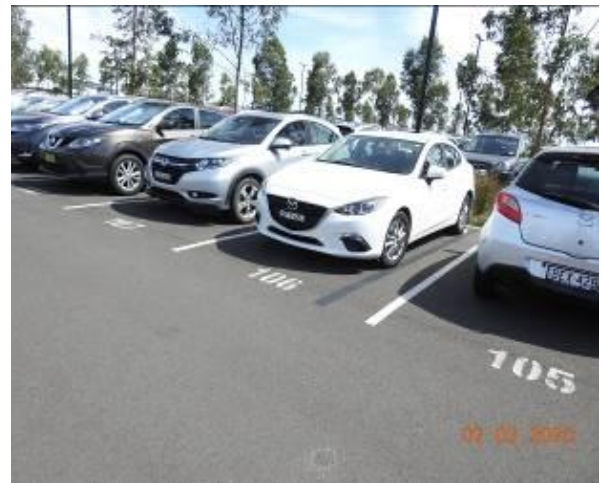
Figure 2961 – General Condition of carpark pavement

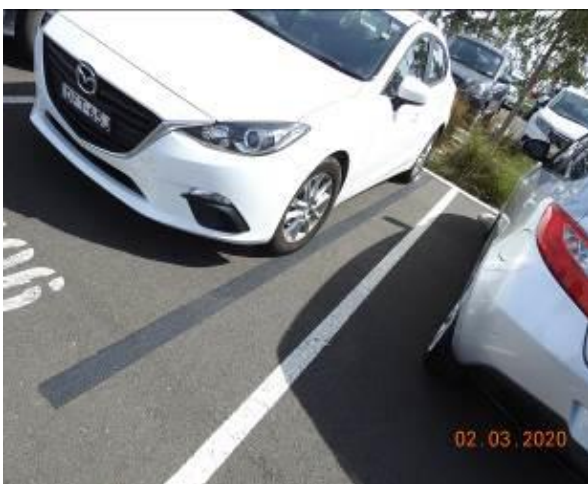
Figure 2962 – General Condition of carpark pavement

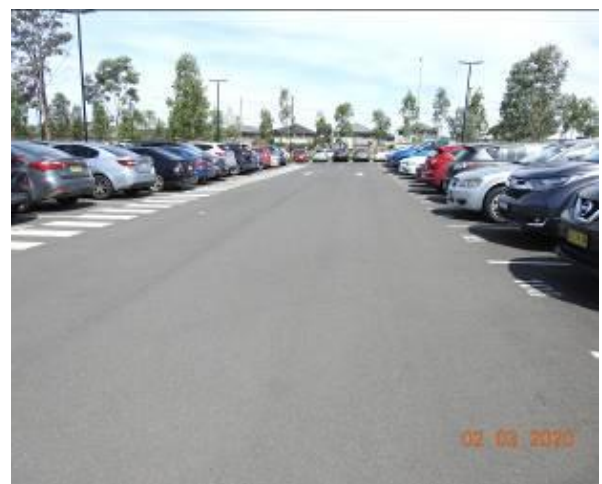
Figure 2963 – General Condition of carpark pavement

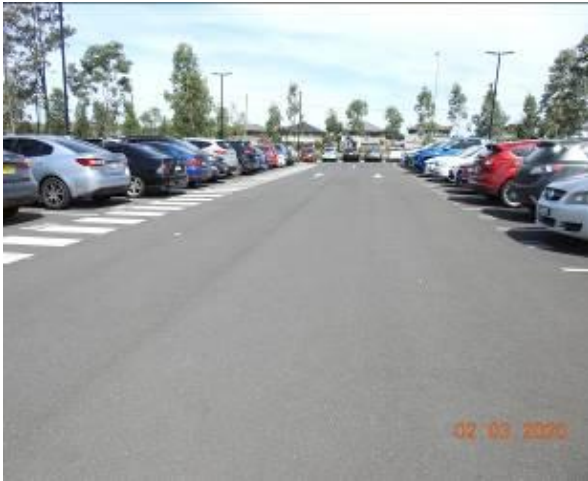
Figure 2964 – General Condition of carpark pavement

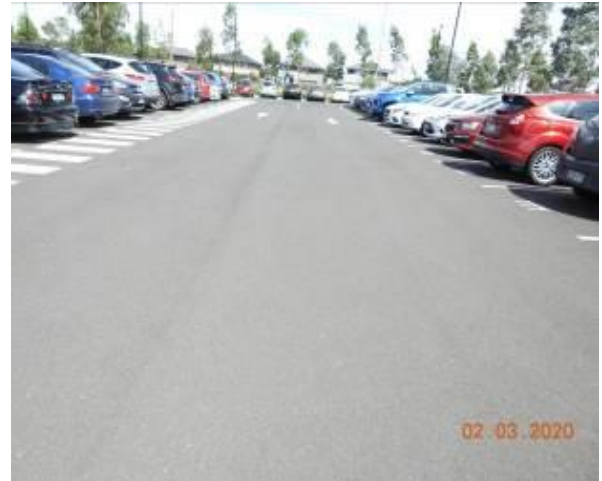
Figure 2965 – General Condition of carpark pavement

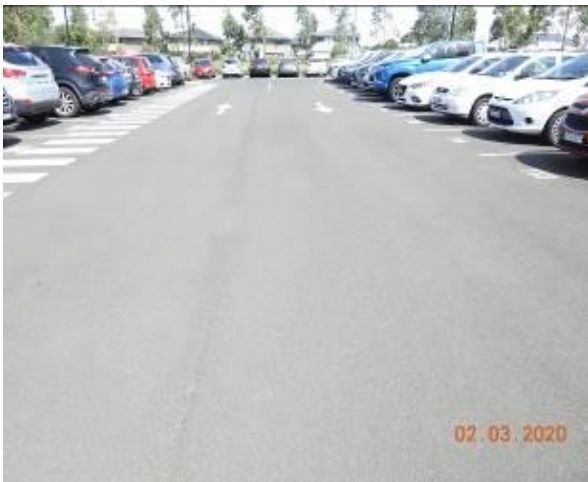
Figure 2966 – General Condition of carpark pavement

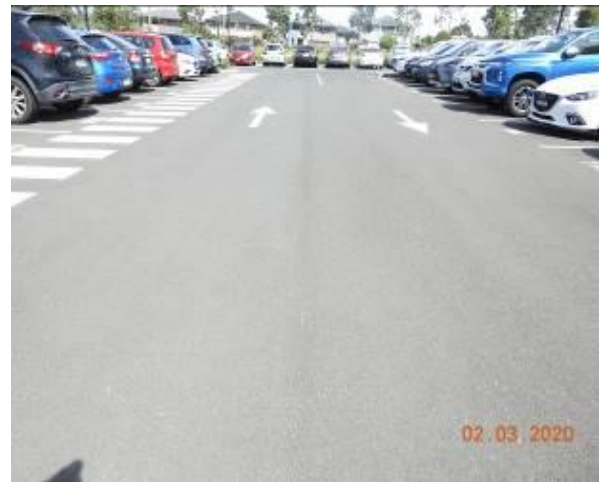
Figure 2967 – General Condition of carpark pavement

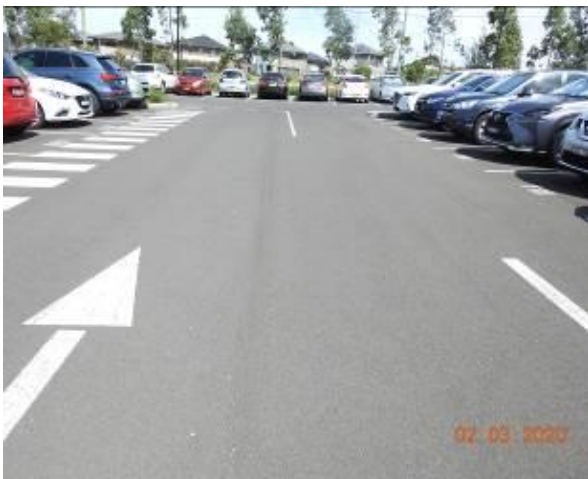
Figure 2968 – General Condition of carpark pavement

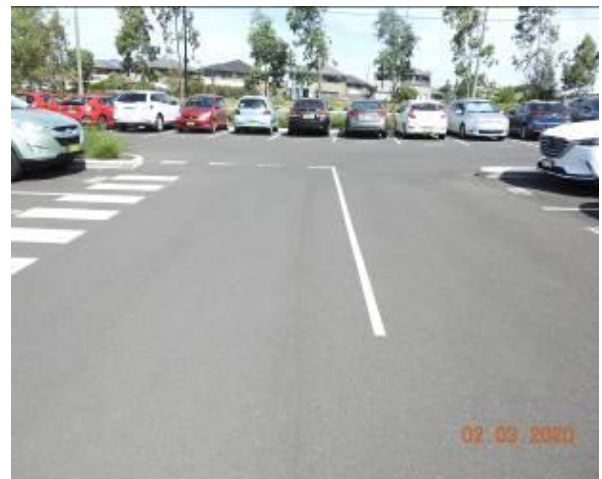
Figure 2969 – General Condition of carpark pavement

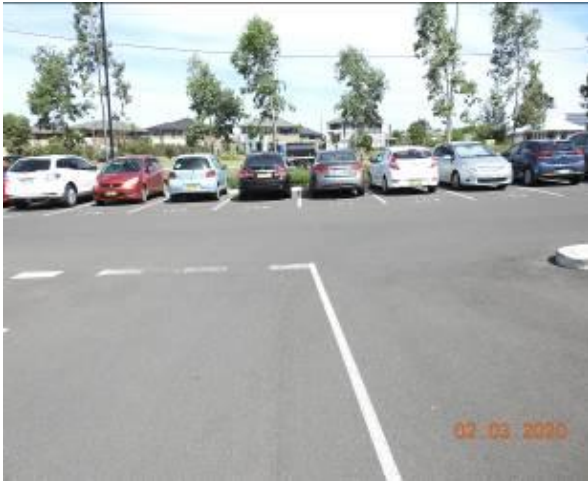
Figure 2970 – General Condition of carpark pavement

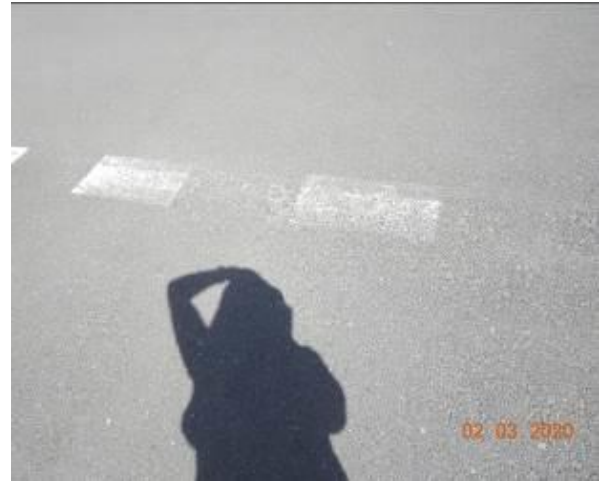
Figure 2971 – Crack propagation through carpark pavement

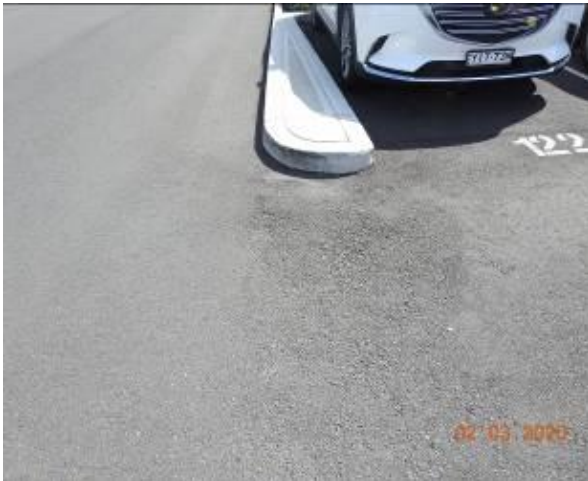
Figure 2972 – General Condition of carpark pavement

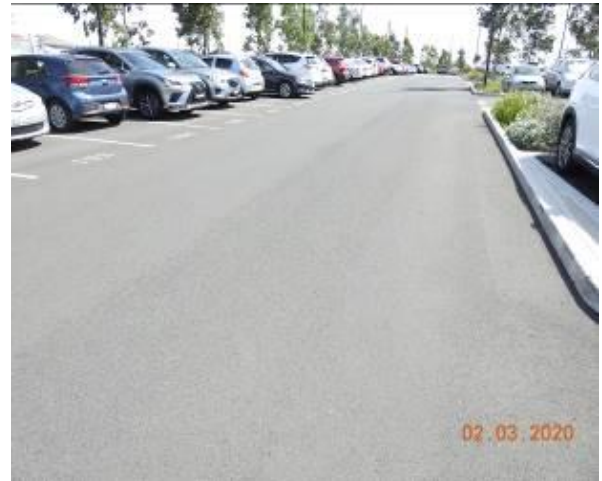
Figure 2973 – General Condition of carpark pavement

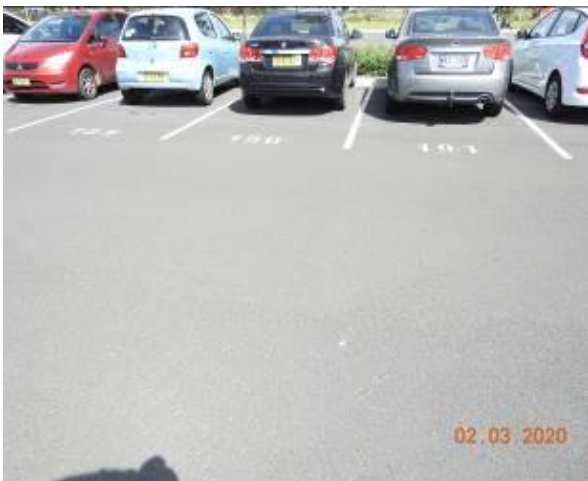
Figure 2974 – General Condition of carpark pavement

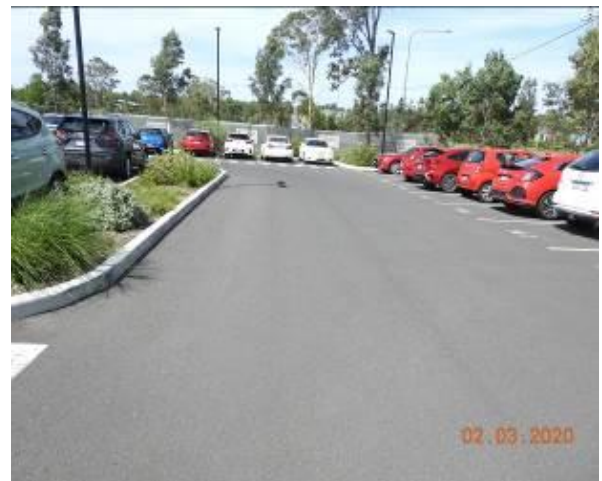
Figure 2975 – General Condition of carpark pavement

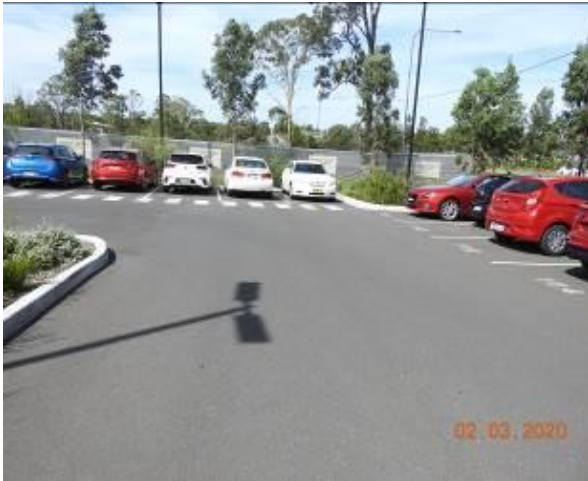
Figure 2976 – General Condition of carpark pavement

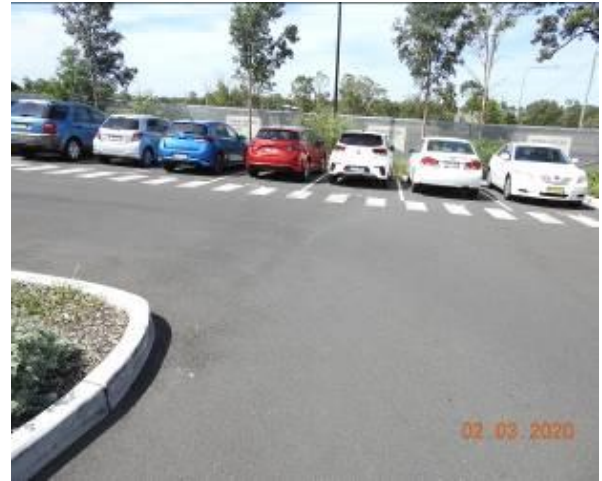
Figure 2977 – General Condition of carpark pavement

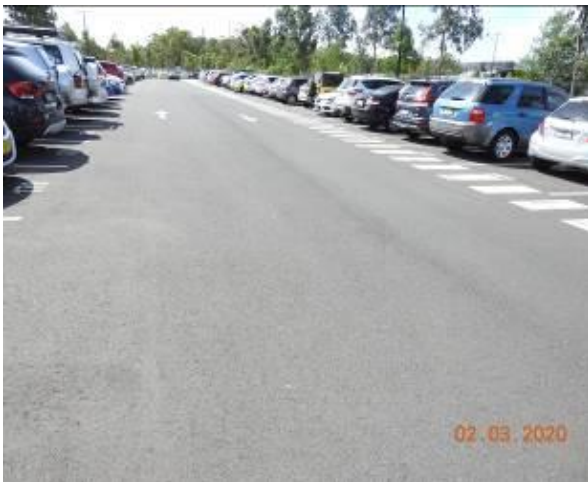
Figure 2978 – General Condition of carpark pavement

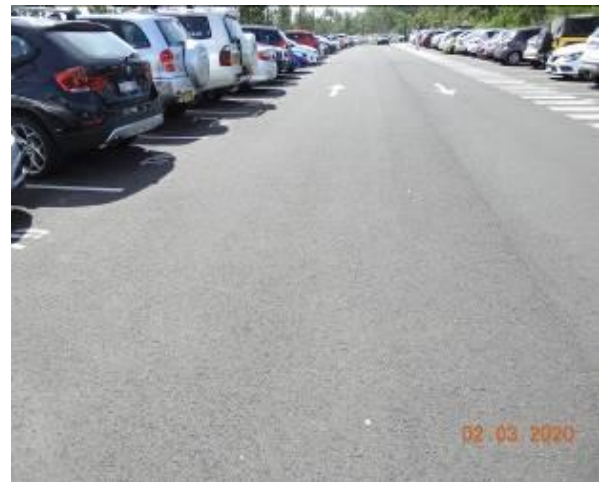
Figure 2979 – General Condition of carpark pavement

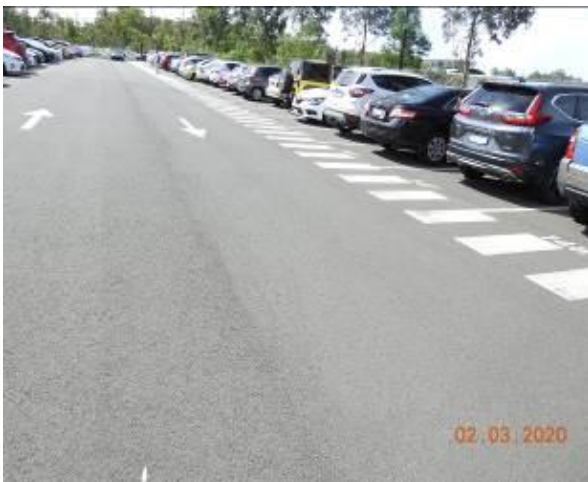
Figure 2980 – General Condition of carpark pavement

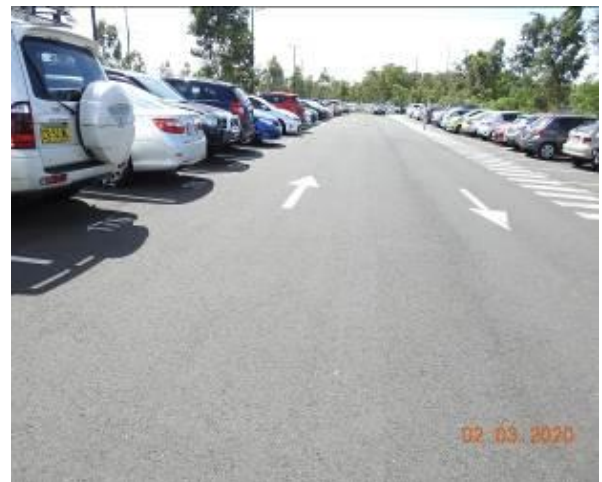
Figure 2981 – General Condition of carpark pavement

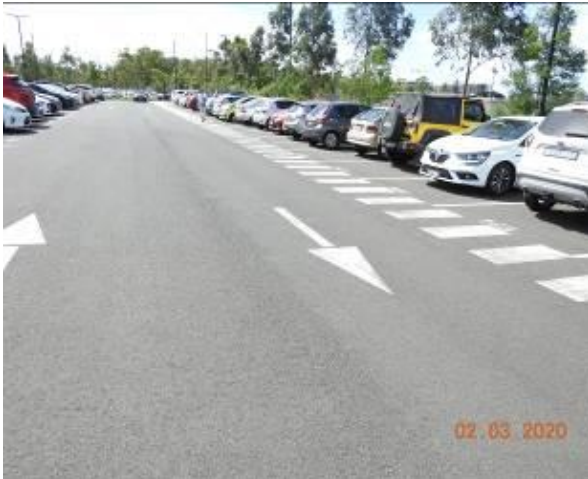
Figure 2982 – General Condition of carpark pavement

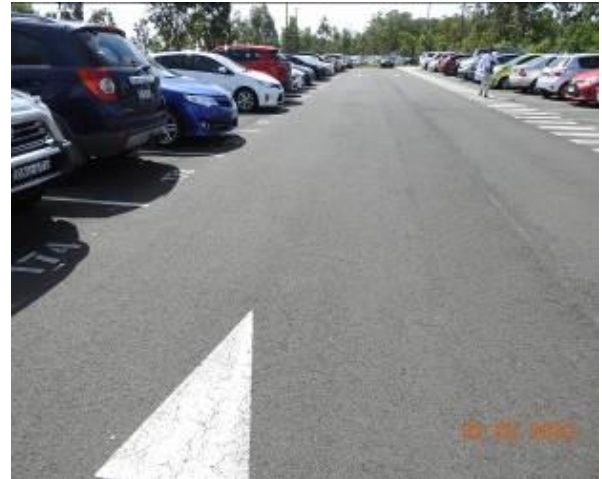
Figure 2983 – General Condition of carpark pavement

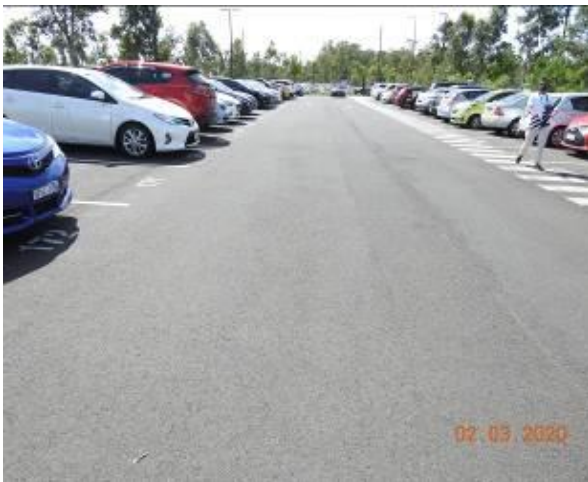
Figure 2984 – General Condition of carpark pavement

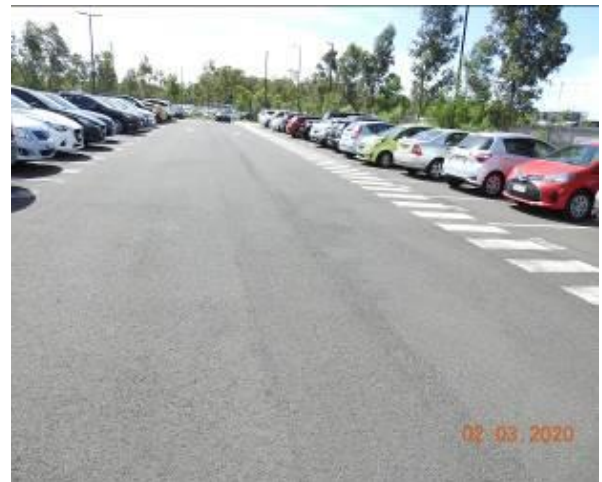
Figure 2985 – General Condition of carpark pavement

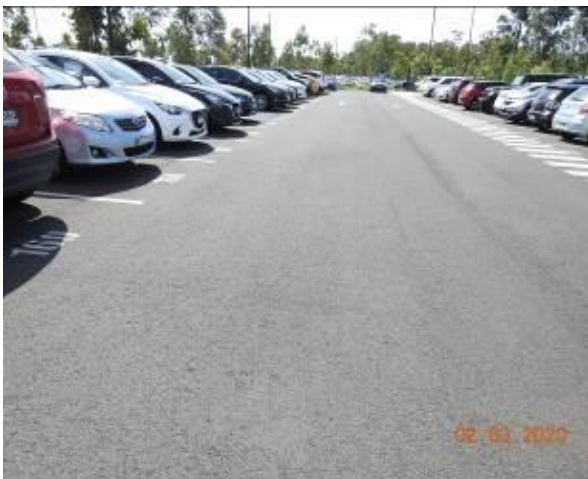
Figure 2986 – General Condition of carpark pavement

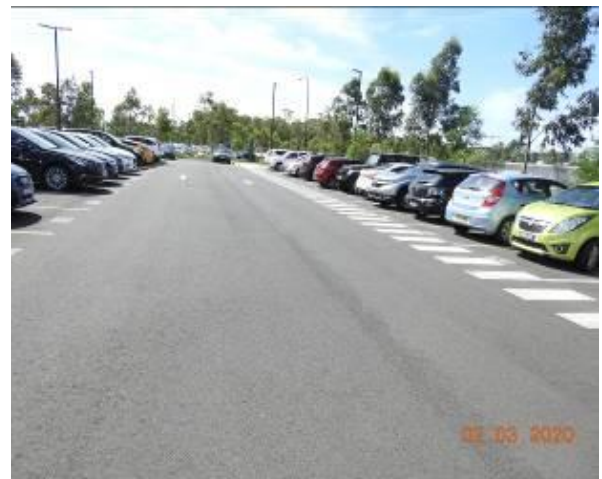
Figure 2987 – General Condition of carpark pavement

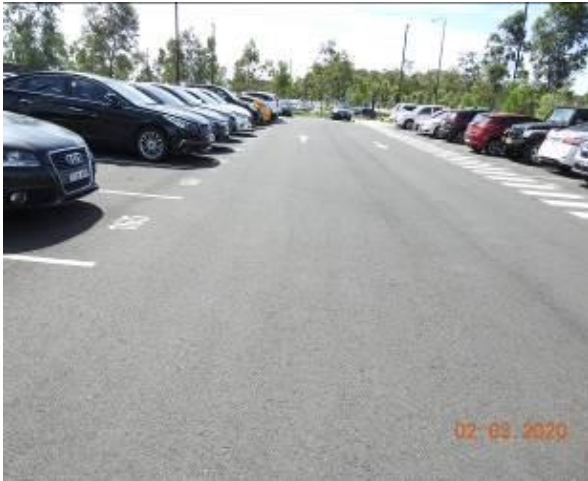
Figure 2988 – General Condition of carpark pavement

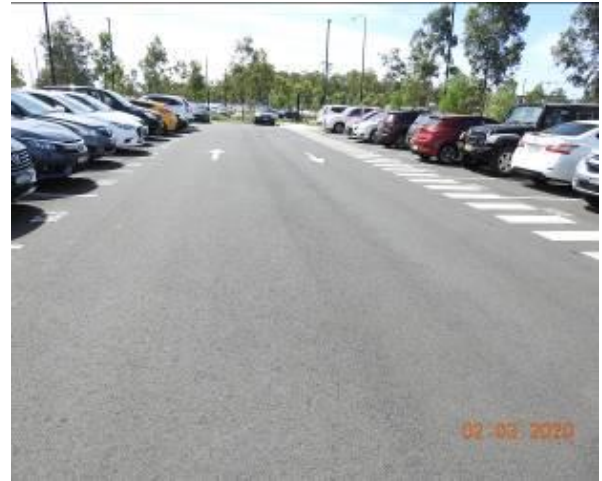
Figure 2989 – General Condition of carpark pavement

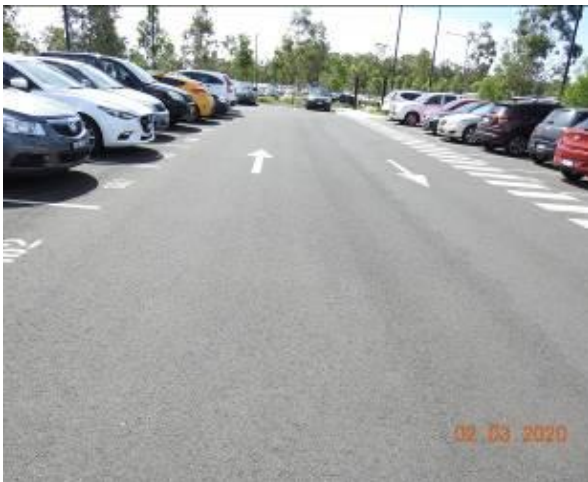
Figure 2990 – General Condition of carpark pavement

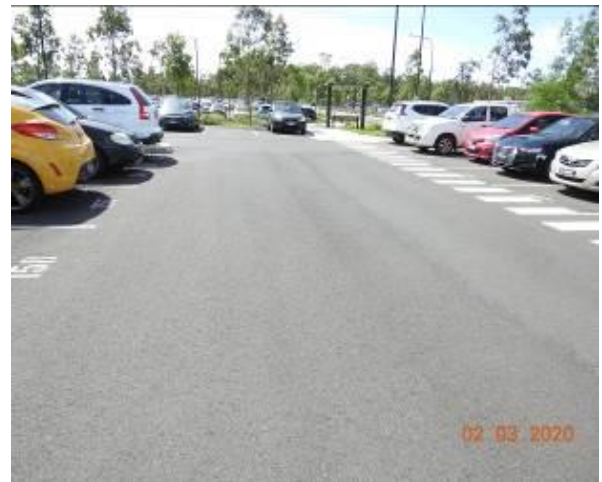
Figure 2991 – General Condition of carpark pavement

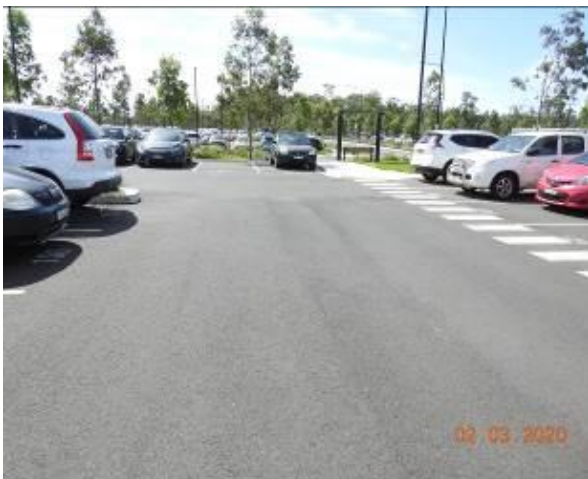
Figure 2992 – General Condition of carpark pavement

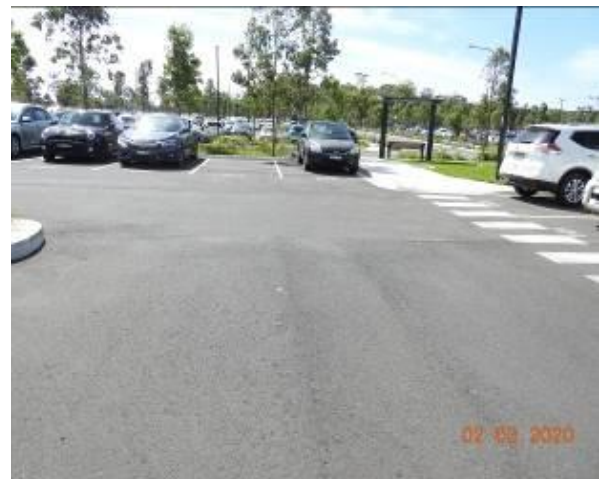
Figure 2993 – General Condition of carpark pavement

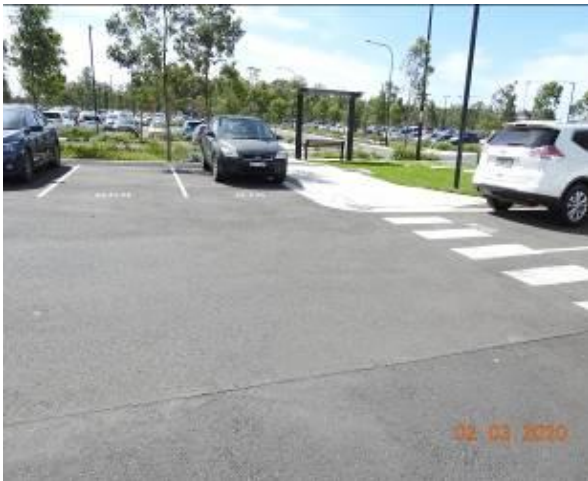
Figure 2994 – General Condition of carpark pavement

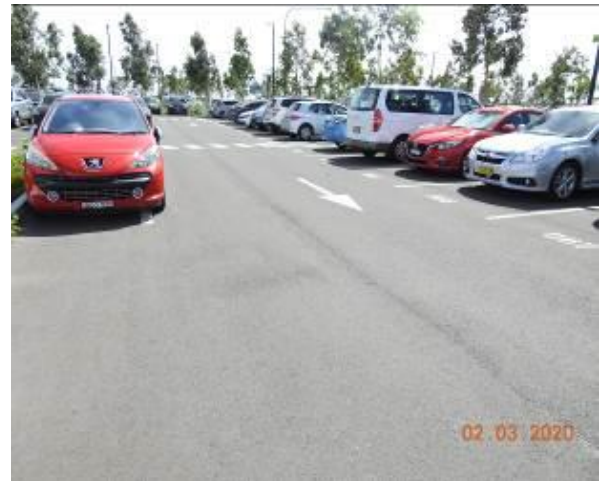
Figure 2995 – General Condition of carpark pavement

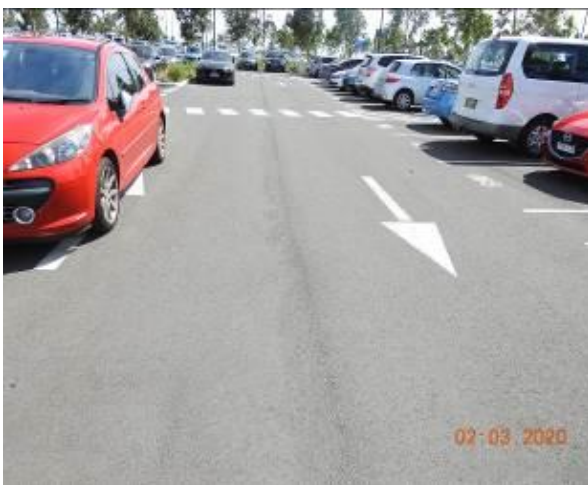
Figure 2996 – Loss of material through carpark pavement

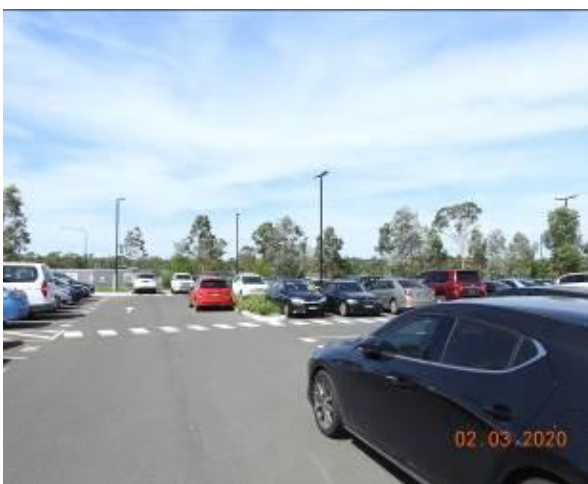
Figure 2998 – General Condition of lamp post / plantation

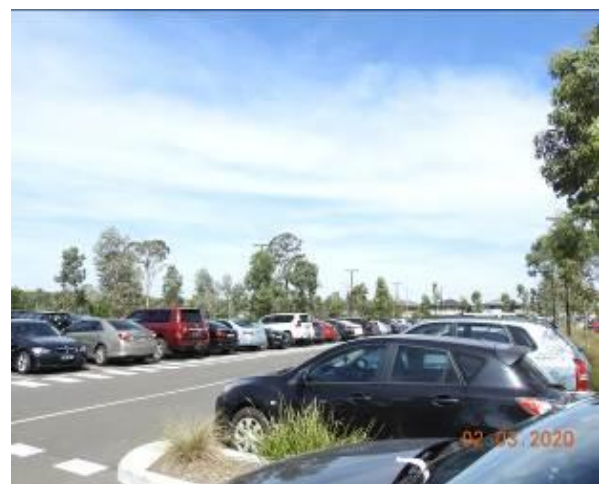
Figure 2999 – General Condition of lamp post / plantation

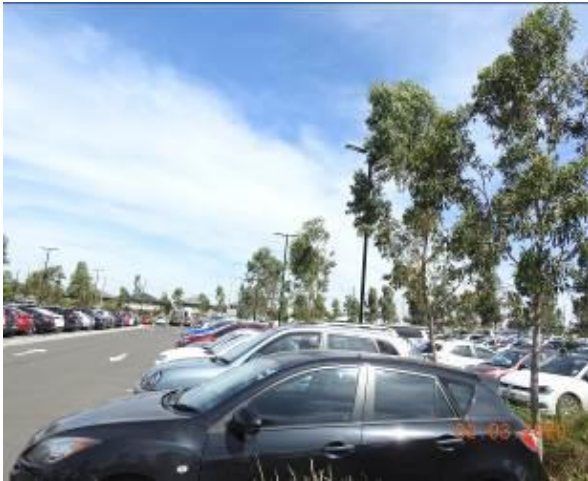
Figure 3000 – General Condition of lamp post / plantation

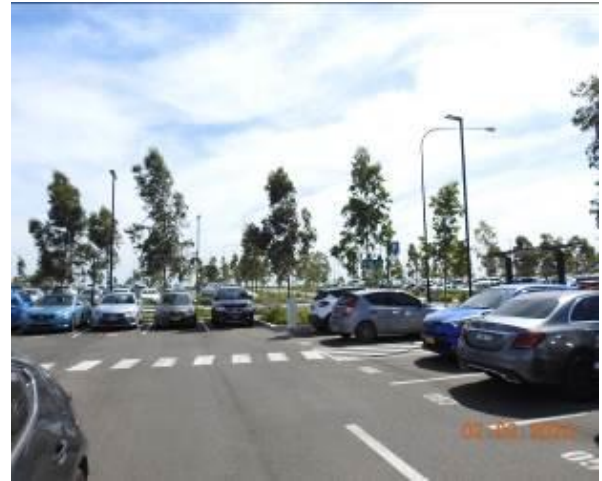
Figure 3001 – General Condition of lamp post / plantation

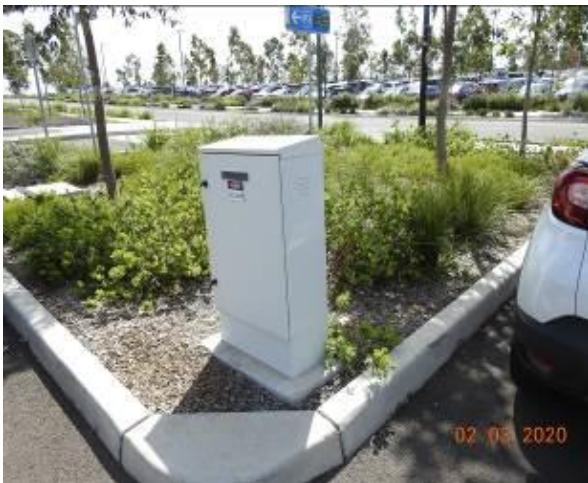
Figure 3002 – General Condition of electricity box

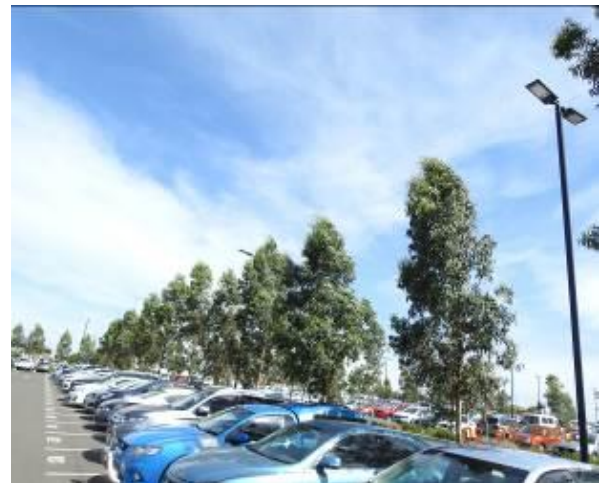
Figure 3003 – General Condition of lamp post / plantation

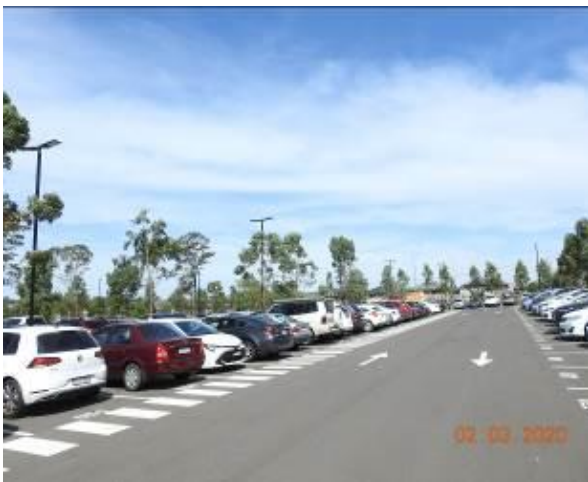
Figure 3004 – General Condition of lamp post / plantation

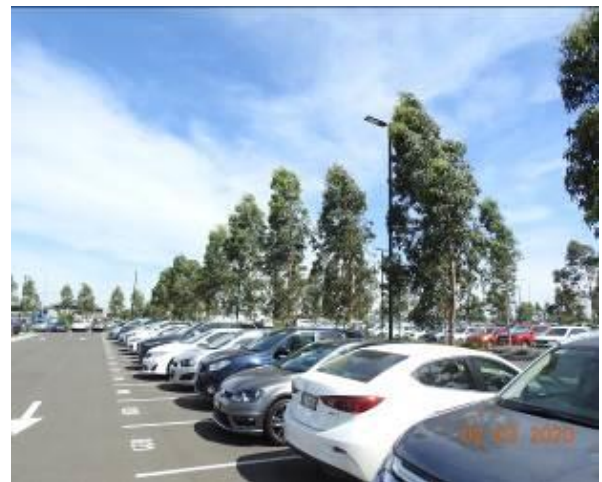
Figure 3005 – General Condition of lamp post / plantation

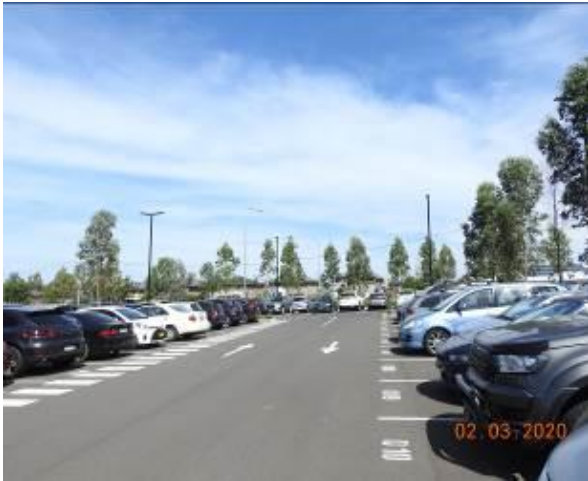
Figure 3006 – General Condition of lamp post / plantation
