**1-15 AND 2-12 CONFERTA AVENUE,
ROUSE HILL NSW 2155
TALLAWONG STATION PRECINCT SOUTH
PRE-DILAPIDATION REPORT**

**DEICORP PROJECTS
(TALLAWONG STATION) PTY LTD**

Job No. 191294.0
24/03/2020

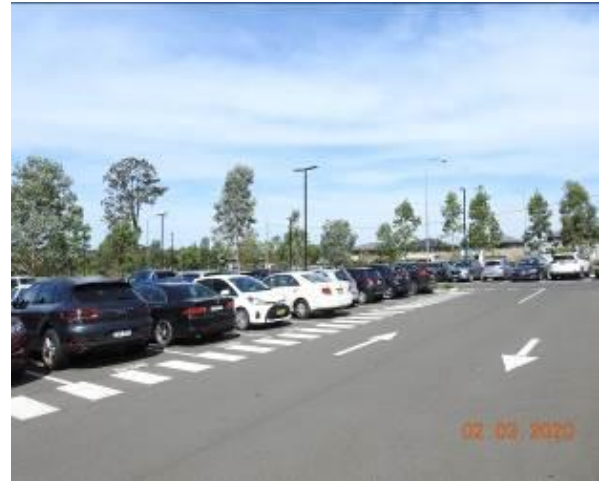
Figure 3007 – General Condition of lamp post / plantation

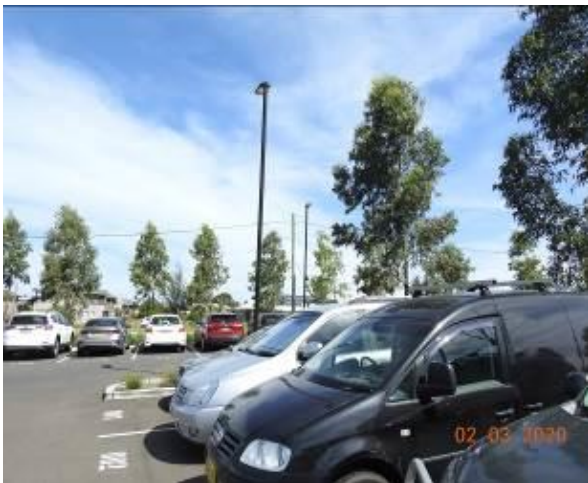
Figure 3008 – General Condition of lamp post / plantation

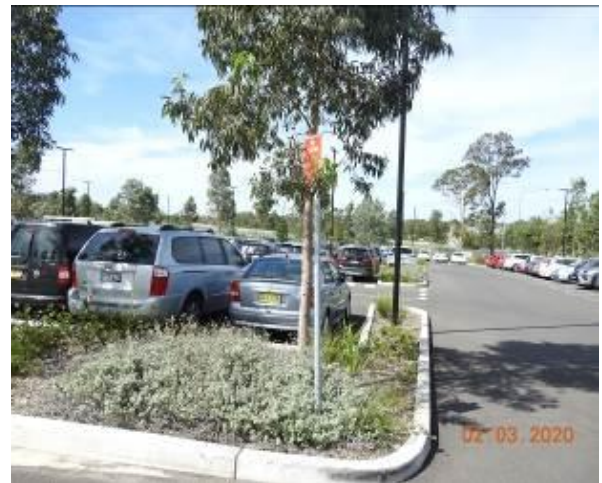
Figure 3009 – General Condition of street sign

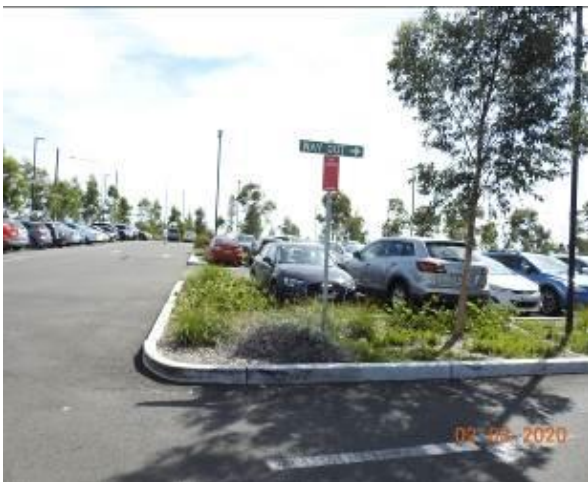
Figure 3010 – General Condition of street sign

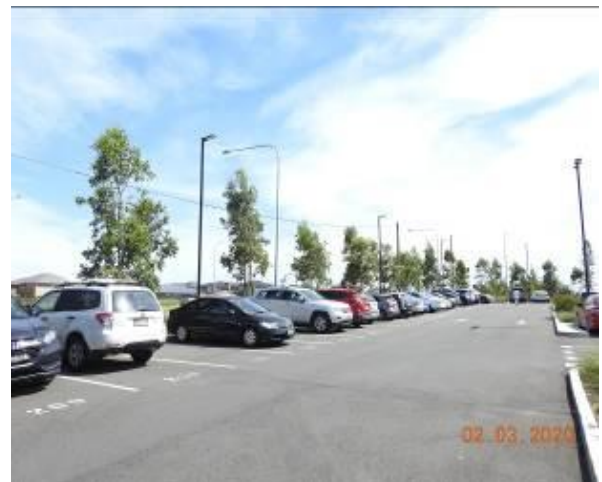
Figure 3011 – General Condition of lamp post / plantation

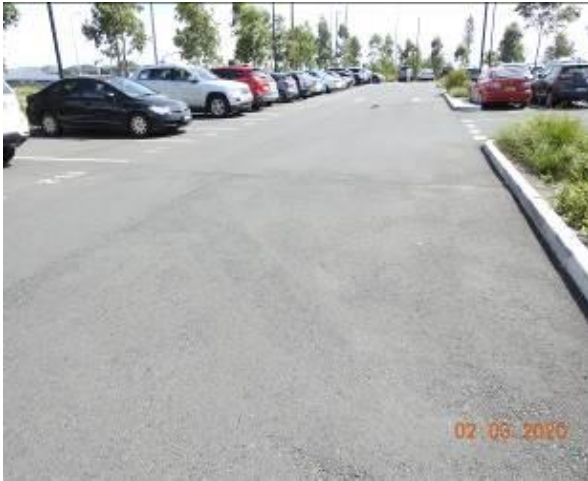
Figure 3012 – General Condition of carpark pavement

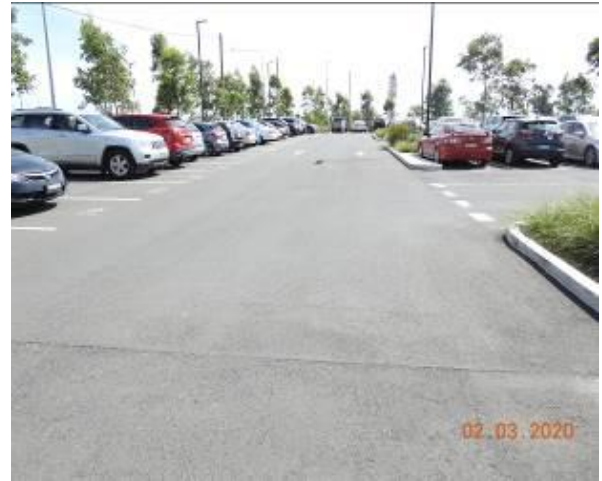
Figure 3013 – General Condition of carpark pavement

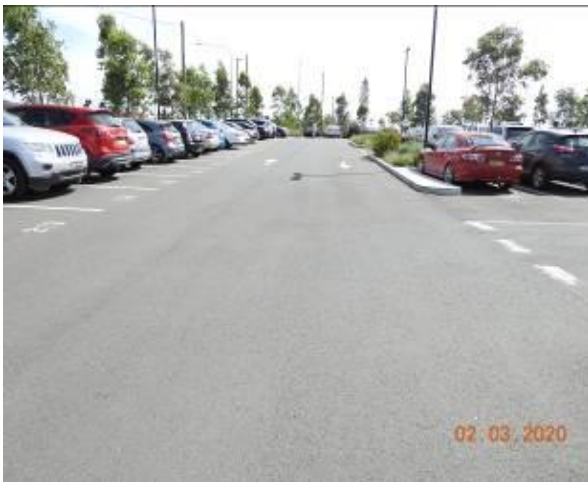
Figure 3014 – General Condition of carpark pavement

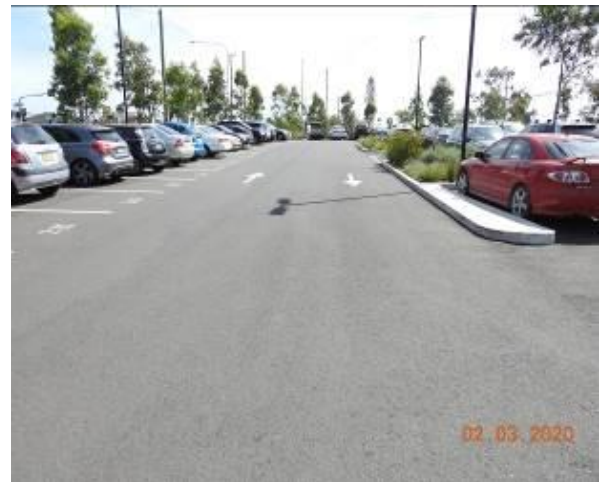
Figure 3015 – General Condition of carpark pavement

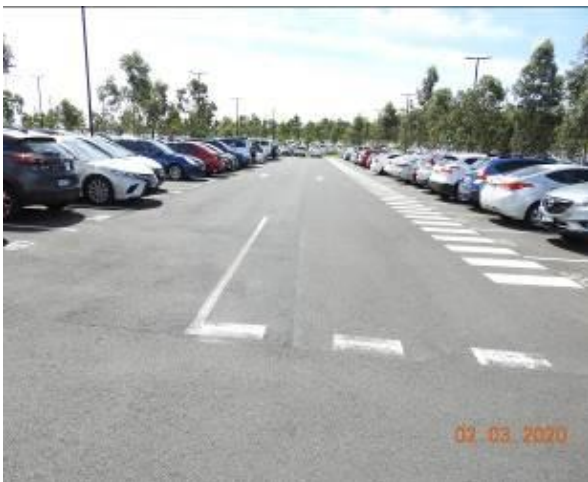
Figure 3016 – General Condition of carpark pavement

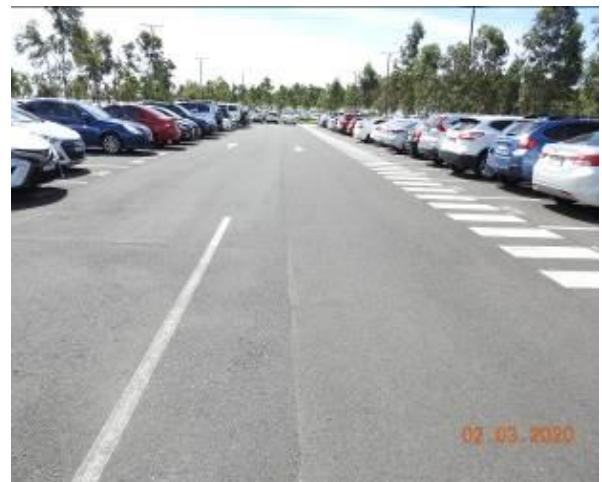
Figure 3017 – Crack propagation through carpark pavement

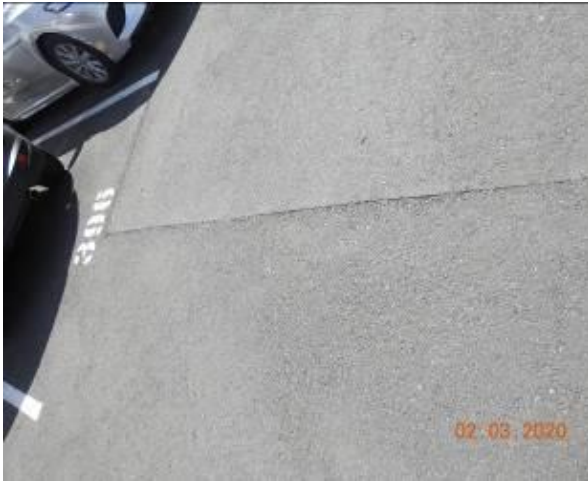
Figure 3018 – Crack propagation through carpark pavement

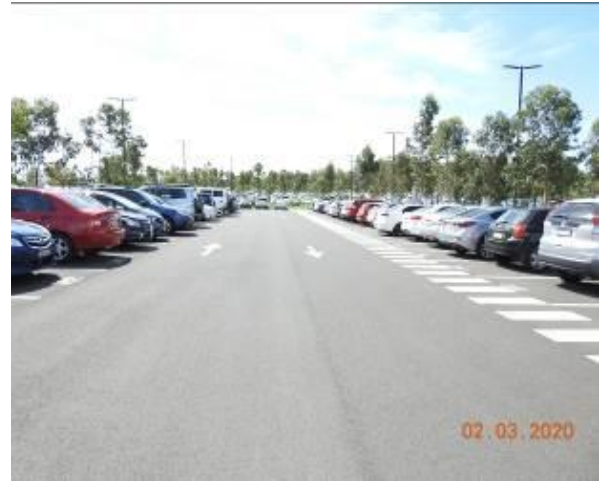
Figure 3019 – General Condition of carpark pavement

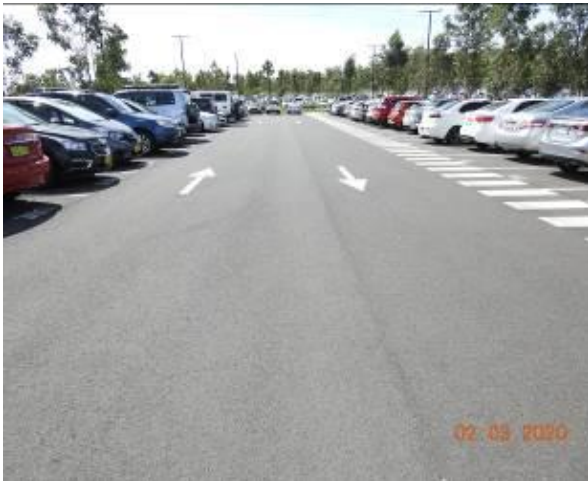
Figure 3020 – General Condition of carpark pavement

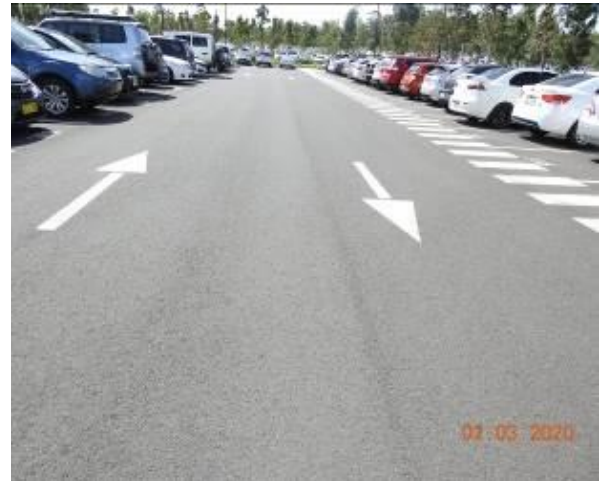
Figure 3021 – General Condition of carpark pavement

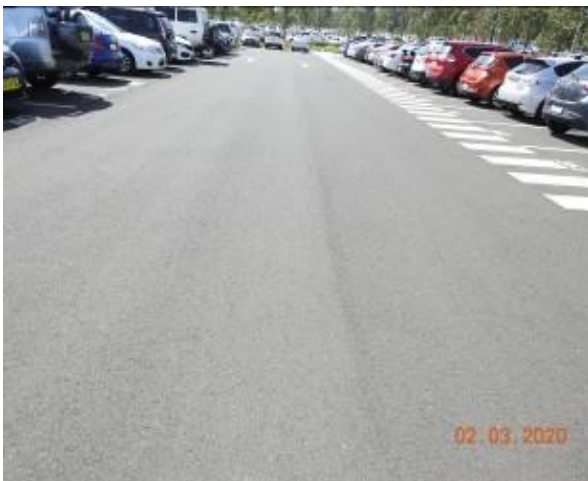
Figure 3022 – General Condition of carpark pavement

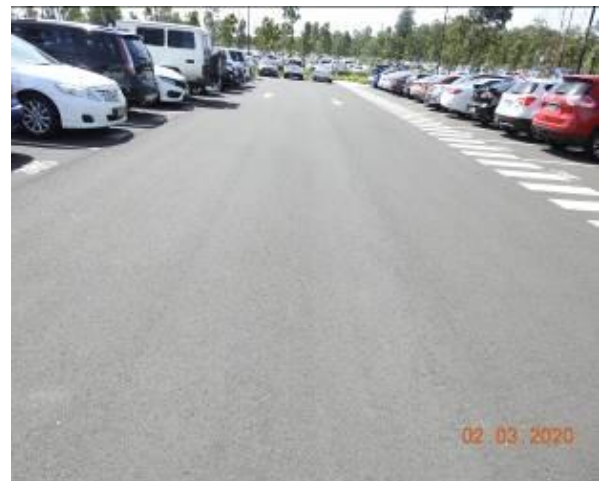
Figure 3023 – General Condition of carpark pavement

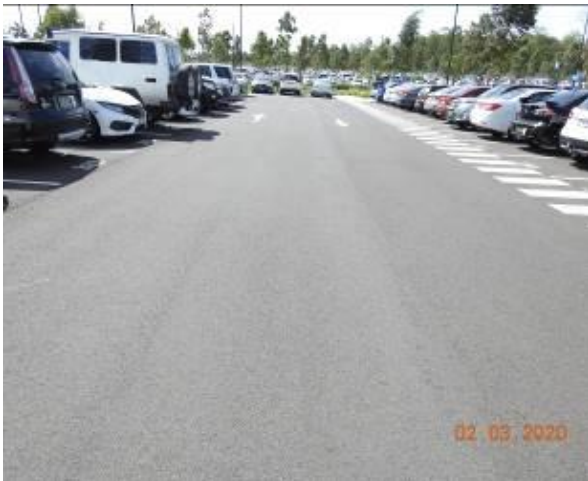
Figure 3024 – General Condition of carpark pavement

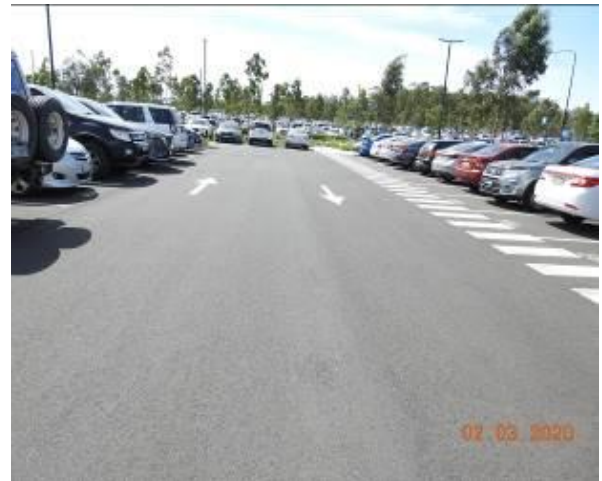
Figure 3025 – General Condition of carpark pavement

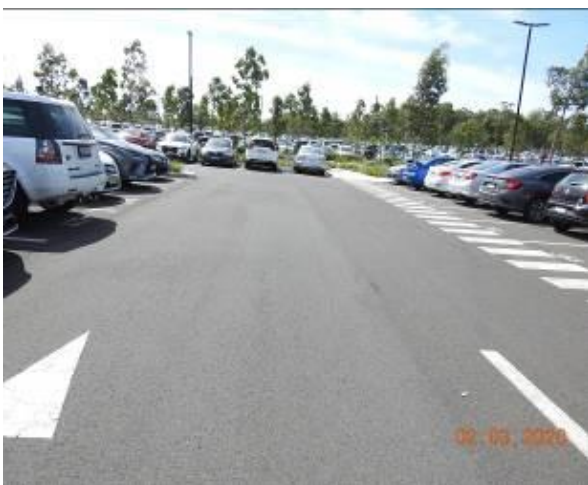
Figure 3026 – General Condition of carpark pavement

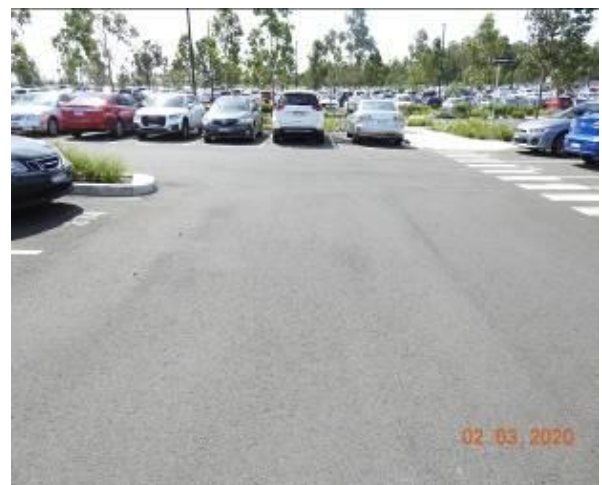
Figure 3027 – General Condition of carpark pavement

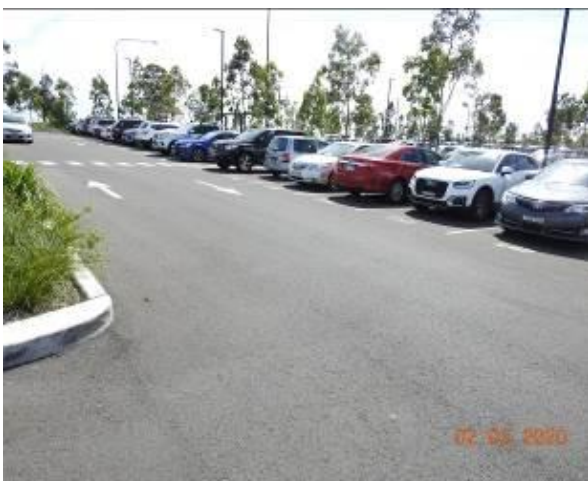
Figure 3028 – General Condition of carpark pavement

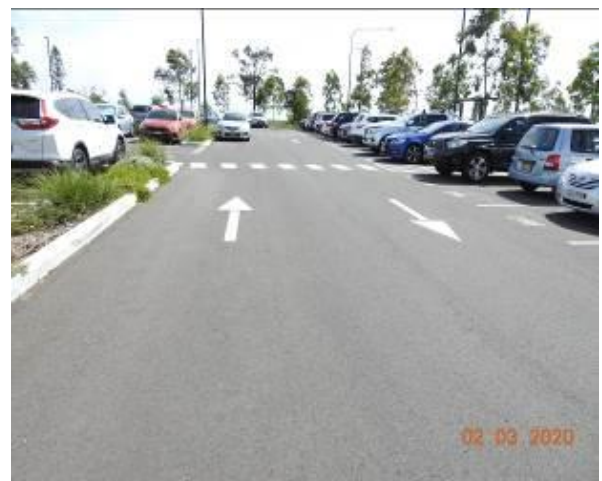
Figure 3029 – General Condition of carpark pavement

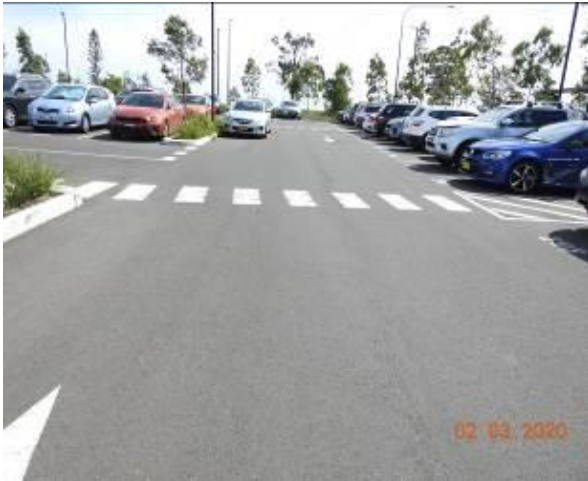
Figure 3030 – General Condition of carpark pavement

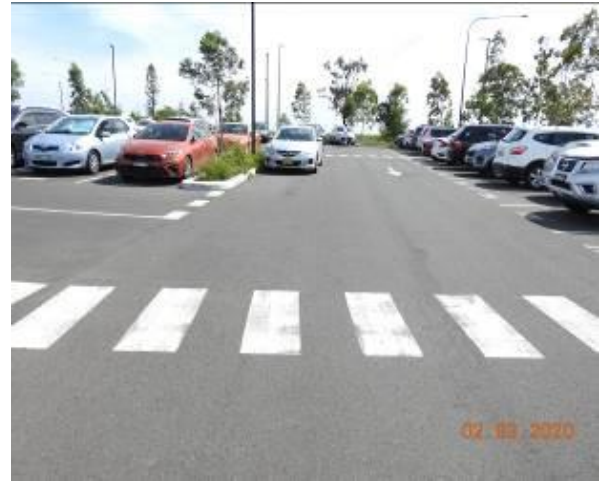
Figure 3031 – General Condition of carpark pavement

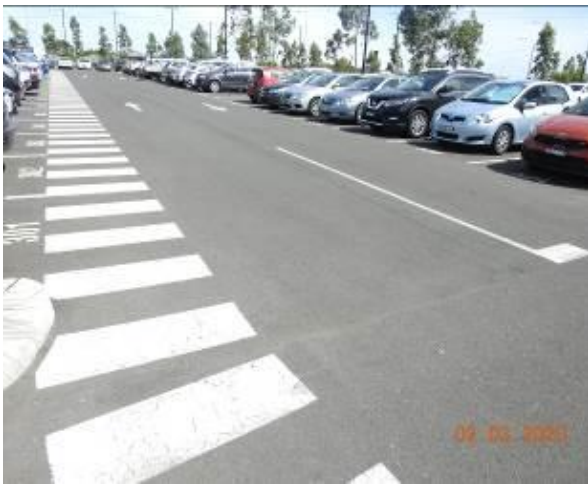
Figure 3032 – General Condition of carpark pavement

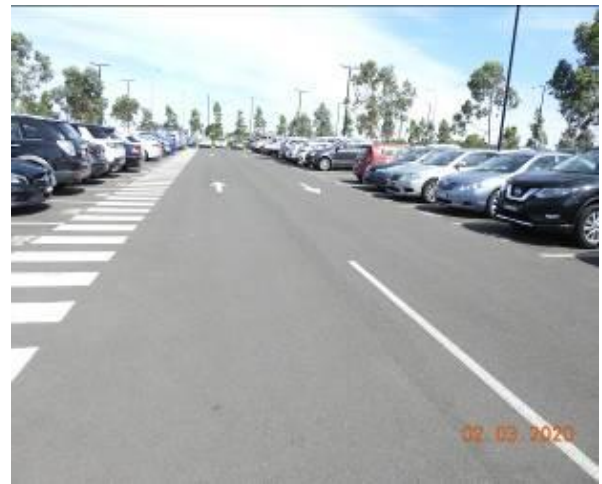
Figure 3033 – General Condition of carpark pavement

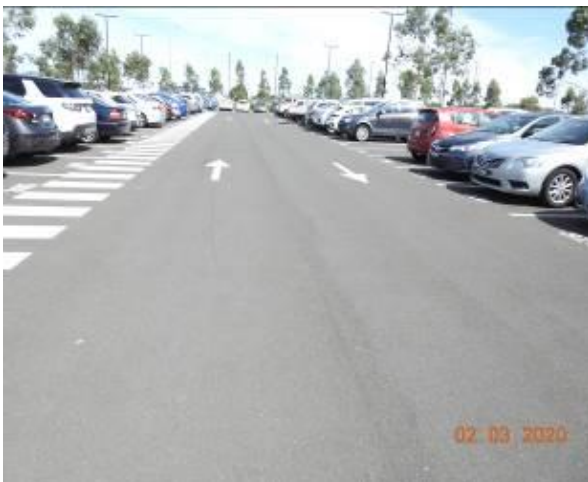
Figure 3034 – General Condition of carpark pavement

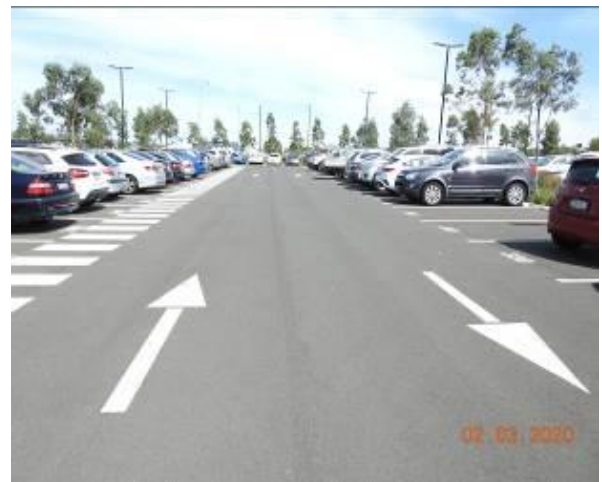
Figure 3035 – General Condition of carpark pavement

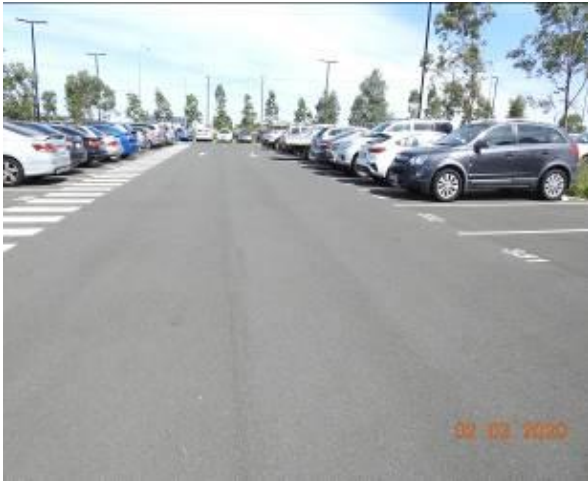
Figure 3036 – General Condition of carpark pavement

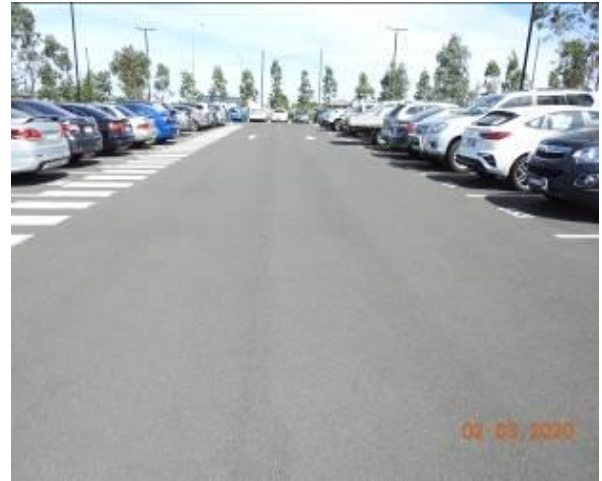
Figure 3037 – General Condition of carpark pavement

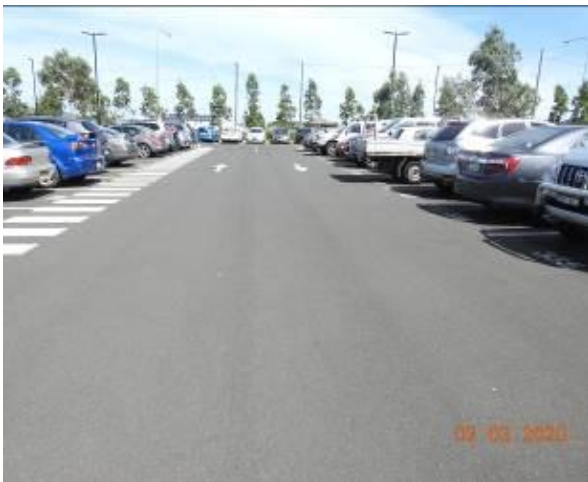
Figure 3038 – General Condition of carpark pavement

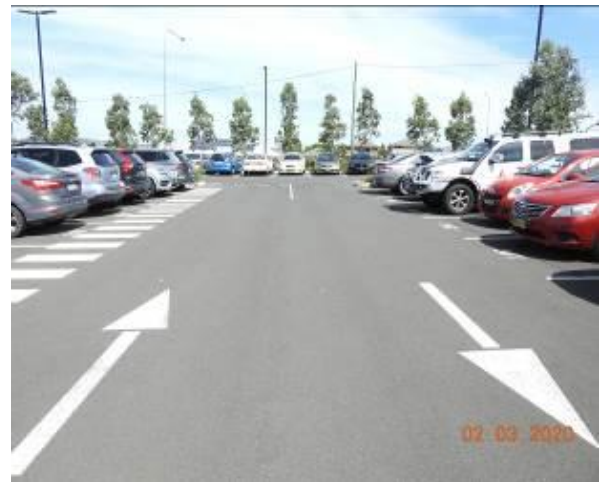
Figure 3039 – General Condition of carpark pavement

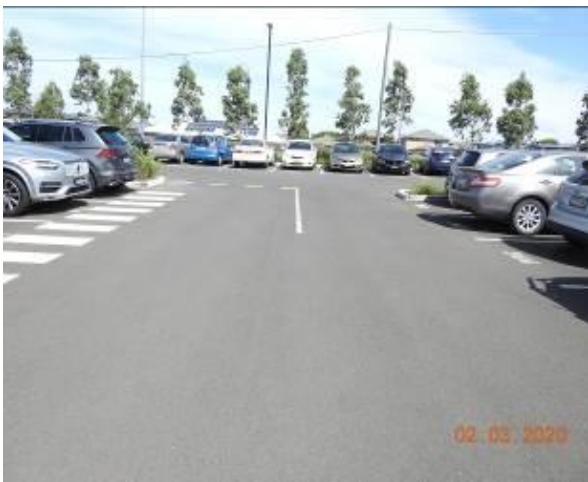
Figure 3040 – General Condition of carpark pavement

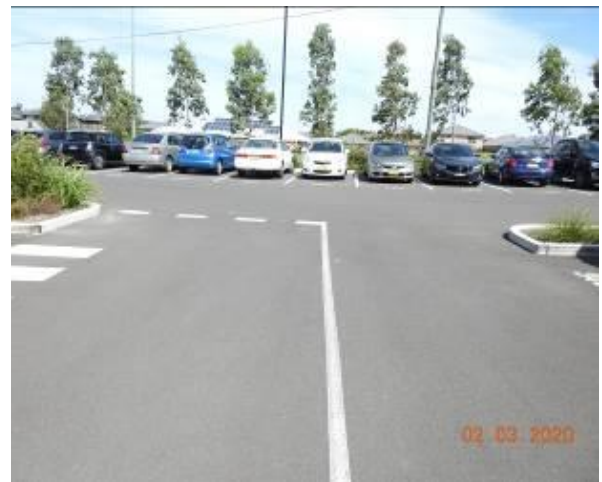
Figure 3041 – General Condition of carpark pavement

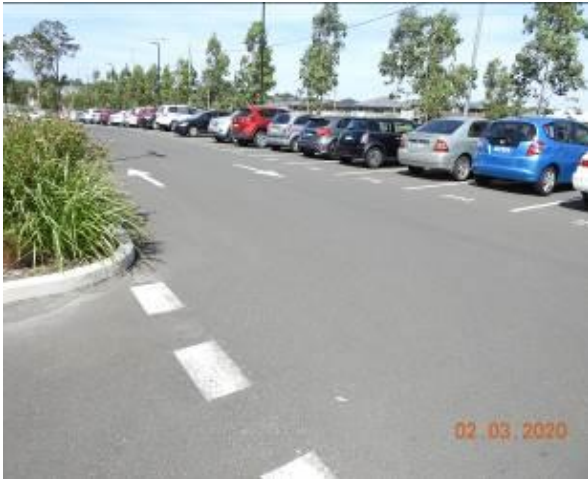
Figure 3042 – General Condition of carpark pavement

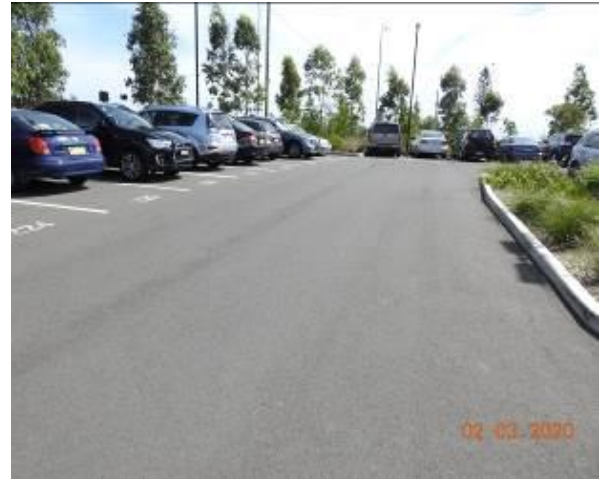
Figure 3043 – General Condition of carpark pavement

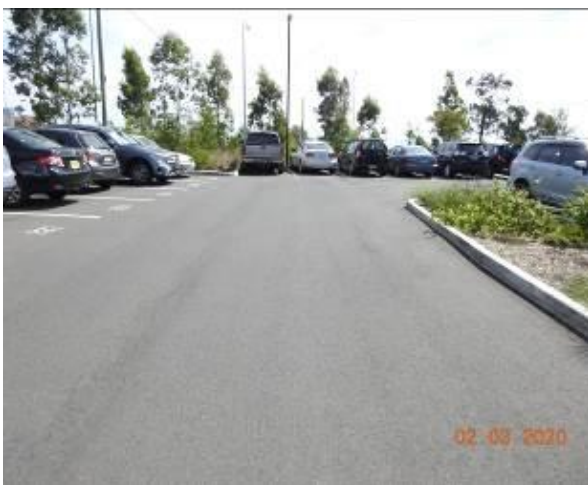
Figure 3044 – General Condition of carpark pavement

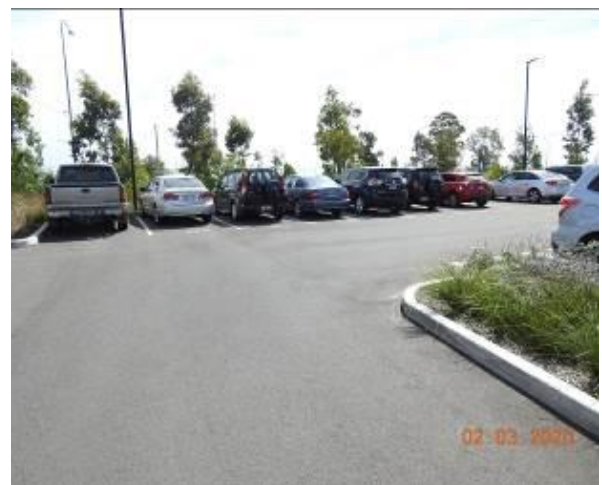
Figure 3045 – General Condition of carpark pavement

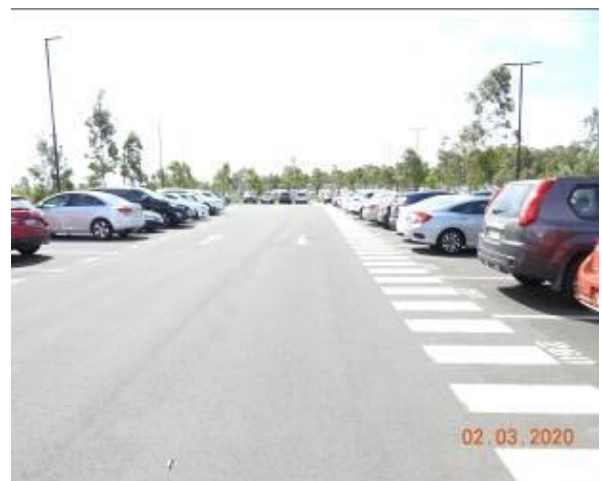
Figure 3047 – General Condition of carpark pavement

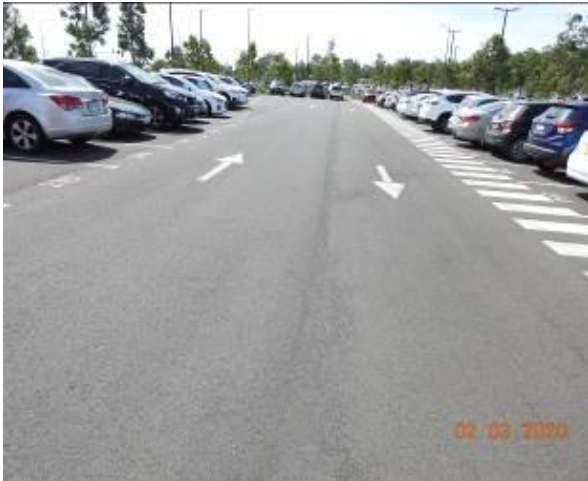
Figure 3048 – Loss of material through carpark pavement

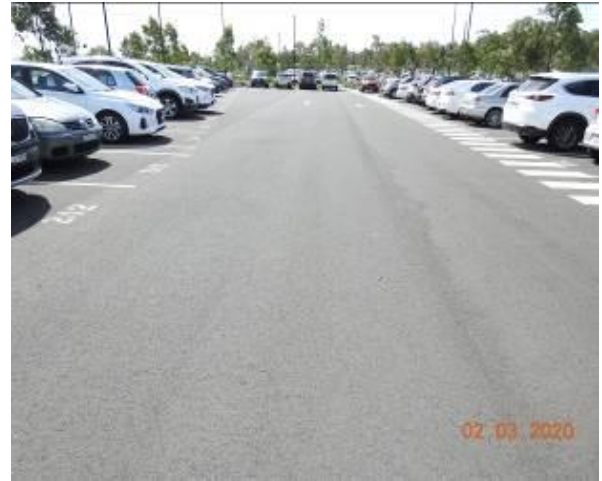
Figure 3049 – General Condition of carpark pavement

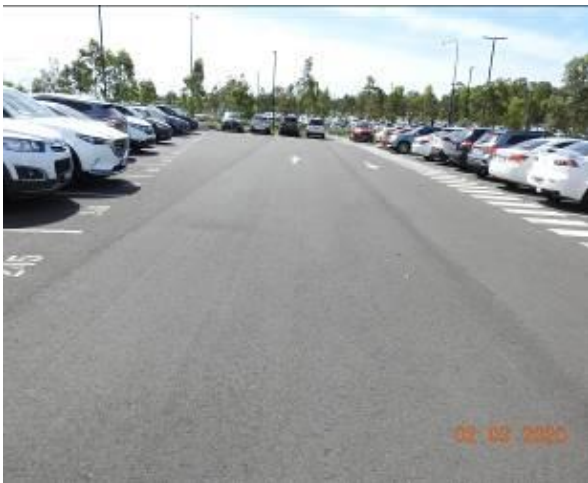
Figure 3050 – General Condition of carpark pavement

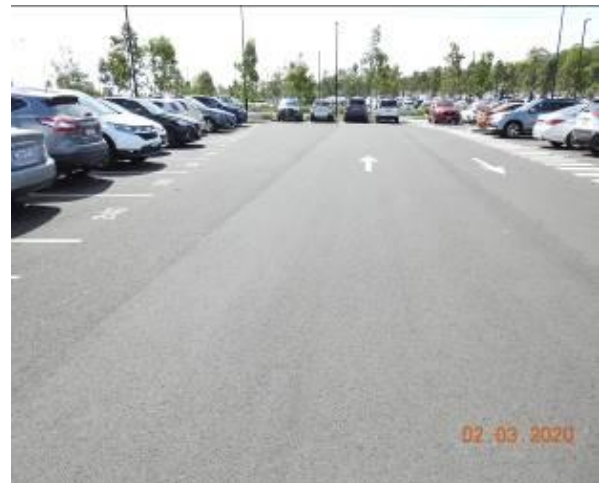
Figure 3051 – General Condition of carpark pavement

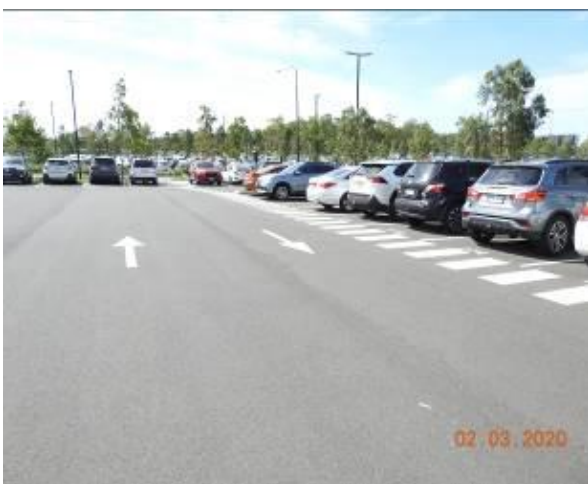
Figure 3052 – General Condition of carpark pavement

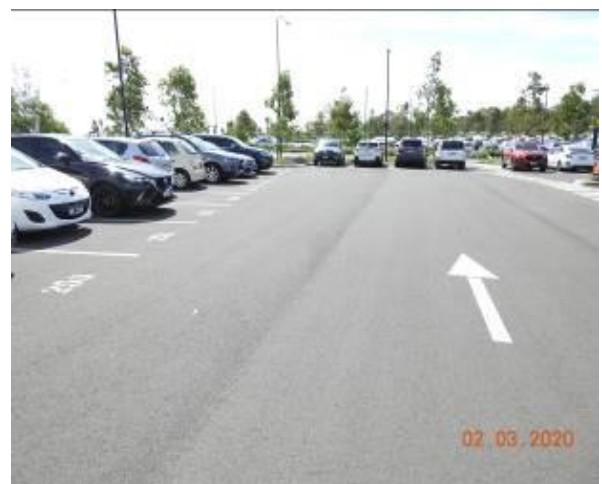
Figure 3053 – General Condition of carpark pavement

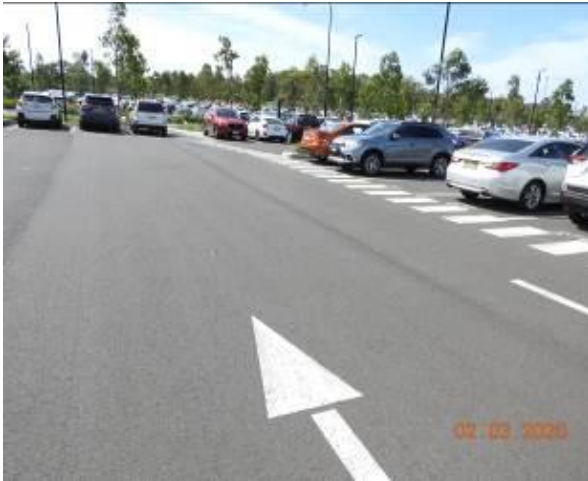
Figure 3054 – General Condition of carpark pavement

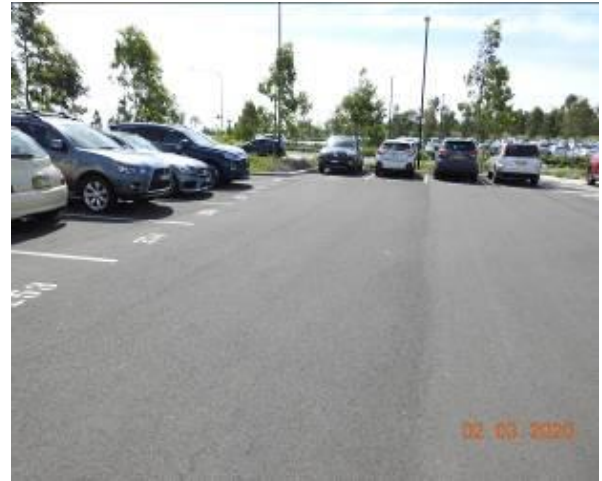
Figure 3055 – General Condition of carpark pavement

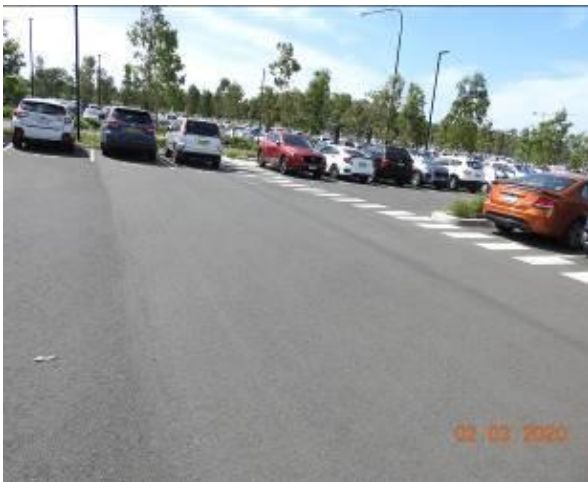
Figure 3056 – General Condition of carpark pavement

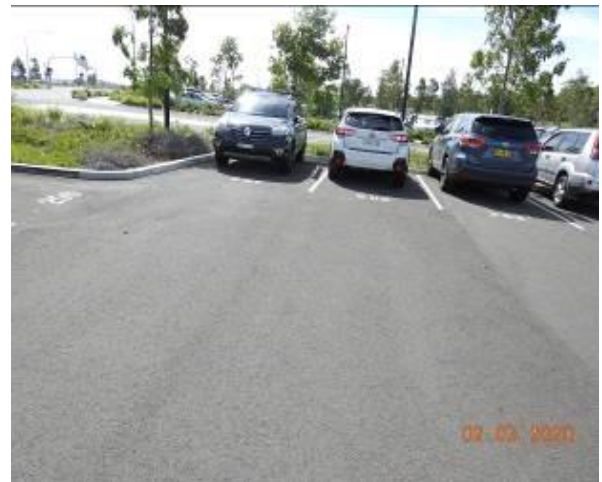
Figure 3057 – General Condition of carpark pavement

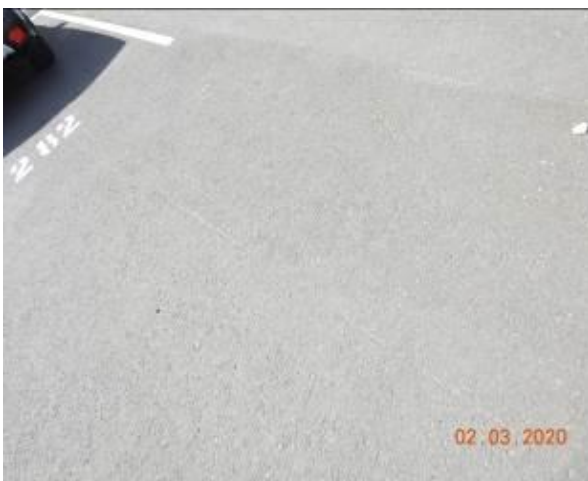
Figure 3058 – Loss of material through carpark pavement

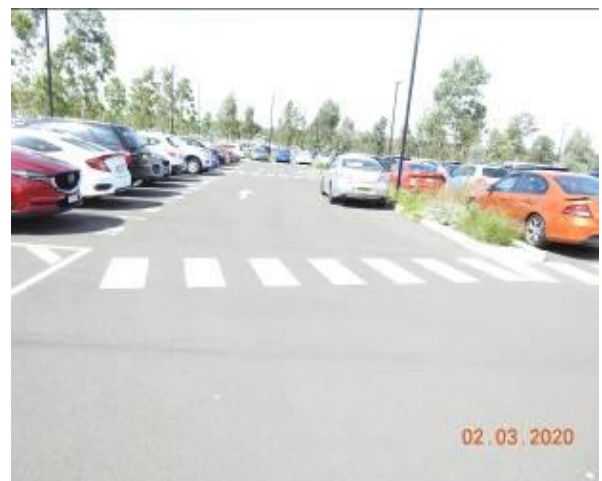
Figure 3059 – General Condition of carpark pavement

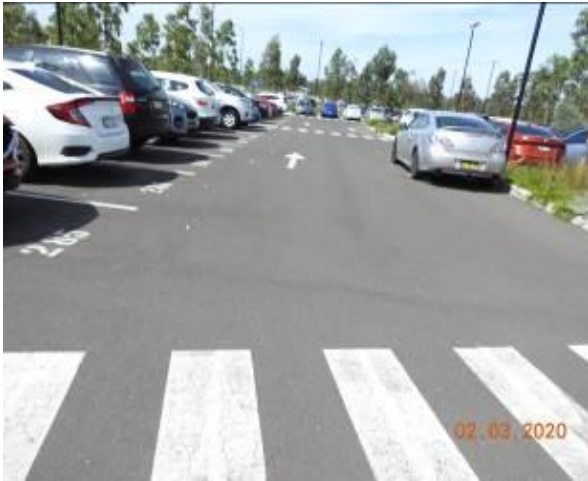
Figure 3060 – General Condition of carpark pavement

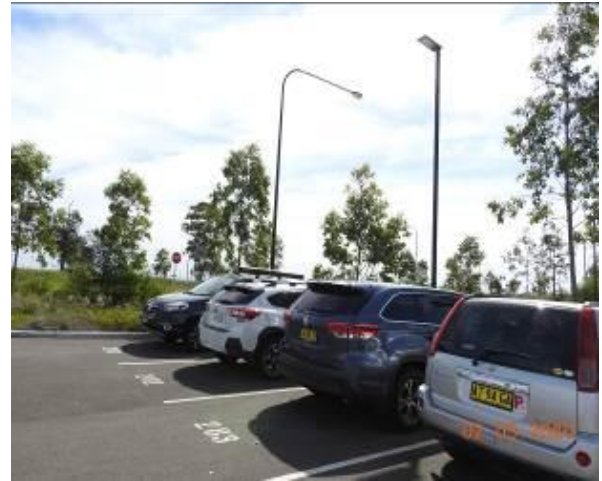
Figure 3061 – General Condition of lamp post / plantation

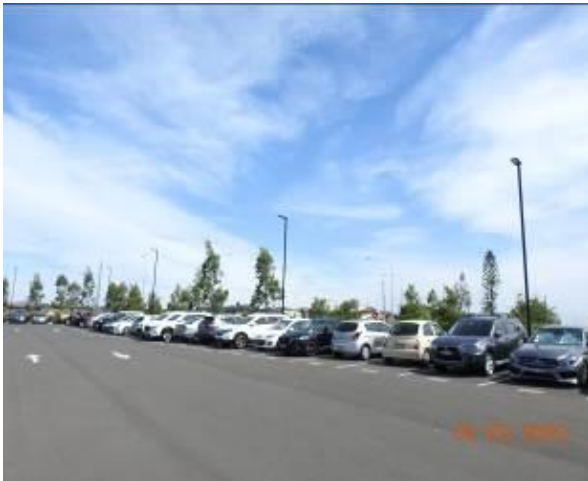
Figure 3062 – General Condition of lamp post / plantation

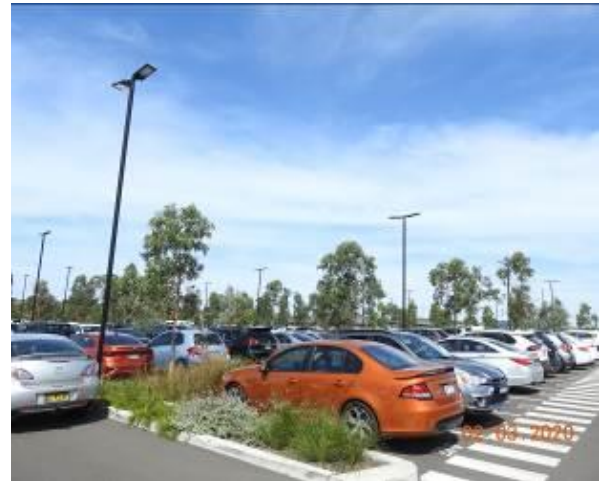
Figure 3063 – General Condition of lamp post / plantation

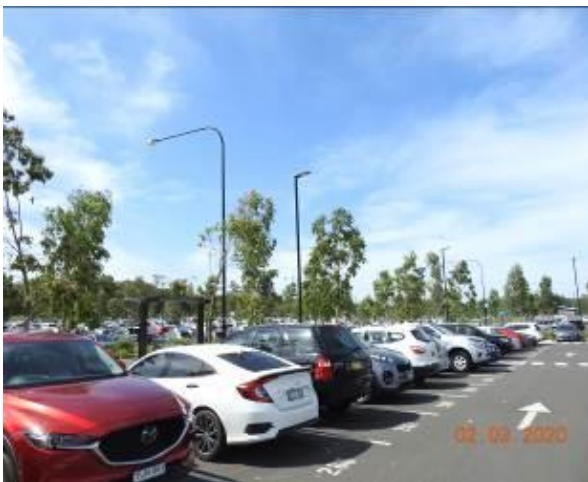
Figure 3064 – General Condition of lamp post / plantation

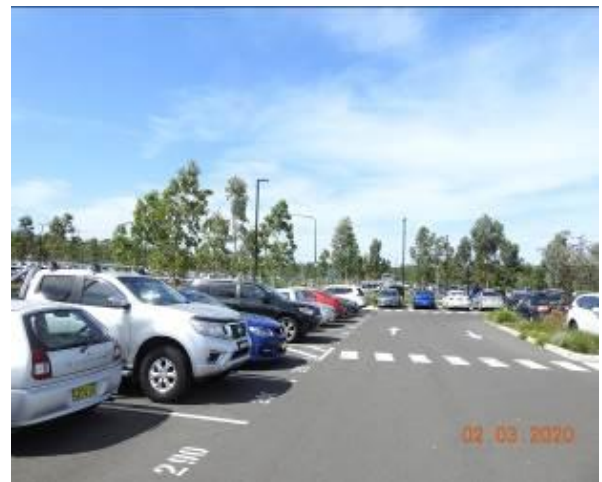
Figure 3065 – General Condition of lamp post / plantation

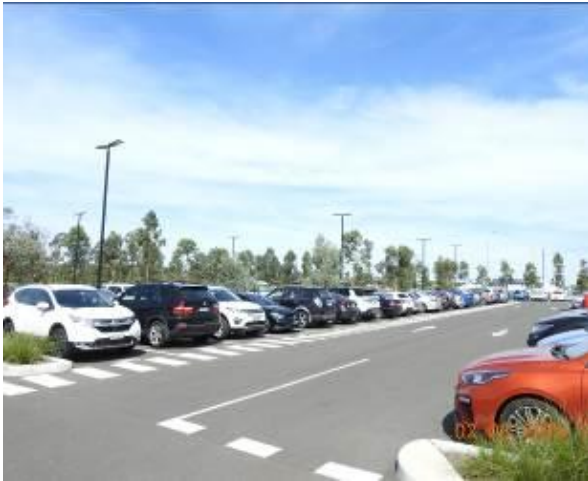
Figure 3066 – General Condition of lamp post /
plantation

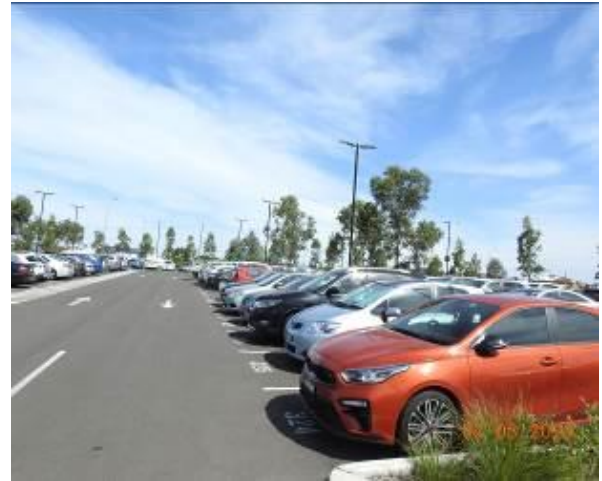
Figure 3067 – General Condition of lamp post /
plantation

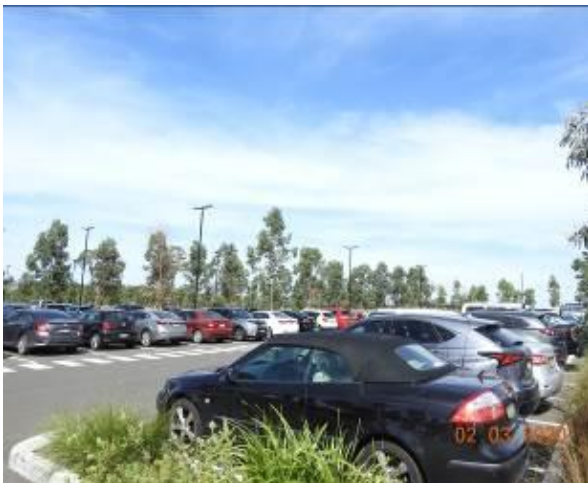
Figure 3068 – General Condition of lamp post /
plantation

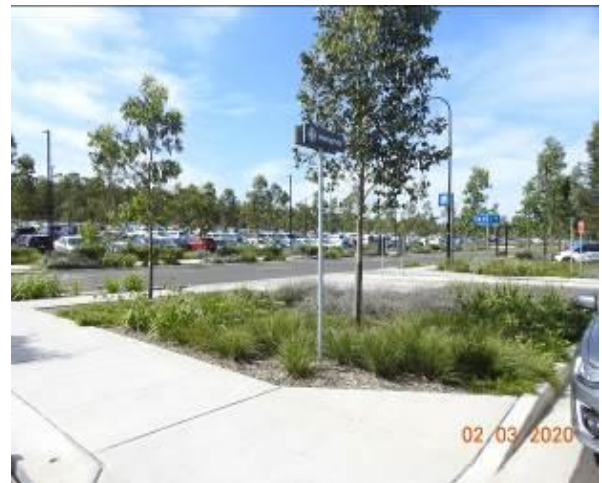
Figure 3069 – General Condition of street sign

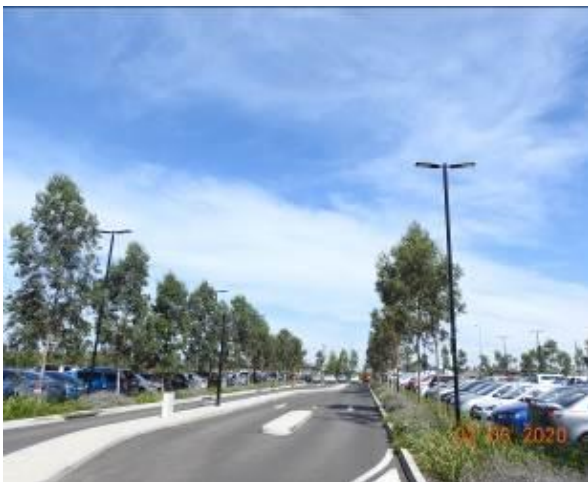
Figure 3070 – General Condition of lamp post /
plantation

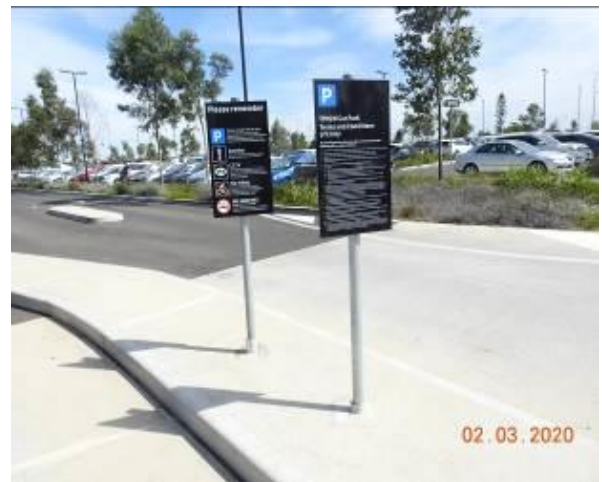
Figure 3071 – General Condition of street sign

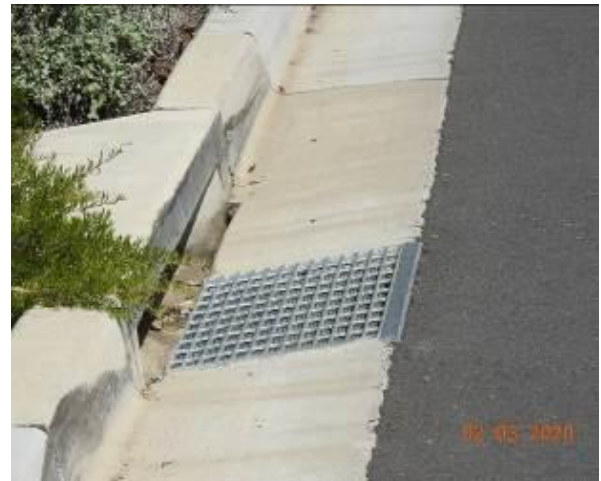
Figure 3073 – General Condition of stormwater inlet pit

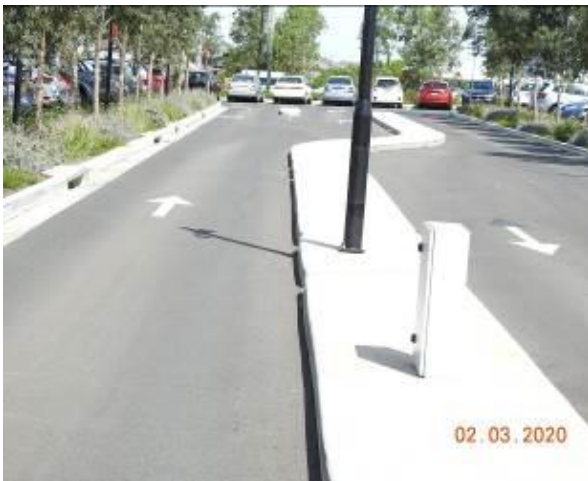
Figure 3074 – General Condition of traffic island kerb

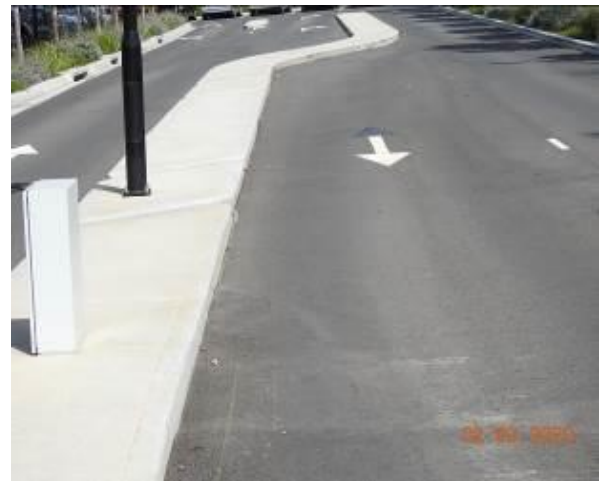
Figure 3075 – General Condition of traffic island kerb

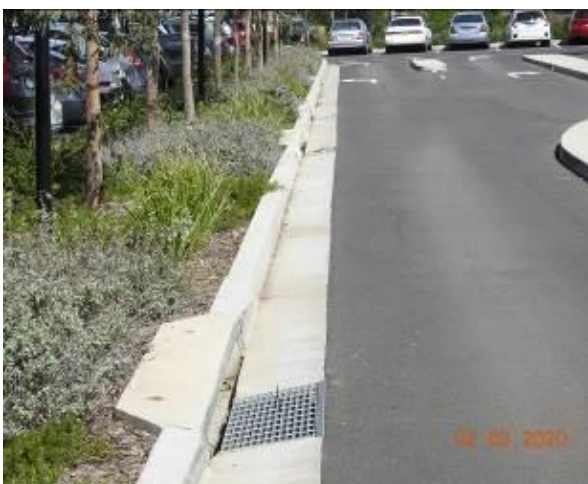
Figure 3076 – General Condition of kerb and gutter

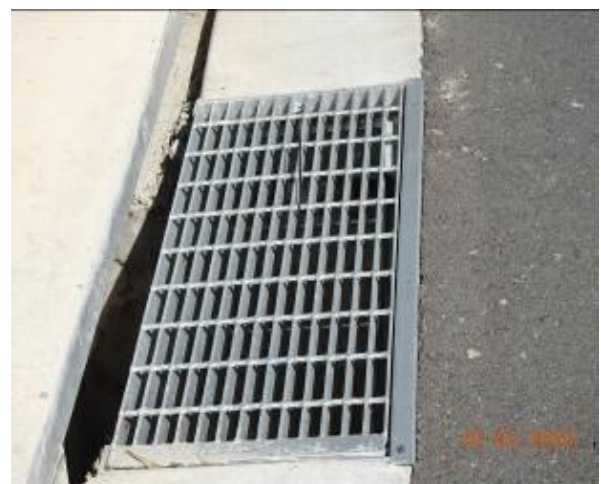
Figure 3077 – General Condition of stormwater inlet pit

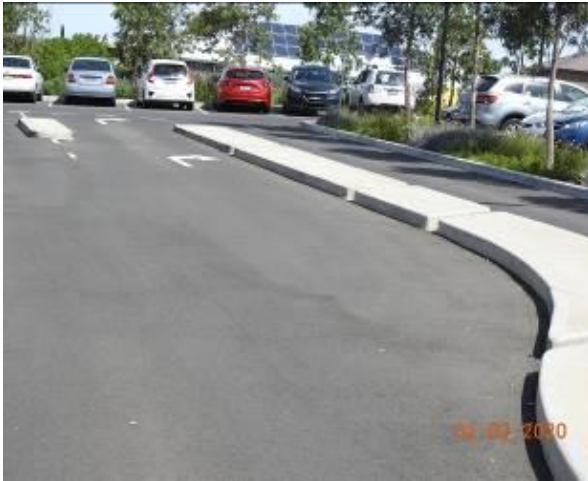
Figure 3078 – General Condition of traffic island kerb

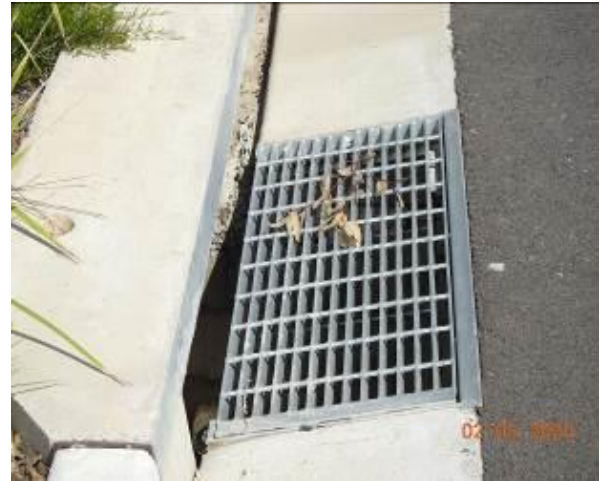
Figure 3079 – General Condition of stormwater inlet pit

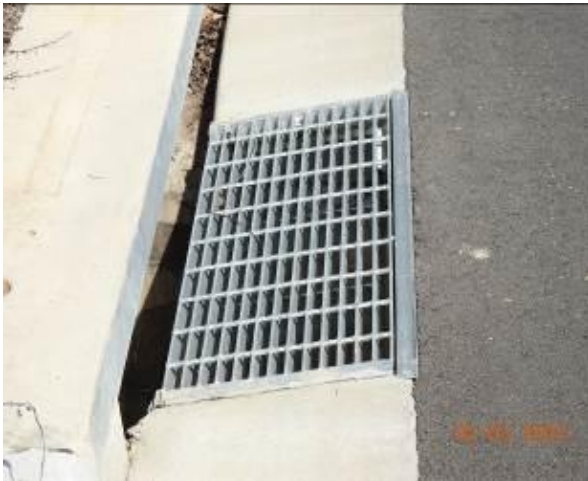
Figure 3080 – Crack propagation through stormwater inlet pit

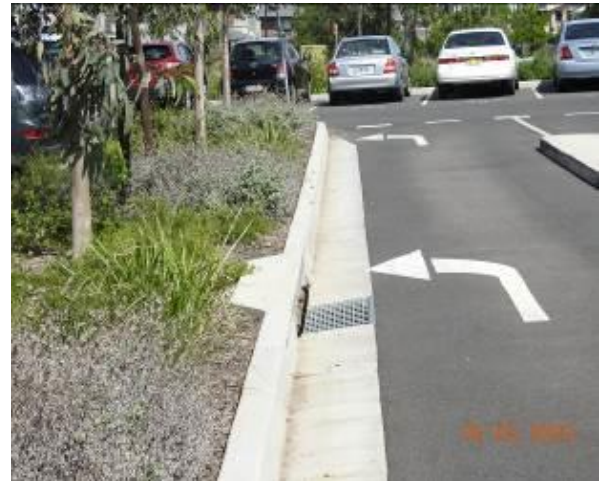
Figure 3081 – General Condition of kerb and gutter

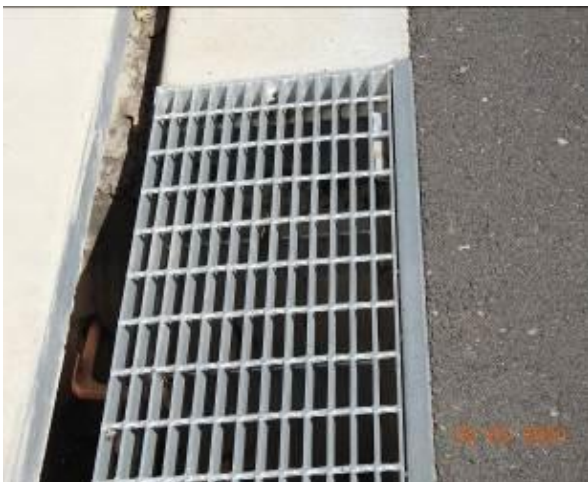
Figure 3082 – General Condition of stormwater inlet pit

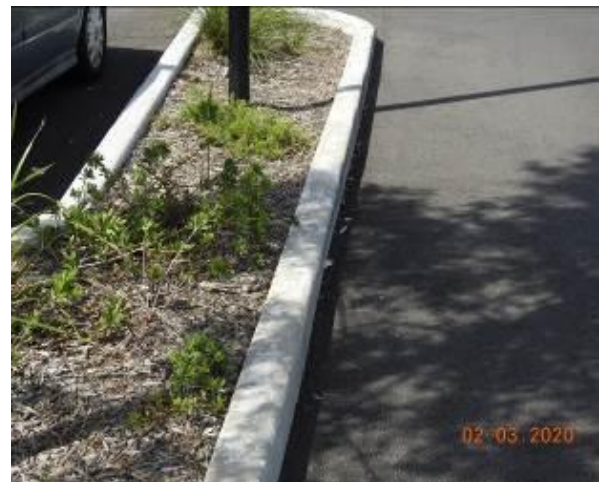
Figure 3083 – General Condition of kerb

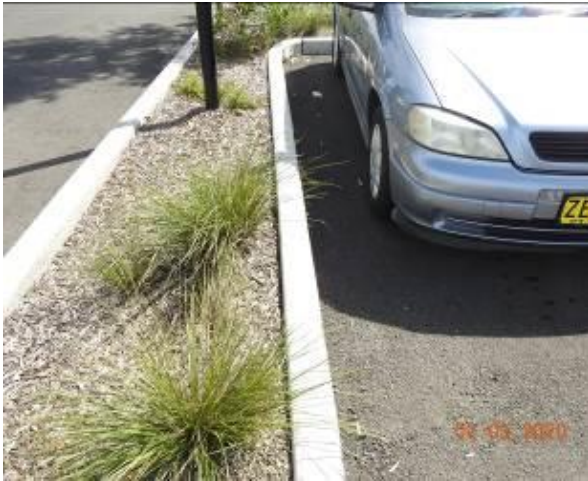
Figure 3084 – General Condition of kerb

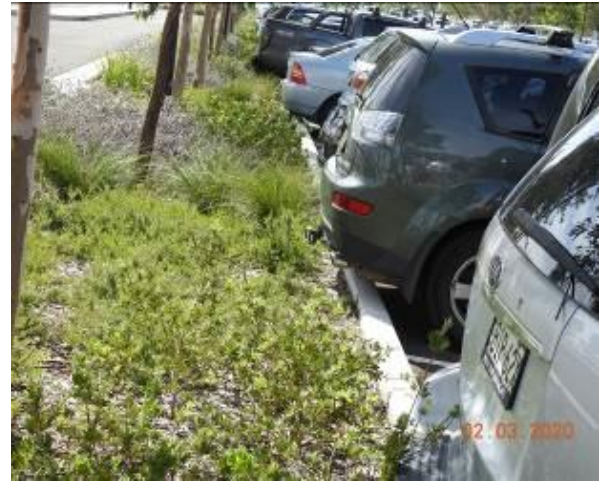
Figure 3085 – General Condition of kerb
