**1-15 AND 2-12 CONFERTA AVENUE,
ROUSE HILL NSW 2155
TALLAWONG STATION PRECINCT SOUTH
PRE-DILAPIDATION REPORT**

**DEICORP PROJECTS
(TALLAWONG STATION) PTY LTD**

Job No. 191294.0
24/03/2020

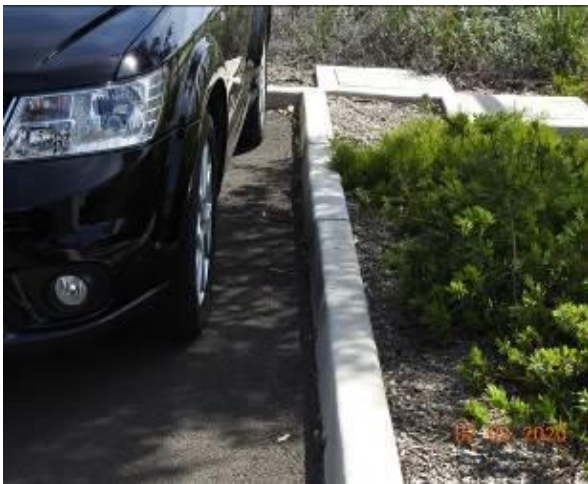
Figure 3086 – General Condition of kerb

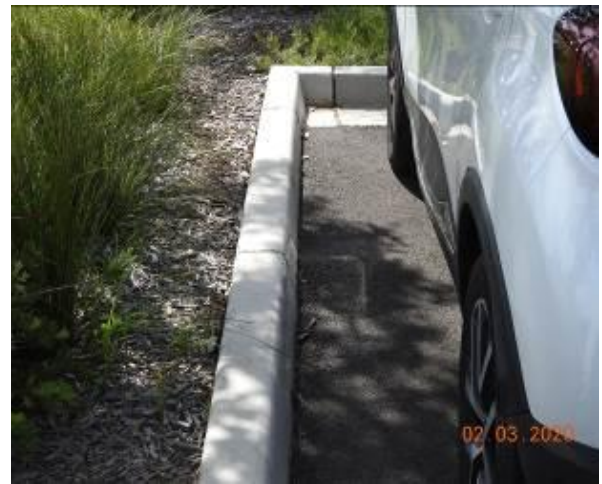
Figure 3087 – General Condition of kerb

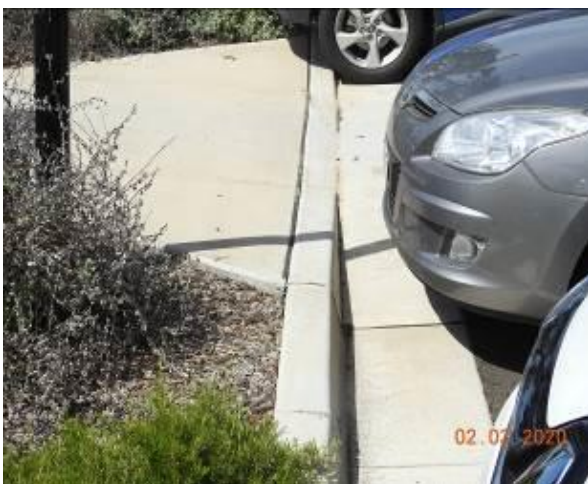
Figure 3088 – General Condition of kerb and gutter

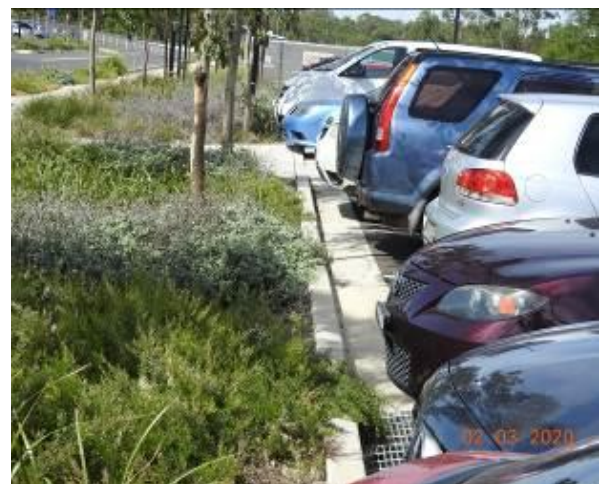
Figure 3089 – General Condition of kerb and gutter

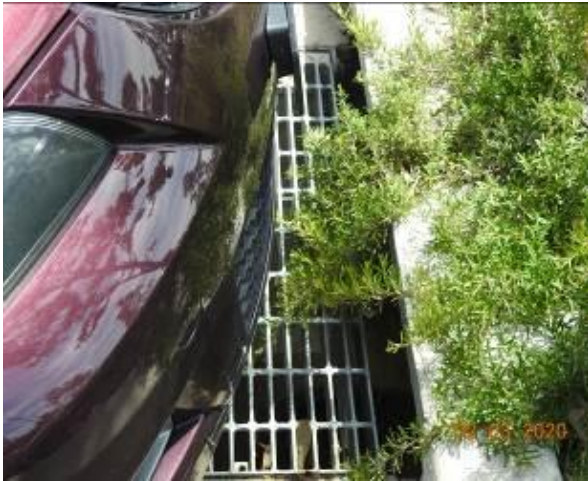
Figure 3090 – General Condition of stormwater inlet pit

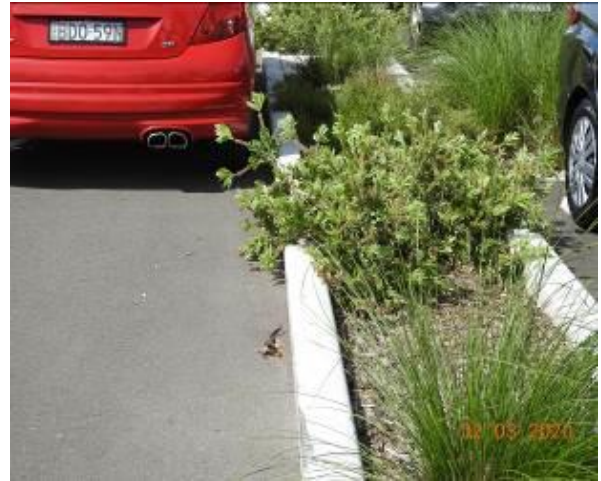
Figure 3091 – General Condition of kerb

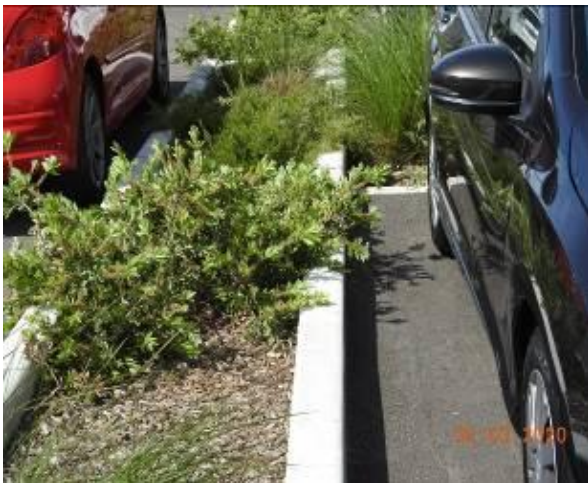
Figure 3092 – General Condition of kerb

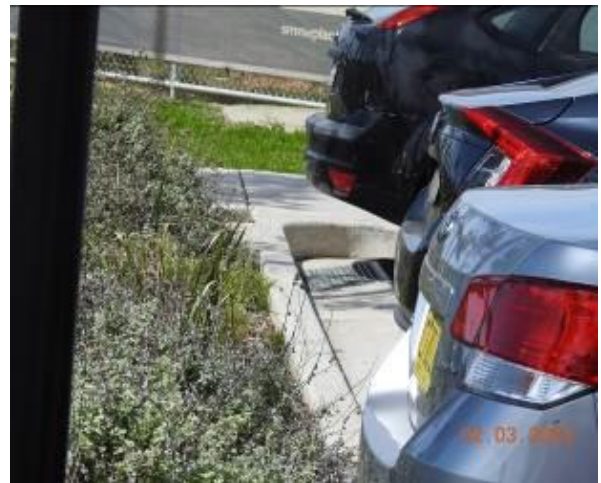
Figure 3093 – General Condition of kerb and gutter

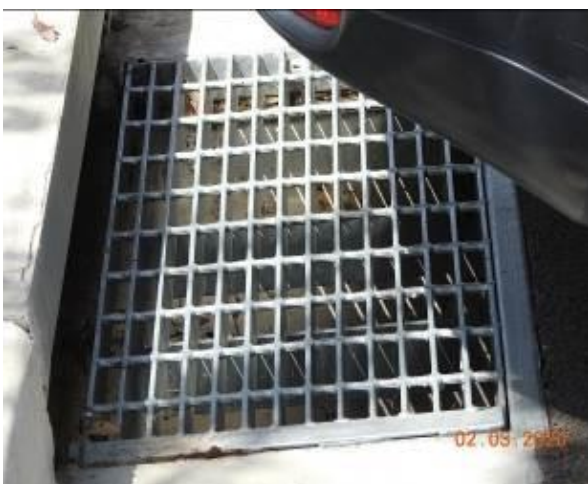
Figure 3094 – Crack propagation through stormwater inlet pit

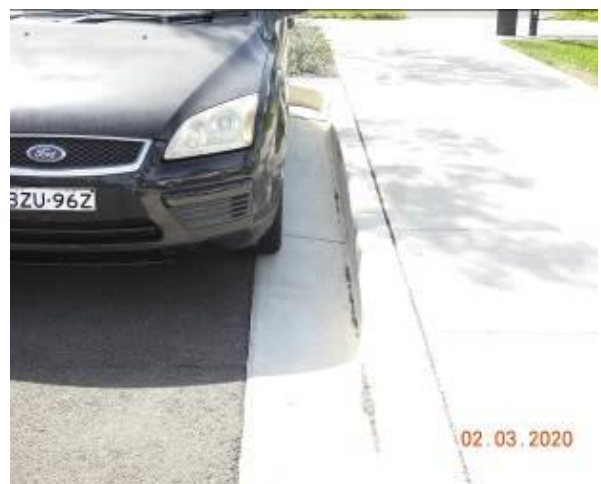
Figure 3095 – General Condition of kerb and gutter

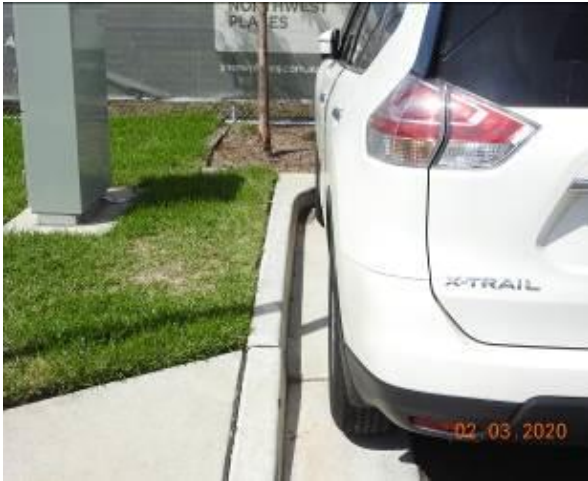
Figure 3096 – General Condition of kerb and gutter

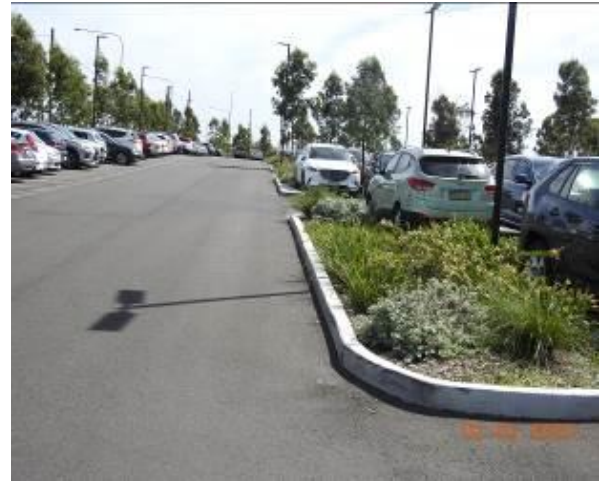
Figure 3097 – General Condition of kerb

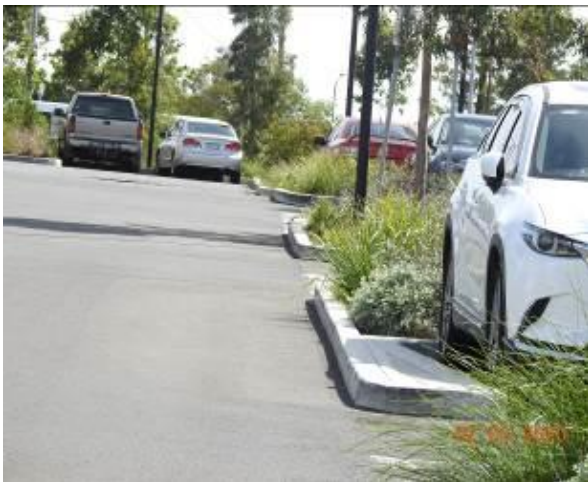
Figure 3098 – General Condition of kerb

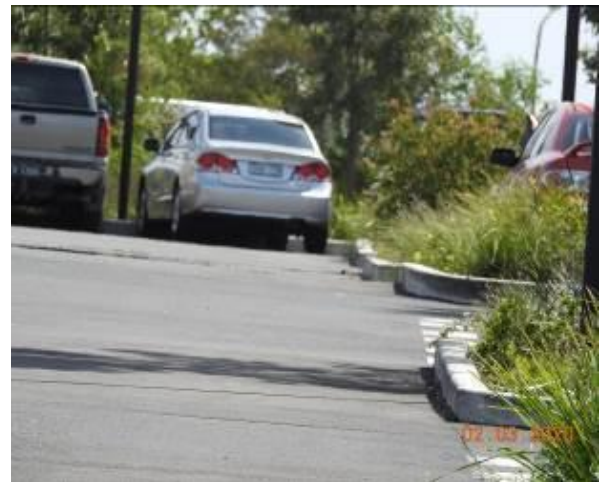
Figure 3099 – General Condition of kerb

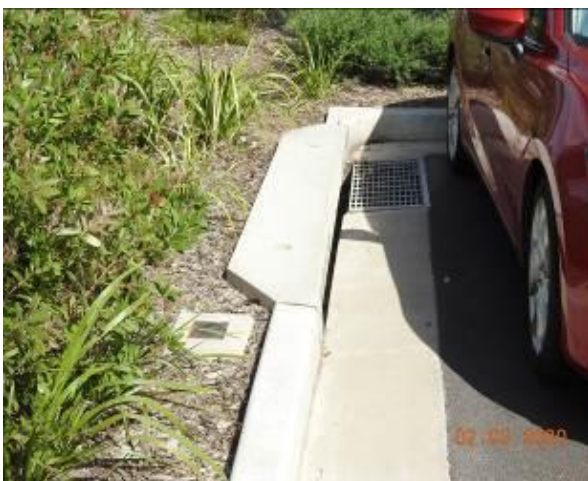
Figure 3100 – General Condition of kerb and gutter

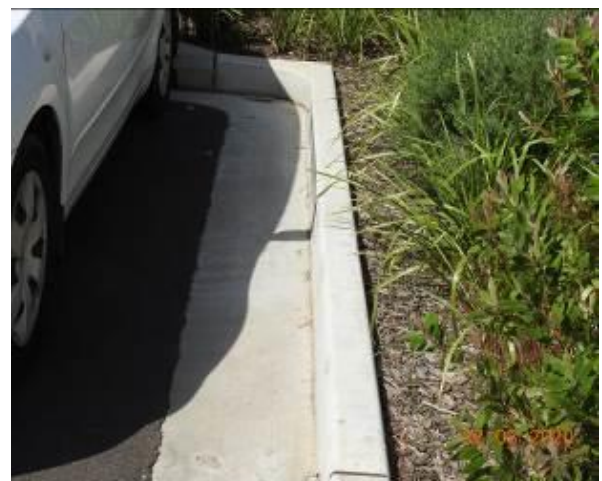
Figure 3101 – General Condition of kerb and gutter

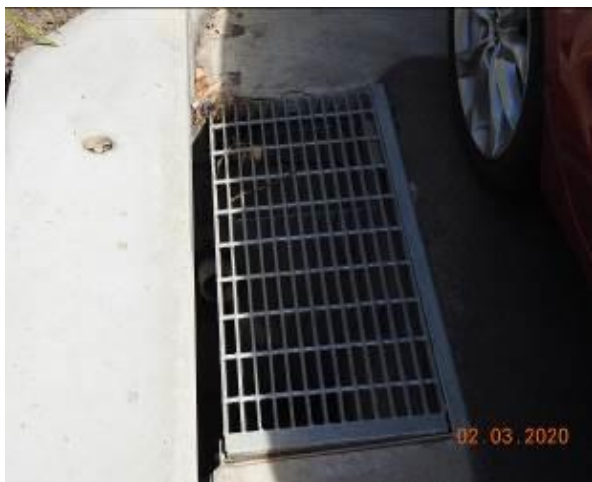
Figure 3102 – General Condition of stormwater inlet pit

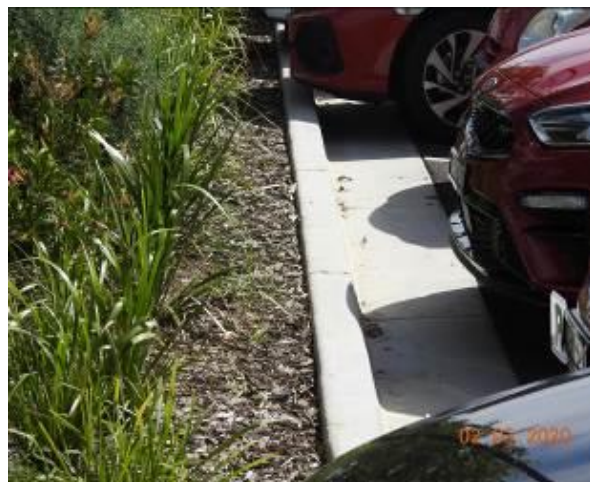
Figure 3103 – General Condition of kerb and gutter

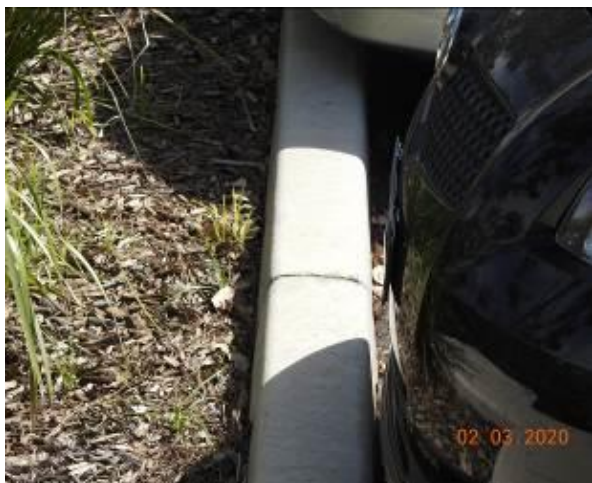
Figure 3104 – Crack propagation through kerb

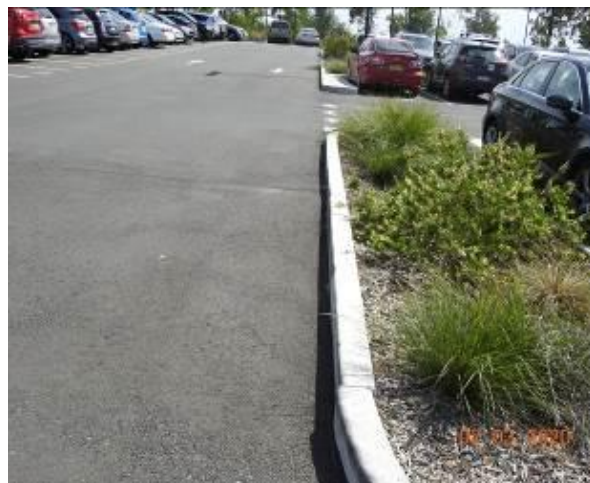
Figure 3105 – General Condition of kerb

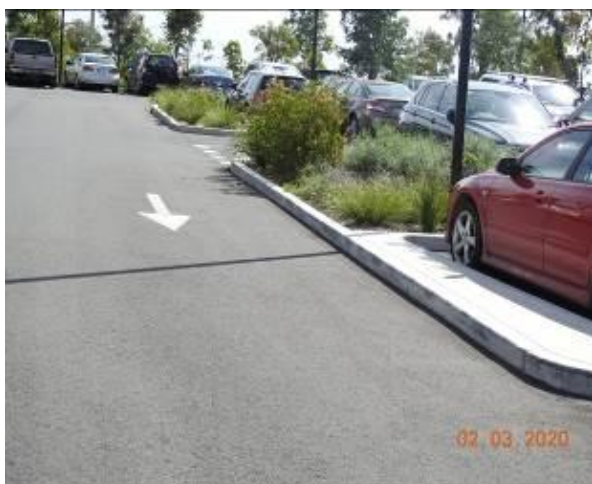
Figure 3106 – General Condition of kerb

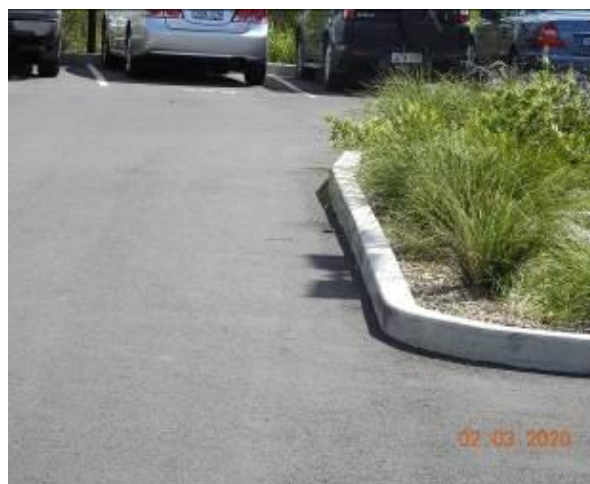
Figure 3107 – General Condition of kerb

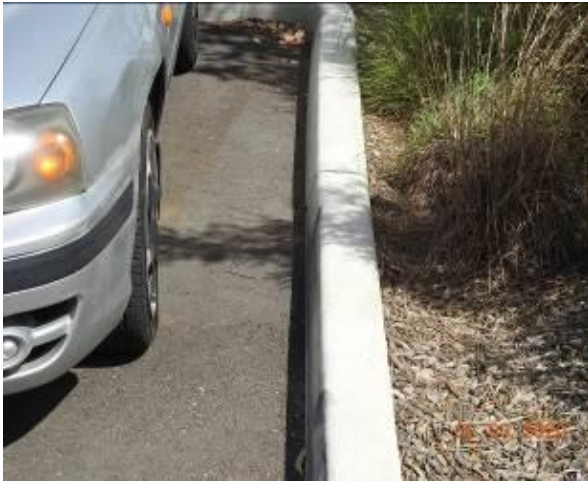
Figure 3108 – General Condition of kerb

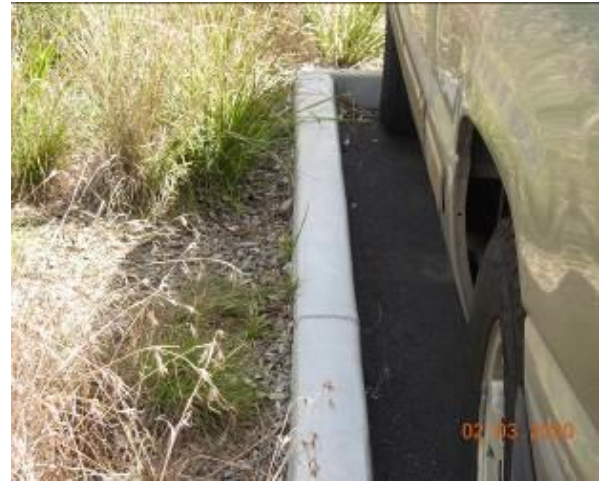
Figure 3109 – General Condition of kerb

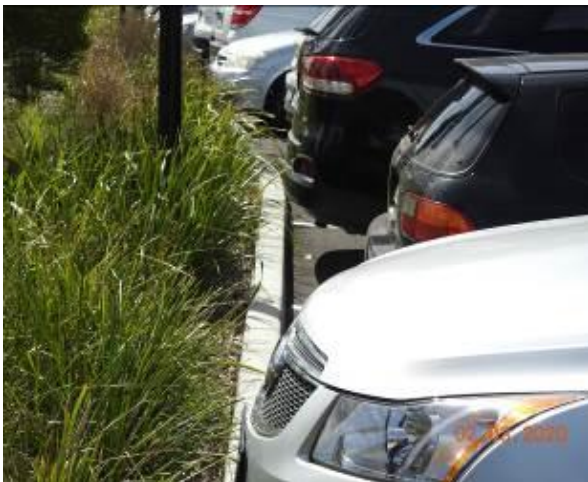
Figure 3110 – General Condition of kerb

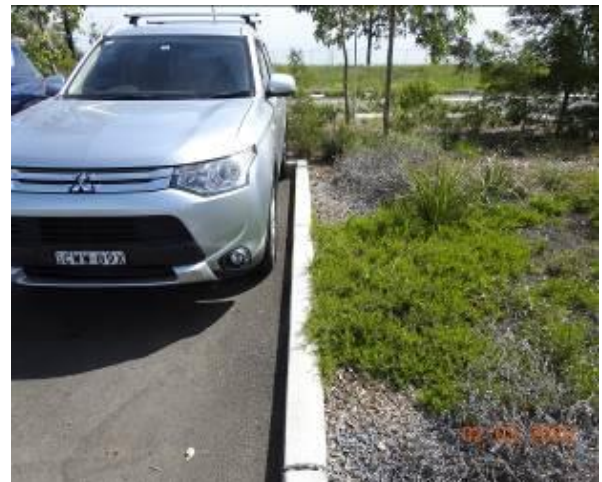
Figure 3111 – General Condition of kerb

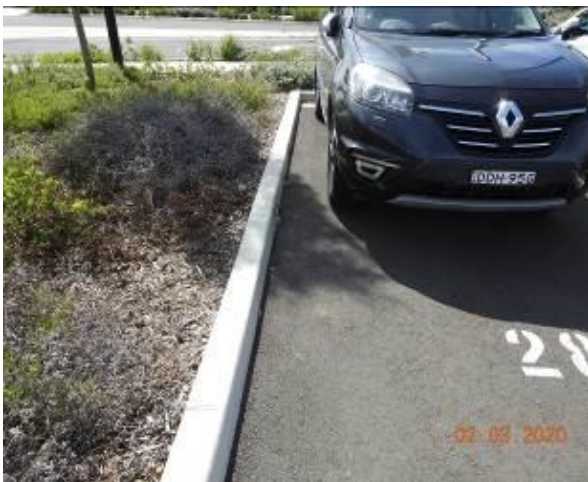
Figure 3112 – General Condition of kerb

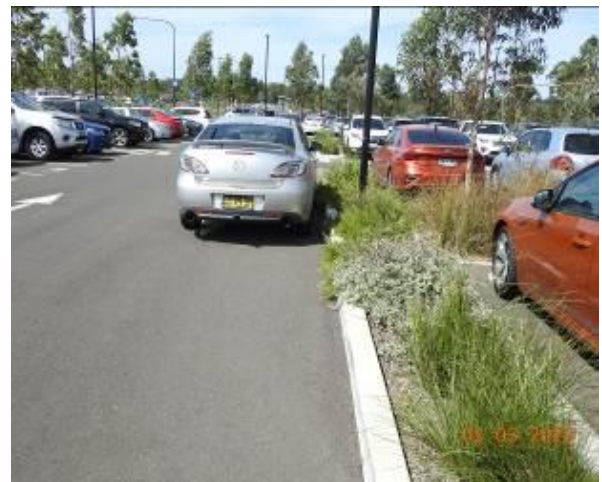
Figure 3113 – General Condition of kerb

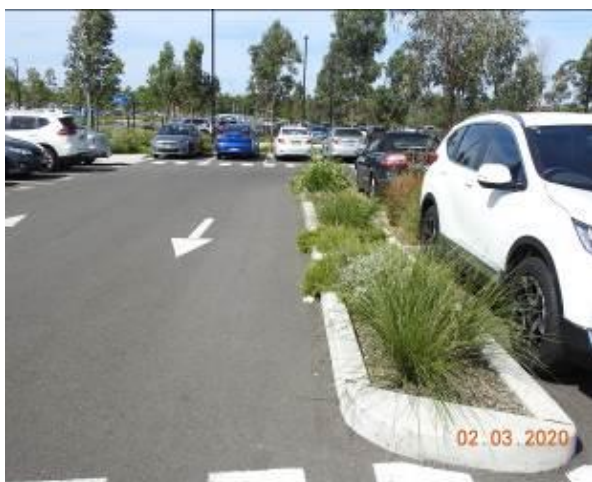
Figure 3114 – General Condition of kerb

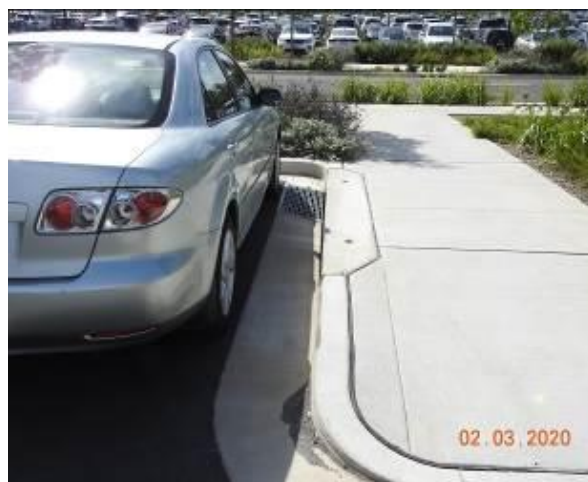
Figure 3115 – General Condition of kerb and gutter

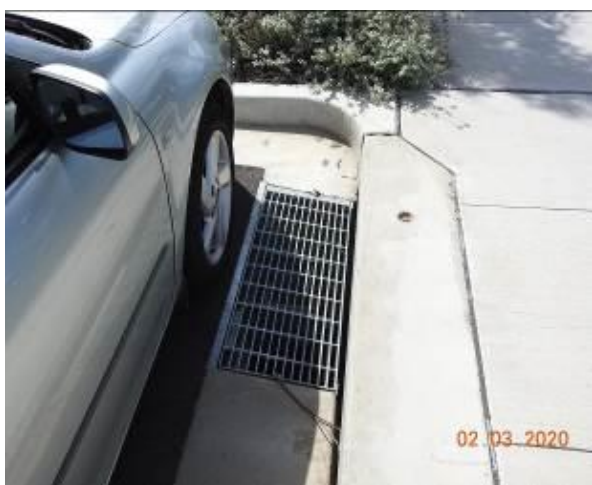
Figure 3116 – General Condition of stormwater inlet pit

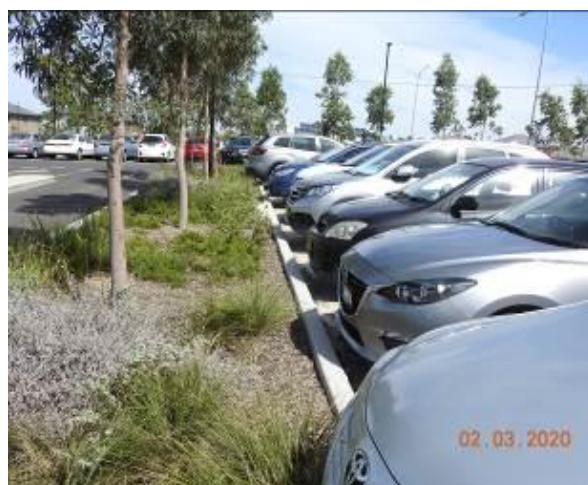
Figure 3117 – General Condition of kerb

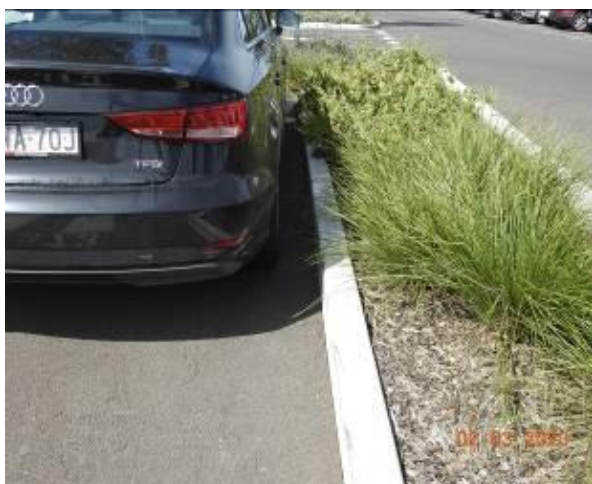
Figure 3118 – General Condition of kerb

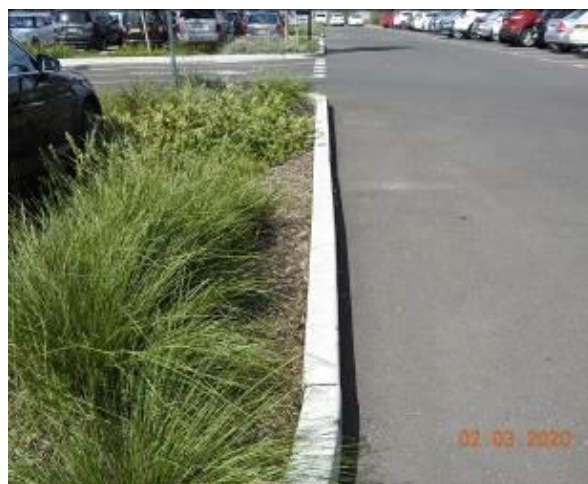
Figure 3119 – General Condition of kerb

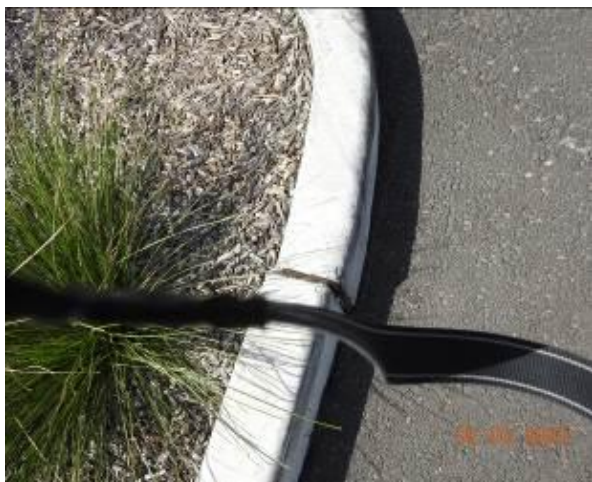
Figure 3120 – Displacement through kerb

The road pavement of the car park was in a reasonable condition with evidence of cracking, material loss and patchwork. The kerb and gutter in the car park were also inspected, they were in a reasonable condition with evidence of displacement through the kerb.

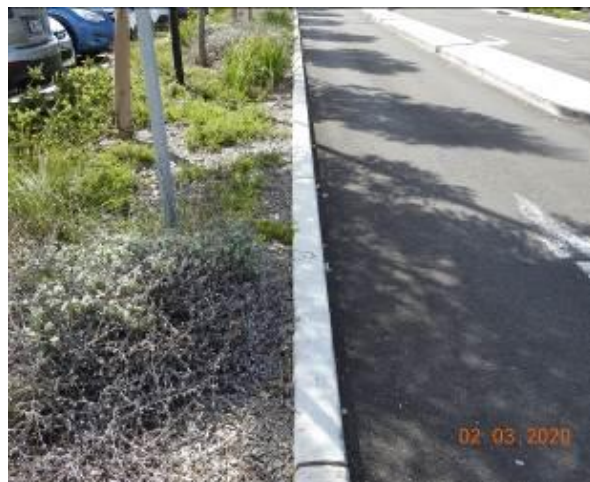
Figure 3121 – General Condition of kerb

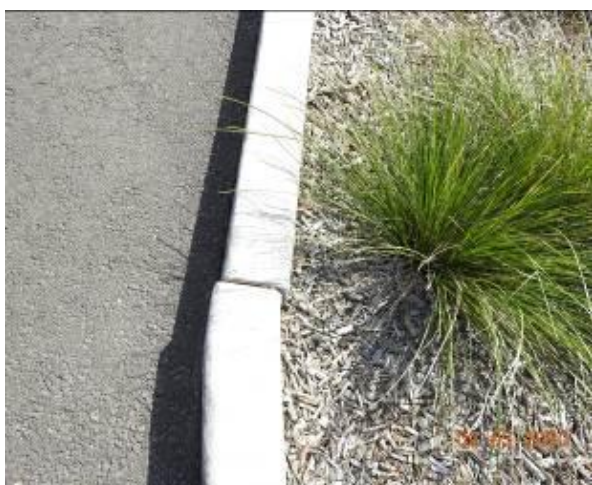
Figure 3122 – Displacement through kerb

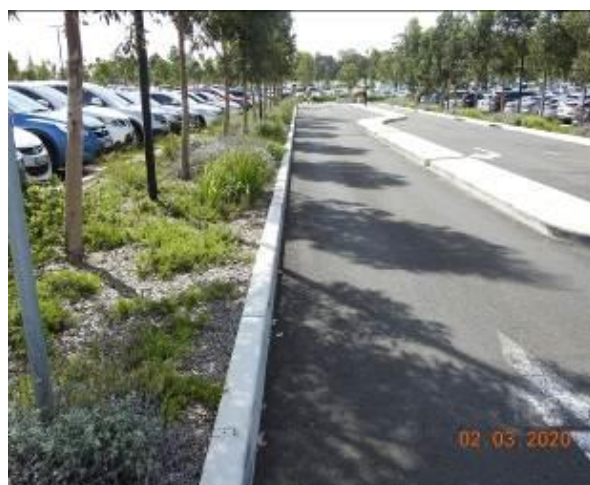
Figure 3123 – General Condition of kerb

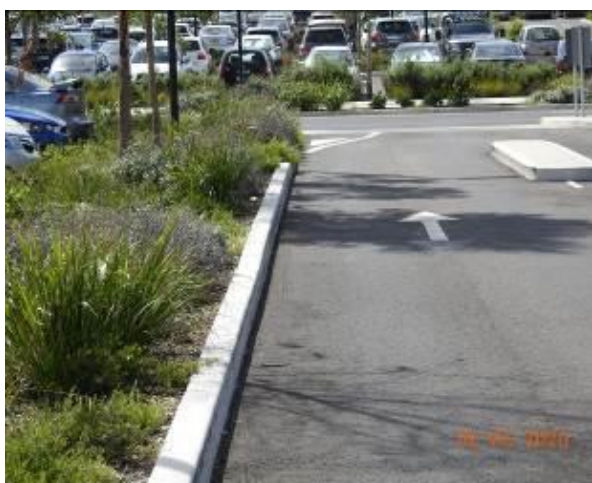
Figure 3124 – General Condition of kerb

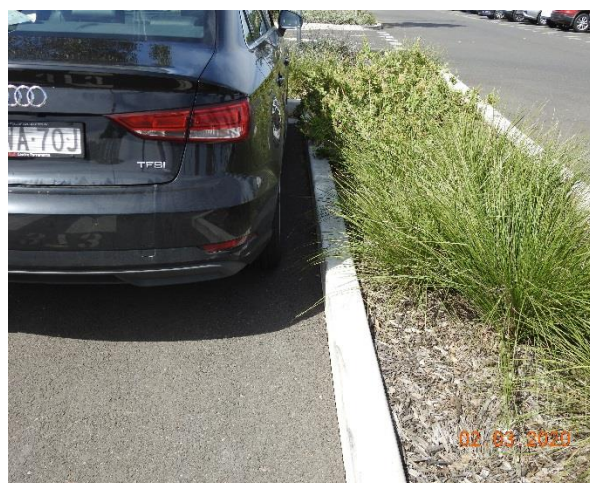
Figure 3125 – General Condition of kerb
