# **Lot 12 Old Maitland Road Sandgate, NSW**

*Hazardous Materials Assessment*

For Crawford's Freightlines Pty Ltd

Date - 28 March 2012

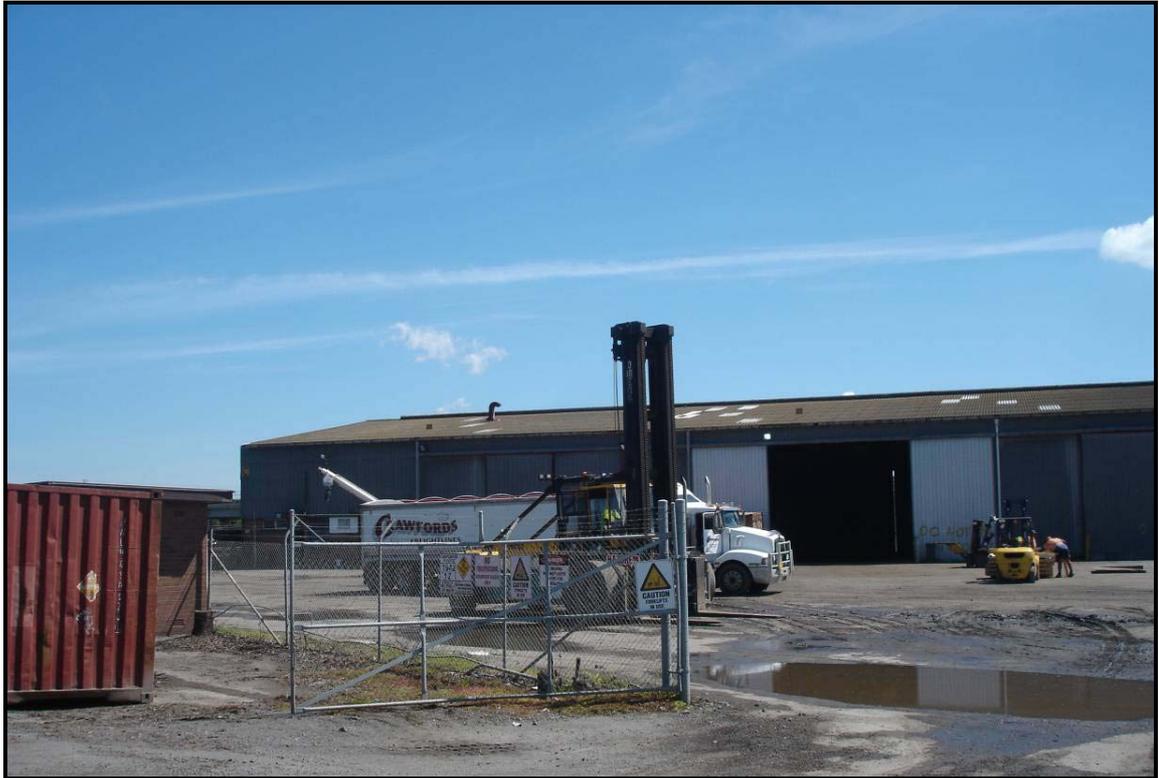
<b>Photograph: 31</b>   View of Shed C from east (23 February 2012).		
Crawfords Freightlines Pty Ltd. (Lot 12, DP625053)	<b>ERM</b>	Lot 12 Old Maitland Road, Sandgate NSW

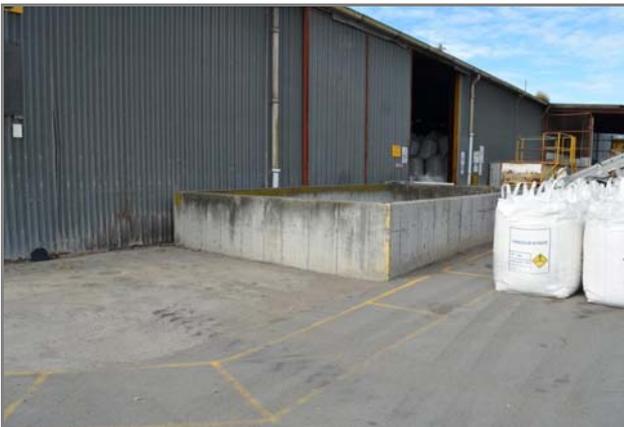
Photograph 11

View south towards former diesel Aboveground Storage Tank (AST) bunded area

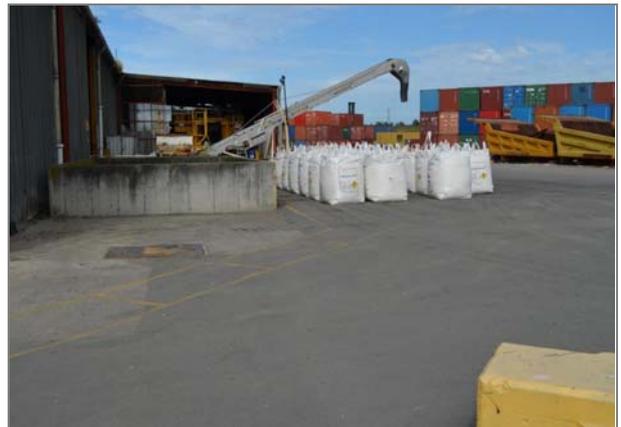
Photograph 12

View south west towards potential location of former Underground Storage Tanks (USTs)

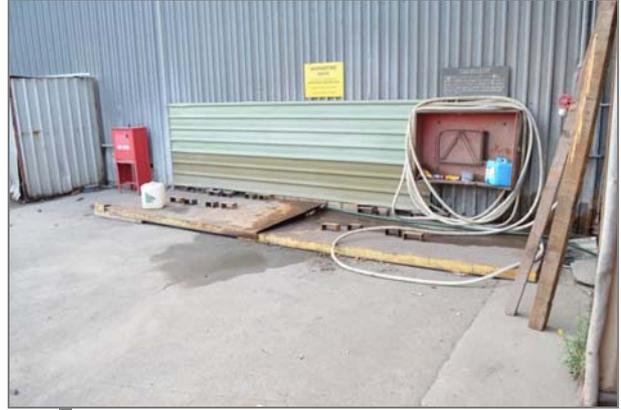
Photograph 14

View east towards sump containing recycled wash bay wastewater

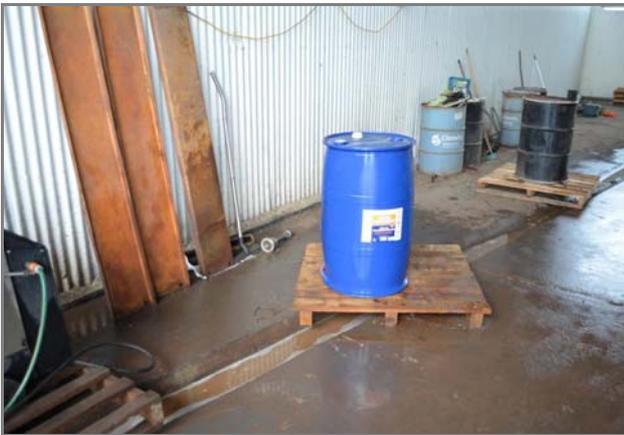
Photograph 15

View south east towards chlorine storage utilised for treatment of recycled wash bay wastewater

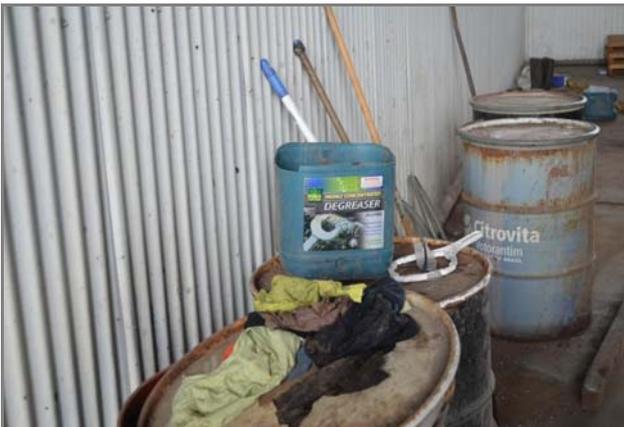
Photograph 17

View south east towards chemical storage utilised for wash bay

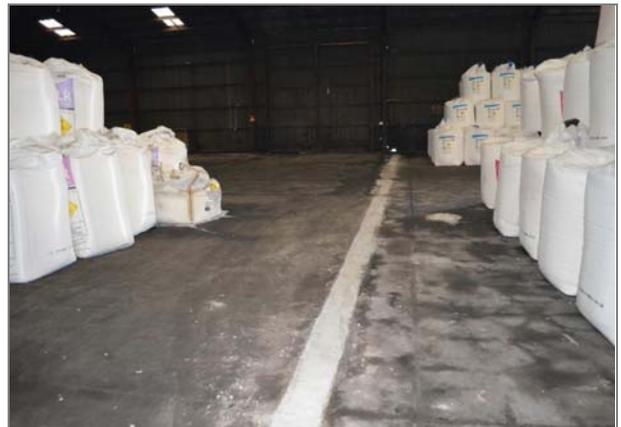
Photograph 18

View west within Shed "D" utilised for ammonium nitrate storage

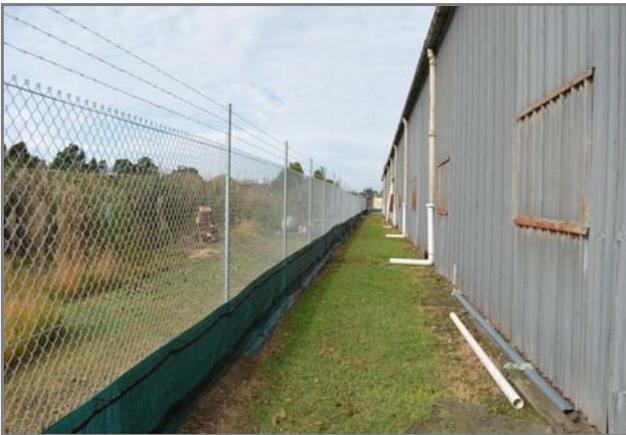
Photograph 21

View south towards stormwater drainage along eastern side of Shed "D"

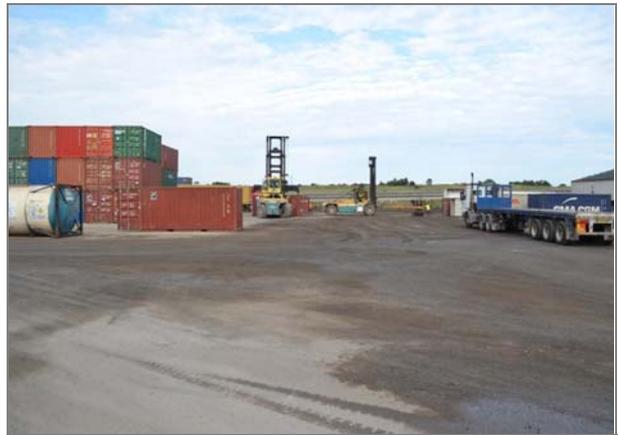
Photograph 22

View west towards ammonium nitrate storage area

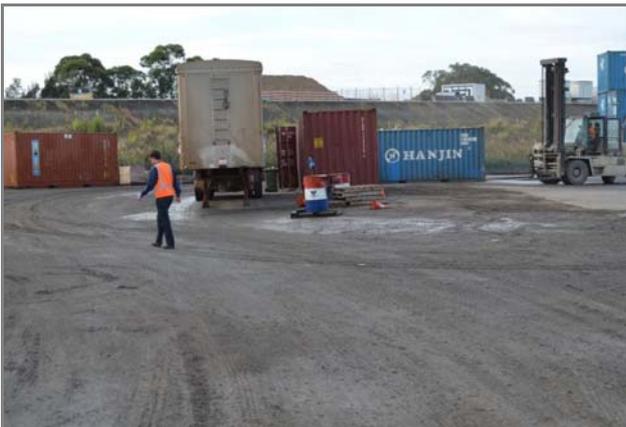
Photograph 23

View south east towards unsealed storage area

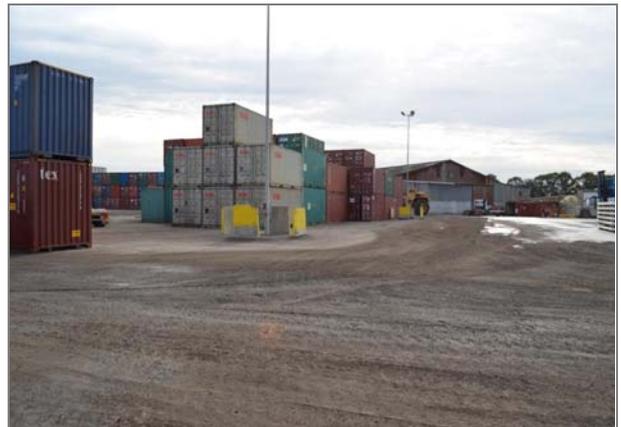
Photograph 29

View north towards stormwater drainage system

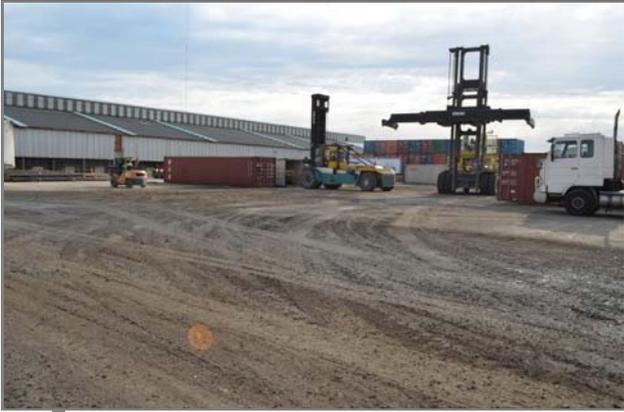
Photograph 30

View east towards storage area

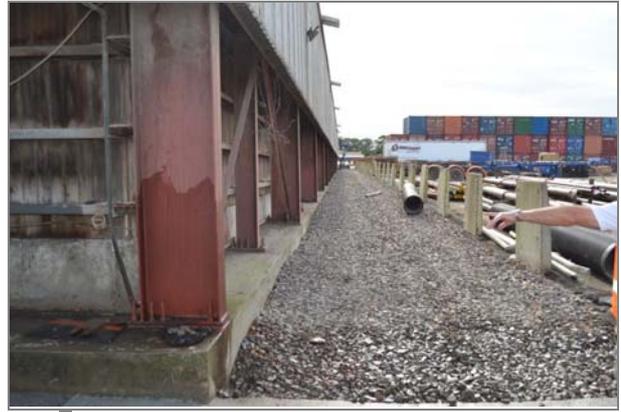
**Photograph 31**

View north east towards storage area

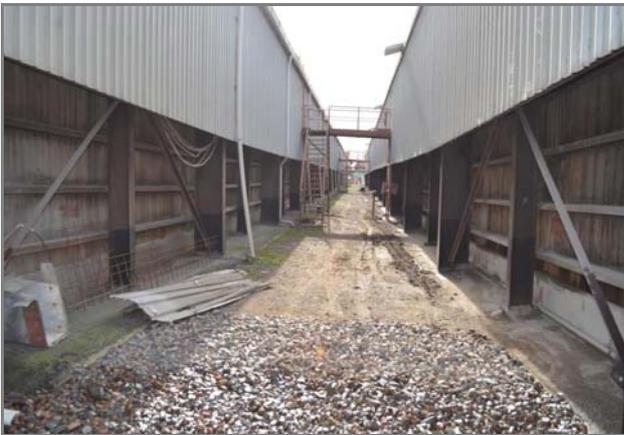
**Photograph 32**

View east towards stormwater drainage along southern boundary of Shed "B"

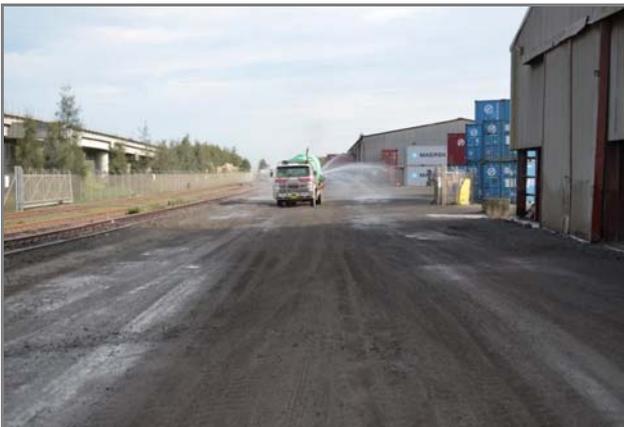
**Photograph 34**

View south east towards stormwater drainage system between Sheds "A" and "B"

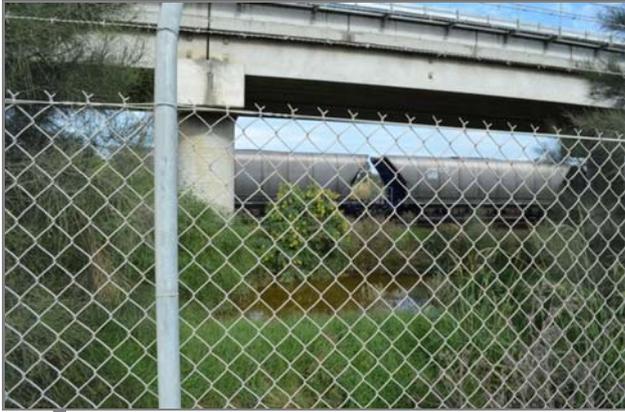
**Photograph 36**

View west towards stormwater egress point

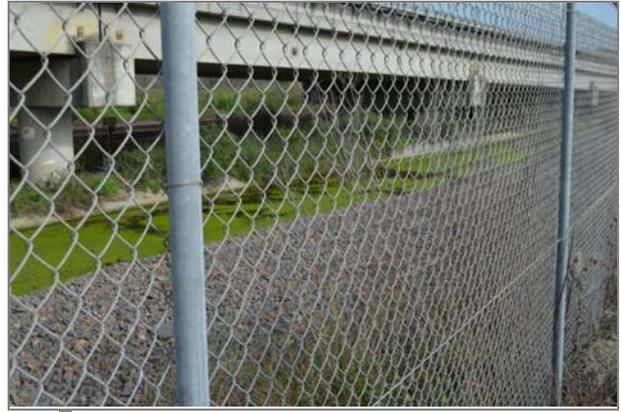
**Photograph 37**

View west towards standing water body on western boundary of site

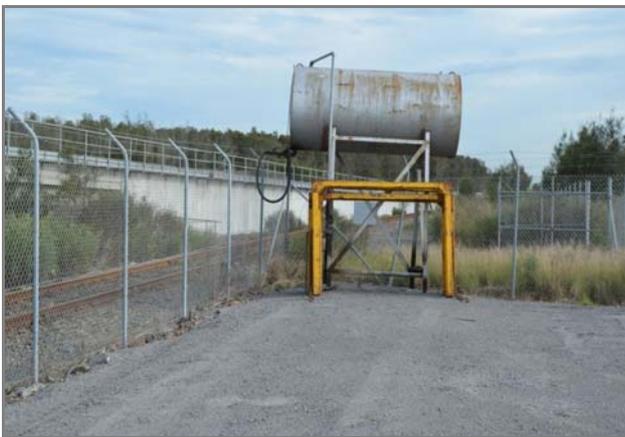
**Photograph 38**

View north west towards standing water body on western boundary of site

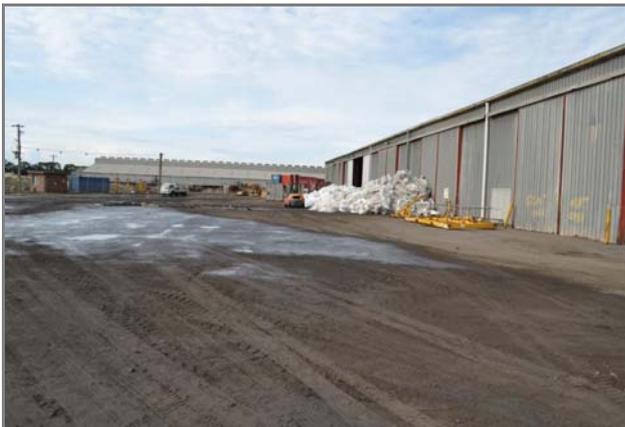
**Photograph 40**

View south east towards Shed "C"

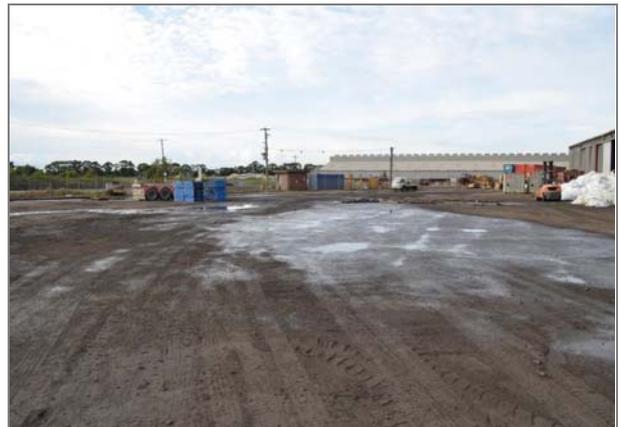
**Photograph 41**

View south towards Shed "C" and spent Ammonium Nitrate bulka bags

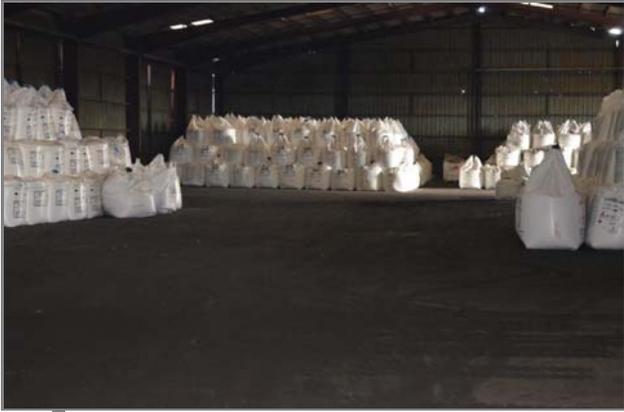
**Photograph 42**

View south towards unsealed area and access road

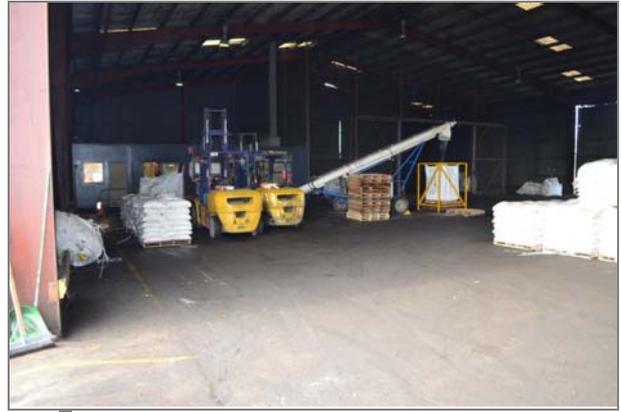
**Photograph 43**

- the storage of ammonium nitrate within Shed "C", Shed "D" and storage area south of Shed "B" represent a potential source of contamination (nutrient loading) as a result of probable historical leaks and spills, potentially contributing to excessive levels of Ammoniacal Nitrogen and Nitrate - Nitrogen within soil and groundwater;

View north within Shed "C" utilised for ammonium nitrate storage

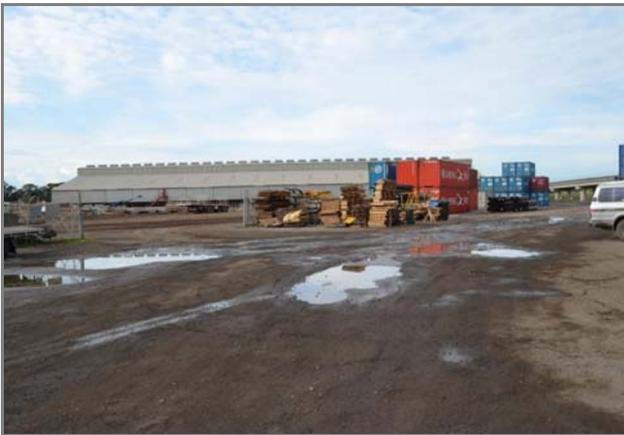
**Photograph 44**

View south towards operations within Shed "C" utilised for ammonium nitrate storage

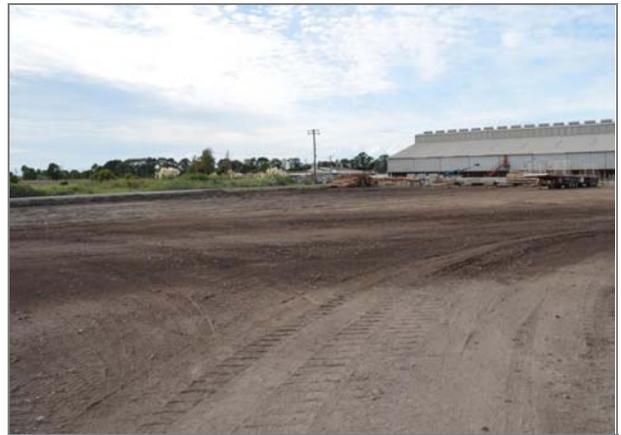
**Photograph 45**

View south towards storage yard utilised for timber storage

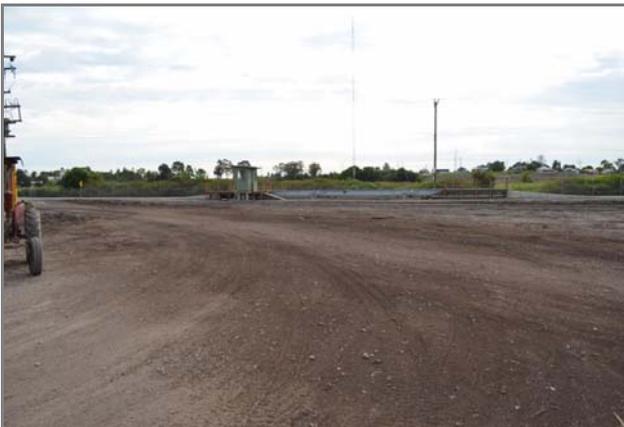
**Photograph 46**

View south east towards storage yard utilised for timber storage
