PRE-CONSTRUCTION DILAPIDATION REPORT AND PHOTOGRAPHIC SURVEY

Project Address: Lot 2 Forrester Road St Marys NSW 2760

Property Inspected: Entry Gate, Road & Council assets at 2 Forrester Road St Marys NSW

Date of Inspection: 04th June 2020

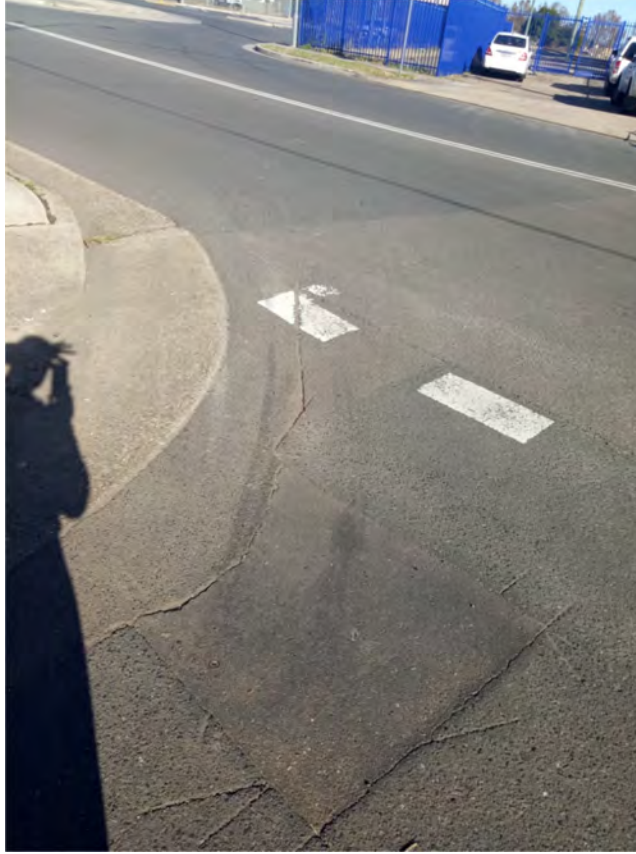
Photo (19): Existing damage/cracks in the road in front of the site entry

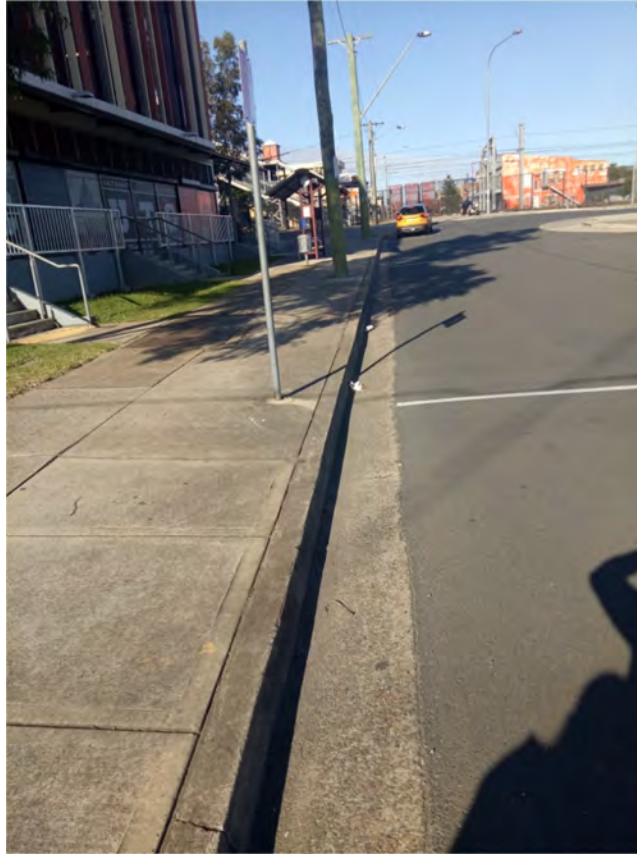
Photo (21): Existing cracks in the kerb & footpath in front of the site entry

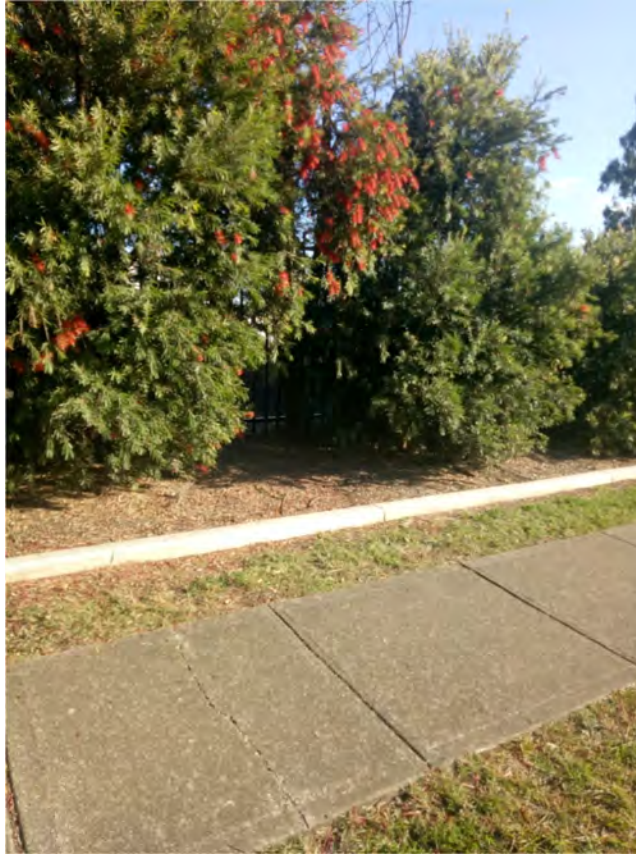
Photo (53): Existing cracks in the footpath along Forrester road (site same side)

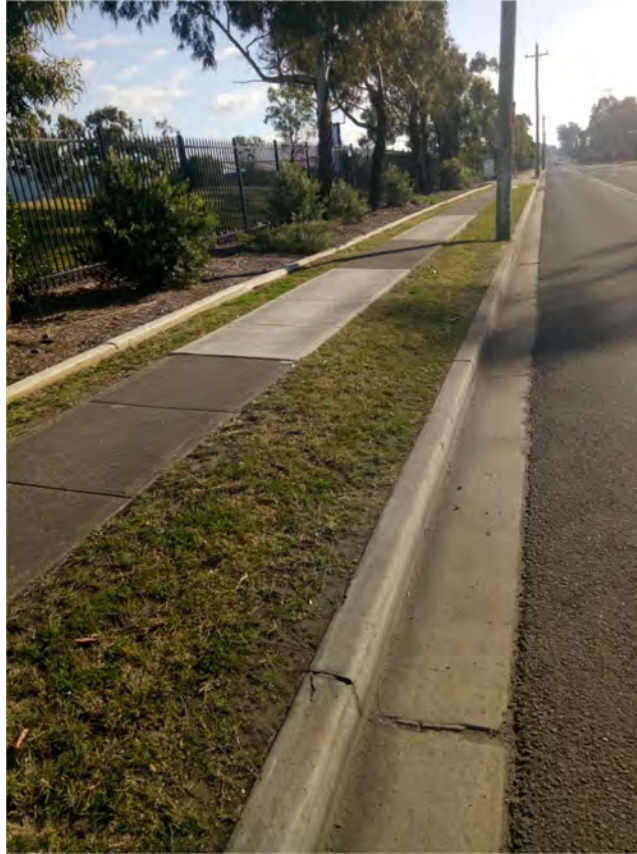
Photo (59): Existing cracks in the kerb & gutter along Forrester road (site same side)

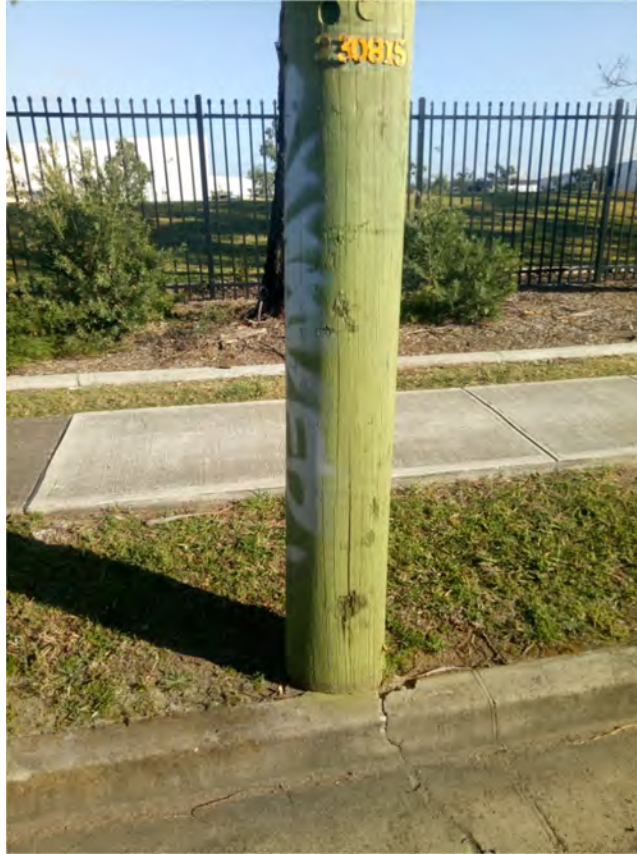
Photo (60): Existing cracks in the kerb & gutter along Forrester road (site same side)

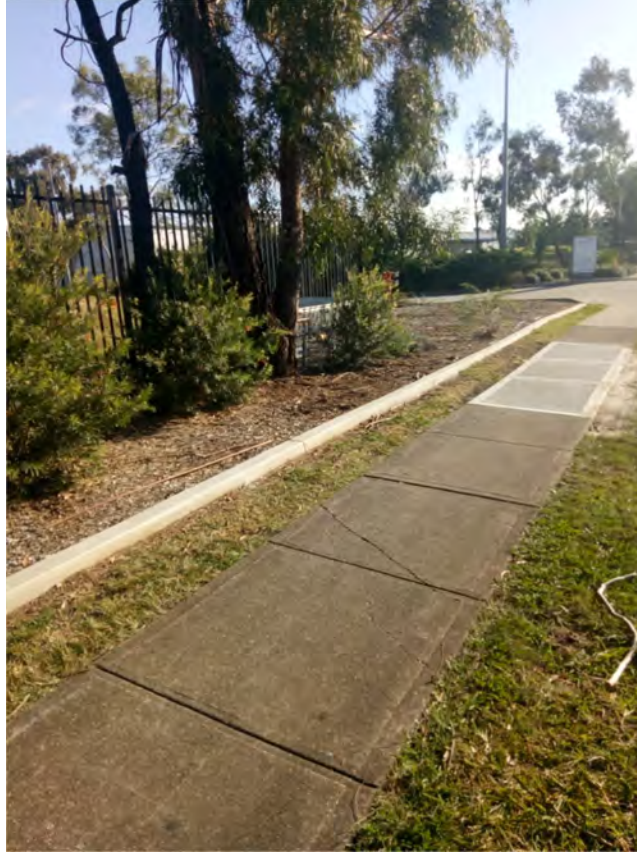
Photo (64): Existing cracks in footpath along Forrester road (site same side)

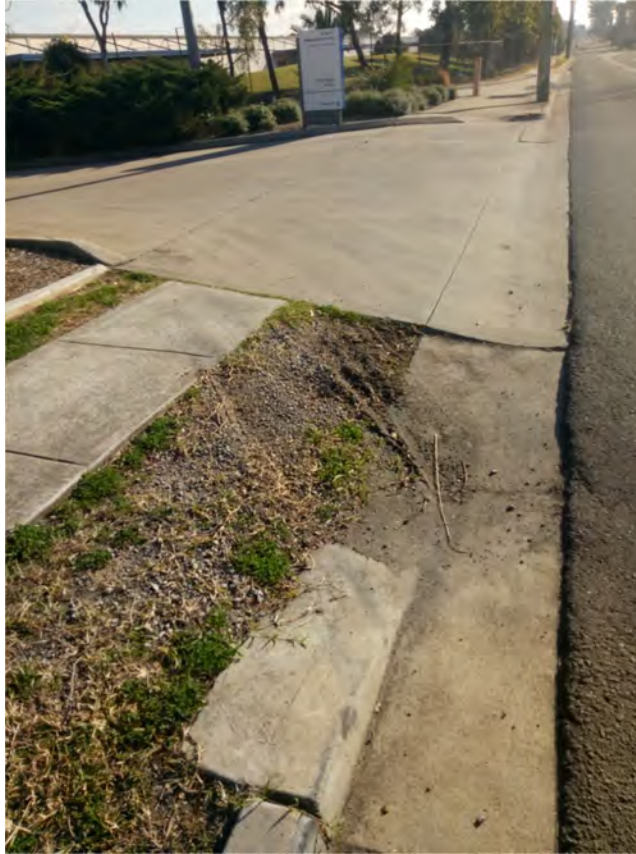
Photo (65): Existing damage in the kerb & gutter along Forrester road (site same side)

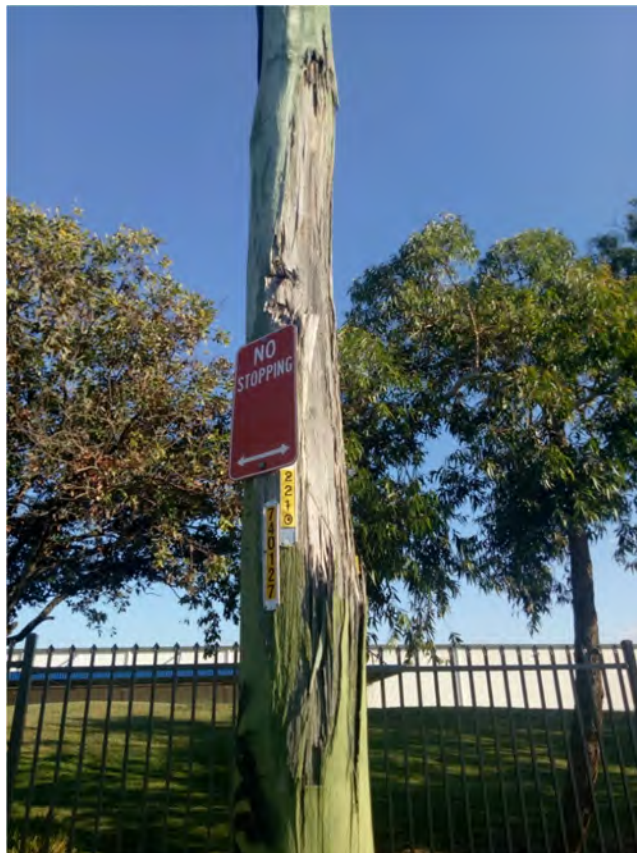
Photo (75): Existing damage in the timber pole along Forrester road (site same side)

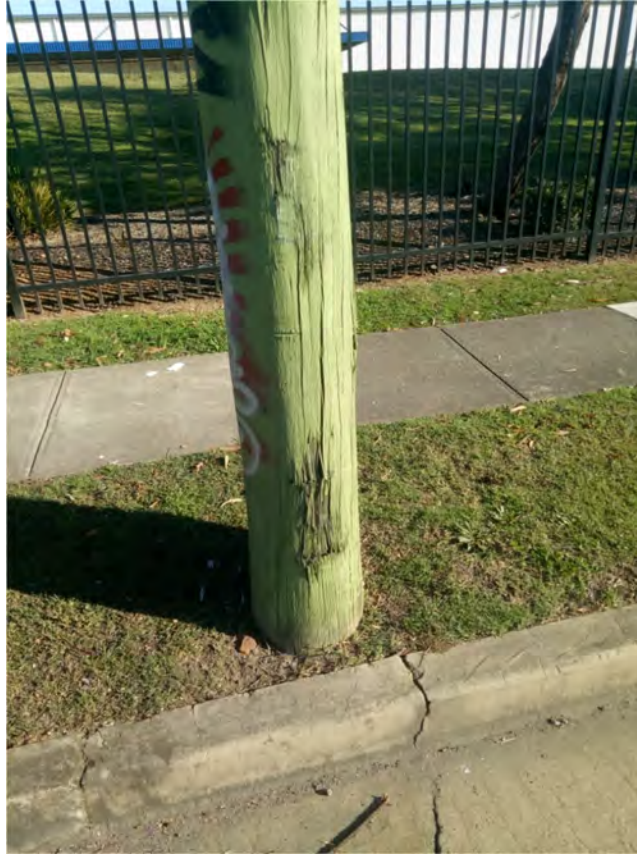
Photo (76): Existing damage in the timber pole, kerb & gutter along Forrester road (site same side)

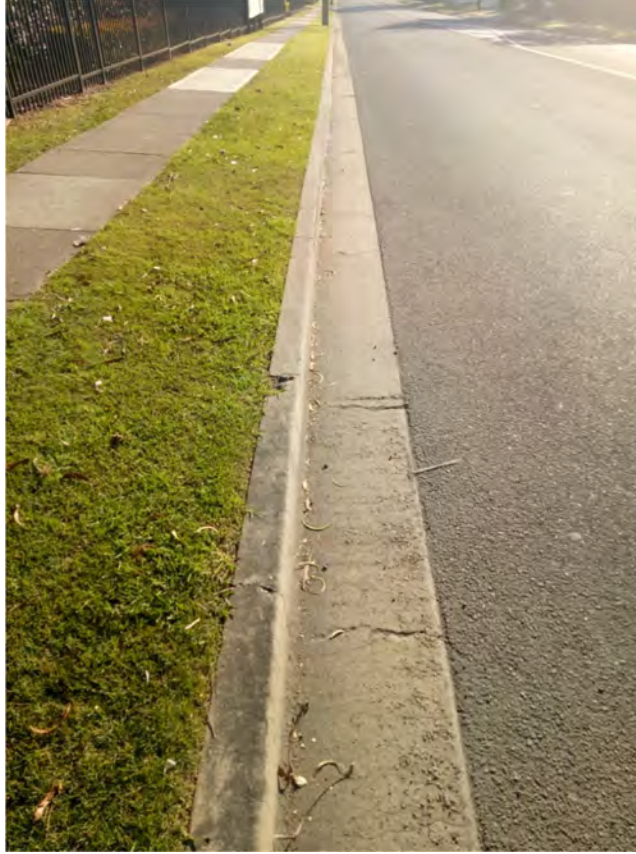
Photo (77): Existing damage in the kerb & gutter along Forrester road (site same side)

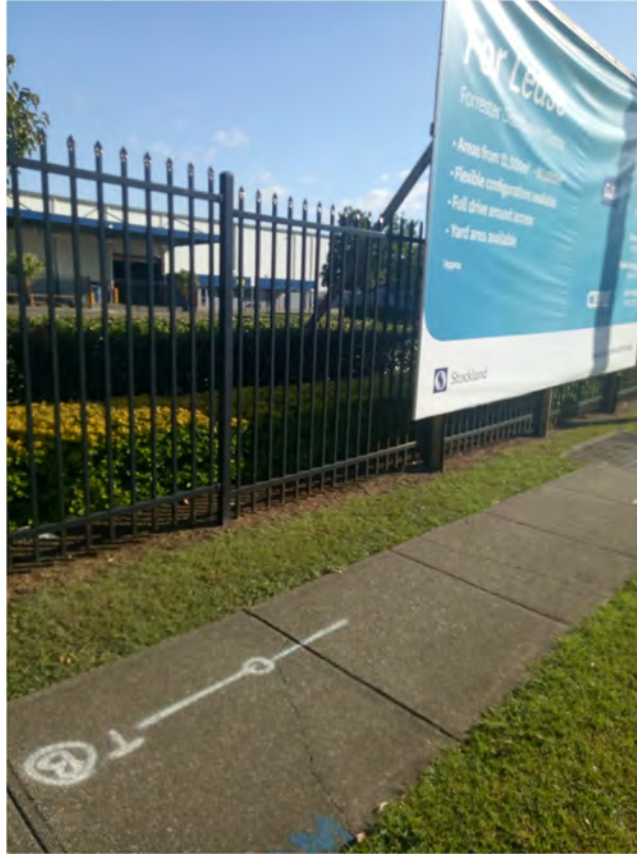
Photo (78): Existing damage in the footpath along Forrester road (site same side)

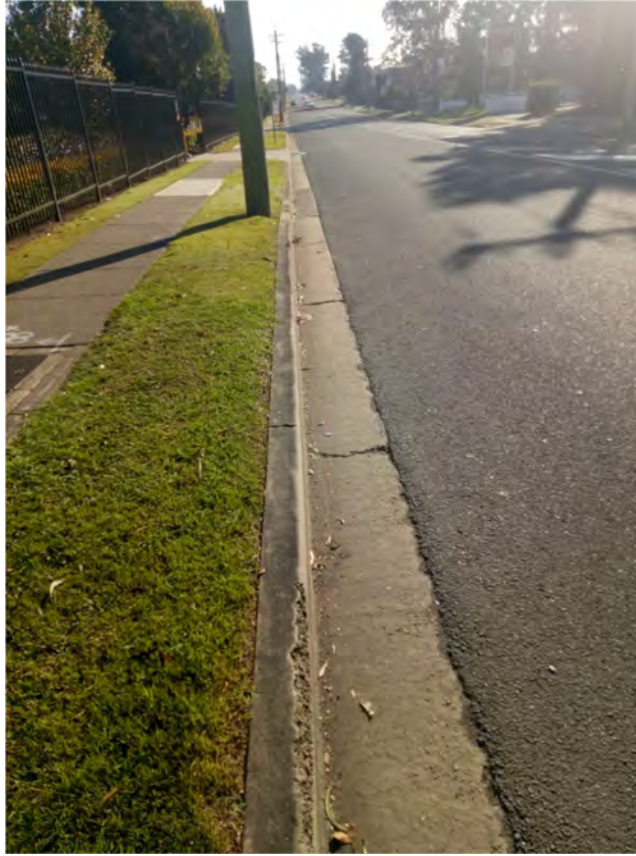
Photo (79): Existing damage in the footpath along Forrester road (site same side)

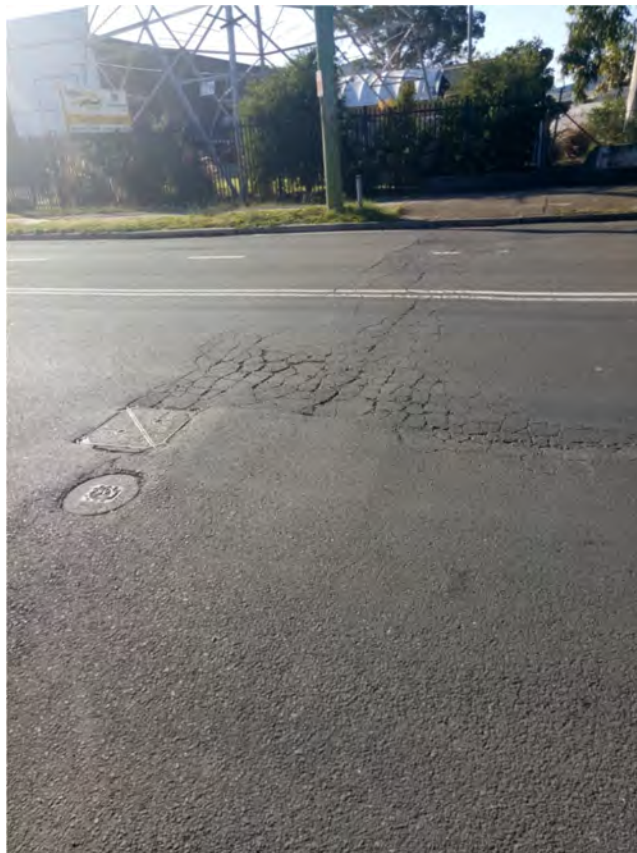
Photo (83): Existing damage in Forrester road

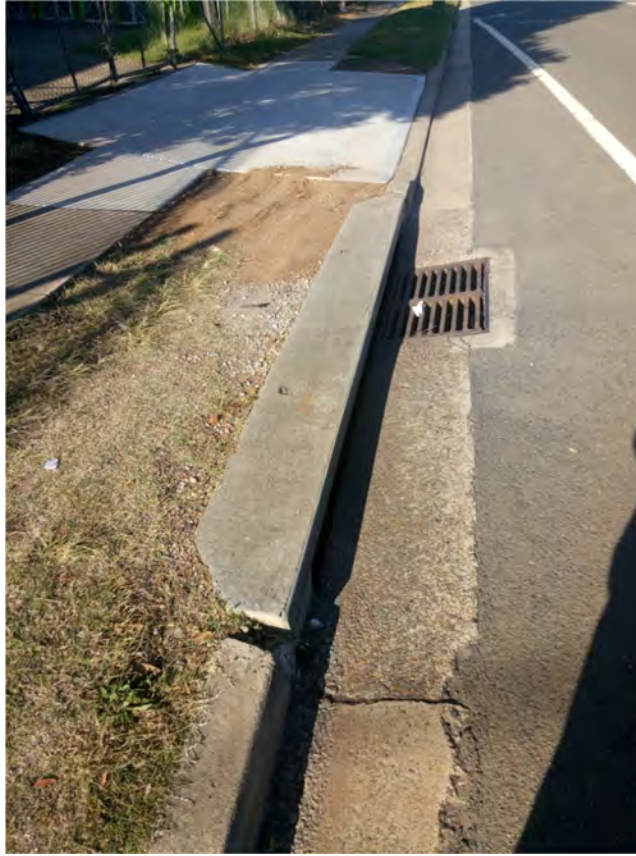
Photo (87): Existing damage in the kerb & gutter along Forrester road (site opposite side)

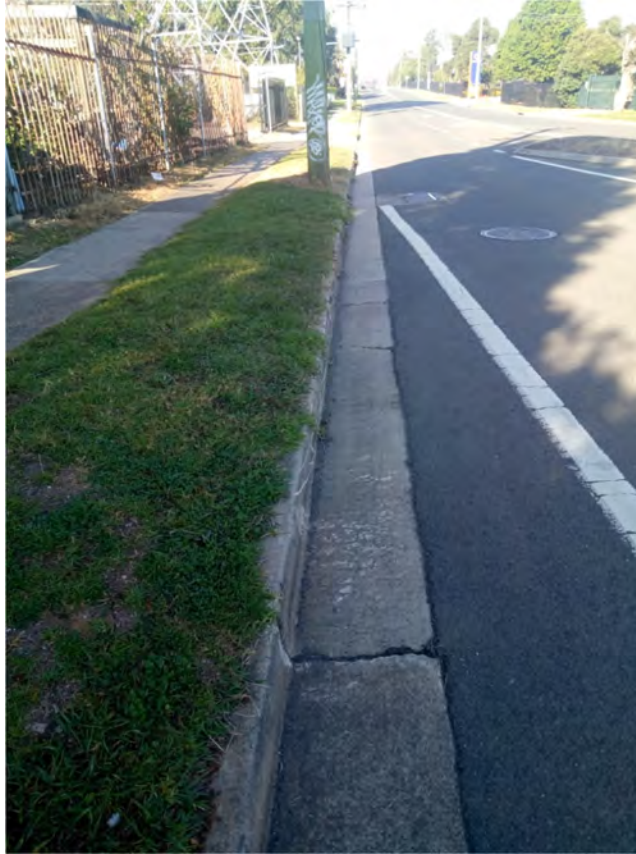
Photo (88): Existing damage in the kerb & gutter along Forrester road (site opposite side)

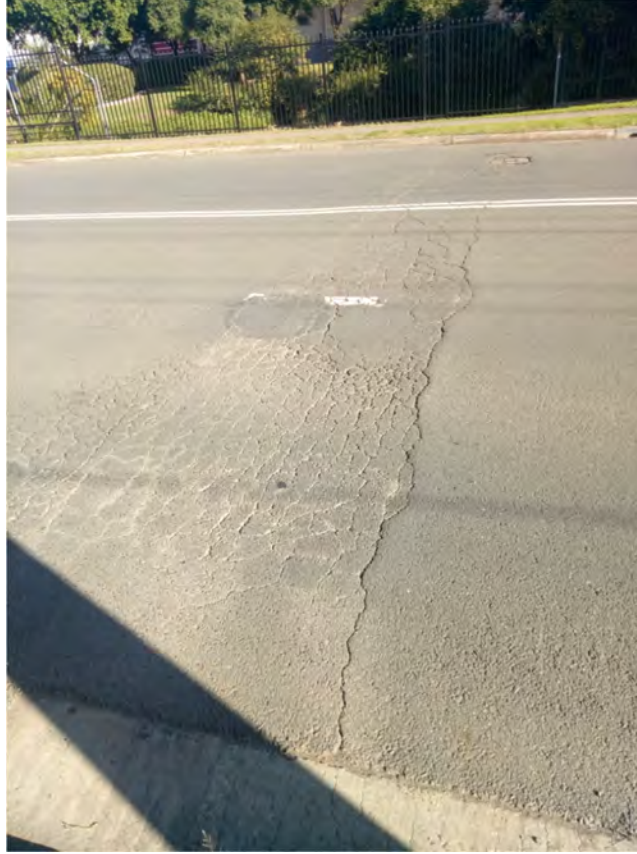
Photo (89): Existing damage in Forrester road

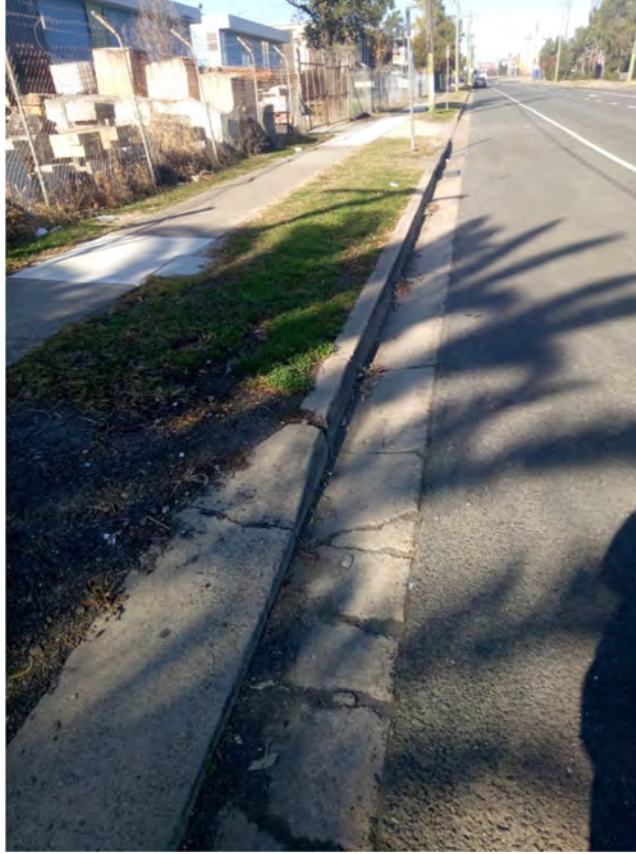
Photo (91): Existing damage in the kerb & gutter along Forrester road (site opposite side)

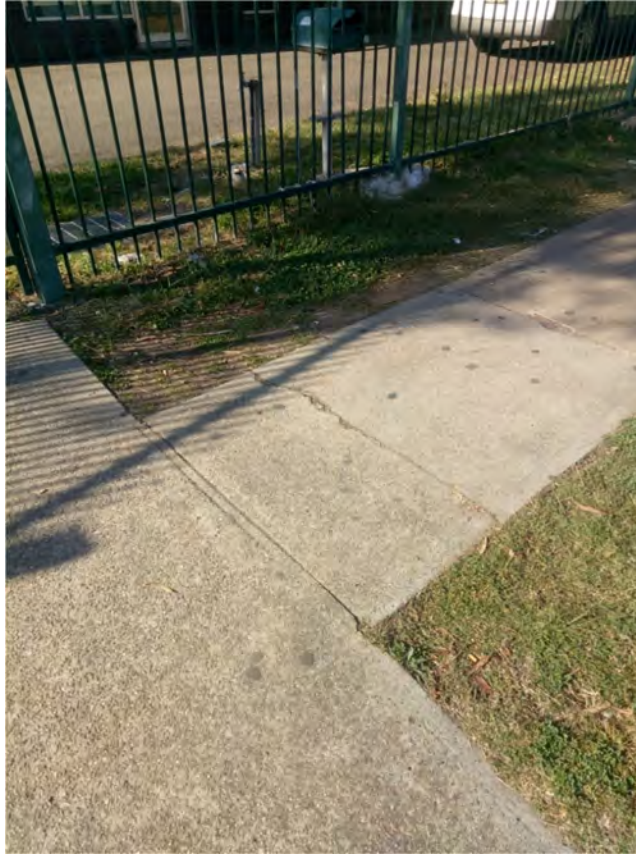
Photo (93): Existing damage in the footpath along Forrester road (site opposite side)
