## Hazardous Building Materials Report

Picton High School  
480 Argyle Street  
Picton NSW 2571

Prepared for  
Billard Leece Partnership Pty Ltd

Project 35252.02  
June 2017

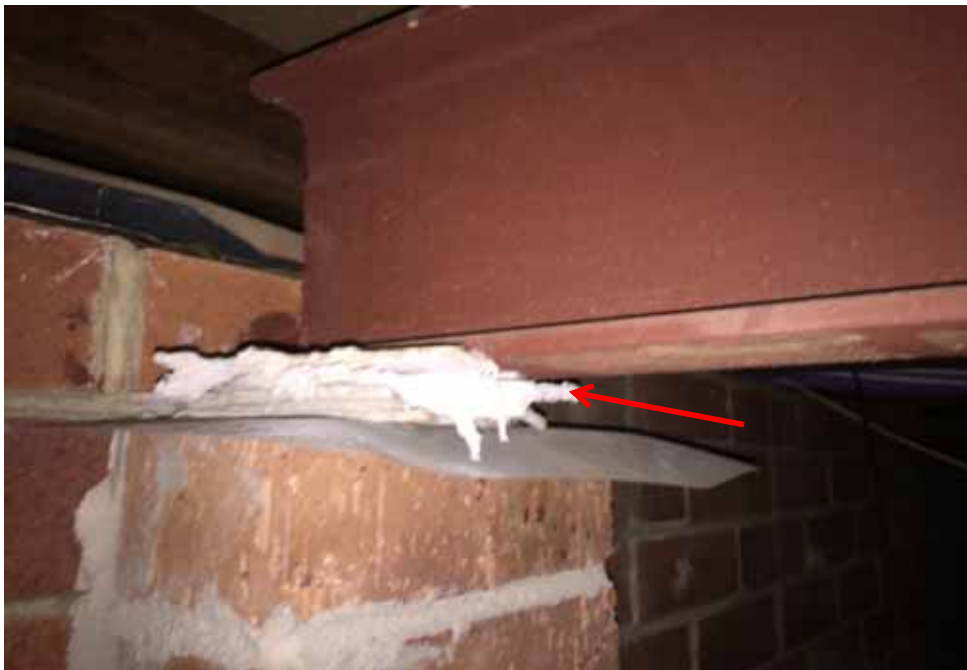
Photograph 6: B00A, subfloor, packing materials.

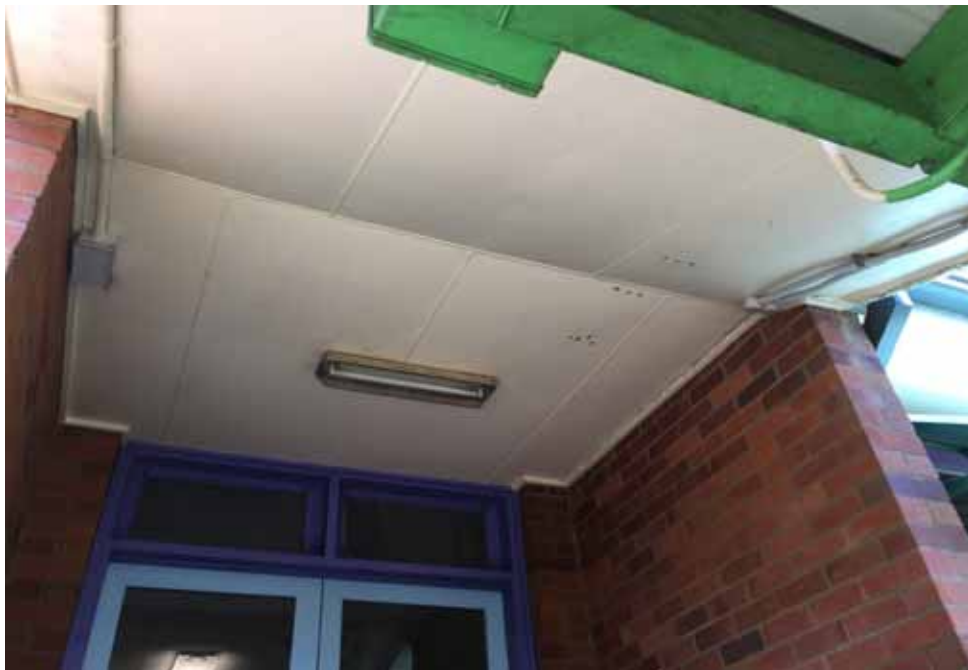
Photograph 8: B00A, R0015, ceiling.

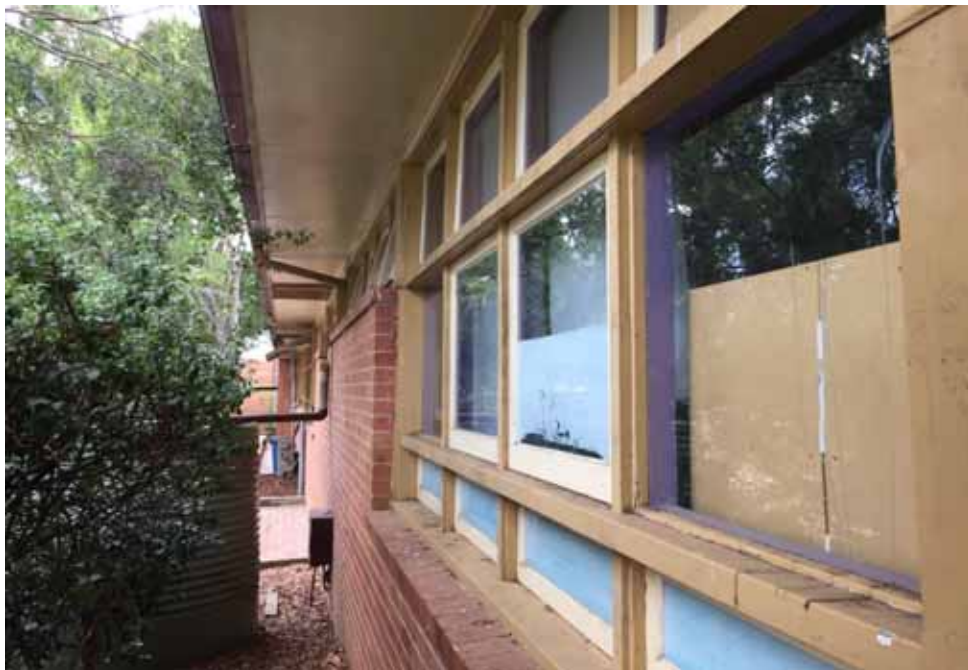
Photograph 16: B00C, exterior, eave lining.

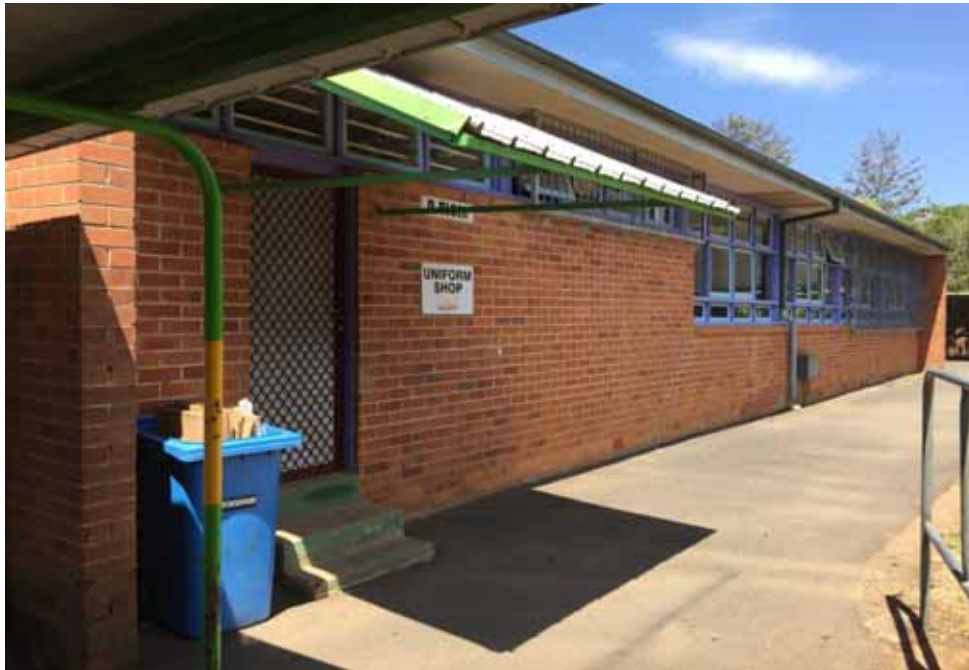
Photograph 19: B00D, exterior, eave linings.

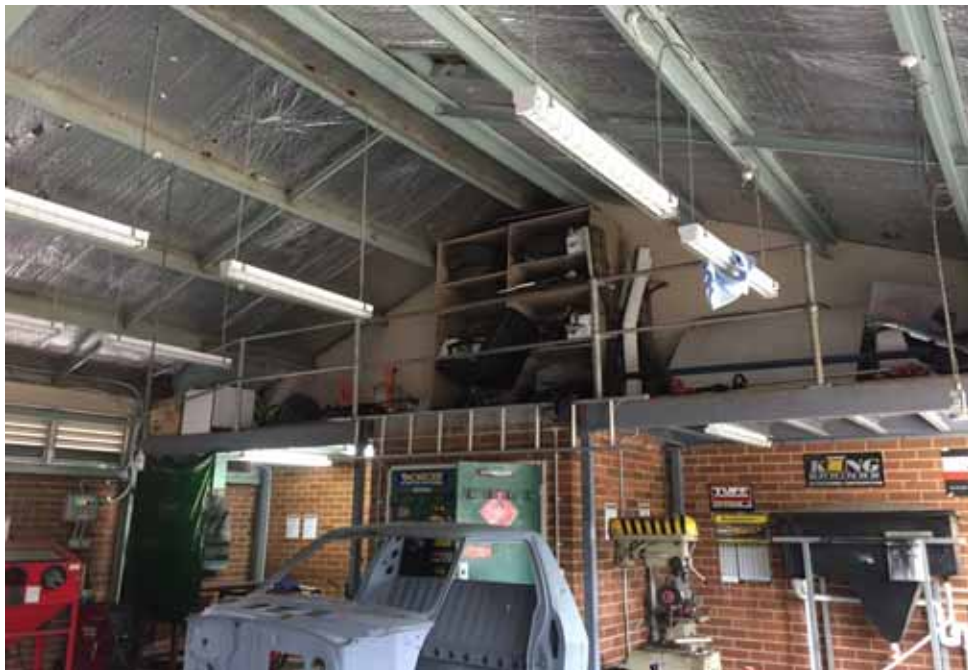
Photograph 30: B00G, R1002, roof insulation behind sarking.

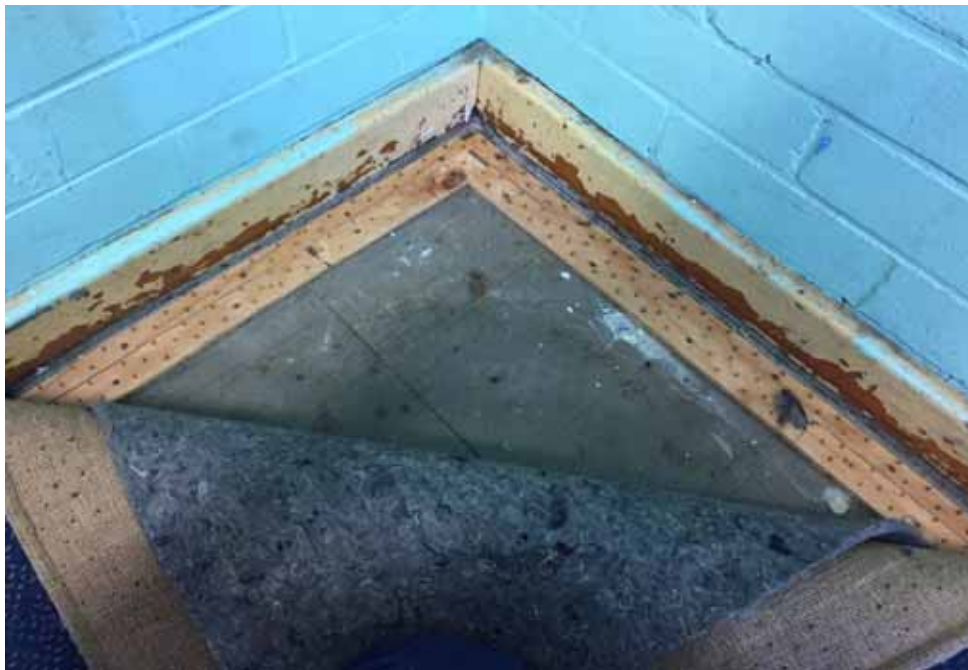
Photograph 36: B00I, typical grey vinyl tiles below carpet/flooring.

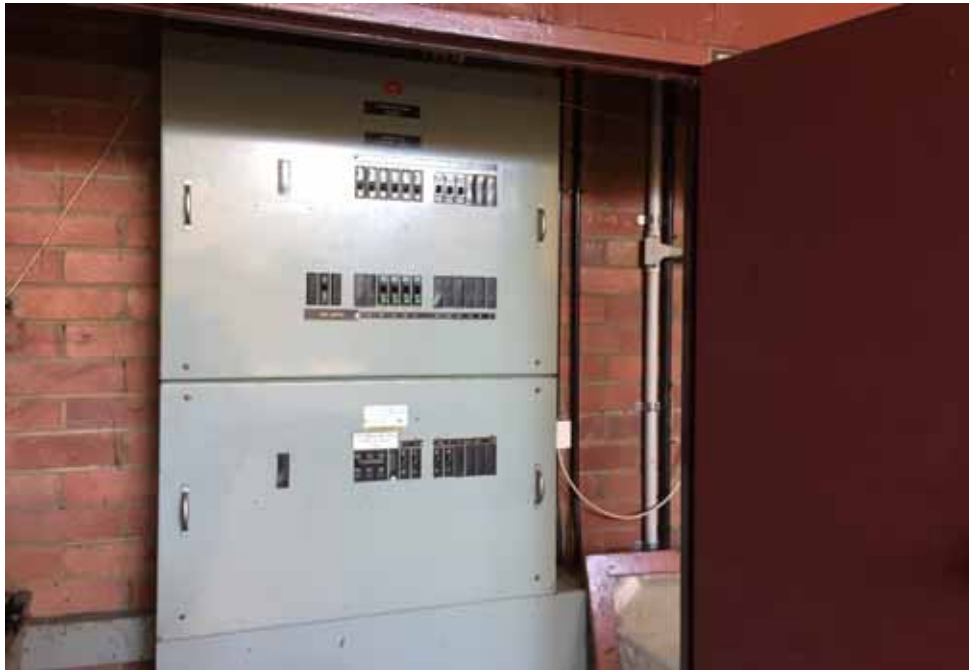
Photograph 37: B00I, typical electrical distribution board.

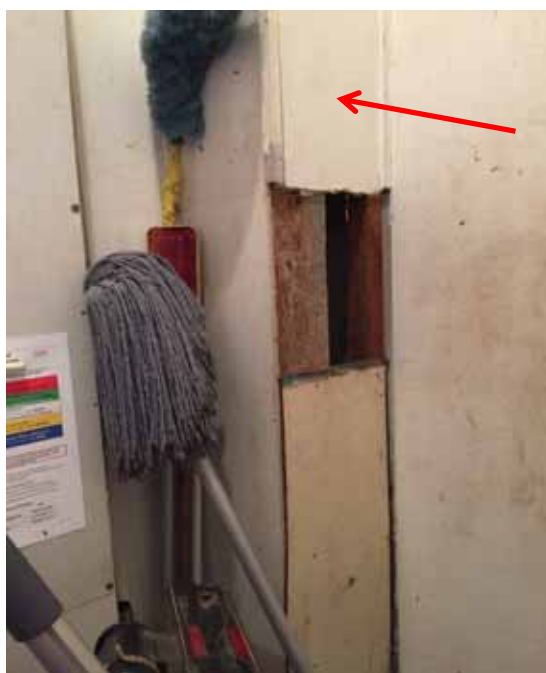
Photograph 39: B00I, R0017, service riser, fibre cement sheeting.

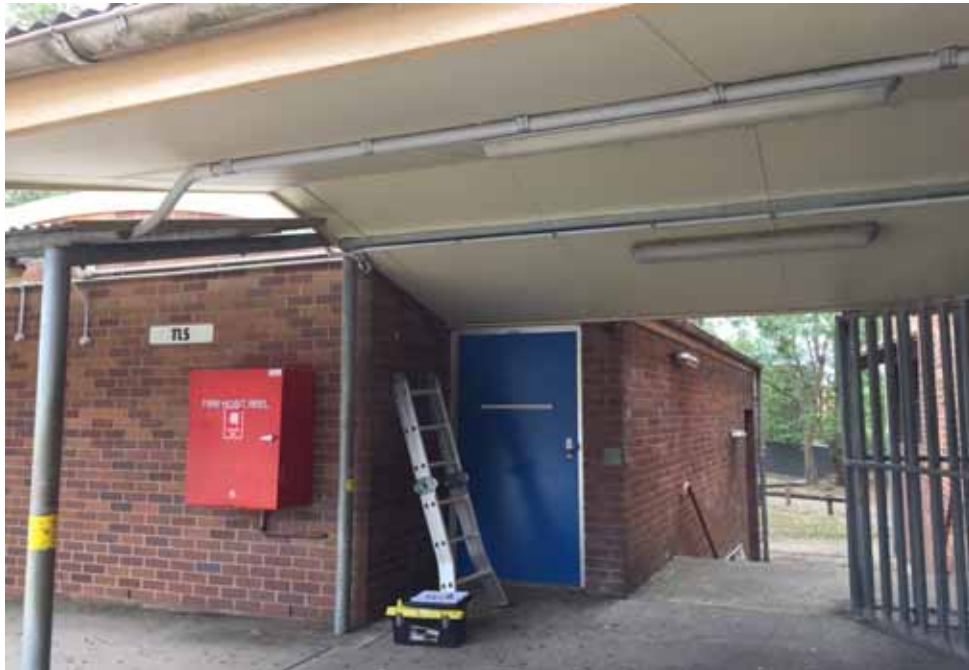
Photograph 45: B00K, R0003, ceiling lining.

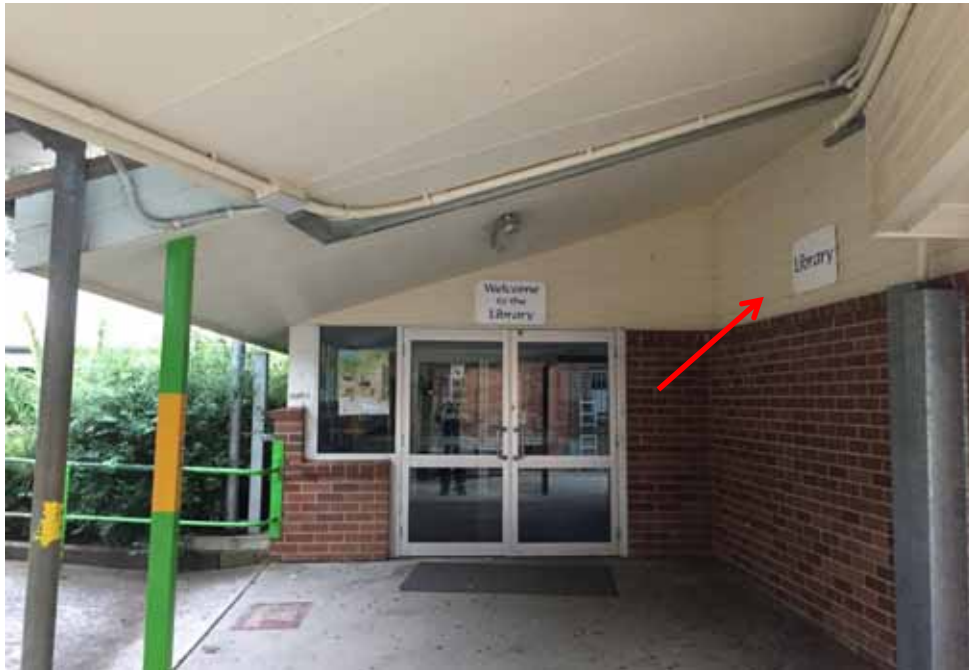
Photograph 49: B00N, exterior, weatherboard cladding

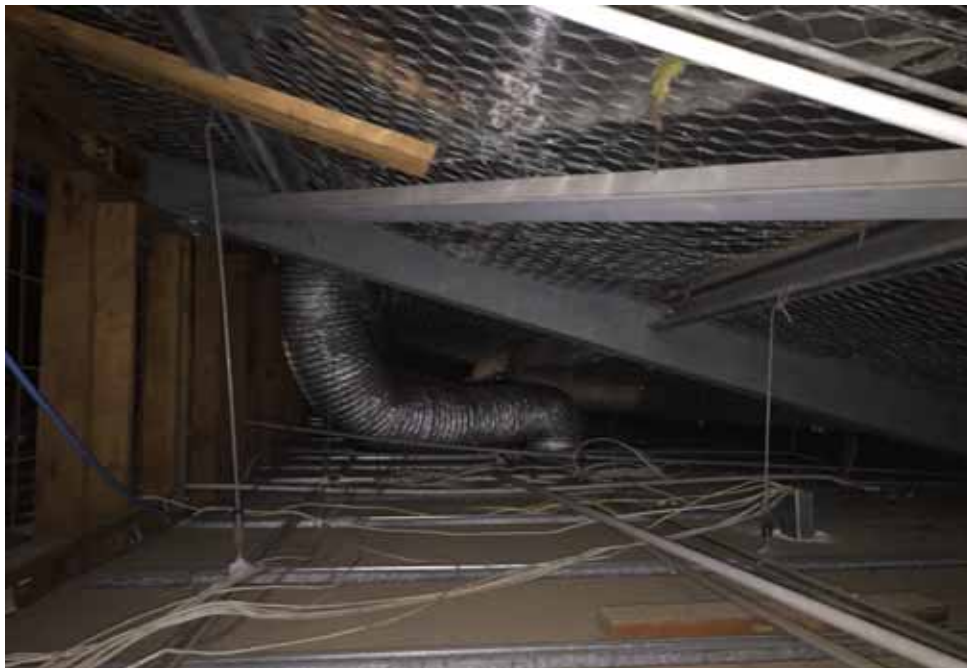
Photograph 50: B00N, ceiling void, insulation to roof and air handling ductwork.

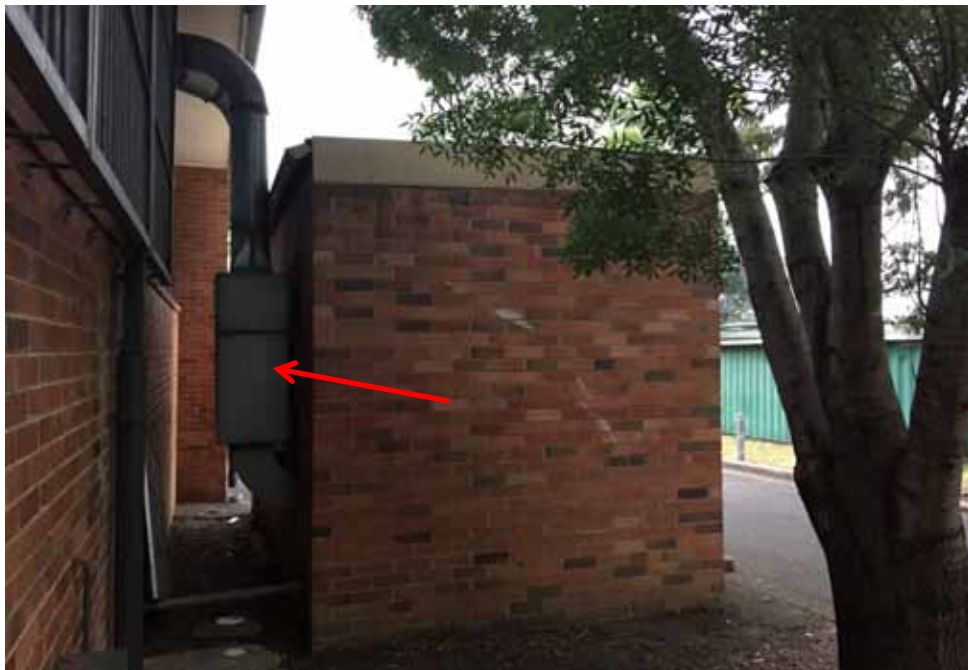
Photograph 54: B00R, exterior, air handling ducts.

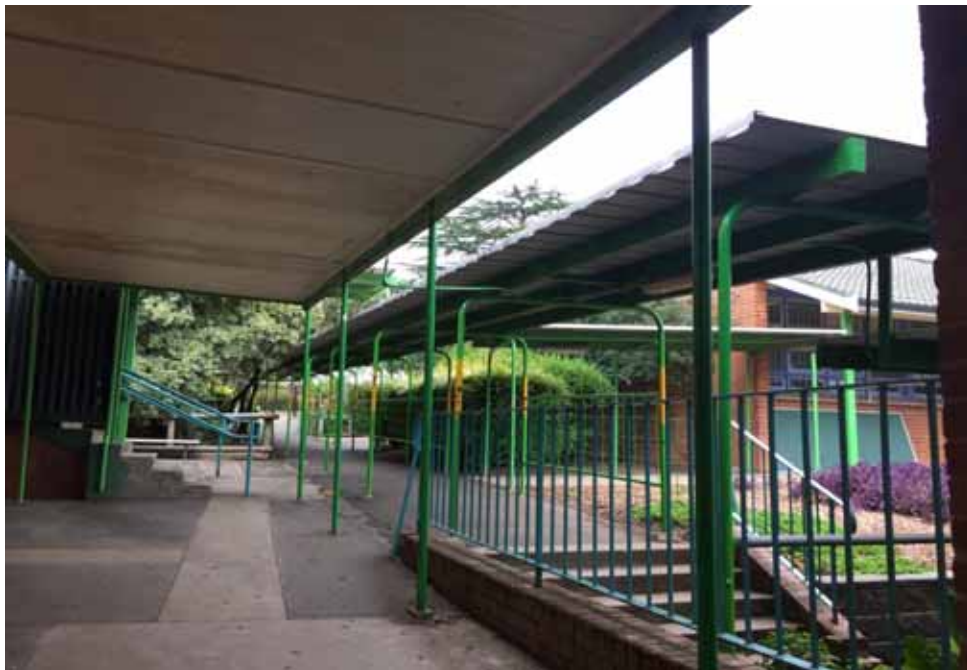
Photograph 56: Covered walkways, ceiling lining.

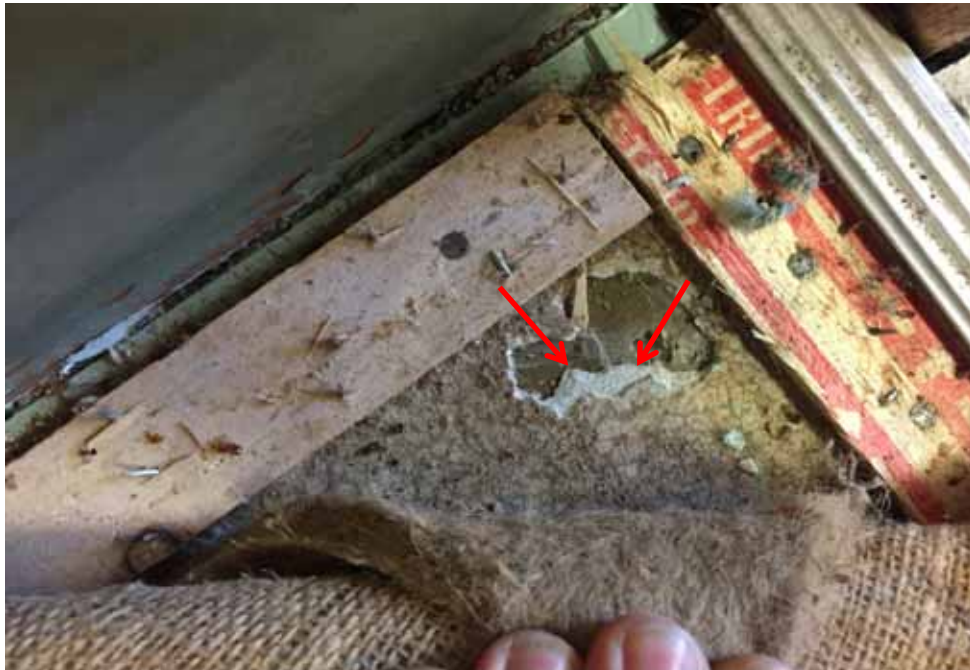
Photograph 65: B00I, R1010, fibrous backing below speckled vinyl sheeting.
