Appendix C

001 – Cranbrook Building Photographs

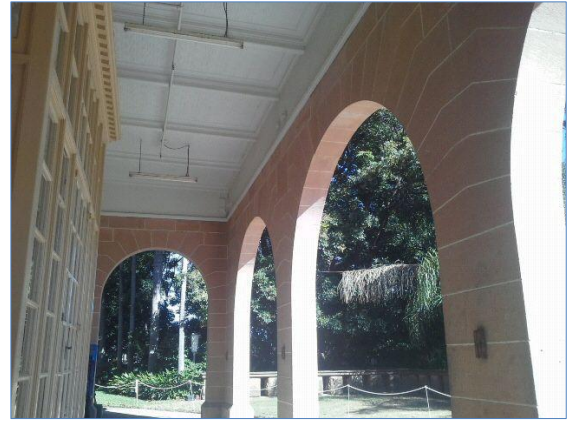
Photograph 02: External perimeter - Green paint to doors and window shutters

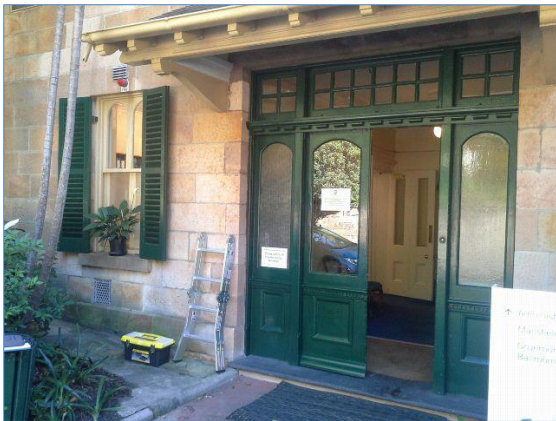
Photograph 05: Presumed asbestos cement infill panels

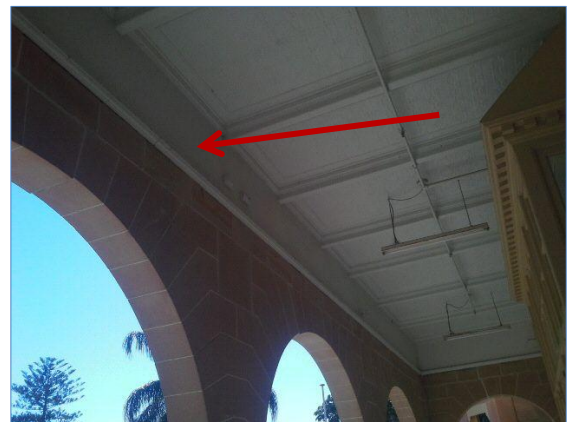
Photograph 03: External perimeter - Cream paint to walls and windows

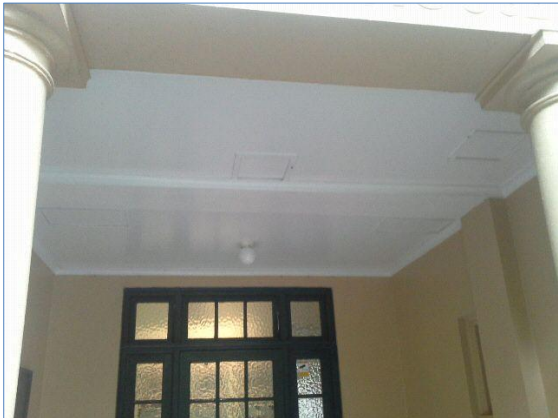
Photograph 05: External perimeter - Asbestos cement eave lining

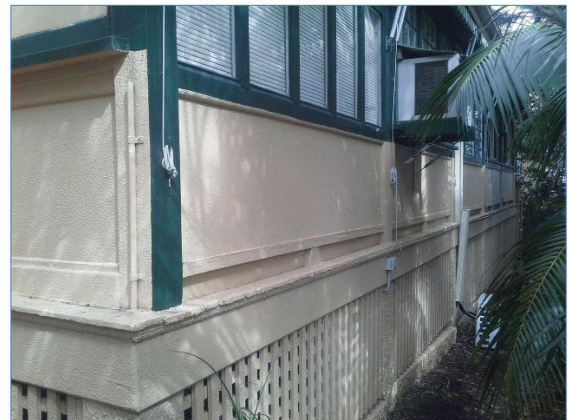
Photograph 09: Rooms 2.2 a & b - Fibre cement ceiling lining and Asbestos cement infill panel either side of the windows

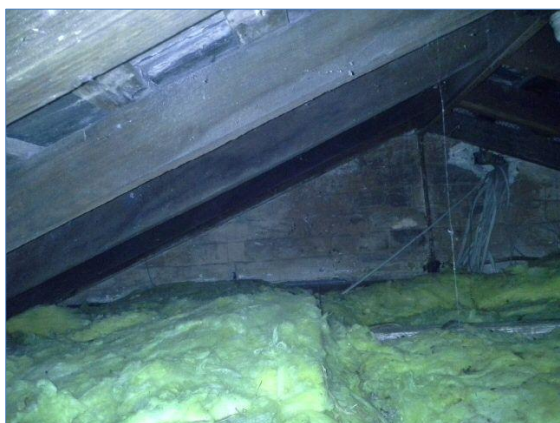
Photograph 02: Laundry 1.17 ceiling space - SMF insulating batts throughout roof space

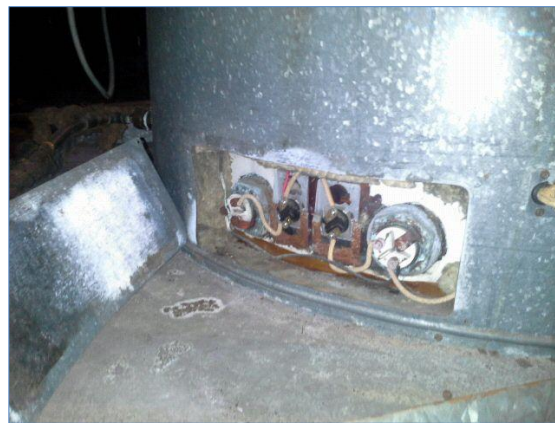
Photograph 05: Roof space attic - hot water tank with asbestos Millboard and SMF insulation. Presumed asbestos insulation to cables

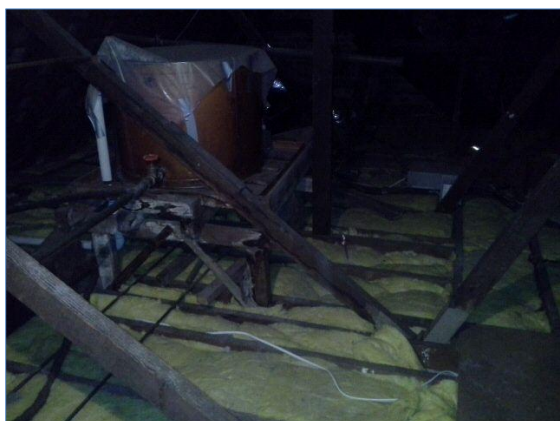
Photograph 03: Roof space attic- insulating batts throughout

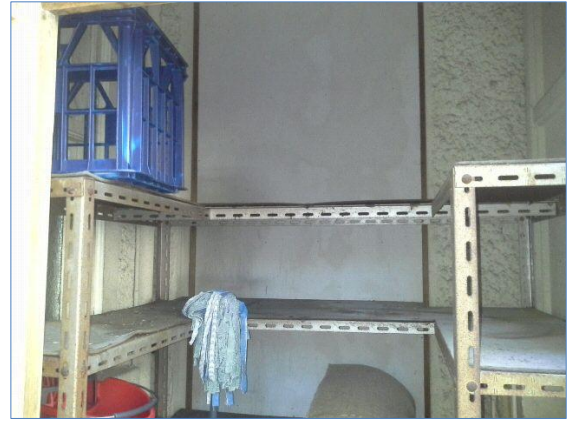
Photograph 09: External store 1.13 - Internal east fibre cement infill panel

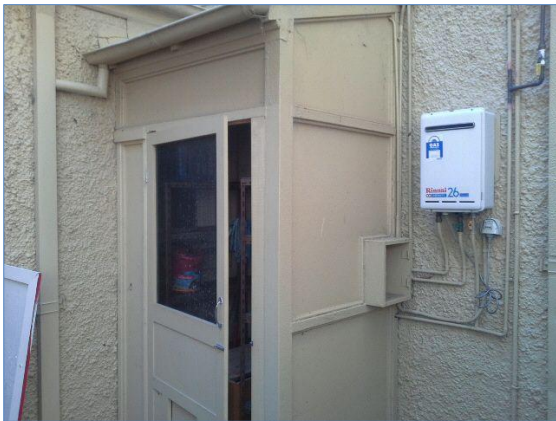
Photograph 08: External store 1.13 - Asbestos cement wall cladding

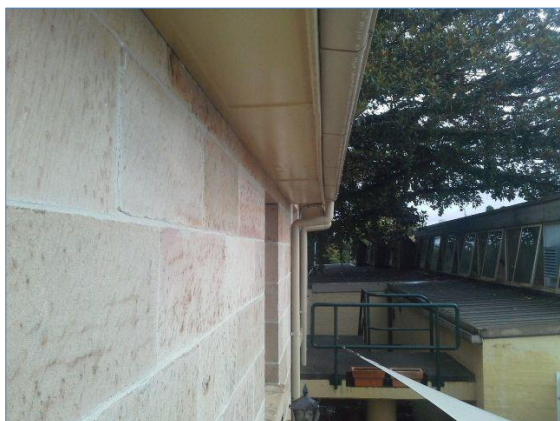
Photograph 02: Asbestos cement eave lining surrounding building

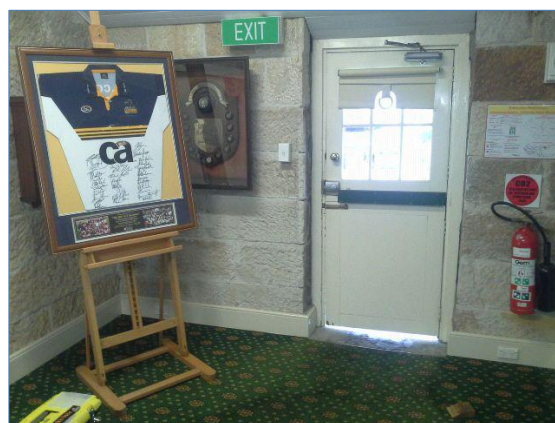
Photograph 05: Level 01 - White paint to doors, frames, windows and skirting boards

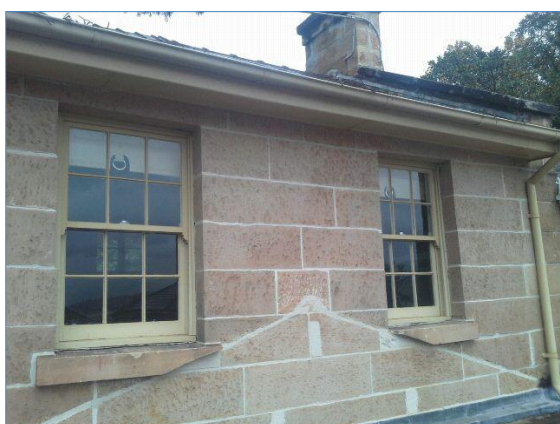
Photograph 03: Cream lead based paint to fascia, eaves and window frames

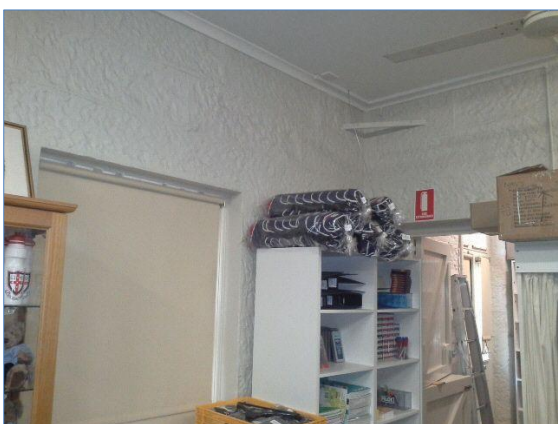
Photograph 08: Ground floor Uniform Shop 1.1, 1.2 white lead paint to walls

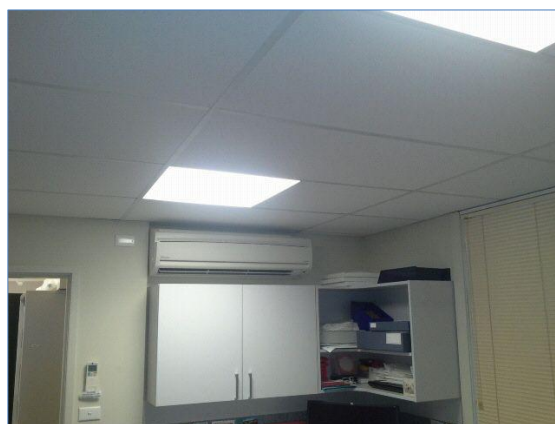
Photograph 11: Ground floor office 1.13, 1.14, 1.15 - SMF containing suspended ceiling tiles

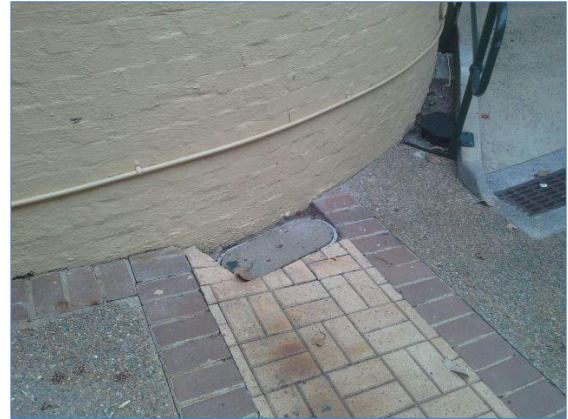
Photograph 04: North grounds - Fibre cement service pit adjacent north wall east of ramp

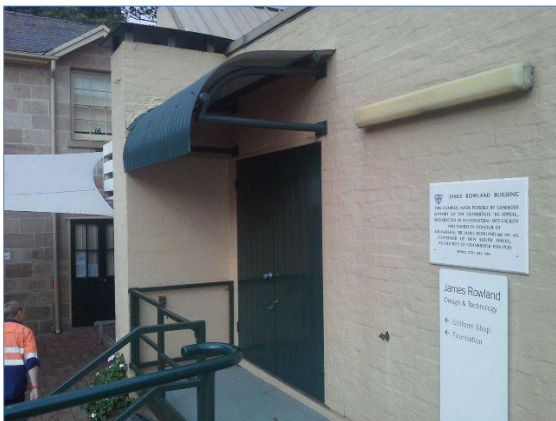
Photograph 02: External - Green paint system to doors, handrail and awning supports

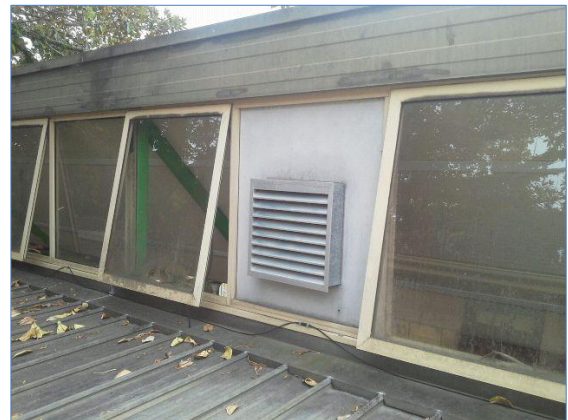
Photograph 05: South elevation - Vent infill panels to level 3 skylights

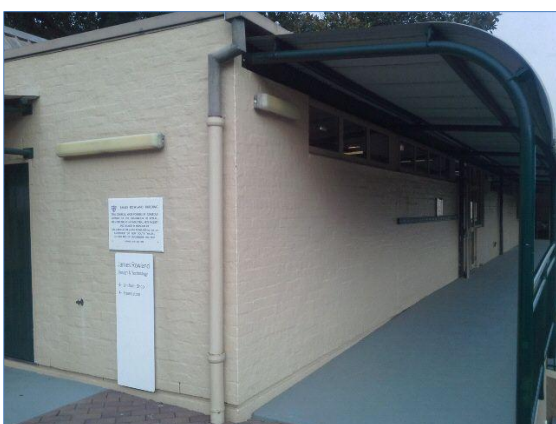
Photograph 03: External - Cream paint to walls throughout

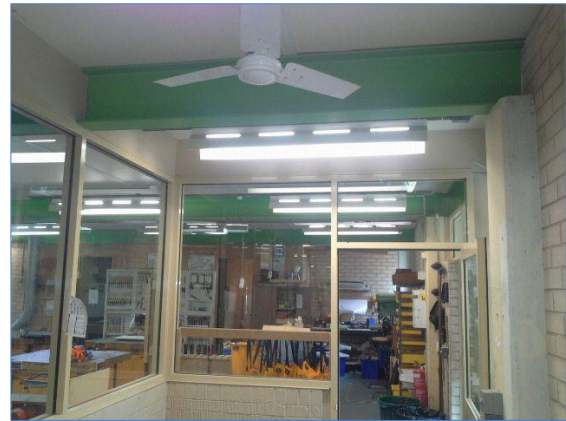
Photograph 10: Rooms 3.2, 3.4, & 3.5 - Fibre cement infill panels above windows

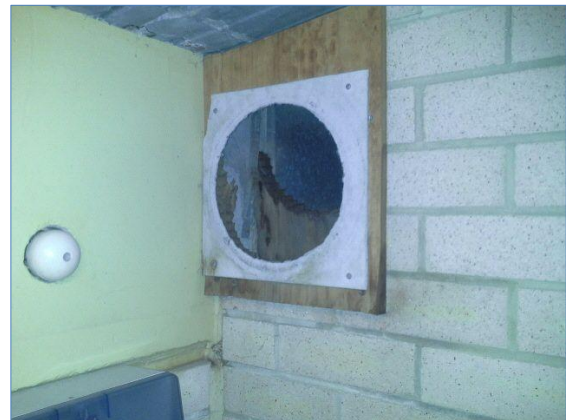
Photograph 11: Room 2.6 - Fibre cement infill panel in location of removed vent fan (south wall)

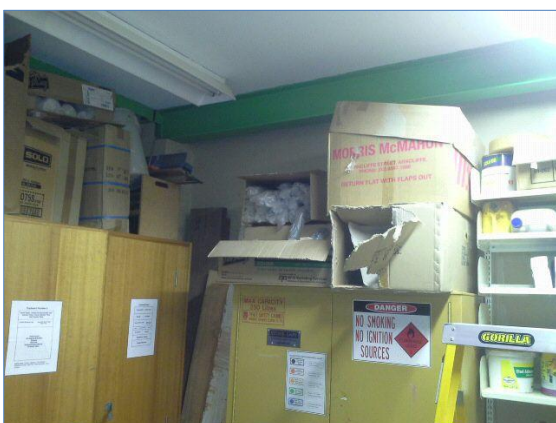
Photograph 09: Room 3.3 Store – Fibre cement north wall lining and infill panels behind flammable cupboard

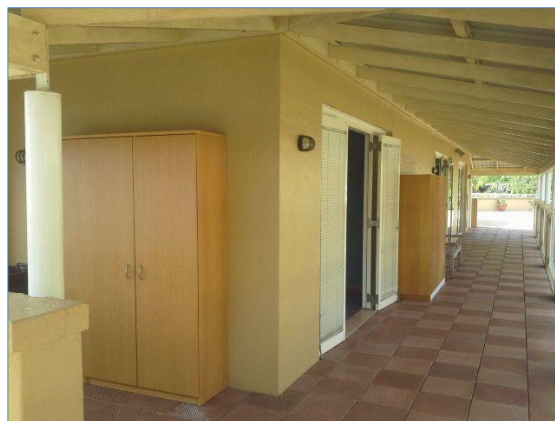
Photograph 04: External - Cream paint to walls

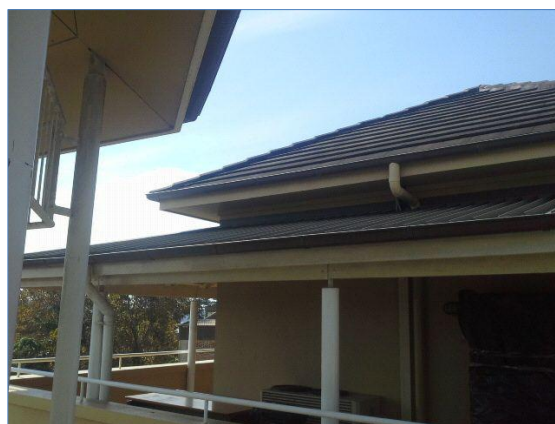
Photograph 05: Level 4 perimeter - Fibre cement eave lining

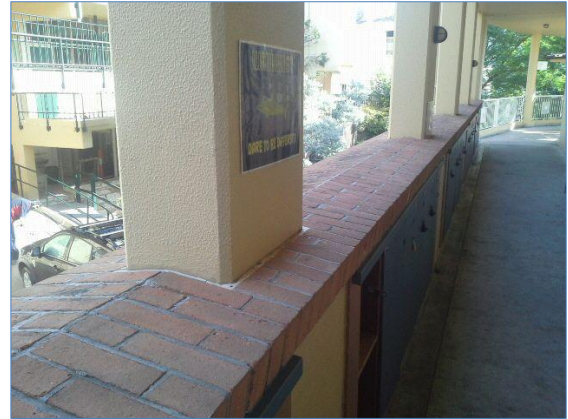
Photograph 10: Level 03 walkway - Expansion gap mastic surrounding columns entering into brick lockers

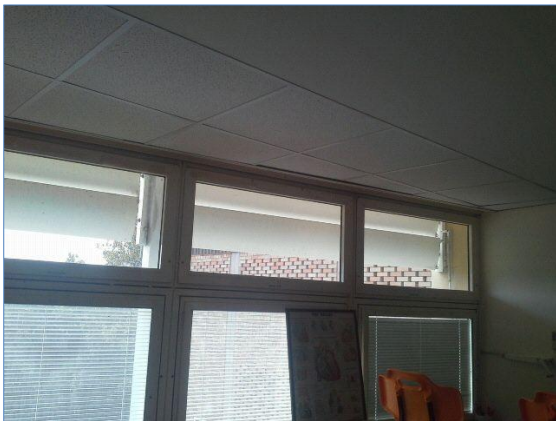
Photograph 08: Level 03 Room 3.12 - SMF containing suspended ceiling tiles

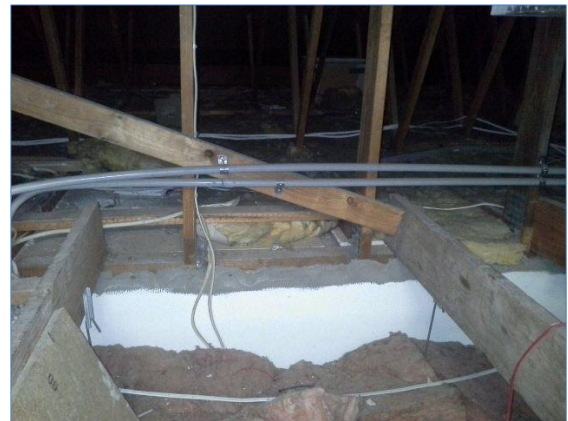
Photograph 11: Level 03 Office of the headmaster wing - SMF insulating batts throughout roof space

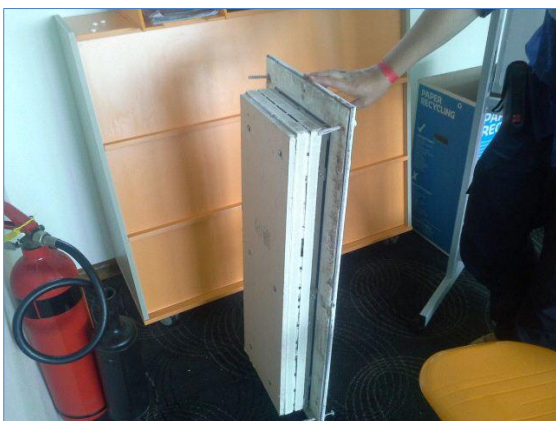
Photograph 09: Level 03 Room 3.11 - SMF containing rise hatch cover

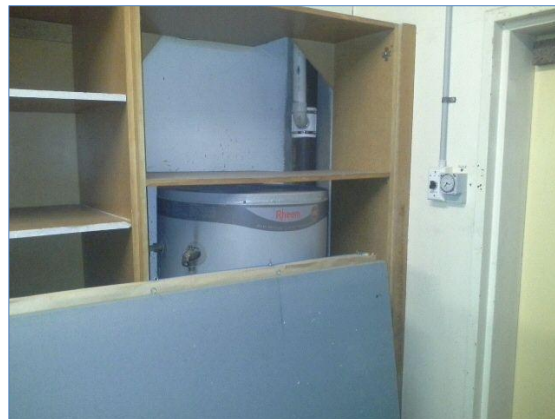
Photograph 16: Level 1 Art Store Room 1.2 - SMF insulation within hot water unit in south west corner of room

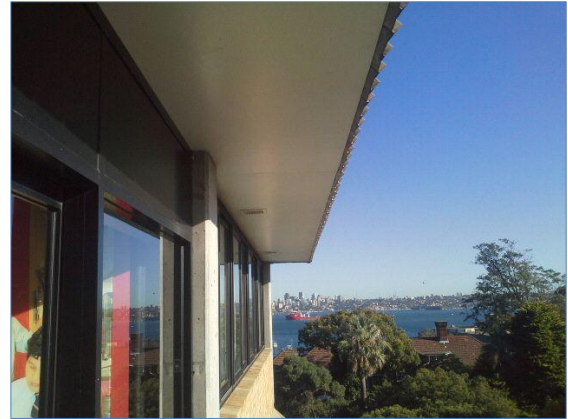
Photograph 04: Level 5 east elevation – Fibre cement eave lining

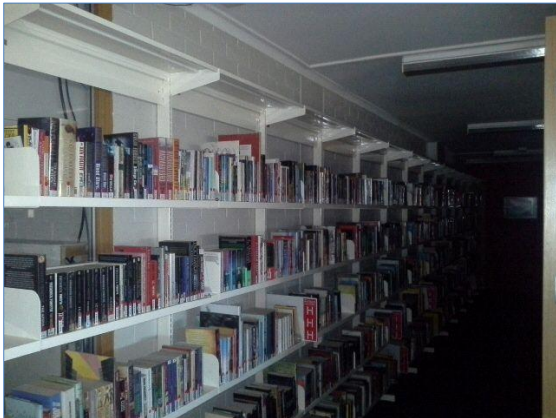
Photograph 02: Internal white paint to walls and columns

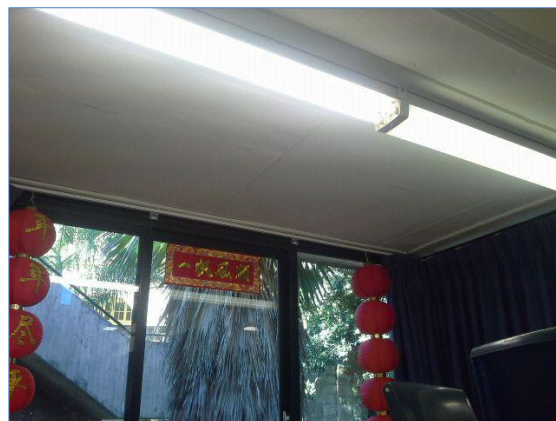
Photograph 10: Room 4.13 - Asbestos cement south ceiling lining

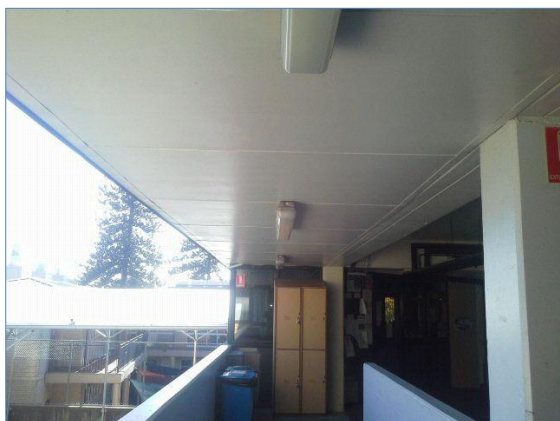
Photograph 08: Corridor 4.26 - Fibre cement ceiling lining

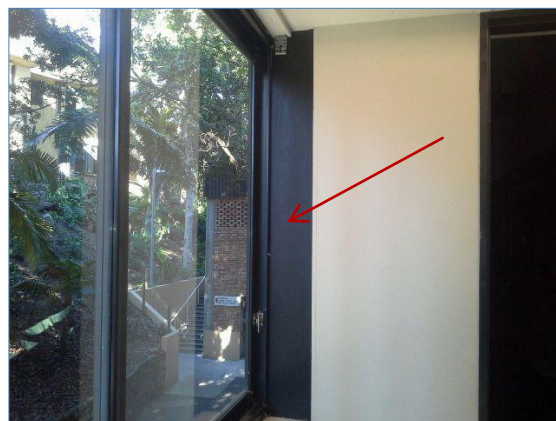
Photograph 11: Rooms 4.6 & 4.7 - Asbestos infill panel extending partition wall to window

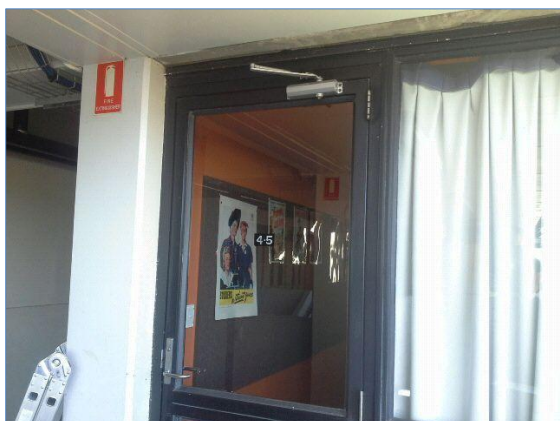
Photograph 09: Level 4 throughout - Black putty between window/door frame and concrete columns/soffit

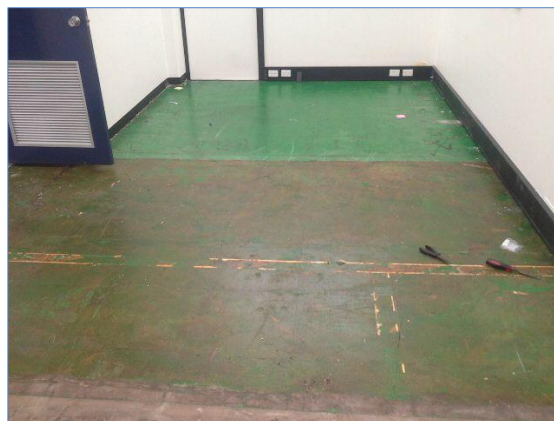
Photograph 22: Level 2 room 2.17 - Asbestos vinyl floor tiles

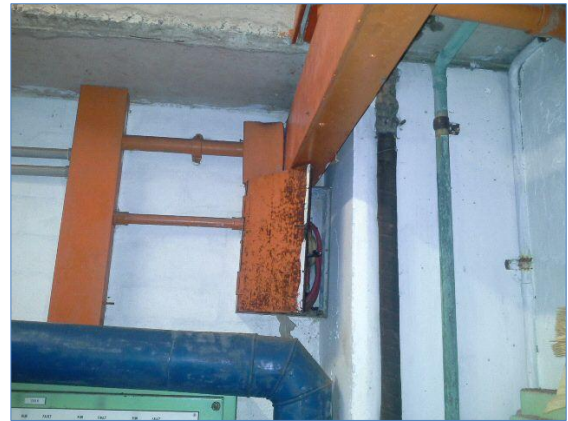
Photograph 28: Level 1 pool treatment room –
Asbestos containing bituminous electrical
cabinet door in North West corner

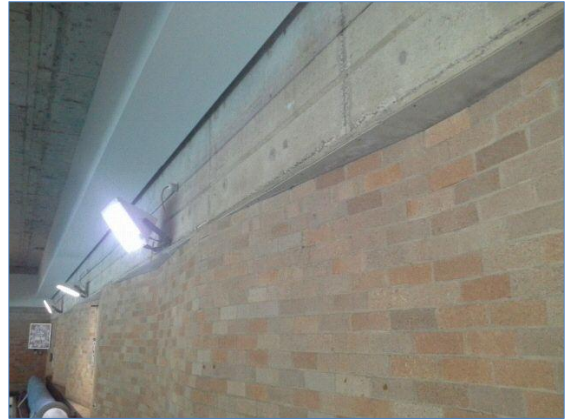
Photograph 33: Level 1 Swimming pool 1.31 - Asbestos cement form work to south concrete upper wall above wavy brick wall

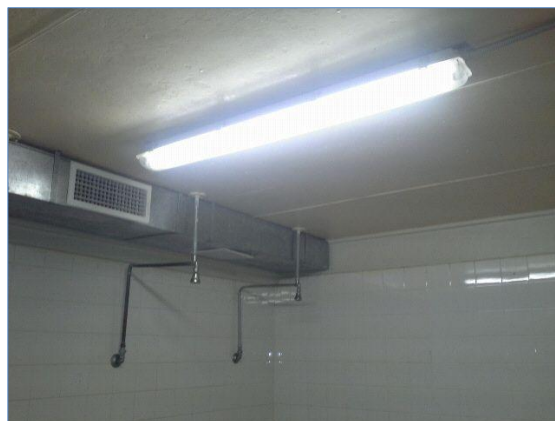
Photograph 04: Level 1 shower G1.11 - Asbestos cement ceiling lining

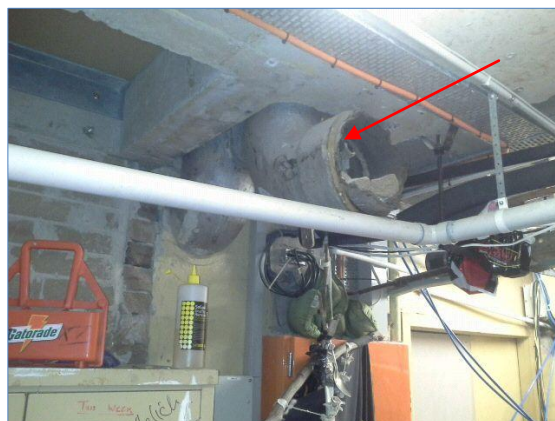
Photograph 05: Level 1 Store MB1.7 - Asbestos pipe

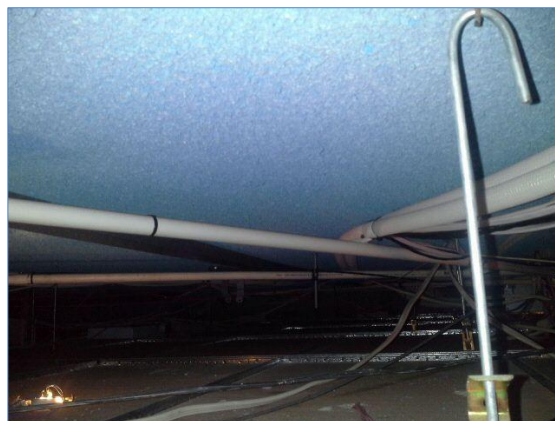
Photograph 16: Level 2 corridor - Vermiculite coating to soffit above suspended ceiling

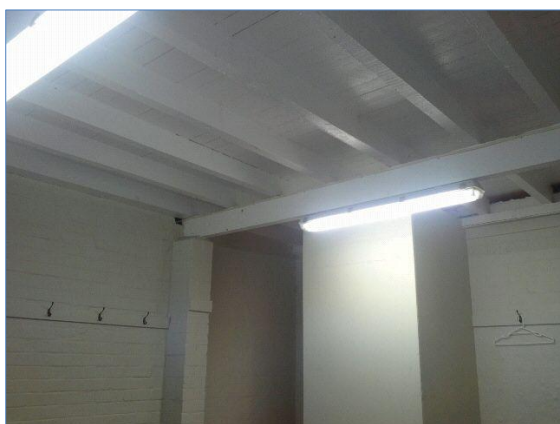
Photograph 14: Level 1 - White paint to timber ceilings and window and door frames

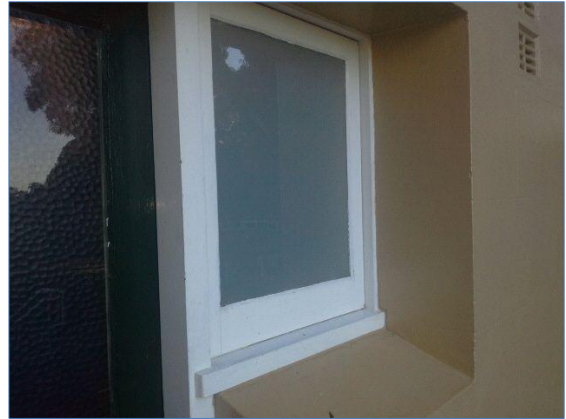
Photograph 21: Exterior - Window putty

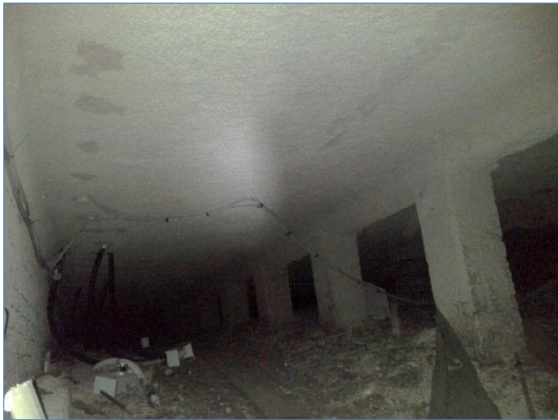
Photograph 02: Basement under floor space - Vermiculite coating to ceiling

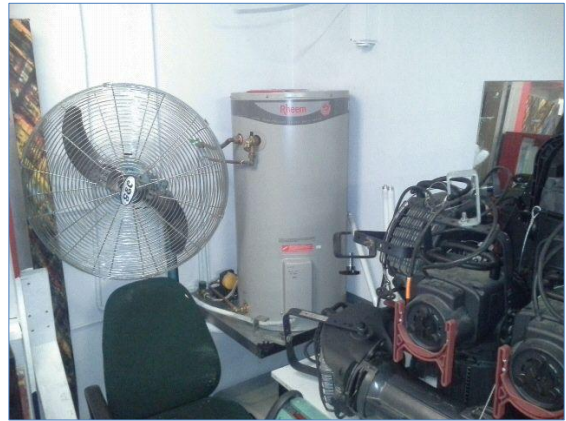
Photograph 05: Basement store 1.9 -- SMF insulation within hot water unit in north east corner

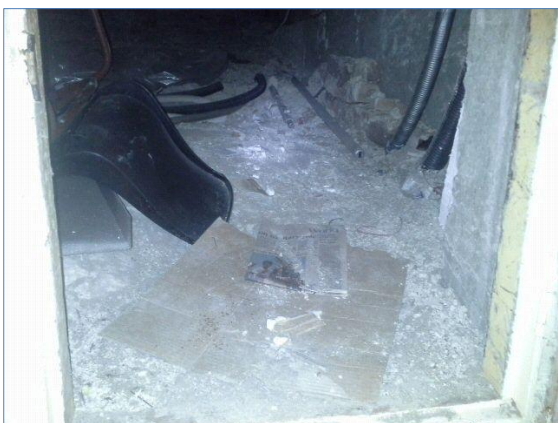
Photograph 03: Basement under floor space - Vermiculite debris throughout area

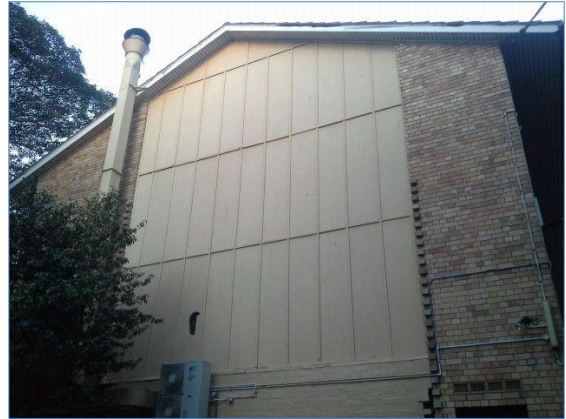
Photograph 10: West elevation - Fibre cement wall cladding

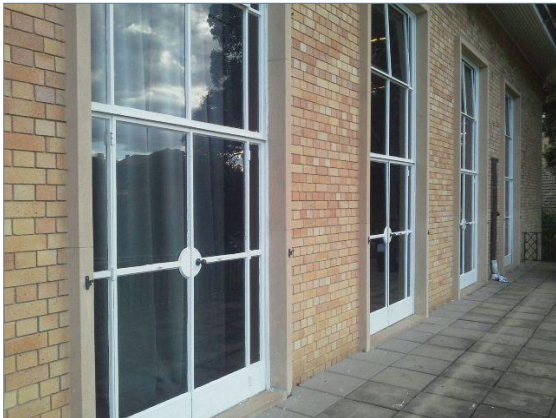
Photograph 08: Ground level external - White paint to doors and frames

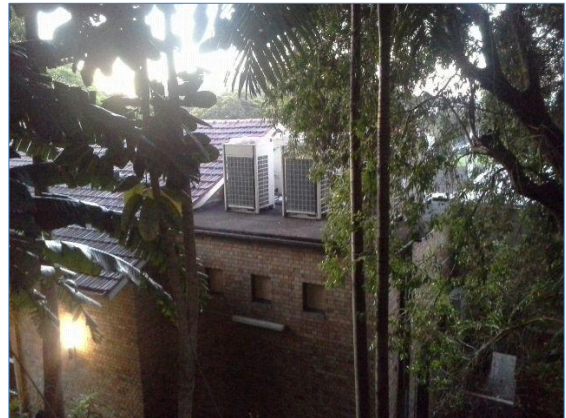
Photograph 11: East wing roof - Presumed asbestos roofing membrane

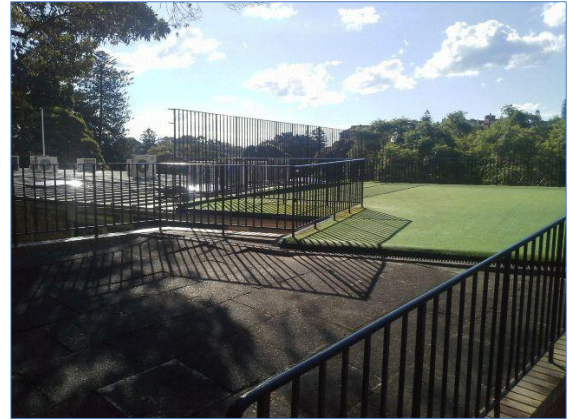
Photograph 04: External perimeter - Black paint to hand rails and balustrades

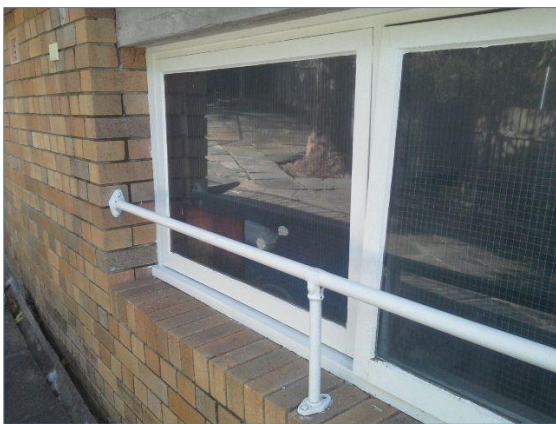
Photograph 02: External south elevation - Putty and white paint to windows

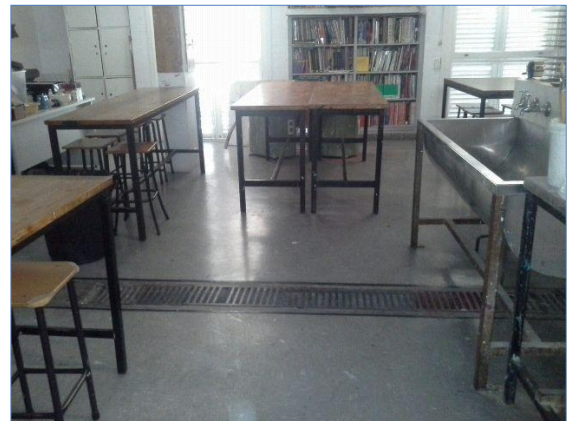
Photograph 05: Studio 3 - 2.5 - Grey vinyl floor tiles

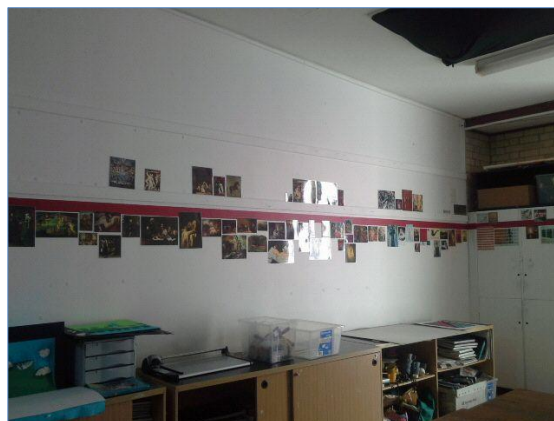
Photograph 10: Studio 2 - 2.4 - Fibre cement west wall lining

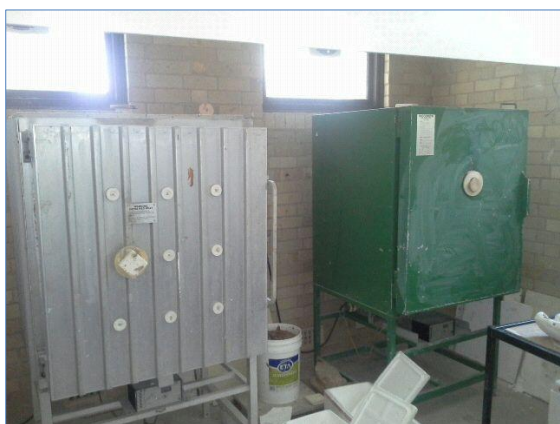
Photograph 08: Kiln room 2.14 - SMF insulated kilns

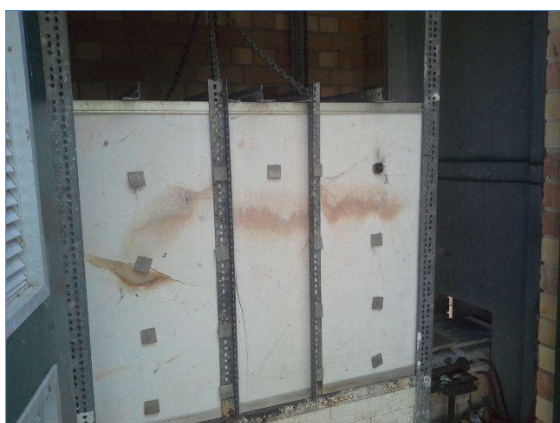
Photograph 09: Kiln room 2.19 - SMF insulation within Kiln

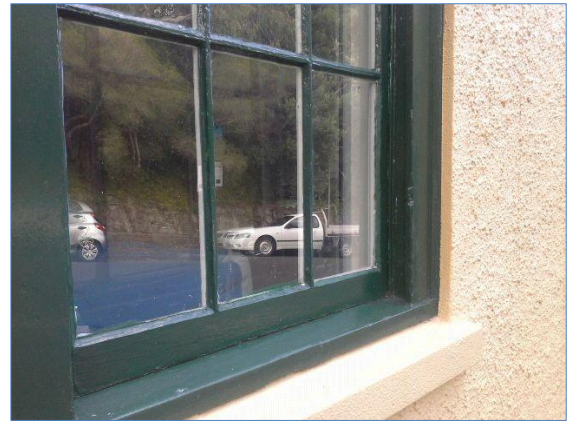
Photograph 04: External perimeter - putty to windows

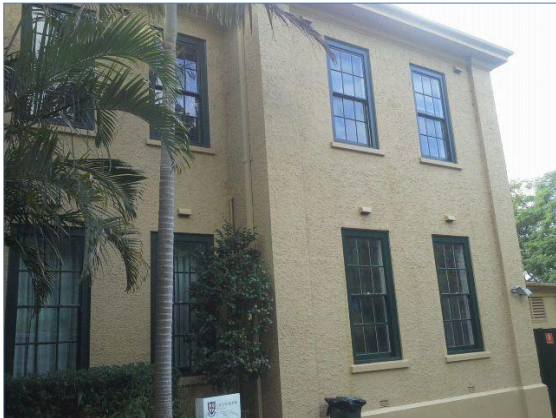
Photograph 02: External perimeter - Cream paint to walls and green paint to doors, frames and windows

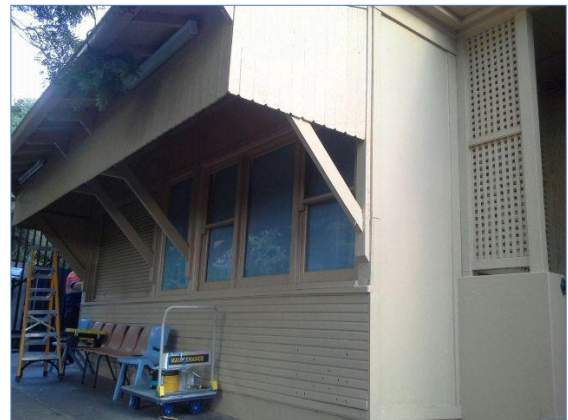
Photograph 05: East elevation - Fibre cement cladding surrounding cleaner's room 1.7

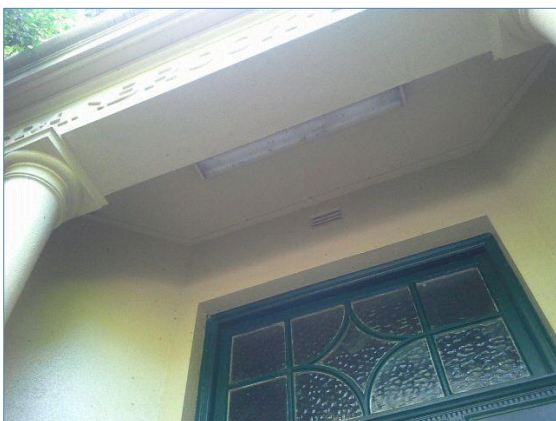
Photograph 03: South entrance - Asbestos cement awning lining

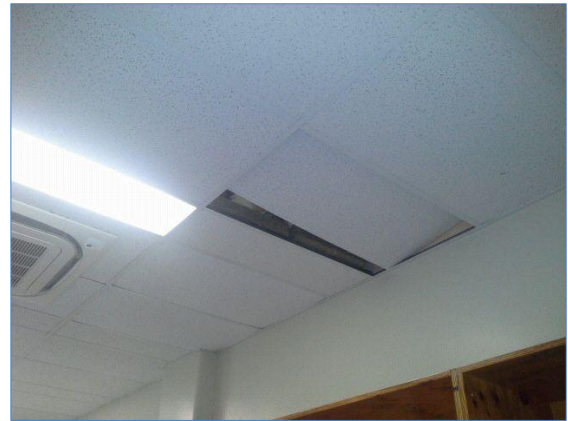
Photograph 10: Level 1 room 2.7 - SMF insulating batts above SMF containing suspended ceiling tiles

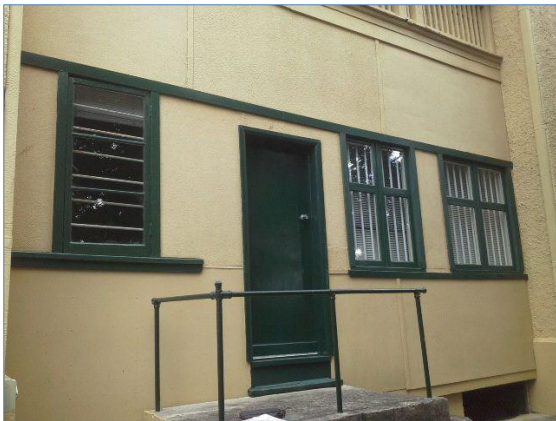
Photograph 08: North elevation entrance to room 1.3 - Asbestos cement wall cladding

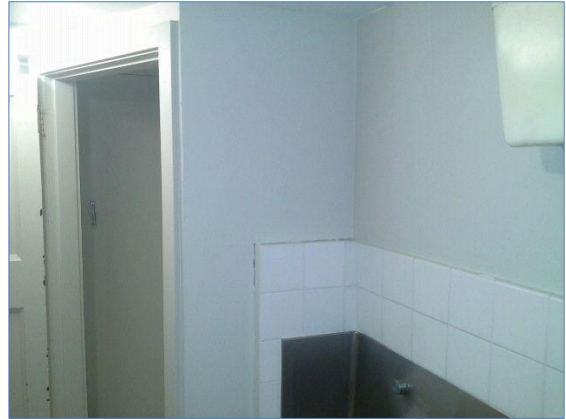
Photograph 15: Ground floor male staff 1.9 - Fibre cement wall lining south of urinal

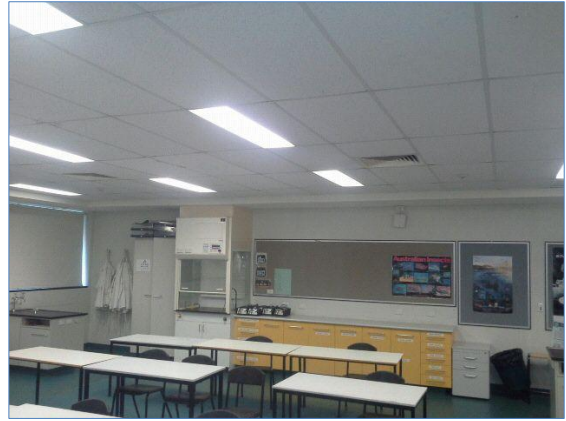
Photograph 03: Throughout SMF suspended ceiling tiles

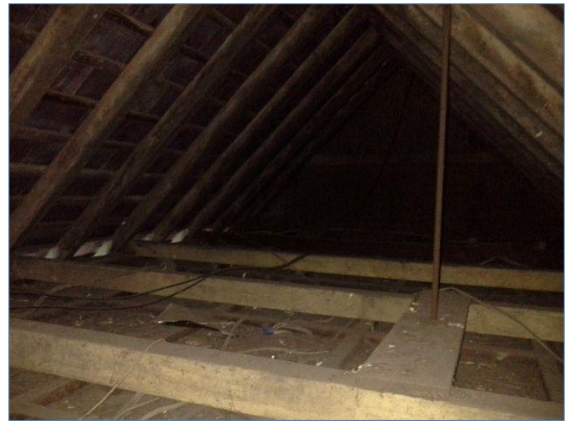
Photograph 03: Canteen ceiling space - Asbestos contaminated dust

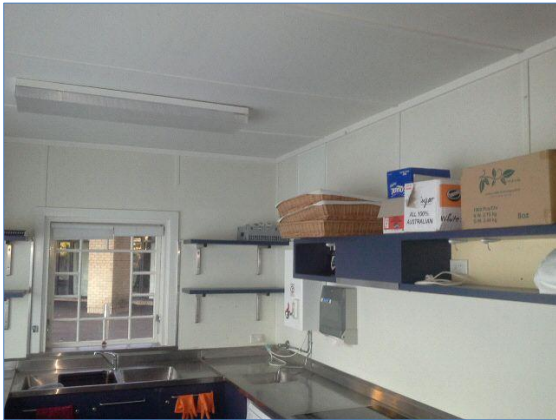
Photograph 02: Canteen - Asbestos cement wall and ceiling lining

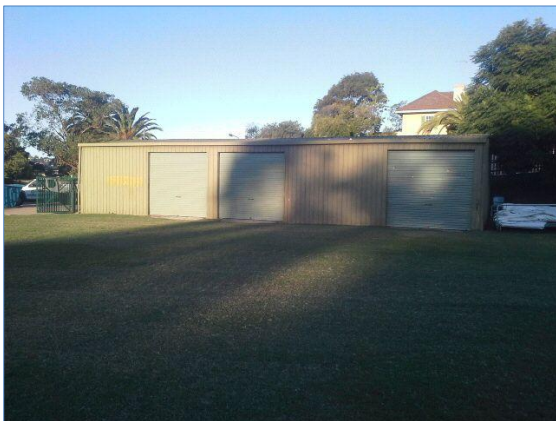
Photograph 02: Grounds keepers shed

No hazmat identified at time of survey
