Stormwater Channel off Lilyfield Road

Photographic Archival Recording and Salvage Report

Prepared for John Holland CPB Joint Venture (JHCPBJV)

March 2021 - FINAL

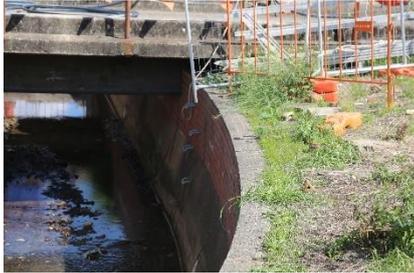
007_LR_SC_2019	SW	Base of the channel filled with sediment.

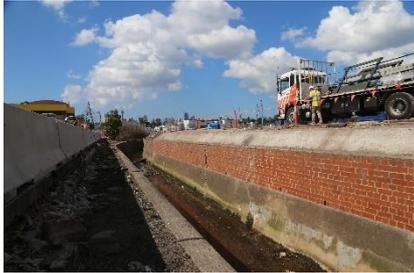
012_LR_SC_2019	SE	Drainage inlet at the base of the brick and concrete walls.

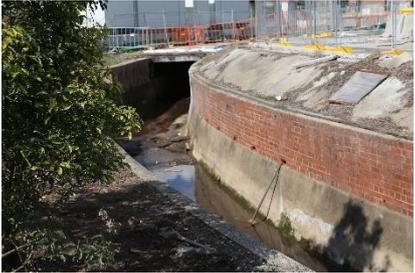
027_LR_SC_2019	SE	Timber beam joist with concrete slab capping.

The only items of historic fabric within the stormwater Channel off Lilyfield Road are the large hardwood timber beams incorporated into the channel as joists or as upper sections of the channel wall. It is recommended that this material is salvaged, and the processes described in section 8.2 and 8.3 of this report are followed to ensure the proper treatment of this material.

- All timbers should be removed carefully to ensure its condition is not compromised. In particular, where it will maintain the integrity of the beam, each timber should be disconnected or be de-bonded from the stormwater channel.
- A Heritage Advisor should be notified if other potential original (and salvageable) building fabric, which has not been identified in the salvage report, is identified during works. A photograph of this item should be emailed to the Heritage Advisor for assessment of its salvage potential prior to disposal.
- Timber beams that have detritus from the Lilyfield road water channel attached or adhered to it should be washed with water.

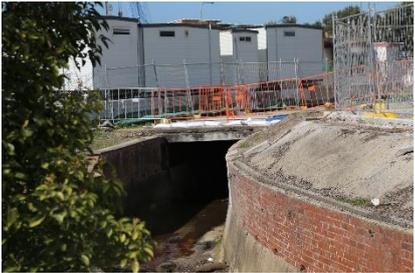
028_LR_SC_2019	W	Timber beam joist with concrete slab capping.

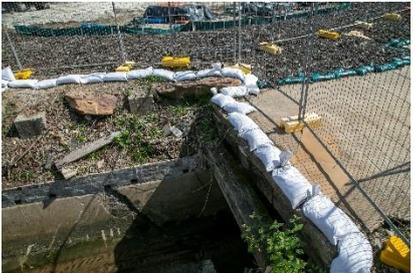
029_LR_SC_2019	SW	Exposed section of the channel showing timber beam joists. Reinforced concrete headwall on the left hand side.

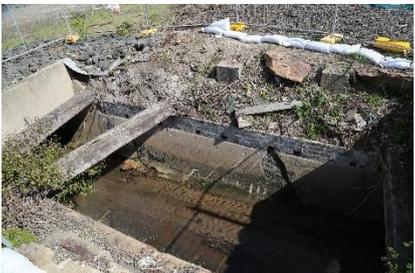
Image name	Direction	Details	Thumbnail
030_LR_SC_2019	SW	Timber beam joists and concrete headwall.

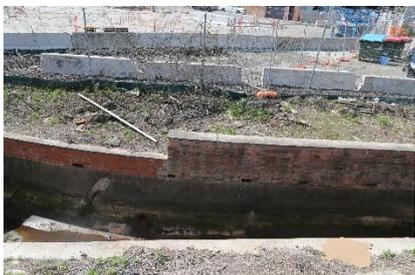
Image name	Direction	Details	Thumbnail
035_LR_SC_2019	E	Stormwater Channel portal with timber beam joist. Note the timber beams used as channel wall.

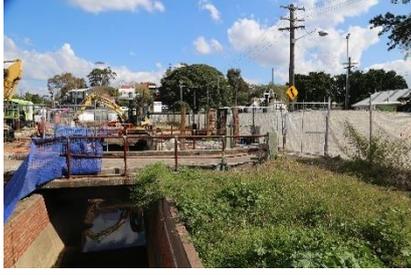
Image name	Direction	Details	Thumbnail
040_LR_SC_2019	SW	Reinforced concrete bridge with steel and concrete pipe and socket fence.

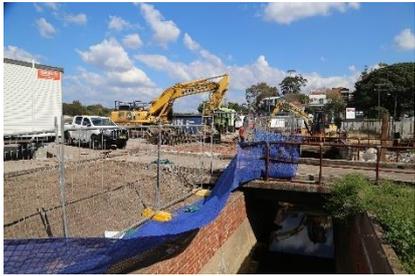
041_LR_SC_2019	SW	Reinforced concrete bridge mounted on steel joist.

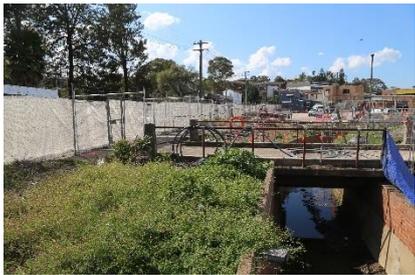
048_LR_SC_2019	NE	detail of reinforced concrete decking mounted on steel joist.

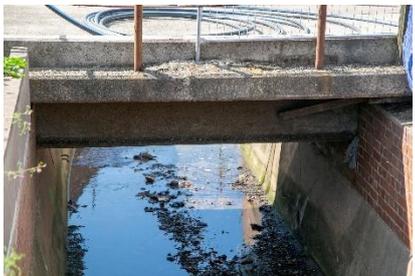
049_LR_SC_2019	SW	Sandstone retaining wall above the stormwater channel. The retaining wall was part of the display for the former building supply centre.

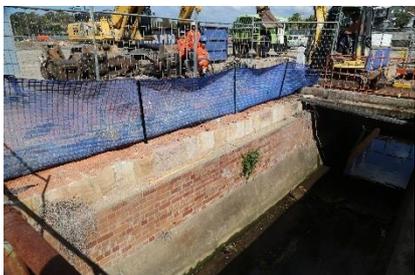
Image name	Direction	Details	Thumbnail
050_LR_SC_2019	SW	Sandstone retaining wall above the stormwater channel. The retaining wall was part of the display for the former building supply centre.

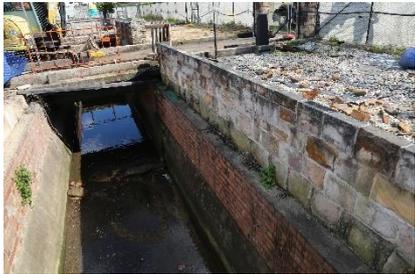
051_LR_SC_2019	SW	Detail of concrete inlet drain.

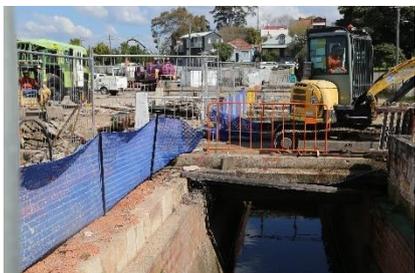
Image name	Direction	Details	Thumbnail
055_LR_SC_2019	NW	Curbing on the reinforced concrete deck.

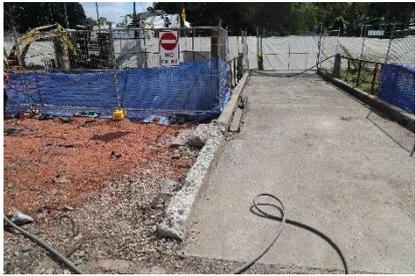
056_LR_SC_2019	NW	Curbing on the reinforced concrete deck.

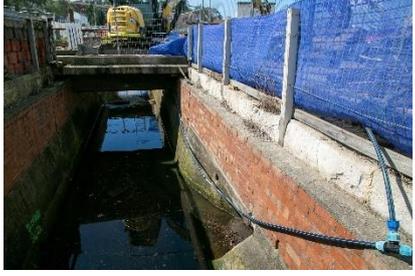
059_LR_SC_2019	NE	Reinforced concrete decking mounted on a steel joist.

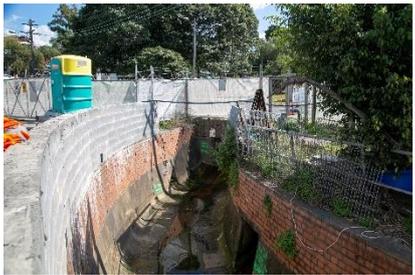
068_LR_SC_2019	W	Detail of the concrete and sandstone masonry headwall.

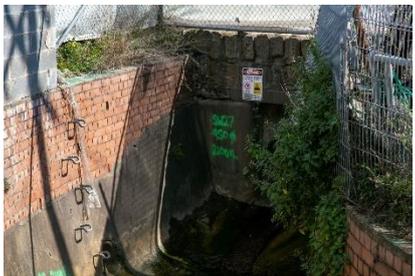
069_LR_SC_2019	W	Concrete and sandstone masonry headwall.

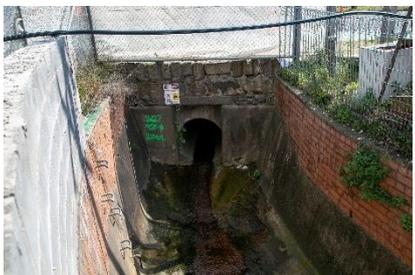
Image name	Direction	Details	Thumbnail
070_LR_SC_2019	NE	Stormwater channel.
